HISTORIC AND DESIGN REVIEW COMMISSION

HDRC CASE NO: 2024-375
ADDRESS: 1002 KAMPMANN BLVD
LEGAL DESCRIPTION: NCB 7011 BLK LOT 9 & W 48 FT OF 8
ZONING: RM-4, H
CITY COUNCIL DIST.: 7
DISTRICT: Monticello Park Historic District
APPLICANT: Adan Ochoa/AO Design, LLC
OWNER: RYAN NATASHA
TYPE OF WORK: Demolition of a rear accessory structure, construction of a 2-story, rear accessory structure
APPLICATION RECEIVED: November 01, 2024 (December 1, 2024, 30-day Demolition Hold)
60-DAY REVIEW: December 31, 2024
CASE MANAGER: Edward Hall

**ENGINEERING INVESTIGATION OF A RESIDENCE
1002 KAMPMANN BOULEVARD
SAN ANTONIO, TEXAS**

On June 12, 2024, we received your assignment, requesting an engineering examination to evaluate the cause and extent of the reported damage to a detached garage located at 1002 Kampmann Boulevard in San Antonio, Texas, associated with the reported tree collapse and impact to the building on April 10, 2024.

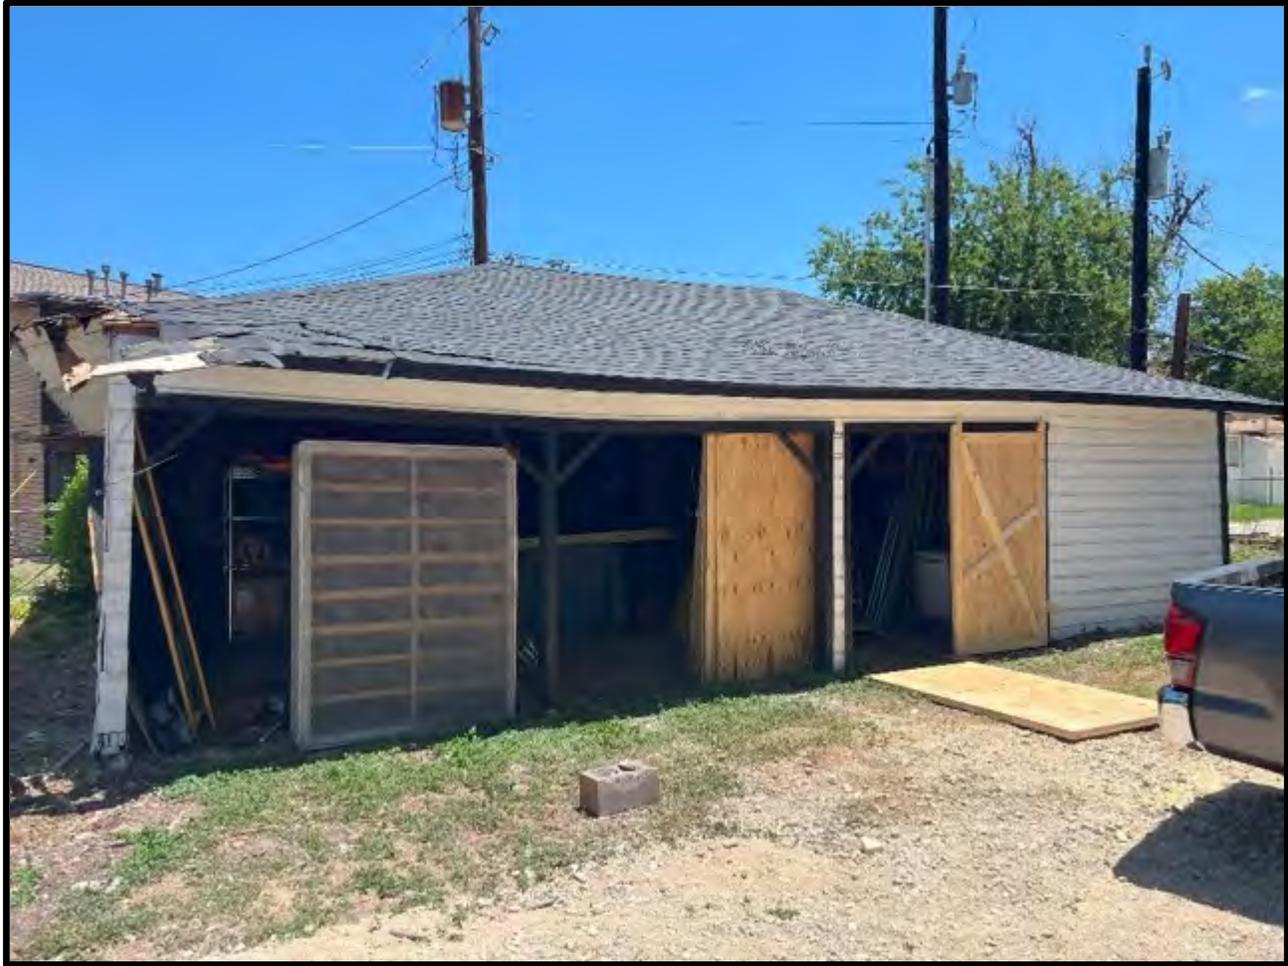
PHOTOGRAPH NO. 1

View of the front (south) elevation of the detached garage building at the Ryan residence, located at 1002 Kampmann Boulevard in San Antonio, Texas.

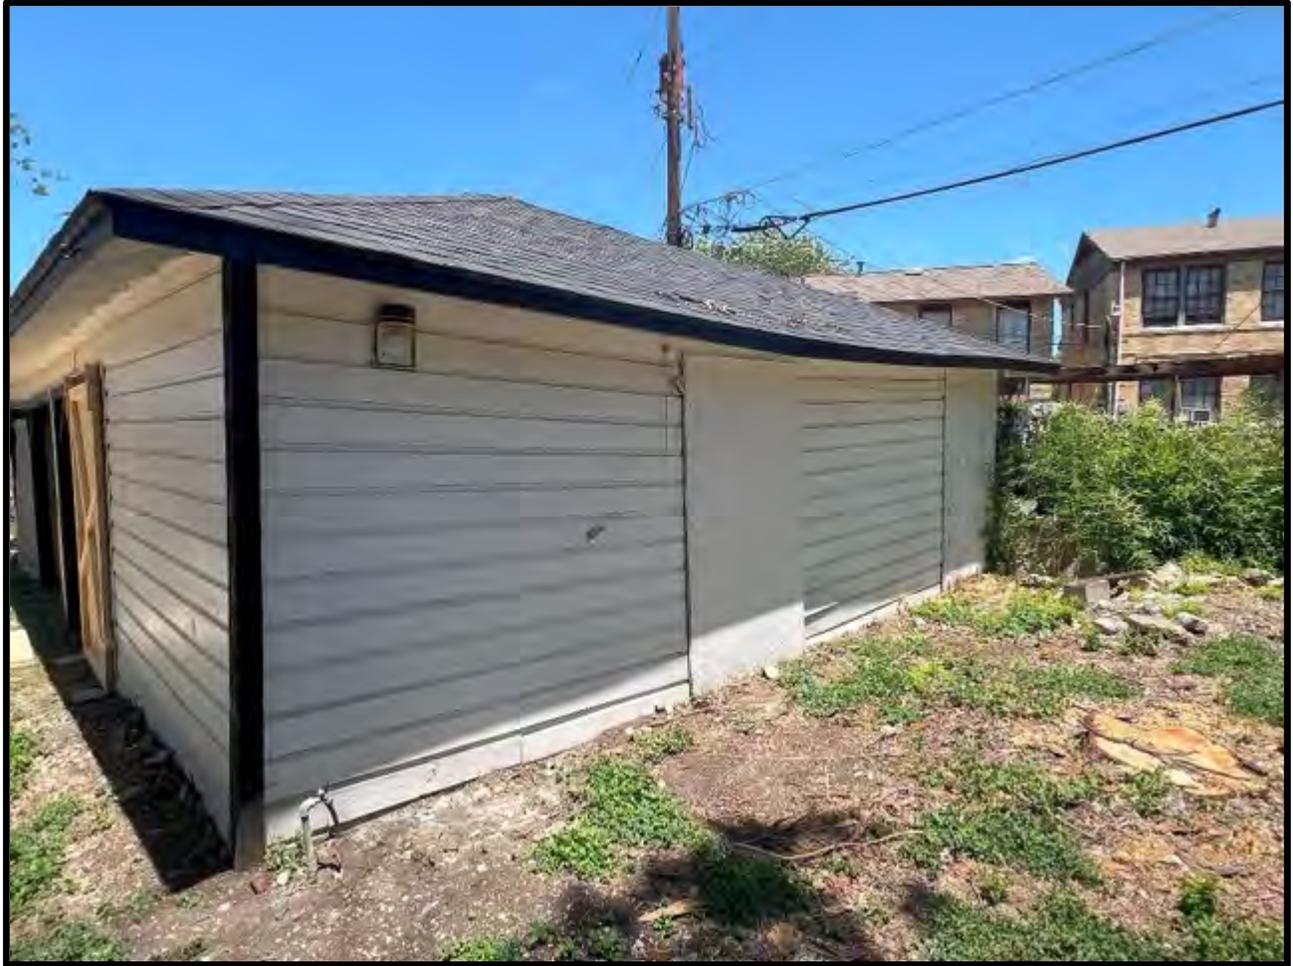
PHOTOGRAPH NO. 2

View of the right side (east) elevation of the detached garage building.

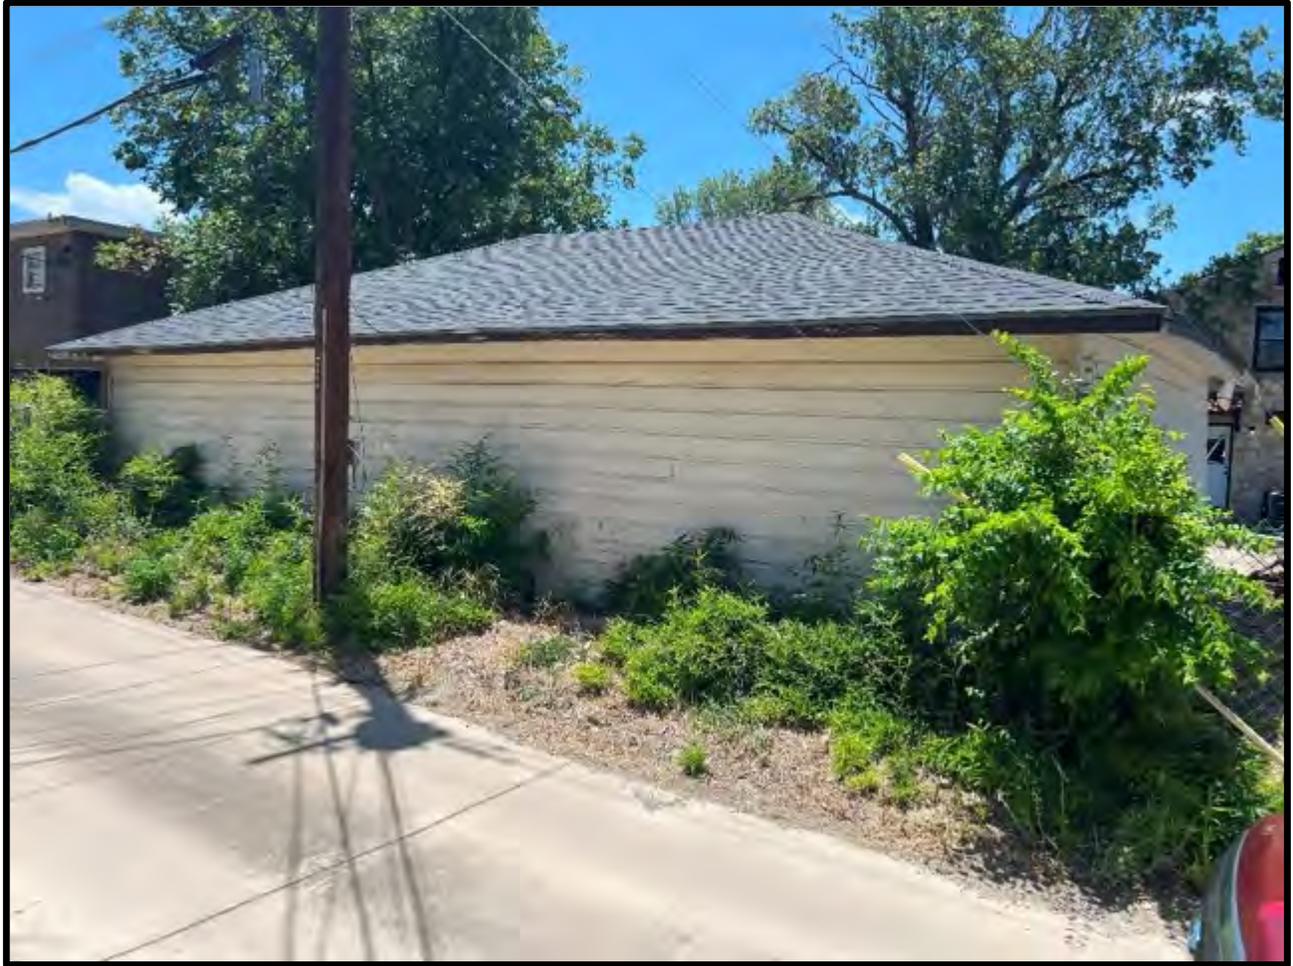
PHOTOGRAPH NO. 3

View of the rear (north) elevation of the detached garage building.

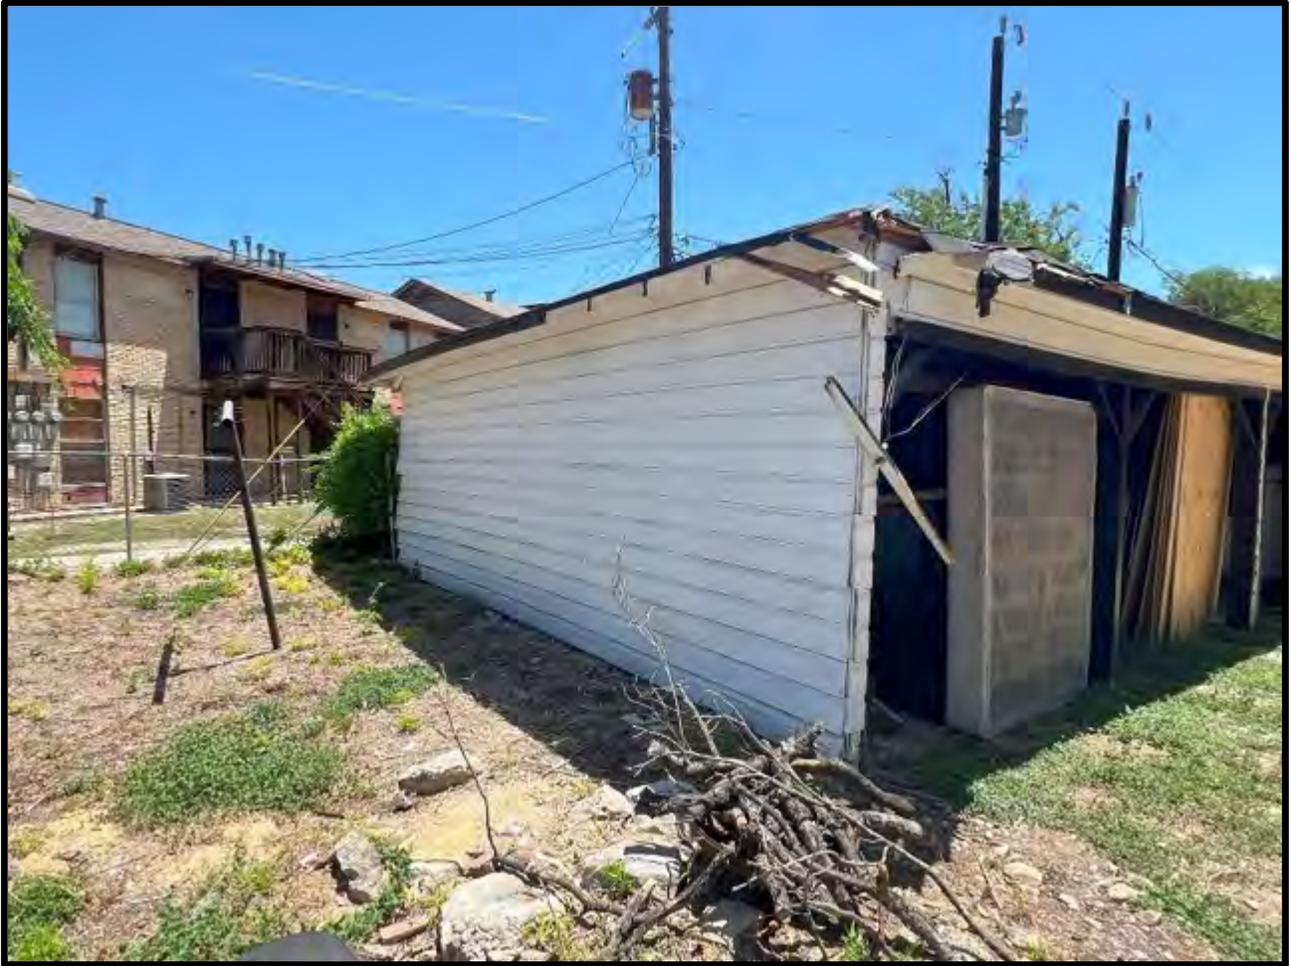
PHOTOGRAPH NO. 4

View of the left side (west) of the detached garage building.

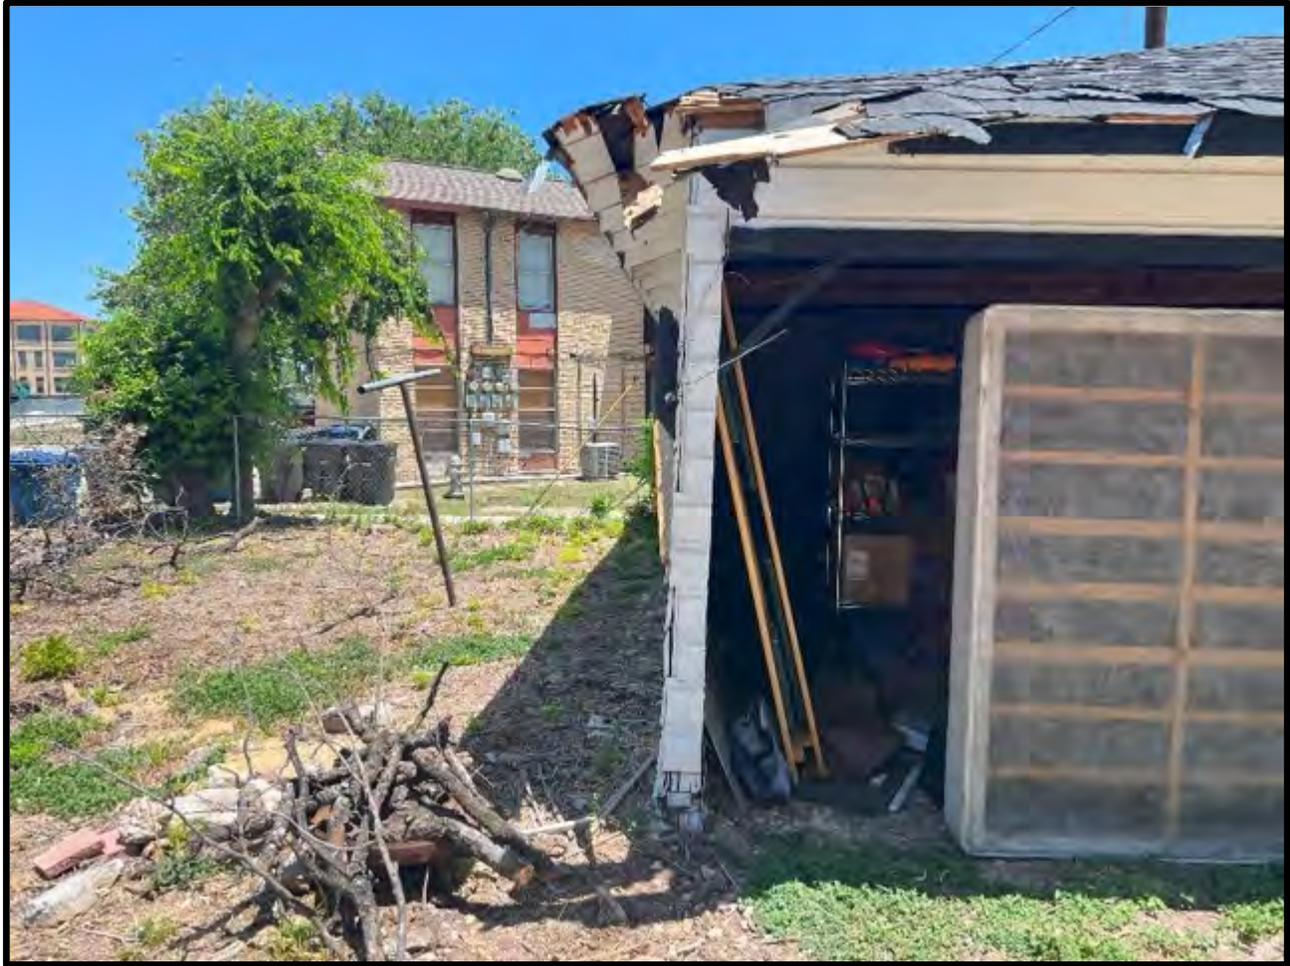
PHOTOGRAPH NO. 5

- Impact damage was evident at the southwest corner of the detached garage building. Deformations and structural distortions were observed on the framing members adjacent to the impact area and along the garage doors (wall openings) at the front of the building. I measured deflection deformation on a header beam of a door opening of up to two (2) inches. Several bracing members were detached and/or displaced from the columns. I also noted a large separation of a header beam from the column post at the southwest area of the detached garage building. I measured the walls and columns for plumbness, and portions of the columns and walls along the front (south) were substantially out of plumb along the assumed direction of the impact area. Portions of the west wall were deformed and out of plumb. Damage to the roof covering was evident at the southwest corner of the detached garage building. The roof framing consisted of 2x4 joists nailed to ridge beams with no collar ties and spaced above sixteen (16) inches from centers. Ceiling joists were present with king posts **(RE: Photograph Nos. 1 – 16)**.

View of the impact area at the southwest corner of the detached garage building.

- Removal and replacement of the entire building.

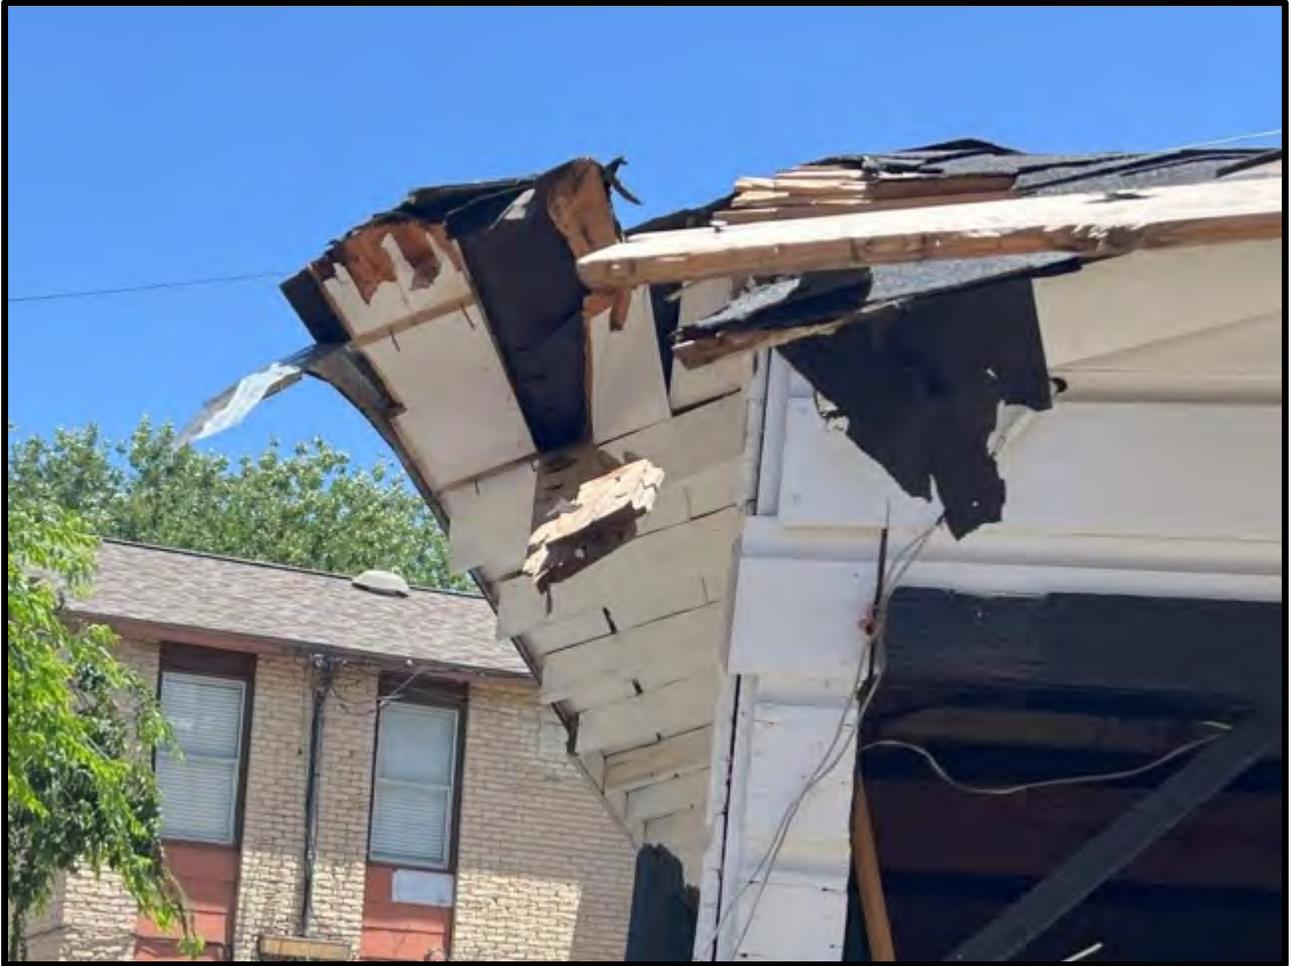
PHOTOGRAPH NO. 6

Close-up view of the impact area at the southwest corner of the detached garage building.

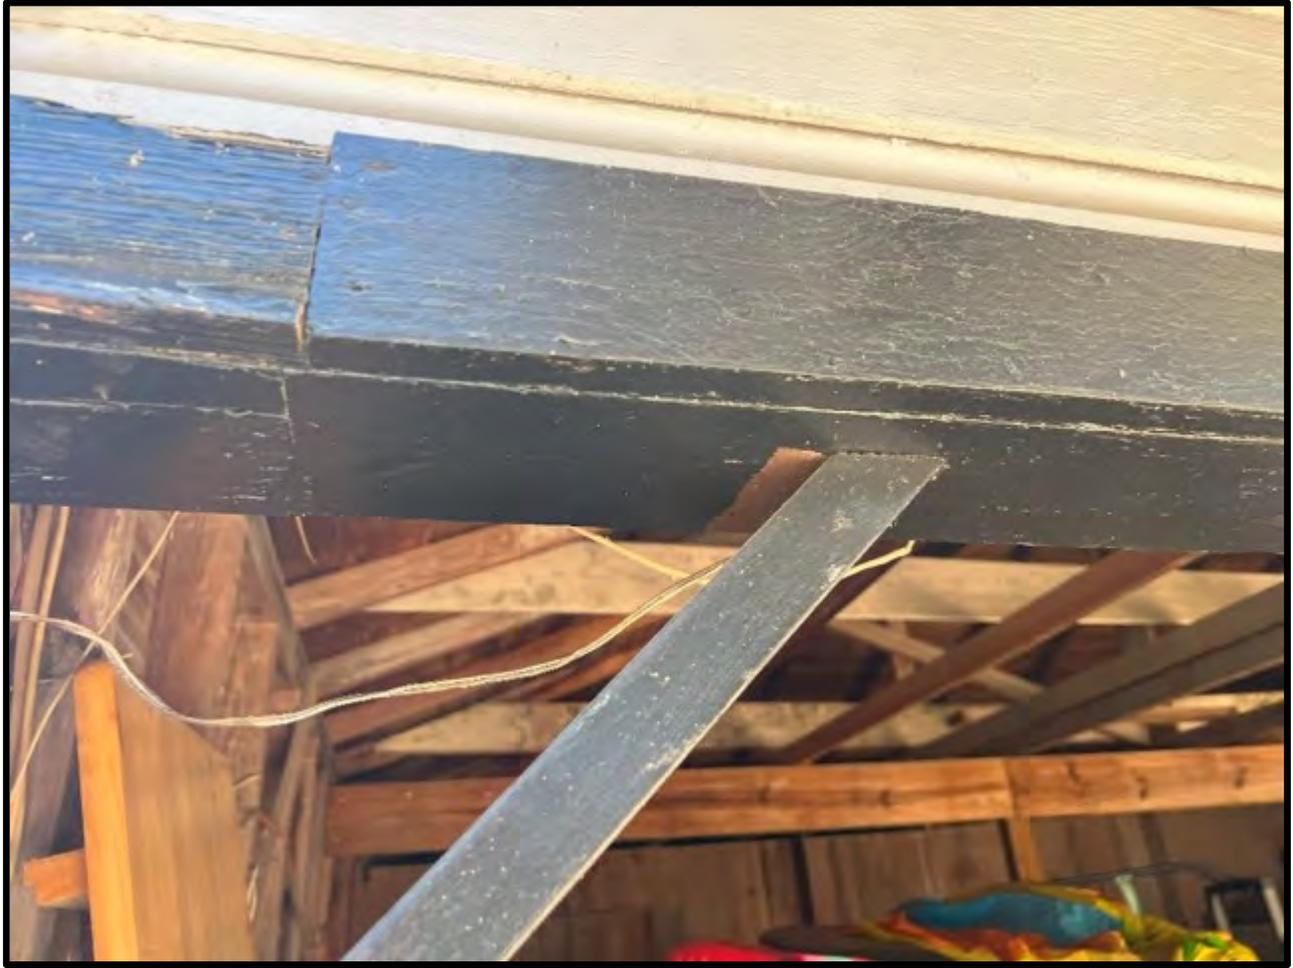
PHOTOGRAPH NO. 7

View of displaced bracing member at the front (south) of the detached garage building.

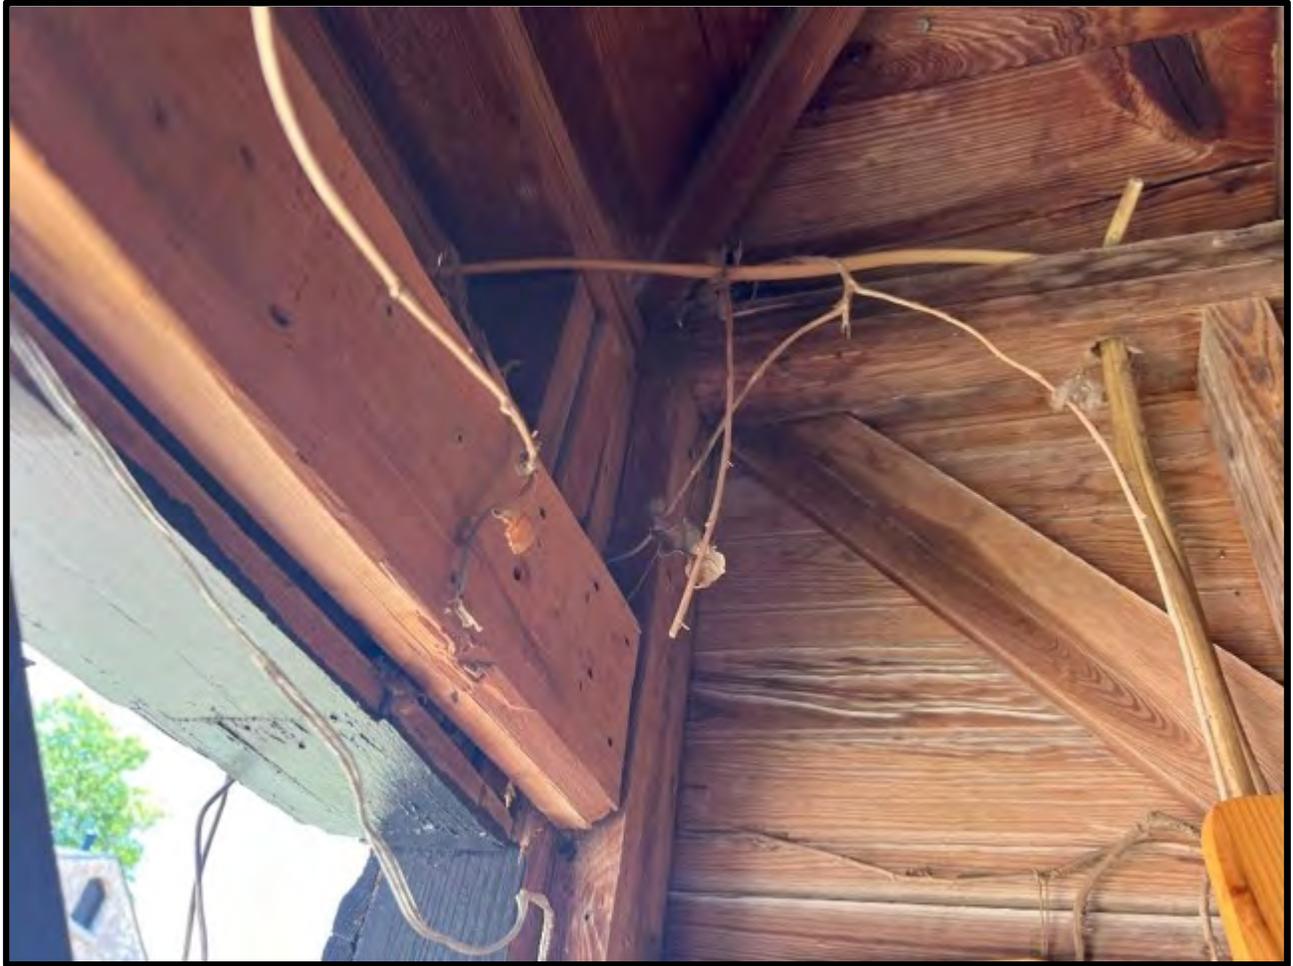
PHOTOGRAPH NO. 8

View of a displaced header (beam) from a column post at the southwest corner of the detached garage building.

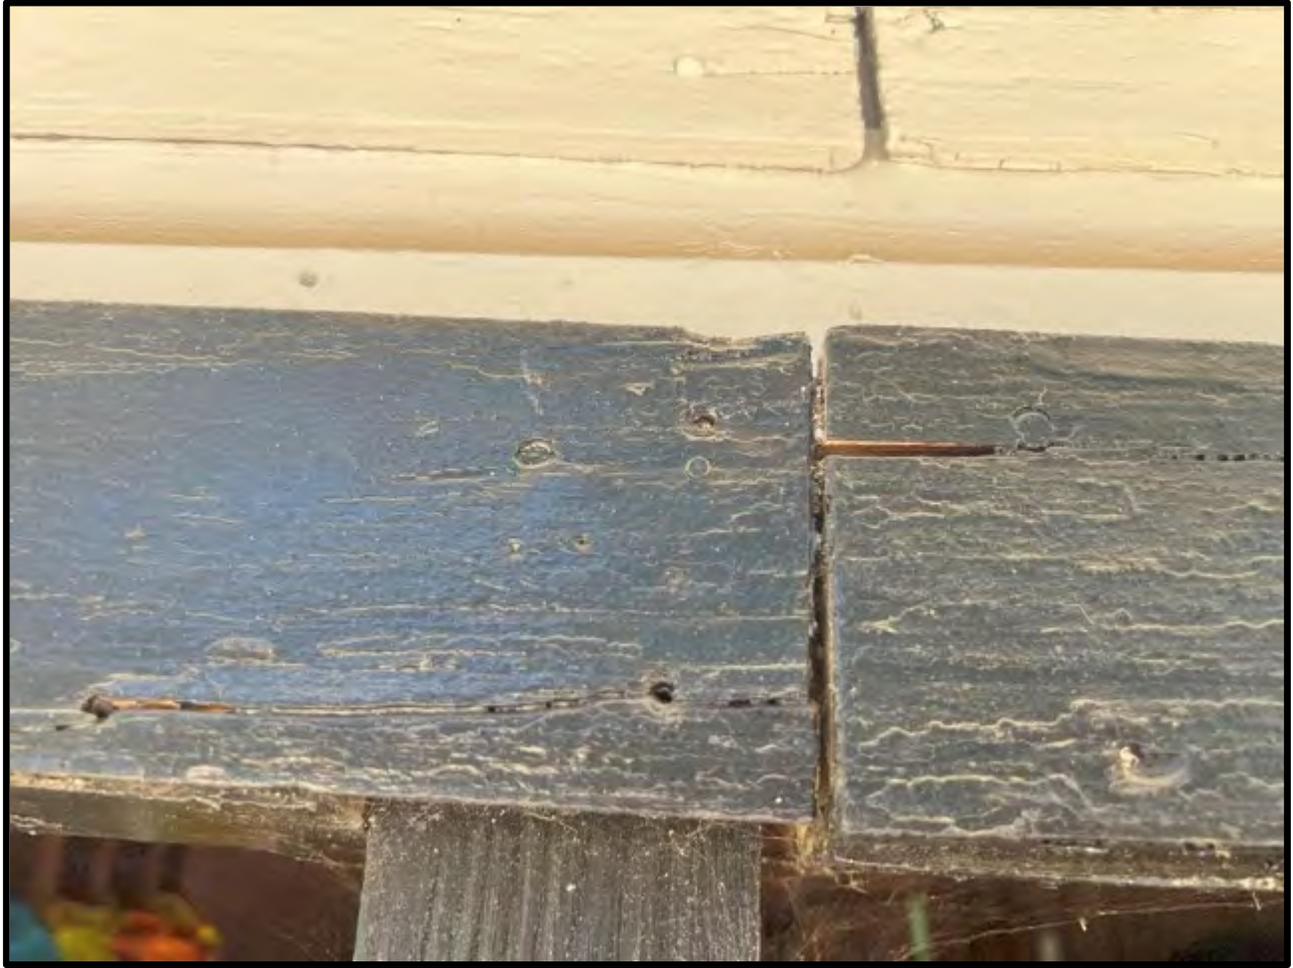
PHOTOGRAPH NO. 9

View of split cracks on the trims at the front (south) of the detached garage building.

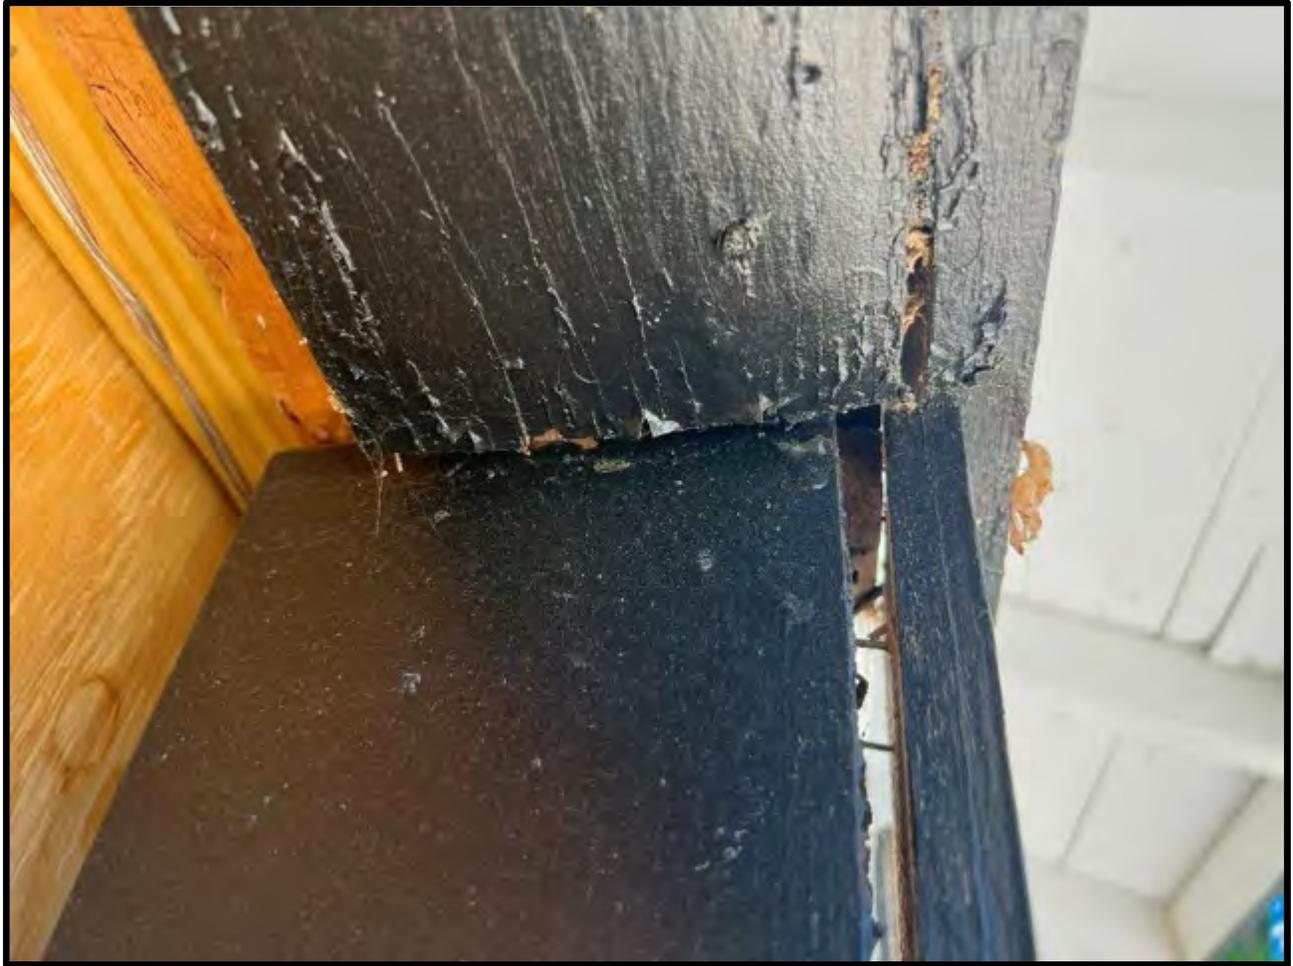
PHOTOGRAPH NO. 10

View of displaced frame and trim at the front (south) of the detached garage building.

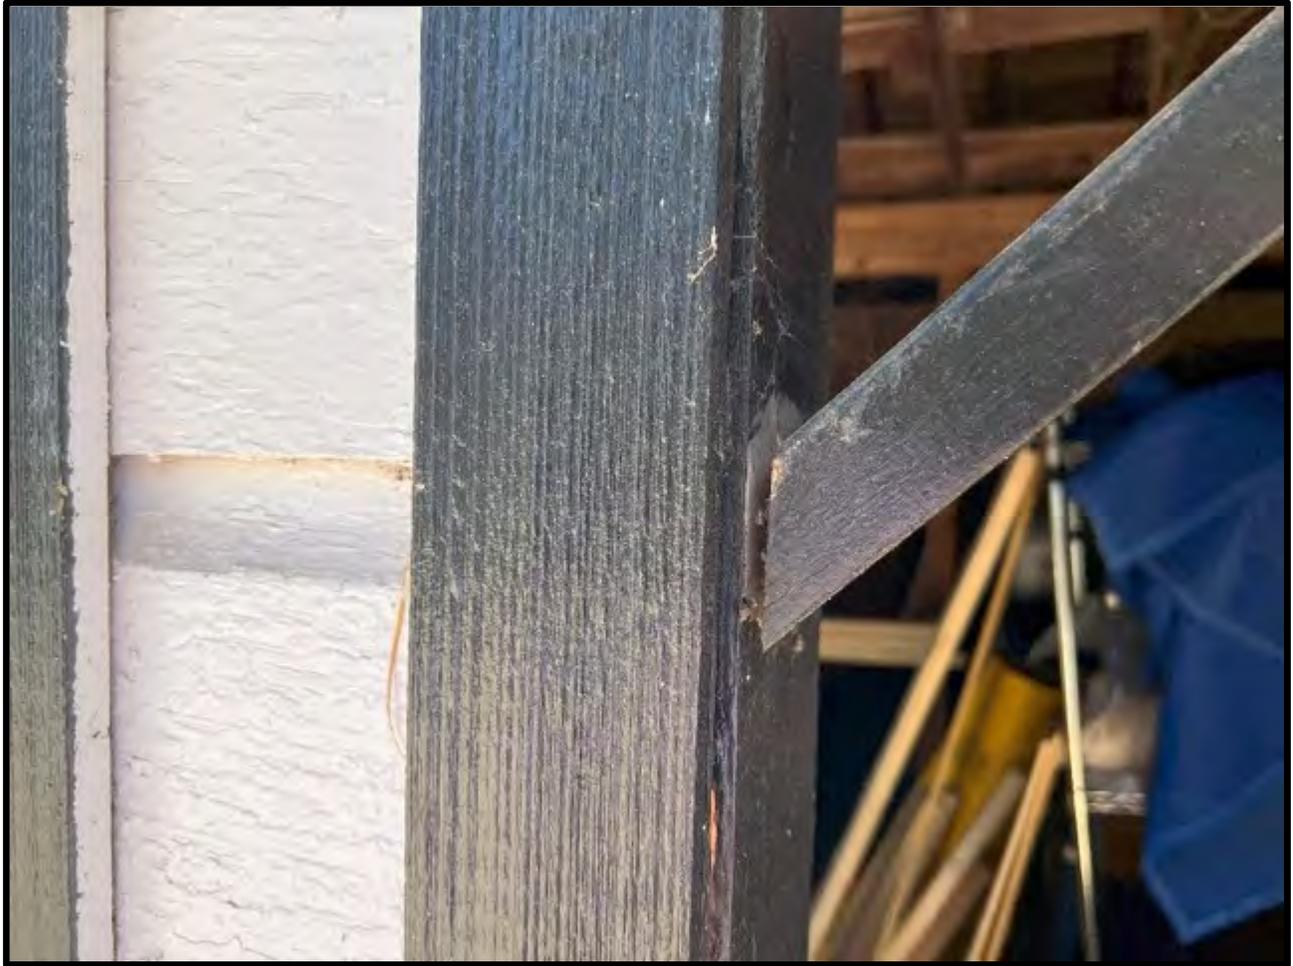
PHOTOGRAPH NO. 11

View of displaced bracing member at the front (south) of the detached garage building.

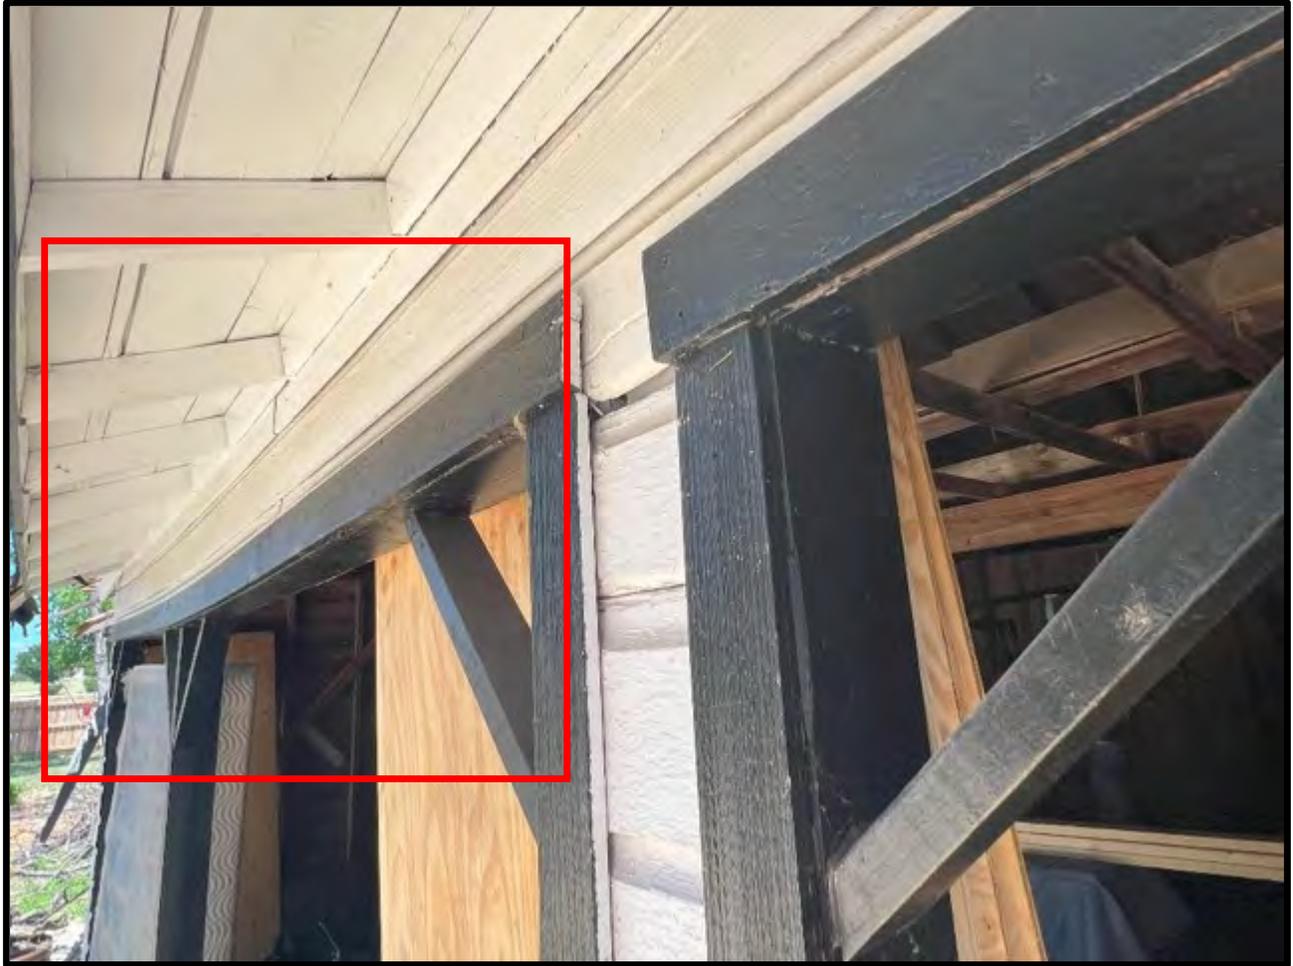
PHOTOGRAPH NO. 12

View of a deflection deformation of the opening header at the front (south) of the detached garage building. Note partially detached trim boards.

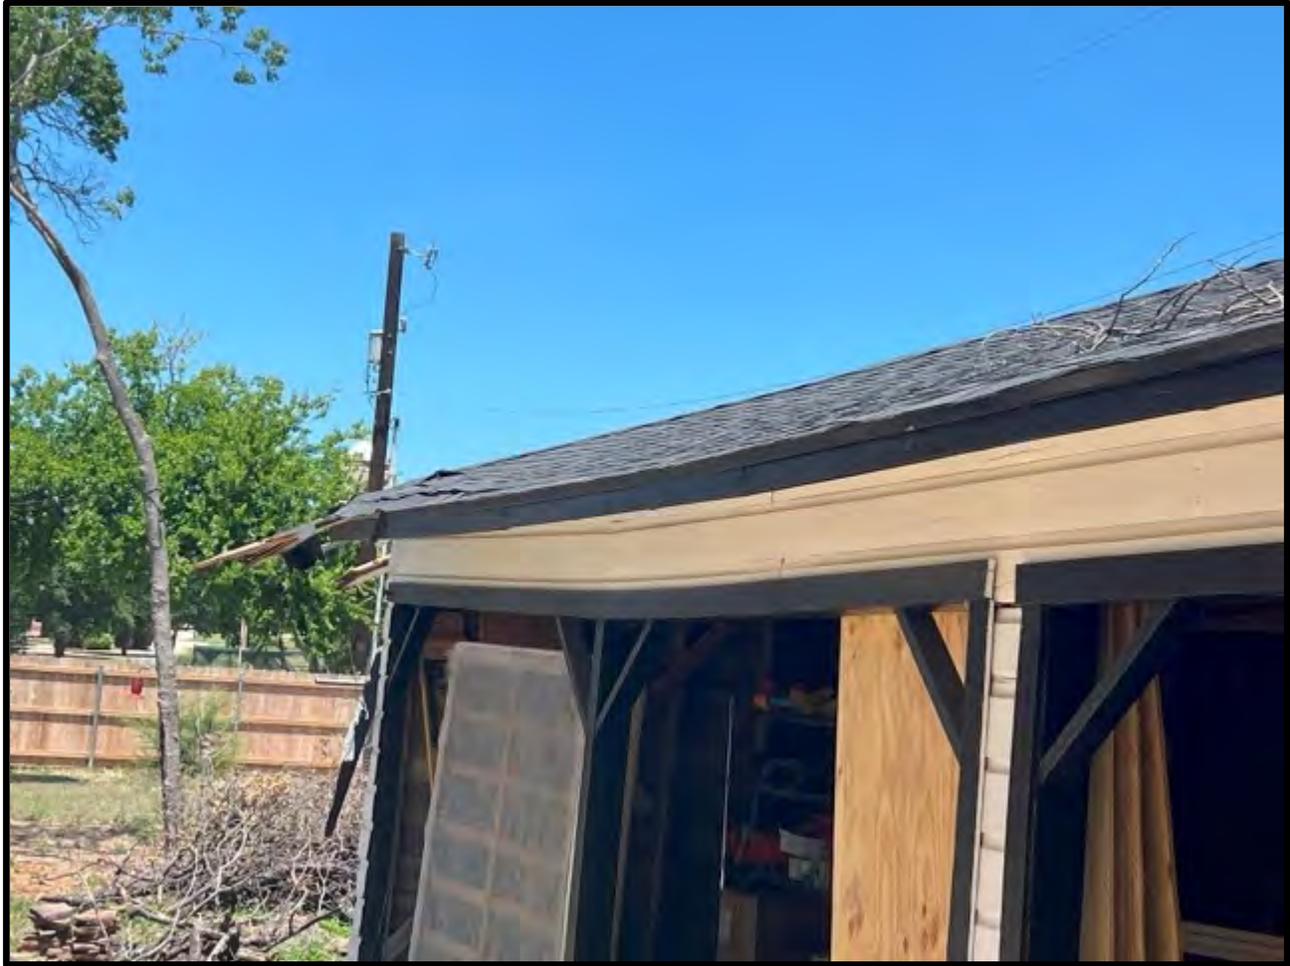
PHOTOGRAPH NO. 13

View of a deflection deformation of the opening header at the front (south) of the detached garage building.

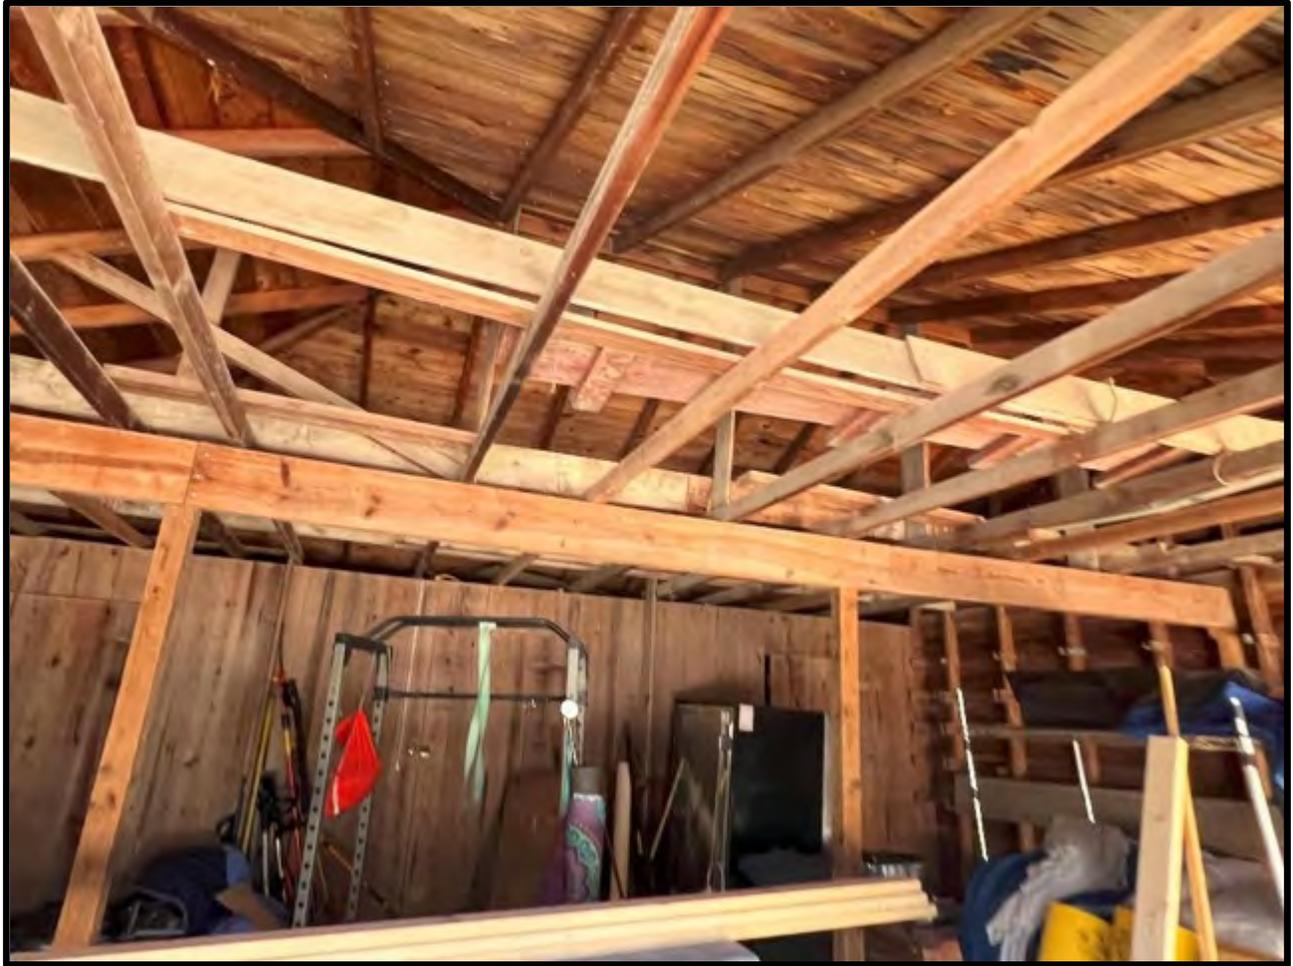
PHOTOGRAPH NO. 14

Overview of the interior framing of the detached garage building.

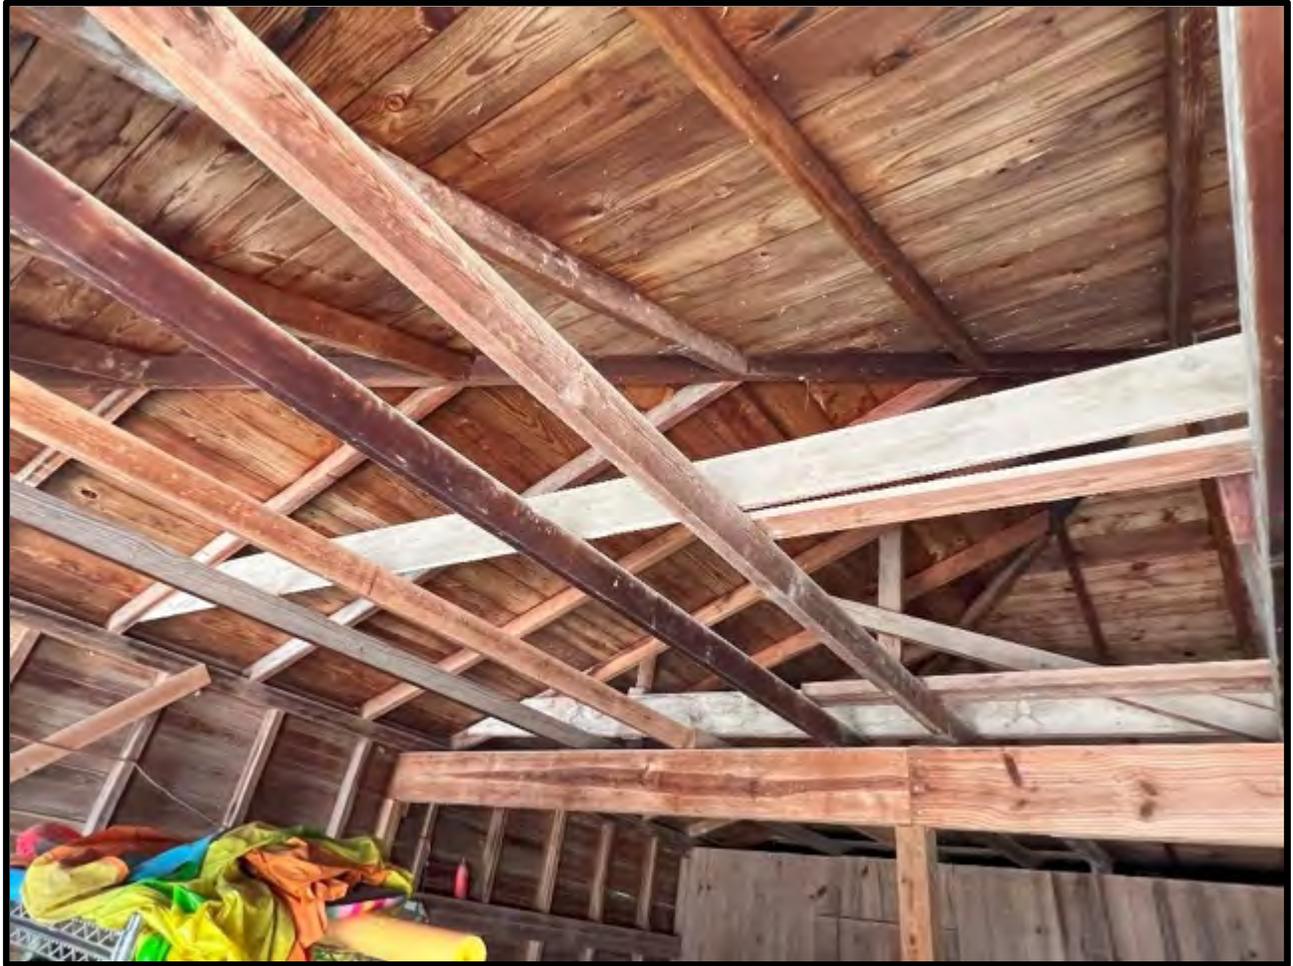
PHOTOGRAPH NO. 15

Overview of the interior framing of the detached garage building.

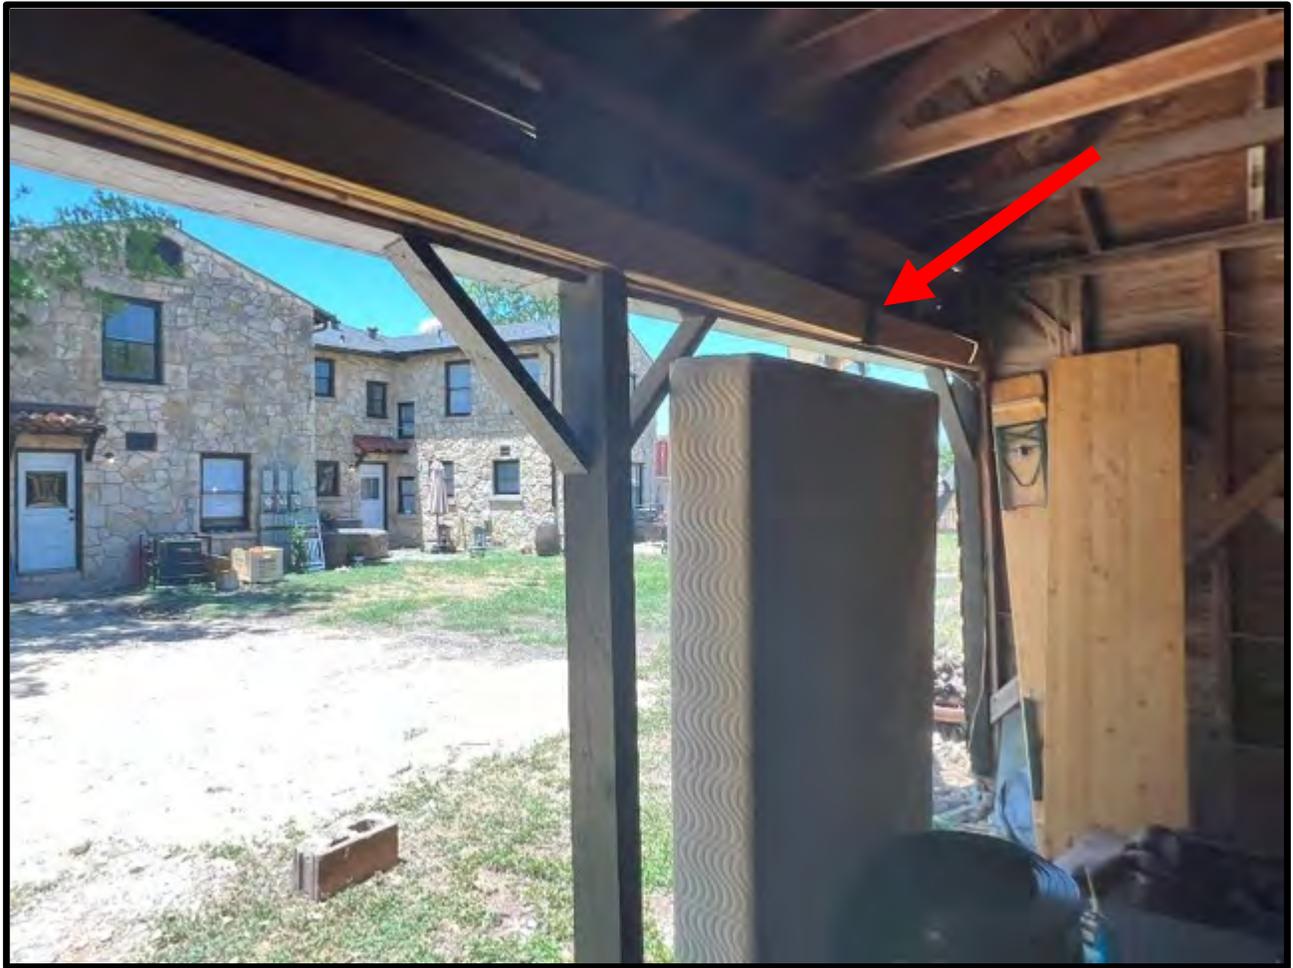
PHOTOGRAPH NO. 16

View of a deflection deformation of the opening header at the front (south) of the detached garage building.
