# HISTORIC PRESERVATION

504 N Hackberry St  
Dignowity Hill Historic District

BOA-24-10300035

May 20, 2024

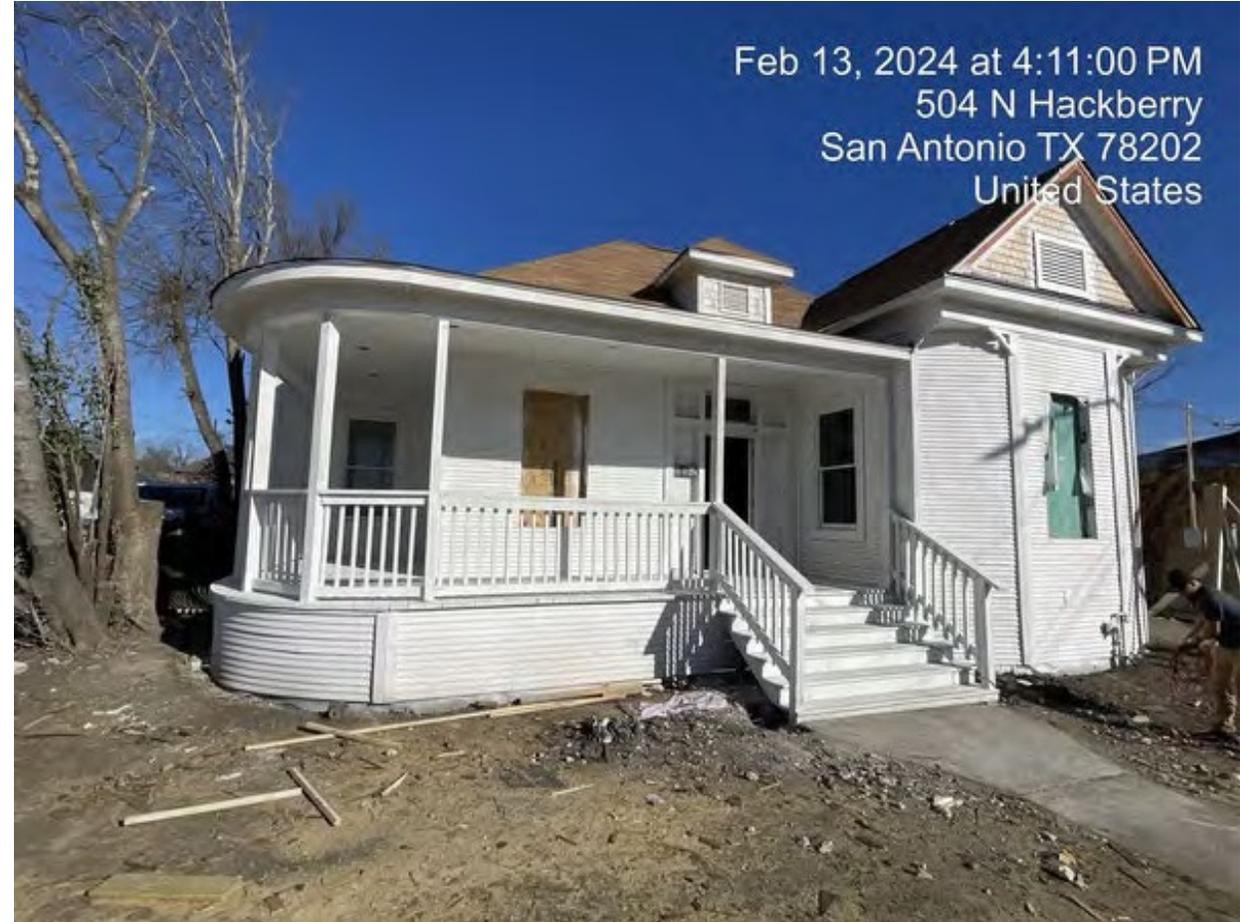
**After**

- c. SITE VISIT – On February 13, 2024, staff conducted a site visit to take current photos of the structures condition. The photos taken show the modifications made as described in finding b.
