HISTORIC AND DESIGN REVIEW COMMISSION

HDRC CASE NO: 2025-122
ADDRESS: 1914 W KINGS HWY
LEGAL DESCRIPTION: NCB 1941 BLK 29 LOT 23
ZONING: R-6, H
CITY COUNCIL DIST.: 7
DISTRICT: Monticello Park Historic District
APPLICANT: Zachary Fischer
OWNER: Zachary Fischer/FISCHER ZACHARY
TYPE OF WORK: Wholesale window replacement and Historic Tax Certification
APPLICATION RECEIVED: April 20, 2025
60-DAY REVIEW: June 19, 2025
CASE MANAGER: Bryan Morales
REQUEST:

1914 West Kings Highway
Certificate of Appropriateness Application
Submitted: 4/20/2025

1914 W Kings Hwy
Exterior Conditions Survey

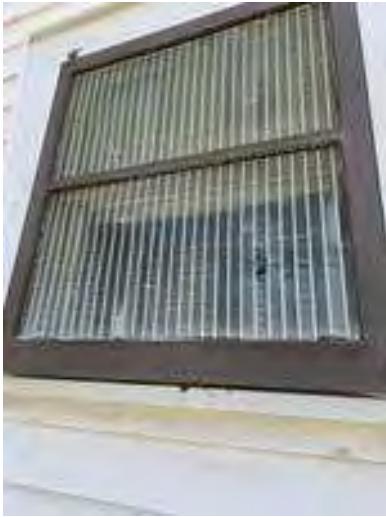
Location: **Bathroom Window #1**

- Needs new lower sash & glass
- Needs structural repair to frame
- Potential water intrusion issue
- Sill flashing needs replacement
- Screen inoperable

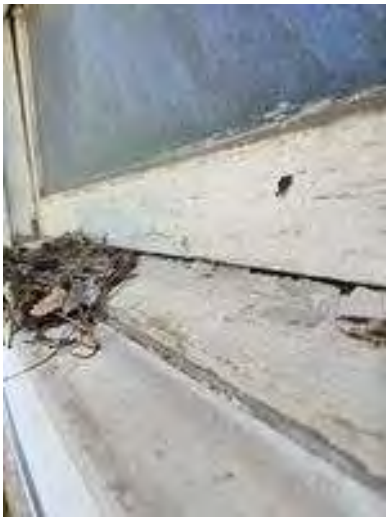
Location: **Bathroom #1**

- Screen inoperable, damage to casing
- Window opening is skewed

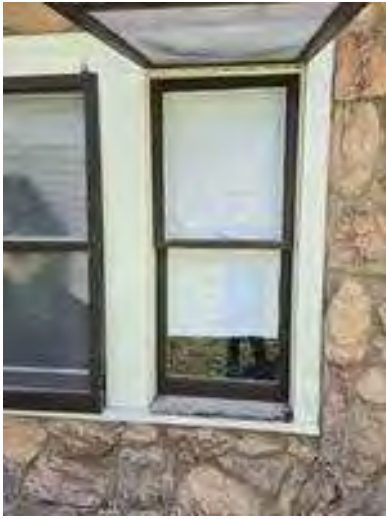
Location: **Living Room Window #1**

- Damage multiple elements of the frame.
- Rough opening needs to be made square
- Bottom sill shows signs of rot.
- Needs lower sash replaced
- 33% of exterior window needs replacement**

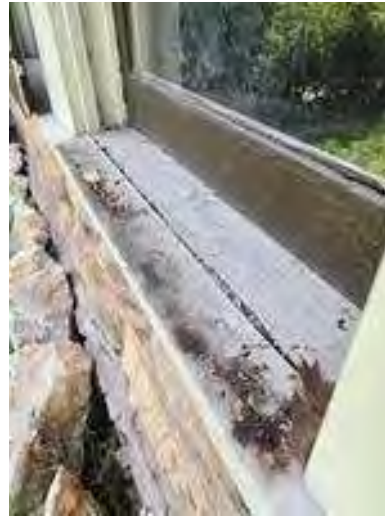
Location: **Living Room Window #1**

- Sill has separated from exterior trim.
- Window trim & sill are rotting
- Missing sill flashing
- Bottom sash does not properly align w/ top.
- Damage to 2 sides of bottom sash

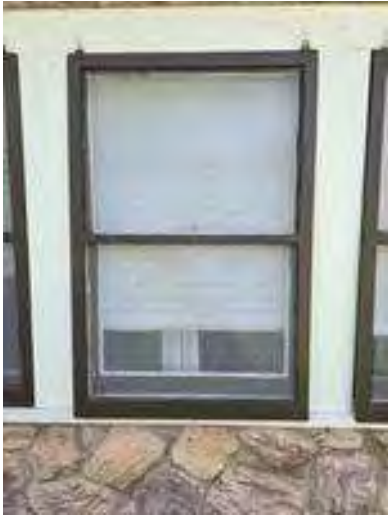
Location: **Living Room Window #2**

- Screen does not fit into window opening, rubs against sill flashing.
- Screen is blown around by wind
- Flashing has pulled back from window sill, creating a gap with moisture intrusion potential

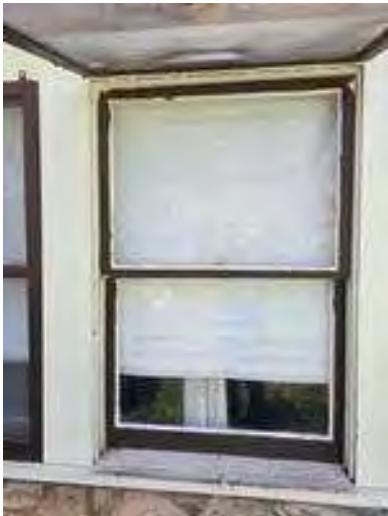
Location: **Dining Room Window #1**

- Top and bottom sashes do not align, large $\frac{1}{2}$ " gap allowing air transfer between inside & outside.
- Trim separating from window frame, moisture intrusion concern

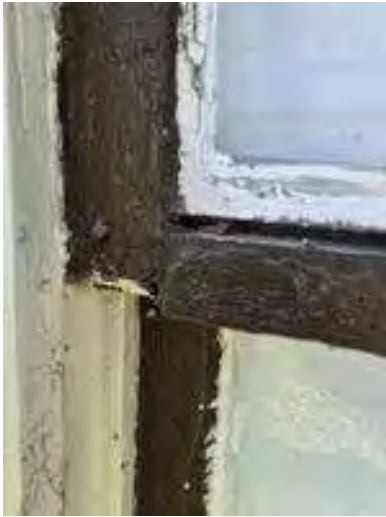
Location: **Dining Room Window #1**

- Damage to frame of top sash
- Wood in frame is rotted

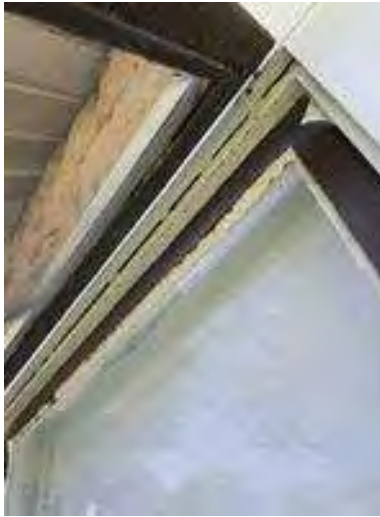
Location: **Dining Room Window #1**

- Some chipping of plaster @ joint w/ window frame
- Damage to screen frame, poor appearance

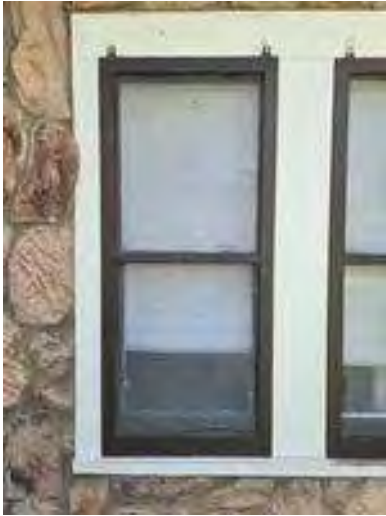
Location: **Living Room Window #3**

-Screen operable, but damage to screen frame.

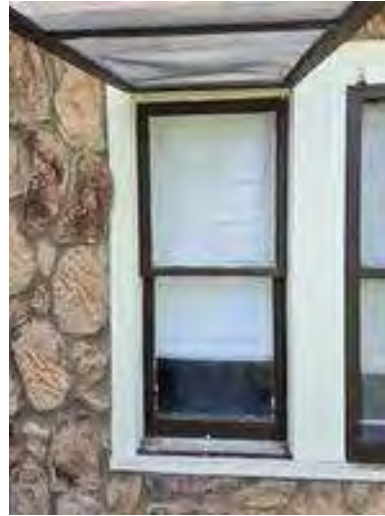
Location: **Living Room Window #3**

-Screen has rubbed paint off of sill and damaged the wood/ flashing where it contacts

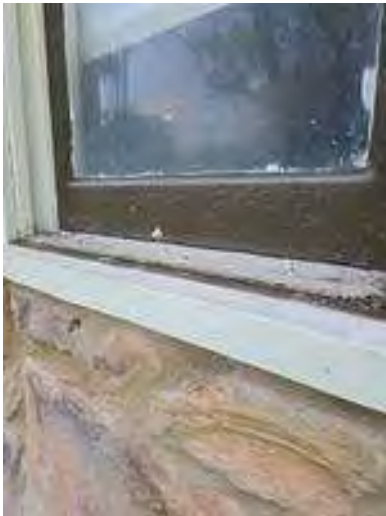
Location: **Living Room Window #3**

- Joint between window sill & flashing is damaged by where window screen rests.
- 1/4" Gap between sash and sill.
- Trim is lifting away from window jambs, moisture intrusion potential.

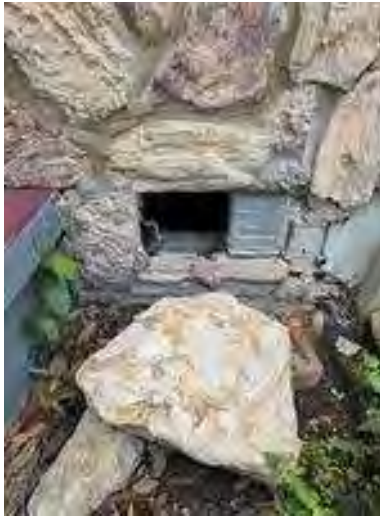
Location: **Front Door Crawl Space Grate**

-Broken Grate in Plaster exterior

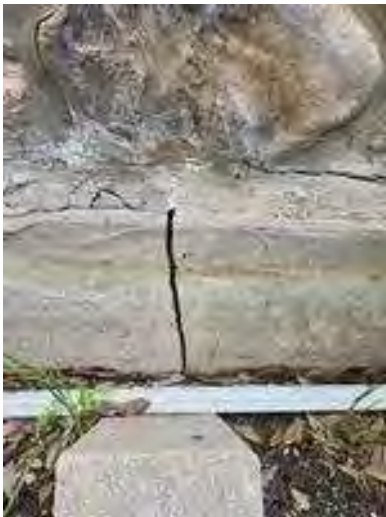
Location: **Dining Room**

-Crack in exterior skirting

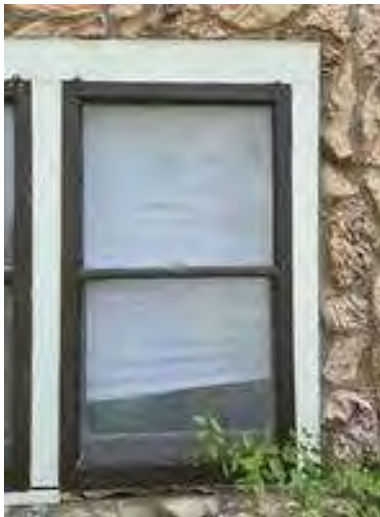
Location: **Dining Room Window #1**

-Moisture intrusion concern w/ exterior cladding

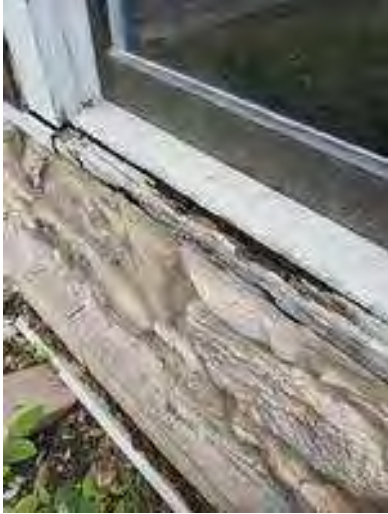
Location: **Dining Room Window #1**

- Gap between sill and bottom sash, $\frac{1}{4}$ " gap allows for air exchange between interior and exterior.

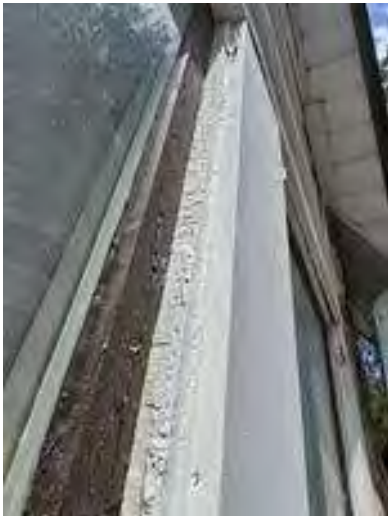
Location: **Dining Room Window #4**

Notes: Damage to window frame and sash.

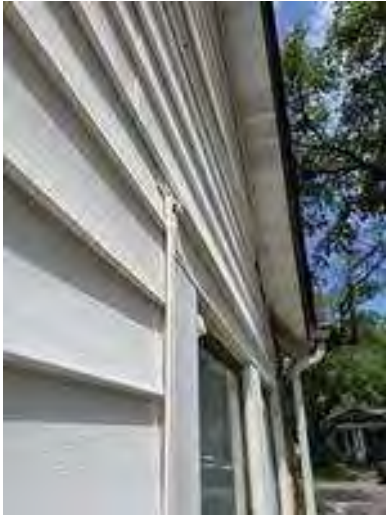
Location: **Dining Room Window #4**

-Drip edge at trim has a gap into window pocket, moisture intrusion concern

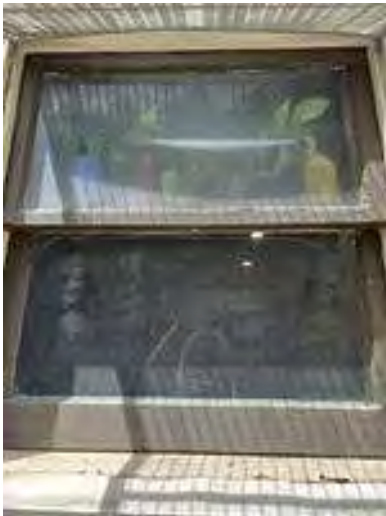
Location: **Kitchen Window #1**

-Gap between sill and bottom sash, 1/4" gap allows for air exchange between interior and exterior.

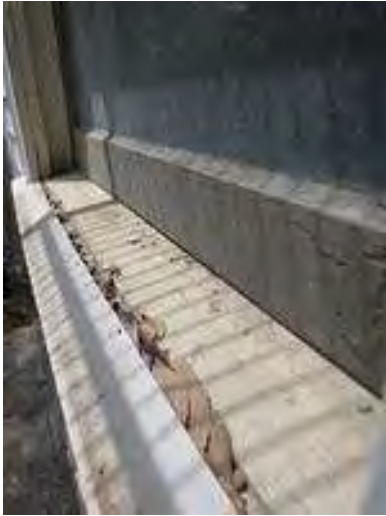
Location: **Kitchen Window #1**

- Trim pulling away from sill, no flashing present

Moisture intrusion concern

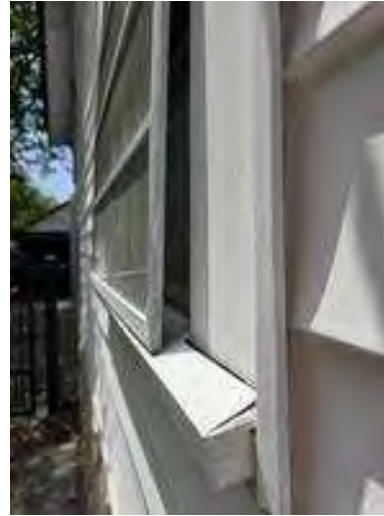
Location: **Kitchen Window #1**

- Gaps between trim and flashing, moisture intrusion concern.
- Metal on metal joint between flashing and aluminum frame

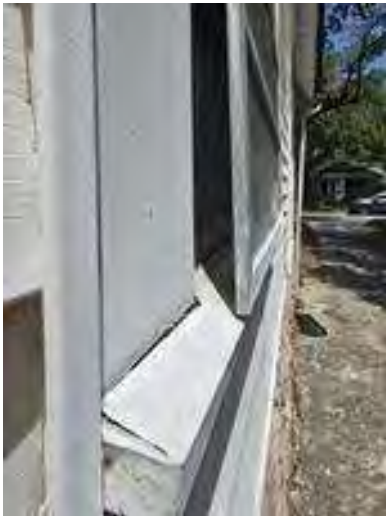
Location: **Kitchen Window #1**

- Gaps between trim and flashing, moisture intrusion concern.
- Metal on metal joint between flashing and aluminum frame

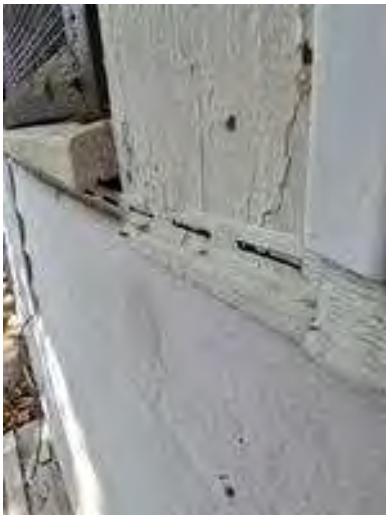
Location: **Kitchen Window #2**

-Unsealed gap between underside of sill and end of jamb. Water intrusion concern

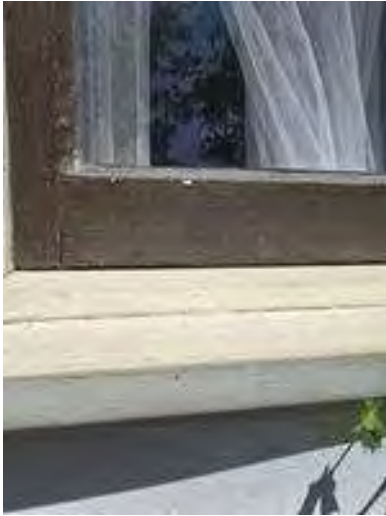
Location: **Master Bedroom Window #1**

-Sash rails are damaged
-Siding pulling away from trim, moisture intrusion concerns.
-Nearby penetrations through wall may have compromised window frame

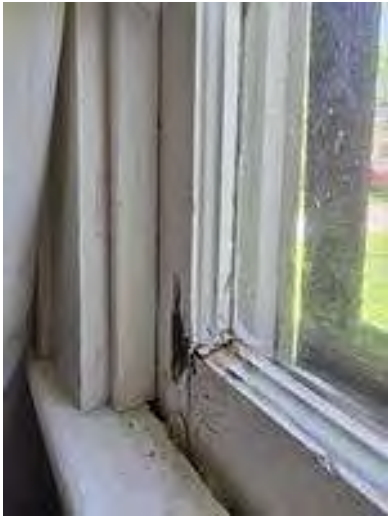
Location: **Living Room**

- Rotting Window frame,
- Previous owners completed poor repair;
- Stool damage

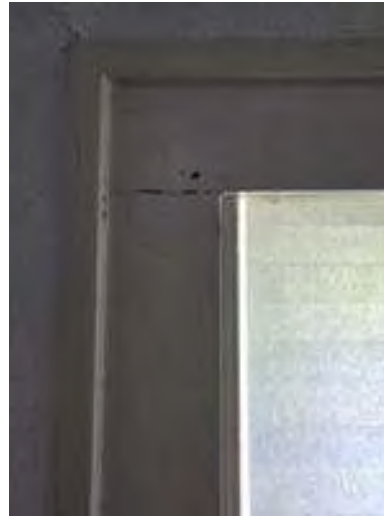
Location: **Living Room, all non-operational windows**

- Casing damage and separation

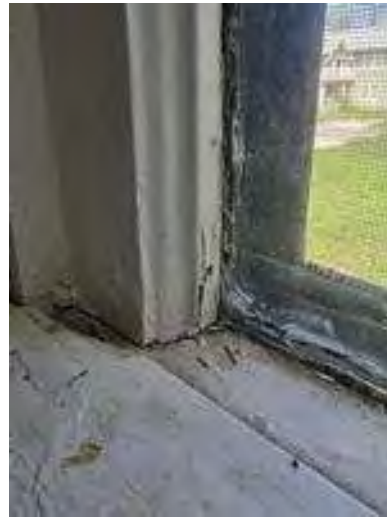
Location: **Living Room**

- Separation of window frame and drywall
- Evidence of poor foundation
- Mismatched trim

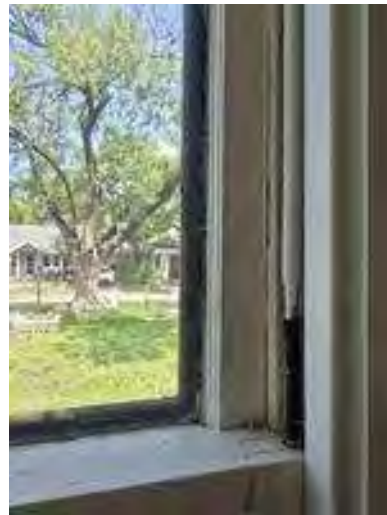
Location: **Dining Room**

- Wood rot
- Miss matched apron

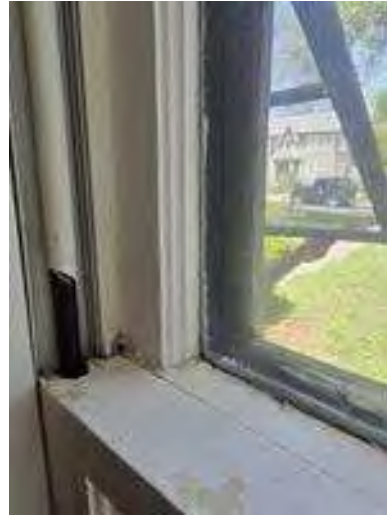
Location: **Dining Room**

- Broken sash cover and cord

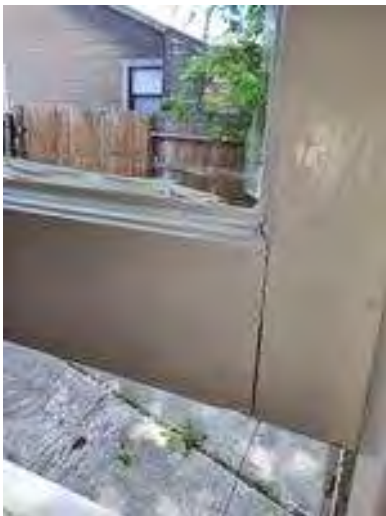
Location: **Bedroom 2**
Notes:
-Cracked frame
-Water damage

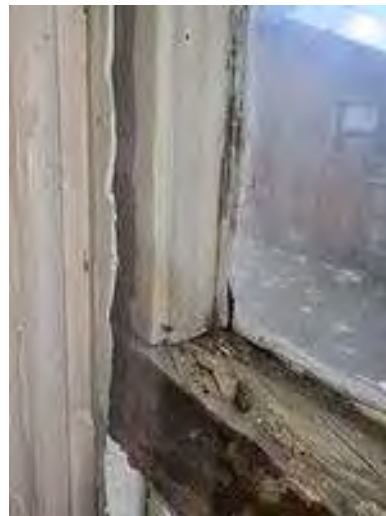
Location: **Bedroom 2**
Notes:
-Damage to frame

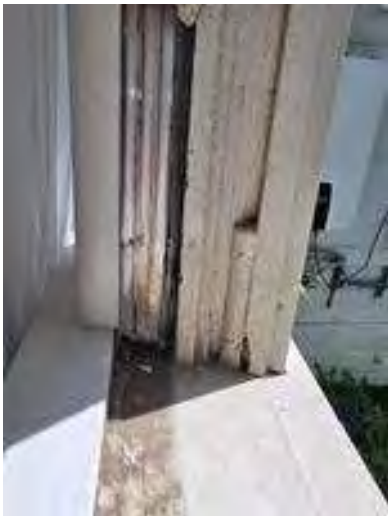
Location: **Bedroom 1**

-Wood rot

-Damaged casing from settlement

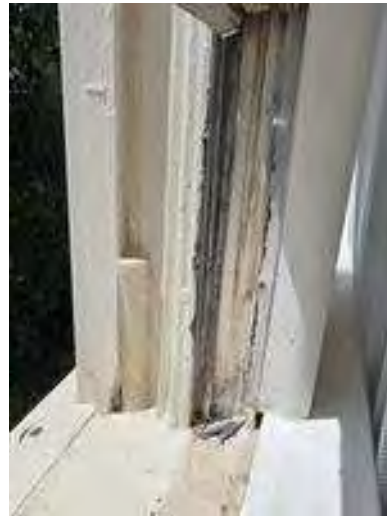
Location: **Bedroom 1**

-Wood rot

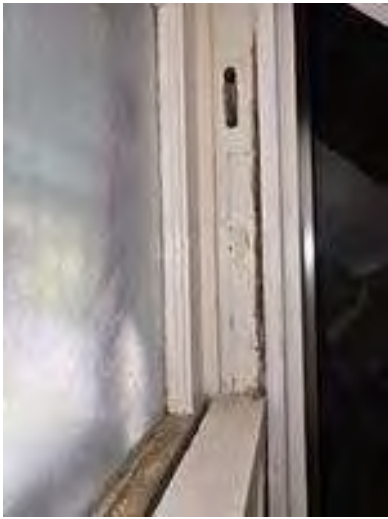
Location: **Bathroom 2**

- Broken sash cover and cord
- Wood rot
- Glass damage
- Missing weights

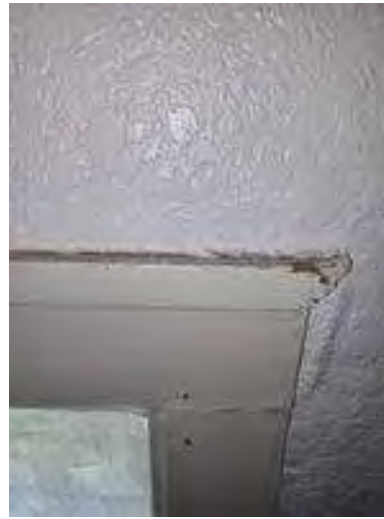
Location: **Living room**

- Mismatched trim
- Damage from settlement
