#	Species	DBH	Multi Stem Notes	Condition Rating	Disposition	Summary and Recommendations	Individual Tree Report with Photos
2691	Pecan	14.5		Very Poor	Not Protected - In Decline/Dead	2691 a 14.5 inch pecan is in very poor overall condition and is a very poor candidate for pres	https://fulcrumapp.io/run/53da7710-
2692	Arizona Ash	12		Very Poor	Not Protected - In Decline/Dead	2692 a 12 inch Arizona Ash is in very poor overall condition and is a very poor candidate for	https://fulcrumapp.io/run/53da7710-
2693	Arizona Ash	12.5		Very Poor	Not Protected - In Decline/Dead	2693 a 12.5 inch Arizona Ash is in very poor overall condition and is a very poor candidate f	https://fulcrumapp.io/run/53da7710-
2694	Arizona Ash	20		Fair	Protected - Significant Category	2694 a 20 inch Arizona Ash is in fair overall condition and is a fair candidate for preservation	https://fulcrumapp.io/run/53da7710-
2695	White Mulberry	12		Invasive	Not Protected - Invasive Species	2695 a 12 inch White Mulberry is in fair overall condition and is a fair candidate for preservat	https://fulcrumapp.io/run/53da7710-

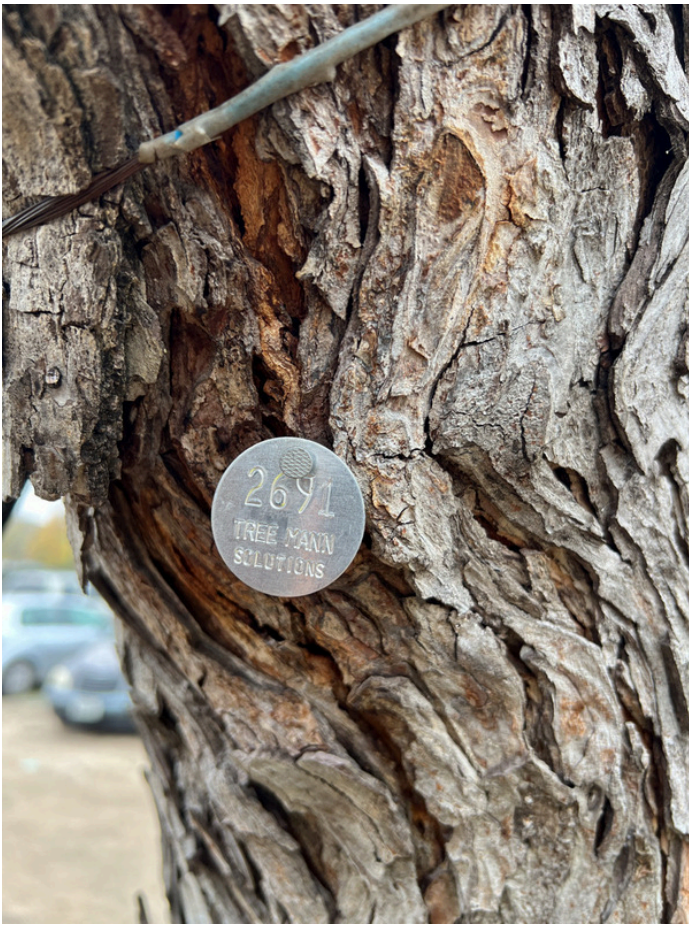
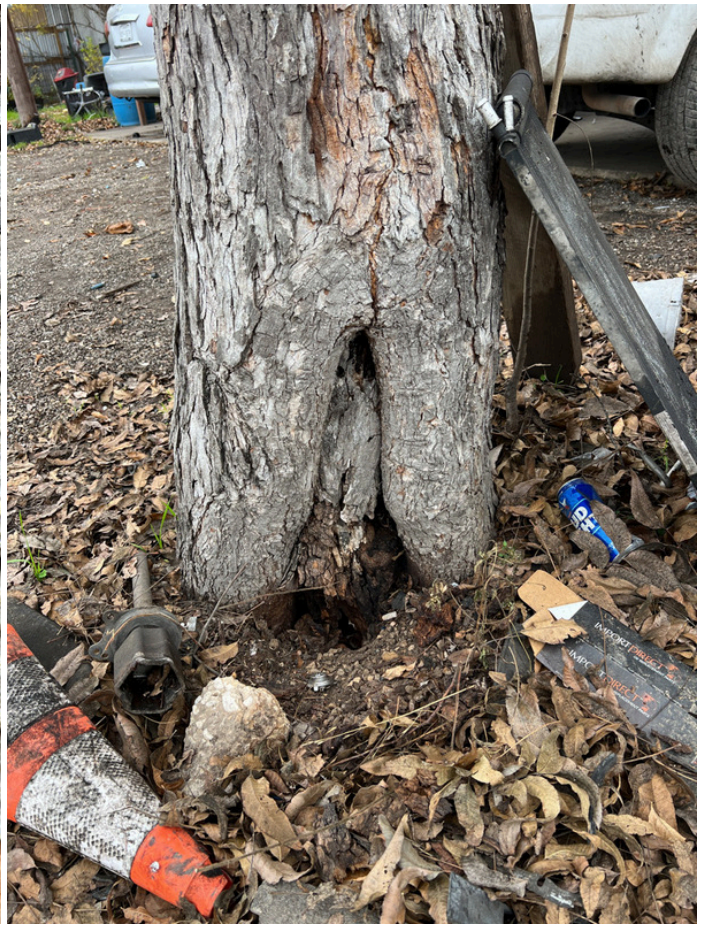
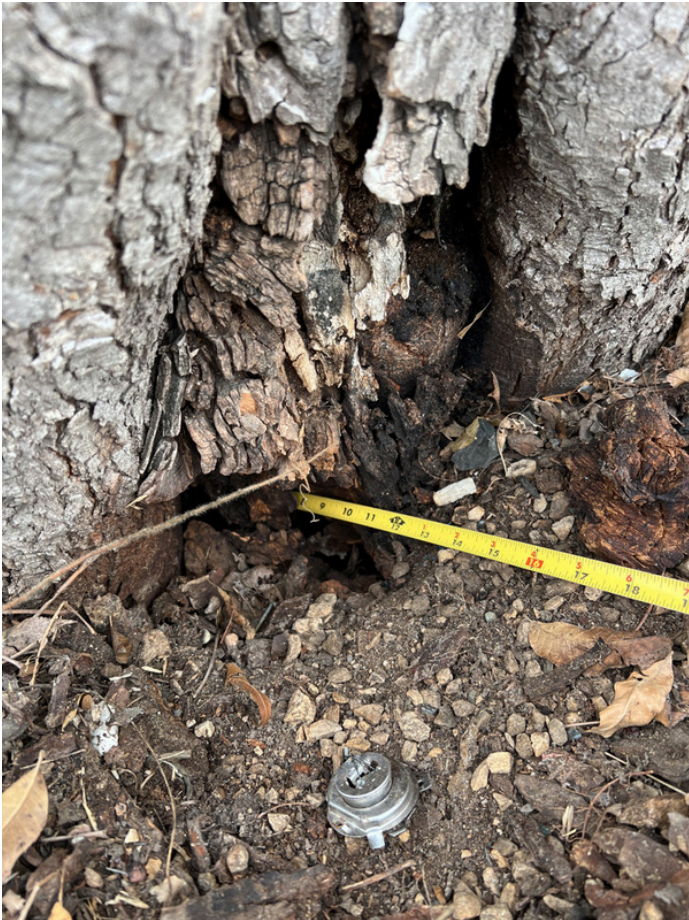
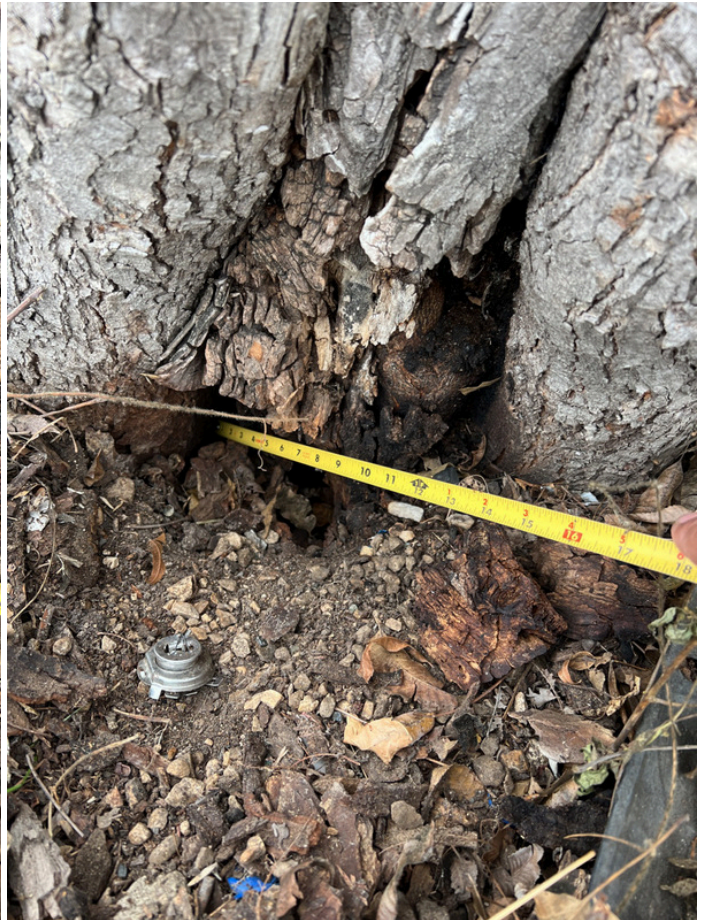
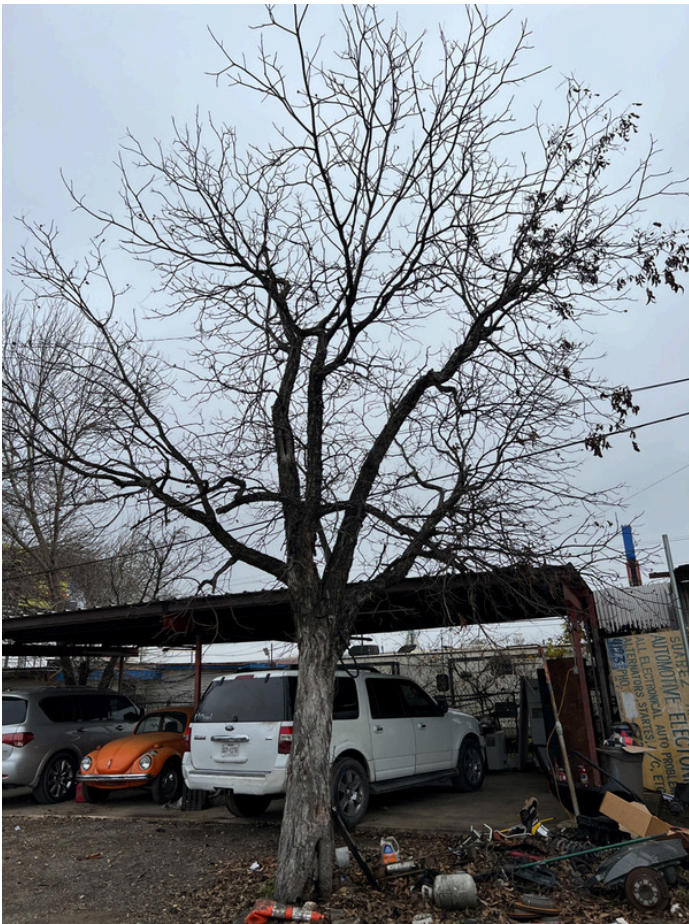
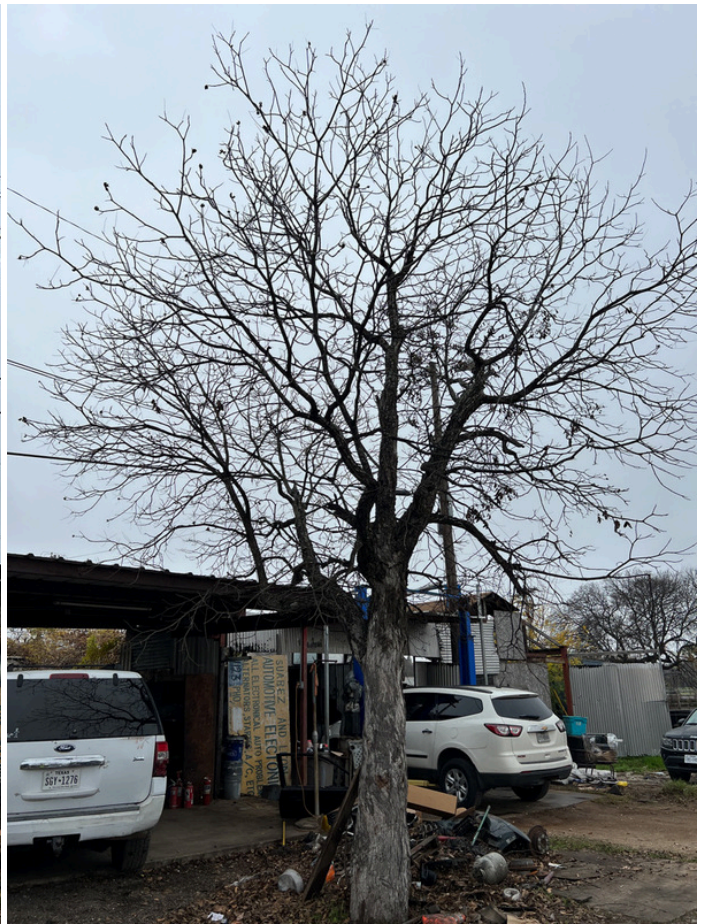
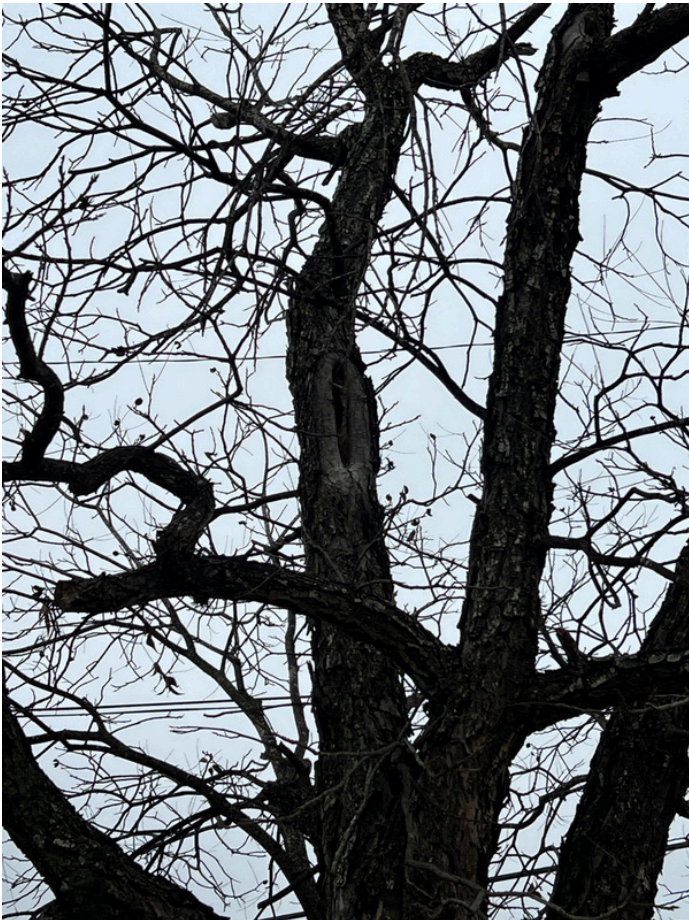
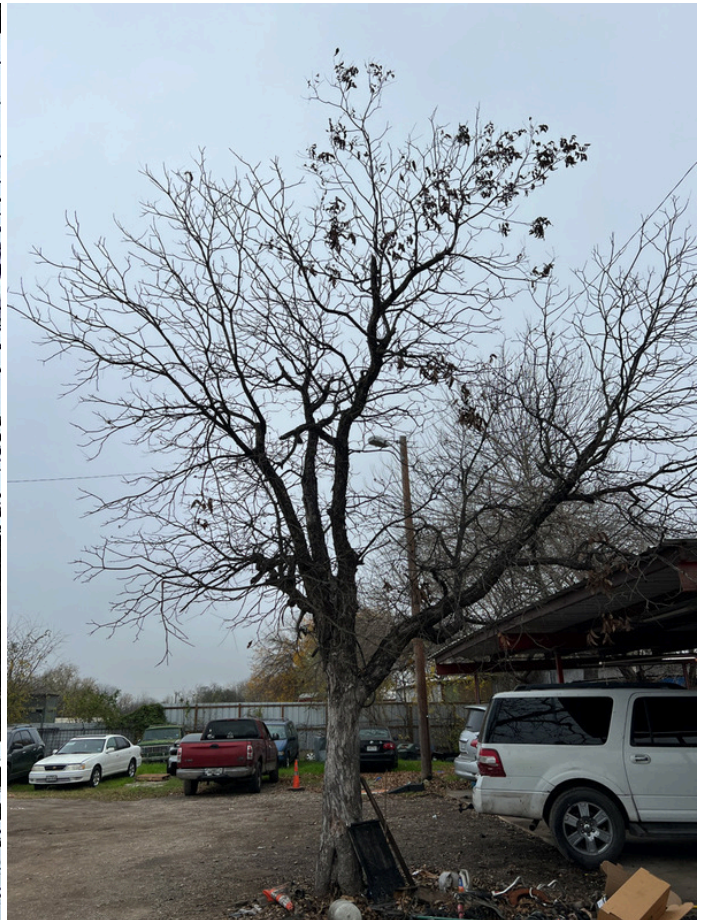
Tree Number	2691
Tree Species	Pecan
Diameter (DBH)	14.5
Multi Stem Notes	
Condition	Very Poor
Summary	2691 a 14.5 inch pecan is in very poor overall condition and is a very poor candidate for preservation due to excessive cavity at the base of the tree. Excessive decay and rot likely impacting structural integrity. Fair overall response growth and wound reaction wood. Significant cavity and decay in major branches. Decay and rot likely at old pruning wounds. Potential canopy approximately 65%. Candidate recommended for removal.

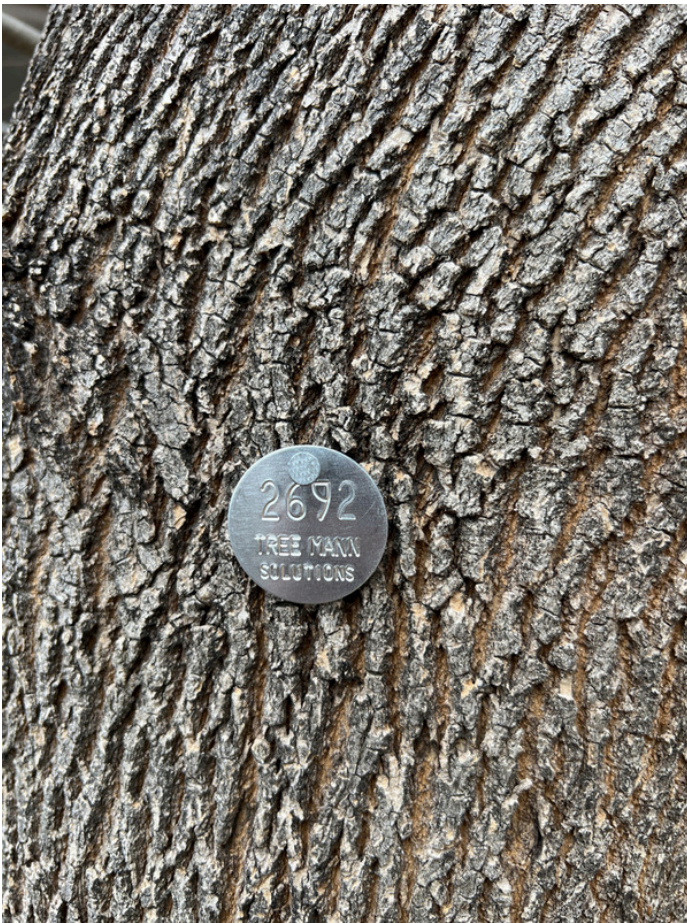
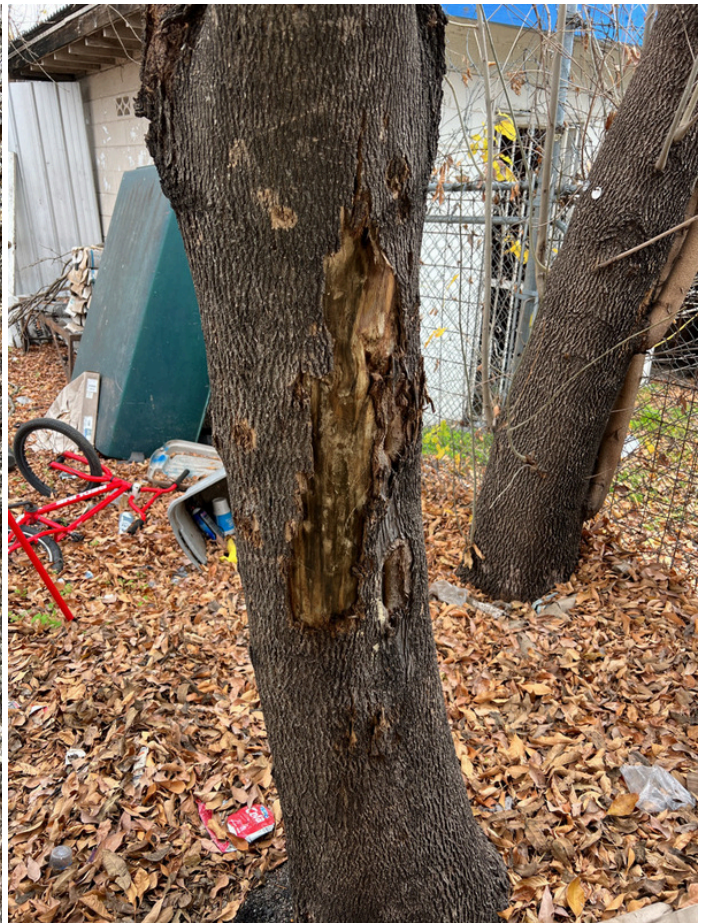
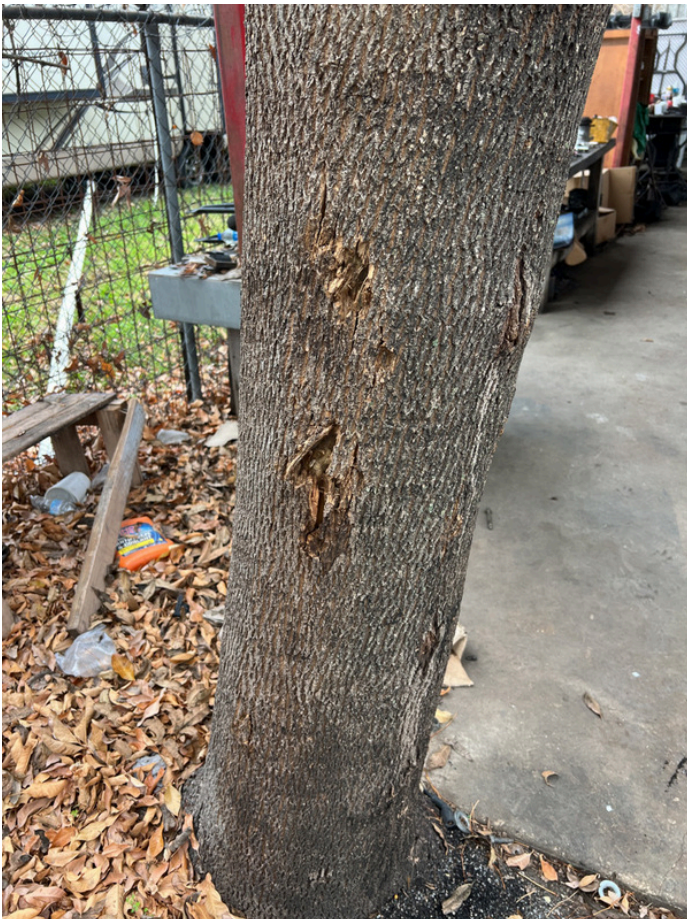
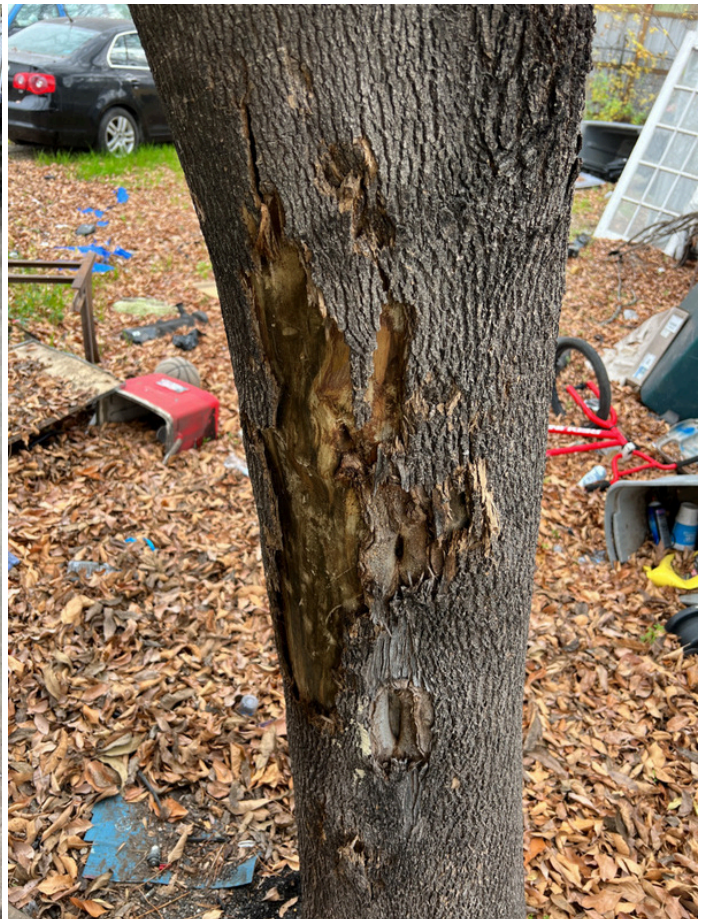
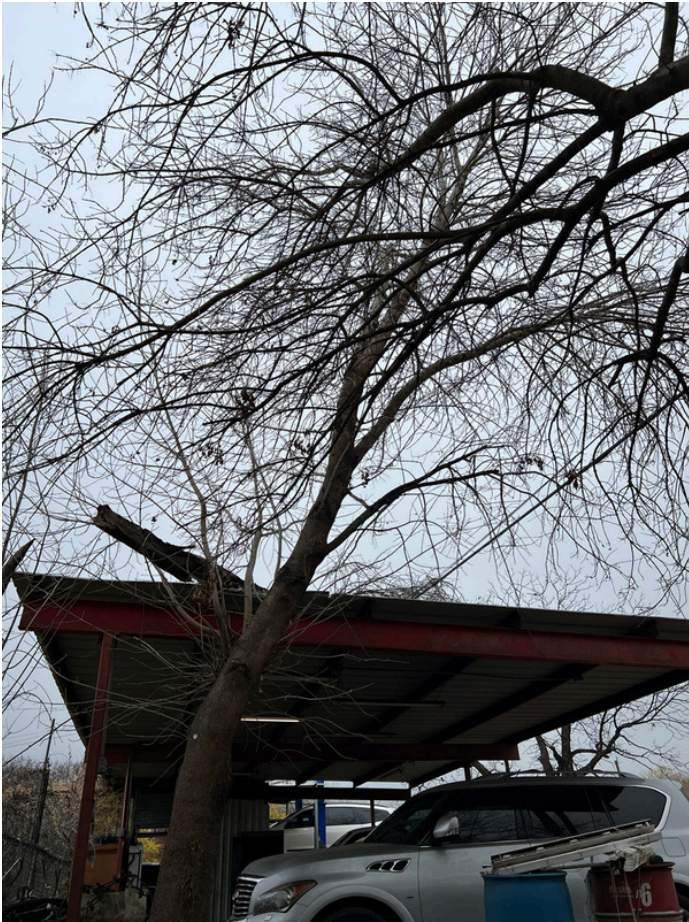
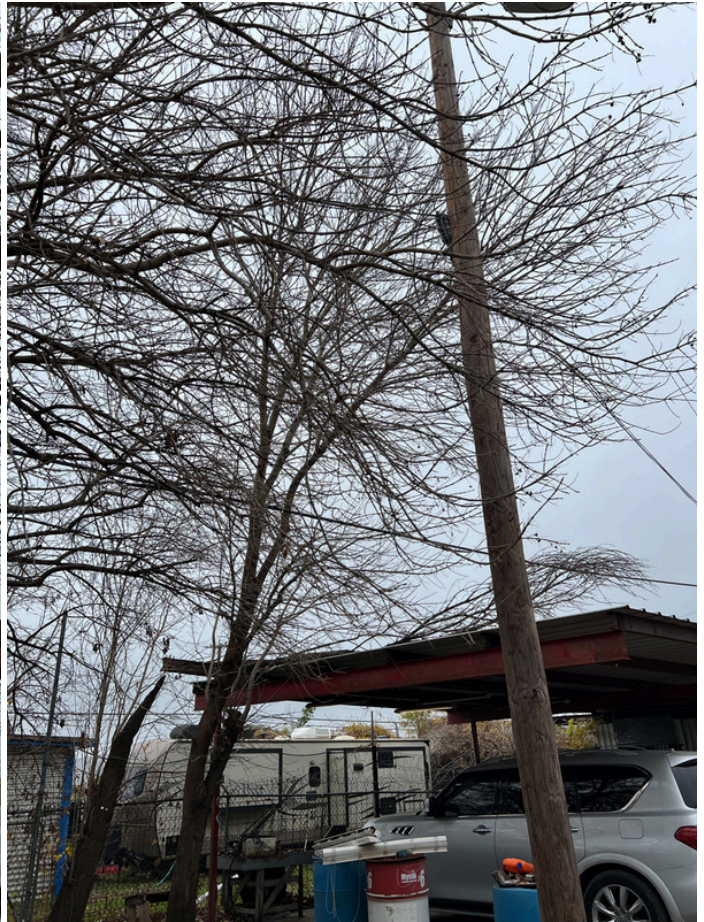
Tree Number	2692
Tree Species	Arizona Ash
Diameter (DBH)	12
Multi Stem Notes	
Condition	Very Poor
Summary	2692 a 12 inch Arizona Ash is in very poor overall condition and is a very poor candidate for preservation. Tree has codominant stem failure. Excessive damage to the trunk with significant decay. Reaction growth is very poor and tree is likely in decline. Candidate recommended for removal.

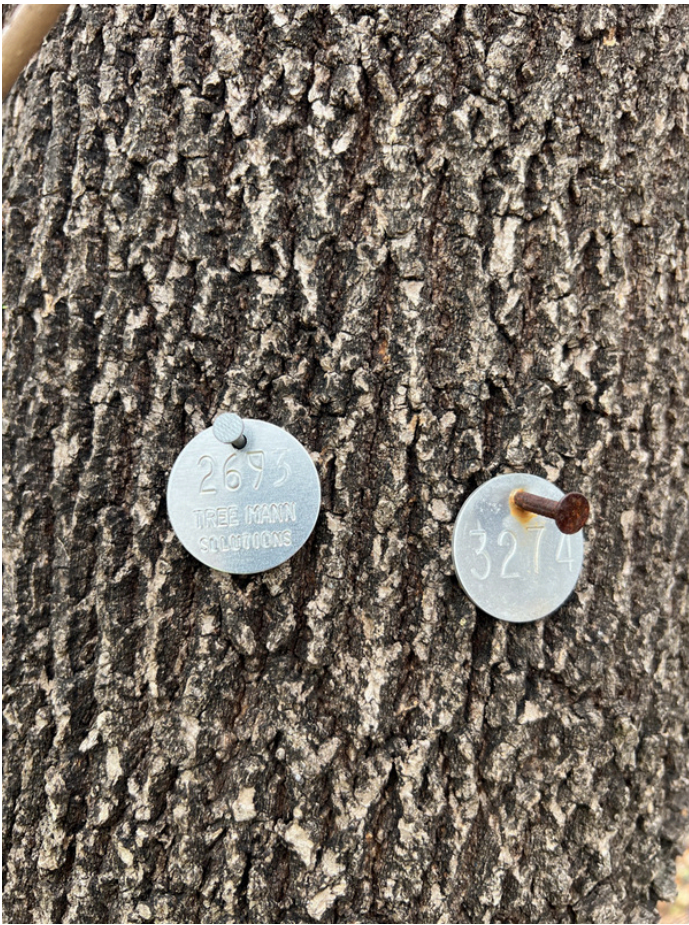
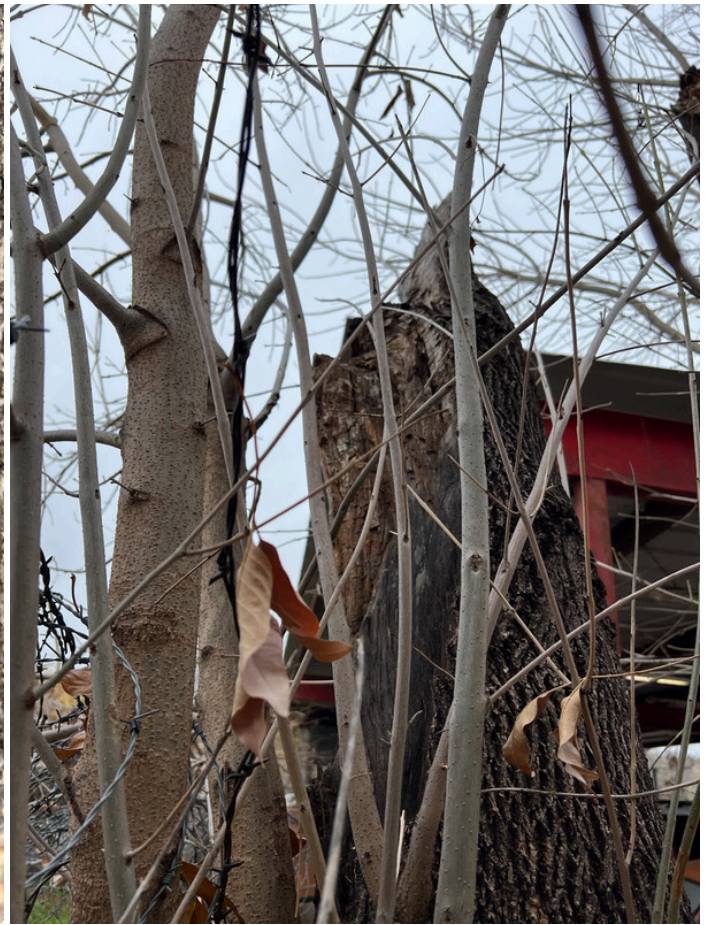
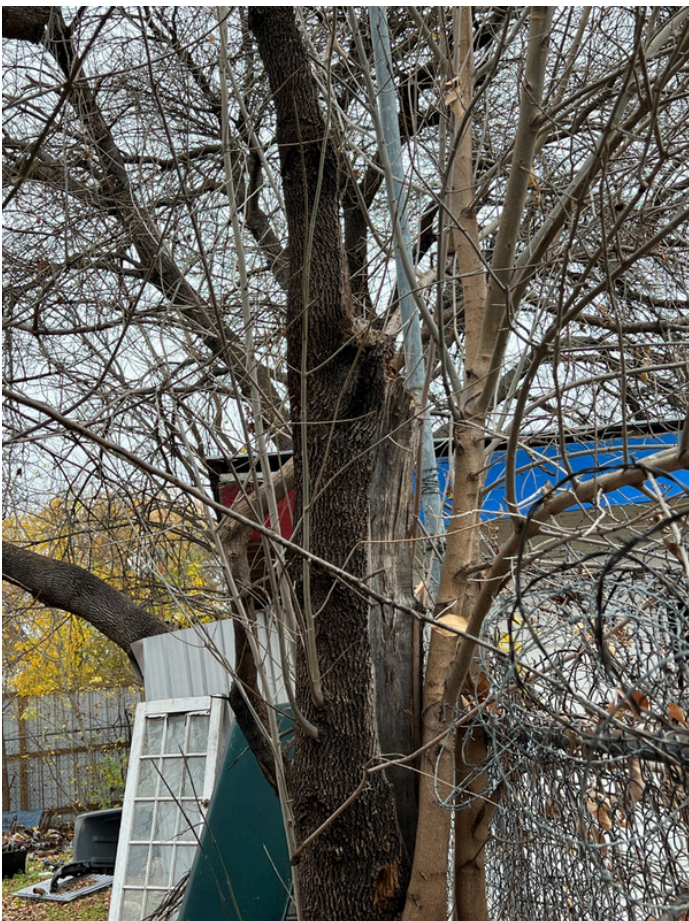
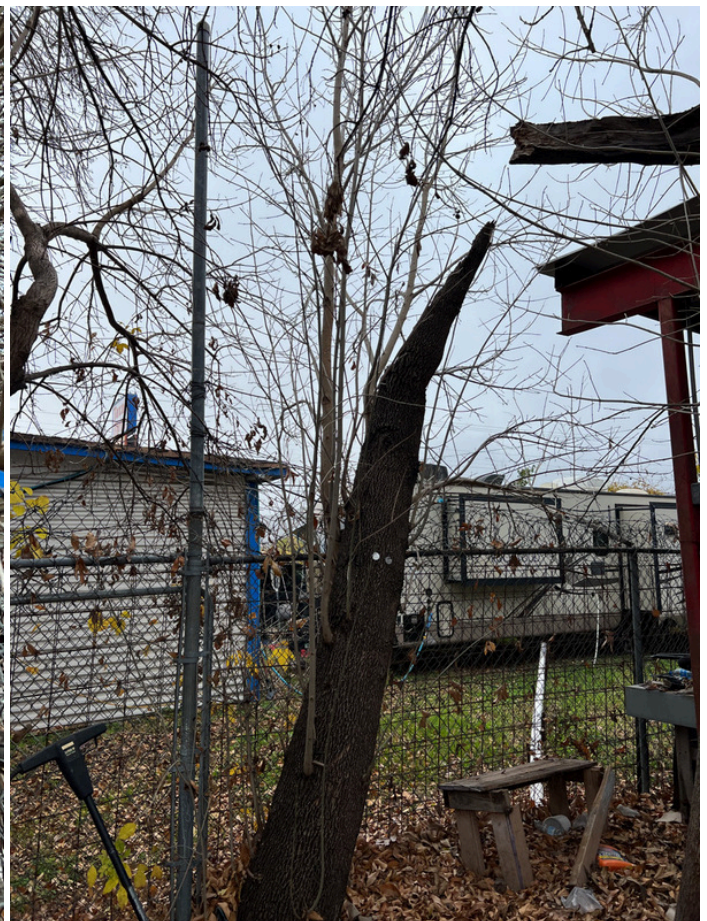
Tree Number	2693
Tree Species	Arizona Ash
Diameter (DBH)	12.5
Multi Stem Notes	
Condition	Very Poor
Summary	2693 a 12.5 inch Arizona Ash is in very poor overall condition and is a very poor candidate for preservation. Tree has main leader failure. Significant decay remains in wound. Low fair response growth. Candidate recommended for removal.

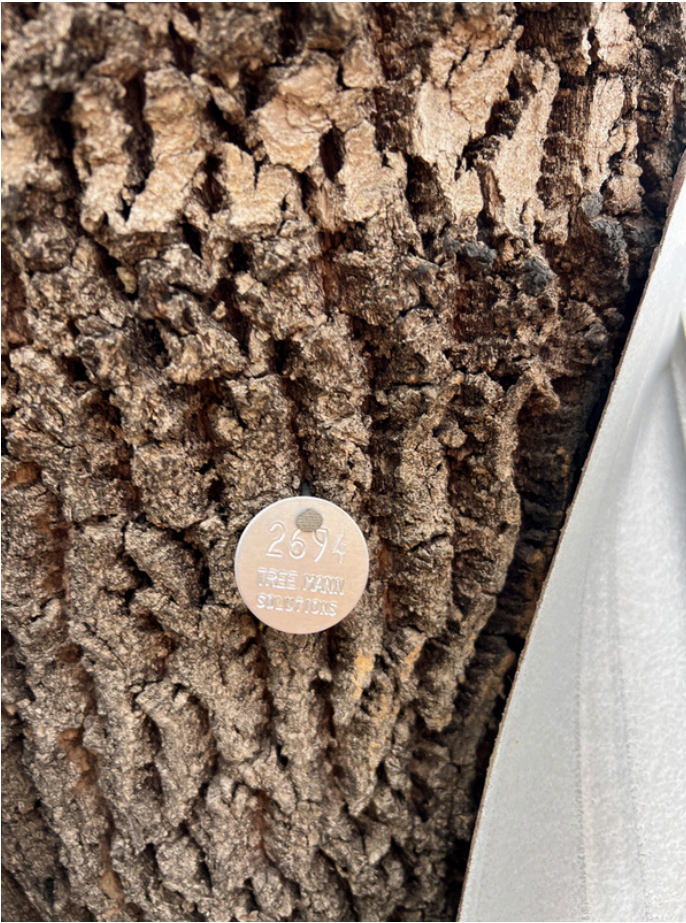
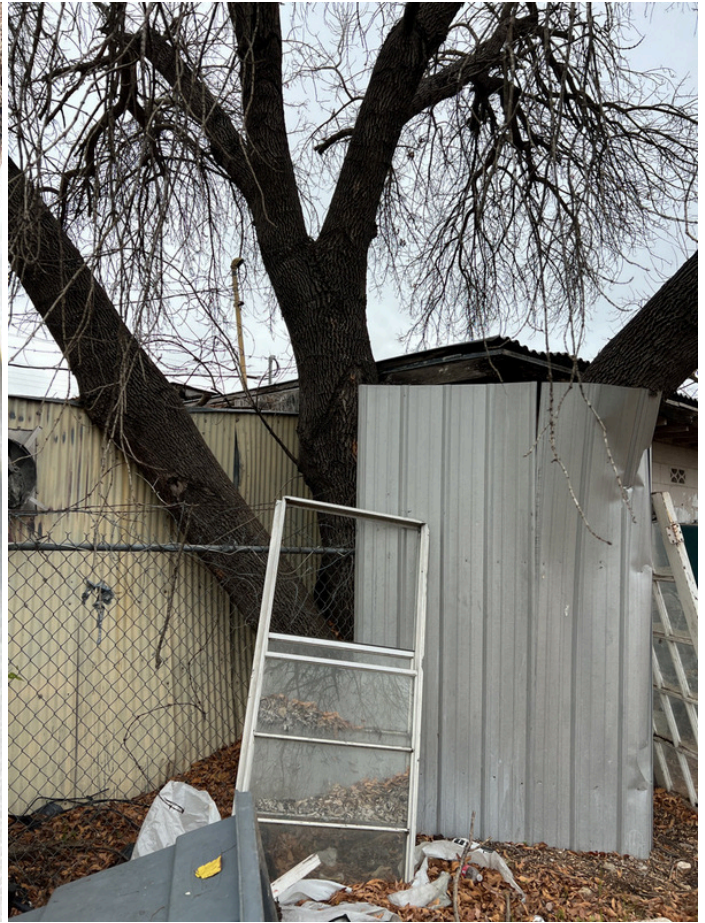
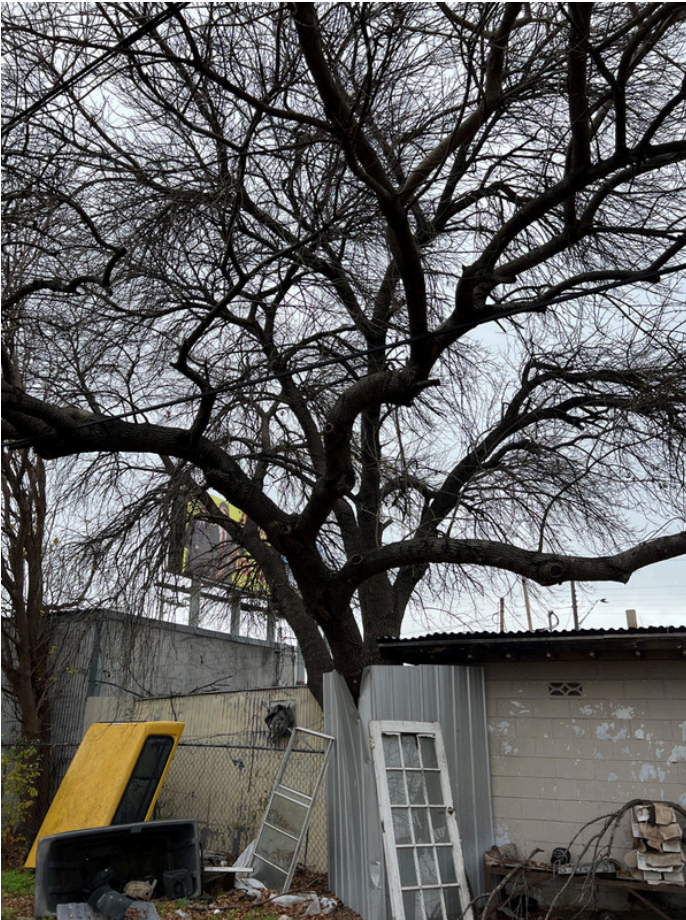
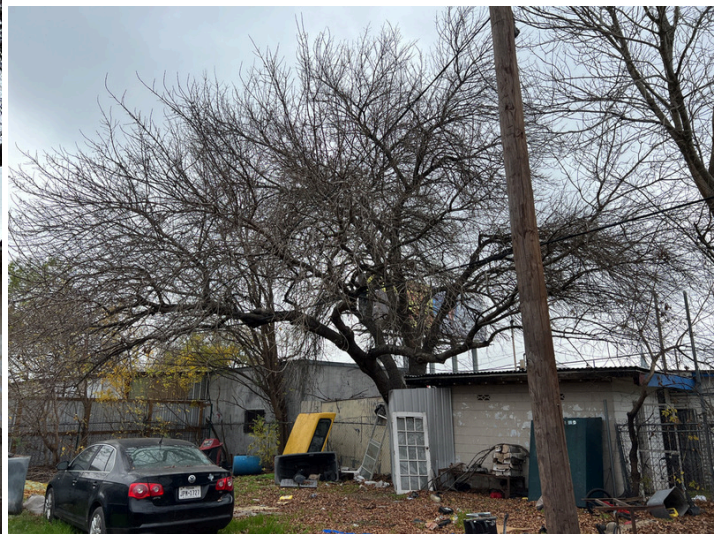
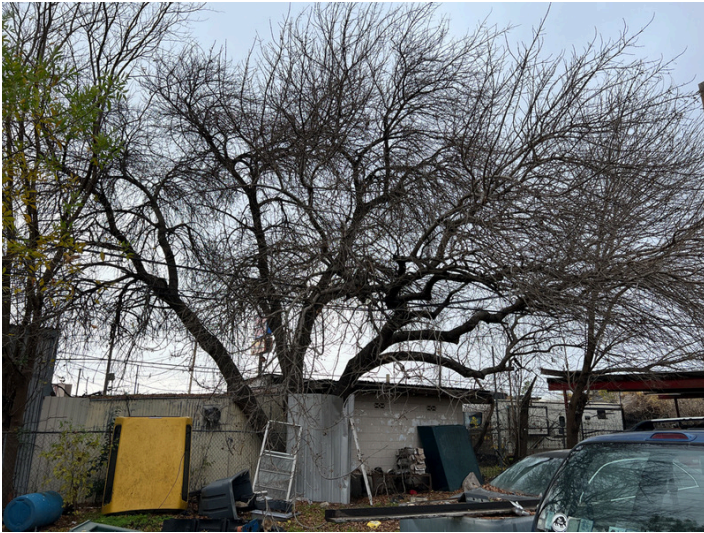
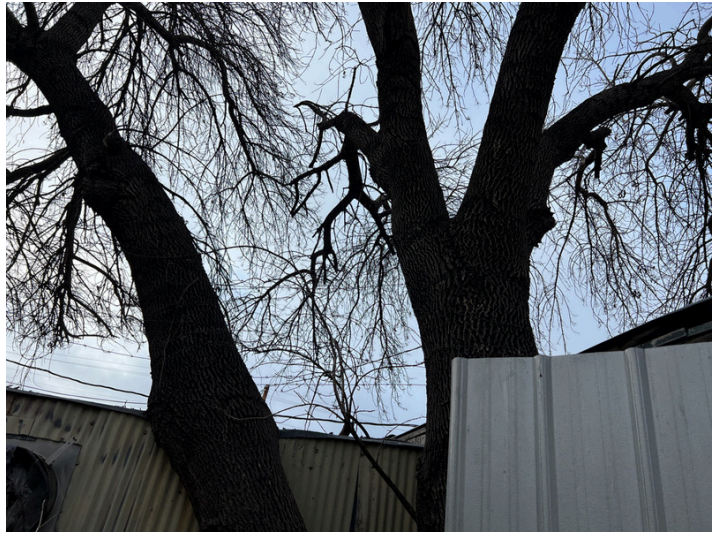
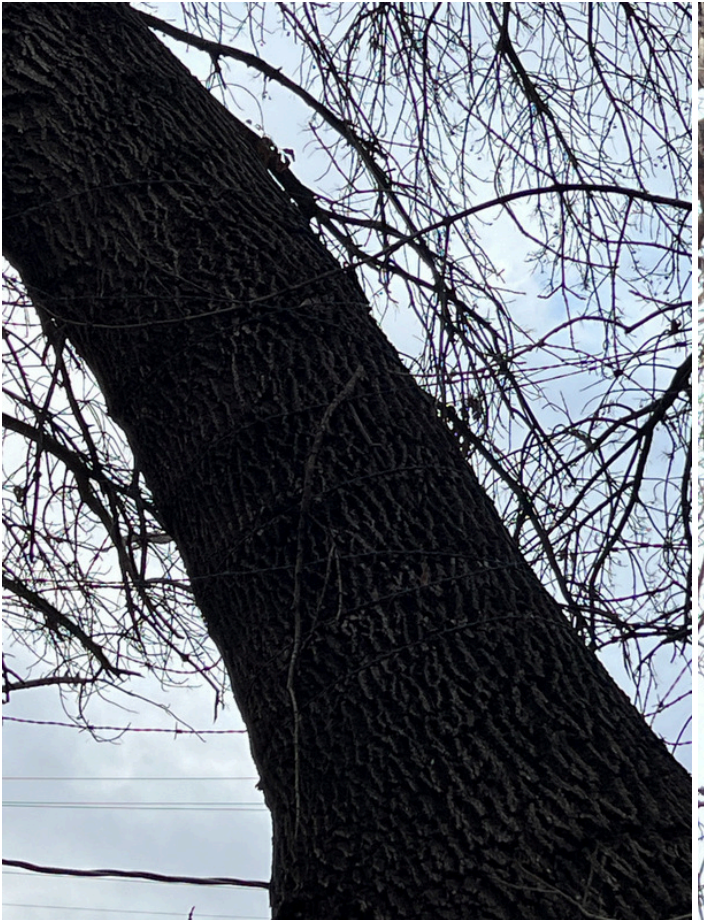
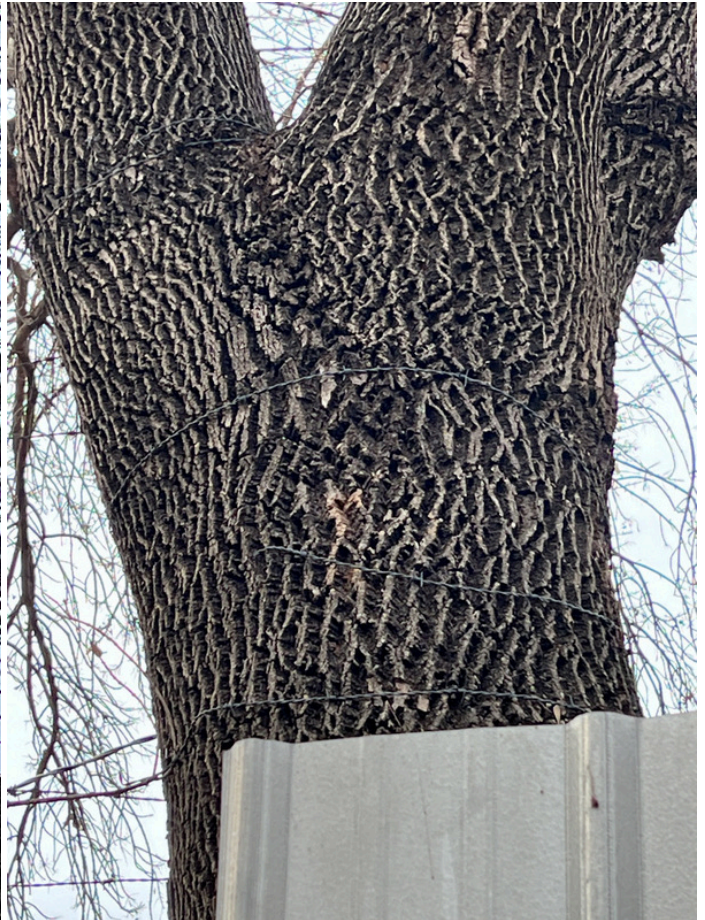
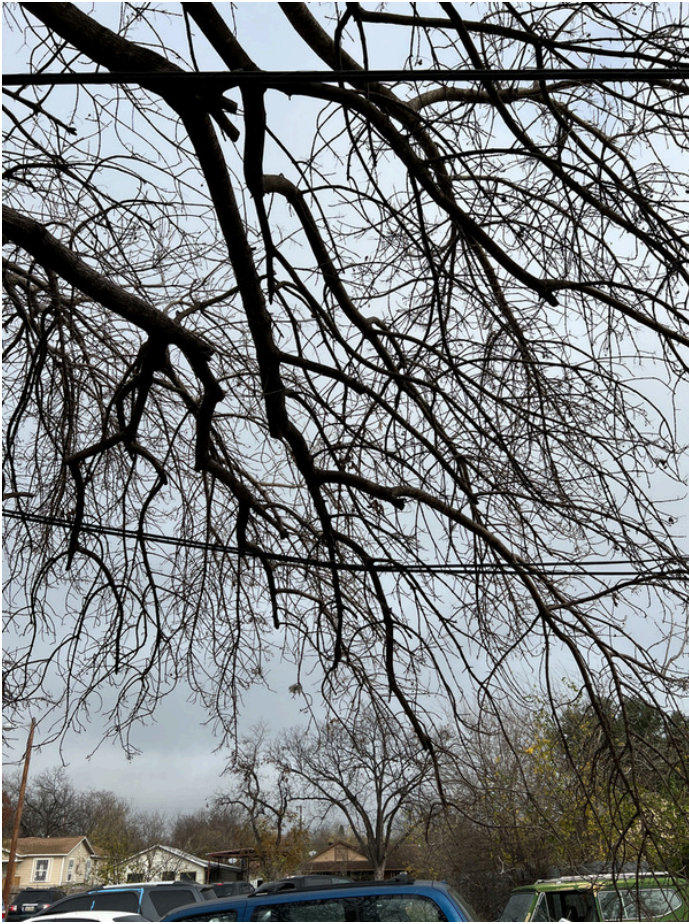
Tree Number	2694
Tree Species	Arizona Ash
Diameter (DBH)	20
Multi Stem Notes	
Condition	Fair
Summary	2694 a 20 inch Arizona Ash is in fair overall condition and is a fair candidate for preservation. Tree is inaccessible, DBH was estimated. Most northern stem on canopy has branching weight resting on utility lines. Barbed wire wrapped around tree affecting vigor and growth, will likely cause tree to prematurely decline.

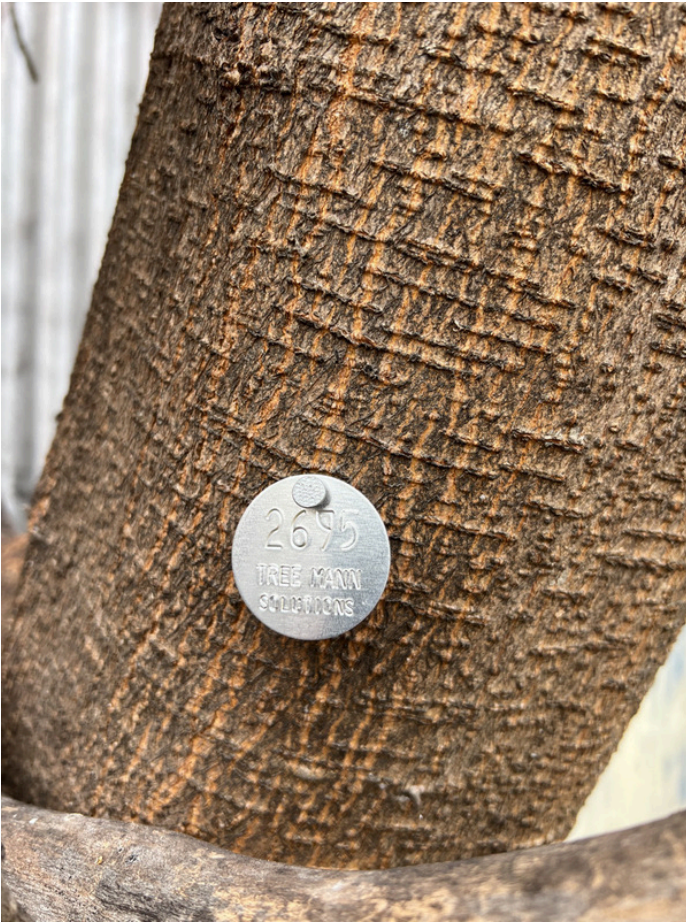
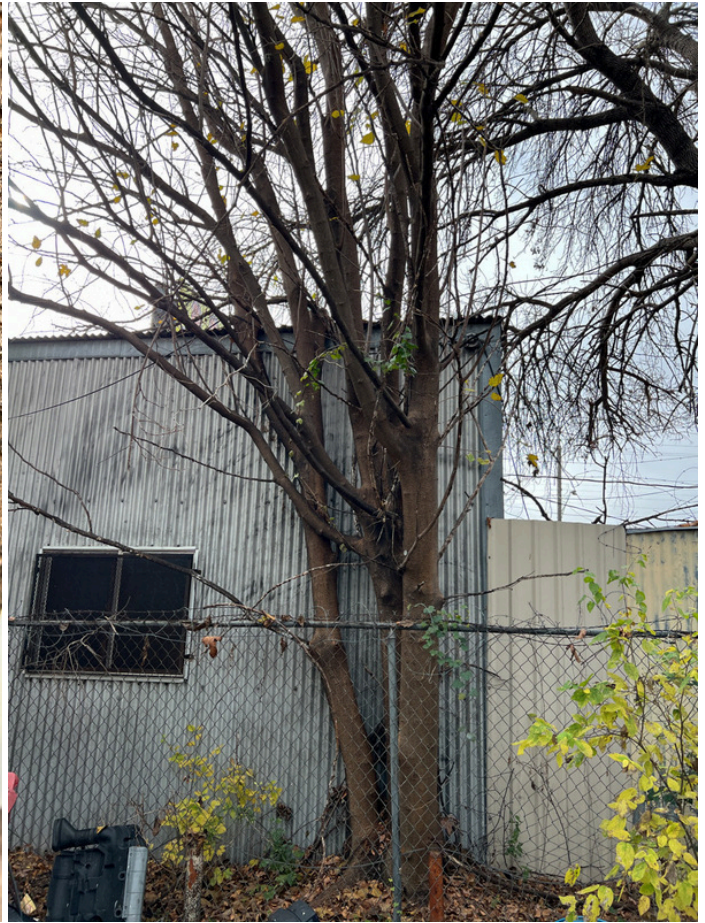
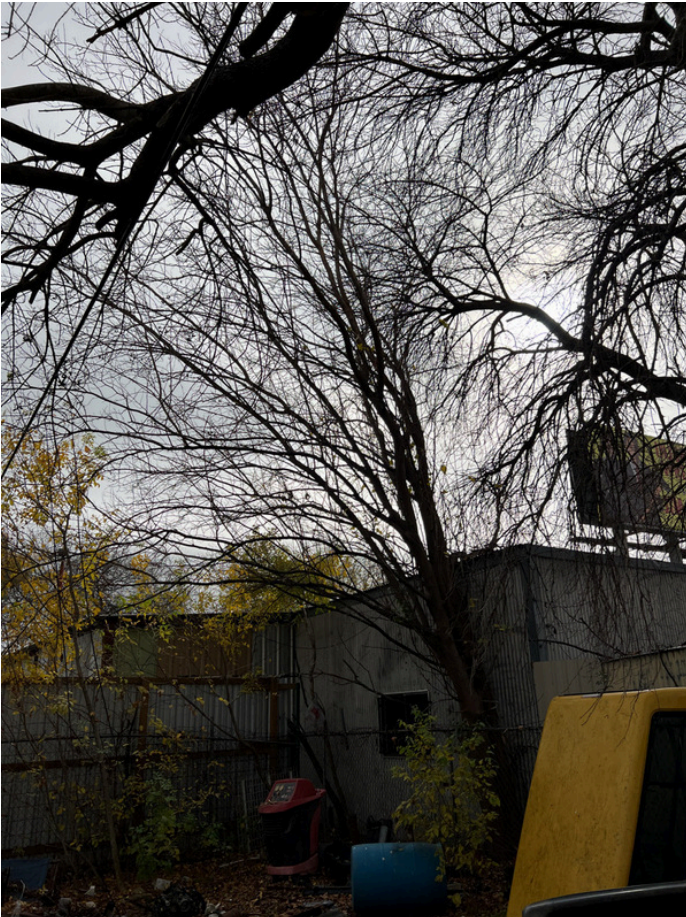
Tree Number	2695
Tree Species	White Mulberry
Diameter (DBH)	12
Multi Stem Notes	
Condition	Invasive
Summary	2695 a 12 inch White Mulberry is in fair overall condition and is a fair candidate for preservation. Tree is inaccessible, DBH was estimated. Tree is listed as not protected.

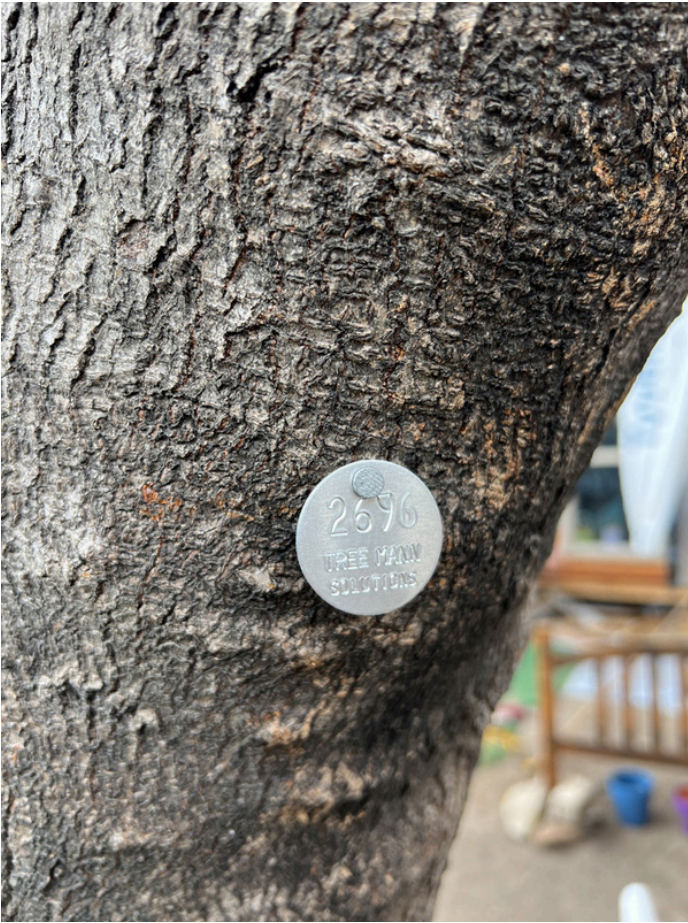
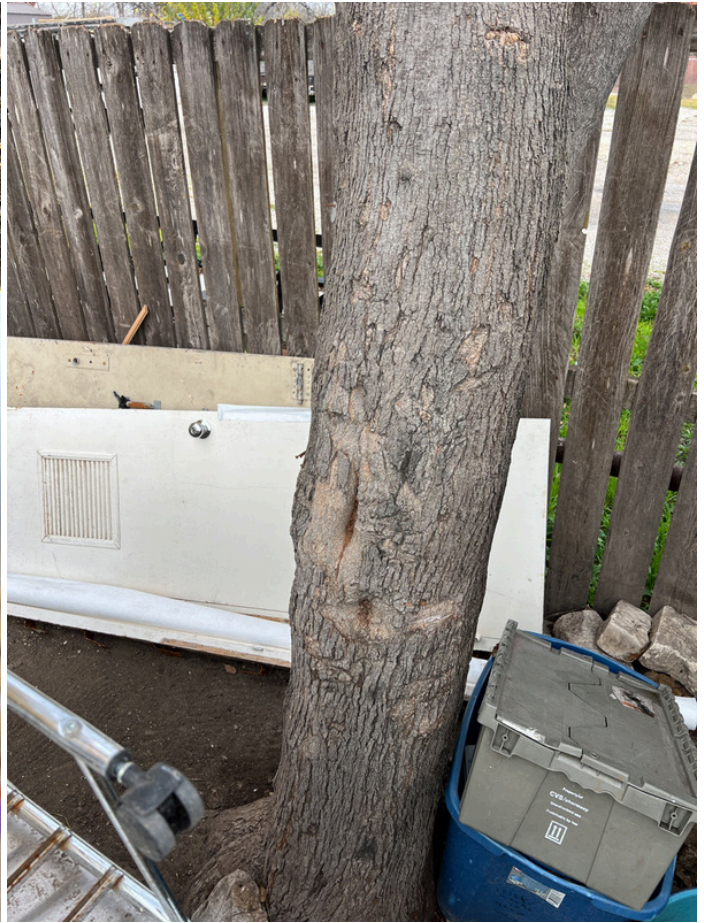
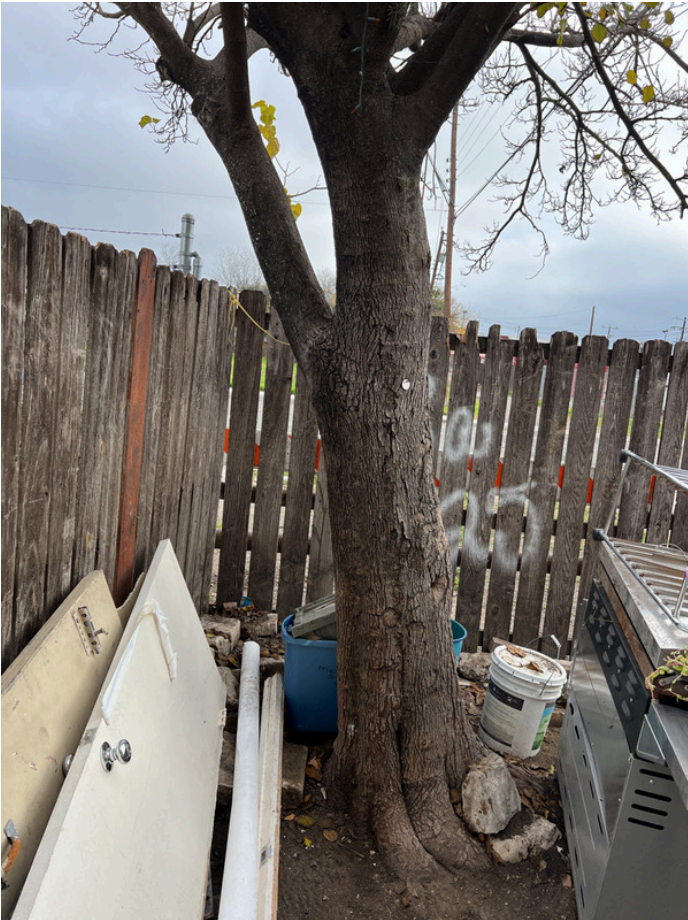
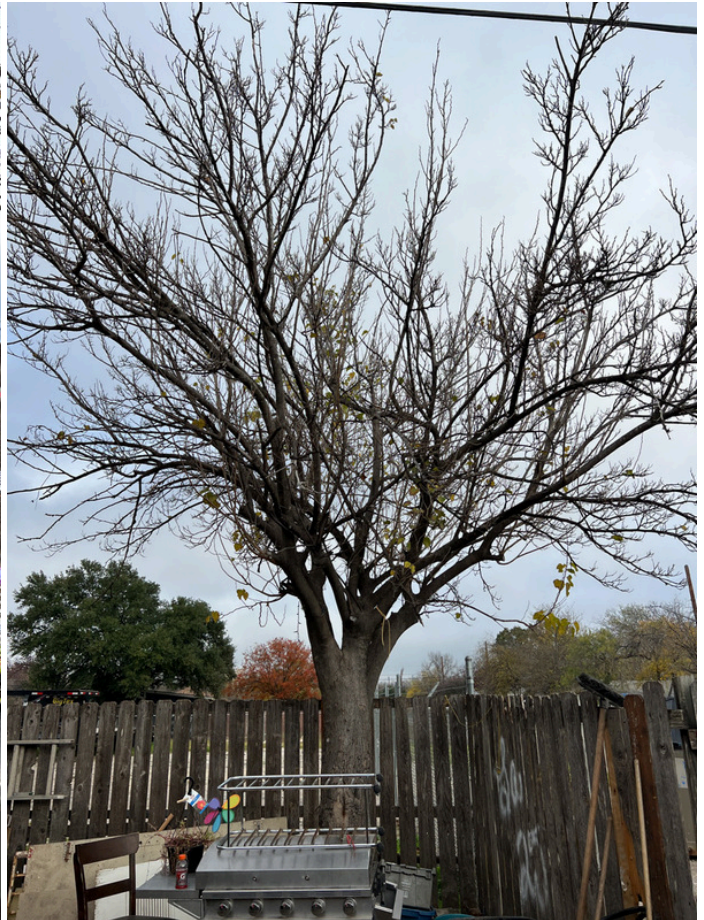
Tree Number	2696
Tree Species	White Mulberry
Diameter (DBH)	15
Multi Stem Notes	
Condition	Invasive
Summary	2696 a 15 inch White Mulberry is in fair overall condition and is a fair candidate for preservation. Tree has significant damage to the trunk, fair overall response growth. Tree is listed as not protected.
