#	Species	DBH	Multi Stem Notes	Condition Rating	Disposition	Summary and Recommendations	Individual Tree Report with Photos
2691	Pecan	14.5		Very Poor	Not Protected - In Decline/Dead	2691 a 14.5 inch pecan is in very poor overall condition and is a very poor candidate for pres	https://fulcrumapp.io/run/53da7710-
2692	Arizona Ash	12		Very Poor	Not Protected - In Decline/Dead	2692 a 12 inch Arizona Ash is in very poor overall condition and is a very poor candidate for	https://fulcrumapp.io/run/53da7710-
2693	Arizona Ash	12.5		Very Poor	Not Protected - In Decline/Dead	2693 a 12.5 inch Arizona Ash is in very poor overall condition and is a very poor candidate f	https://fulcrumapp.io/run/53da7710-
2694	Arizona Ash	20		Fair	Protected - Significant Category	2694 a 20 inch Arizona Ash is in fair overall condition and is a fair candidate for preservation	https://fulcrumapp.io/run/53da7710-
2695	White Mulberry	12		Invasive	Not Protected - Invasive Species	2695 a 12 inch White Mulberry is in fair overall condition and is a fair candidate for preservat	https://fulcrumapp.io/run/53da7710-

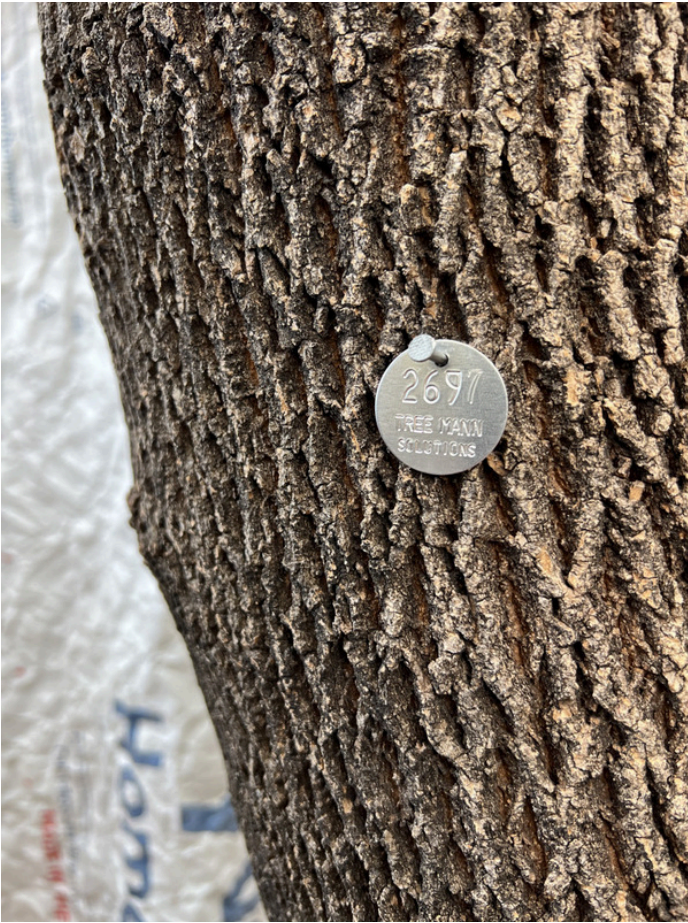
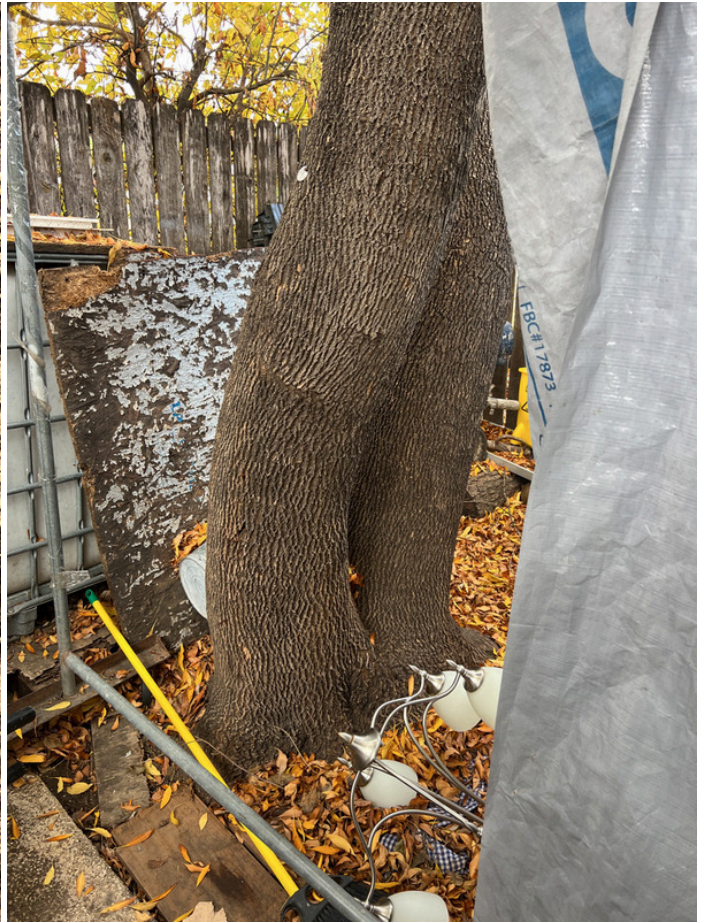
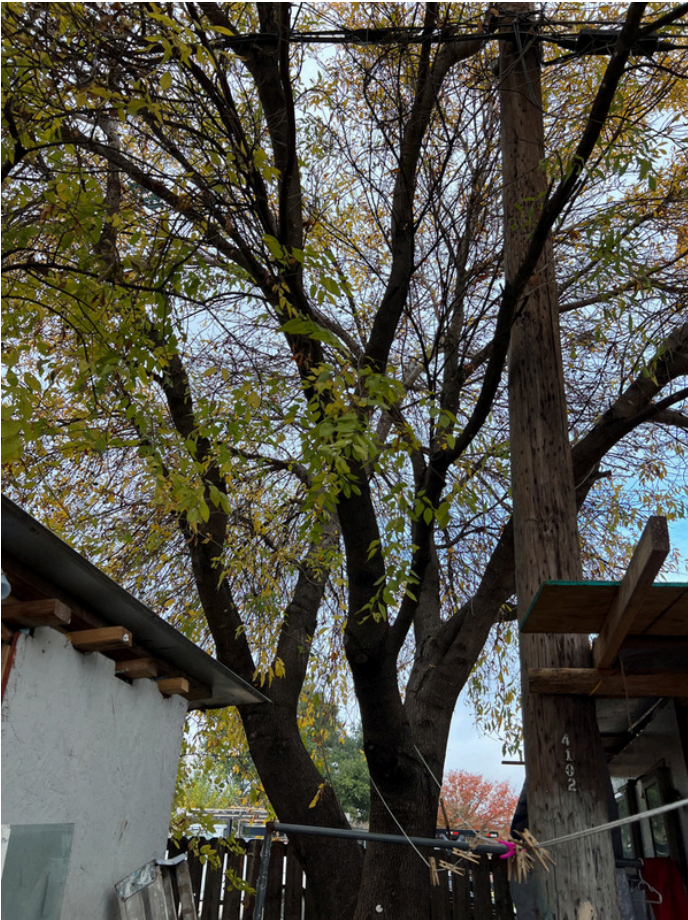
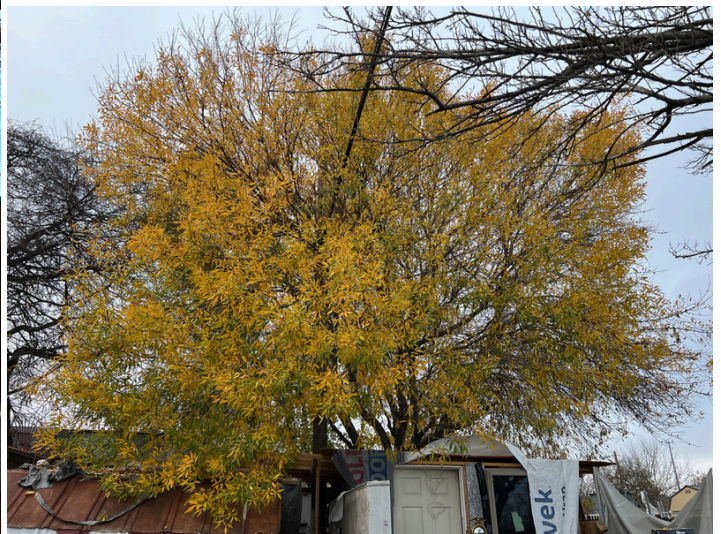
Tree Number	2697
Tree Species	Arizona Ash
Diameter (DBH)	14
Multi Stem Notes	
Condition	Fair
Summary	2697 a 14 inch multi stem Arizona Ash is in fair overall condition and is a fair candidate for preservation.

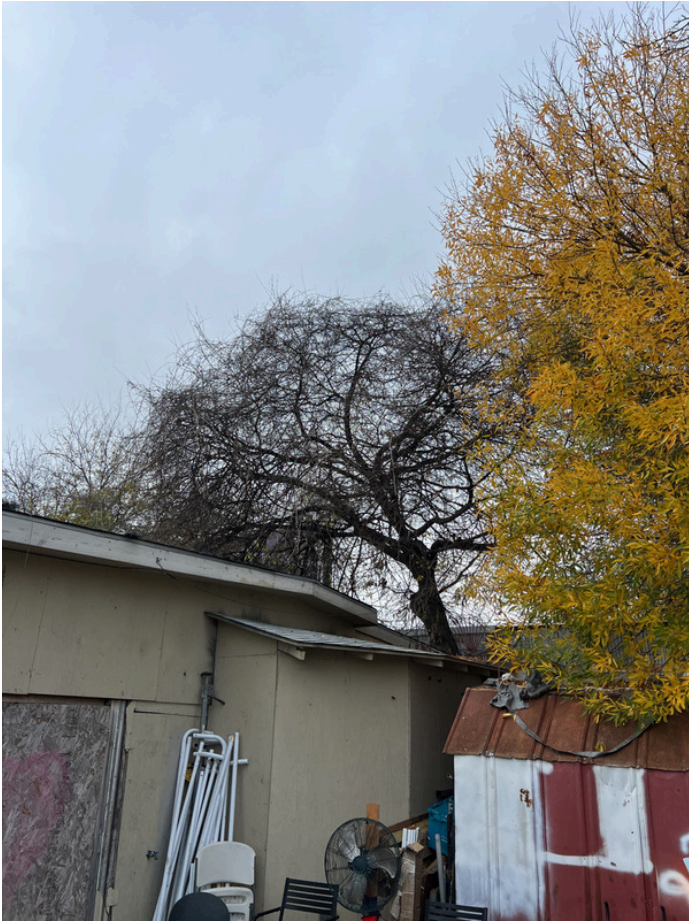
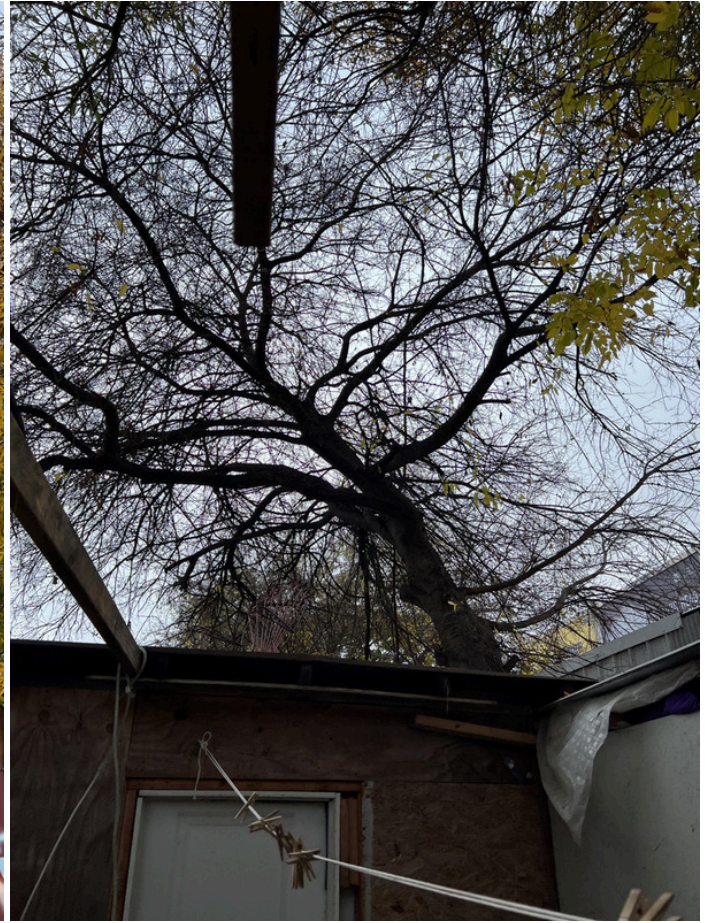
Tree Number	2698
Tree Species	Hackberry
Diameter (DBH)	15
Multi Stem Notes	
Condition	Fair
Summary	2698 a 15 inch Hackberry is in fair overall condition and is a fair candidate for preservation. Tree is inaccessible between buildings, DBH was estimated. Significant lean to the southeast over building.
