# HISTORIC AND DESIGN REVIEW COMMISSION

**HDRC CASE NO:** 2022-085  
**COMMON NAME:** Young Women's Leadership Academy  
**ADDRESS:** 2123 W HUISACHE AVE  
**LEGAL DESCRIPTION:** NCB 6827 BLK LOT 41 SAISD MANN MIDDLE SCHOOL SUB  
**ZONING:** R-6, H  
**CITY COUNCIL DIST.:** 7  
**DISTRICT:** Monticello Park Historic District  
**APPLICANT:** Mitchell Ford/Cox McLain Environmental Consulting, Inc. - now Stantec  
**OWNER:** Nkonye Adaikpoh/SAN ANTONIO ISD  
**TYPE OF WORK:** Partial demolition, new construction of additions, window replacement, exterior alterations, site work  
**APPLICATION RECEIVED:** May 27, 2022  
**60-DAY REVIEW:** Not applicable Due to City Council Emergency Orders  
**CASE MANAGER:** Rachel Rettaliata  
**REQUEST:**

#### **DRAFT REPORT**

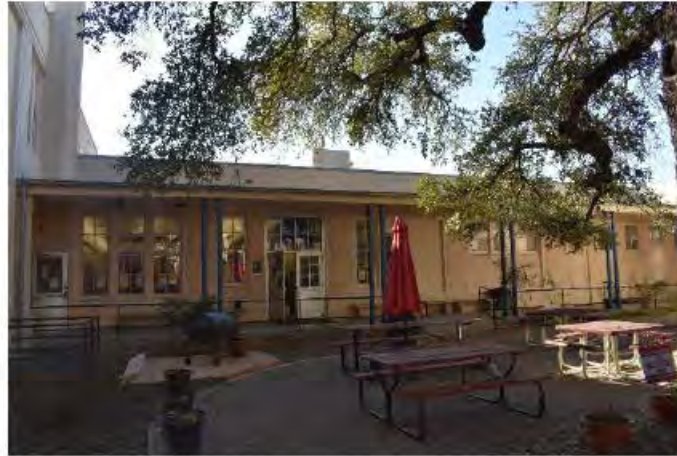
*Image 1: Library wing facing west*

Although OHP has determined the library wing as a contributing component of the building, it is our assessment that this section of the building has lost most of its integrity and does not convey historical significance to the same degree as the main building volume.

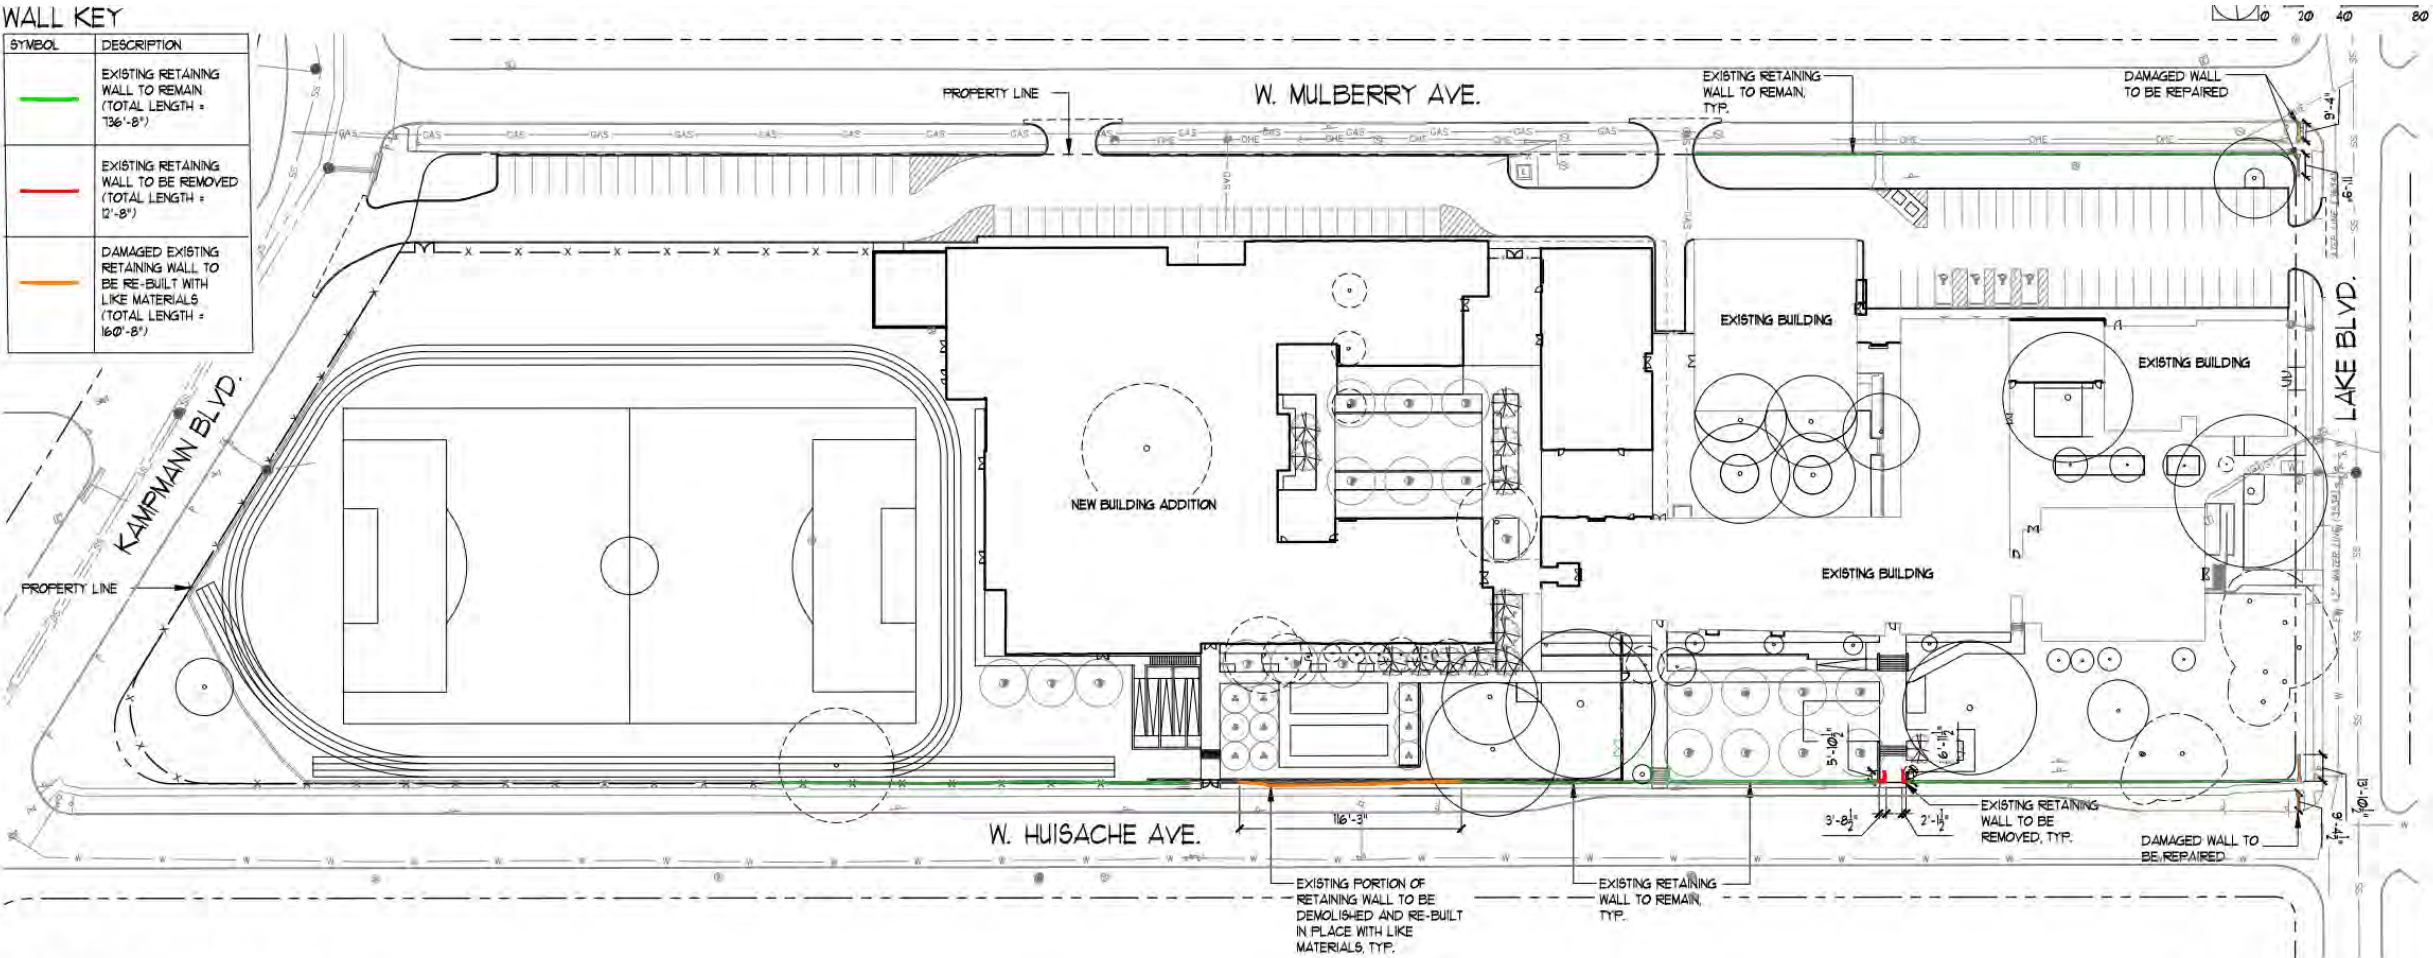
# RETAINING WALL EXHBIT

DAMAGED EXISTING RETAINING WALL TO BE RE-BUILT WITH LIKE MATERIALS (TOTAL LENGTH = 160'-8")

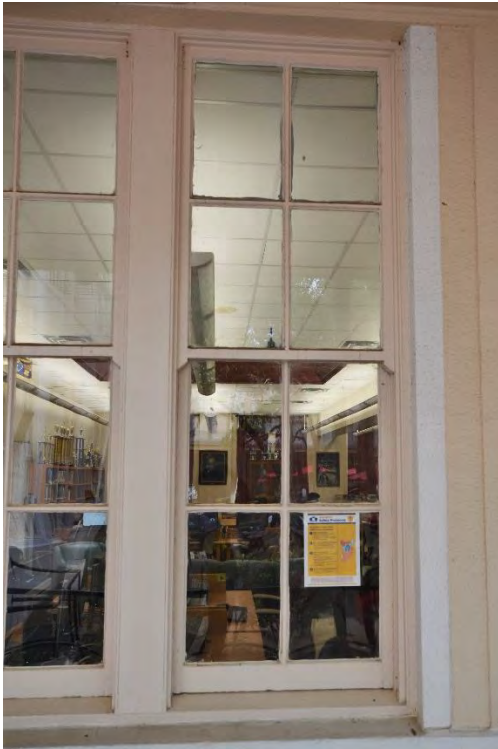
Figure 3. Original double hung sashes in an original frame, east elevation of library in courtyard.

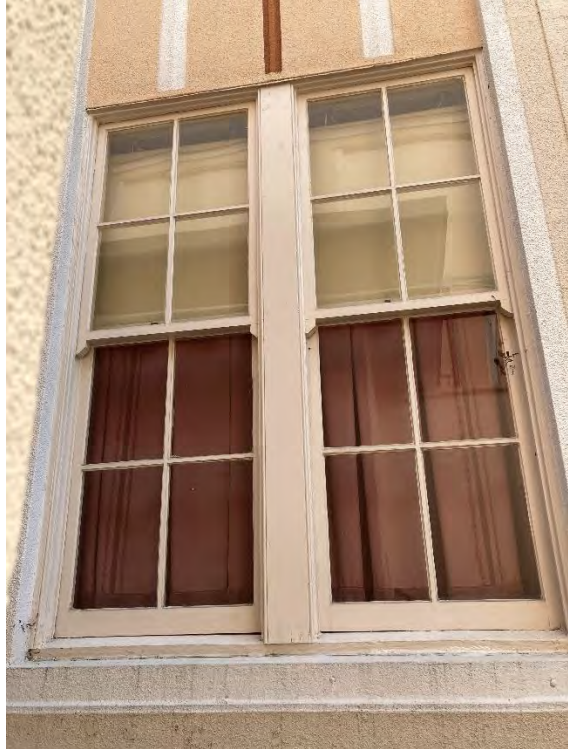
Figure 4. Replacement double hung sashes in an original frame, east elevation of auditorium.

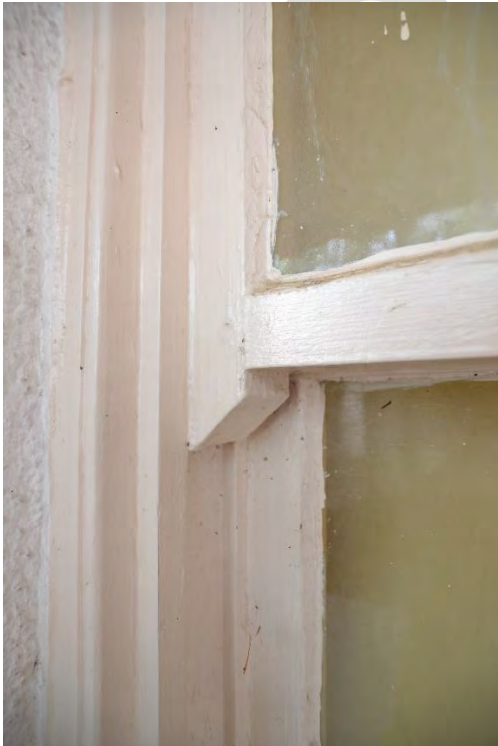
Figure 5. Upper sash tail block detail on an original window. Sash contains glazing putty. Sash is painted shut.

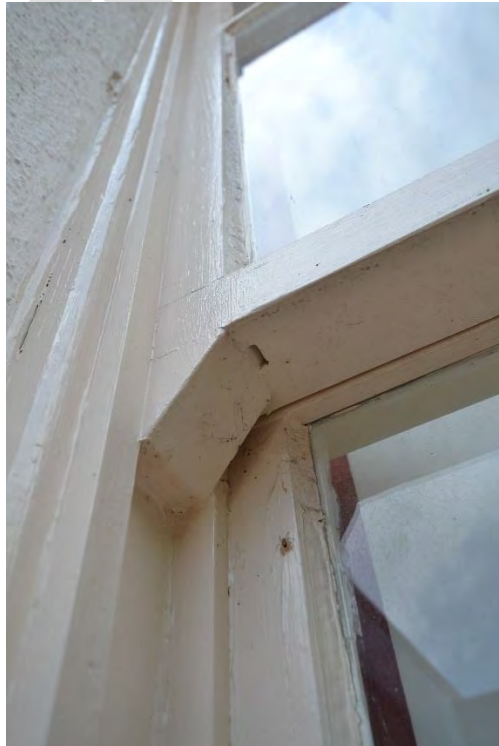
Figure 6. Upper sash tail block detail on a replacement window with sealant at glazing. Sash is painted shut.

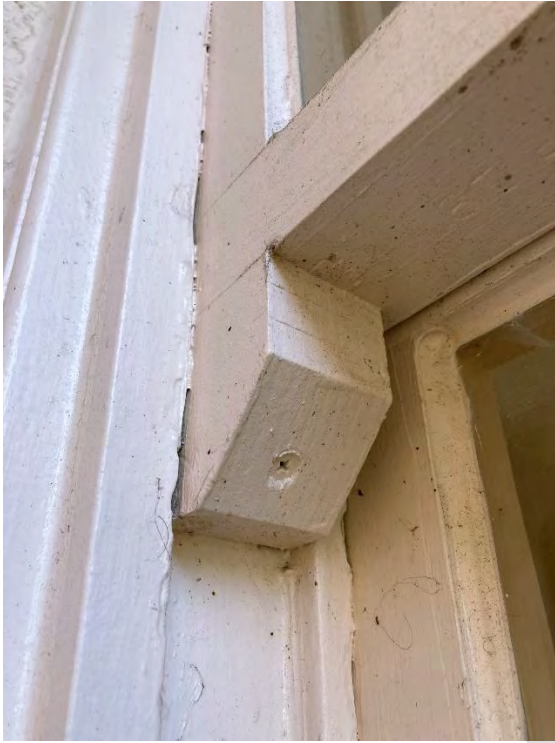
Figure 7. Upper sash tail block detail on a replacement window with sealant at glazing. Sash is screwed in place.

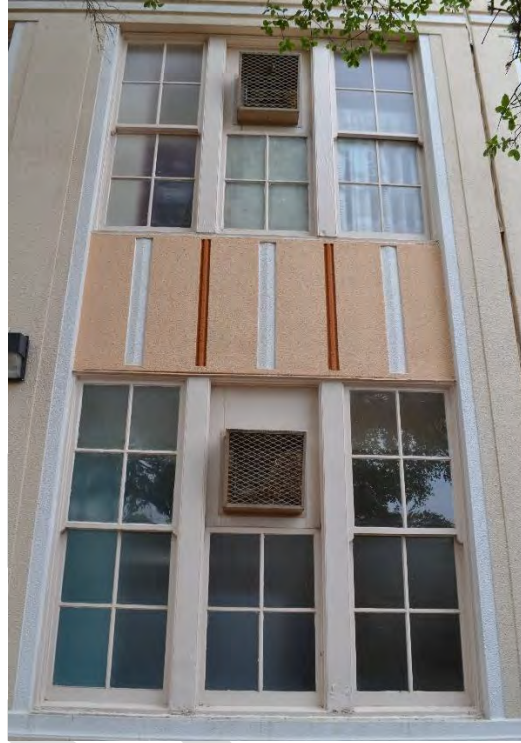
Figure 8. Removed sashes and inappropriate repairs at stiles.

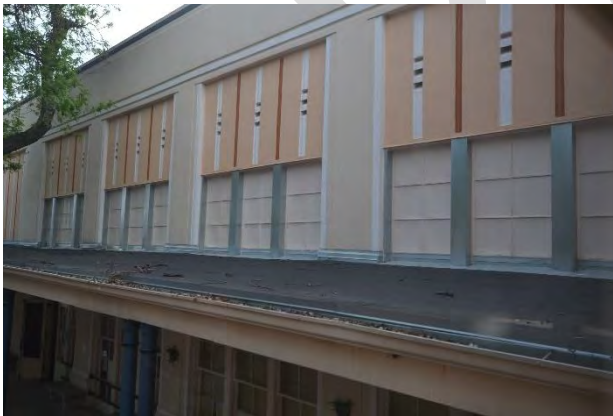
Figure 9. West elevation auditorium windows have been blocked off.

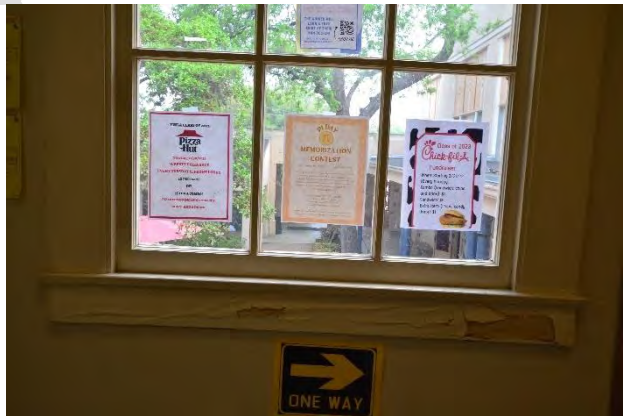
Figure 10. Moisture damage at the apron, sill and adjacent wall in the east stair.

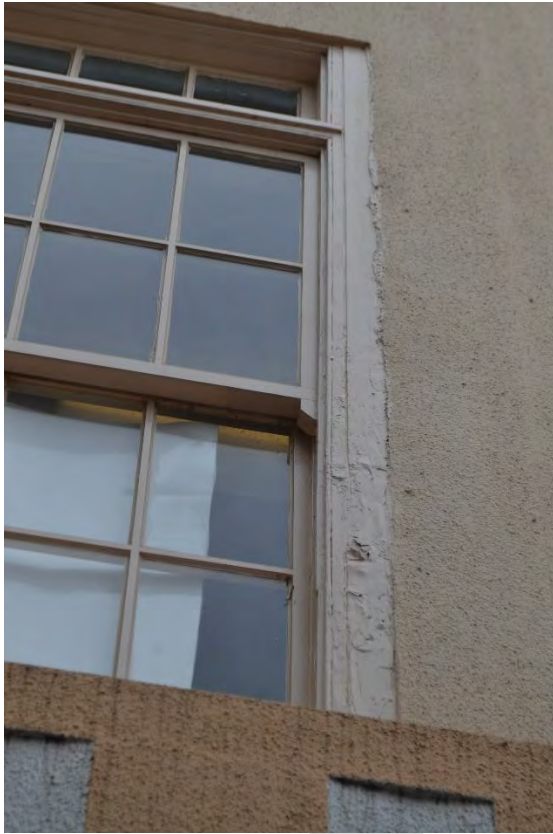
Figure 11. Damage to frame at west stair window.

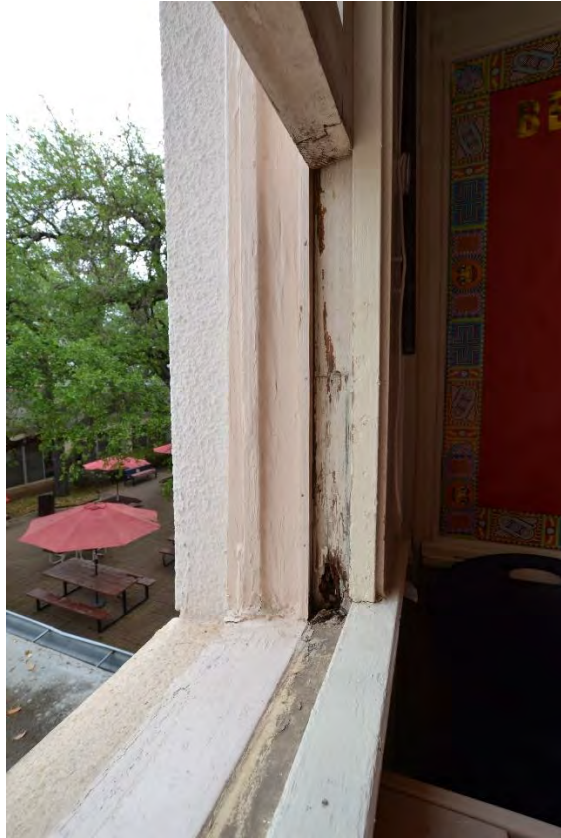
Figure 12. Rotted frame at window jamb and sill.

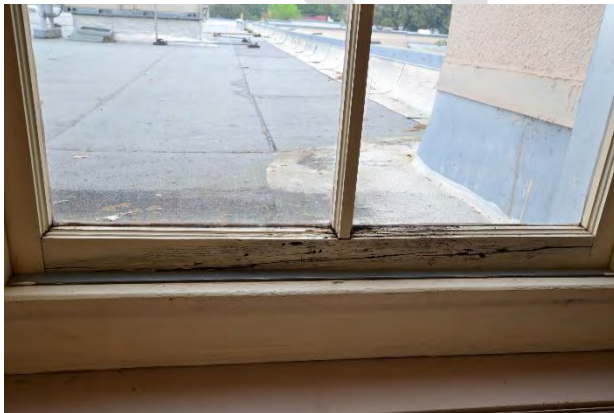
Figure 13. Moisture damage at sash near plane of roof. Note roof flashing turned into frame at sill.

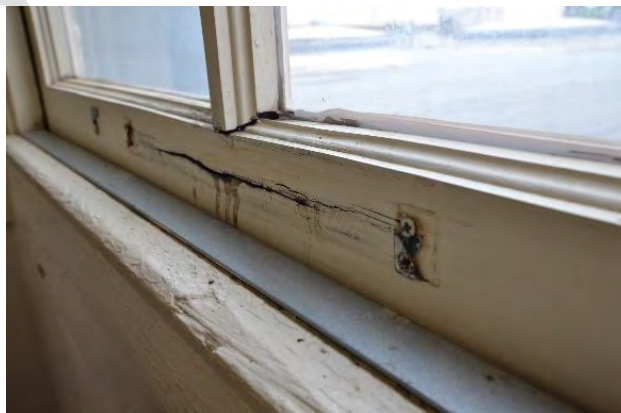
Figure 14. Roof flashing tied into windowsill.

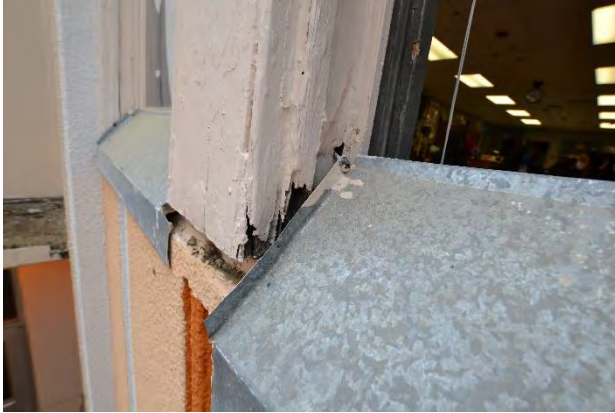
Figure 15. Moisture damage at stile and loose-laid sill pan flashing.

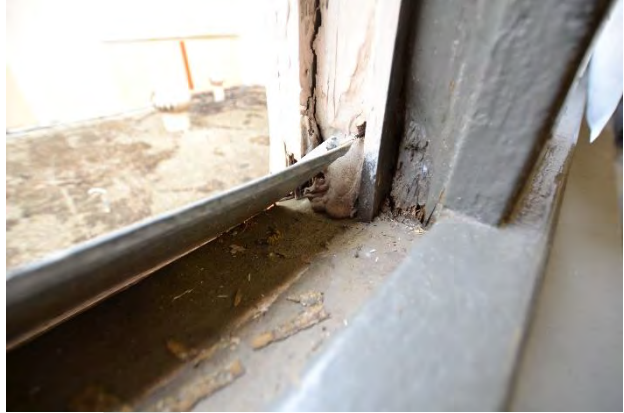
Figure 16. Rotted frame and inappropriate sealant repair at window jamb and sill. Moisture damage likely exacerbated by loose-laid sill pan flashing.

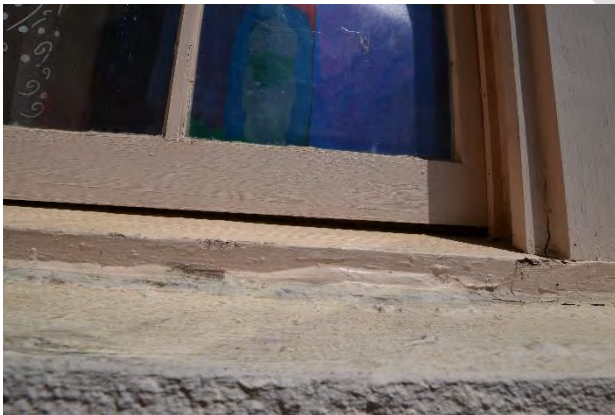
Figure 17. Window not fully closed.

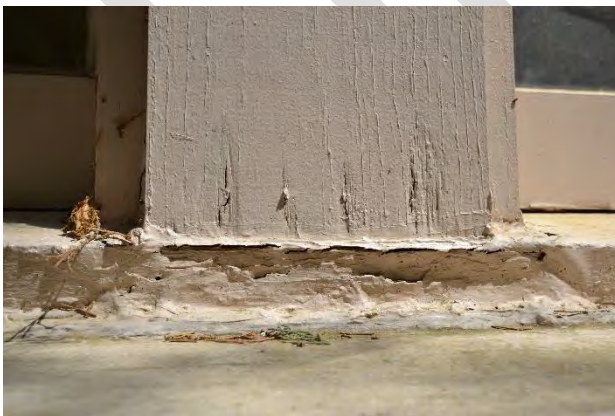
Figure 19. Deterioration at mullion and sill.

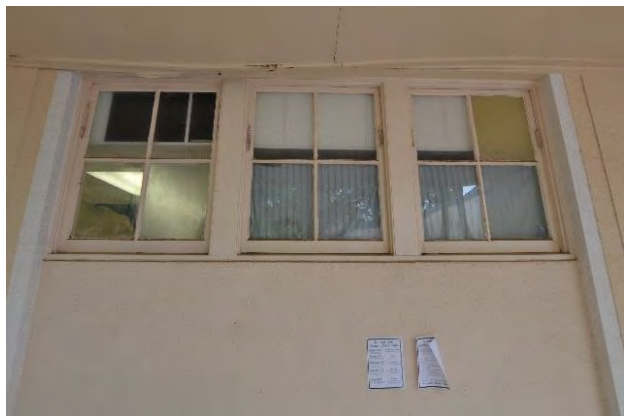
Figure 20. Mismatched replacement glazing.

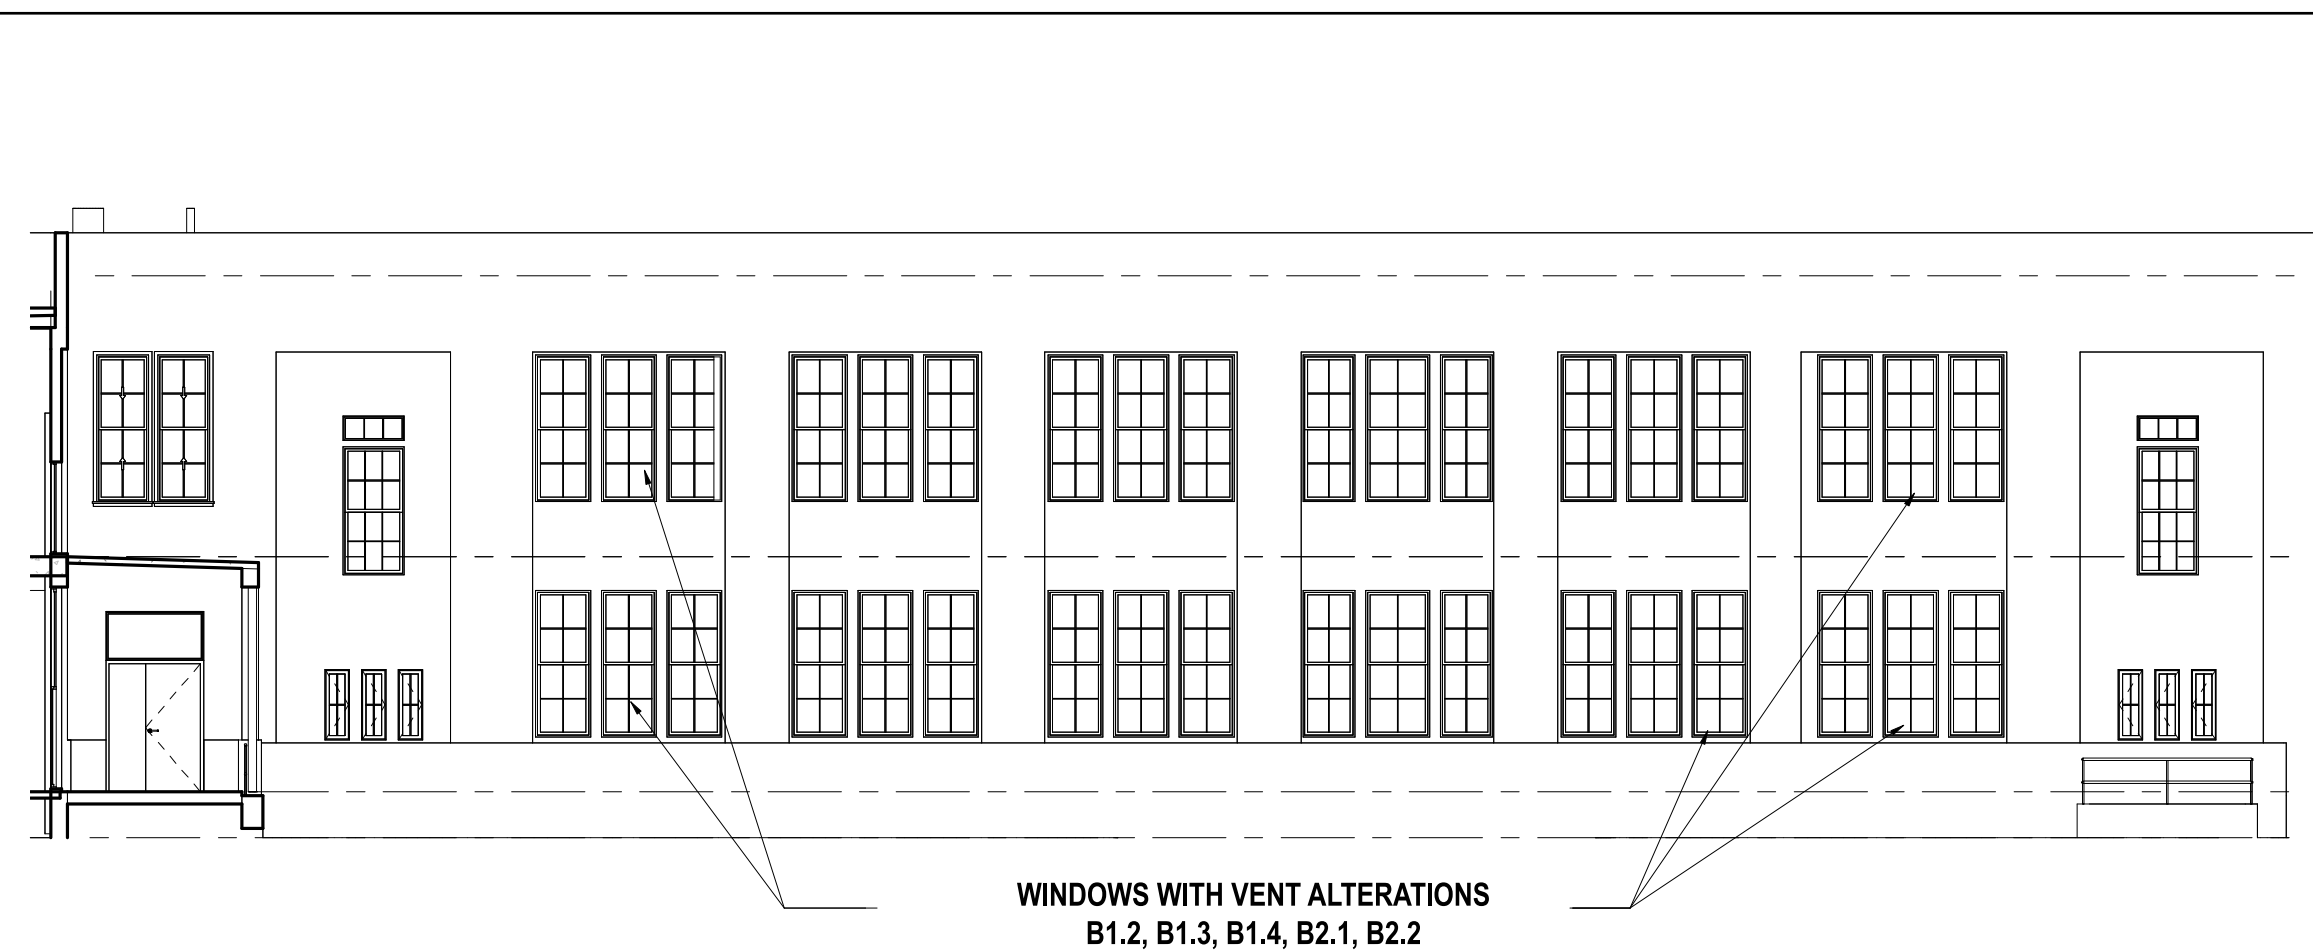
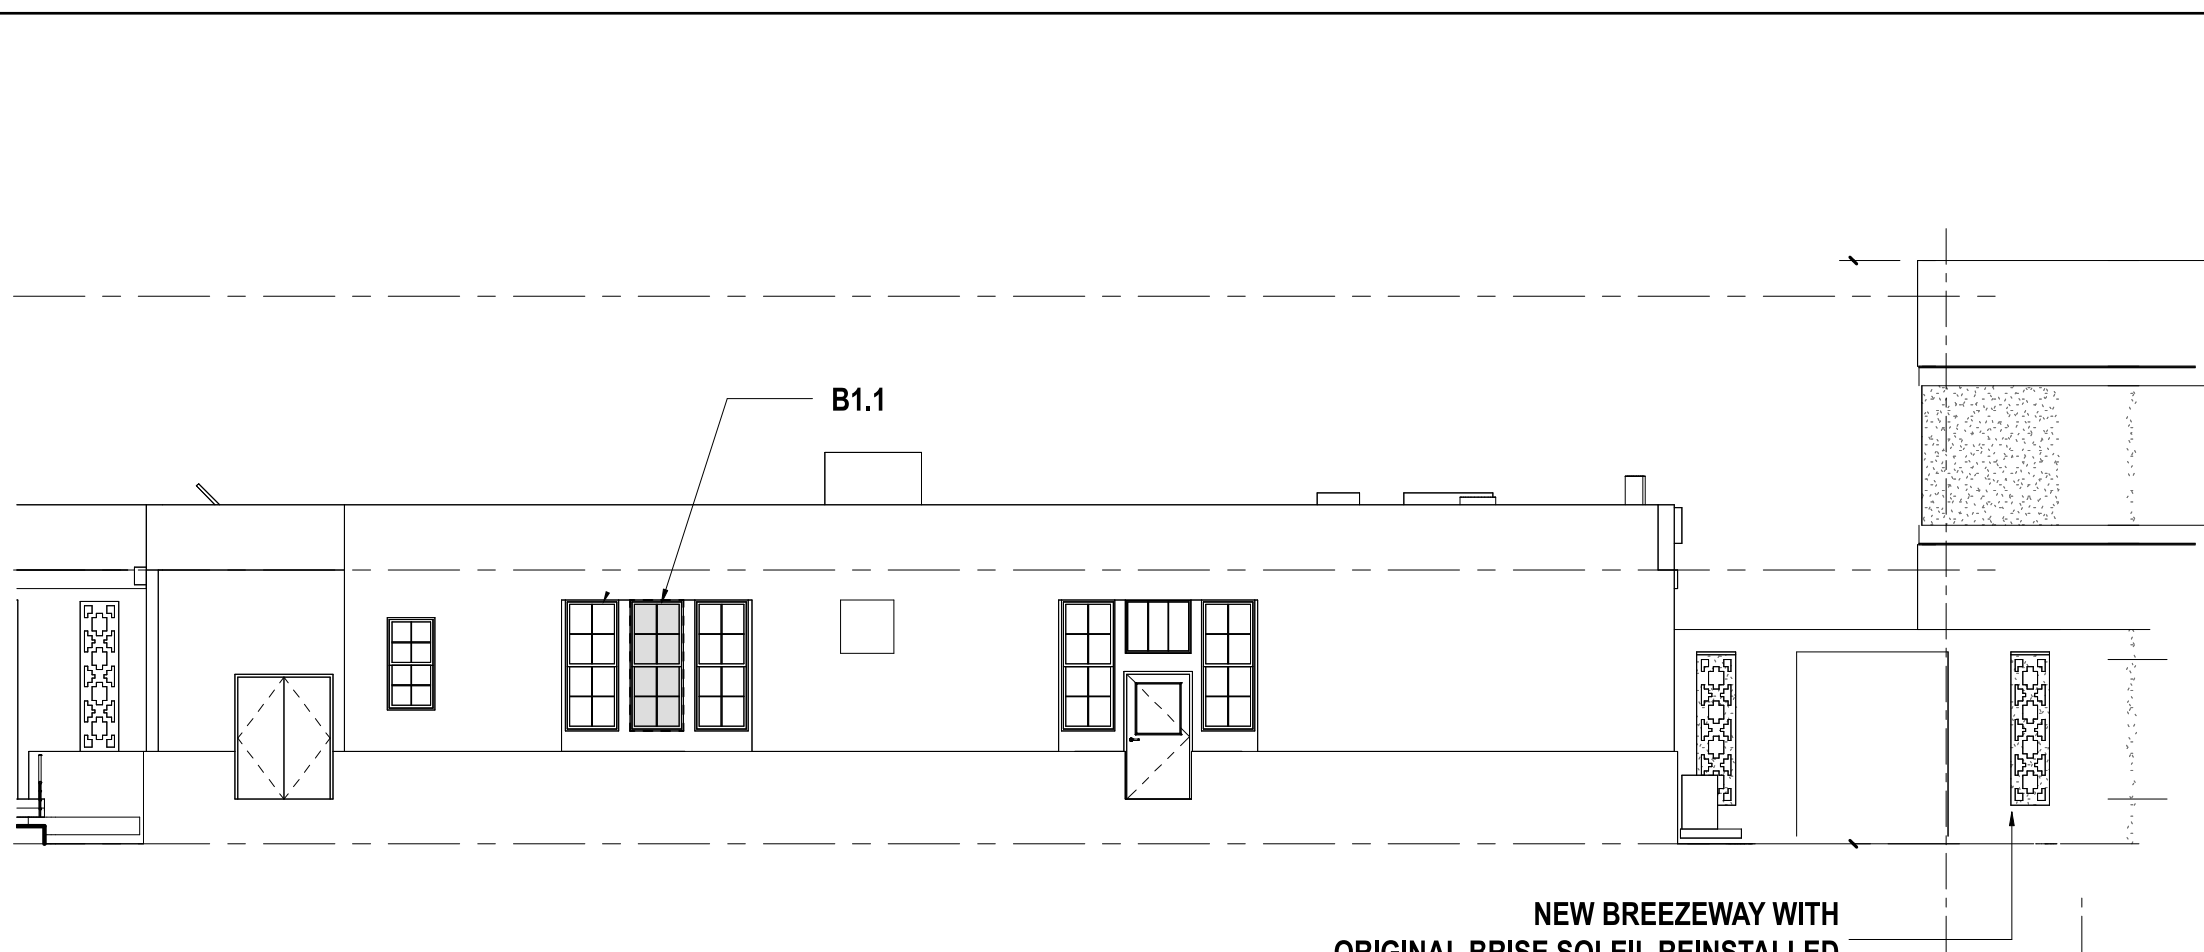
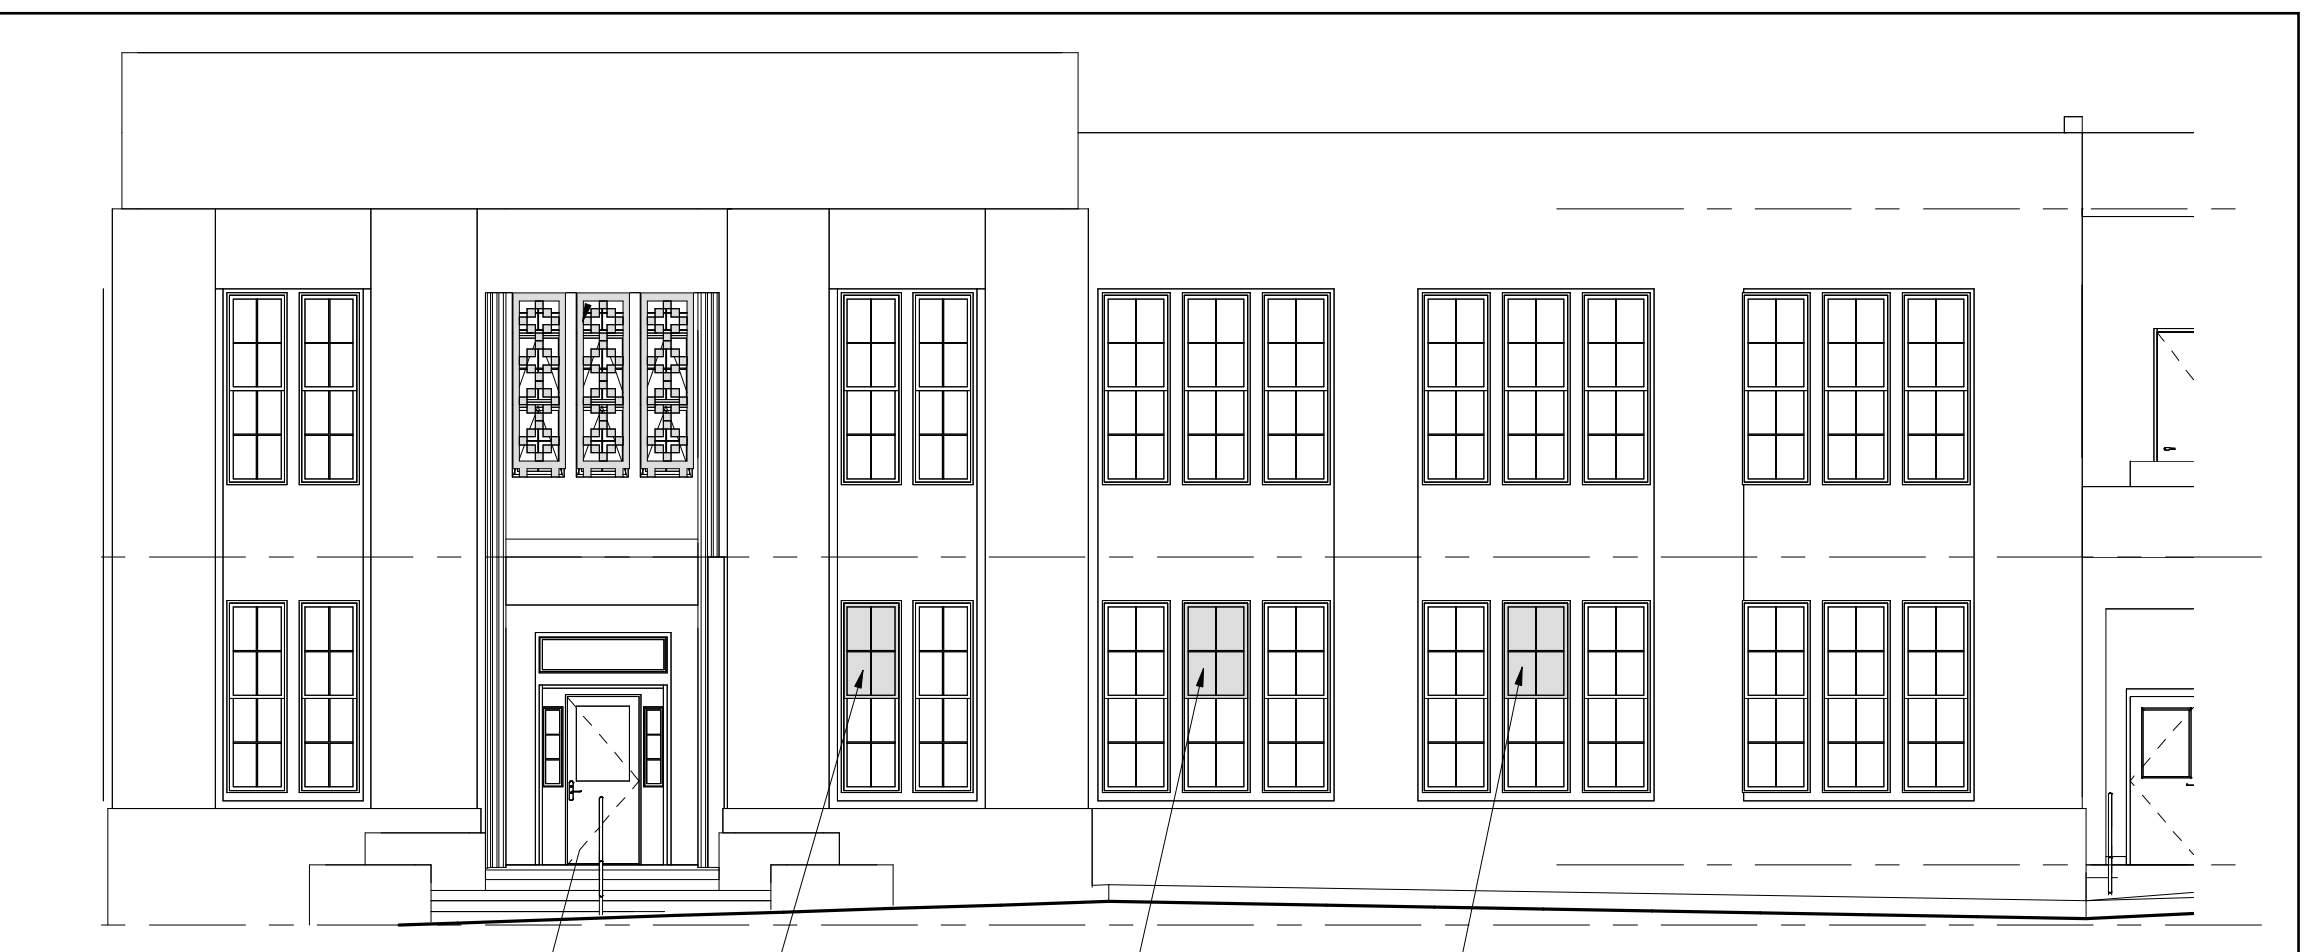
DETAIL A. NORTH ELEVATION COURTYARD VIEW  
ALTERED WINDOWS WITH VENTS; REPLACE WINDOWS WITH SALVAGED SASHES

DETAIL B. NORTH ELEVATION REAR  
ALTERED WINDOWS WITH VENTS; REPLACE WINDOWS WITH SALVAGED SASHES

DETAIL C. SOUTH FACADE  
ALTERED WINDOWS WITH VENTS; REPLACE WINDOWS WITH SALVAGED SASHES

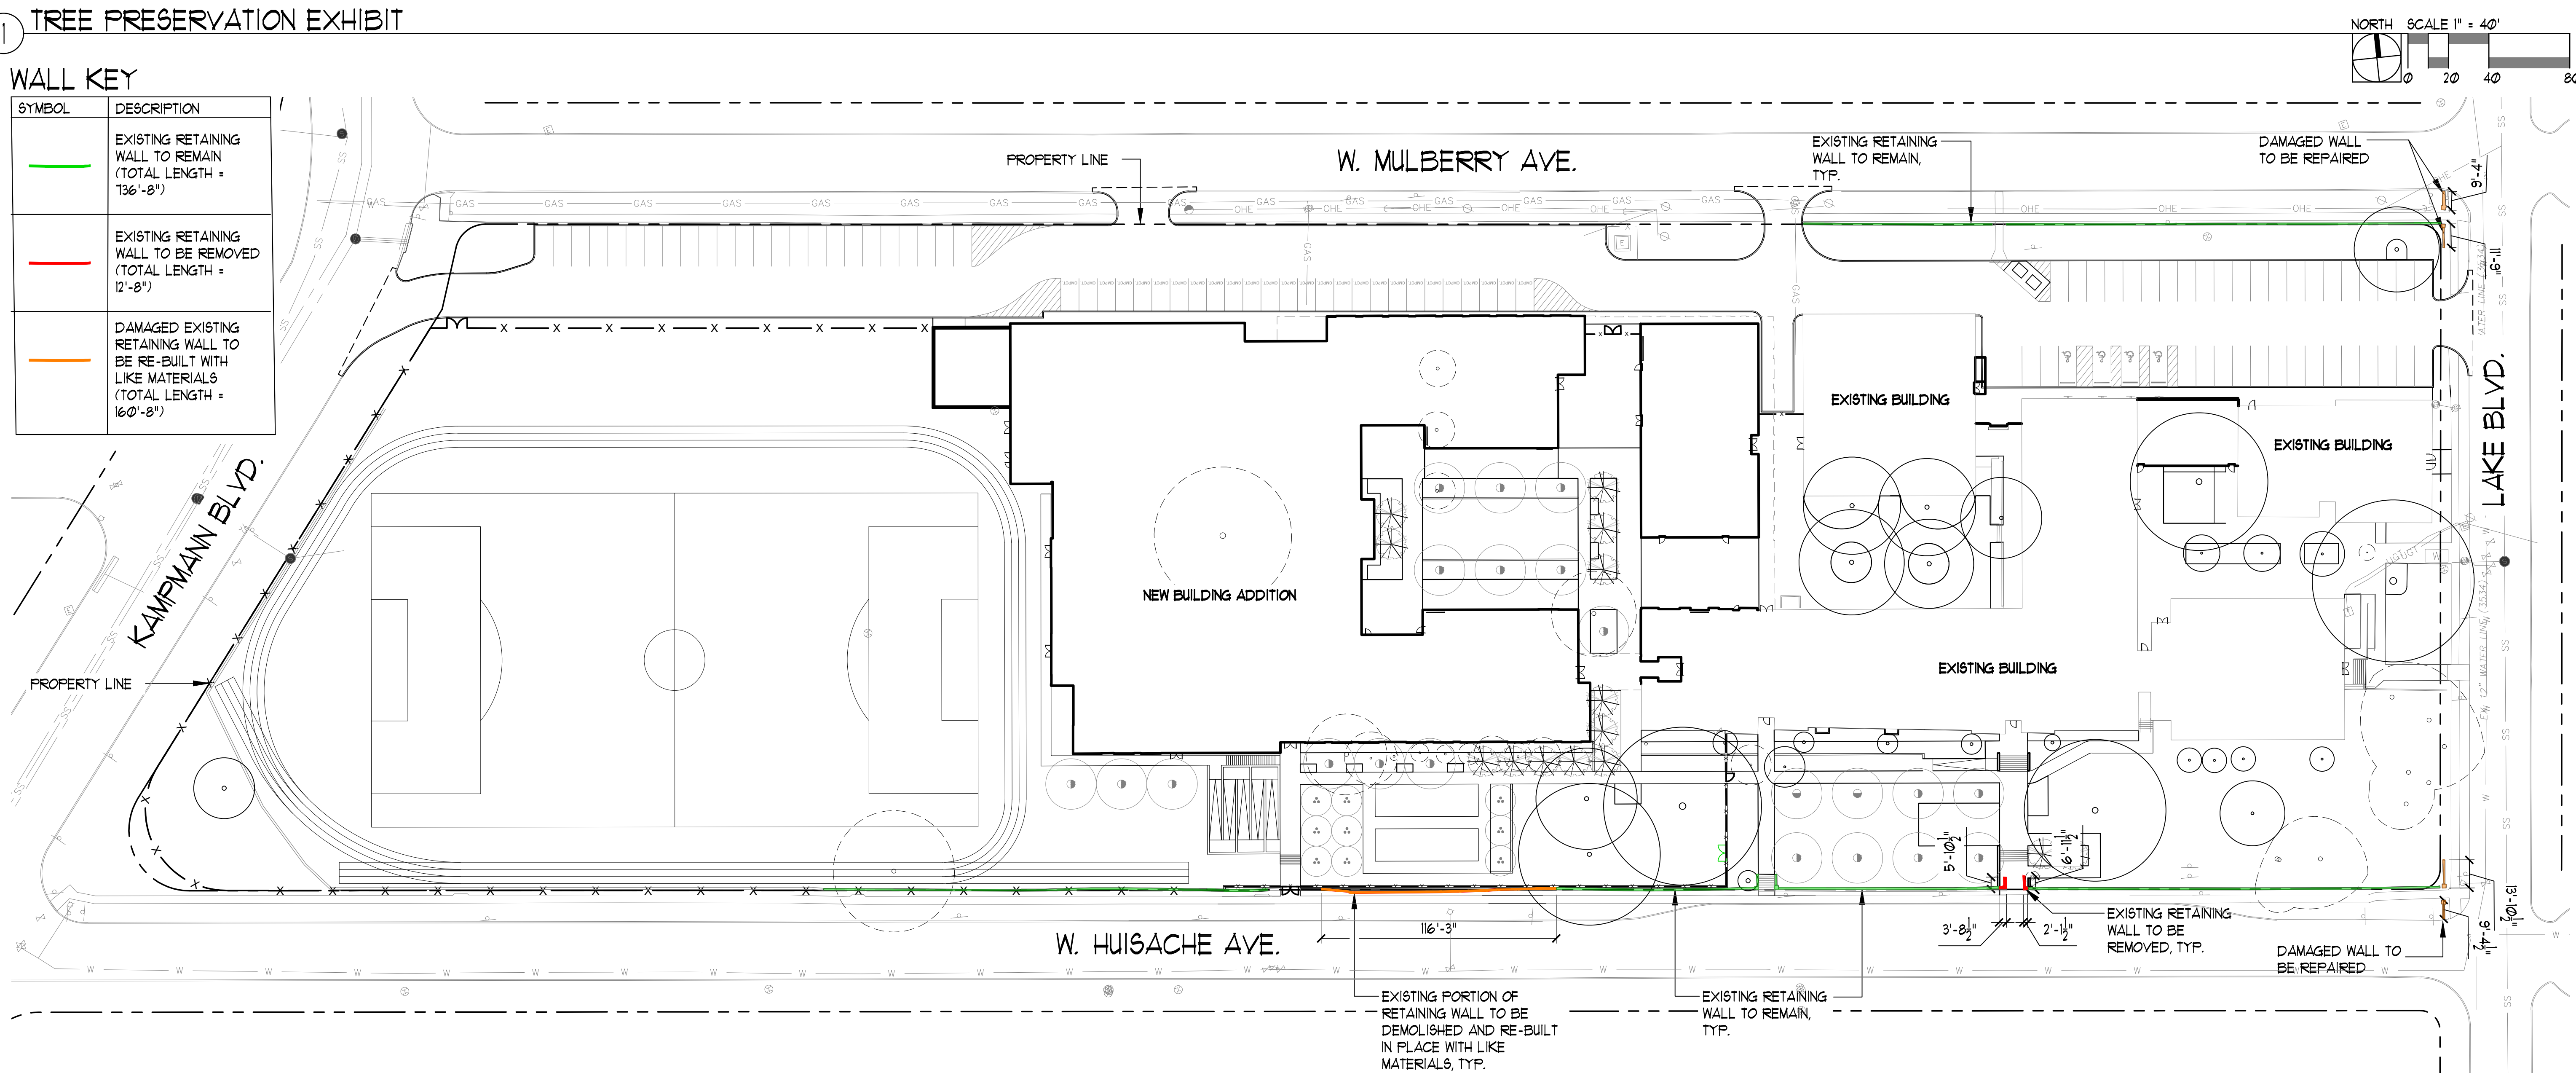
2 RETAINING WALL EXHIBIT

DAMAGED EXISTING RETAINING WALL TO BE RE-BUILT WITH LIKE MATERIALS (TOTAL LENGTH = 160'-8")
