# HISTORIC AND DESIGN REVIEW COMMISSION

**HDRC CASE NO:** 2022-428  
**ADDRESS:** 1614 E HOUSTON ST  
**LEGAL DESCRIPTION:** NCB 577 BLK 16 LOT 5  
**ZONING:** RM-4, H  
**CITY COUNCIL DIST.:** 2  
**DISTRICT:** Dignowity Hill Historic District  
**APPLICANT:** William Brewer/Done Right Construction DBA  
**OWNER:** GOFORTH DERETHA & PATRICIA SCOTT  
**TYPE OF WORK:** Demolition of a landmark  
**APPLICATION RECEIVED:** July 12, 2022  
**60-DAY REVIEW:** Not applicable due to City Council Emergency Orders  
**CASE MANAGER:** Claudia Espinosa  
**REQUEST:**

## **Structural Assessment – Fire Damage Report**

Roof, Foundation and Framing Inspection, Fire Damage-1614 E. Houston St, San Antonio, TX.

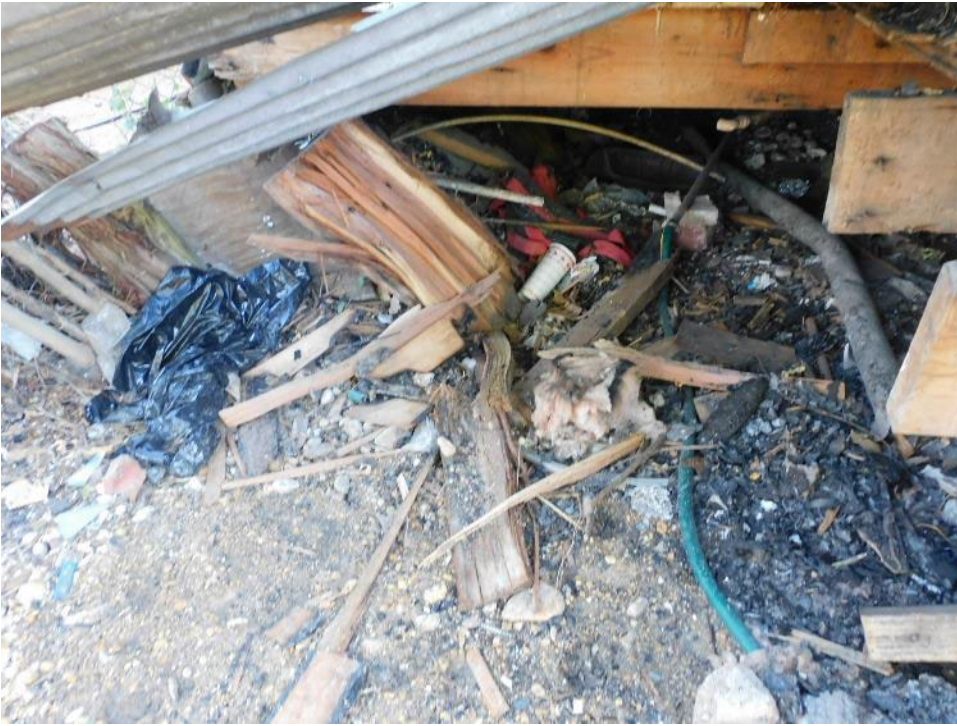
1. The foundation consisted of cedar post supporting wood beams and wood joists.
2. The cedar posts were toppled, tilted, or dislodged.
3. The wood beams were dislodged or tilted.
4. The wood joists were buckled and tilted.
5. The floor framing at the rear was severely damaged and charred.
6. An elevation survey was not conducted on the interior due to the conditions observed.

Photo 11, Crawlspace, damaged foundation pier.

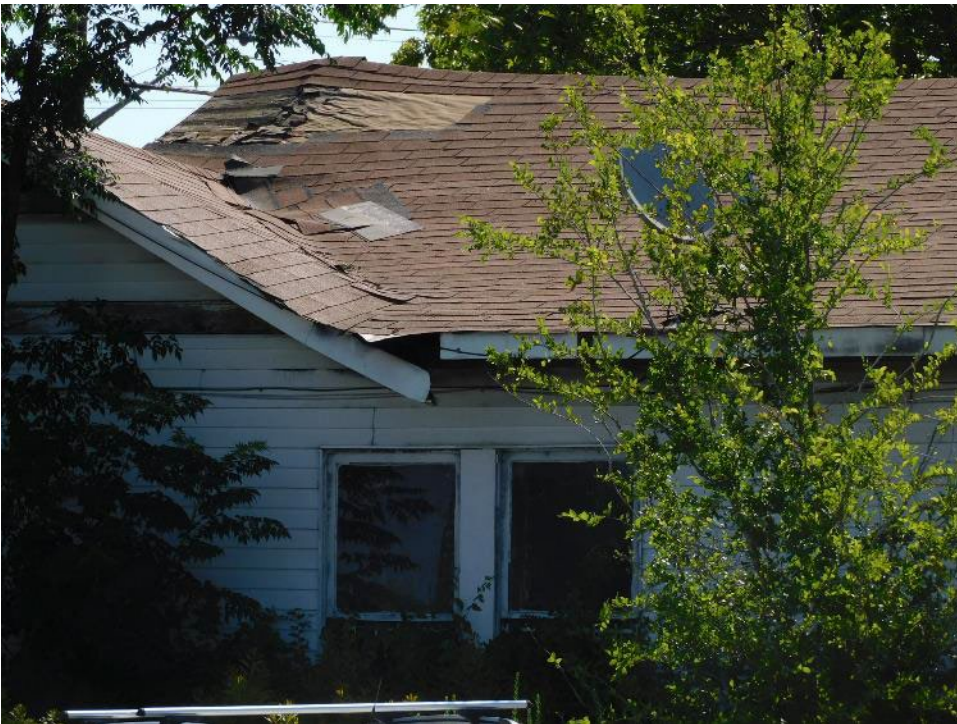
Photo 12, Exterior, damaged roof, east elevation.

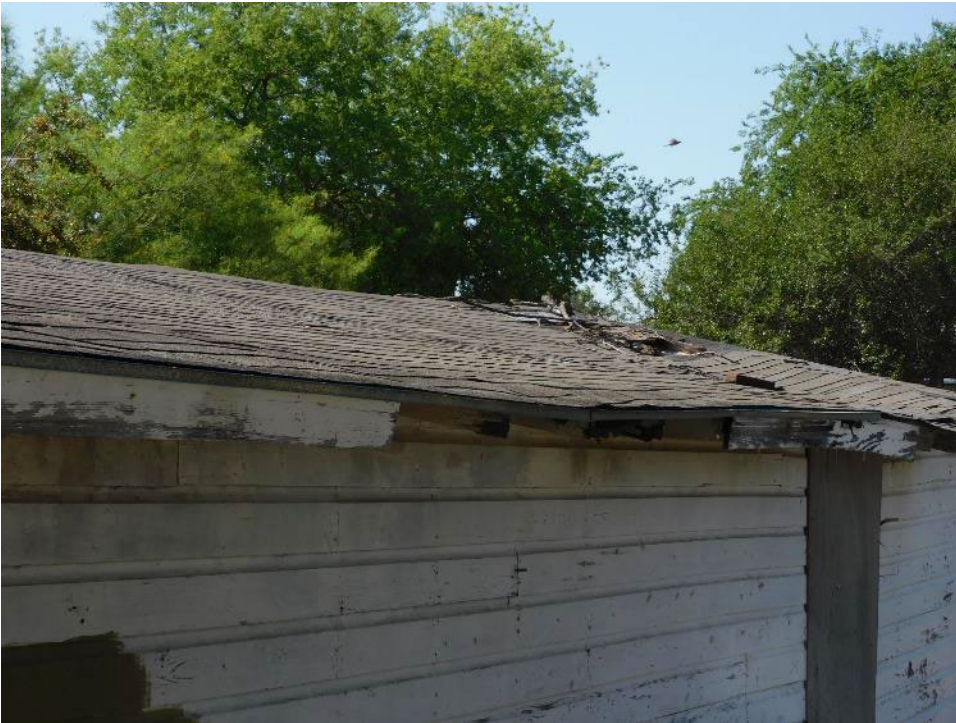
1. The exterior cladding was aluminum siding and wood panels.
2. There were signs of damage to the aluminum siding along the east and north elevations.
3. The exterior framing was visibly racked to the west.
4. The roof line was visibly buckled and bowed.
5. The garage showed signs of weathering and age.
6. The garage roof framing was bowed with a hole in the roof deck.

Photo 13, Exterior, garage roof.

As discussed, onsite, we recommend mechanical methods for the demolition of the structure for safety concerns. The structure should be considered "unsafe" and under no conditions should anyone enter the interior or access the roof. The existing conditions for the detached garage also warrant demolition and the same methods should be considered.

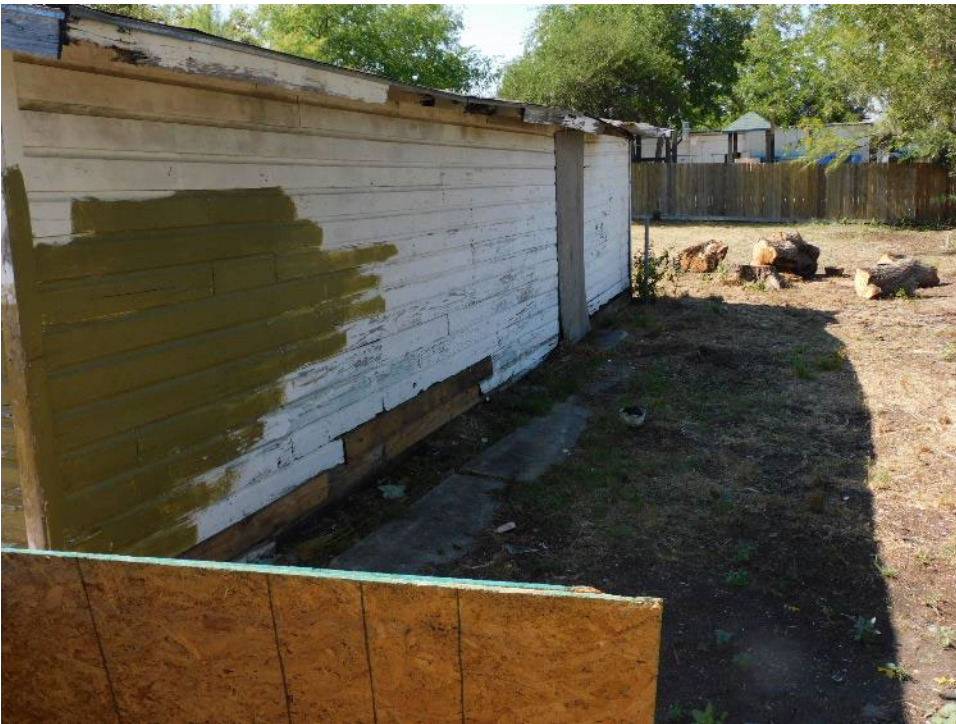
Photo 14, Exterior, garage cladding.
