# HISTORIC AND DESIGN REVIEW COMMISSION

**HDRC CASE NO:** 2022-428  
**ADDRESS:** 1614 E HOUSTON ST  
**LEGAL DESCRIPTION:** NCB 577 BLK 16 LOT 5  
**ZONING:** RM-4, H  
**CITY COUNCIL DIST.:** 2  
**DISTRICT:** Dignowity Hill Historic District  
**APPLICANT:** William Brewer/Done Right Construction DBA  
**OWNER:** GOFORTH DERETHA & PATRICIA SCOTT  
**TYPE OF WORK:** Demolition of a historic landmark  
**APPLICATION RECEIVED:** July 12, 2022  
**60-DAY REVIEW:** Not applicable due to City Council Emergency Orders  
**CASE MANAGER:** Claudia Espinosa  
**REQUEST:**

## **Structural Assessment – Fire Damage Report**

Roof, Foundation and Framing Inspection, Fire Damage-1614 E. Houston St, San Antonio, TX.

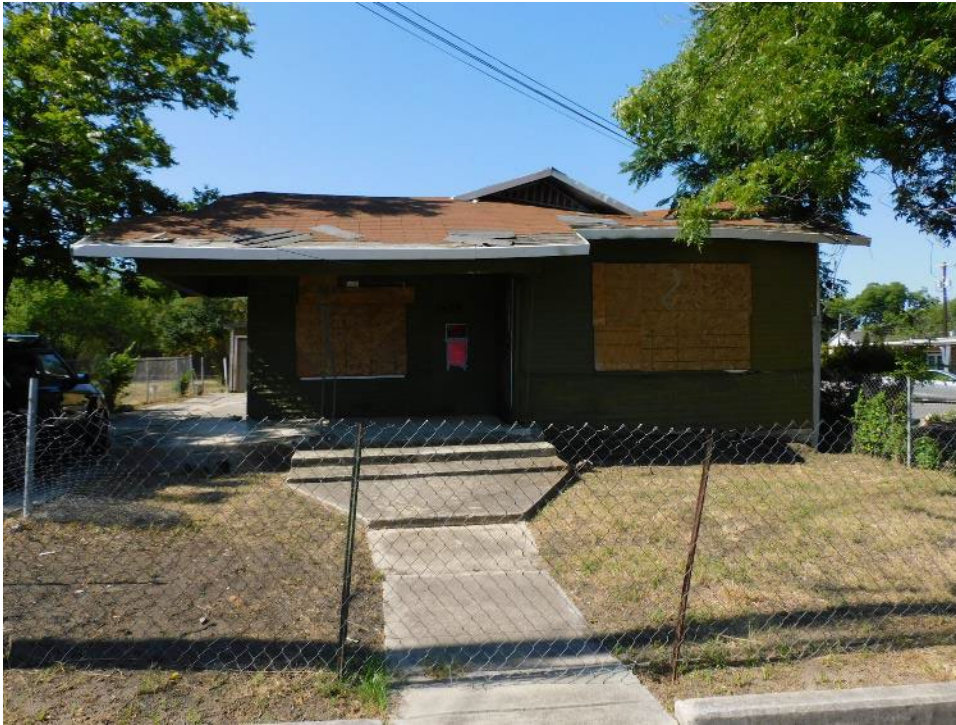
Photo 1, North elevation, overall (front).

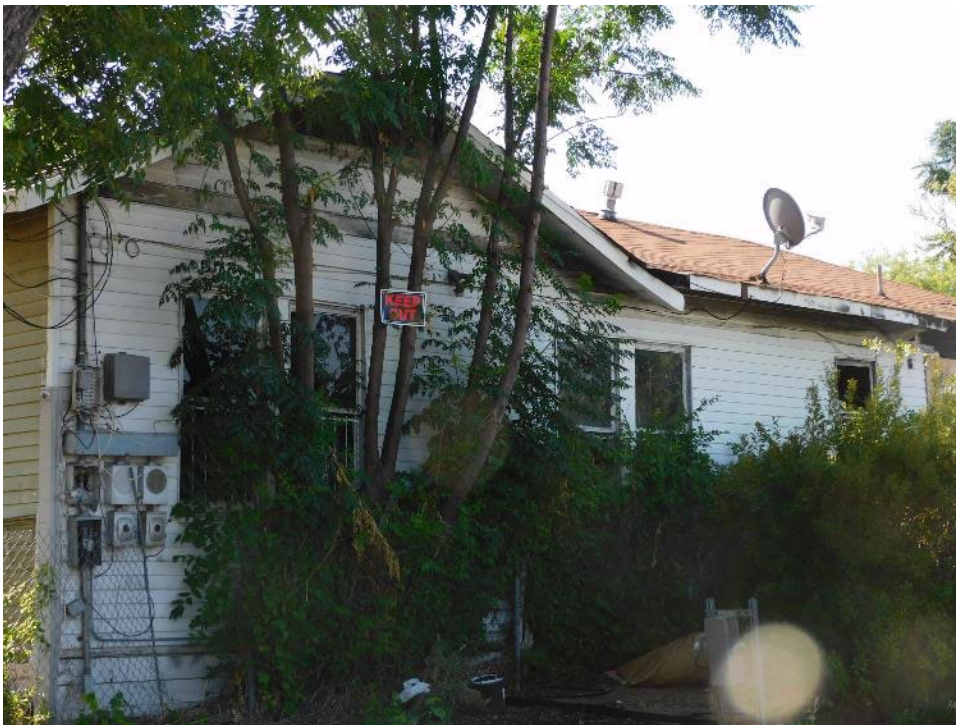
Photo 2, West elevation.

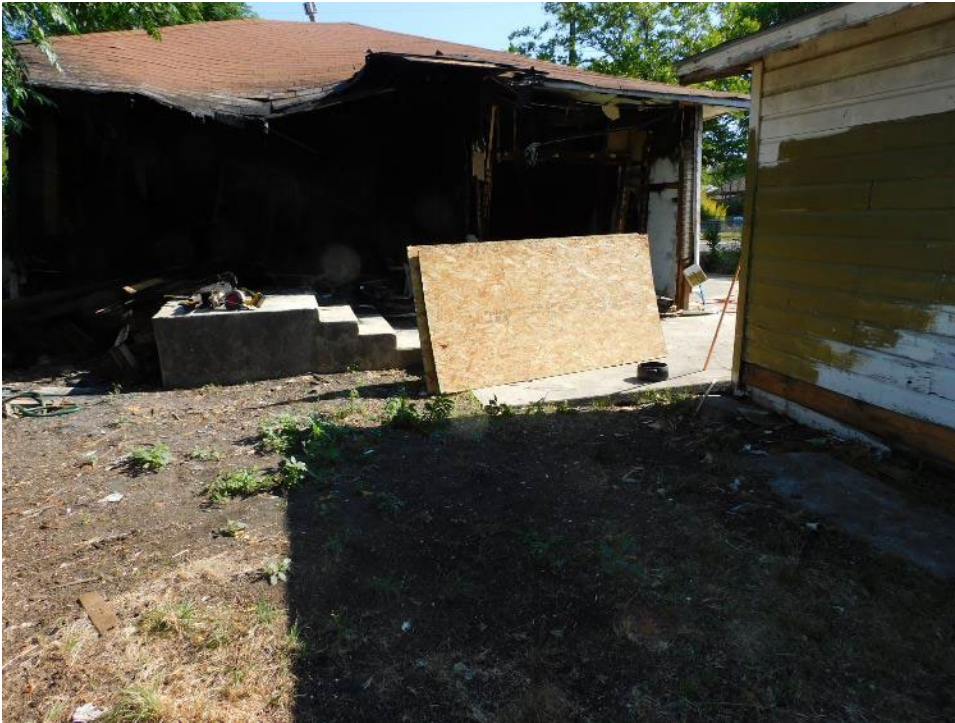
Photos 3, South (rear) elevation.

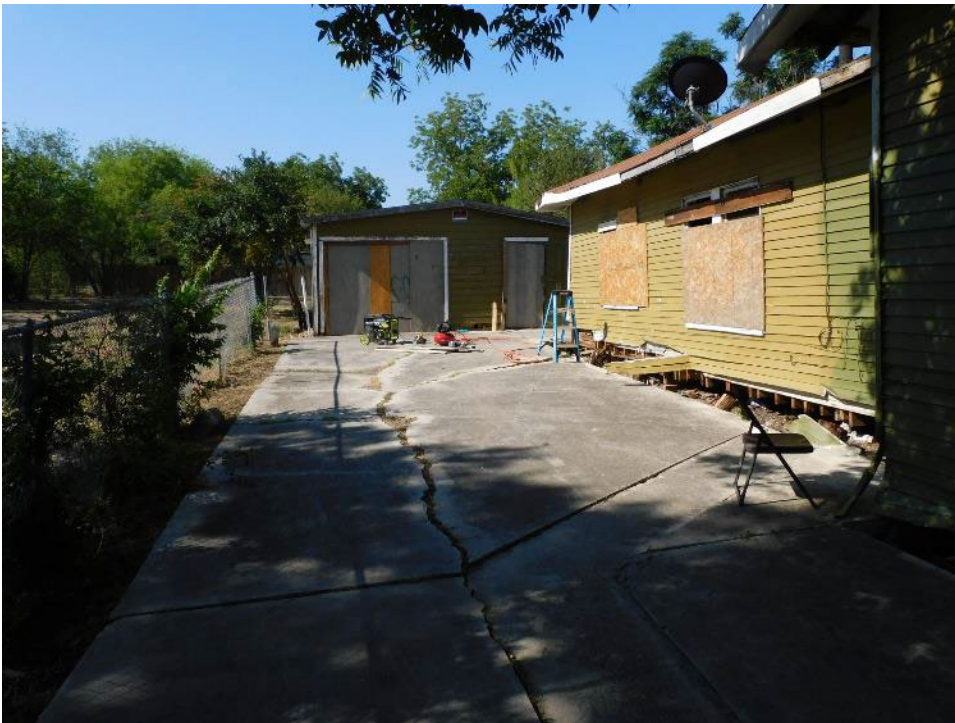
Photo 4, East elevation.

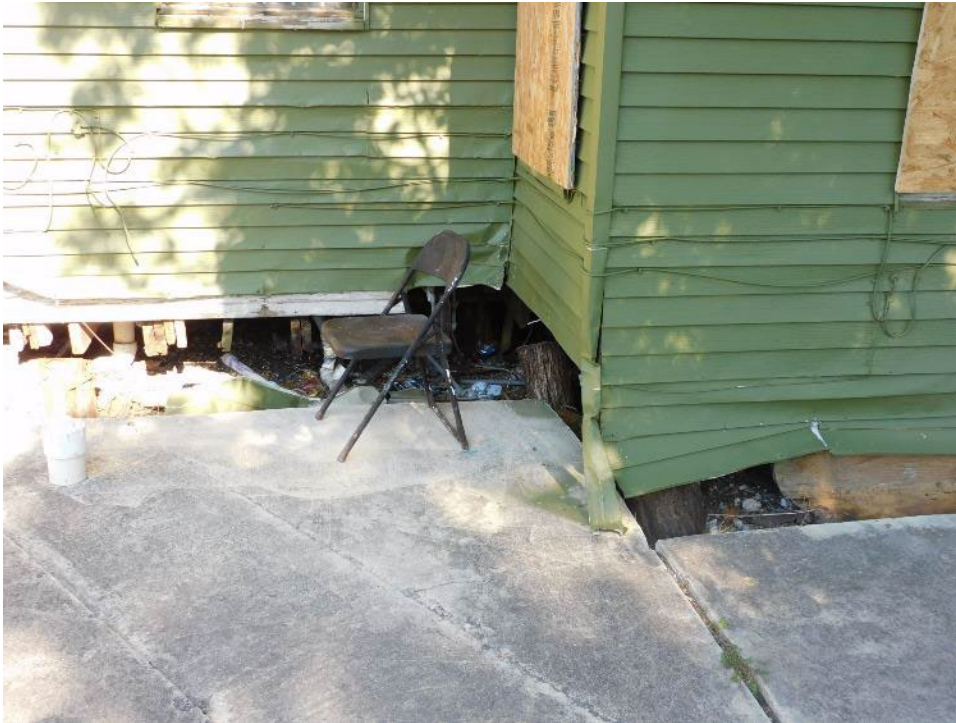
1. The exterior cladding was aluminum siding and wood panels.
2. There were signs of damage to the aluminum siding along the east and north elevations.
3. The exterior framing was visibly racked to the west.
4. The roof line was visibly buckled and bowed.
5. The garage showed signs of weathering and age.
6. The garage roof framing was bowed with a hole in the roof deck.

Photo 5, Exterior, damage to skirting and cladding, east elevation.

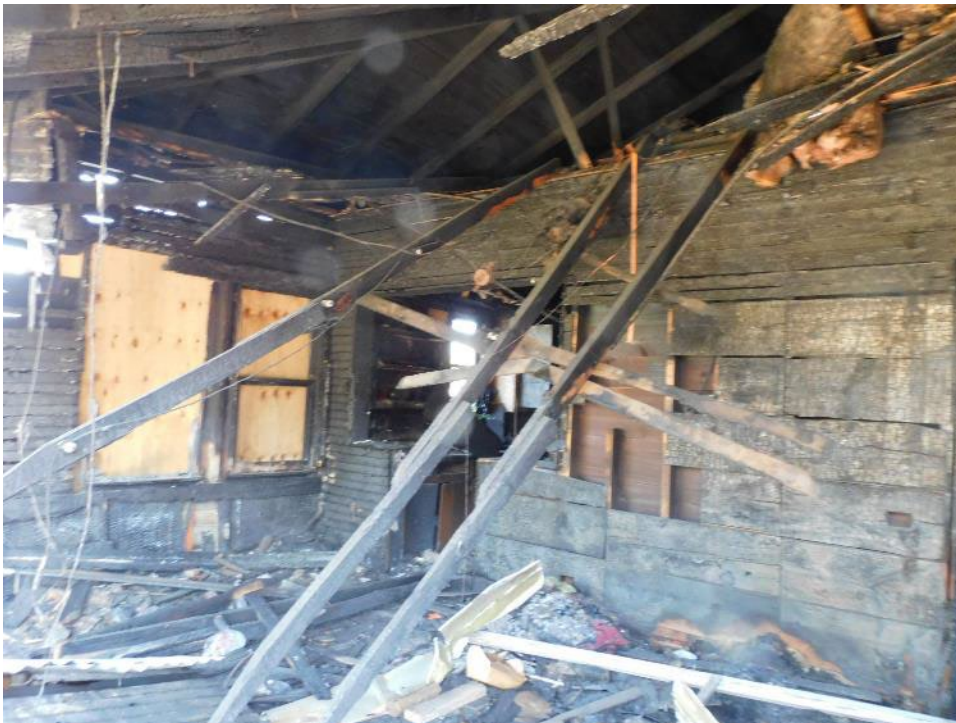
1. The rear walls and ceilings were severely damaged.
2. The damage consisted charring of the shiplap and wood walls studs.
3. The ceiling rafters and wood paneling was charred.
4. The fire damage extended from the rear into the front rooms.
5. The rear walls had collapsed, and the exterior rear wall was missing.
6. The floor deck was charred, buckled and missing sections.

Photo 6, Interior, damage to framing and walls.

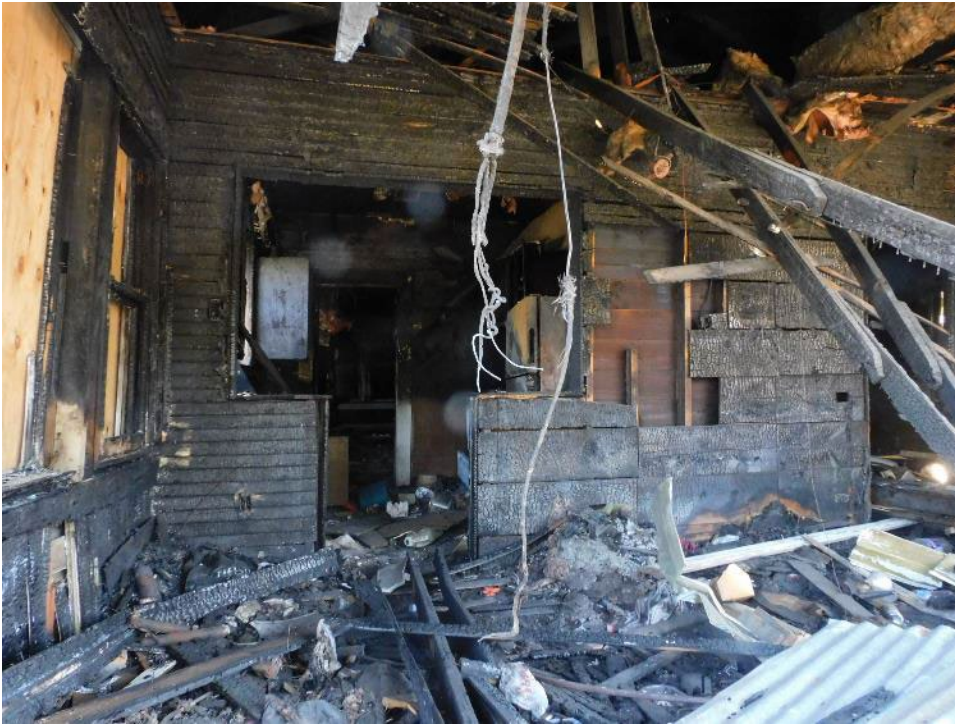
Photo 7, Interior, damage to walls and framing.

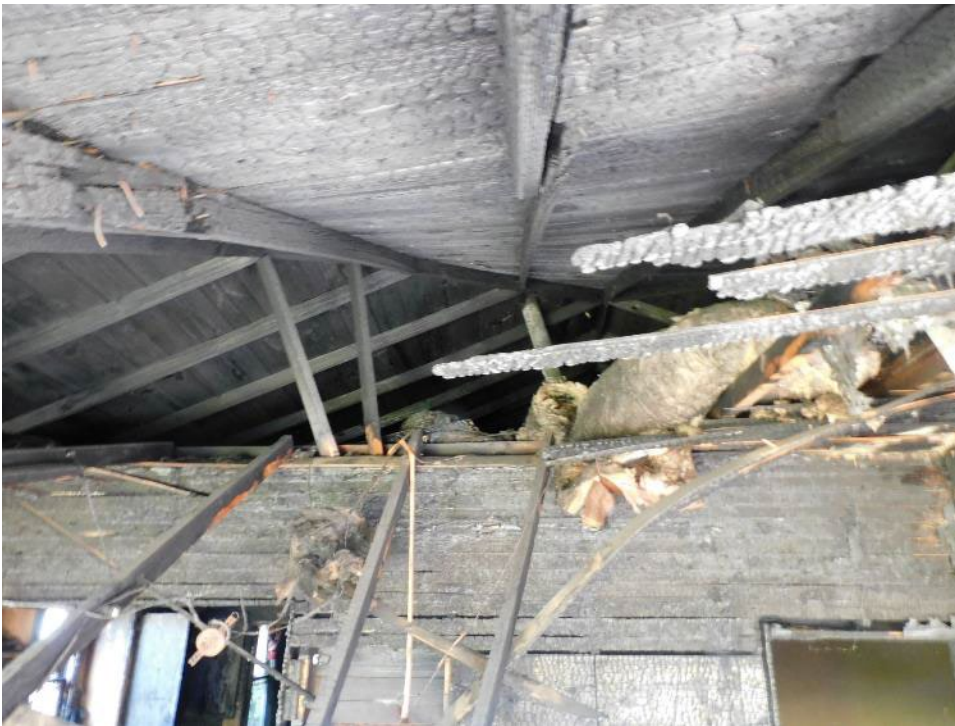
1. The roof framing consisted of rafter with purling bracing.
2. The rafters and purlin bracing were severely charred and damaged.
3. The rafters had collapsed at the rear and towards the front.
4. The roof deck was severely damaged and charred.

Photo 8, Attic, damaged roof framing.

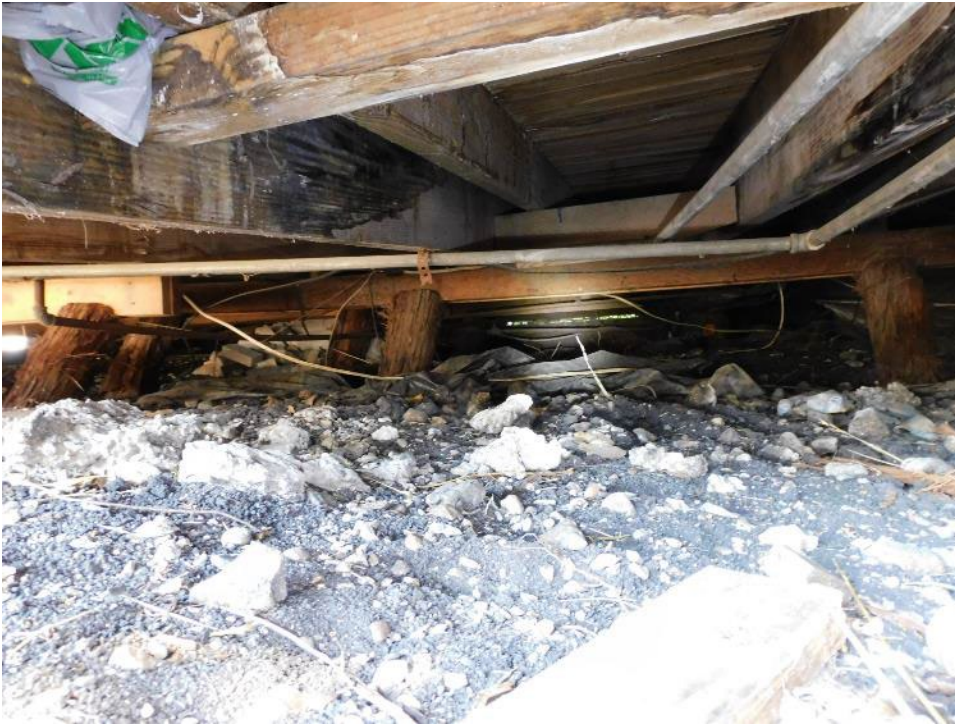
1. The foundation consisted of cedar post supporting wood beams and wood joists.
2. The cedar posts were toppled, tilted, or dislodged.
3. The wood beams were dislodged or tilted.
4. The wood joists were buckled and tilted.
5. The floor framing at the rear was severely damaged and charred.
6. An elevation survey was not conducted on the interior due to the conditions observed.

The foundation consisted of cedar posts supporting wood beams and wood floor joists. The existing foundation piers were found to be toppled, tilted, or dislodged. Based on the condition of the overall structure, we can reasonably conclude that the foundation has also been compromised and unsalvageable.

Photo 9, Crawlspace, toppled foundation piers.

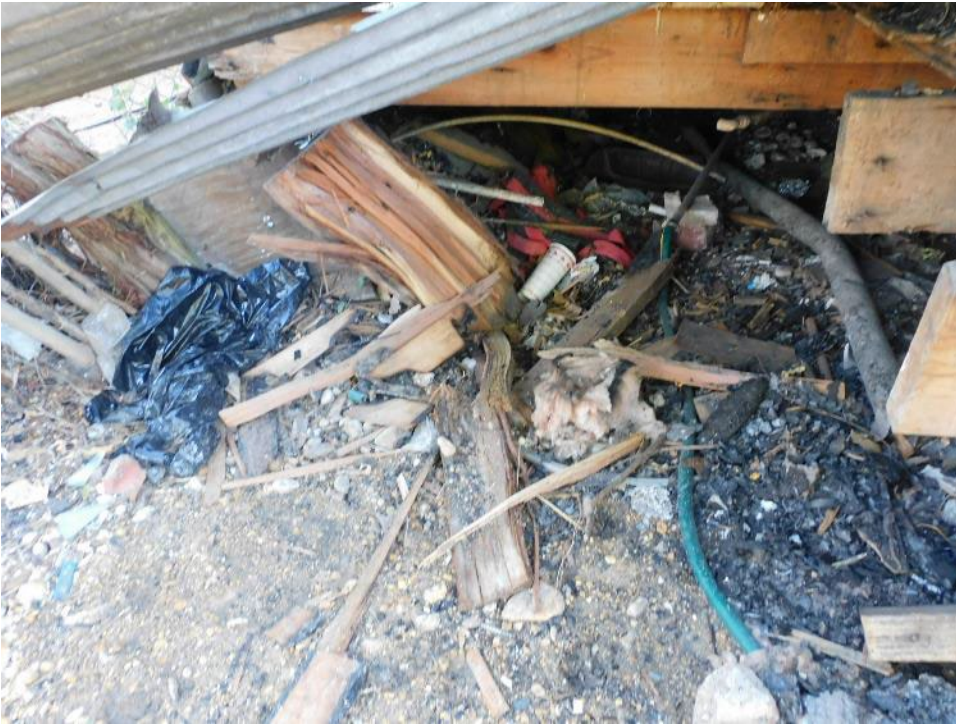
Photo 11, Crawlspace, damaged foundation pier.

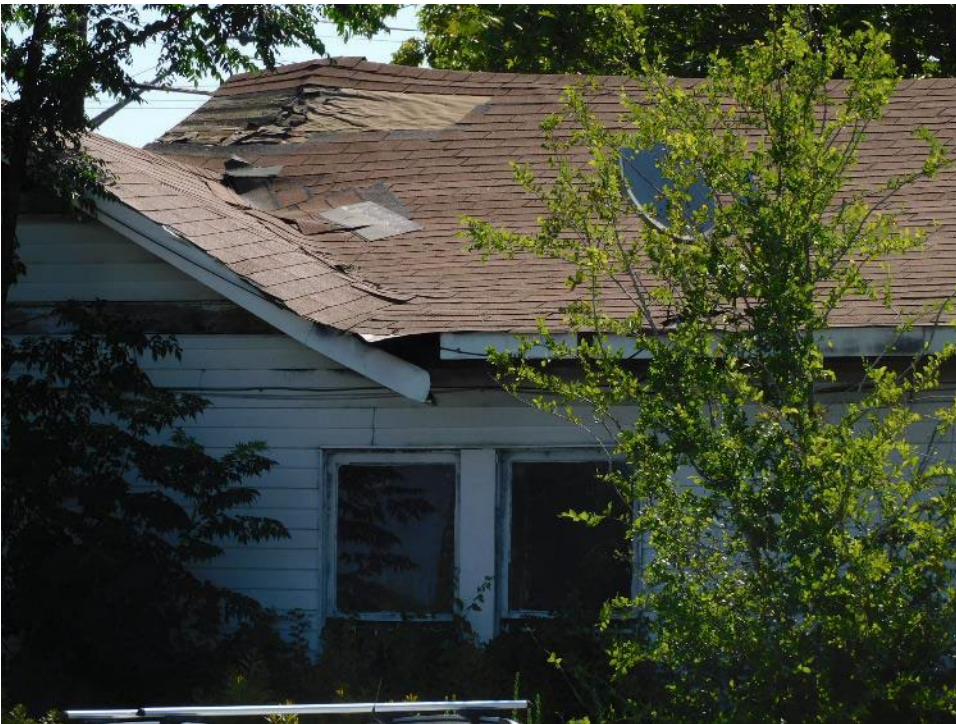
Photo 12, Exterior, damaged roof, east elevation.

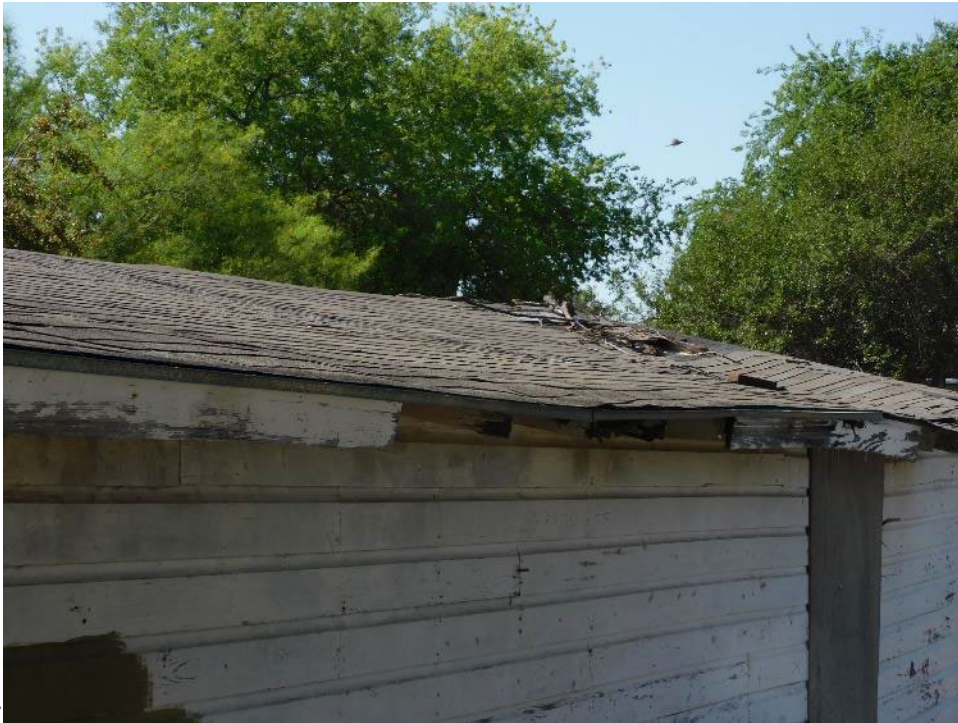
Photo 13, Exterior, garage roof.

As discussed, onsite, we recommend mechanical methods for the demolition of the structure for safety concerns. The structure should be considered "unsafe" and under no conditions should anyone enter the interior or access the roof. The existing conditions for the detached garage also warrant demolition and the same methods should be considered.

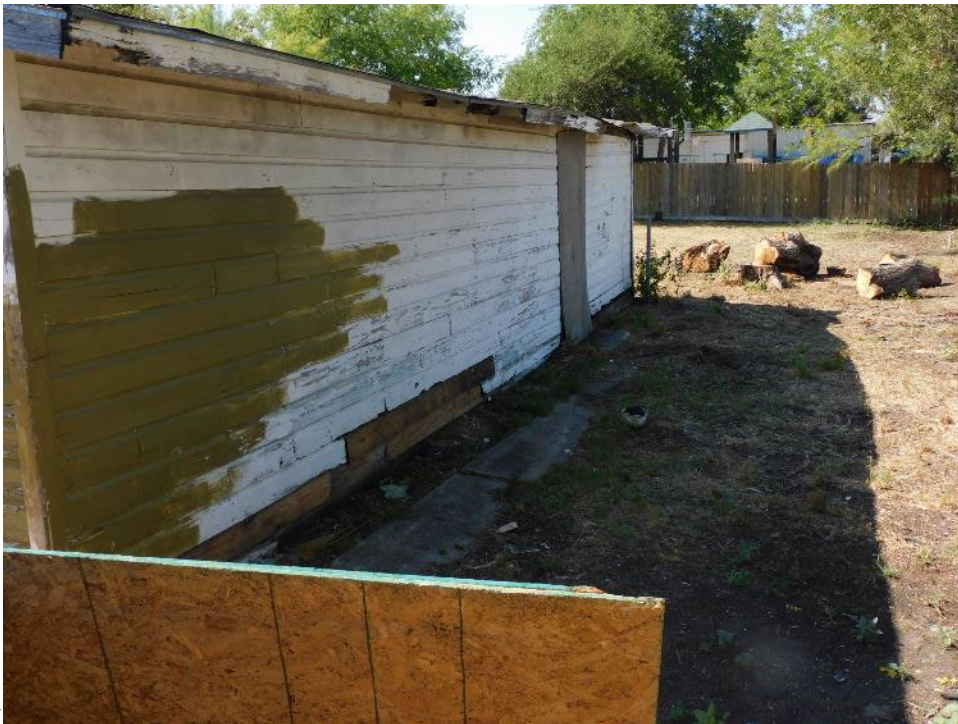
Photo 14, Exterior, garage cladding.
