HISTORIC AND DESIGN REVIEW COMMISSION

HDRC CASE NO: 2023-271
ADDRESS: 116 CAMARGO
LEGAL DESCRIPTION: NCB 923 BLK 4 LOT E 49.8 FT OF 3
ZONING: RM-4, H
CITY COUNCIL DIST.: 1
DISTRICT: Lavaca Historic District
APPLICANT: Nate Manfred/French & Michigan
OWNER: Rebecca Trujillo/VILLARREAL CARLOS & TRUJILLO REBECCA
TYPE OF WORK: Amendment to a previously approved design; removal of caliche wing and reconstruction with wood framing
APPLICATION RECEIVED: July 06, 2023
60-DAY REVIEW: September 04, 2023
CASE MANAGER: Edward Hall

116 CAMARGO
RENOVATION & ADDITION
SAN ANTONIO, TEXAS 78210

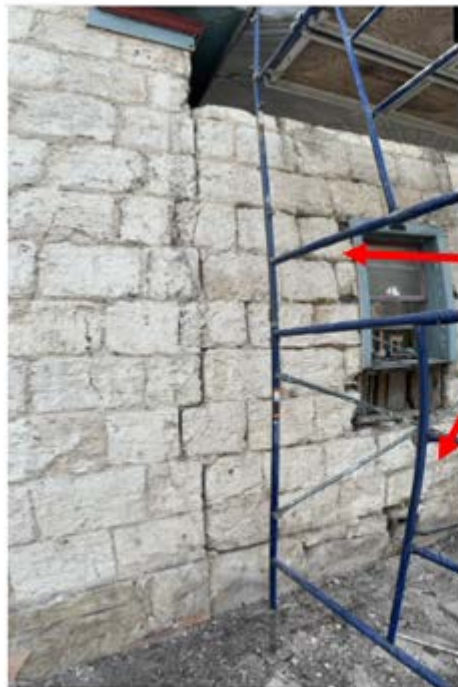
West wall. This is the same wall as above but different angle. Due to roof leaking water and no gutter, the wall has eroded and bowed in approx.. 4 inches inward

West wall.
We are
proposing
to remove
due to it
leaning to
the right 4
inches.

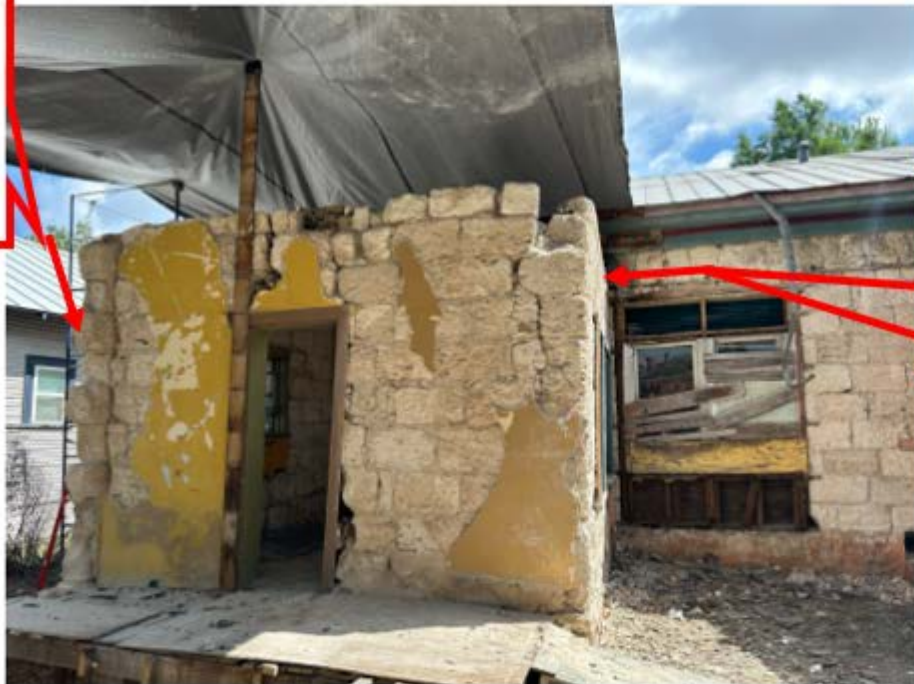
East wall. We are
proposing to remove
due to it leaning to the
right 3 inches.

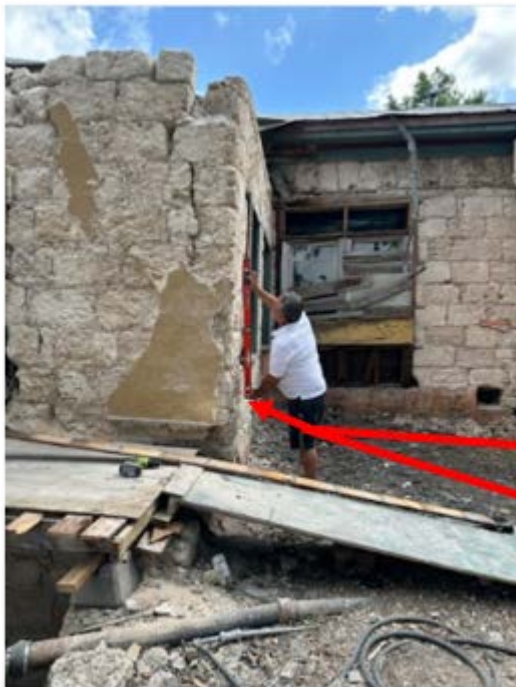
West wall. Picture of a level applied, showing its out of plump to the right approx. 3 inches.
