HISTORIC AND DESIGN REVIEW COMMISSION

HDRC CASE NO: 2023-327
ADDRESS: 1023 N PINE ST
LEGAL DESCRIPTION: NCB 522 BLK 15 LOT 1 TO 18
ZONING: RM-4, H
CITY COUNCIL DIST.: 2
DISTRICT: Dignowity Hill Historic District
APPLICANT: Brian Sowell/WestEast Design Group, LLC
OWNER: Cathleen Crabb/CITY OF SAN ANTONIO
TYPE OF WORK: Demolition of four (4) structures and conceptual review of a schematic plan
APPLICATION RECEIVED: July 26, 2023
60-DAY REVIEW: Not applicable
CASE MANAGER: Rachel Rettaliata

1. A Certificate of Appropriateness for approval to demolish four (4) structures at the Ella Austin campus.
2. Conceptual approval of schematic replacement plans.

Ella Austin Community Center

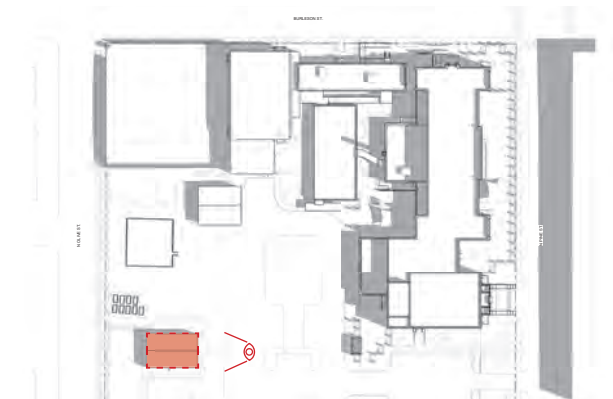
Classroom Building (Circa 1985)

The Classroom building is a pre-engineered metal building located in the Southwest corner of the campus, below the community gardens. Aerial images from [Historicaerials.com](https://historicaerials.com) suggest the building was constructed in 1985.

The building is in poor condition and suffers from many issues including significant leaks

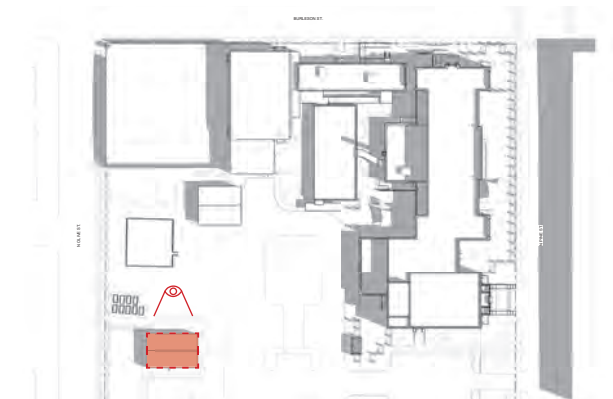
Classroom Building (Circa 1985)

- Today the building is largely unused due to infrastructural issues including leaks.

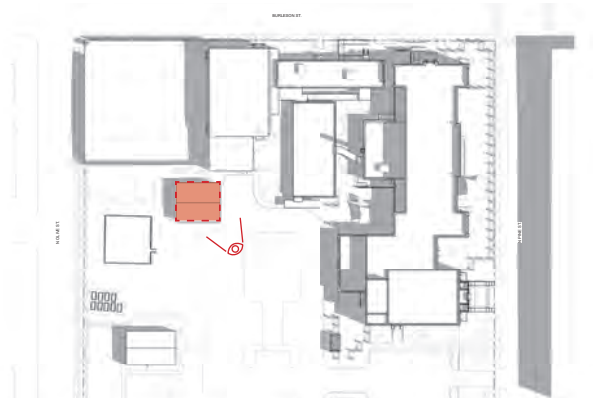
Site Storage (Circa 1985)

The Site Storage building is a pre-engineered metal building located South of the Gymnasium. Aerial images suggest the building was constructed in 1985

Like the classroom building, the Site Storage building suffers from infrastructural issues including leaks, which have caused corrosion to the structural supports.

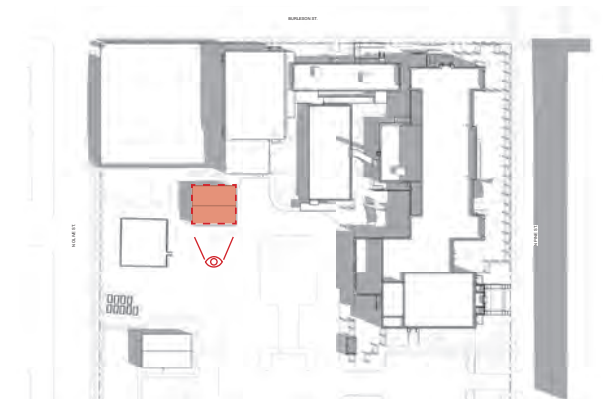
Site Storage (Circa 1985)

- Rusting is apparent throughout the structure as the result of significant leaks, and the building has reached the end of its servicable life.

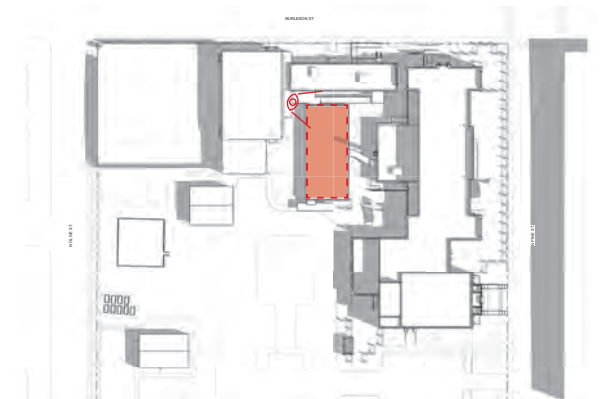
- There were no major deficiencies noted in the building assesment, although the general finishes of the building are showing their age.
- The building is served by a drop-off loop in the parking lot. Because the floor level is below grade however, the access is generally poor as navigating a large interior ramp is required to enter the main room.

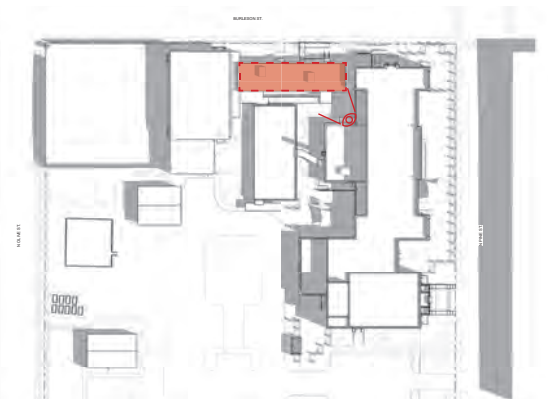
Physical Culture Building (Gym Annex)

An assessment of the structure was performed by a structural engineer, who produced their findings in a report dated May 19th, 2023. In the report, the Structural Engineer identified significant settling and damage to the existing foundation and slab due to water migration under the slab, creating valleys in the floor slab with differentials exceeding 2".

The foundation cannot be salvaged and must be replaced in order to make the building usable.

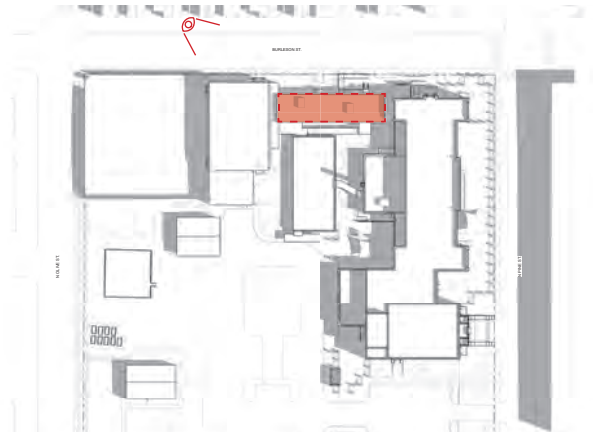
Physical Culture Building (Gym Annex)

In addition to the foundation issues, the structural engineer identified corrosion on the roof deck and joists due to leaks, and the report suggests that the entire roof structure will have to be replaced, including any damaged joists.

Outside of the structural issues, all the existing windows must be replaced as they have succumbed to rot and damage, and are no longer functional.

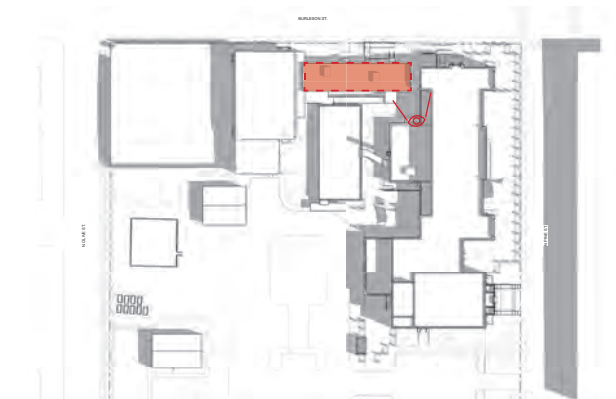
Physical Culture Building (Gym Annex)

The scope of repairs required for the building is such that the entire structure would have to be gutted, and the only portion of the building that could be salvaged are the exterior walls. However, the exterior walls are in poor condition as well, as the settling of the slab has caused cracks to form in the brick joints.

Due to the scope of repairs required, bringing the building into a usable state is not financially feasible and would create a severe economic hardship.

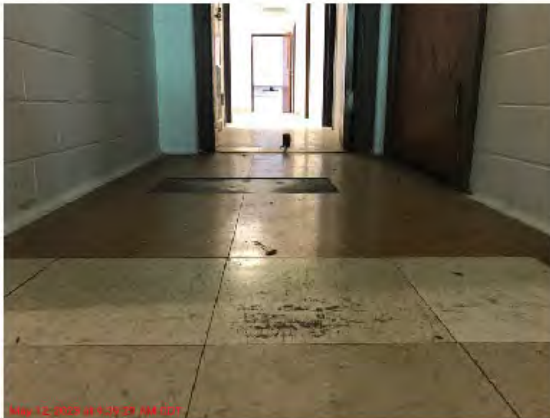
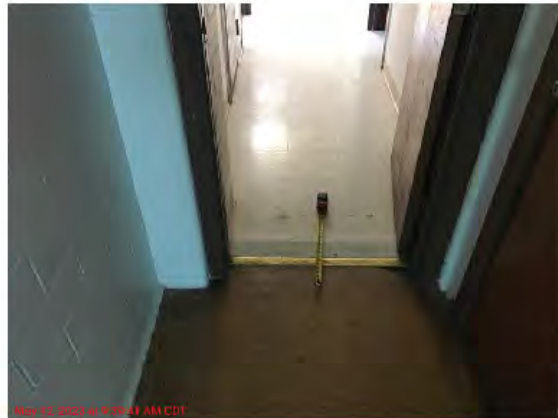
Issue #1 – OPEN (1/1)

Foundational differential 1 1/2" +/- Photo left to right slope of foundation

LOCATION: Transition B/w Gym & Annex
PRIORITY: Normal
DUE DATE: No due date
DISCIPLINES:
ASSIGNEE:

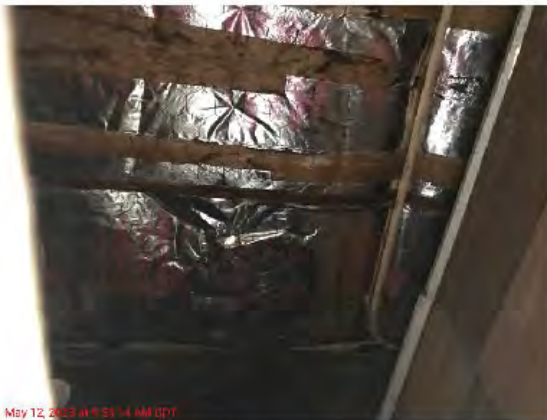
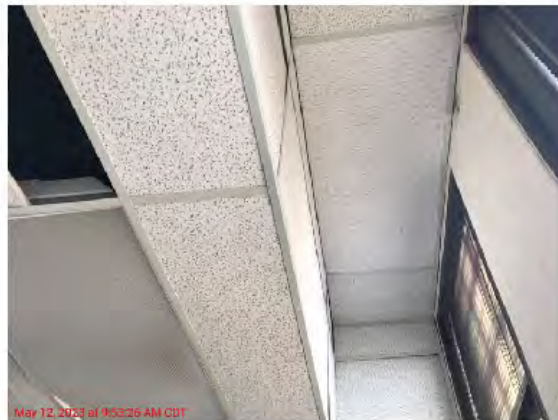
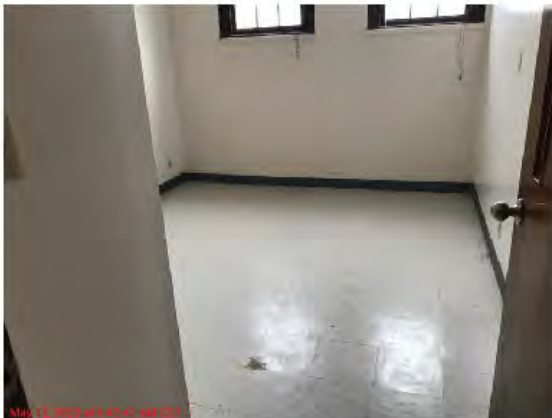
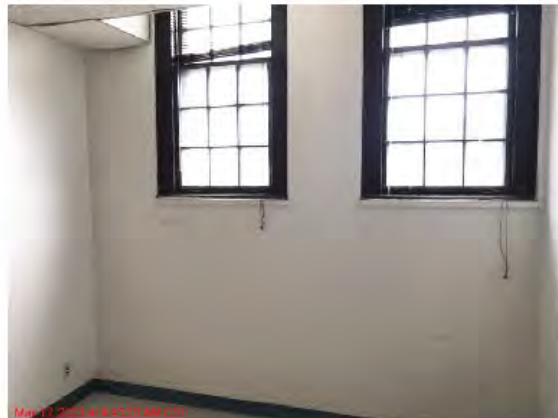
Issue #2 – OPEN (1/1)

Exterior CMU walls w/ steel joists running plan N/S Foundation sloping in 2 directions photo left to right and far to near photo 2 Drop ceiling removed and view of structure above obstructed in room with duct and insulation

LOCATION: 1st Room Left
PRIORITY: Normal
DUE DATE: No due date
DISCIPLINES:
ASSIGNEE:

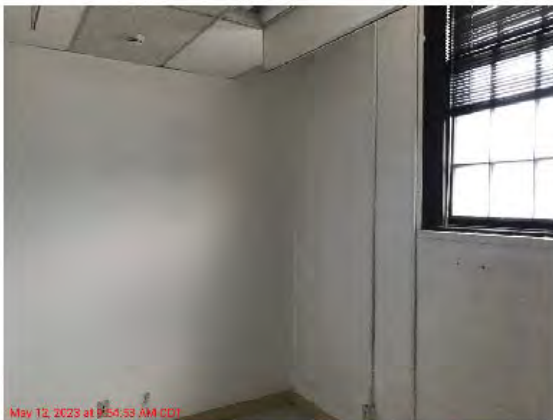
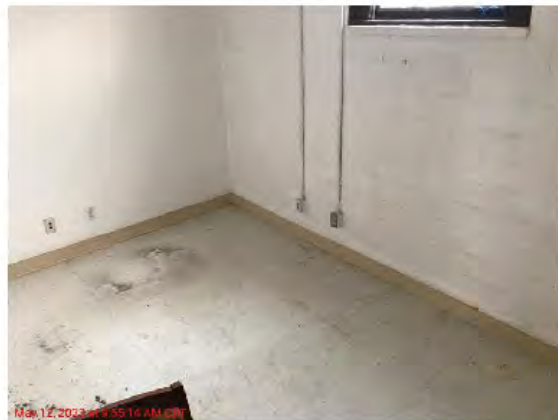
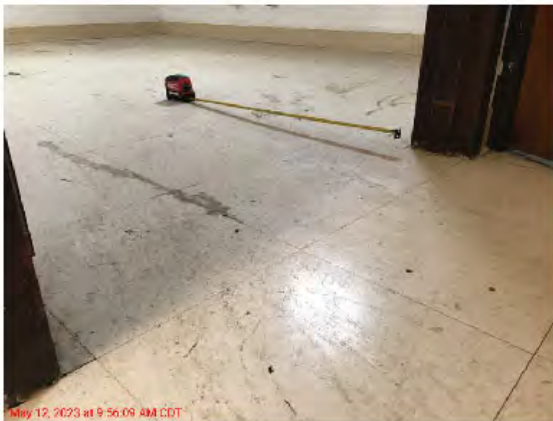
Multiple foundational valleys w/in room from 1/2" approx to 2" + Red masonry 5 1/4-1/2" x 12wide cmu

LOCATION: Room 2 Left
PRIORITY: Normal
DUE DATE: No due date
DISCIPLINES:
ASSIGNEE:

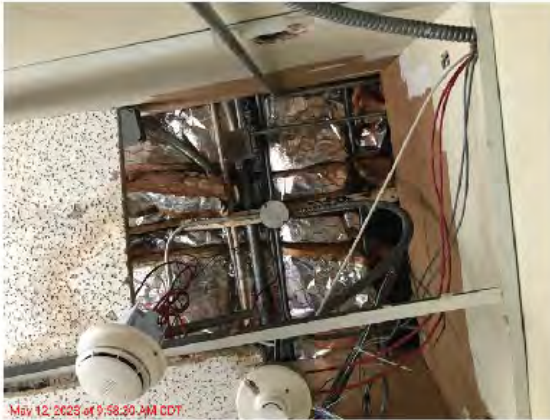
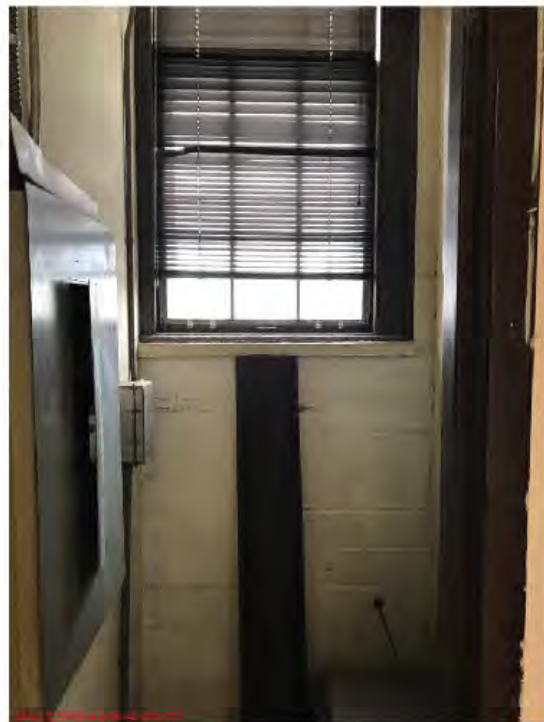
Issue #6 – OPEN (1/1)

Exposed joist soffit within insulation. Paint on joist peeling, cannot determine if it is steel that is delaminating or rusted.

LOCATION: Elec Closet Left
PRIORITY: Normal
DUE DATE: No due date
DISCIPLINES:
ASSIGNEE:

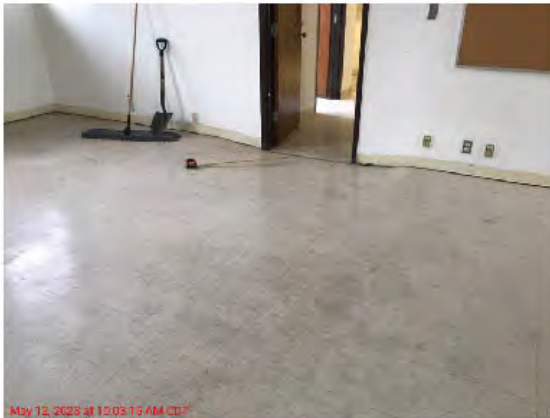
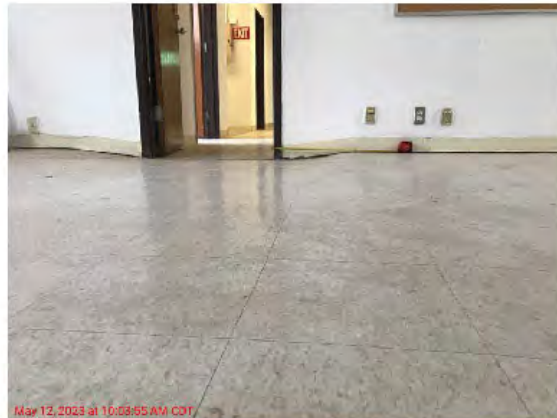
3" + foundational drop/warp

LOCATION: 1st Large Room
PRIORITY: Normal
DUE DATE: No due date
DISCIPLINES:
ASSIGNEE:

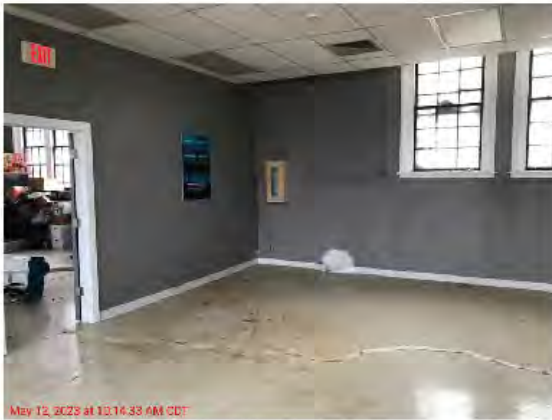
Multiple foundational valleys and heaves

LOCATION: Second Large Room
PRIORITY: Normal
DUE DATE: No due date
DISCIPLINES:
ASSIGNEE:

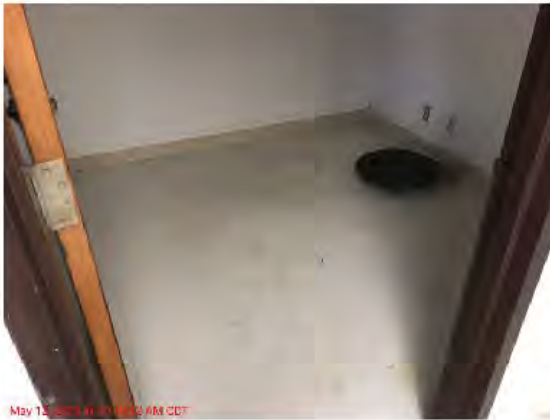
Foundational valley middle of room heave at exterior wall

LOCATION: 2nd Small Room Right
PRIORITY: Normal
DUE DATE: No due date
DISCIPLINES:
ASSIGNEE:

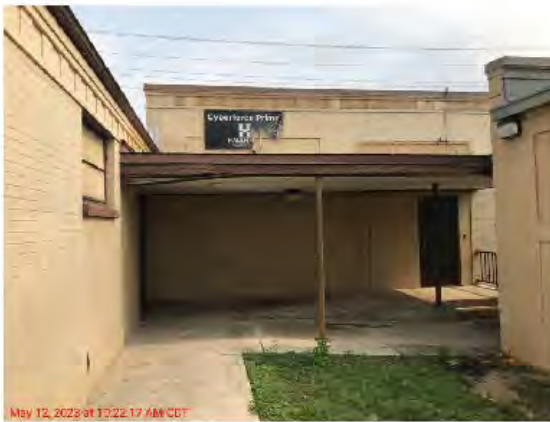
No noticeable cracking in painted brick. exterior standard brick backed by the noted 5 1/4" CMU x 12" w.

LOCATION: Exterior South
PRIORITY: Normal
DUE DATE: No due date
DISCIPLINES:
ASSIGNEE:

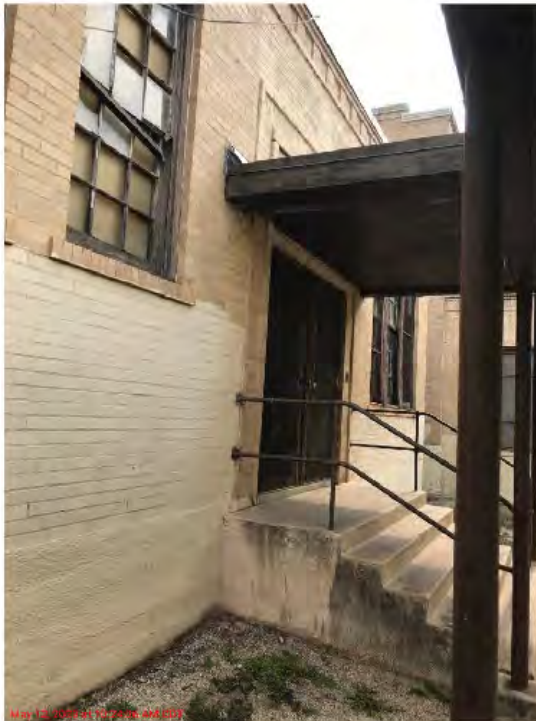
some cracking in brick exterior

LOCATION: Exterior South
PRIORITY: Normal
DUE DATE: No due date
DISCIPLINES:
ASSIGNEE:

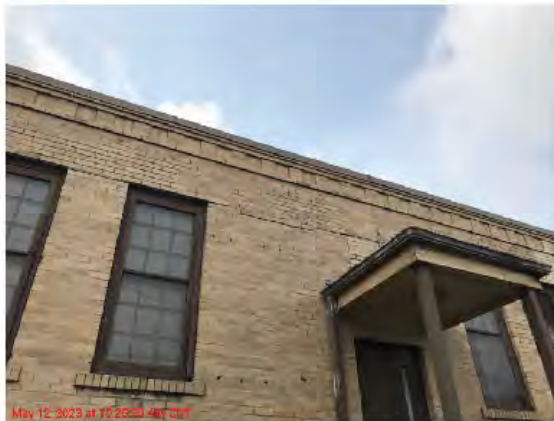
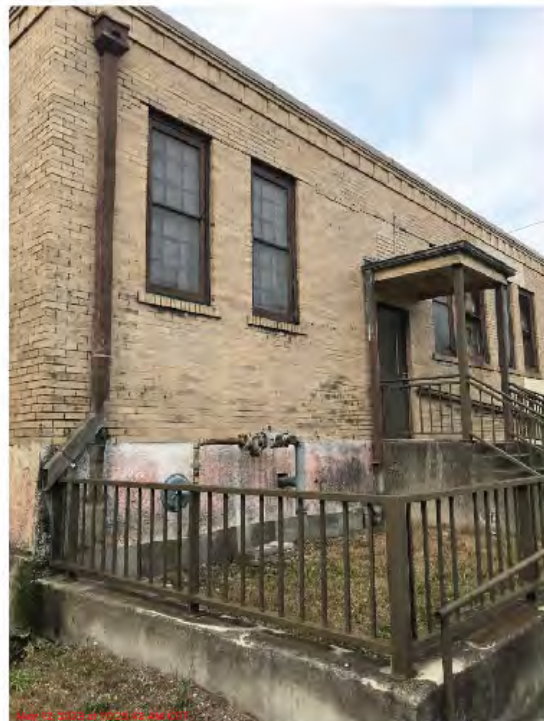
cracking and movement at window headers.

LOCATION: Exterior North
PRIORITY: Normal
DUE DATE: No due date
DISCIPLINES:
ASSIGNEE:

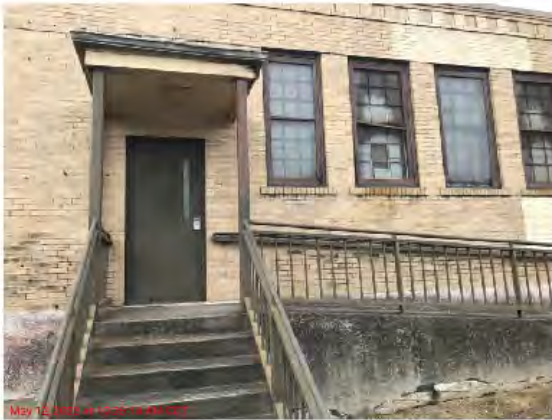
Issue #31 – OPEN (1/1)

foundation cracking at ramp beam soffit.

LOCATION: Exterior North
PRIORITY: Normal
DUE DATE: No due date
DISCIPLINES:
ASSIGNEE:
