September 27, 2022

To: City of San Antonio, Office of Historic Preservation

Subject: 836 Laredo Street Structural Evaluation

## Appendix A - Photos

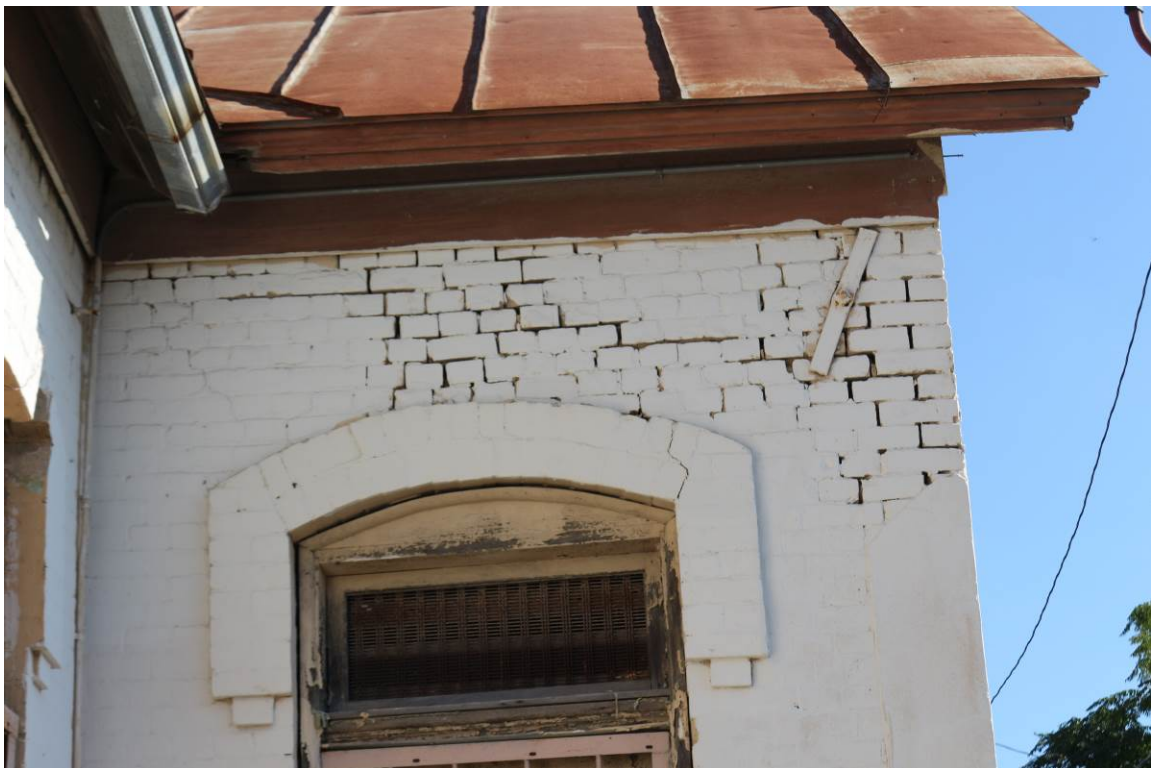
There was missing mortar, cascading and/or sagging masonry, cracked and misaligned door and window lintels, and localized out-of-plane buckling observed in the exposed masonry of the perimeter walls (Photos 6 and 7). This indicated that the masonry had reached the end of its serviceable and effective life. It further indicated that the outer layer of masonry was no longer functioning in a load bearing capacity and only the inner layer of the perimeter walls was carrying the vertical loads of the building.

**Photo No. 6:** There was missing mortar, cascading and/or sagging masonry, cracked and misaligned lintels, and localized out-of-plane buckling. (1 of 2)

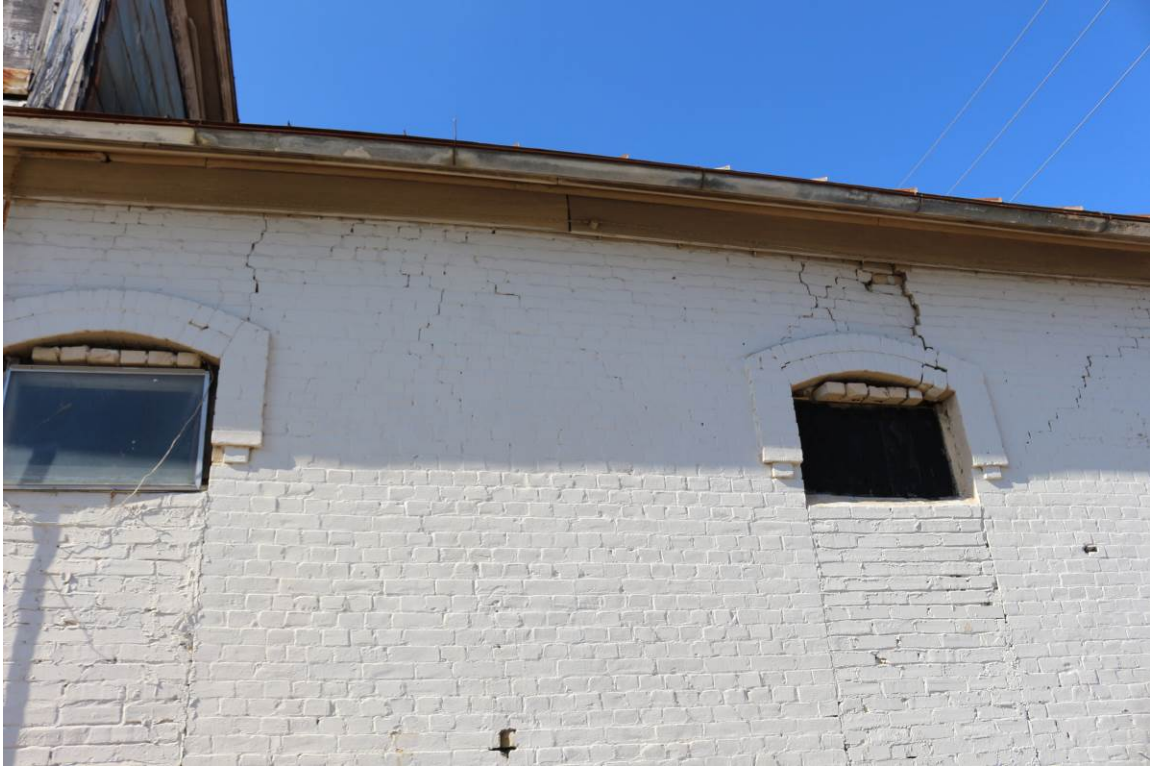
**Photo No. 7:** There was missing mortar, cascading and/or sagging masonry, cracked and misaligned lintels, and localized out-of-plane buckling. (2 of 2)

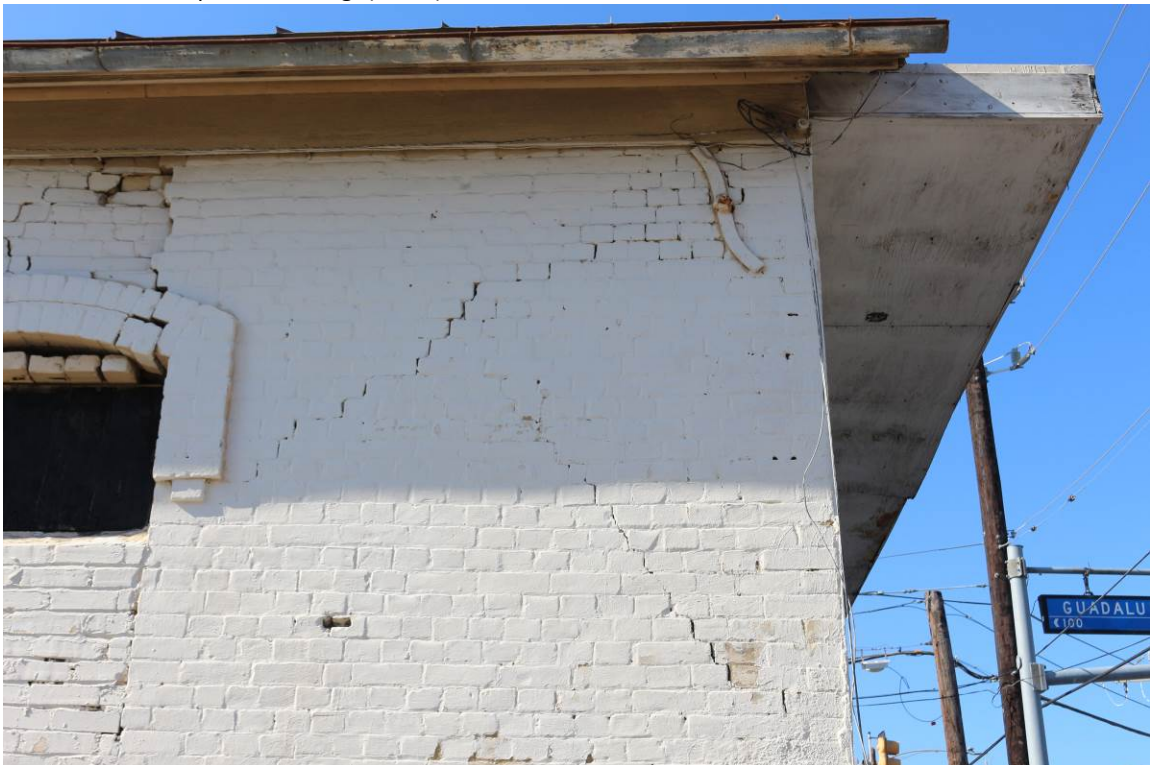
There were rods with bearing plates spanning from wall to wall, across entire rooms, observed at several corners of the building (Photos 8 and 9). This was not uncommon with aged masonry walls, but it indicated that the structural deficiencies had been suspected, or identified, in the masonry walls at some point in the past and the walls required additional support to continue carrying the intended loads.

**Photo No. 8:** There were rods with bearing plates spanning from wall to wall, across entire rooms, observed at several corners of the building. (1 of 2)

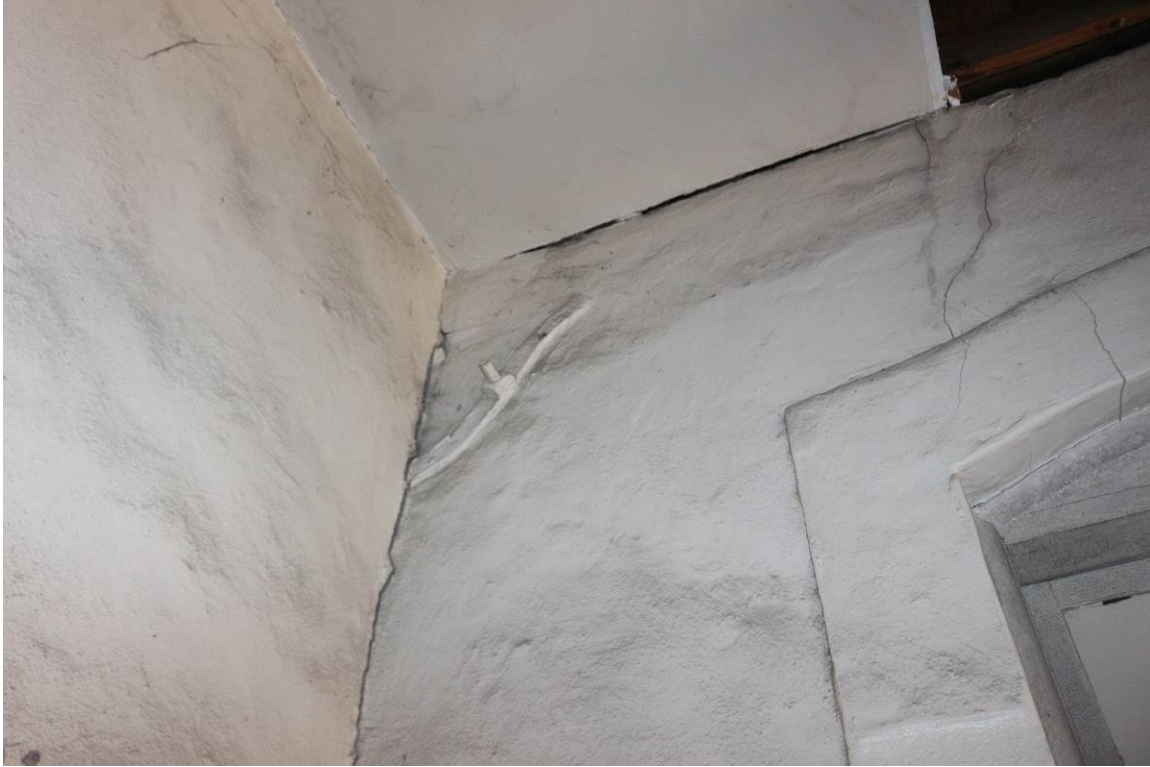
**Photo No. 9:** There were rods with bearing plates spanning from wall to wall, across entire rooms, observed at several corners of the building. (2 of 2)

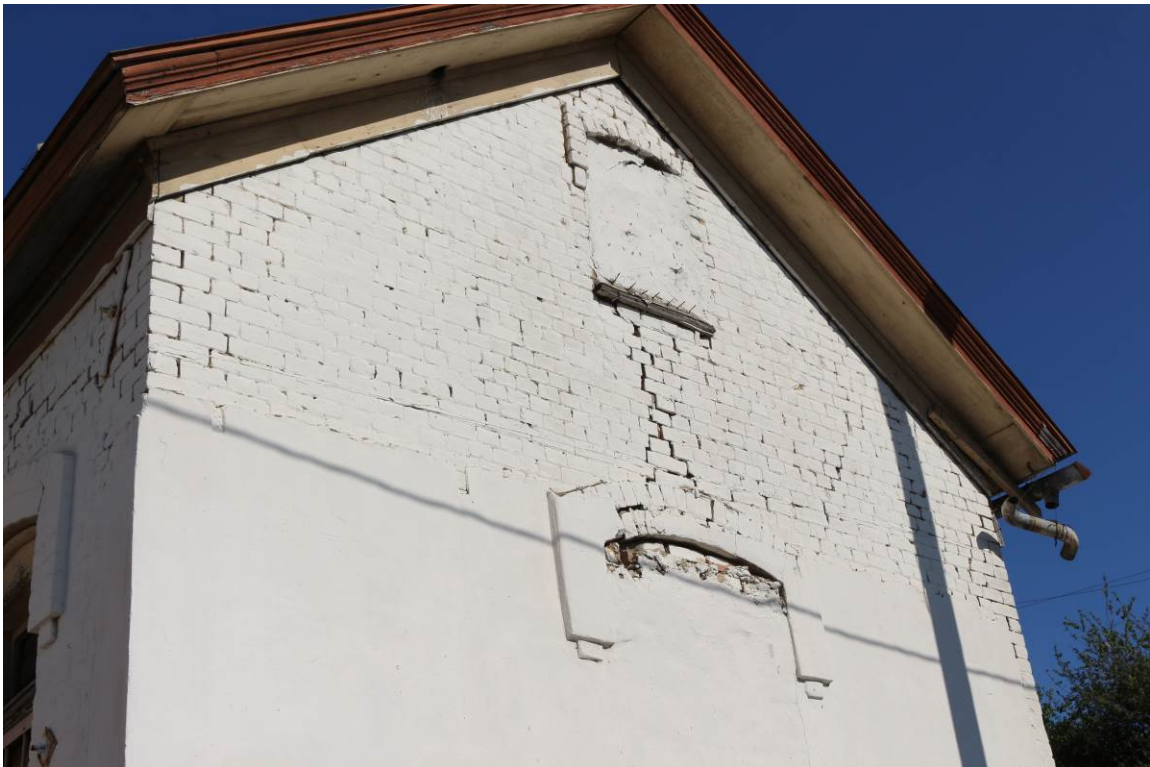
There were numerous and widespread vertical and diagonal cracks and separations in the walls of the building (Photos 10 and 11). It also appeared as though the top of the foundation footings dipped down at the corners of the building (Photo 12). When combined, these two observations indicated that the foundation experienced movement at some point in the past. This contributed or resulted in further structural deficiencies in the masonry walls.

**Photo No. 10:** There were numerous and widespread vertical and diagonal cracks and separations in the walls of the building. (1 of 2)

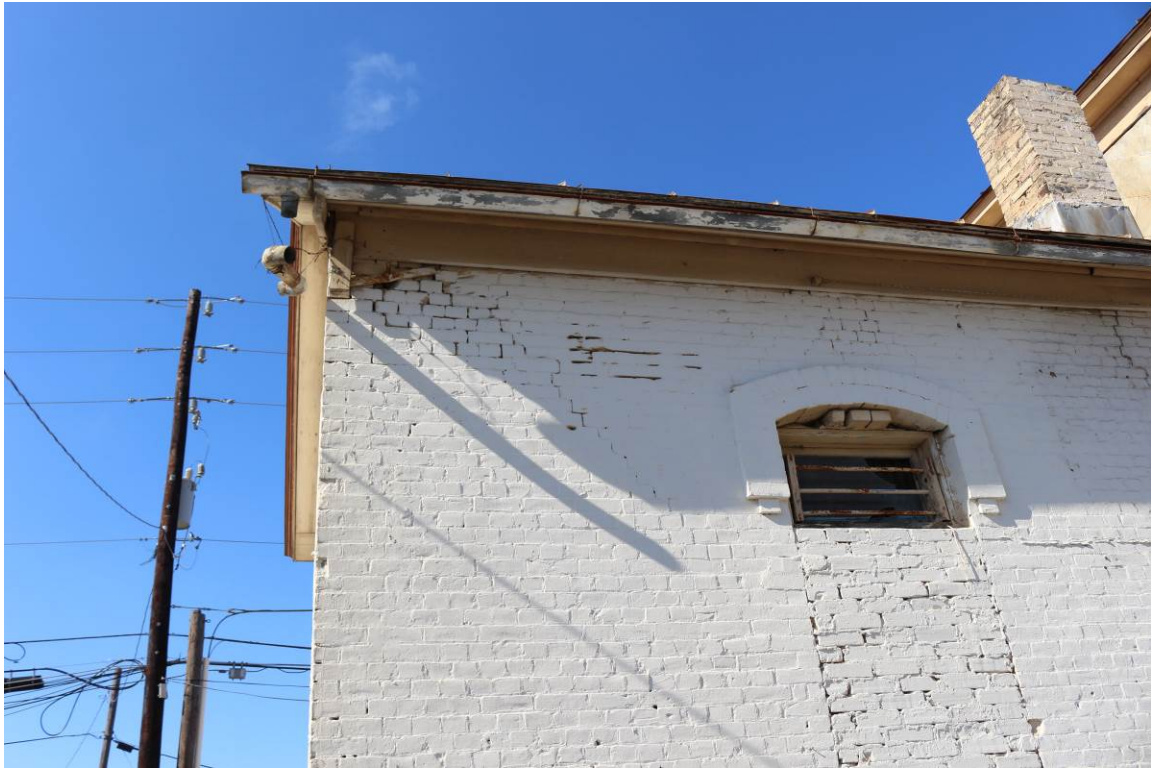
**Photo No. 11:** There were numerous and widespread vertical and diagonal cracks and separations in the walls of the building. (2 of 2)

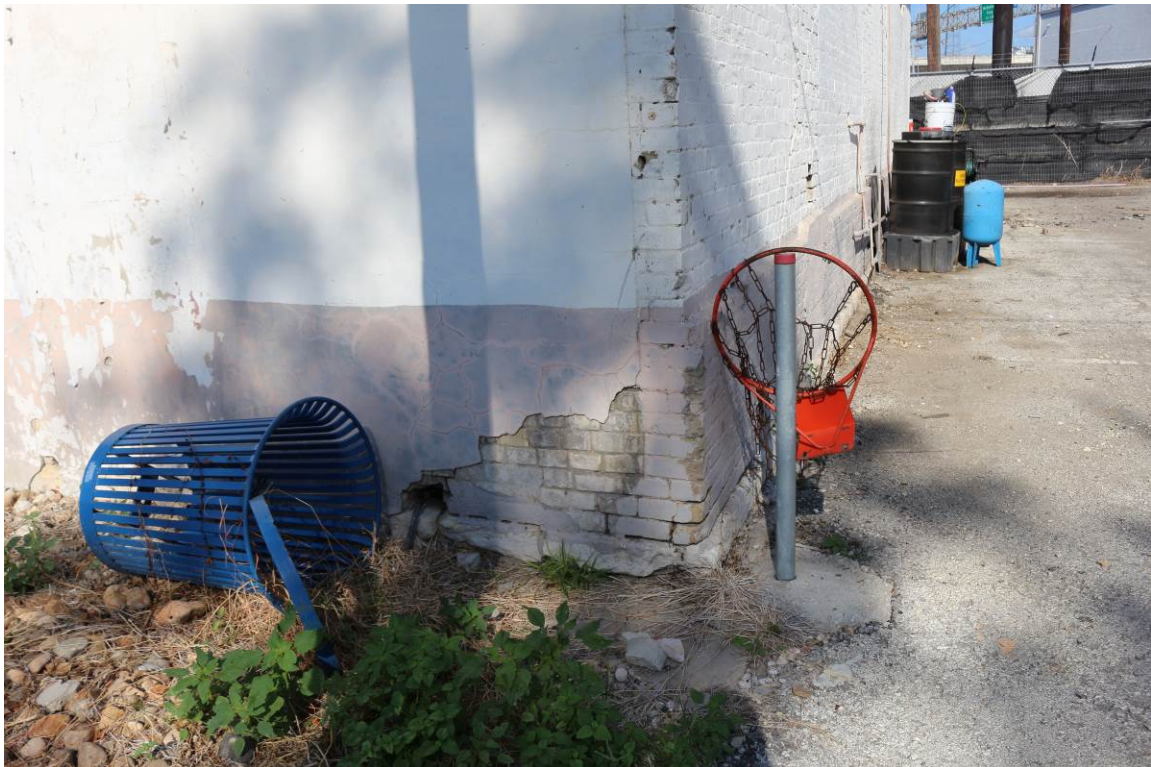
**Photo No. 12:** It appeared as though the top of the foundation footings dipped down at the corners of the building.

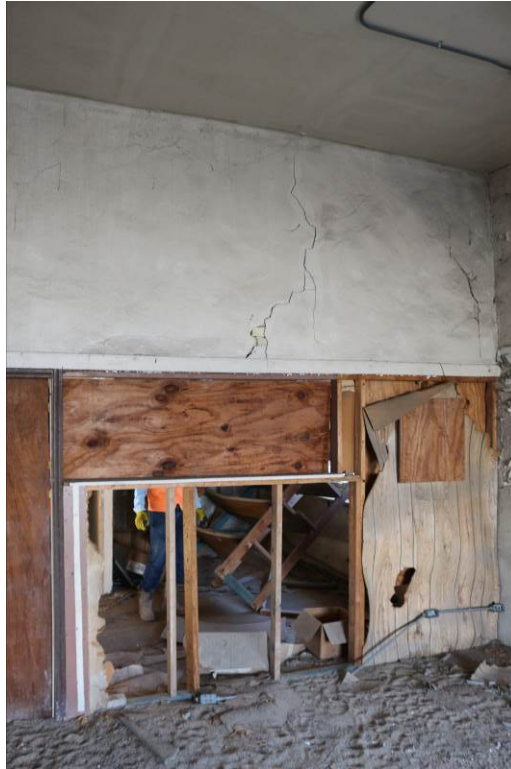
On the south side of the house, it appeared that the lower half of an interior load bearing masonry wall had been removed and was then supported with wood stud framing (Photos 13 and 14). Additionally, there was sagging in both the remaining (upper) half of the masonry wall and the wood framing supporting it. This indicated that the wood framing, thus the wall, was insufficient to function as originally intended.

**Photo No. 13:** On the south side of the house, it appeared that the lower half of an interior masonry wall had been removed, was supported with wood stud framing, and appeared to be sagging. (1 of 2)

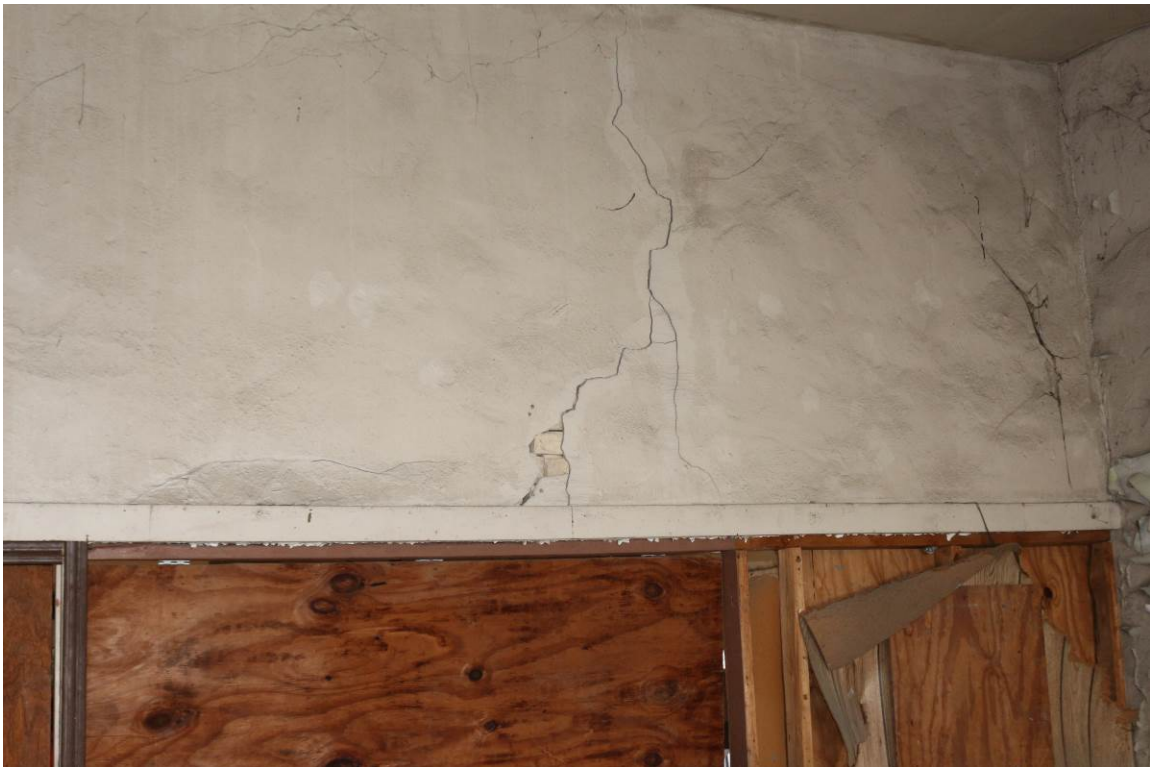
**Photo No. 14:** On the south side of the house, it appeared that the lower half of an interior masonry wall had been removed, was supported with wood stud framing, and appeared to be sagging. (2 of 2)

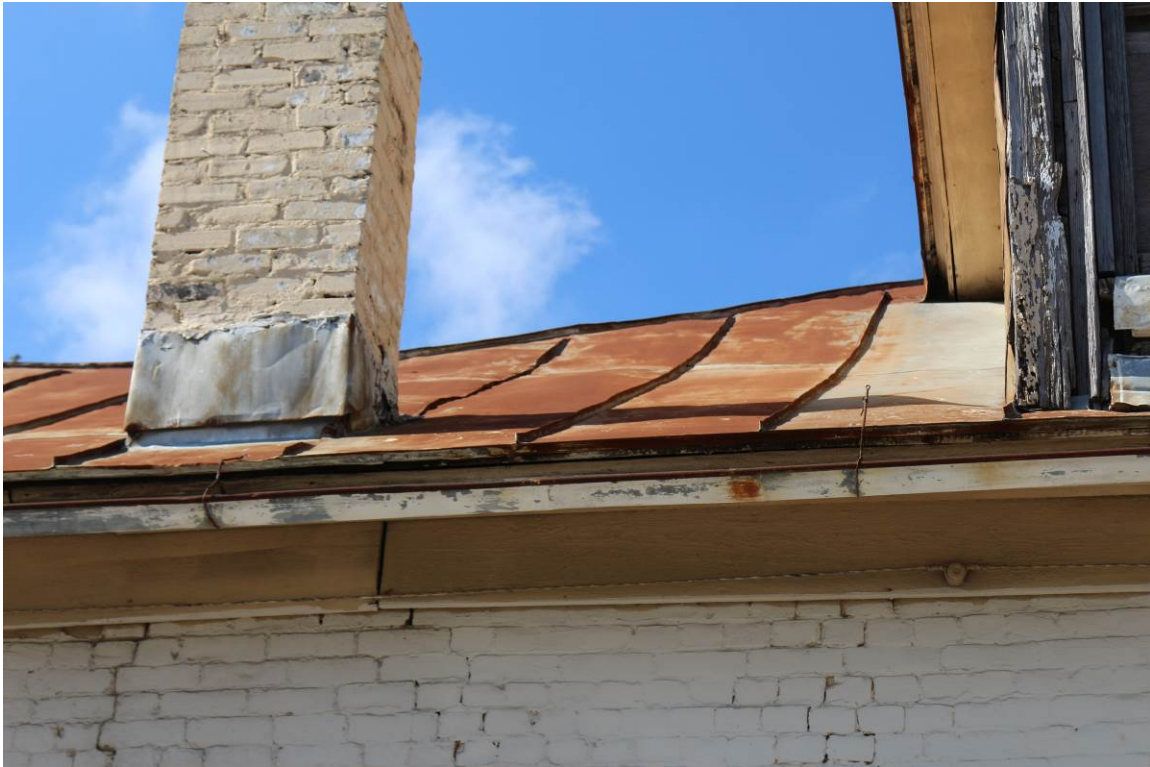
On the roof, I observed sagging in several locations (Photo 15). In the attic, I observed that there was widespread rotting and possible biological growth (Photo 16). Further, on the first floor, approximately 40% of the flooring was rotted or missing entirely (Photo 17). This was especially notable at the southwest corner of the building where an addition had been constructed at some point in the past. As rot and possible biological growth spread across wood framing members, the strength of those structural elements was reduced, resulting in sagging. This indicated that the wood roof framing and floor framing on the first floor was no longer functioning as intended.

**Photo No. 15:** There were areas of sagging roof.

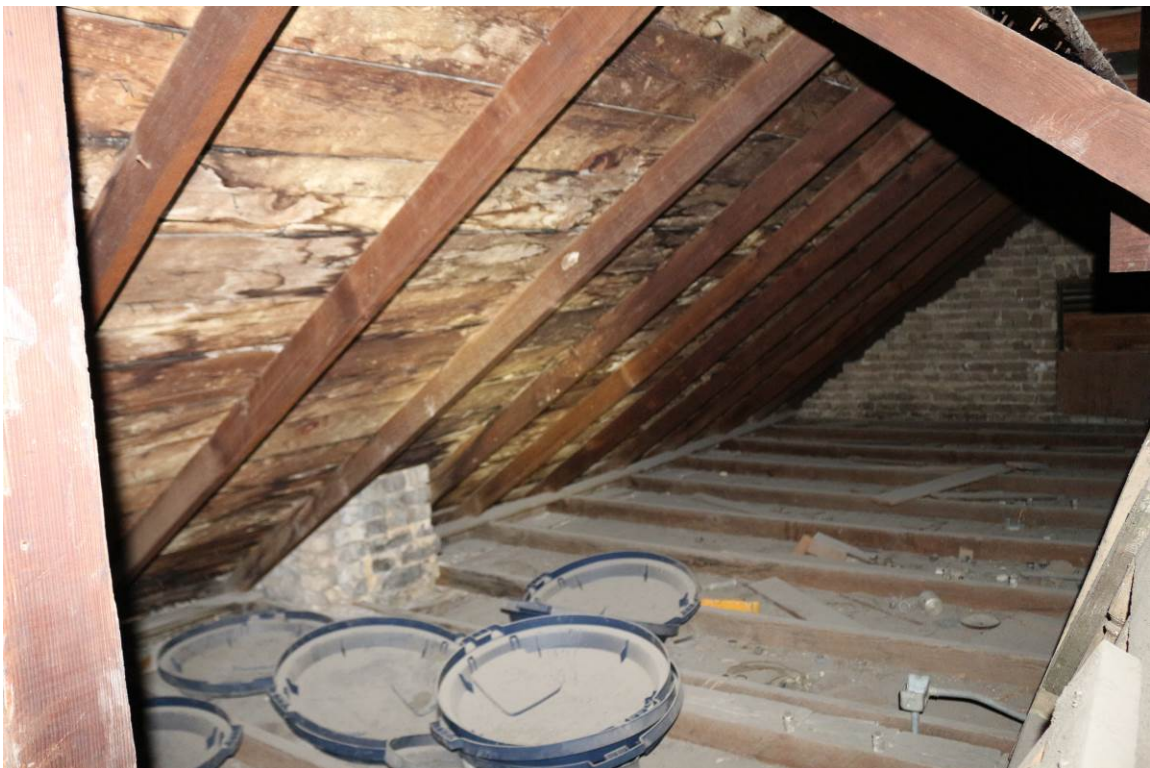
**Photo No. 16:** There was widespread rot and possible biological growth on most of the roof framing and decking.

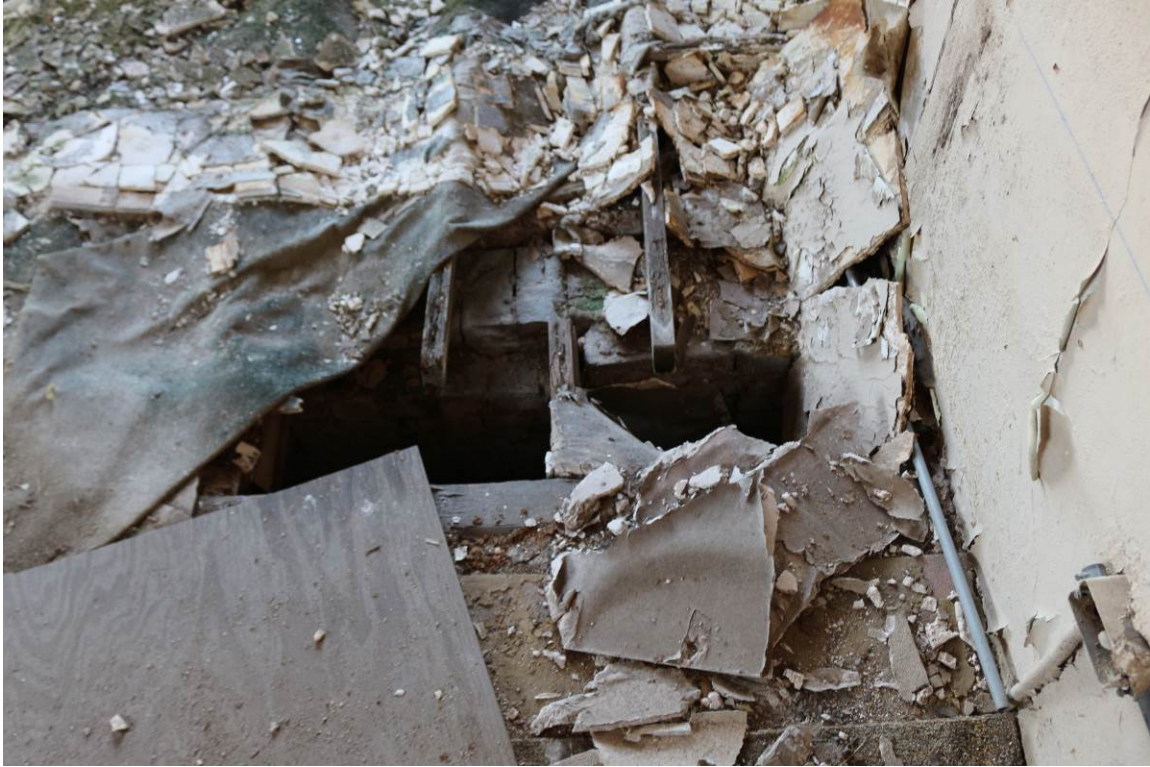
**Photo No. 17:** On the first floor, approximately 40% of the flooring was rotted or missing entirely
