# HISTORIC AND DESIGN REVIEW COMMISSION

**HDRC CASE NO:** 2022-563  
**ADDRESS:** 338 ARMY  
**LEGAL DESCRIPTION:** NCB 3855 BLK 1 LOT 6 & W 25 FT OF 5  
**ZONING:** RM-4 CD, H  
**CITY COUNCIL DIST.:** 2  
**DISTRICT:** Westfort Historic District  
**APPLICANT:** Read Ebersole/EBERSOLE READ & REBECCA  
**OWNER:** Read Ebersole/EBERSOLE READ & REBECCA  
**TYPE OF WORK:** Historic Tax Certification & Verification  
**APPLICATION RECEIVED:** November 28, 2022  
**60-DAY REVIEW:** Not applicable due to City Council Emergency Orders  
**CASE MANAGER:** Rachel Rettaliata

The applicant is requesting Historic Tax Certification & Verification for the property at 338 Army.

# Blue Knight Home Inspections, P.C.

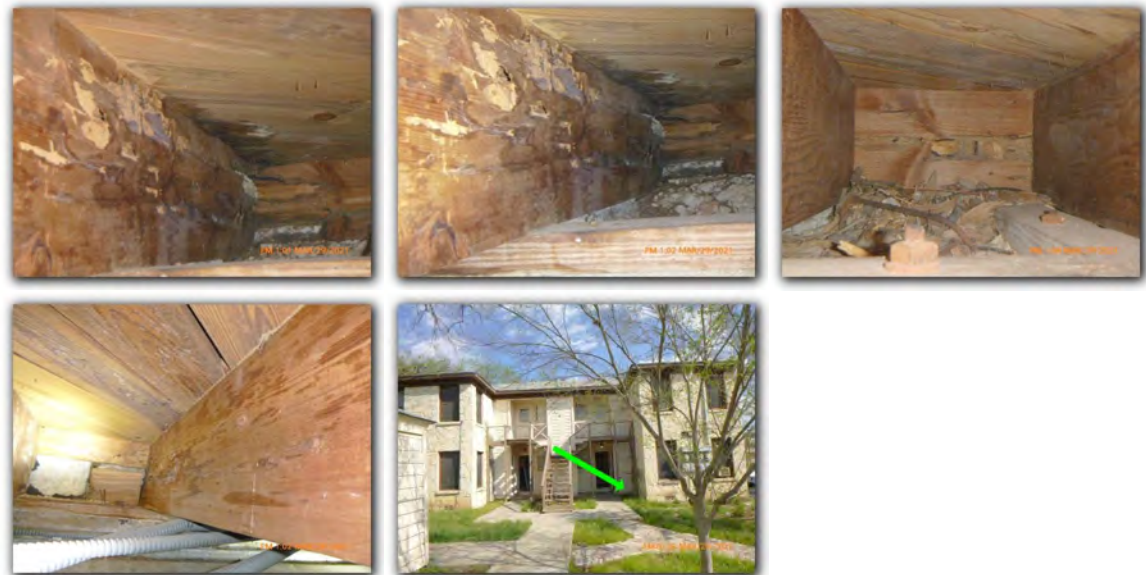
Beams located under unit #2 between kitchen and hallway area has been severely compromised from wood destroying insects (see WDI report). This beam and cross beam both need replacing.

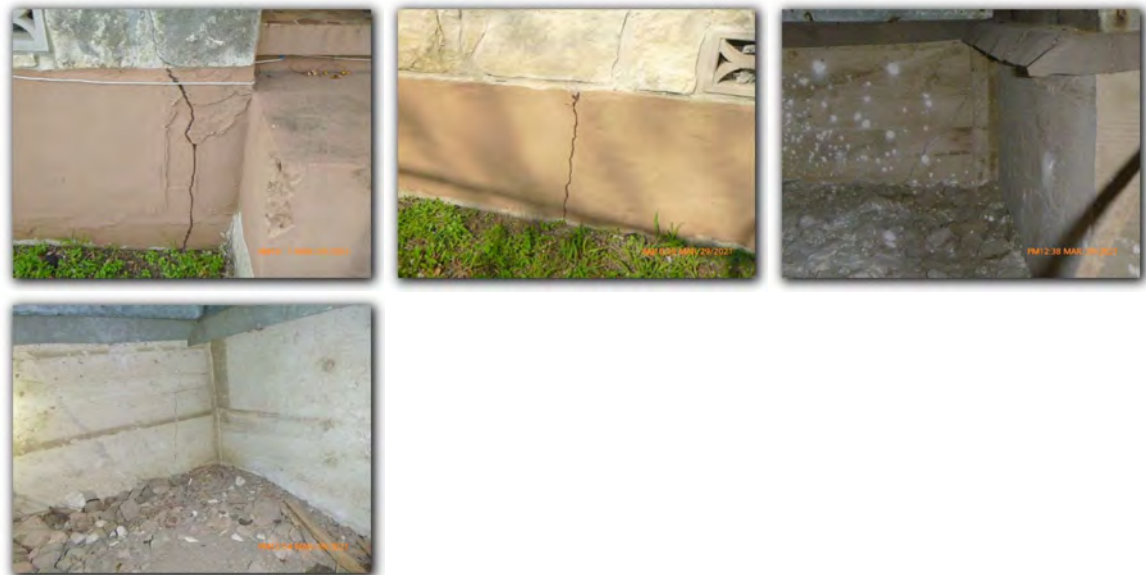
Some cracks noted in grade beams present (viewed from exterior and interior of crawl space).

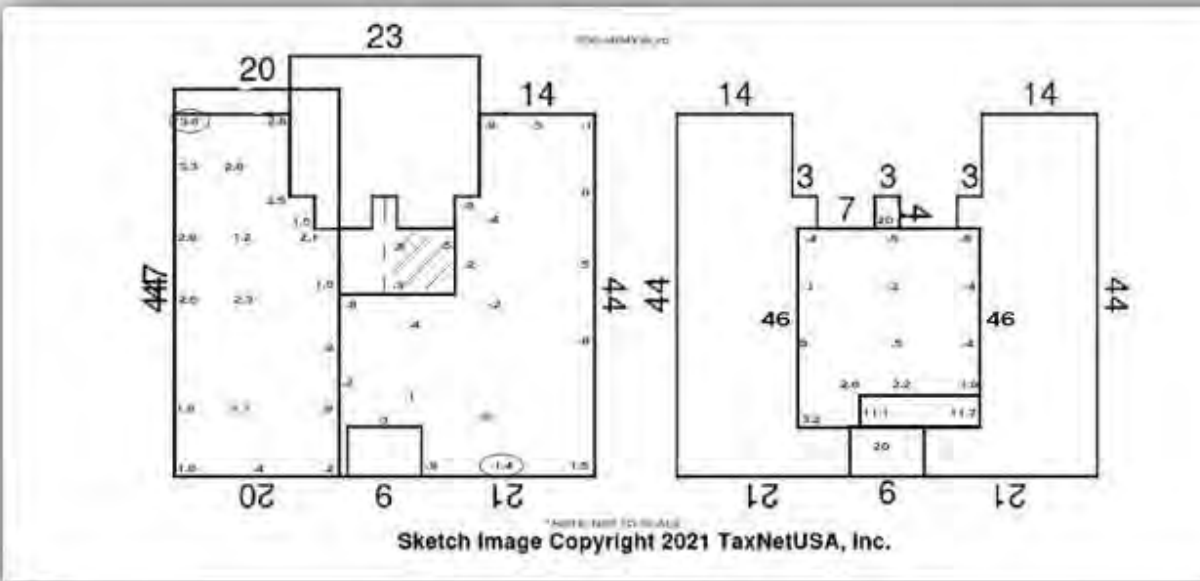
The foundation was inspected with a digital zip level and found to be about 5.0 inch difference between the highest and lowest points, this is a fairly significant difference, so for this reason would strongly request a second opinion from a Licensed professional structural engineer prior to close. (Main house diagram on left).

The foundation was inspected with a digital zip level and found to be about 3.6 inch difference between the highest and lowest points, this is a fairly significant difference, so for this reason would strongly request a second opinion from a Licensed professional structural engineer prior to close. (Guest house)

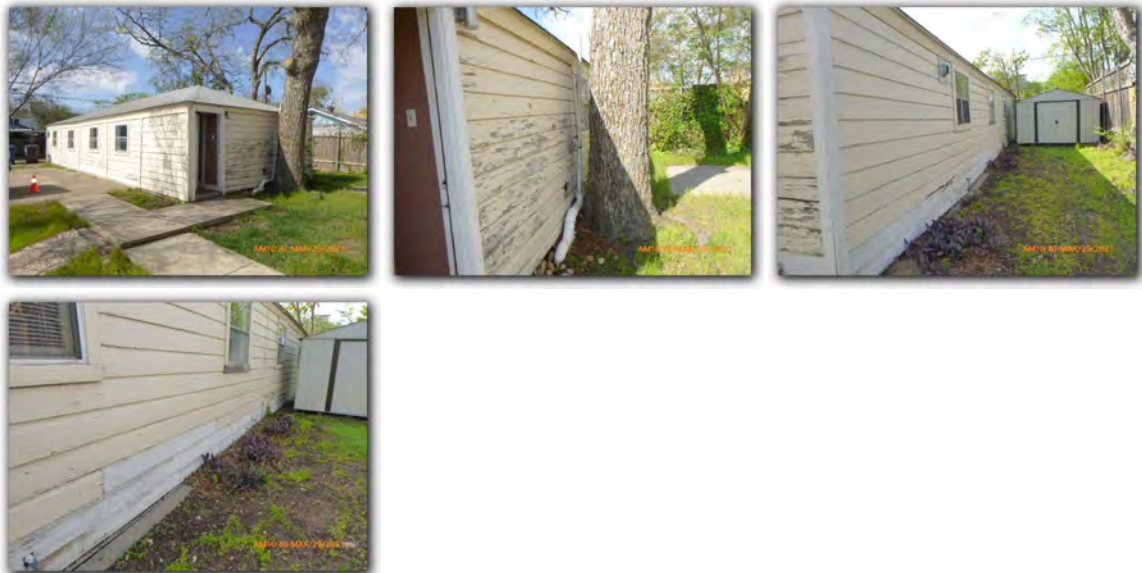
High grade along detached guest unit #5 along front side and along back side. Large tree to close to unit.

**Note:** The ground should slope away from the house at a rate of one inch per foot for at least the first ten feet. Ideally, at least eight inches of clearance should be maintained between soil level and top of the foundation walls.

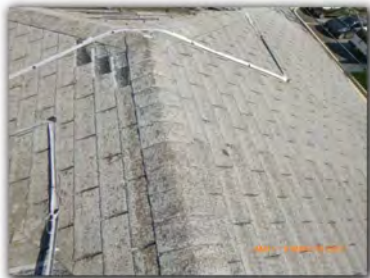
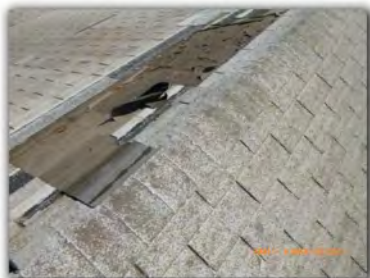
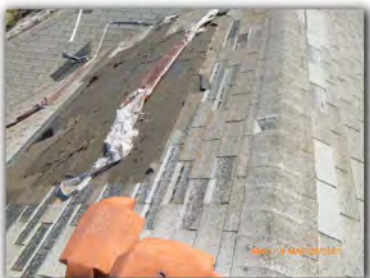
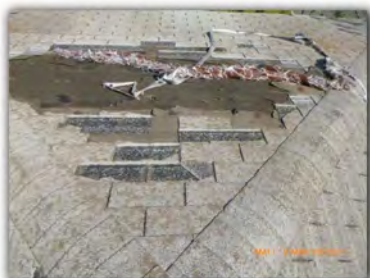
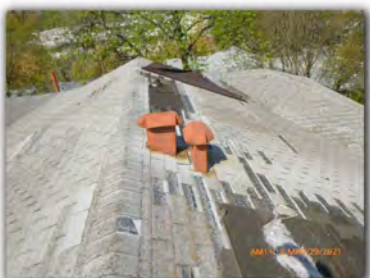
Roof is considered to be in Poor condition with major deficiencies.

Roof must be replaced, large amount of singles are missing, damaged and considerable amount of granular loss.

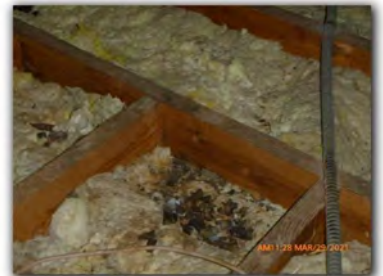
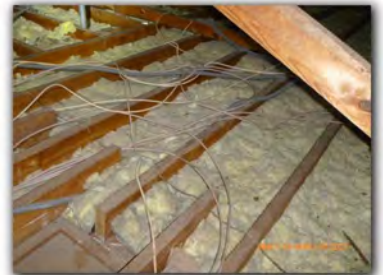
The level of ventilation should be improved, located soffit vents and just two gable vents. It is generally recommended that one square foot of free vent area be provided for every one hundred and fifty square feet of ceiling area. Proper ventilation will help to keep the house cooler during warm weather and extend the life of roofing materials. In colder climates, it will help reduce the potential for ice dams on the roof and condensation within the attic.

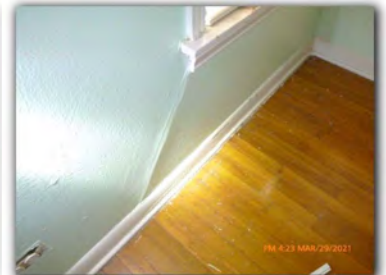
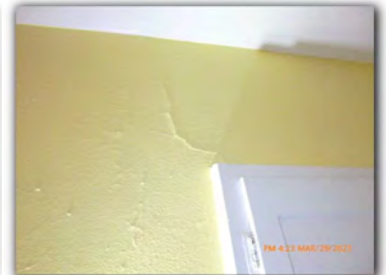
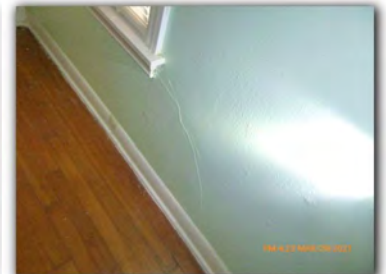
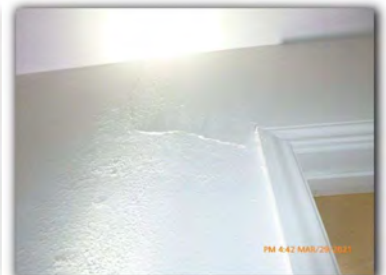
Settlement / movement cracks present throughout.  
Unit #1

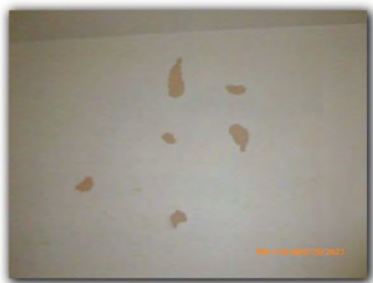
Paint peeling at unit #2 wall.

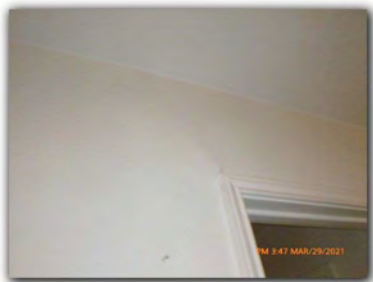
Settlement / movement cracks present throughout.  
Unit #2

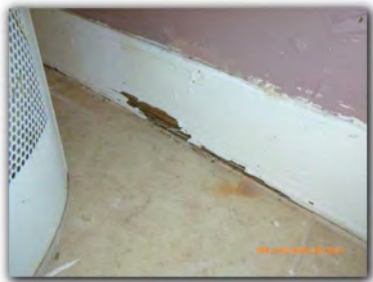
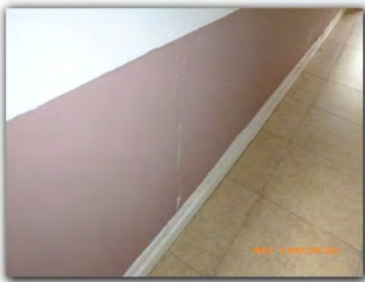
Unit #5 water damaged walls, insect activity at unit #5 in kitchen.  
**Exterior Walls:**

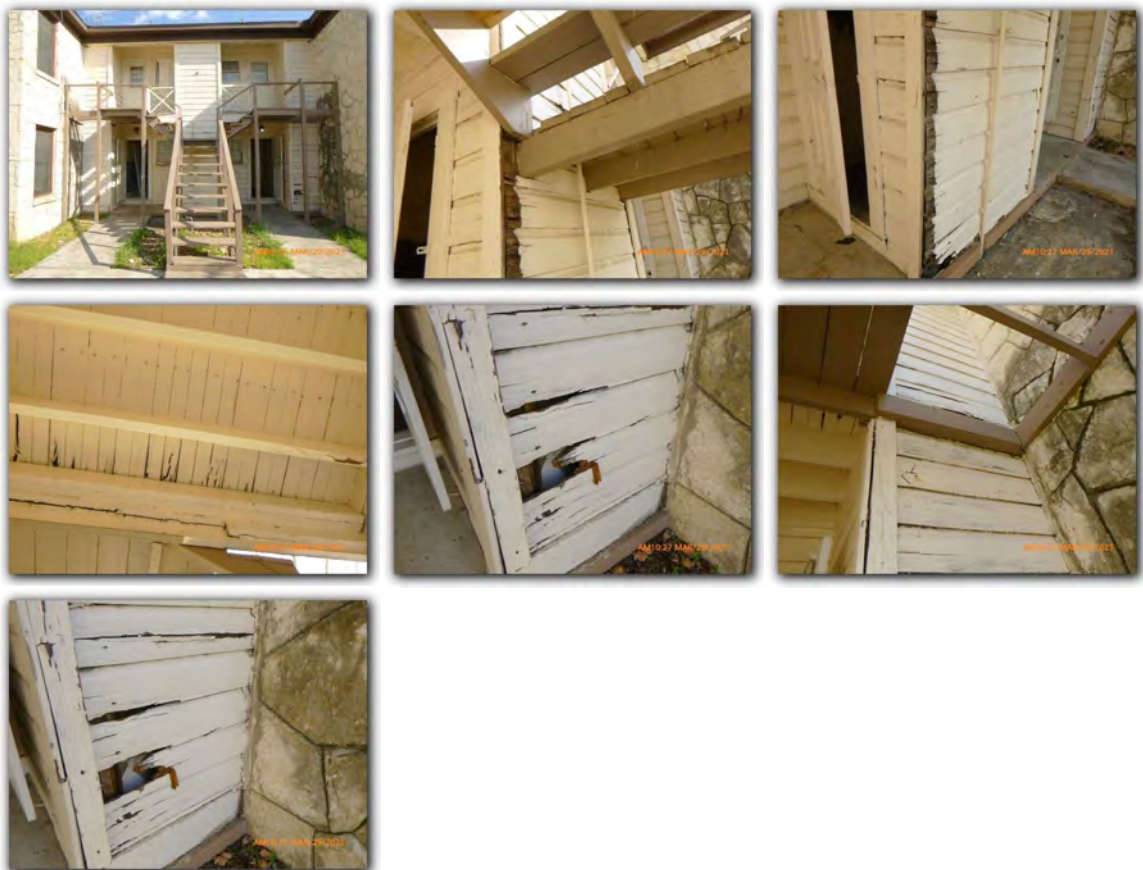
Considerable dry rot along back wood siding, that has allowed water to gain access at multiple areas.

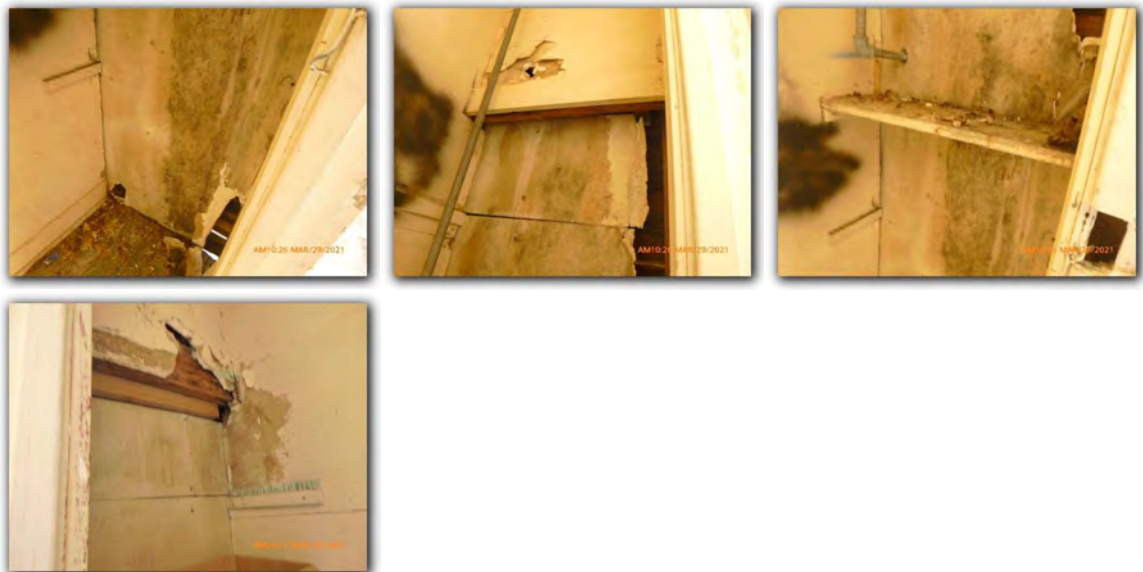
Microbial growth present in outdoor closets (on back side), suggest remediation after repairing / replacing siding first.

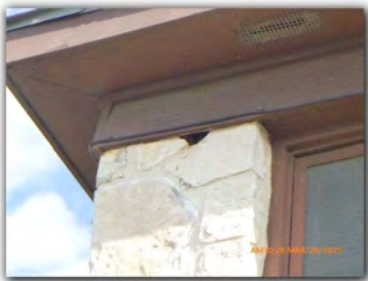
Open area should be sealed (birds are living inside wall).

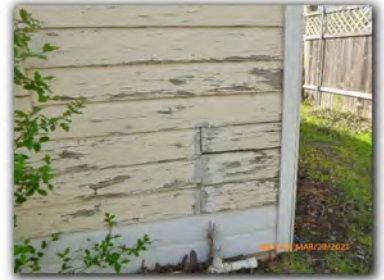
Siding on detached unit needs refinishing.

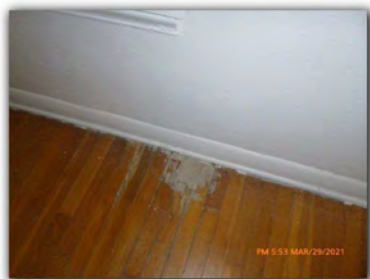
Wood floors have been damaged at all units.

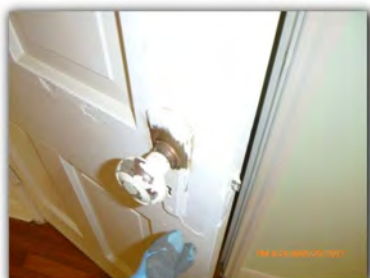
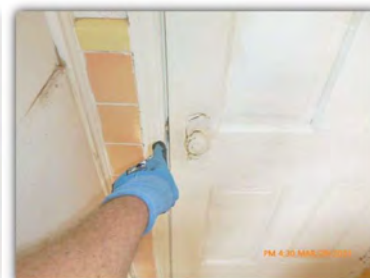
Unit #1 does not latch at bathroom and door is damaged.

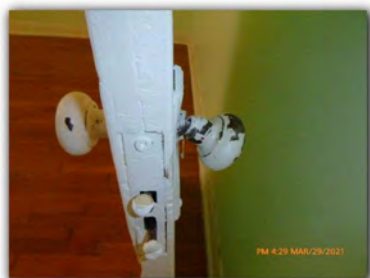
Damaged hardware.

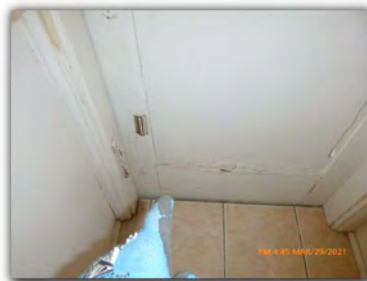
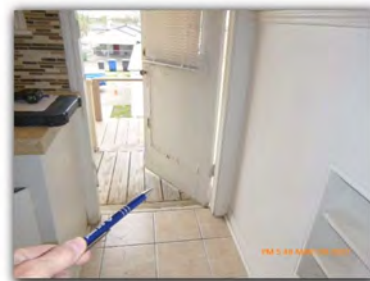
Back door has water damage and is hard to open and close at unit #3.

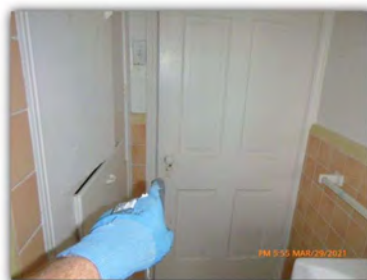
Door does not latch at unit #4 bathroom.

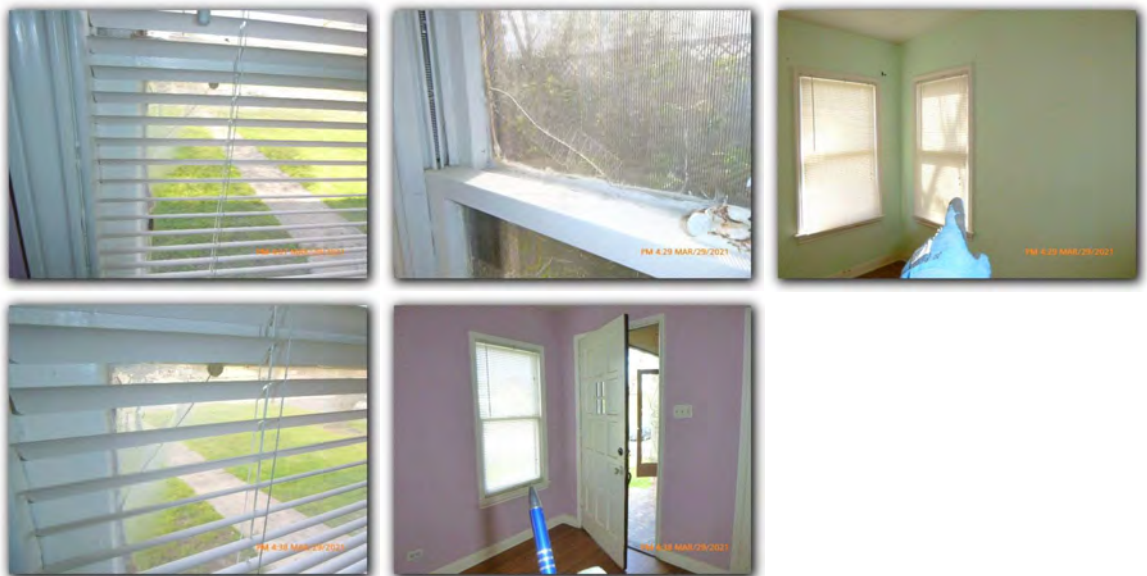
Crack window next to front main entry and at bedroom.  
Unit#1

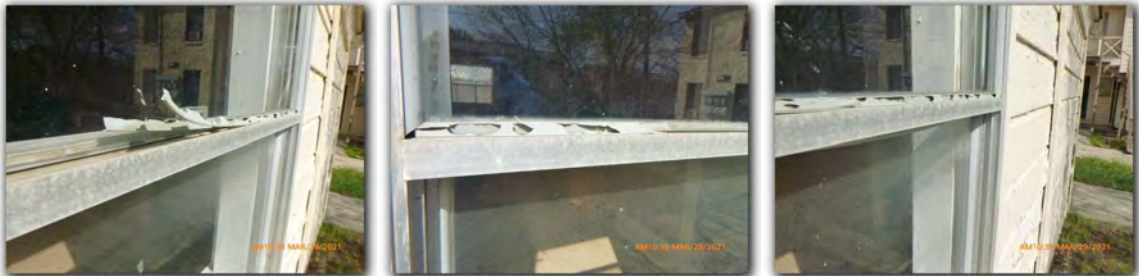
Plastic framing glazing bead (decorative piece that frames glass) is damaged at exterior of some windows.  
Unit#5

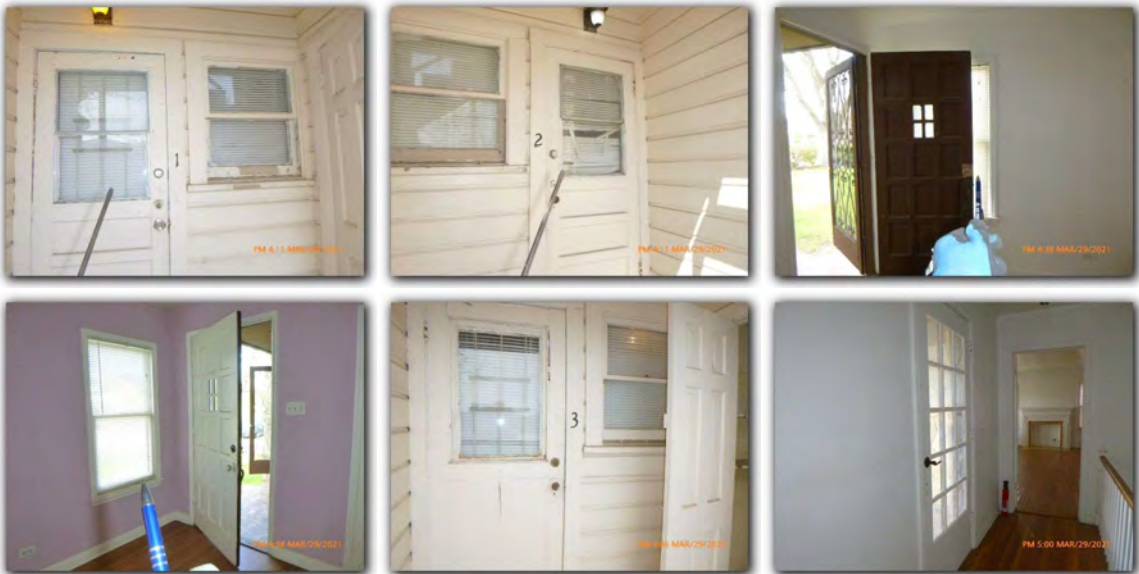
Safety glass etchings were not observed on the glass within the windows at back doors and all windows next to back doors & unit #3 & unit #1 next to front entry and front balcony door. This glass is required for windows close to the floor or in hazardous locations and is generally identified by an etching in the corner of the glass pane.

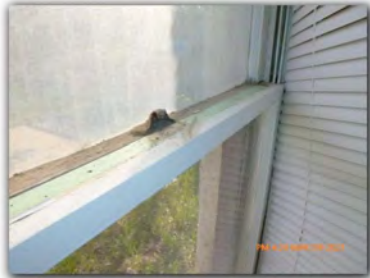
Missing locks at several windows throughout.

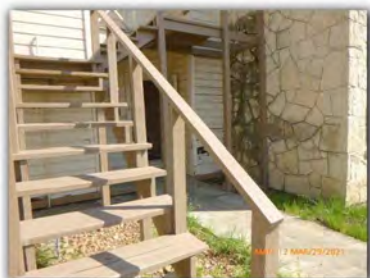
The height of the railing is not high enough ( minimum recommend height is 36") to prevent from topping over the railing. It is recommended that this condition be repaired for improved safety.

The openings in the railing are large enough to allow an object larger than 4 inches to fall through. It is recommended that this condition be repaired for improved safety.

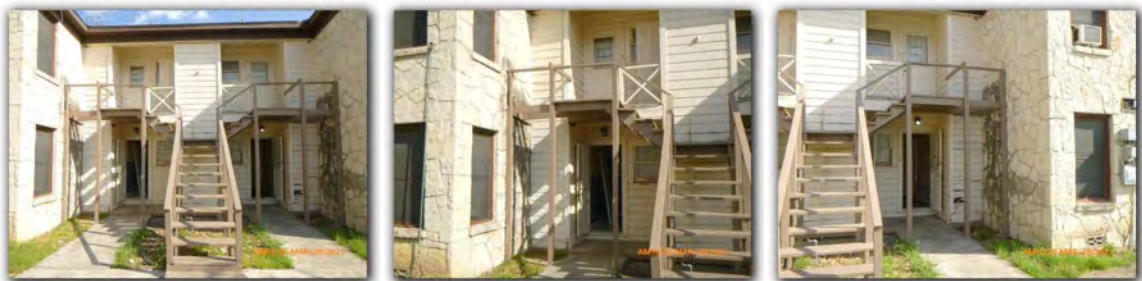
It is now required that posts over 8' high need to be 4X6, not 4X4, currently most posts are 4X4.

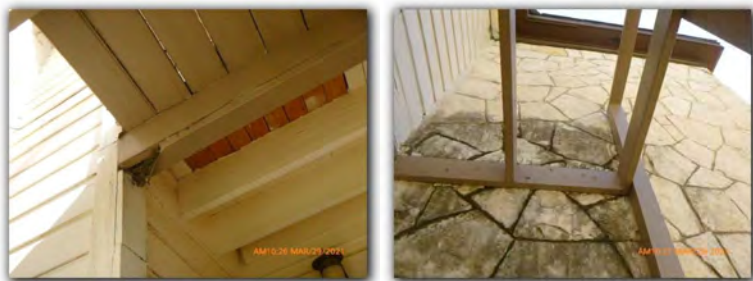
Suggest improving post joint connection with using lag or carriage bolts and joist hangers and T bracing, most connections are toe-nailed with nails.

Licensed contractor should give estimate of replacement.

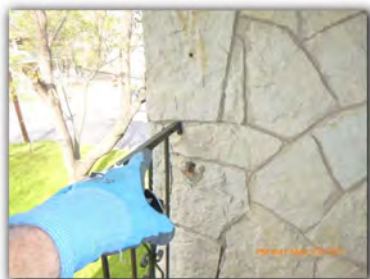
Loose railing at front balcony.

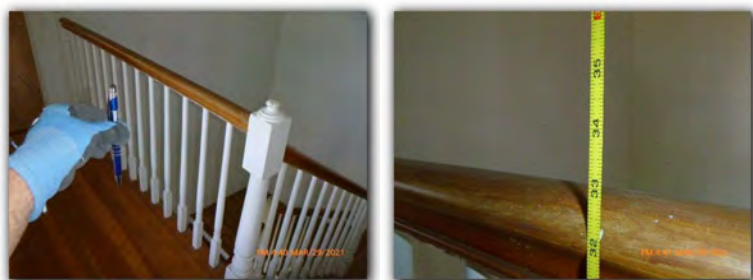
Balcony less than 36 inches.

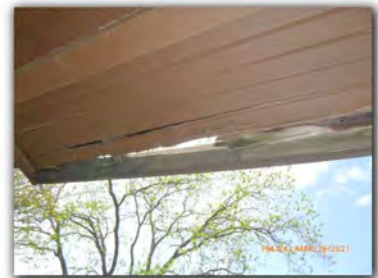
Water damage present on balcony ceiling

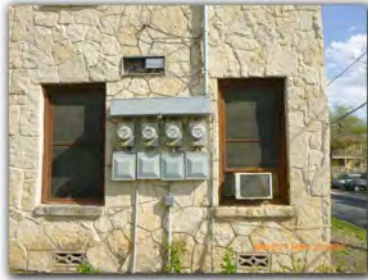
Panel bonding screw or strap is not present.

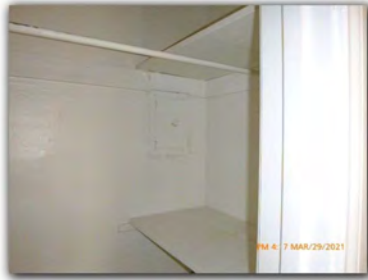
Panels are located in clothes closets, this location is not longer allowed, however not required to re-locate unless replacing panel.

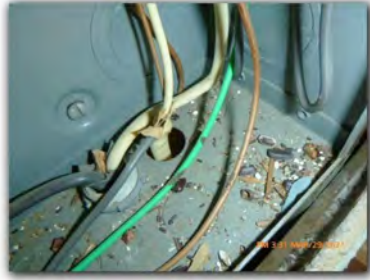
Wire bushing missing at bottom of panel, they help protect wires from being cut by panel knockout hole edges.

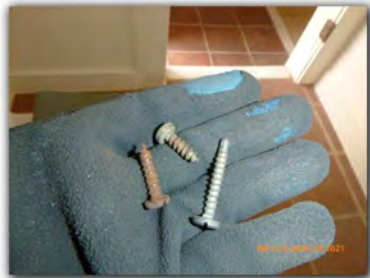
Inappropriate screws were observed at the box cover plate and should be replaced with blunt tipped screws.

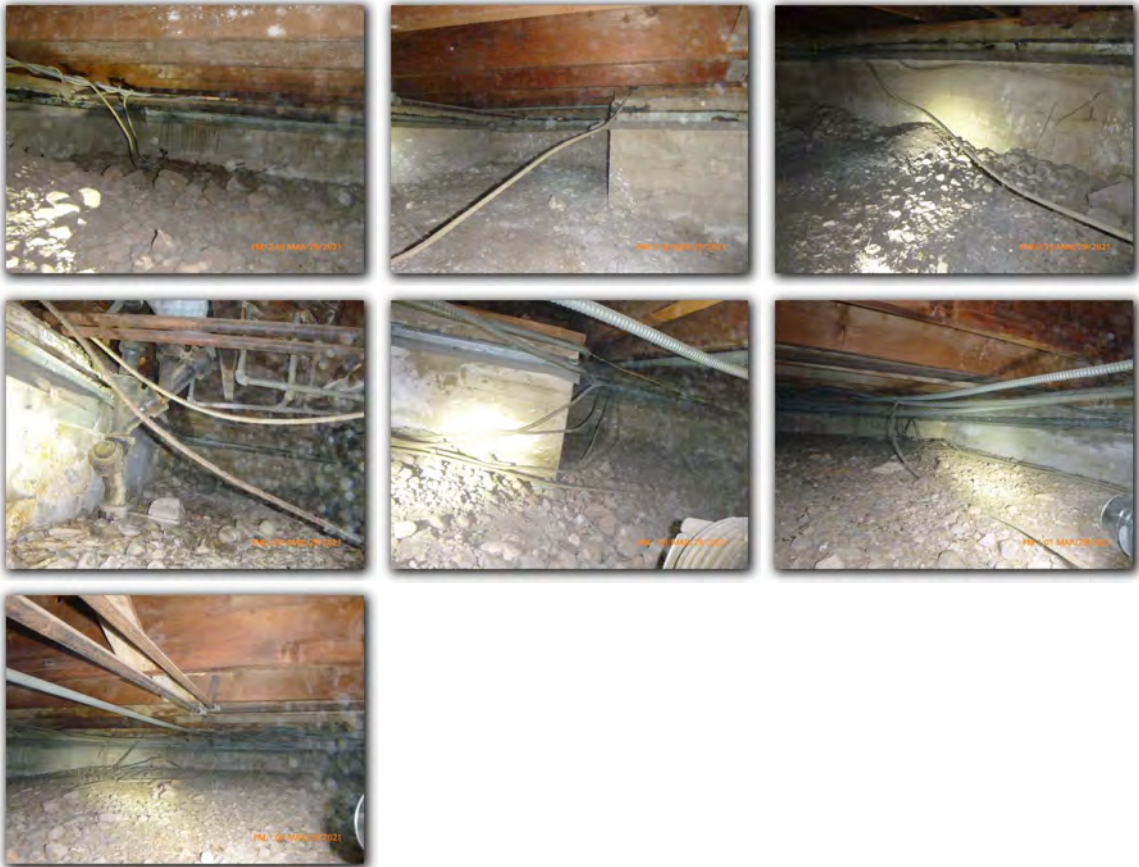
Wires in crawl space should be properly strapped up.

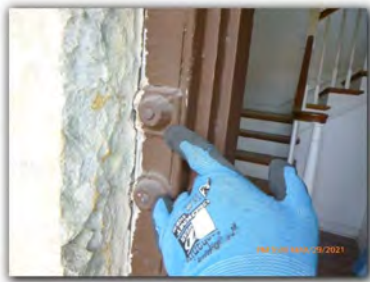
Door bells do not function.

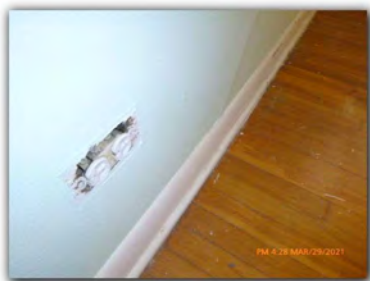
Missing receptacle covers.

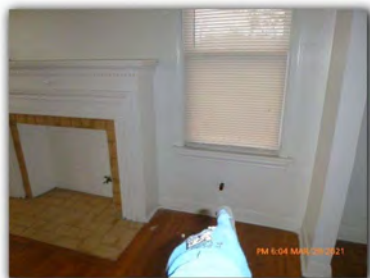
Not power to receptacle at unit #4.

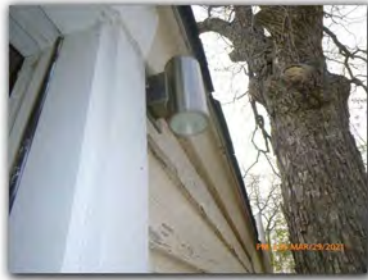
Light at unit #5 flickers.

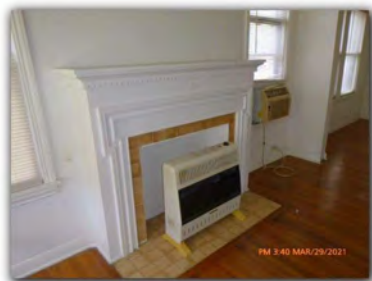
Free standing units were not inspected, buyer is going to remove and cap gas lines.

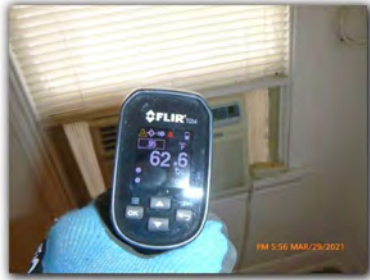
Unit #4 Window unit does function.

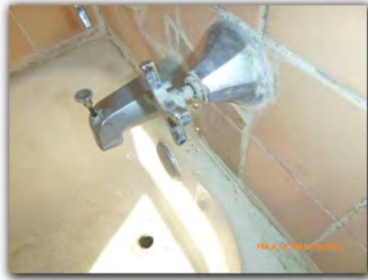
Tub control handles leak when on.

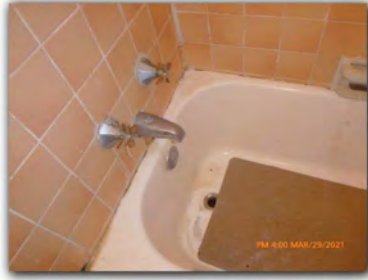
Leak at handles at unit #2.

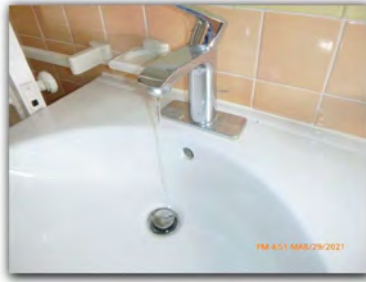
Low pressure at vanity fixture.

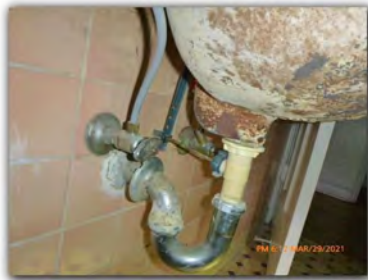
Leak at vanity sink.

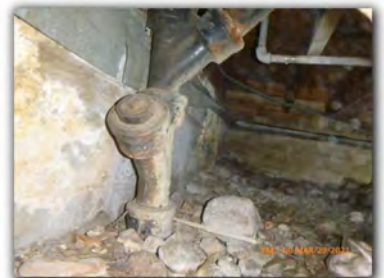
Located leaks under unit #1 & unit #2 bathrooms.

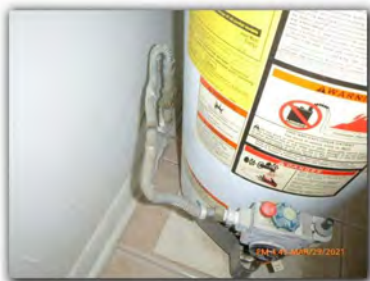
Gas line sediment trap is not present, this allows debris that could be within the gas to "drop" into and not clog orifices in system.

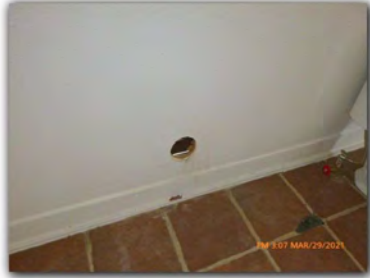
Unit #5

Dryer vent sleeve is missing through wall.
