HISTORIC AND DESIGN REVIEW COMMISSION

December 21, 2022

HDRC CASE NO: 2022-002
ADDRESS: 1135 S ST MARYS ST
LEGAL DESCRIPTION: NCB 2963 BLK LOT A22
ZONING: C-2, H
CITY COUNCIL DIST.: 1
DISTRICT: King William Historic District
APPLICANT: Ann McGlone/Post Oak Preservation Solutions
OWNER: Manuel Vogt/PSMV MANAGEMENT LLC
TYPE OF WORK: Historic Tax Verification
APPLICATION RECEIVED: December 08, 2022
60-DAY REVIEW: Not applicable due to City Council Emergency Orders
CASE MANAGER: Rachel Rettaliata

The applicant is requesting Historic Tax Verification for the property at 1135 S St Mary's.

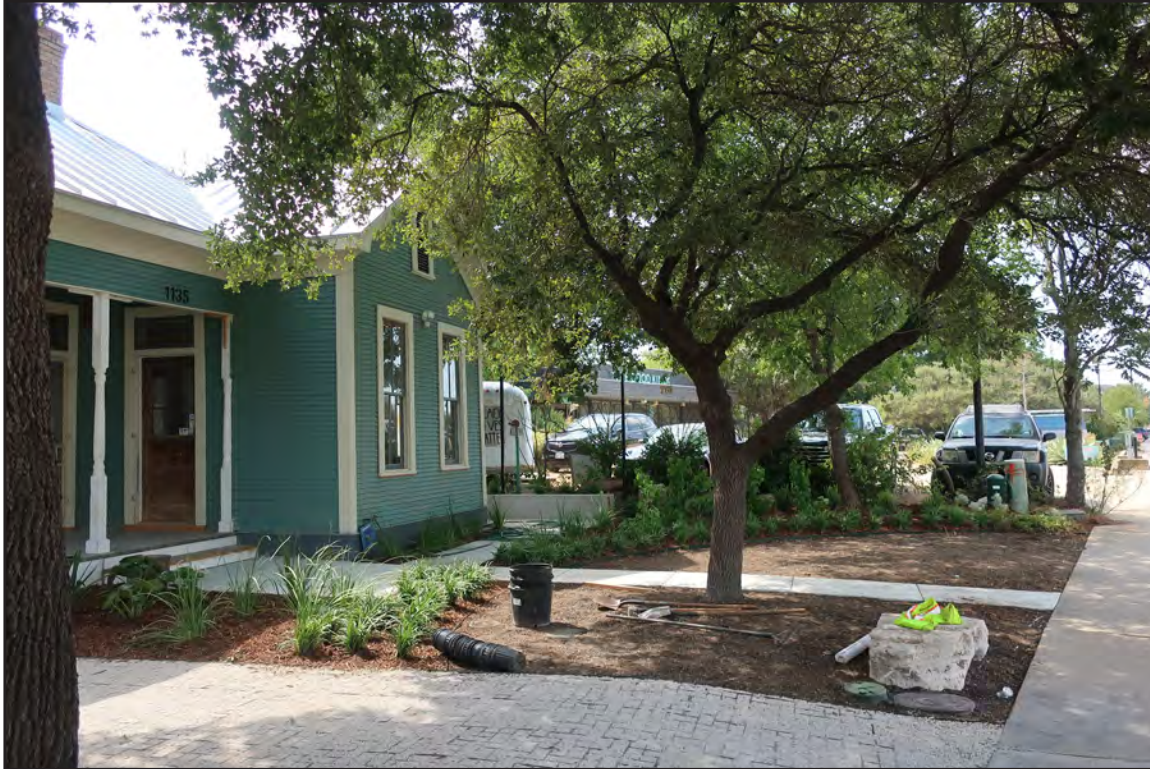
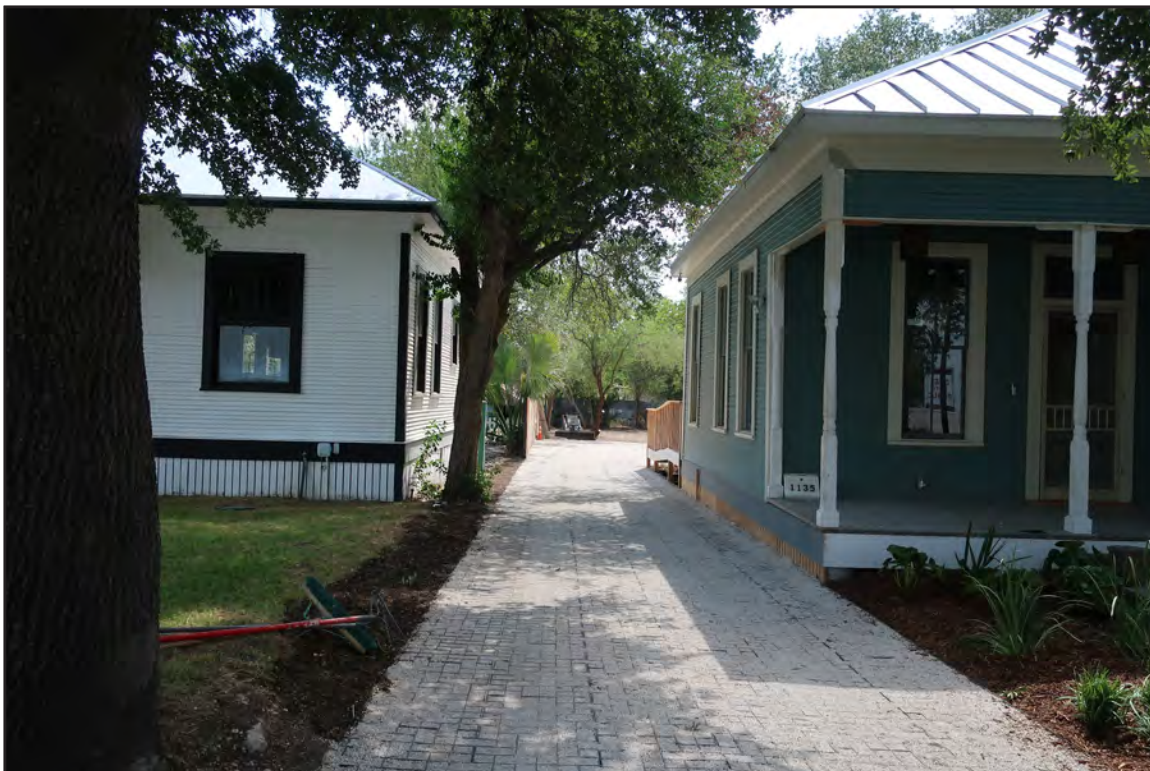
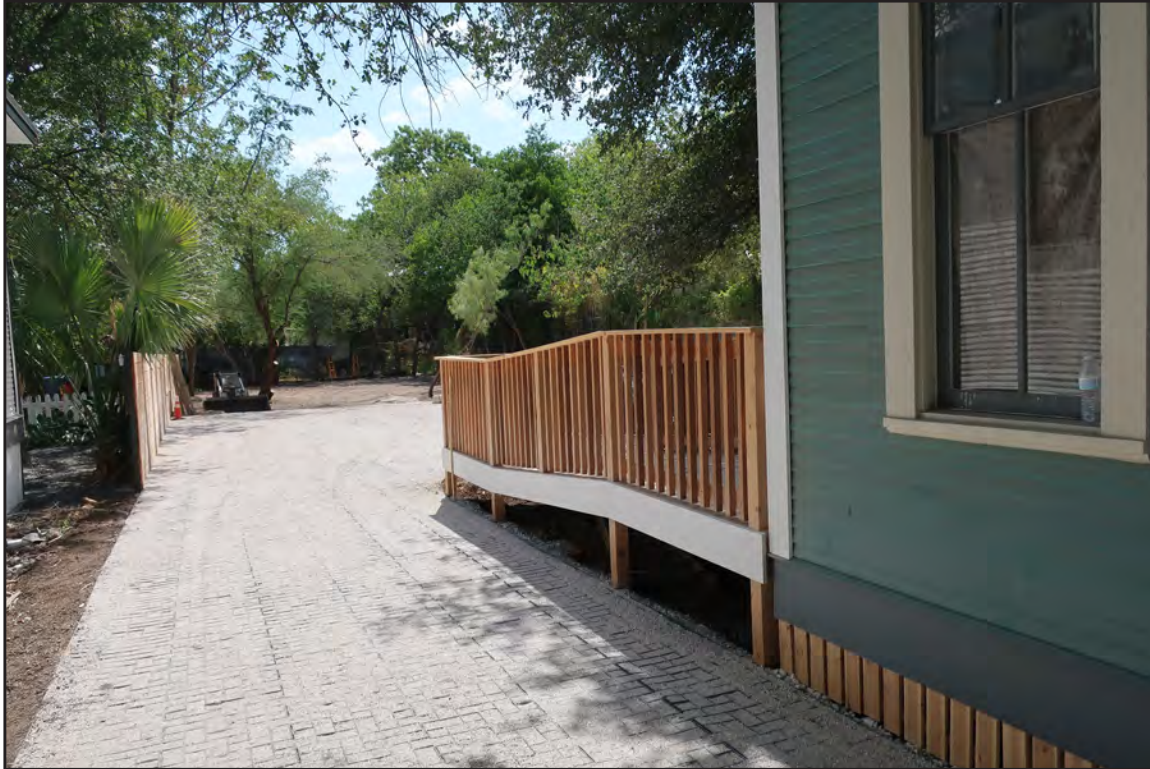
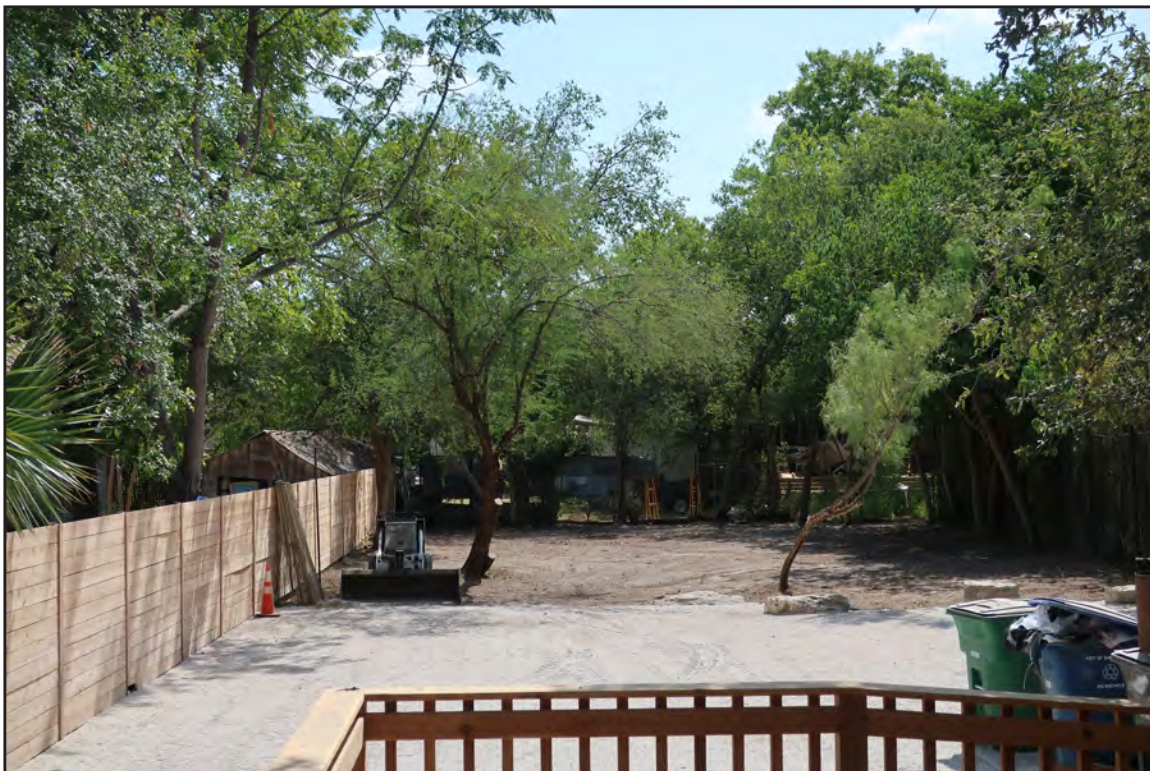
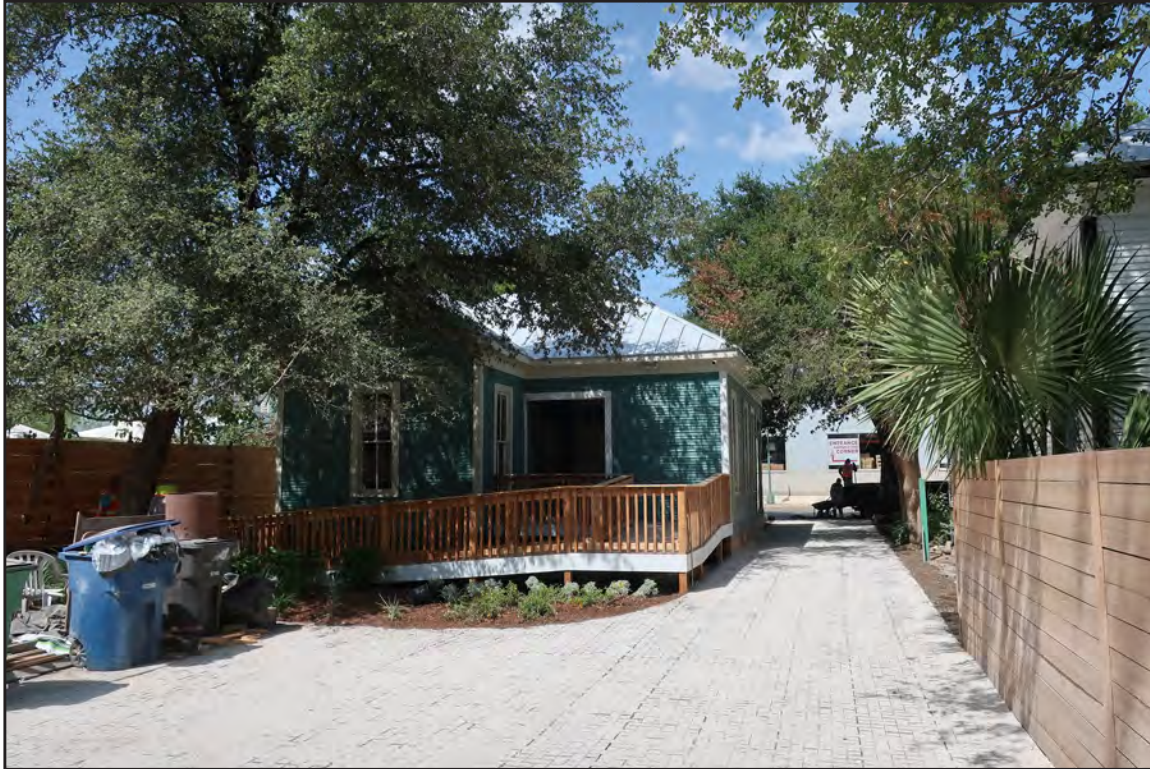
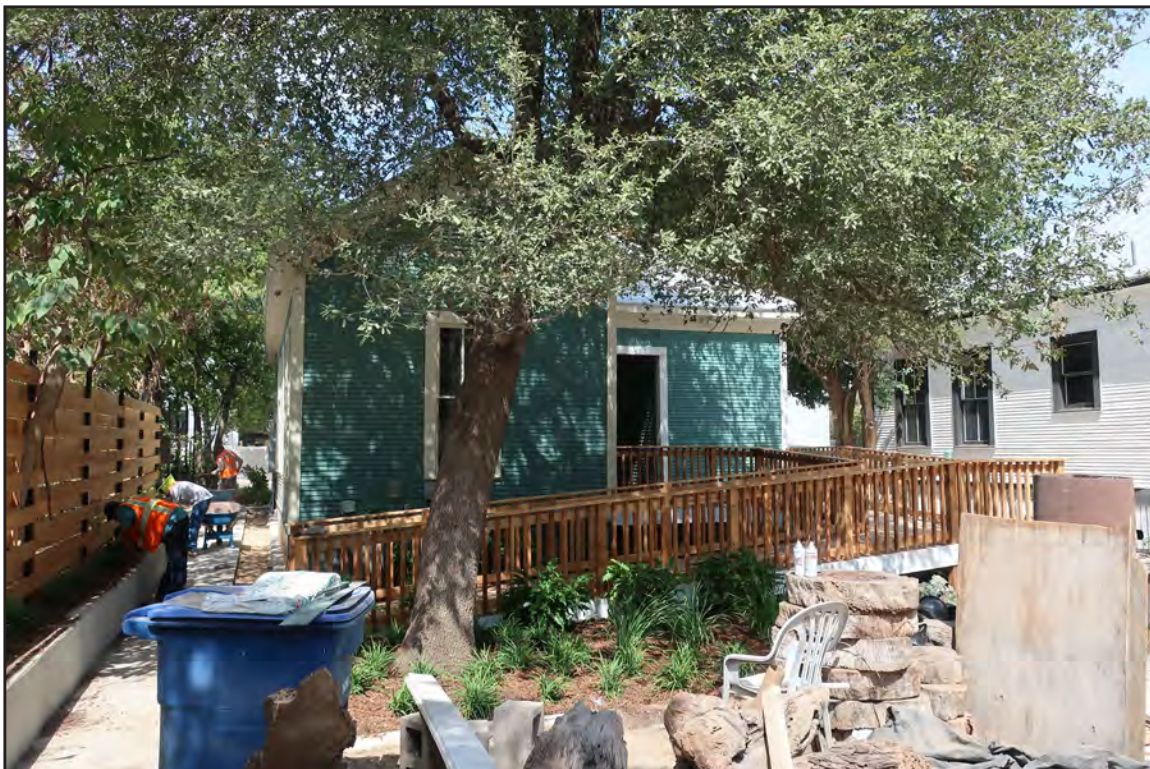
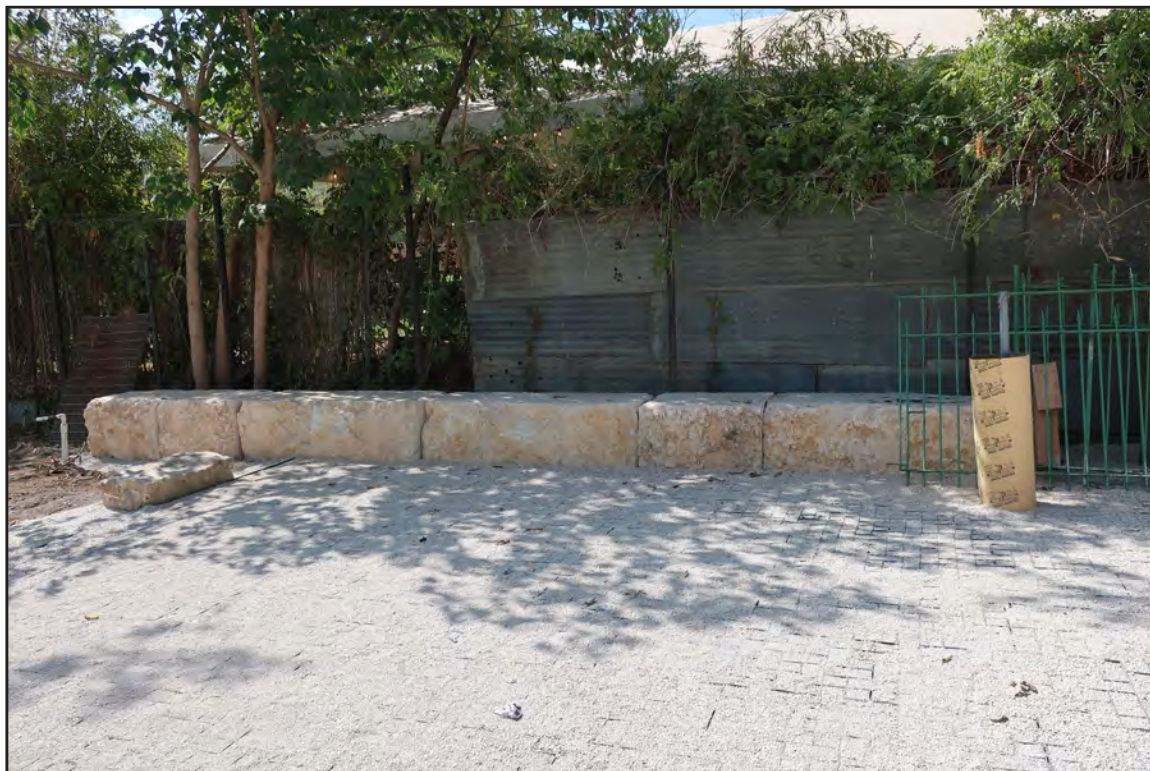
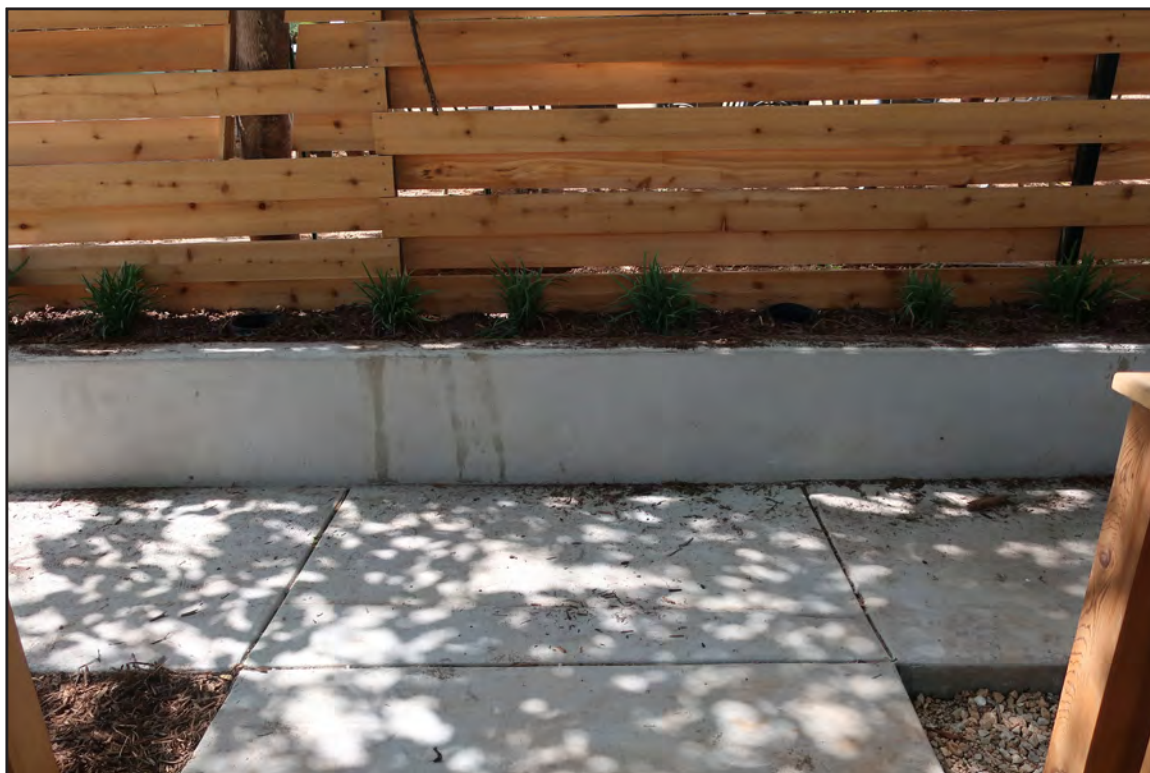
1.
Site: Front Yard
View NW

2.
Site: Driveway
View SW

3.
Site: Driveway
Looking into
Rear Parking
Lot
View W

4.
Site: Rear
Parking Lot
and Yard from
ADA Ramp
View SW

5.
Site: Rear
Parking Lot
Showing New
ADA Ramp
View NE

6.
Site: New ADA
Ramp and
Wood Fence
View E

7.
Site: Retaining
Wall
View NW

8.
Site:
Landscaping
and Fence
View NW

The subject building is situated on the southwest side of S St. Mary's St between its intersections with S Alamo St to the northwest and Stieren St to the southeast. This narrative will use the Plan cardinal directions. The primary elevation faces north into a grass front yard with mature trees. A sidewalk lines S St. Marys St. A gravel driveway lining the south elevation of the building leads west to a fenced-in backyard with mature trees. There is a non-historic wood and concrete quonset hut/ shed structure in the backyard.

In the front yard, the Applicants added a sidewalk accessing the front porch; they also added simple landscaping and flora here. They retained the existing driveway location to the south of the building and repaved it with composite granite. The driveway accesses the rear yard, where the Applicants paved a portion to create a parking lot. The Applicants installed a new ADA accessible wood ramp accessing the rear porch from the new parking lot.

New, simple wood fencing borders the backyard and the outer edge of the driveway. The Applicants constructed a stone retaining wall lining the north sidewalk at the property line to prevent erosion. Existing trees in the rear yard remain. The Applicants have also removed the non-contributing wood and concrete quonset hut/ shed in the backyard.

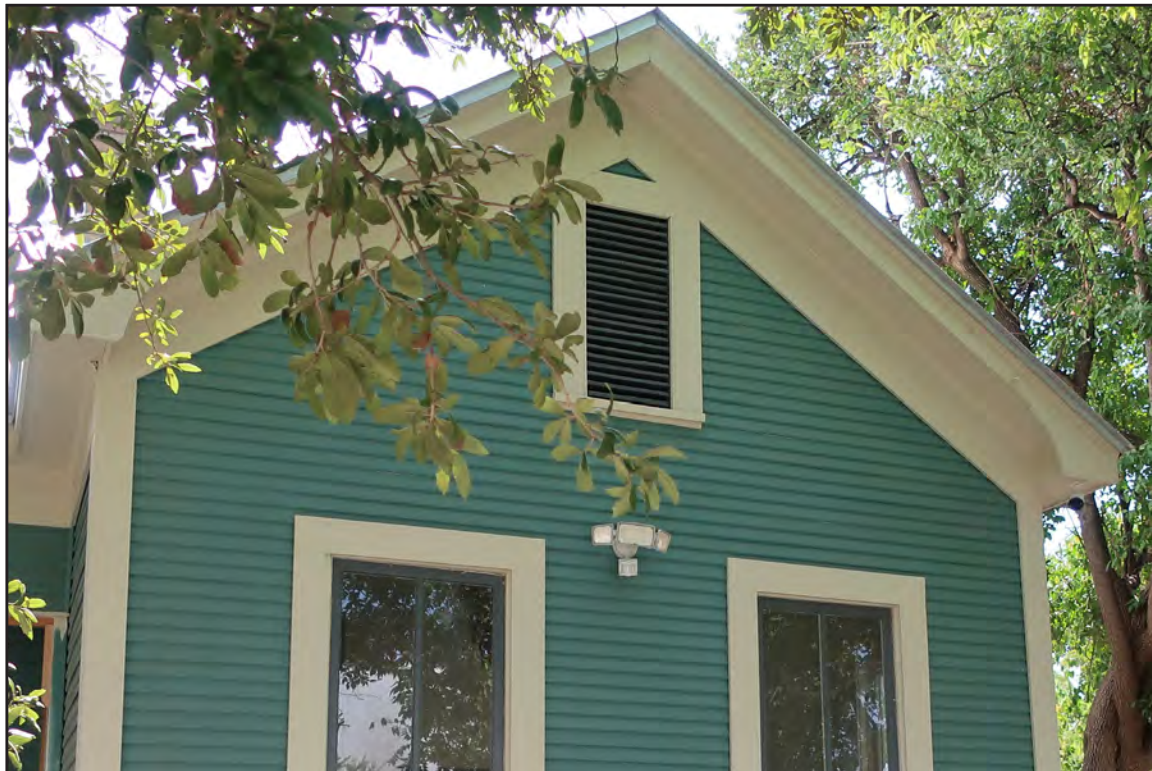
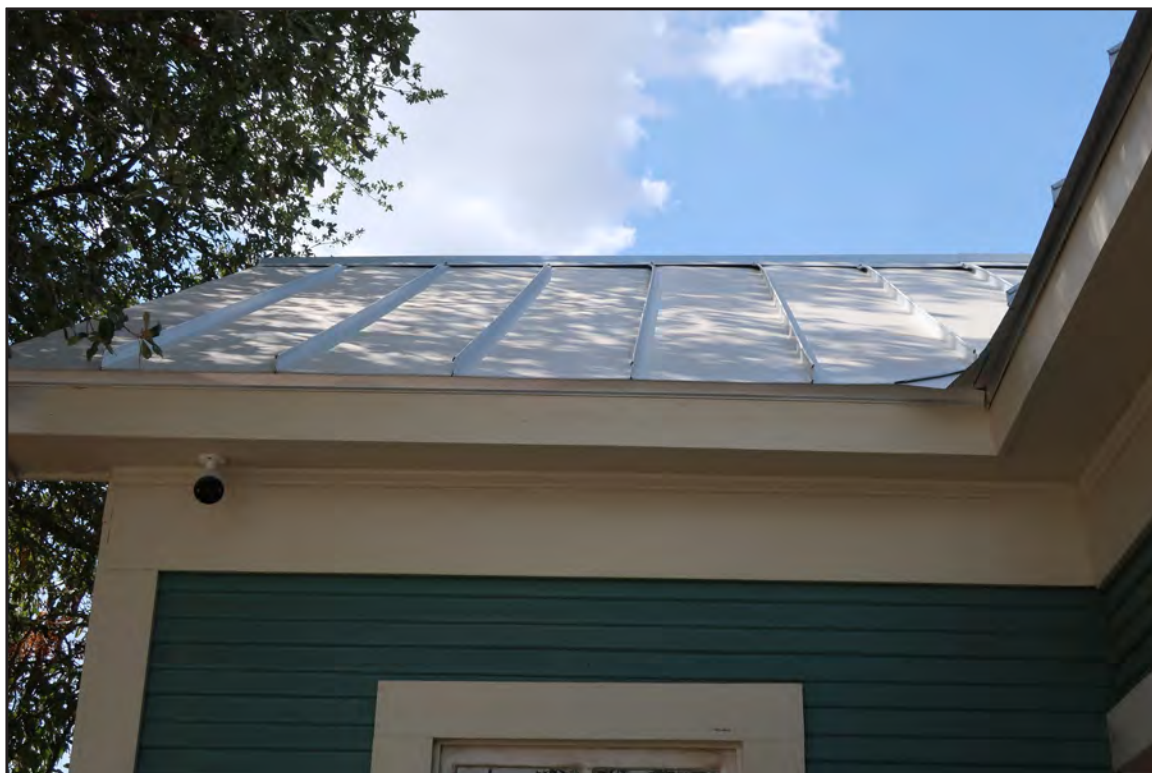
9.
Repaired Roof
Gable
View NW

10.
New Standing
Seam Roof
View NE

The building has a front-gable-on-pyramid metal standing seam roof. It is rusted and leaking.

The Applicants have replaced this roof with a new metal standing seam roof matching the old in appearance and materials.

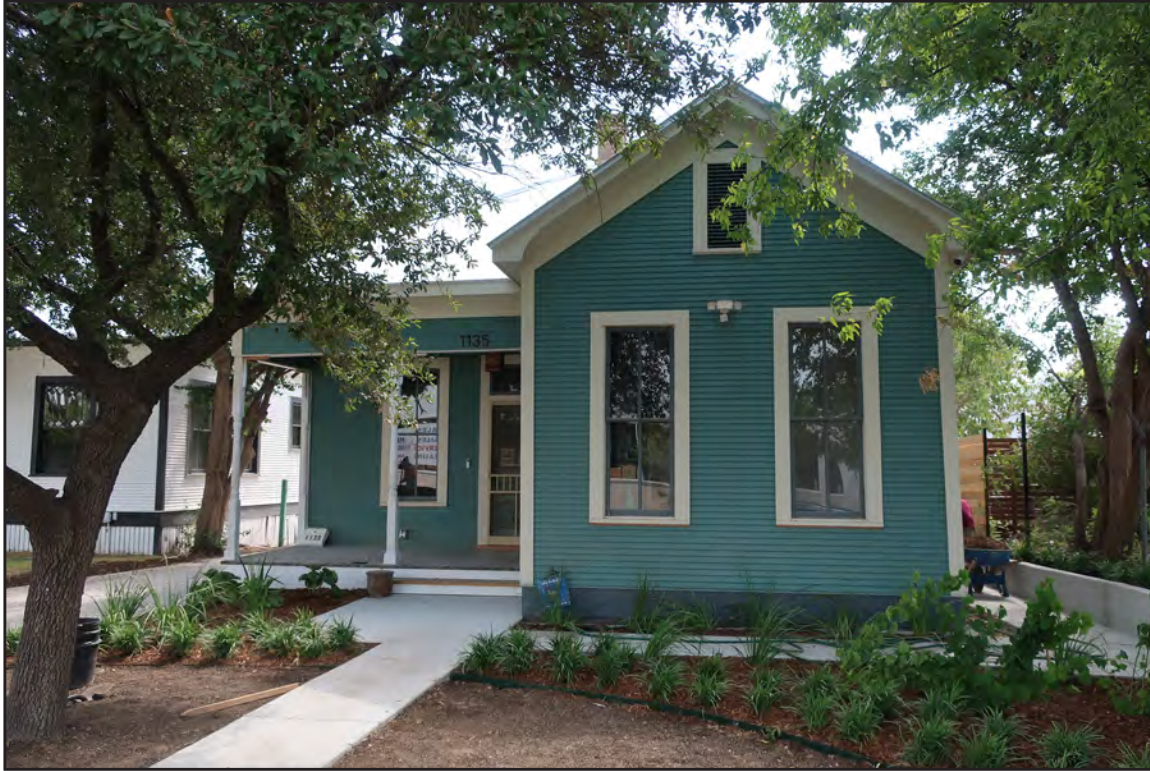
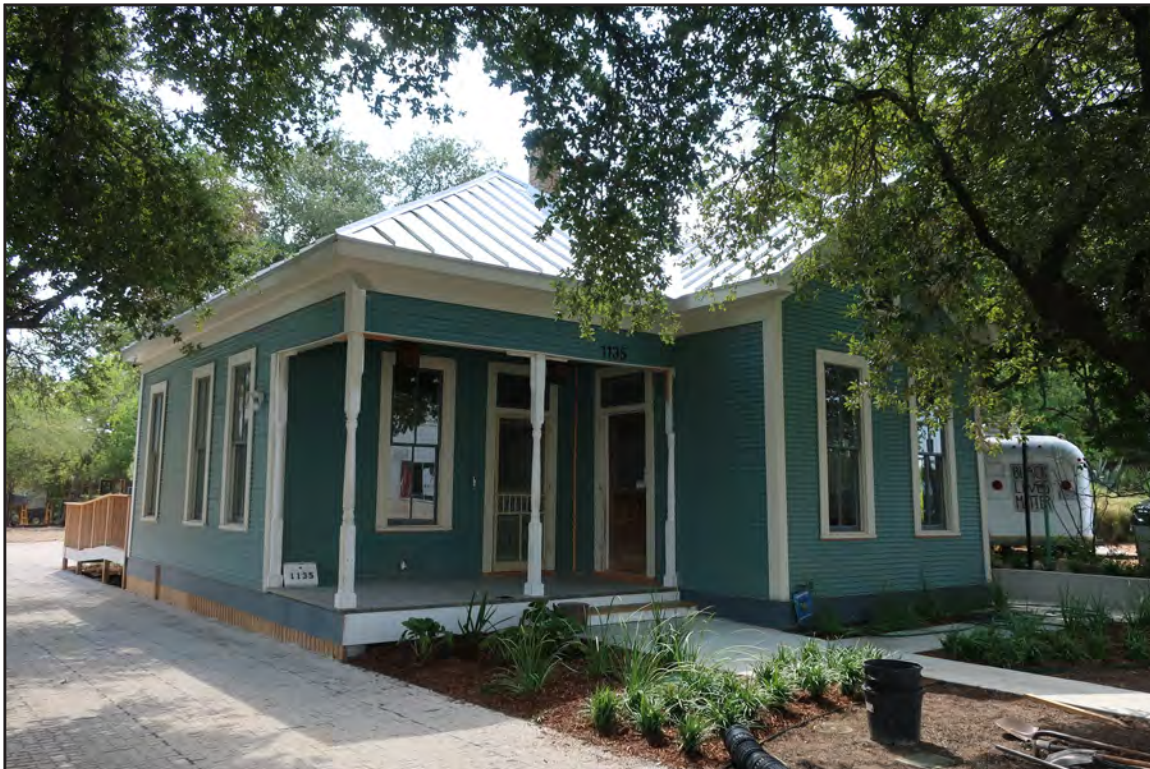
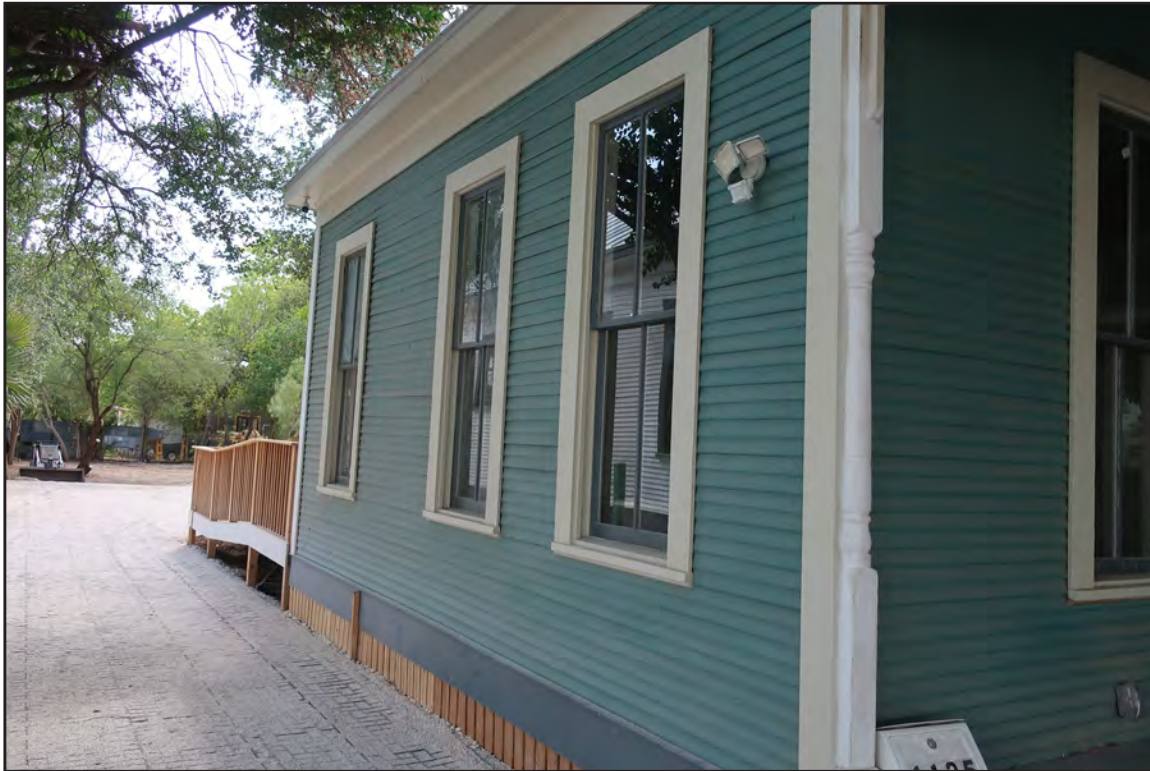
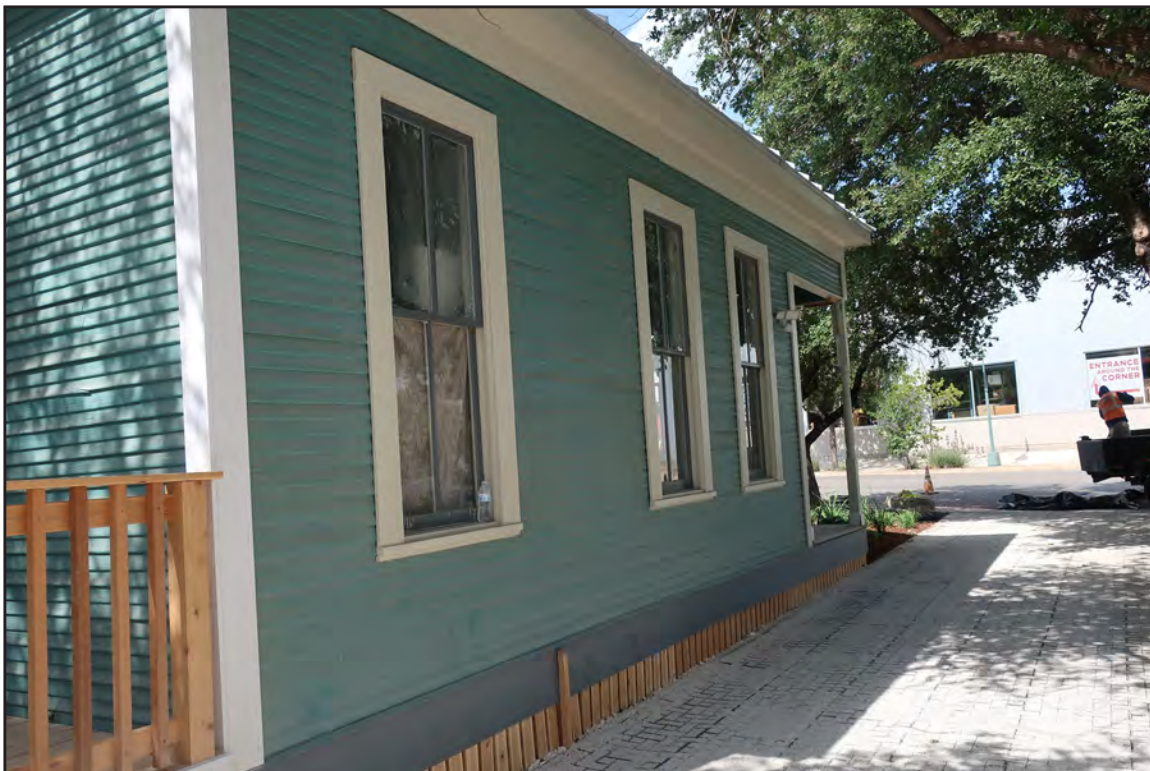
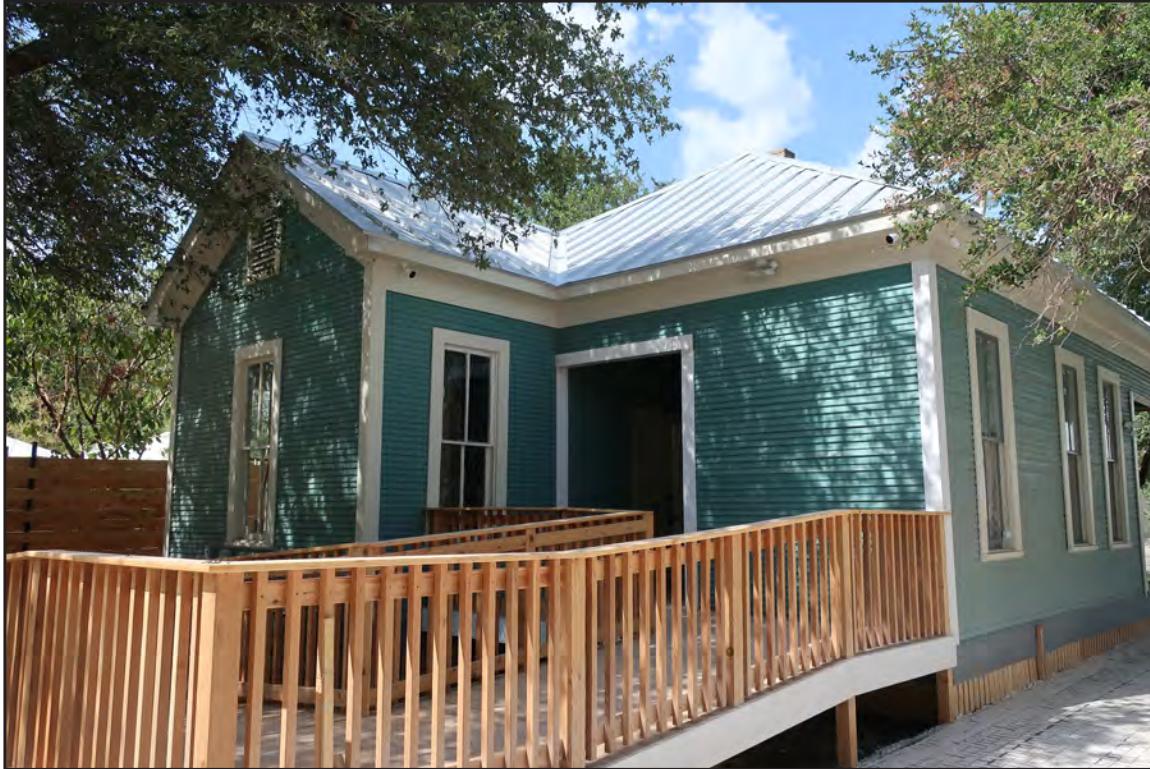
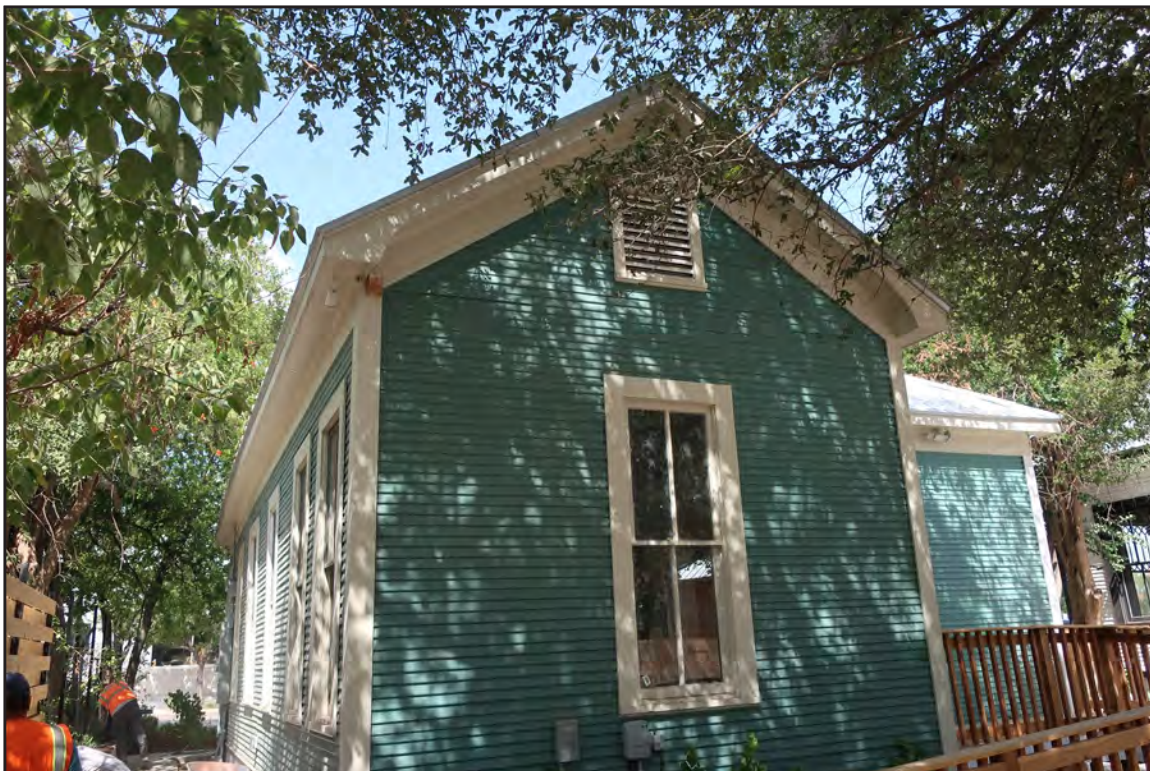
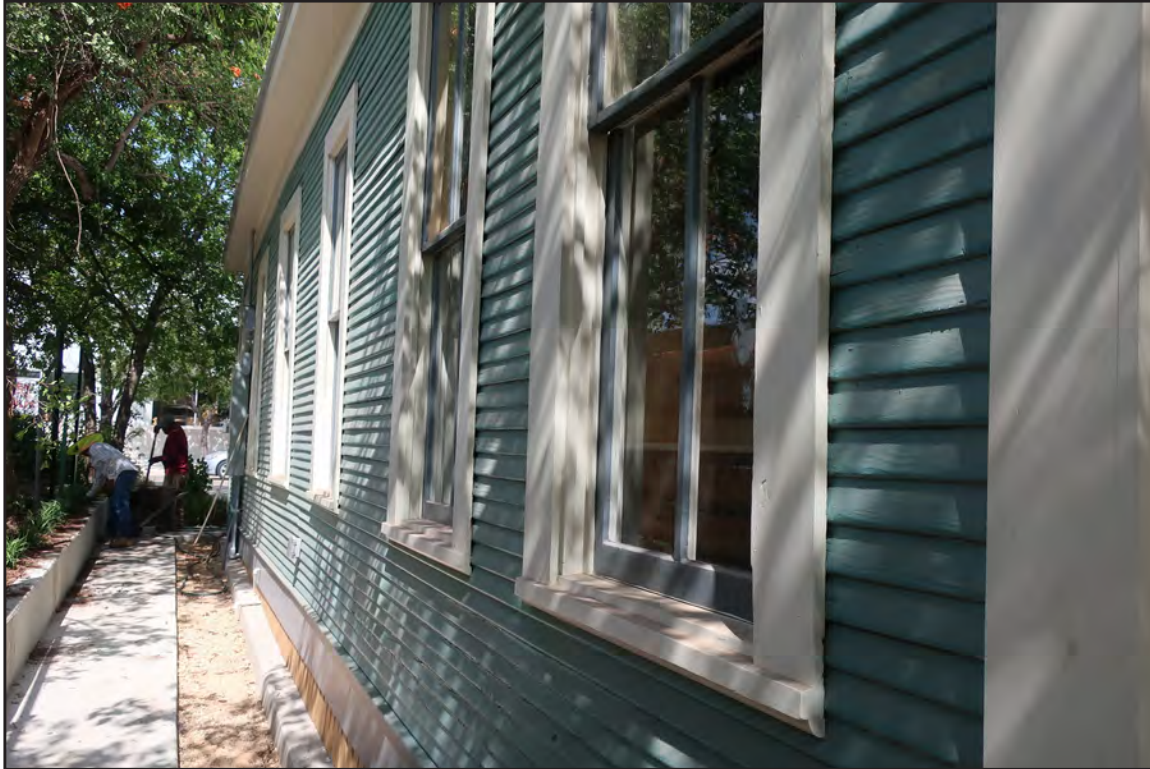
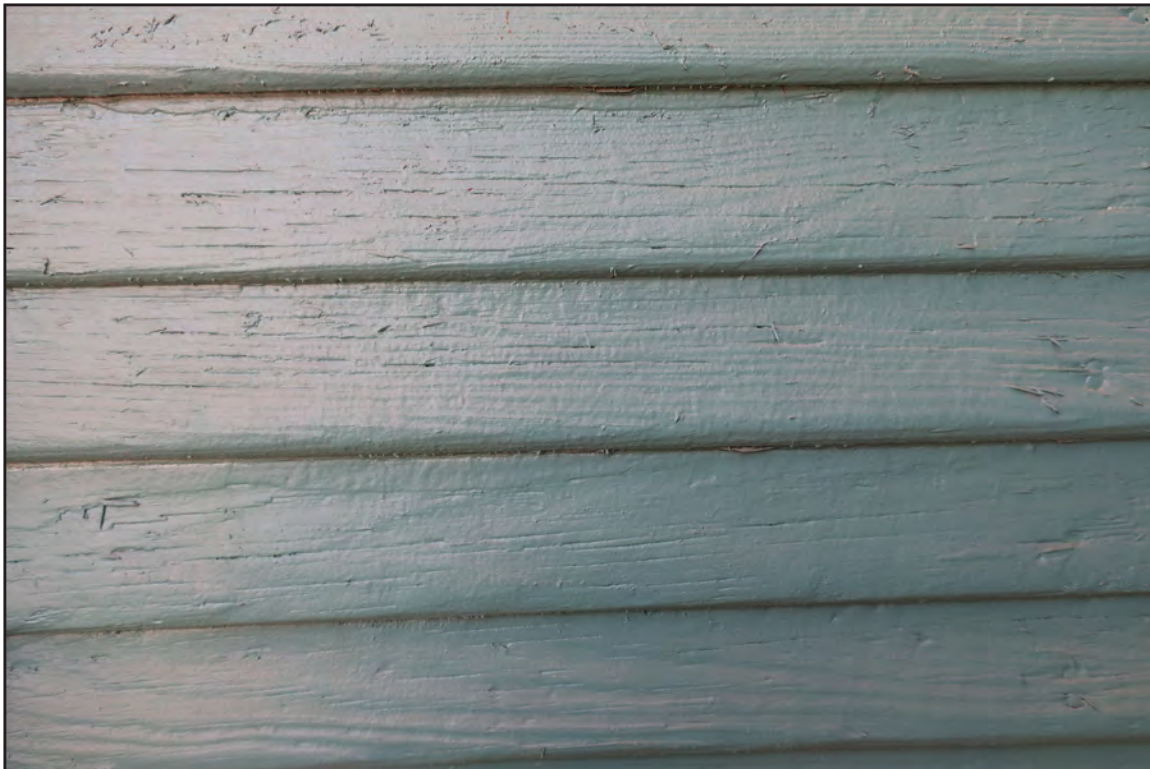
11.
Primary (NE)
Elevation
View SW

12.
Oblique:
Primary (NE)
and Southeast
Elevations
View W

13.
Southeast
Elevation
View W

14.
Southeast
Elevation
View NE

15.
Rear (SW)
Elevation
View NE

16.
Rear (SW)
Elevation
View SE

17.
Northwest
Elevation
View NE

18.
Restored
Wood Siding
View SE

The building has wood siding that is in varying condition. Some siding is original, while some areas have been replaced. Much of the original siding has deteriorated beyond repair. Wood siding is painted blue.

The Applicants repaired existing wood siding and replaced it in kind where it was deteriorated beyond repair. The Applicants repaint the exterior siding the same color. Trim is painted white.

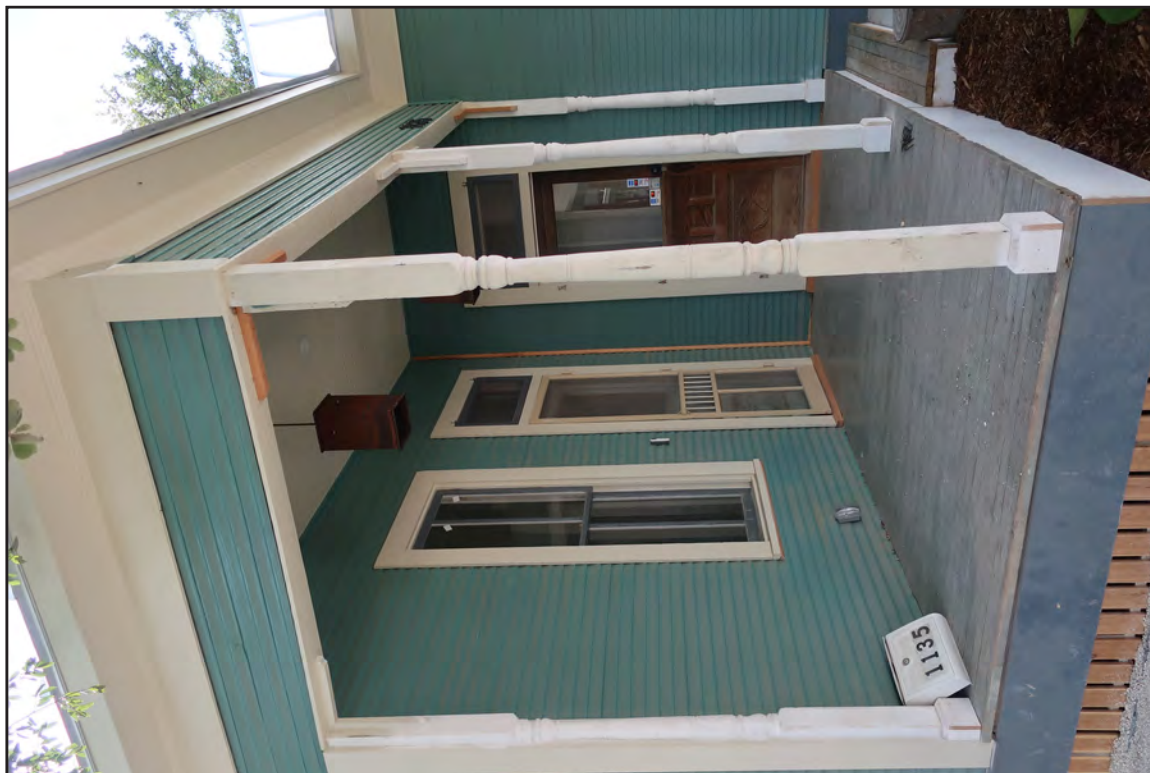
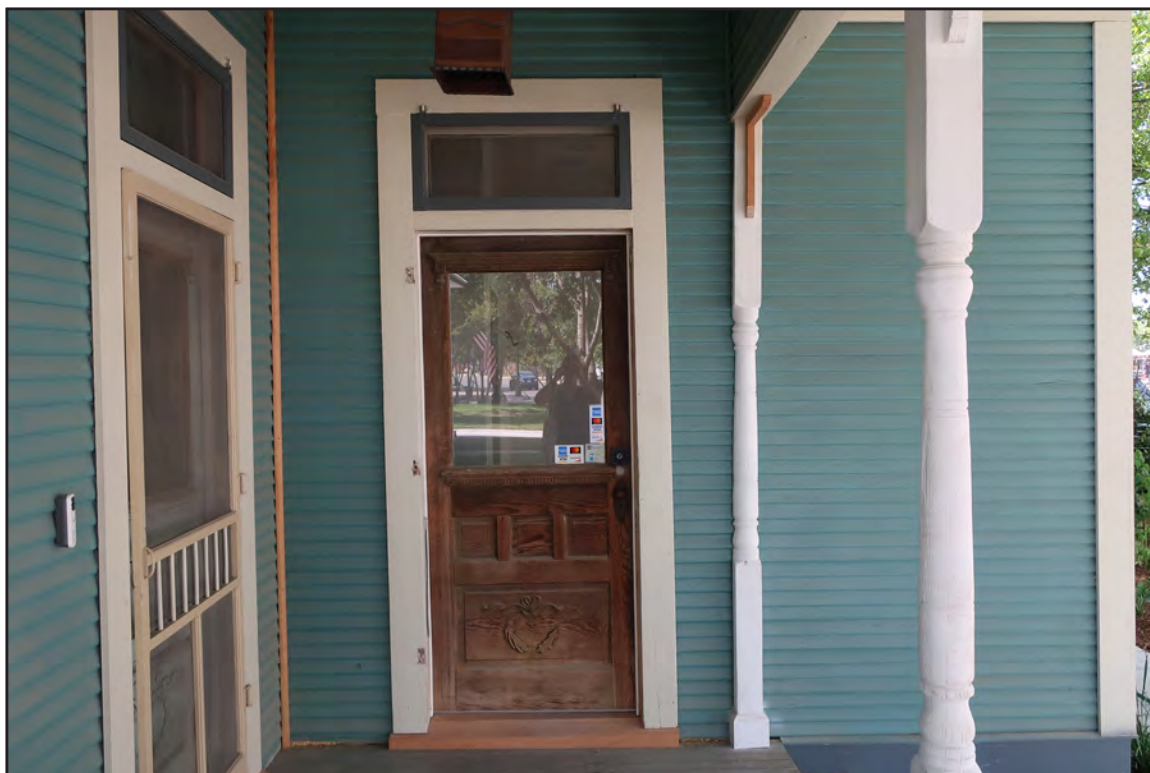
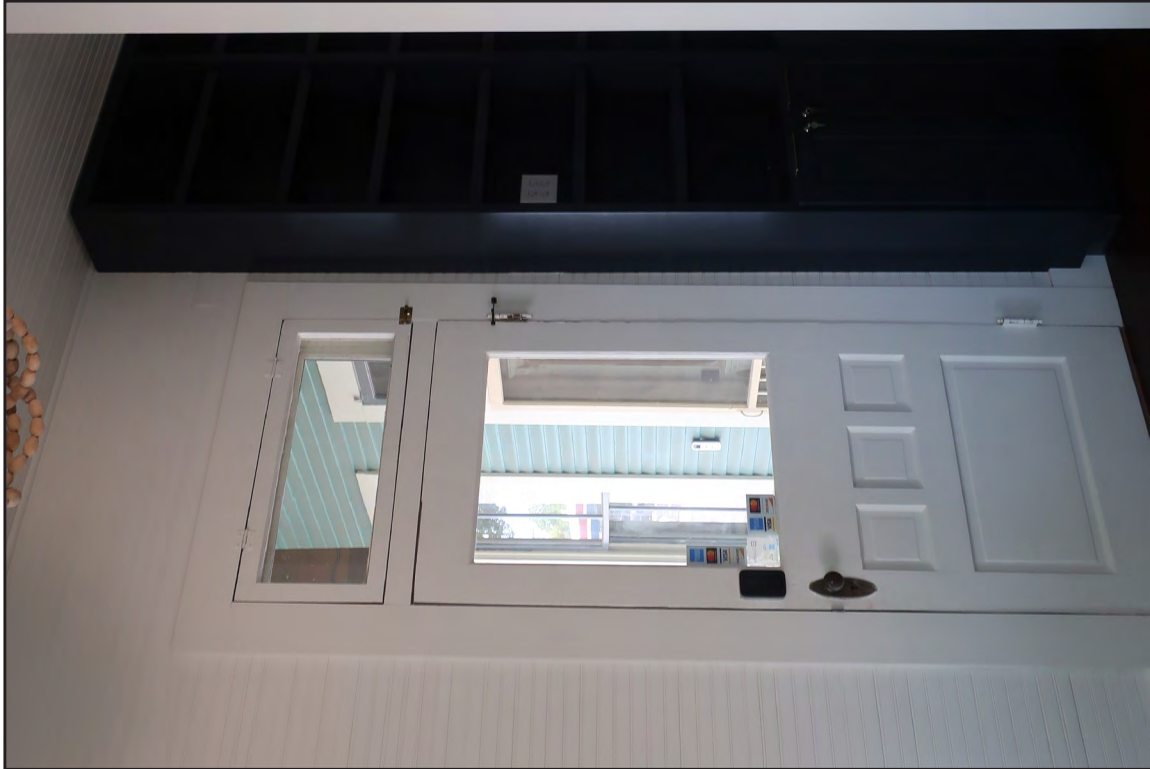
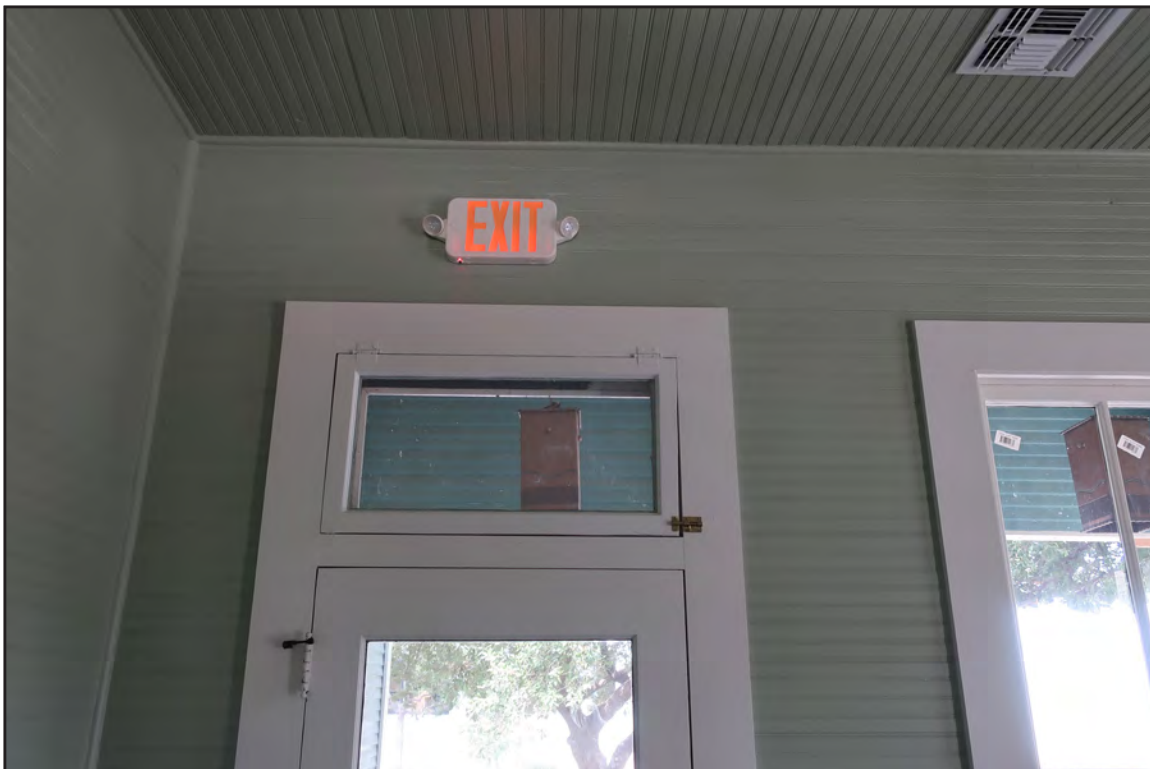
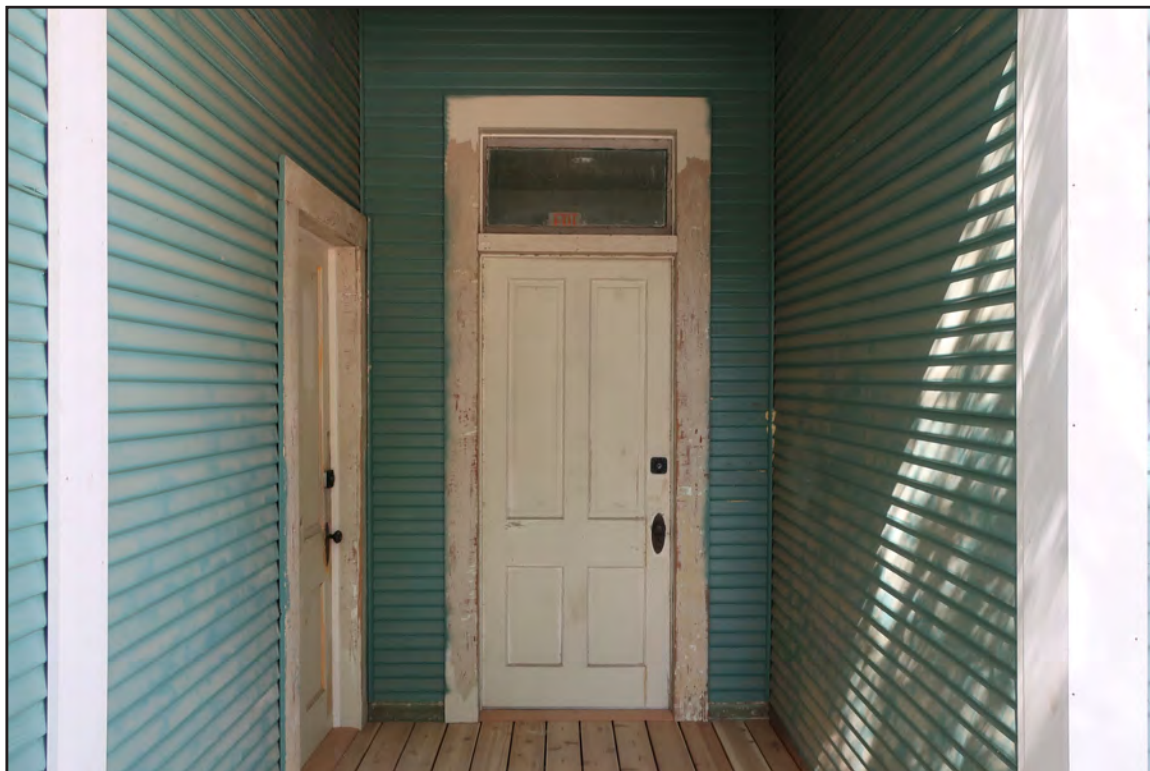
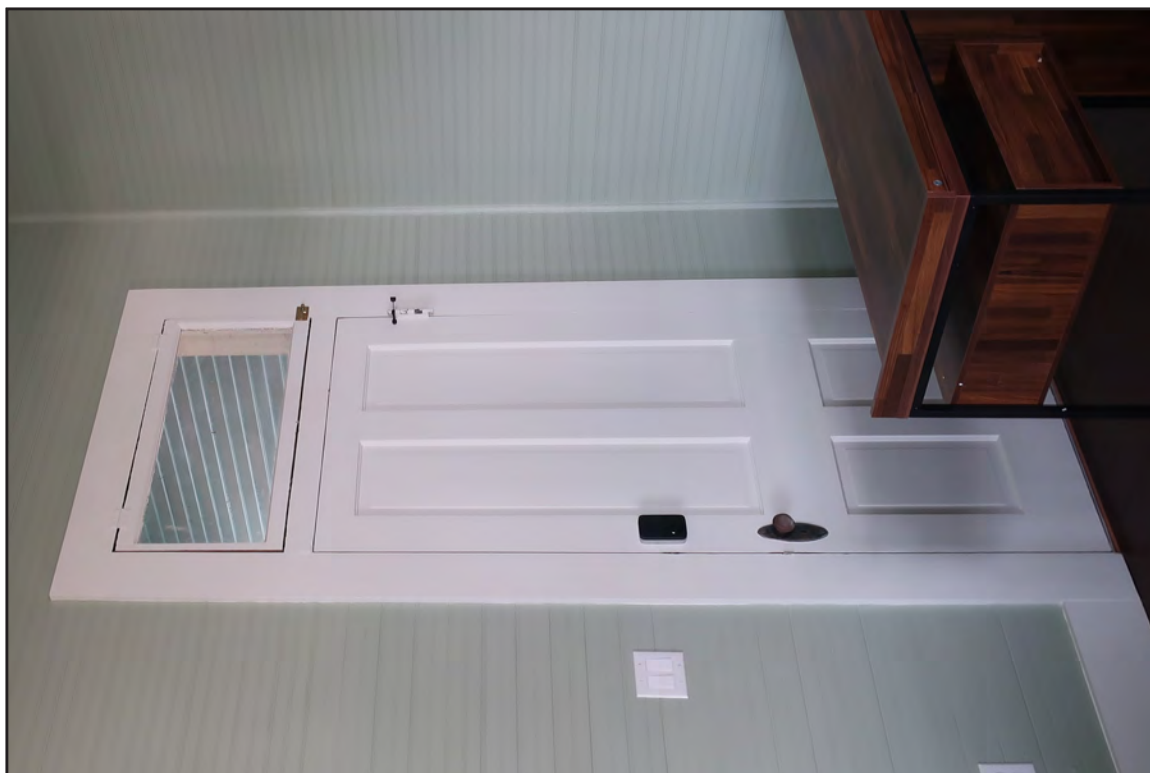
19.
Front Porch
View NW

20.
Office
Entrance
Showing
Historic Door
View NW

21.
Historic Door
from Office
Interior
View SW

22.
Historic
Transom
Detail from
Reception/
Waiting Area
Interior
View NE

23.
Rear Entrance
Showing
Historic Door
View NE

24.
Historic Rear
Door from
Interior
View NW

The building has an inset half porch on the primary elevation that has a wood floor and a beadboard ceiling supported by wood posts. The porch is in good condition. The building also has a small non-historic porch situated between the rear kitchen and bathroom extensions. It is accessed by an opening with a screened surround.

The Applicants retained and restored the front porch, including floors, posts, and steps. They also retained the rear porch. The Applicants retained the entrance configurations and restored all historic doors.
