HISTORIC AND DESIGN REVIEW COMMISSION

December 21, 2022

HDRC CASE NO: 2022-002
ADDRESS: 1135 S ST MARYS ST
LEGAL DESCRIPTION: NCB 2963 BLK LOT A22
ZONING: C-2, H
CITY COUNCIL DIST.: 1
DISTRICT: King William Historic District
APPLICANT: Ann McGlone/Post Oak Preservation Solutions
OWNER: Manuel Vogt/PSMV MANAGEMENT LLC
TYPE OF WORK: Historic Tax Verification
APPLICATION RECEIVED: December 08, 2022
60-DAY REVIEW: Not applicable due to City Council Emergency Orders
CASE MANAGER: Rachel Rettaliata

The applicant is requesting Historic Tax Verification for the property at 1135 S St Mary's.

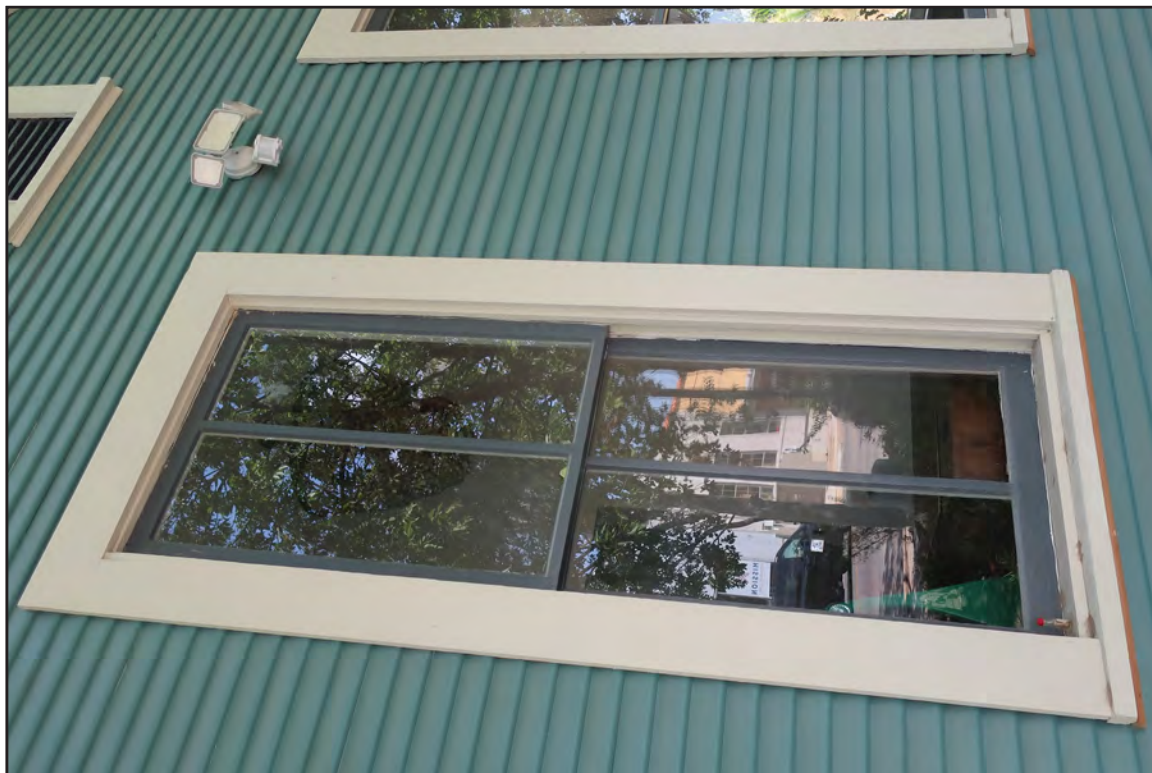
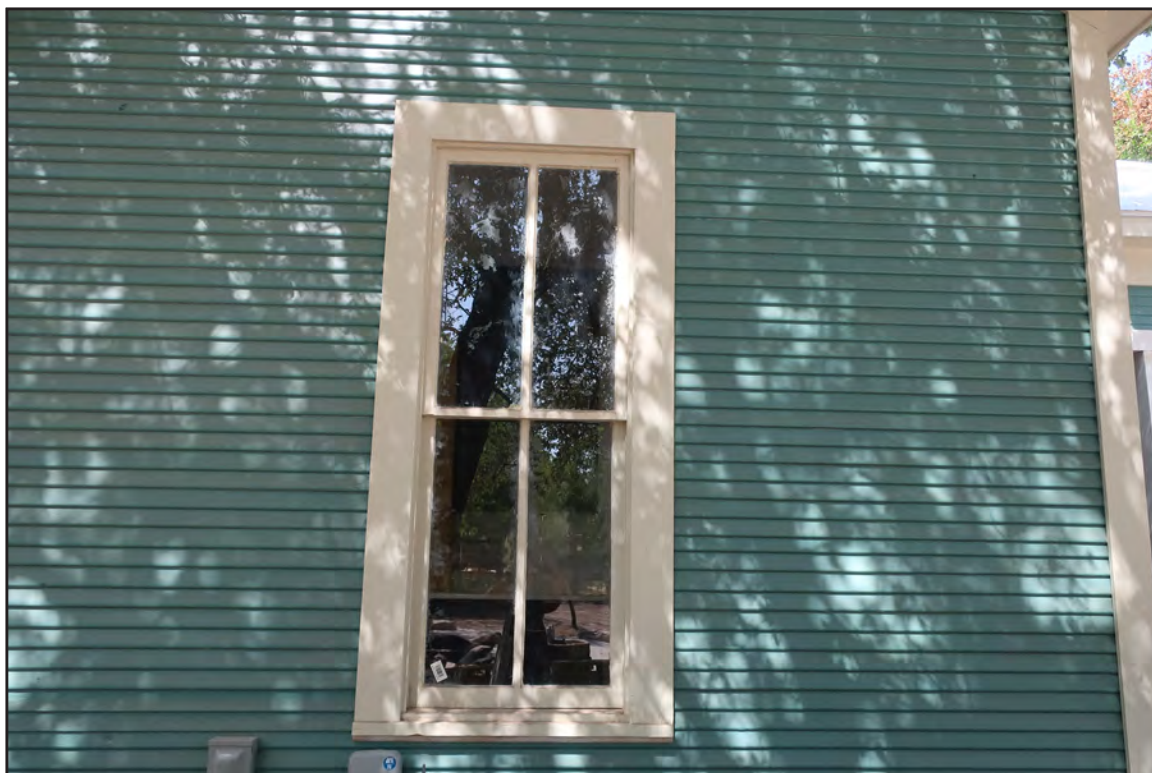
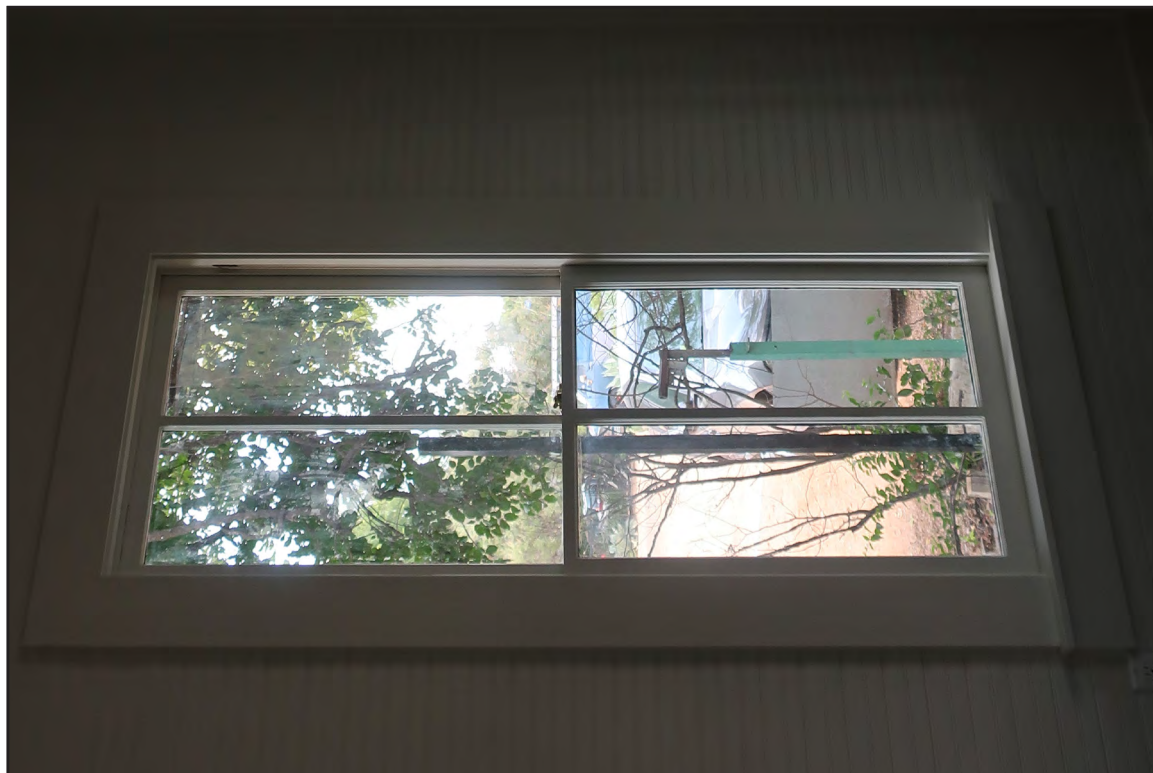
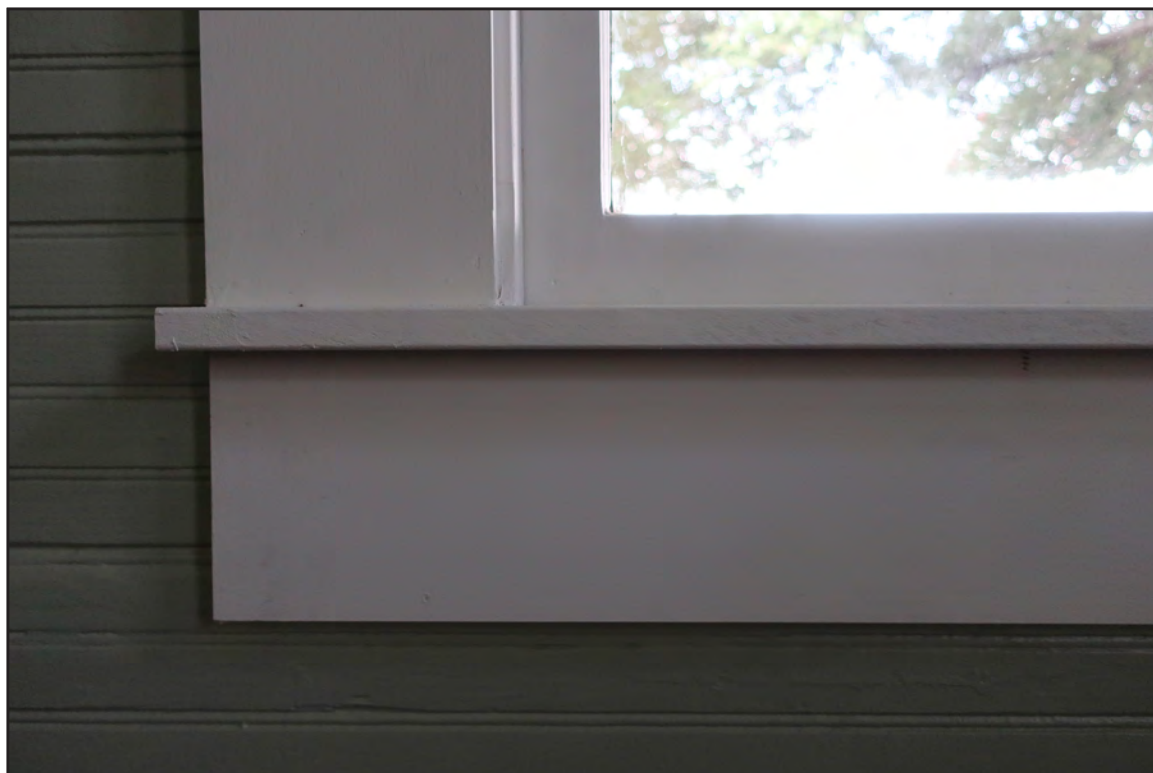
25.
Restored
Window
View NW

26.
Restored
Window
View NE

27.
Restored
Window from
Interior
View NE

28.
Restored
Window Detail
from Interior
View NE

The building retains historic wood double-hung two-over-two windows. Windows are in fair condition with areas of deteriorated wood.

The Applicants removed the historic windows, restored them off-site, and reinstalled them in original window openings.

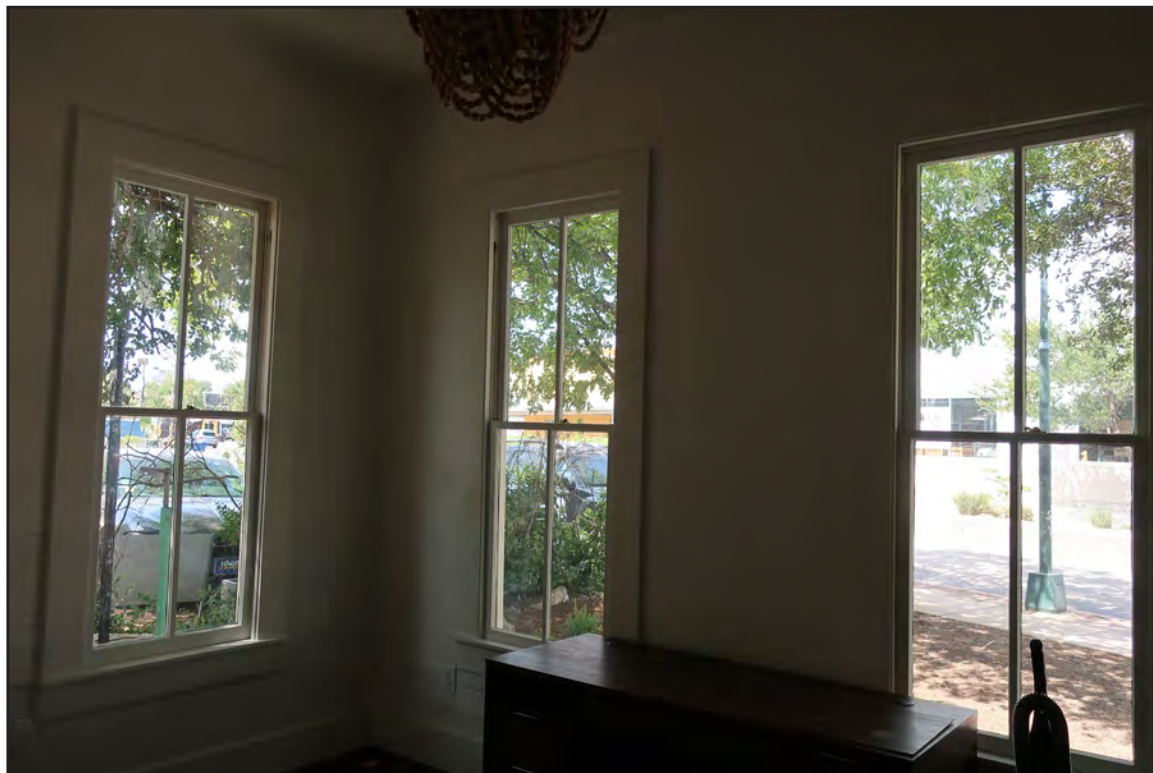
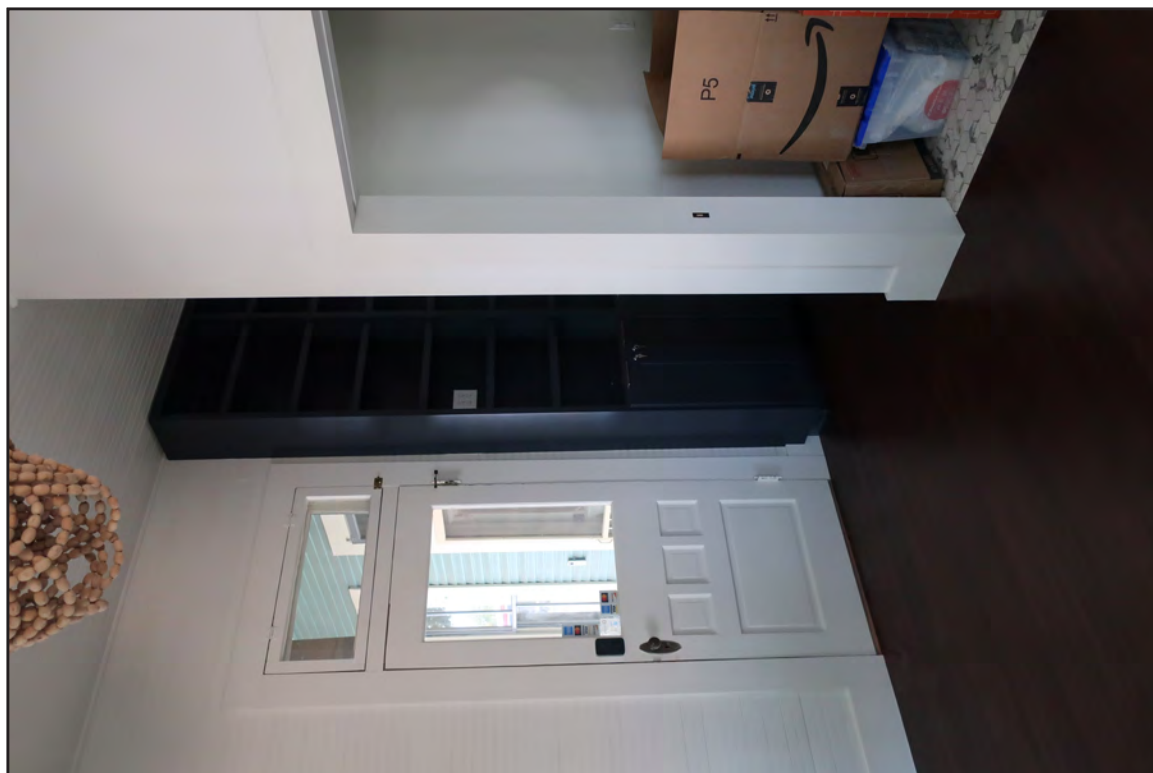
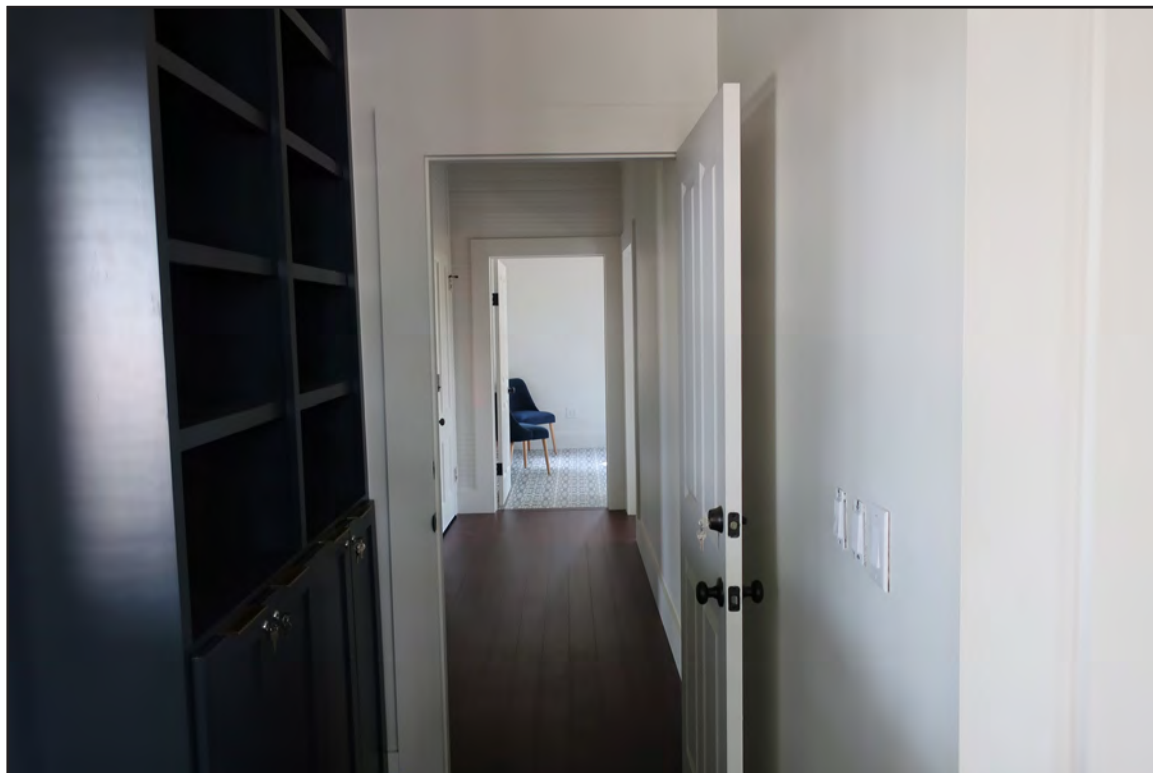
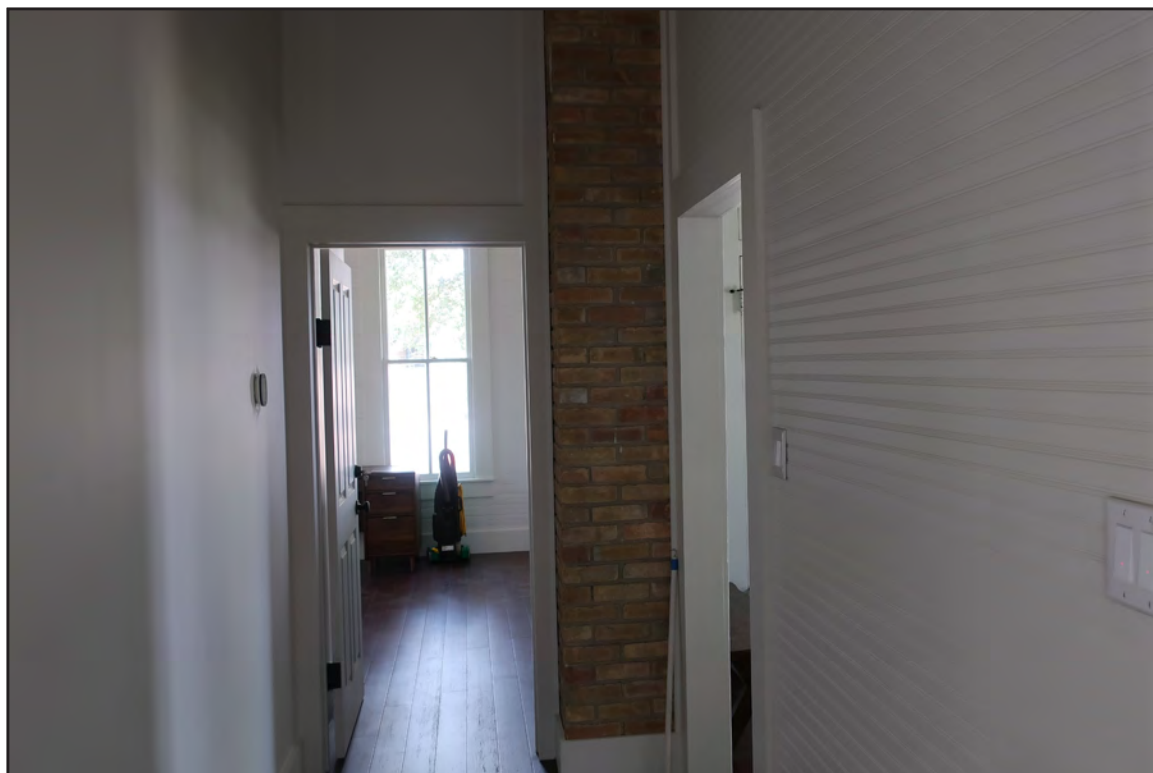
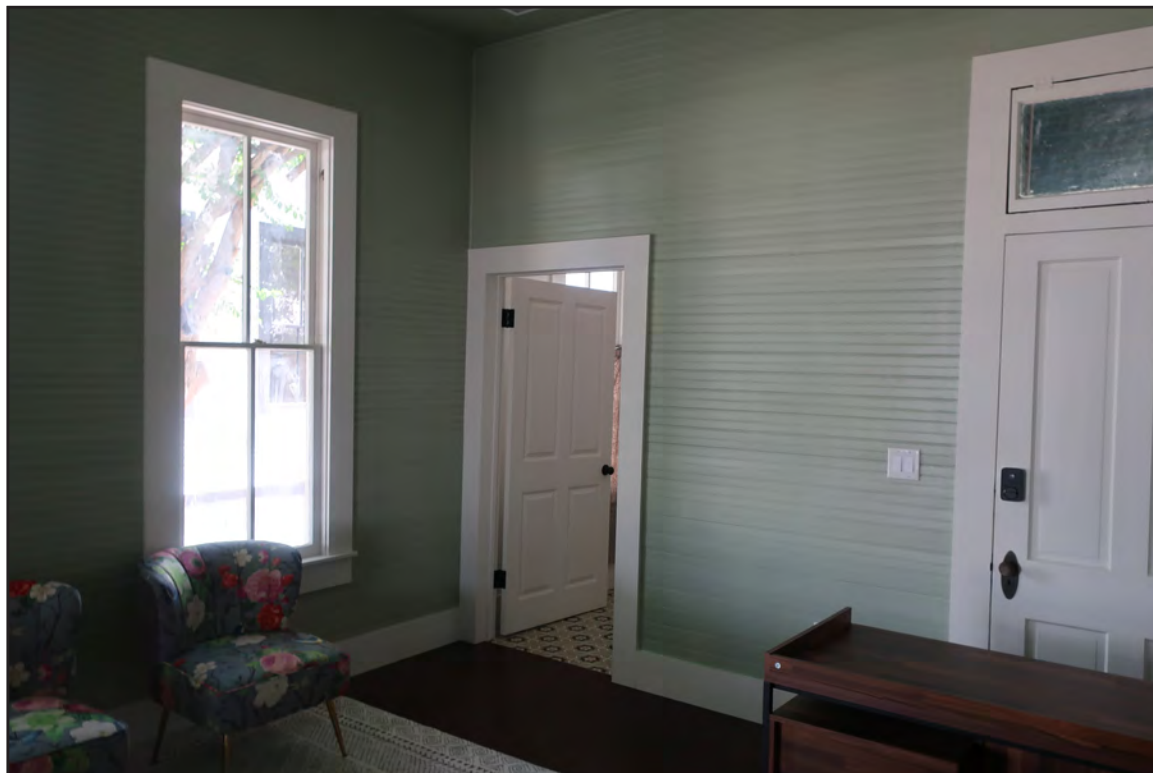
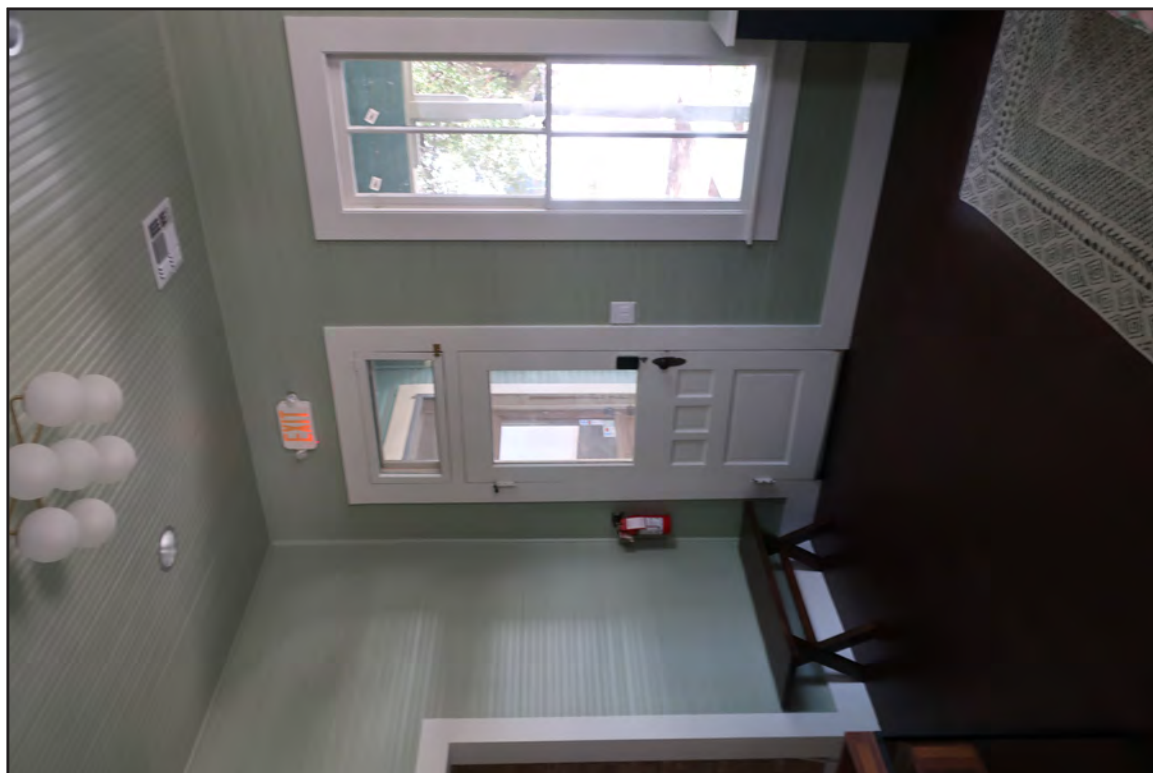
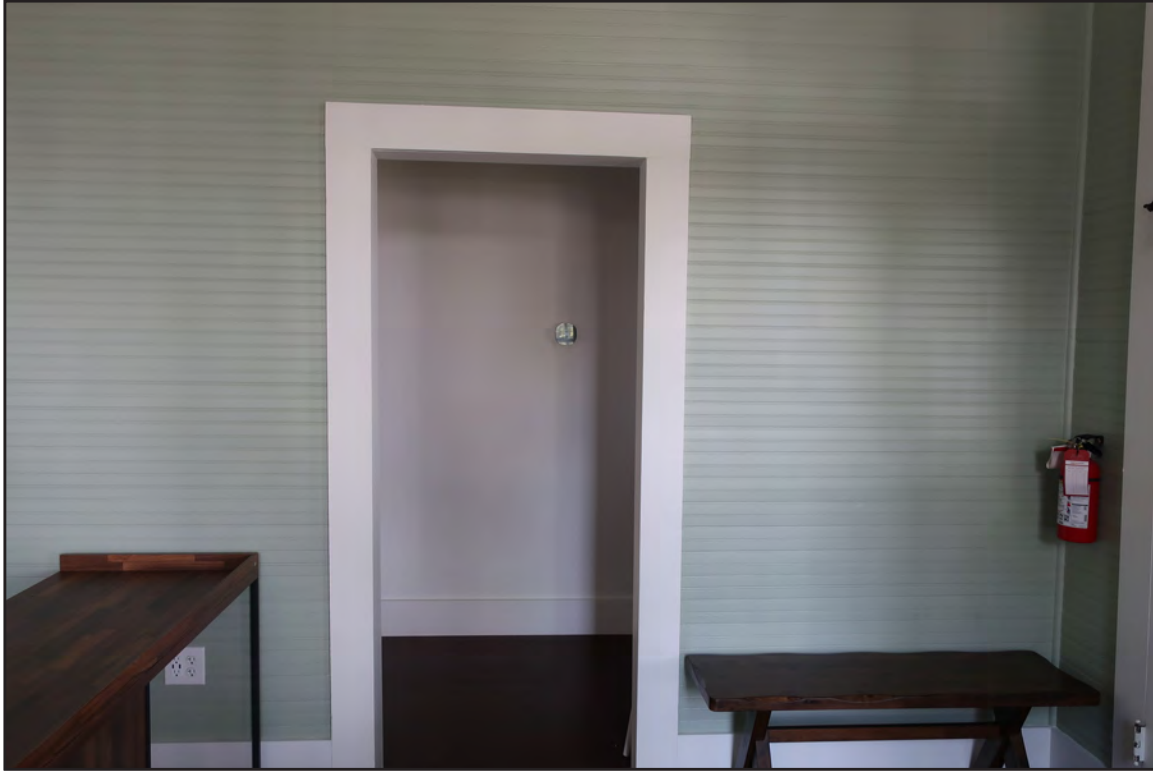
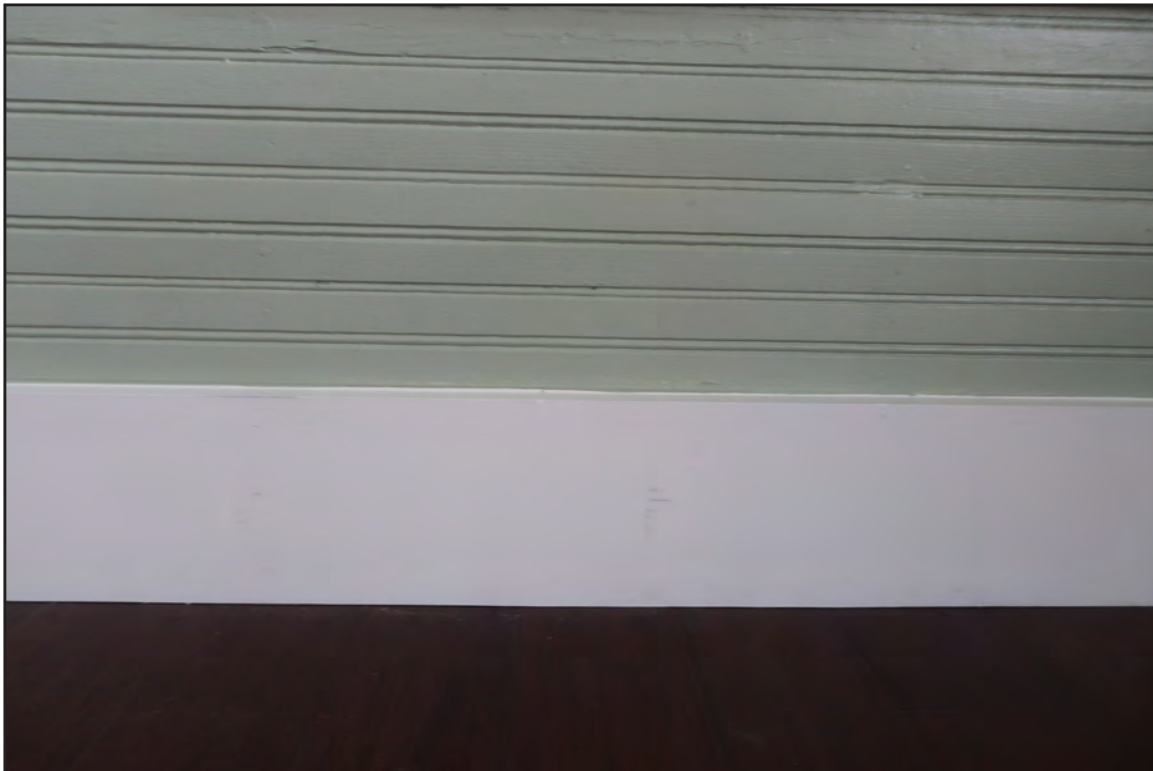
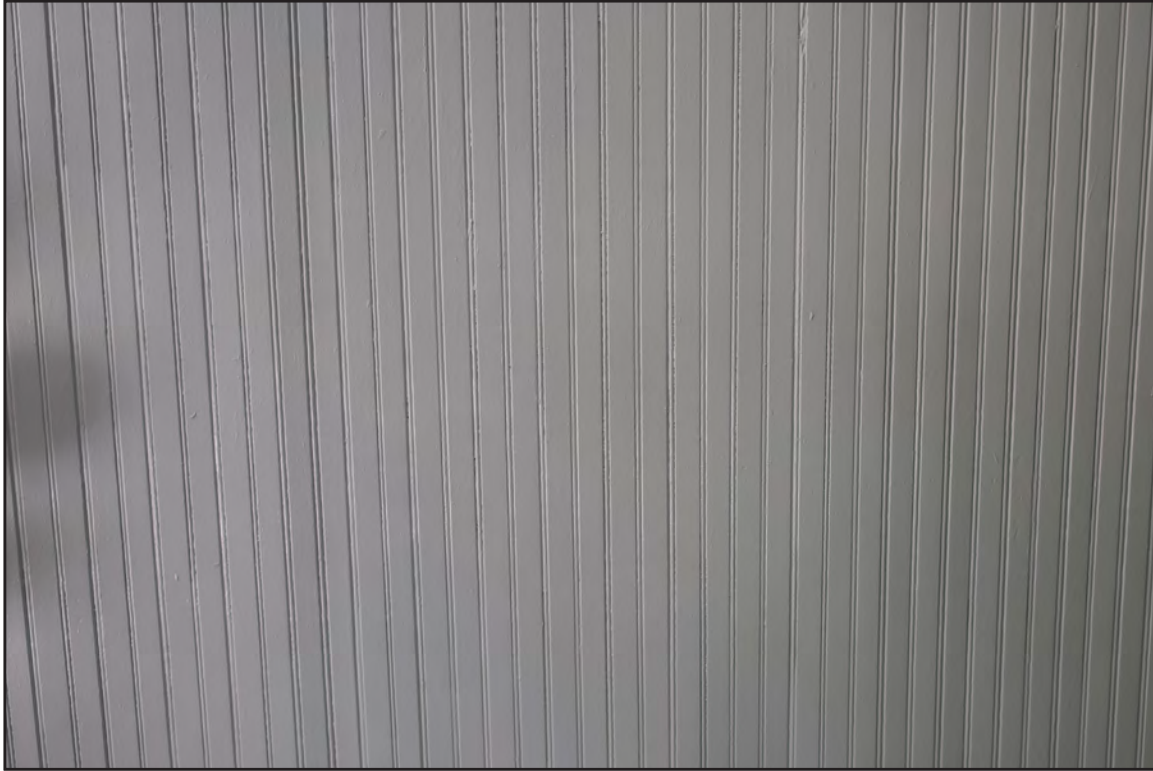
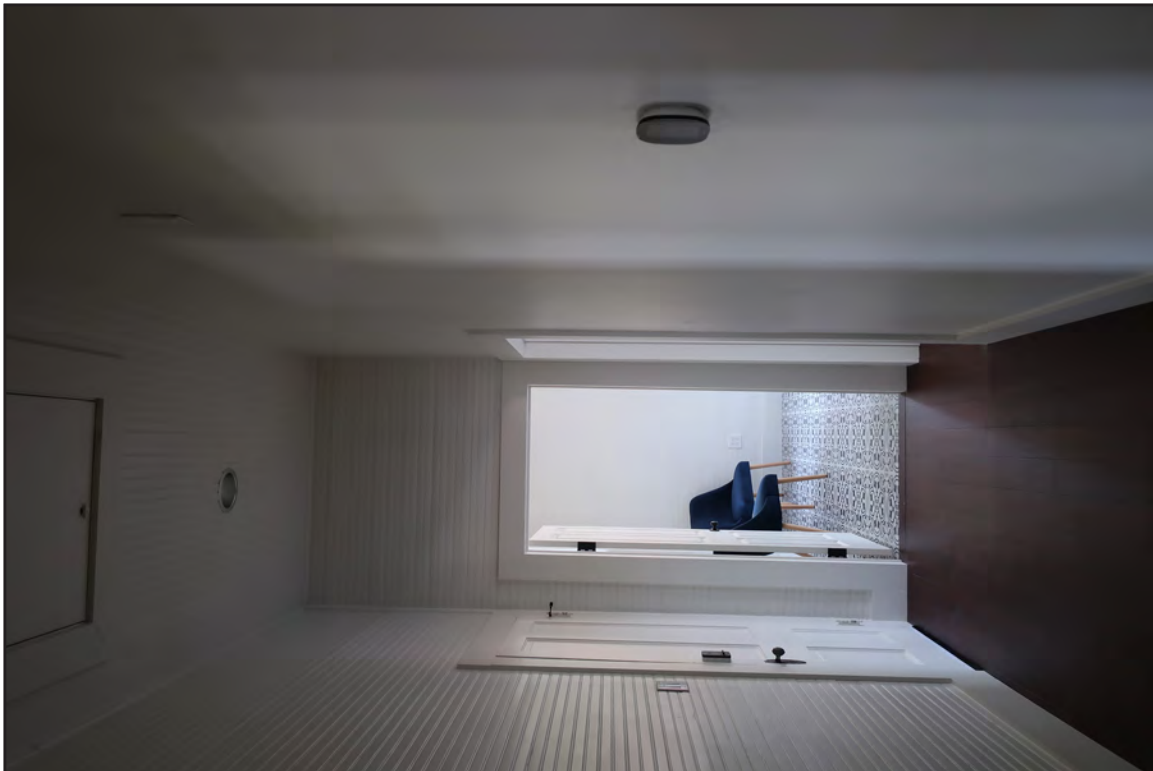
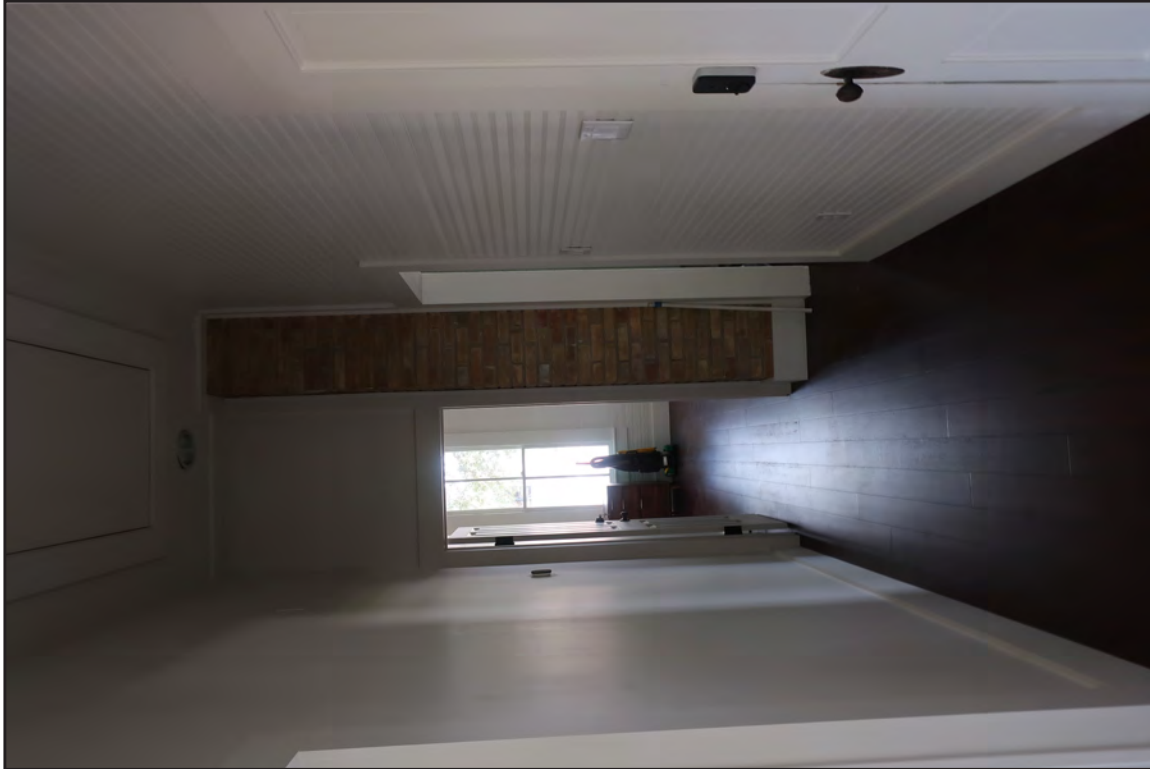
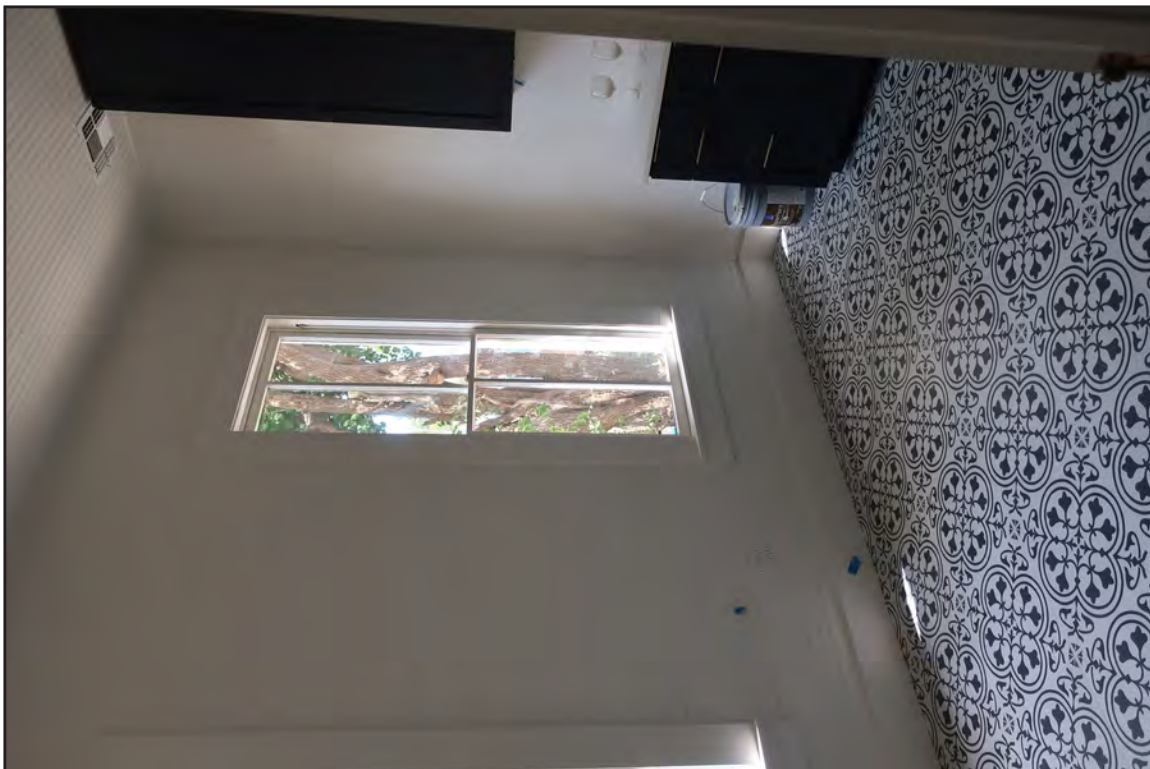
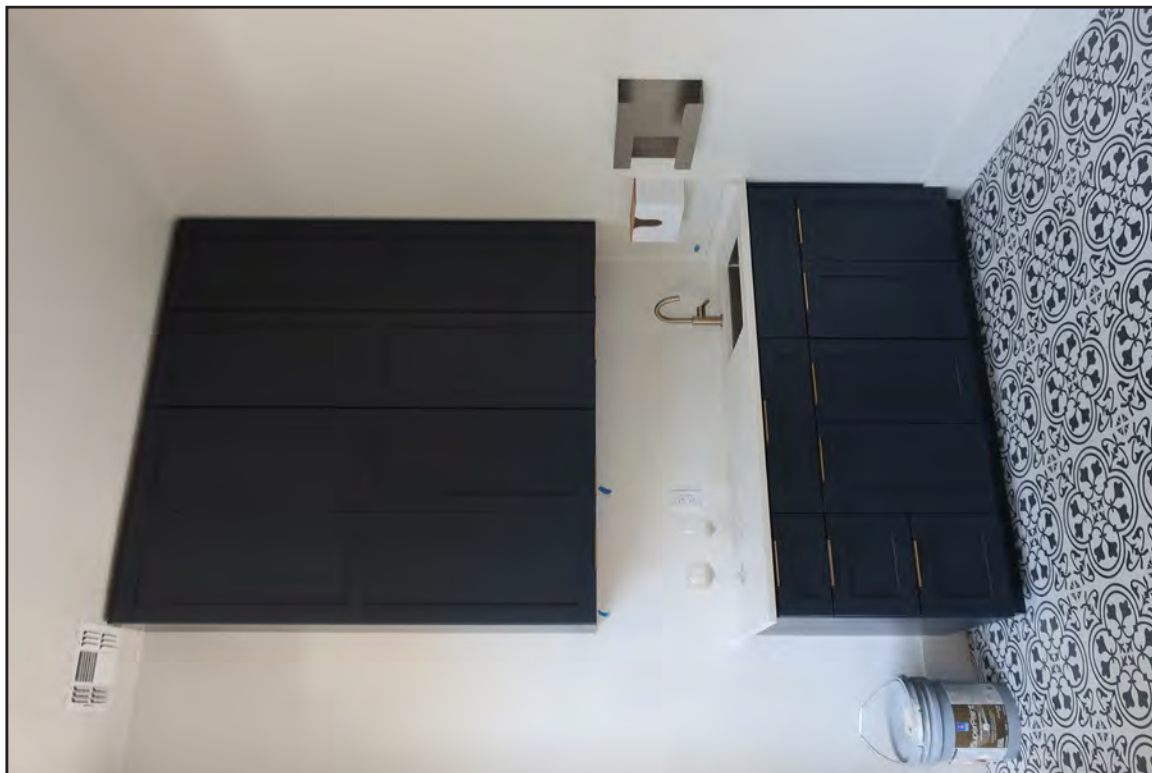
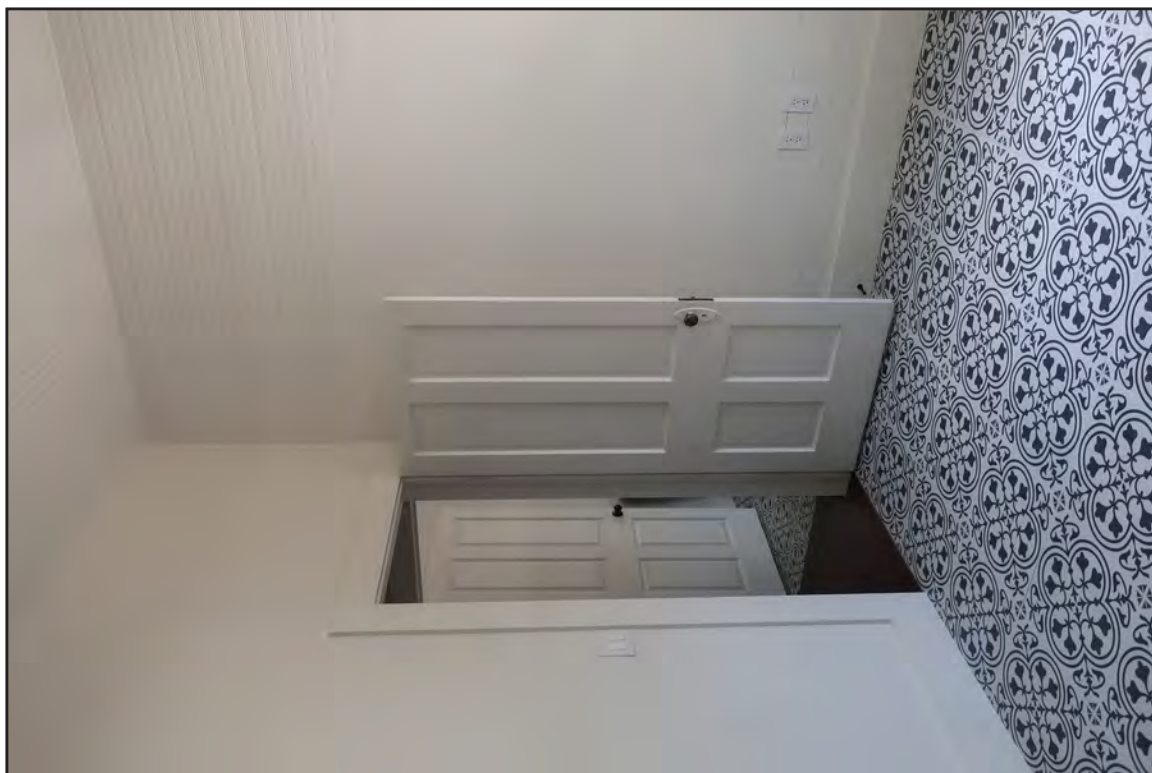
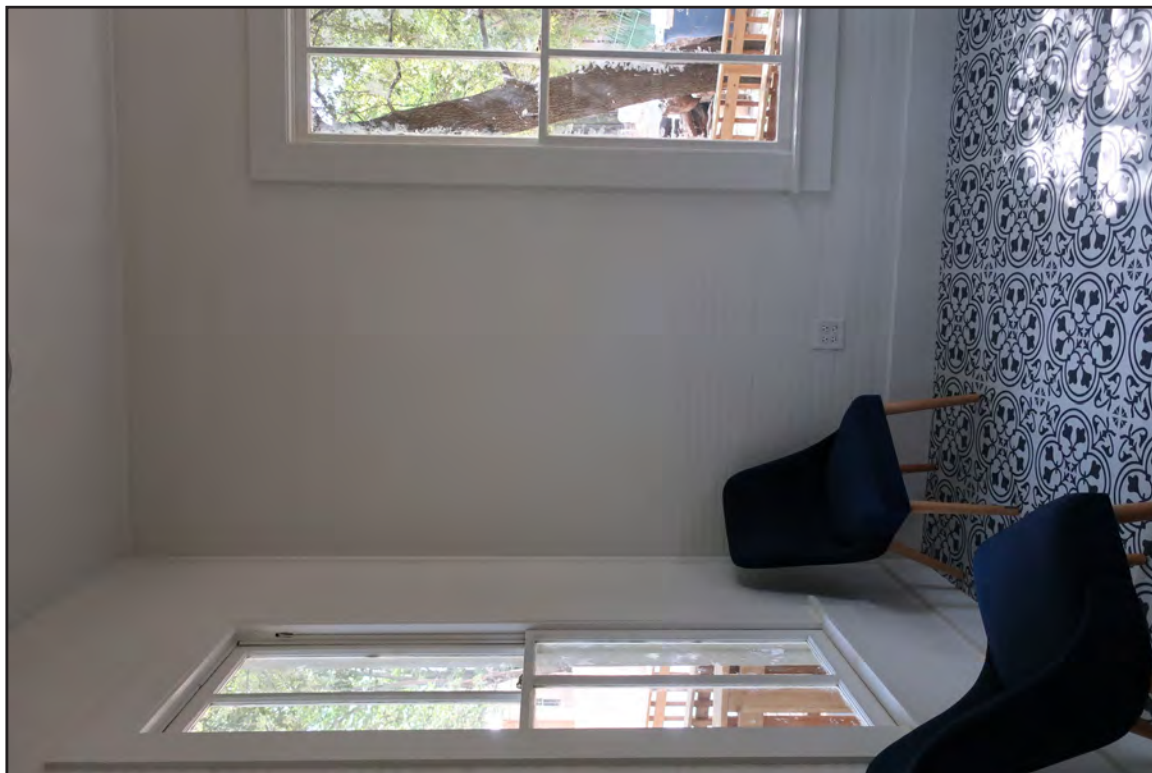
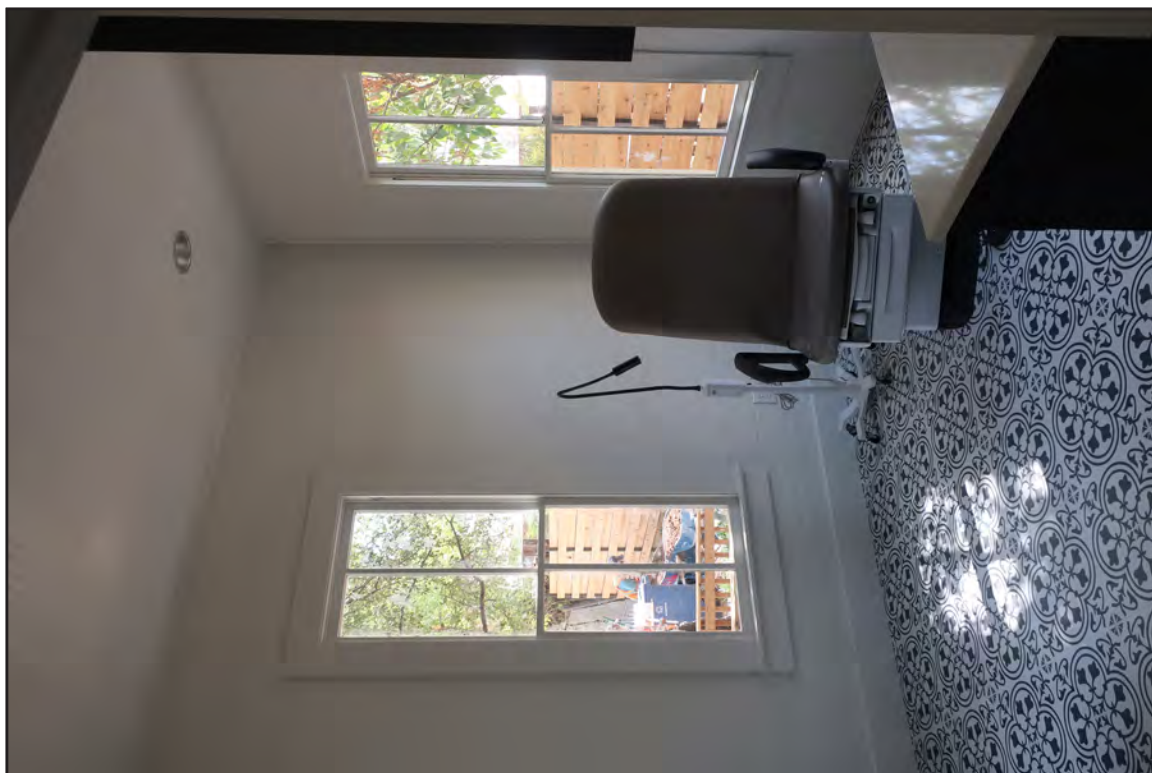
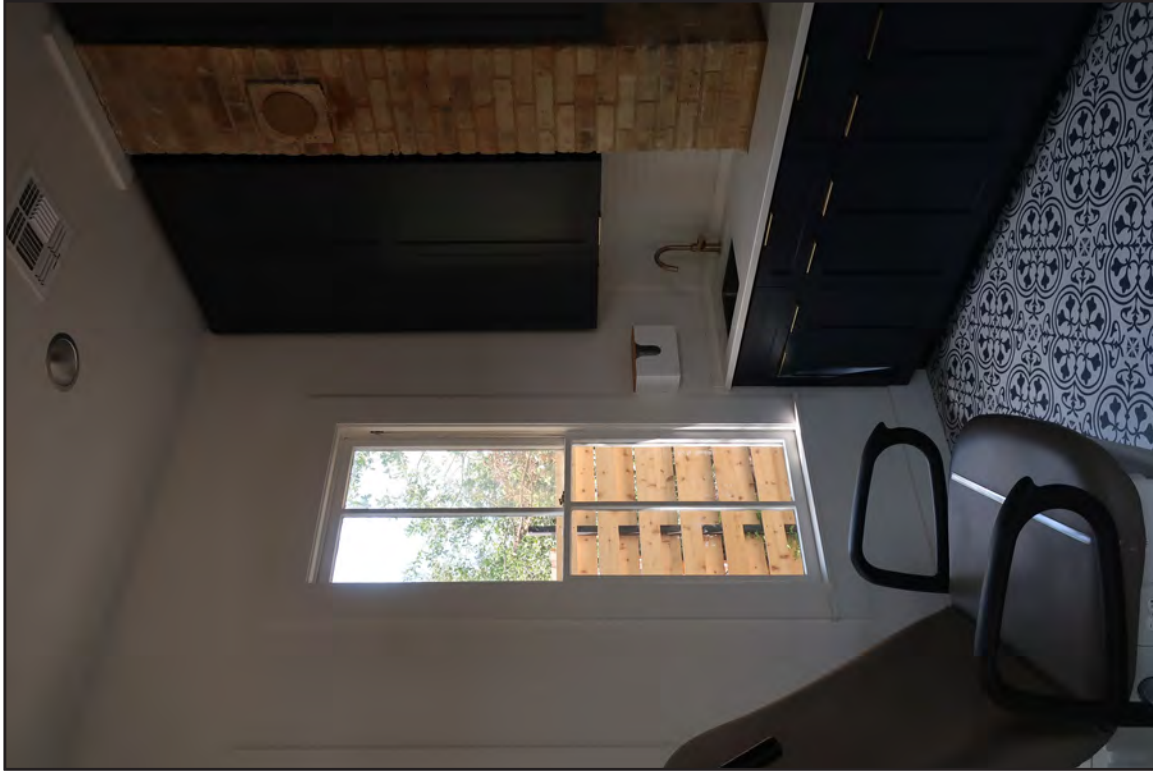
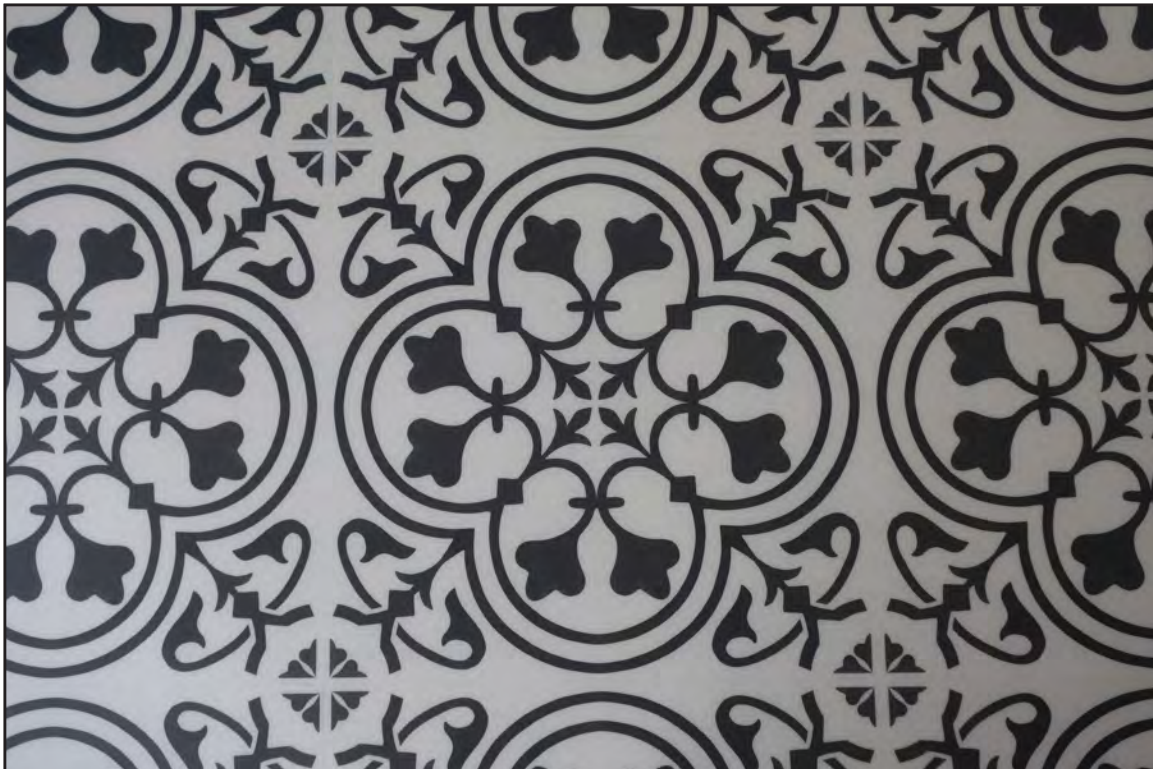
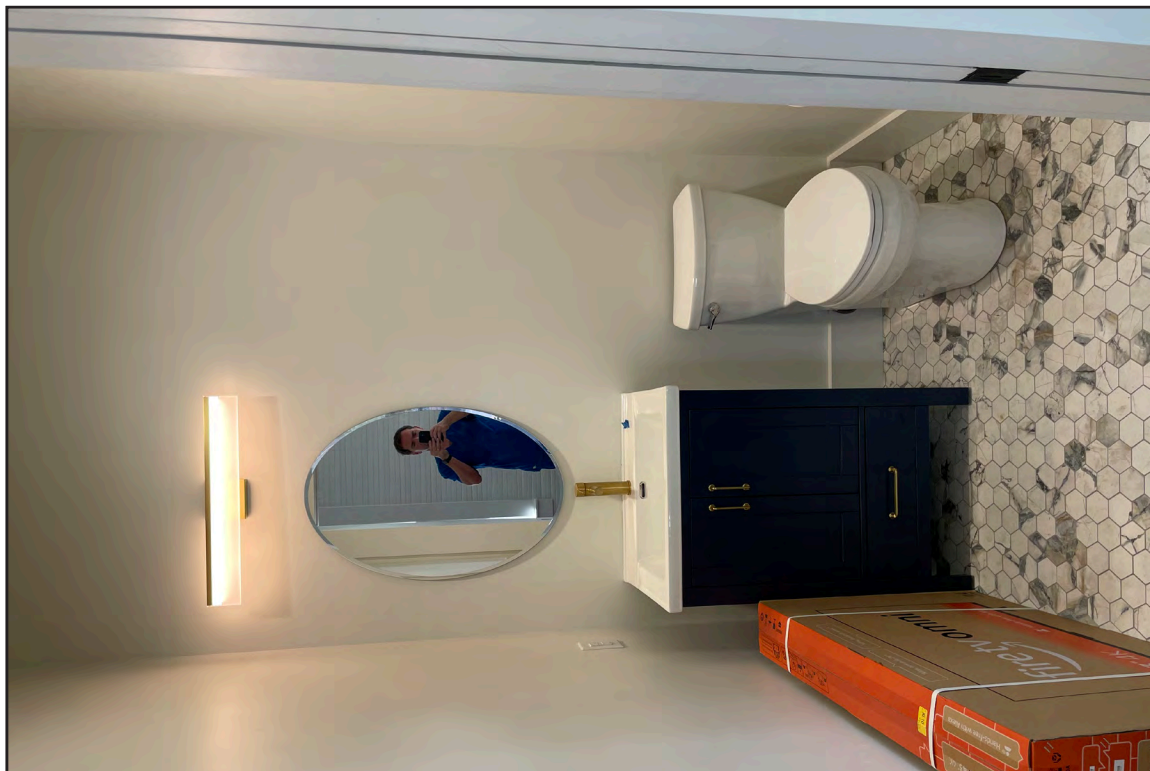
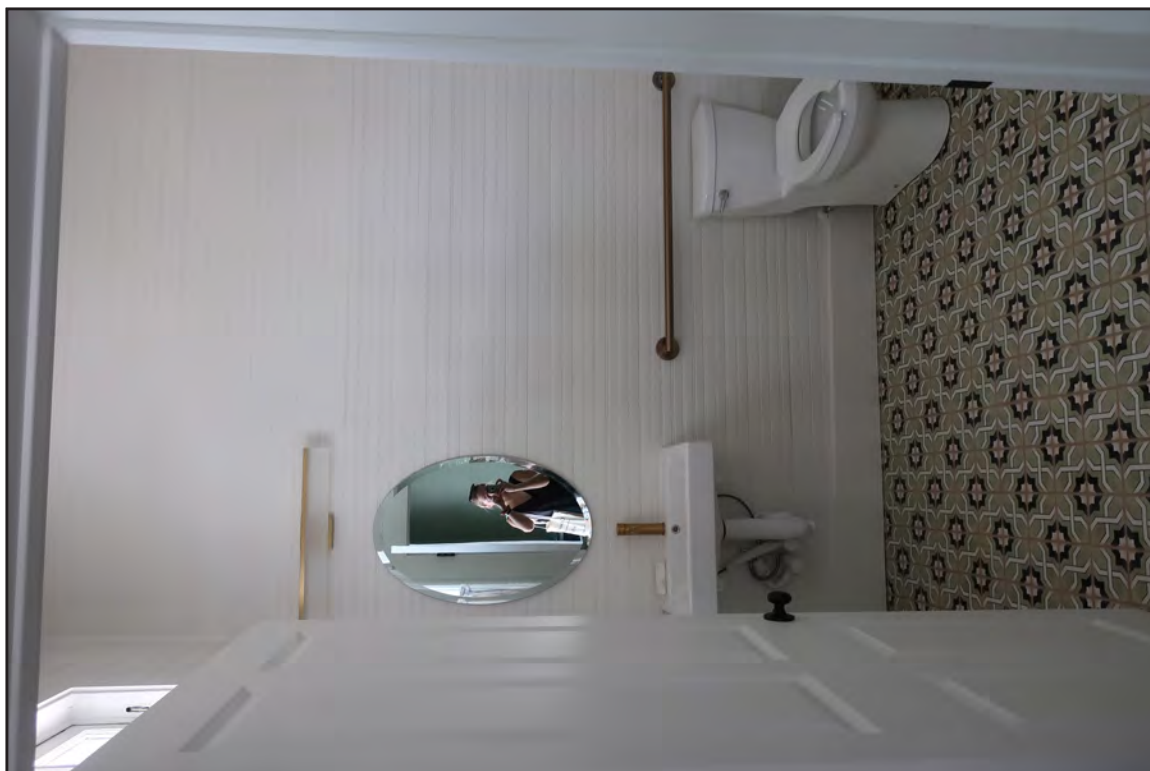
29.
Office
View N

30.
Office
View SW

31.
Hall from
Office
View SW

32.
Office from
Hall Showing
Chimney
View E

33.
Reception/
Waiting Area
View SW

34.
Reception/
Waiting Area
View NE

35.
Reception/
Waiting Area
Looking to Hall
View NW

36.
Restored
Beadboard
Walls and Trim
in Reception/
Waiting Area
View SE

37.
Restored
Beadboard
Ceiling in
Reception/
Waiting Room
View Typical

38.
Hall Showing
New Gypsum
Board Walls
and Wood
Floor Installed
in a "Floating"
Fashion
View SW

39.
Hall Showing
New Gypsum
Board Walls,
Floated Wood
Floors, and
Chimney
View NE

40.
Exam Room 1
View NE

41.
Exam Room 1
View SE

42.
Exam Room 1
View SW

43.
Exam Room 2
View SW

44.
Exam Room 2
View NW

45.
Exam Room
2 Showing
Chimney
View N

46.
Exam Room
2 Showing
Floor Installed
in a "Floating"
Fashion
View Typical

47.
Restroom
View SW

48.
Restroom
View SW

The interior retains historic finishes such as hardwood floors and horizontal beadboard walls and ceilings.

The Applicants retained the existing configurations of the northwest kitchen and the southeast living room and bathroom. They reconfigured the long northeast room to contain a northeast corner room with a bathroom, an east-to-west hall, and a small room north of the hall, along the north perimeter wall.

The reconfigured space contains the office and bathroom to the northeast and a patient exam room along the north wall. The historic kitchen location in the northwest corner is a second patient exam room. The former living room at the southeast contains the reception/ waiting area and the existing bathroom. The Applicants retained the chimneys in the former bedroom and kitchen spaces.

The Applicants retained and restored historic beadboard walls and ceilings. They made every effort to restore the historic hardwood floors, but they were beyond repair. As such, the Applicants retained the floors and installed new flooring atop these in a removable, "floating" fashion. The office, reception/ waiting area, and hall have new, floated hardwood floors. The bathrooms and exam rooms have floated vinyl tile floors. New partitions are gypsum board.
