HISTORIC AND DESIGN REVIEW COMMISSION

September 04, 2024

HDRC CASE NO: 2024-267
ADDRESS: 2619 MCCULLOUGH AVE
LEGAL DESCRIPTION: NCB 1704 BLK 12 LOT N1-2 OF 12 & 13
ZONING: O-1, H
CITY COUNCIL DIST.: 1
DISTRICT: Monte Vista Historic District
APPLICANT: Matthew Gilbert/Ortiz McKnight PLLC
OWNER: ZUNIGA LAW PLLC
TYPE OF WORK: Requesting a waiver, fenestration modifications
APPLICATION RECEIVED: July 19, 2024
60-DAY REVIEW: September 17, 2024
CASE MANAGER: Claudia Espinosa

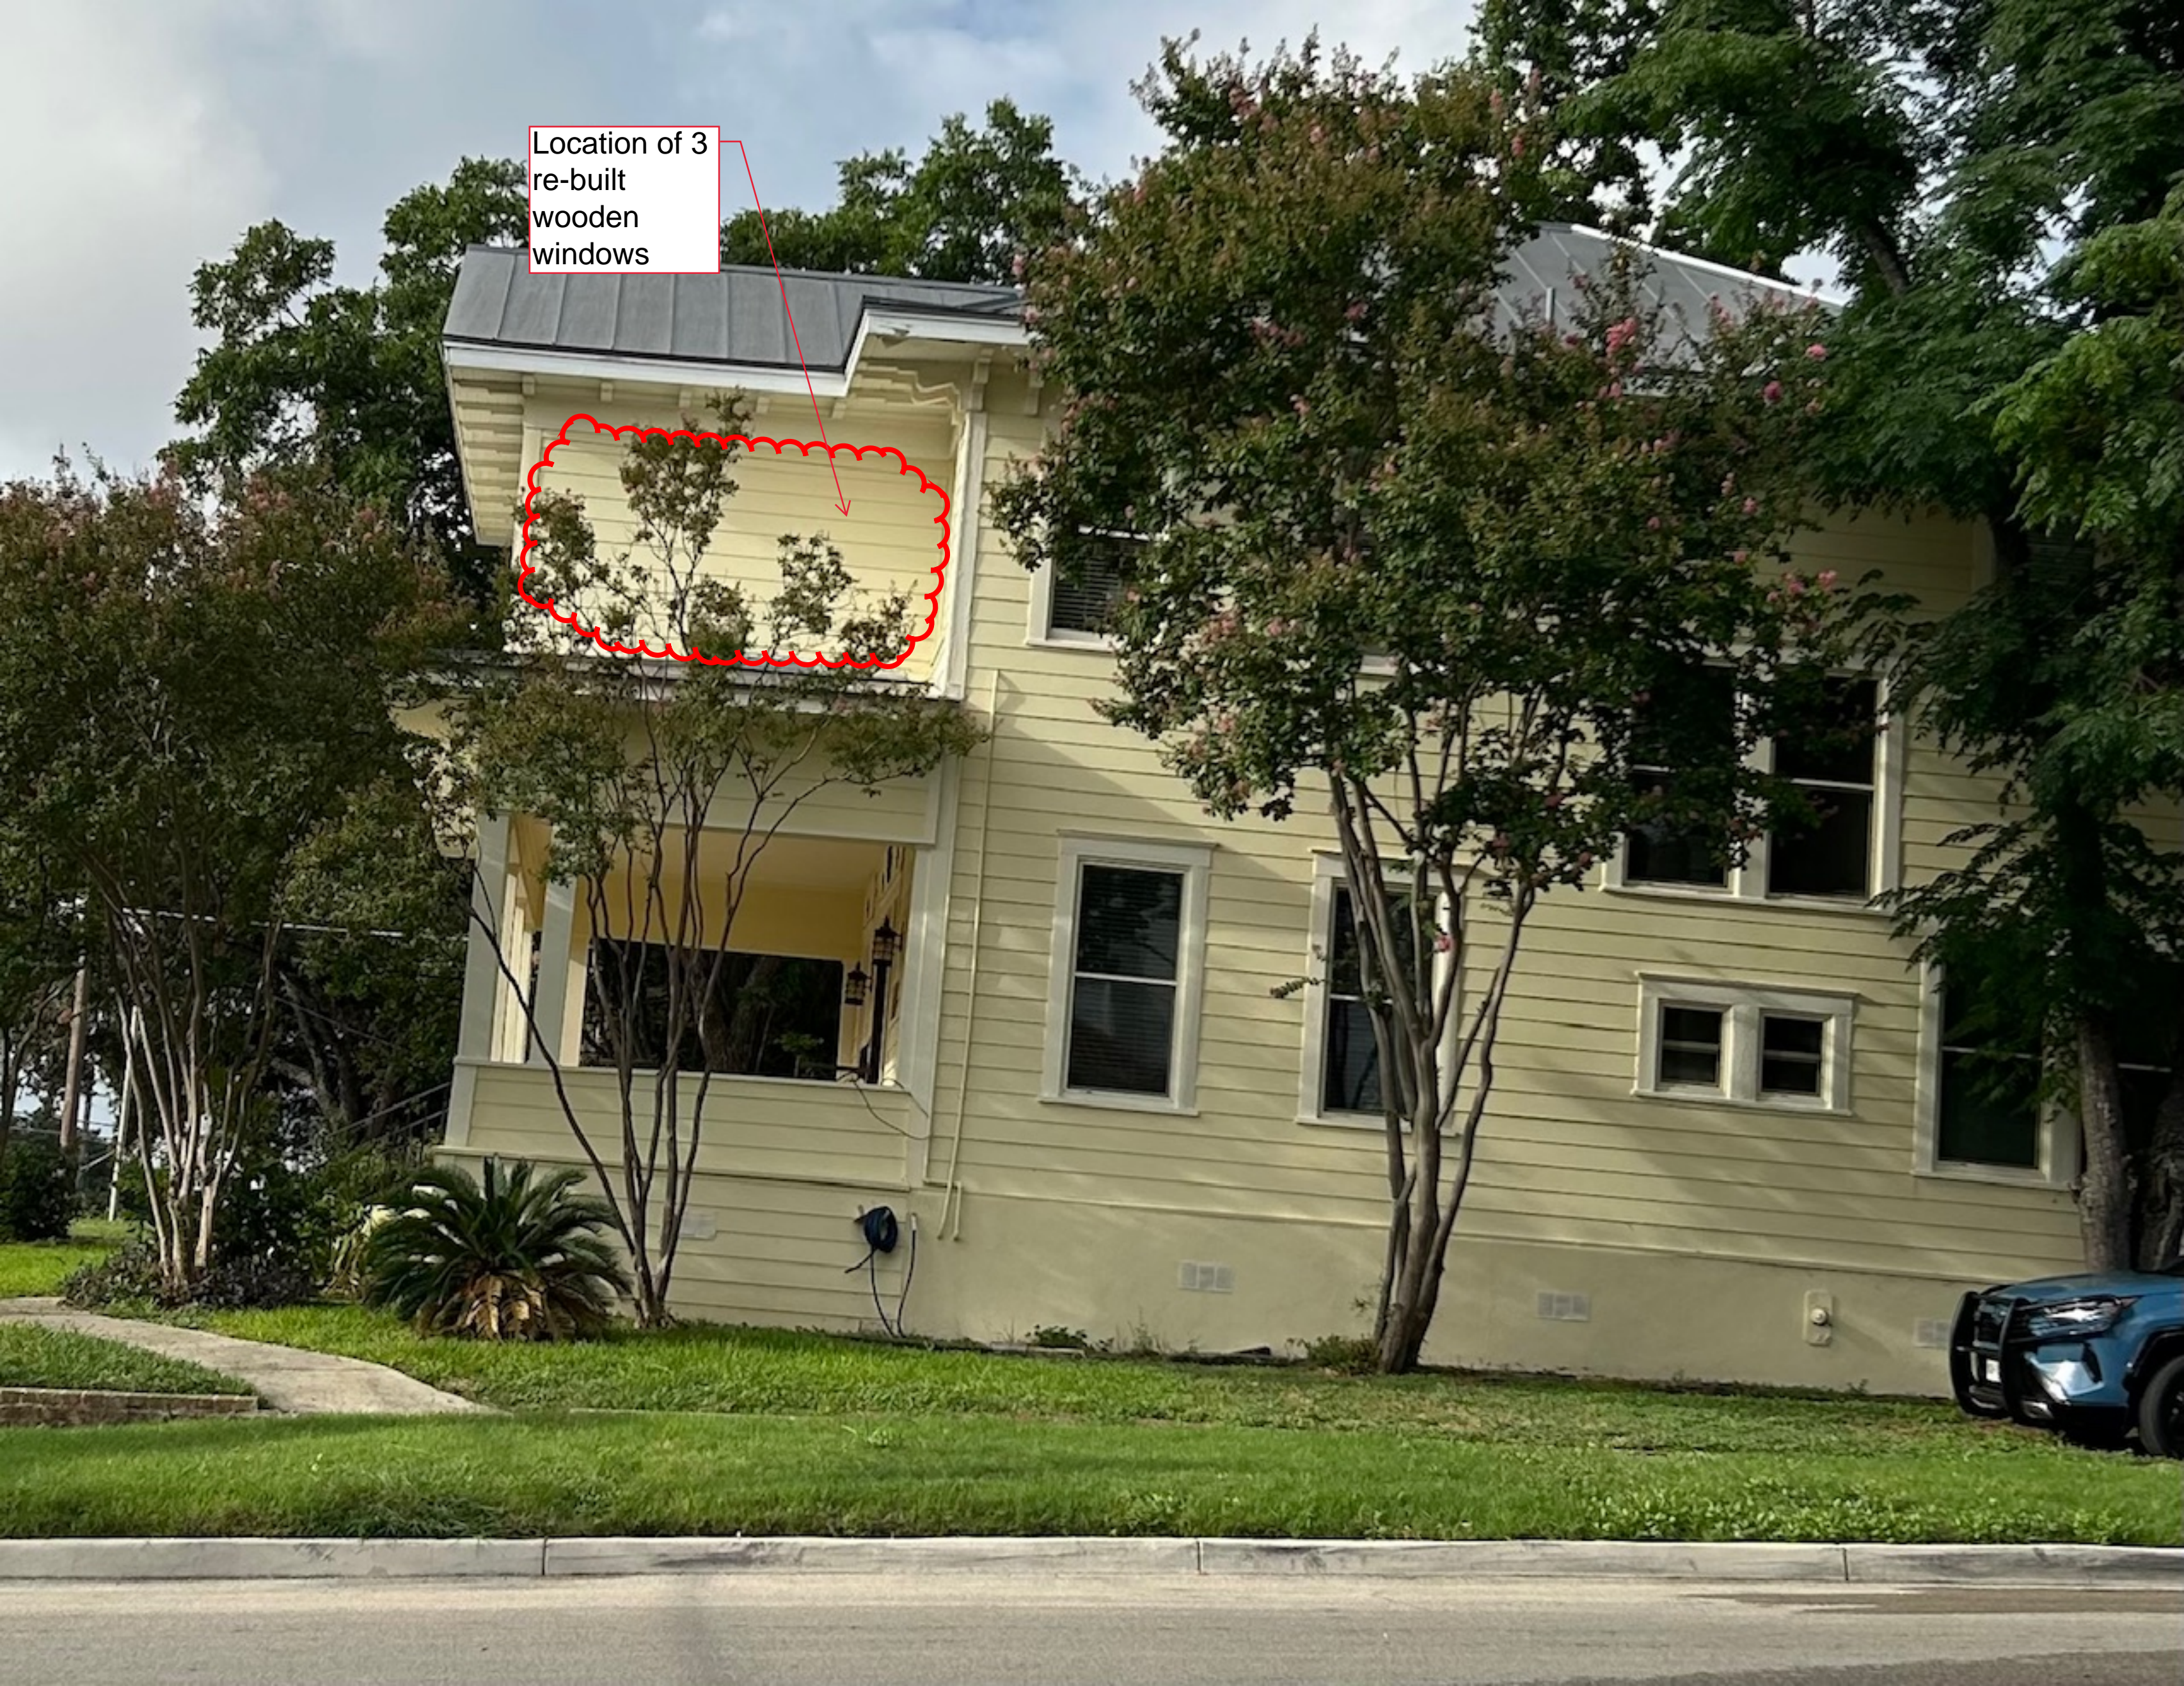
Location of 3
re-built
wooden
windows

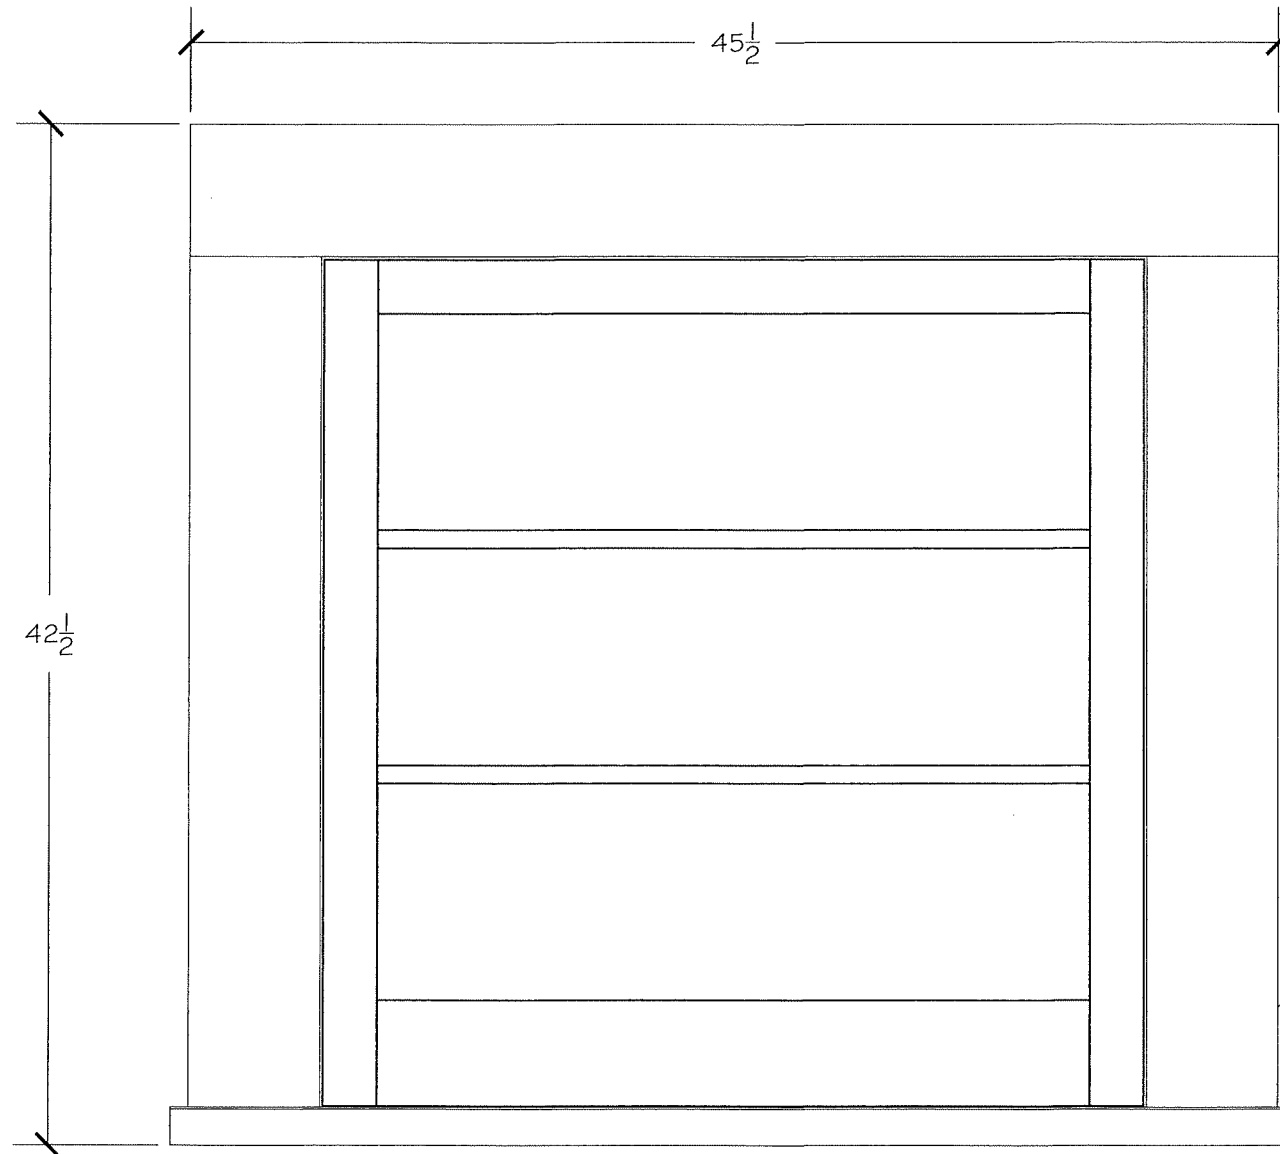
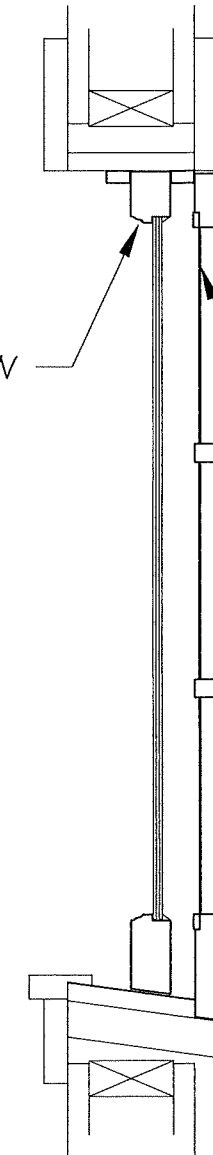
CK BY:
SHEET
3

EXISTING REPLACEMENT WINDOW

NEW WOOD WINDOW SCREEN.
INSTALLED TO CONCEAL WINDOW
