**HISTORIC AND DESIGN REVIEW
COMPLIANCE AND TECHNICAL ADVISORY BOARD**

HDRC CASE NO: 2024-378
ADDRESS: 415 BELKNAP PLACE
LEGAL DESCRIPTION: NCB 1881 BLK 3 LOT E 80.78 OF 3
ZONING: R-4, H
CITY COUNCIL DIST.: 1
DISTRICT: Monte Vista Historic District
APPLICANT: Trevor Pollard
OWNER: Trevor Pollard/ALLESEE LORI & POLLARD TREVOR
TYPE OF WORK: Siding replacement
APPLICATION RECEIVED: October 28, 2024
60-DAY REVIEW: December 27, 2024
CASE MANAGER: Bryan Morales

REQUEST:

The applicant is requesting a Certificate of Appropriateness for approval to replace the existing wood siding located on the north, south, and west wall planes with fiber cement siding with a similar profile.

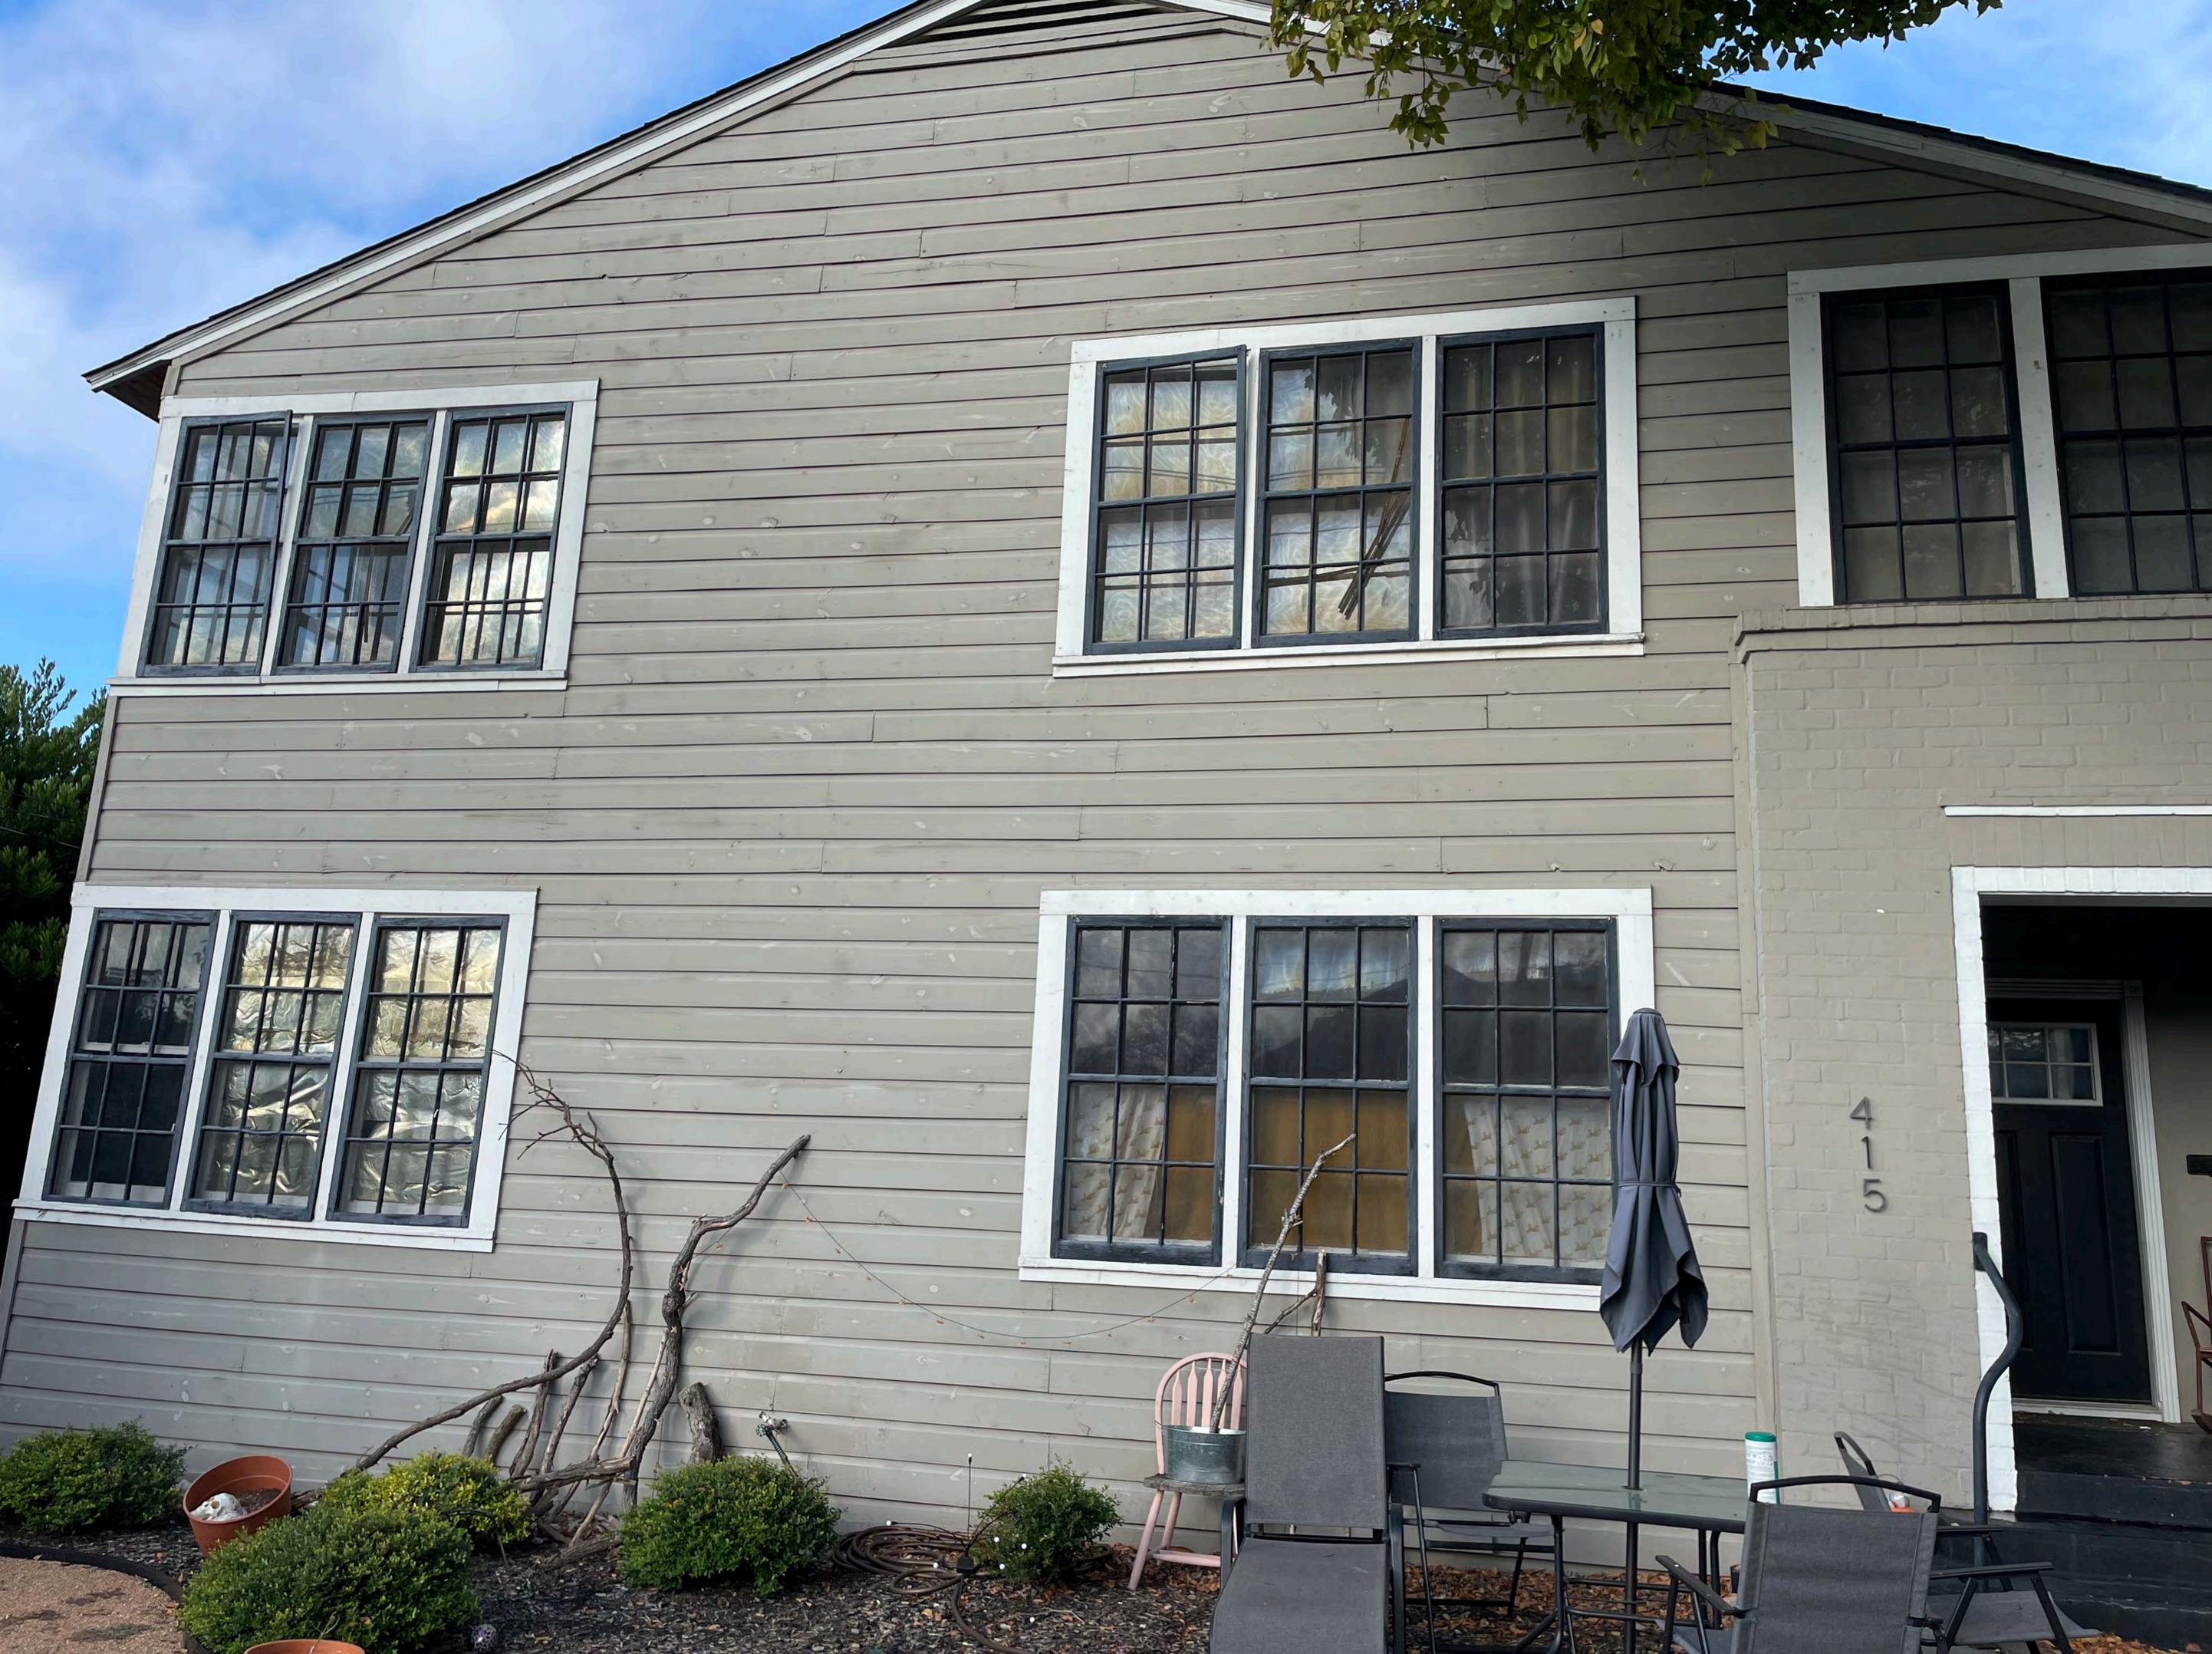
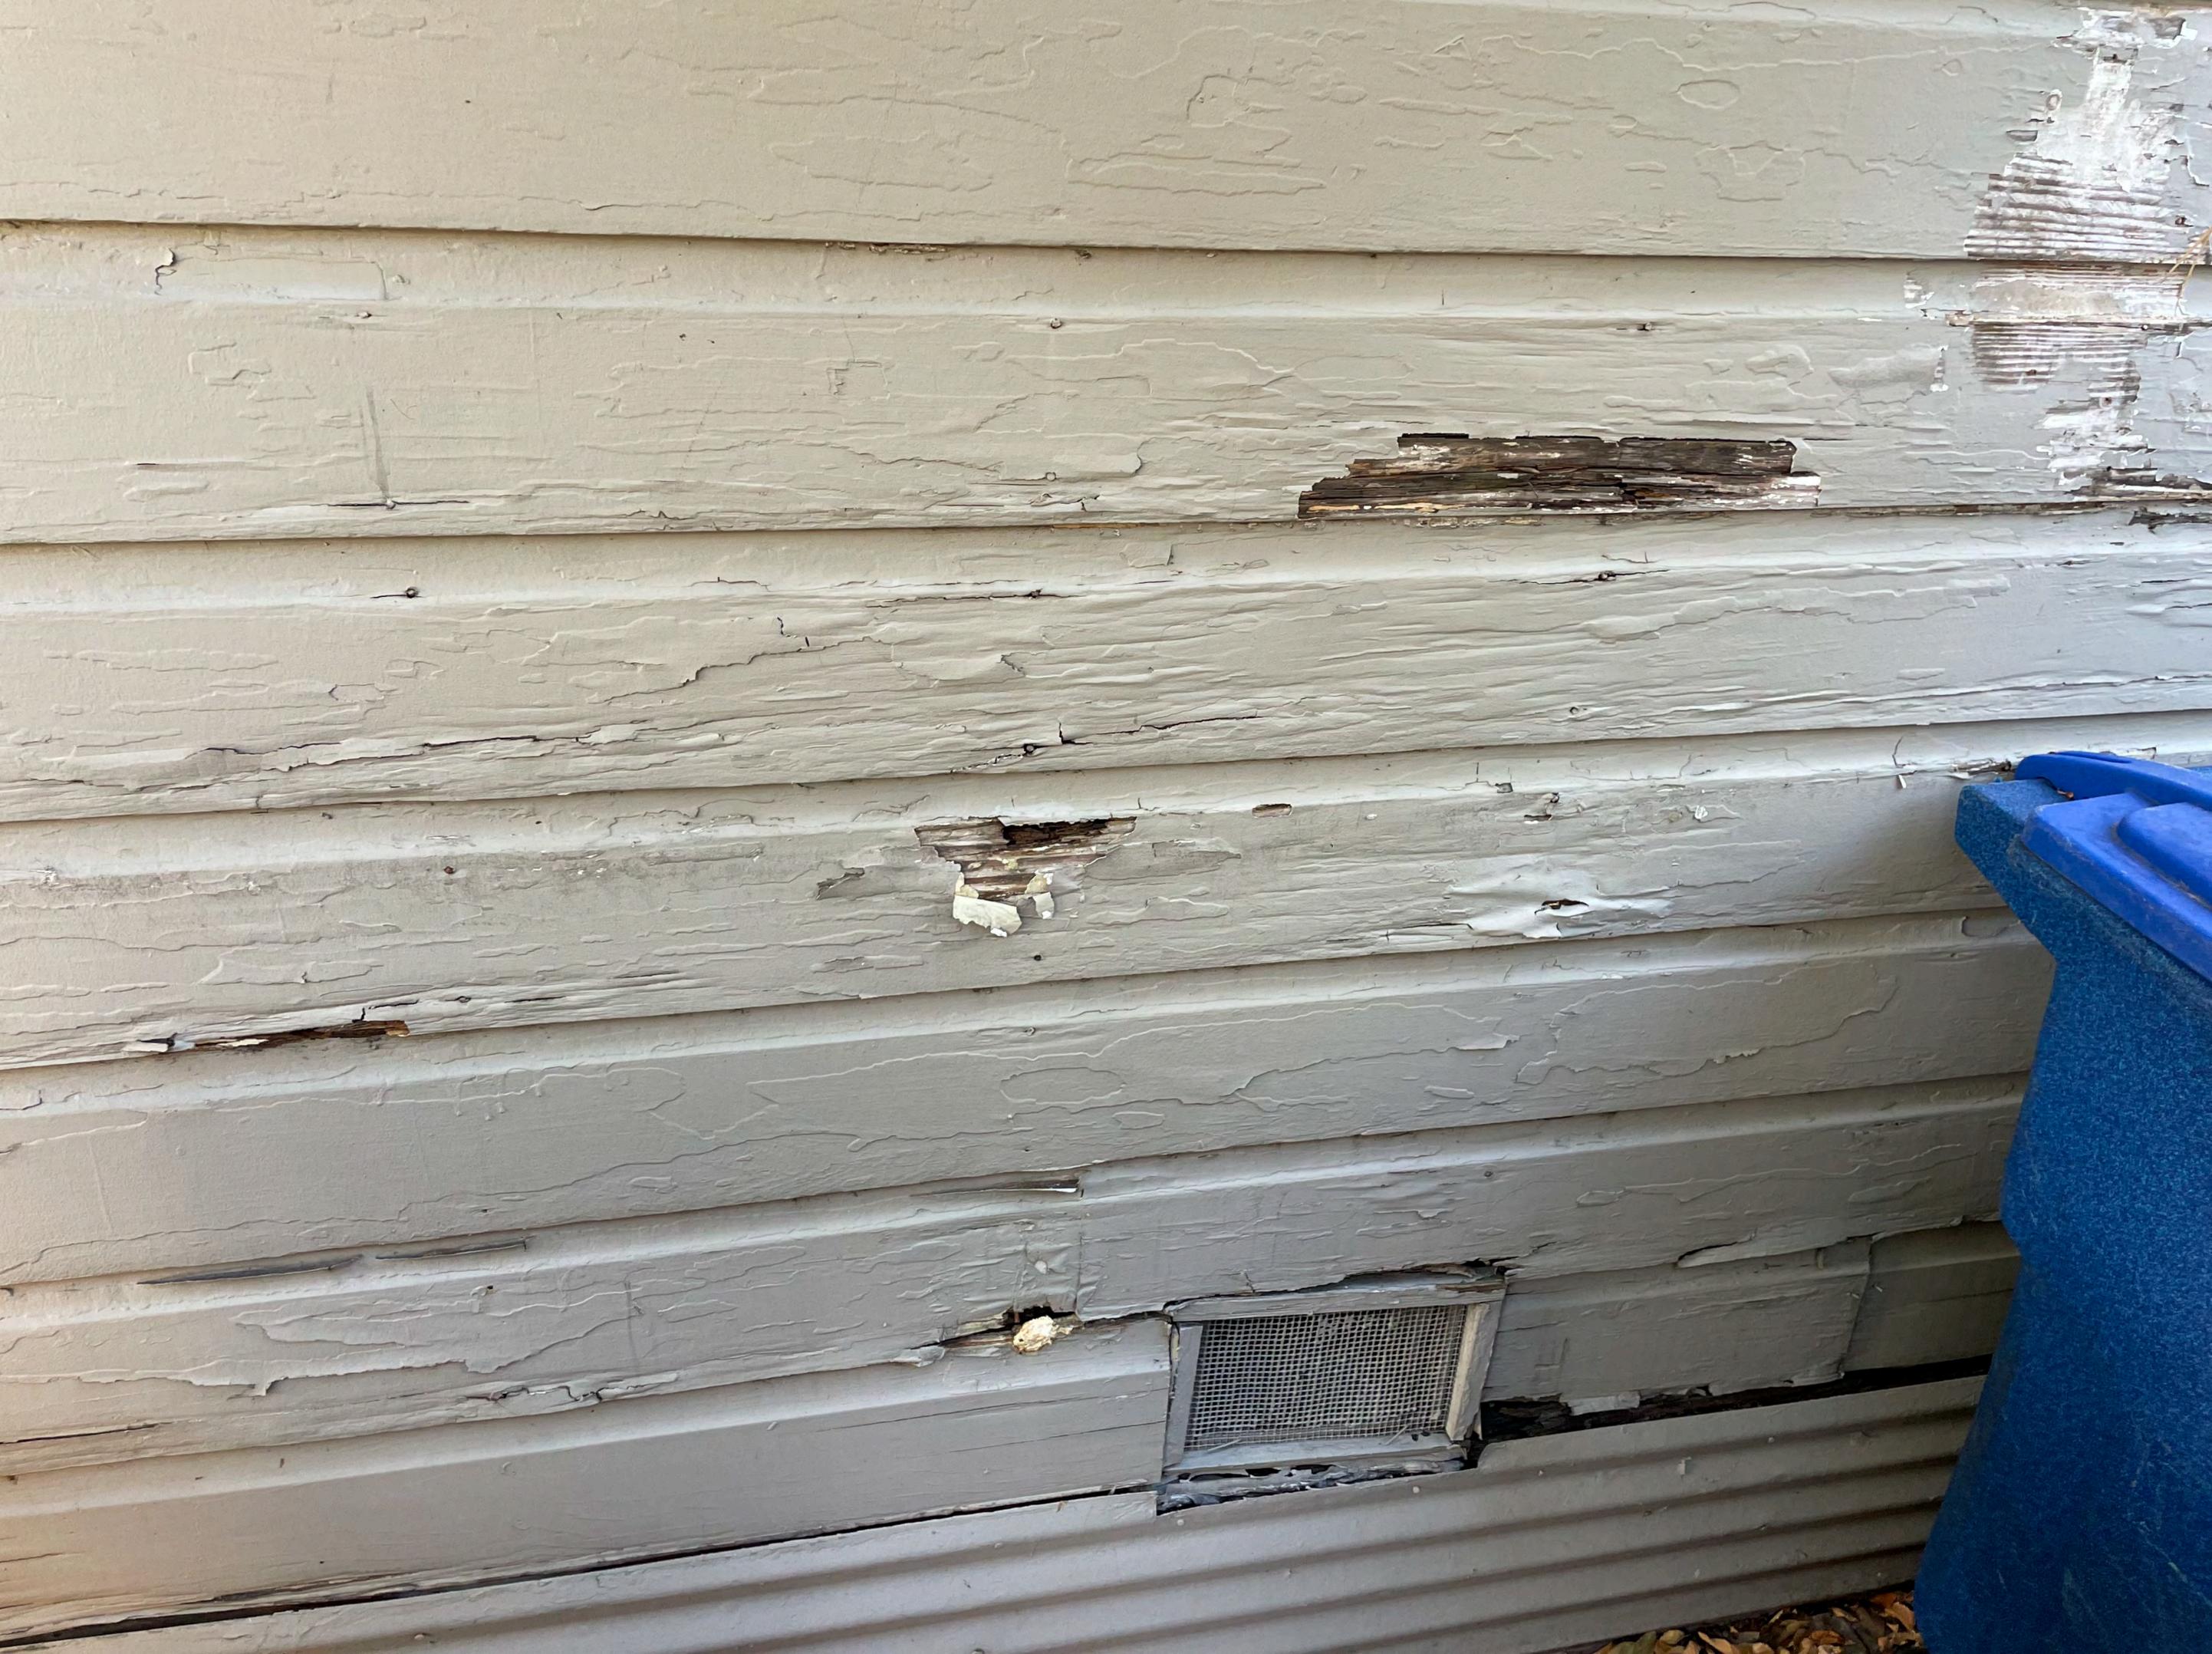
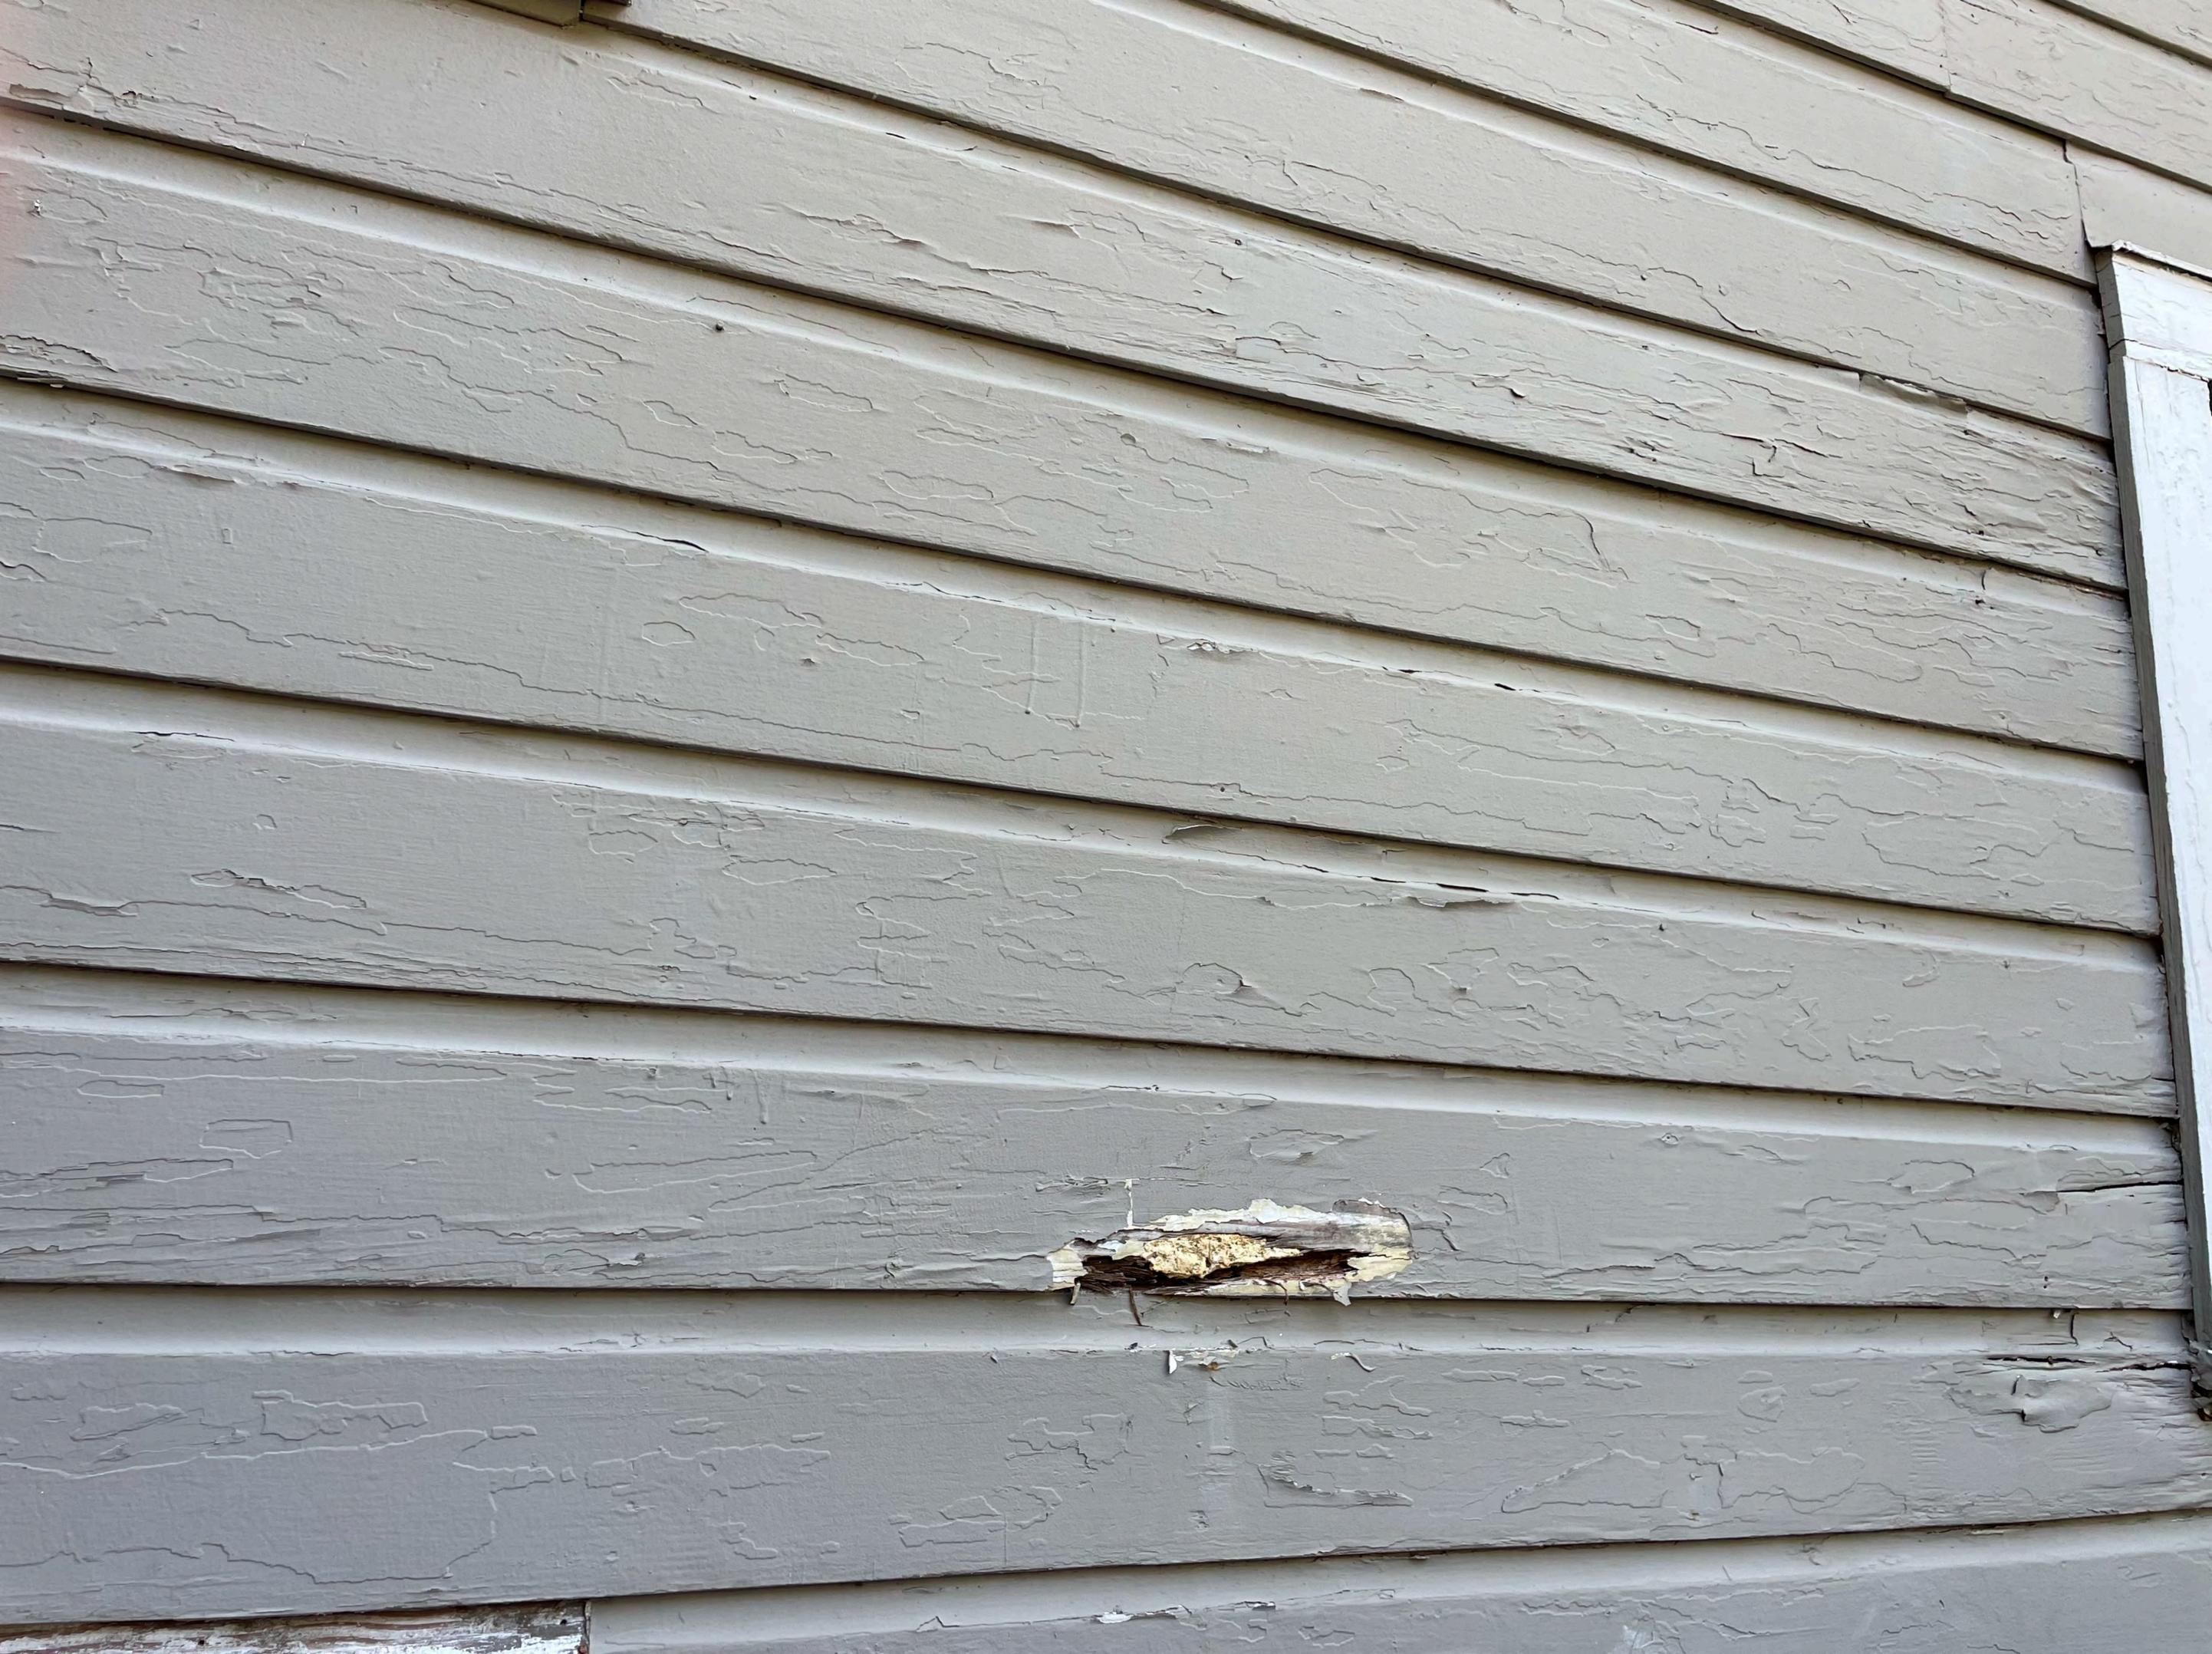
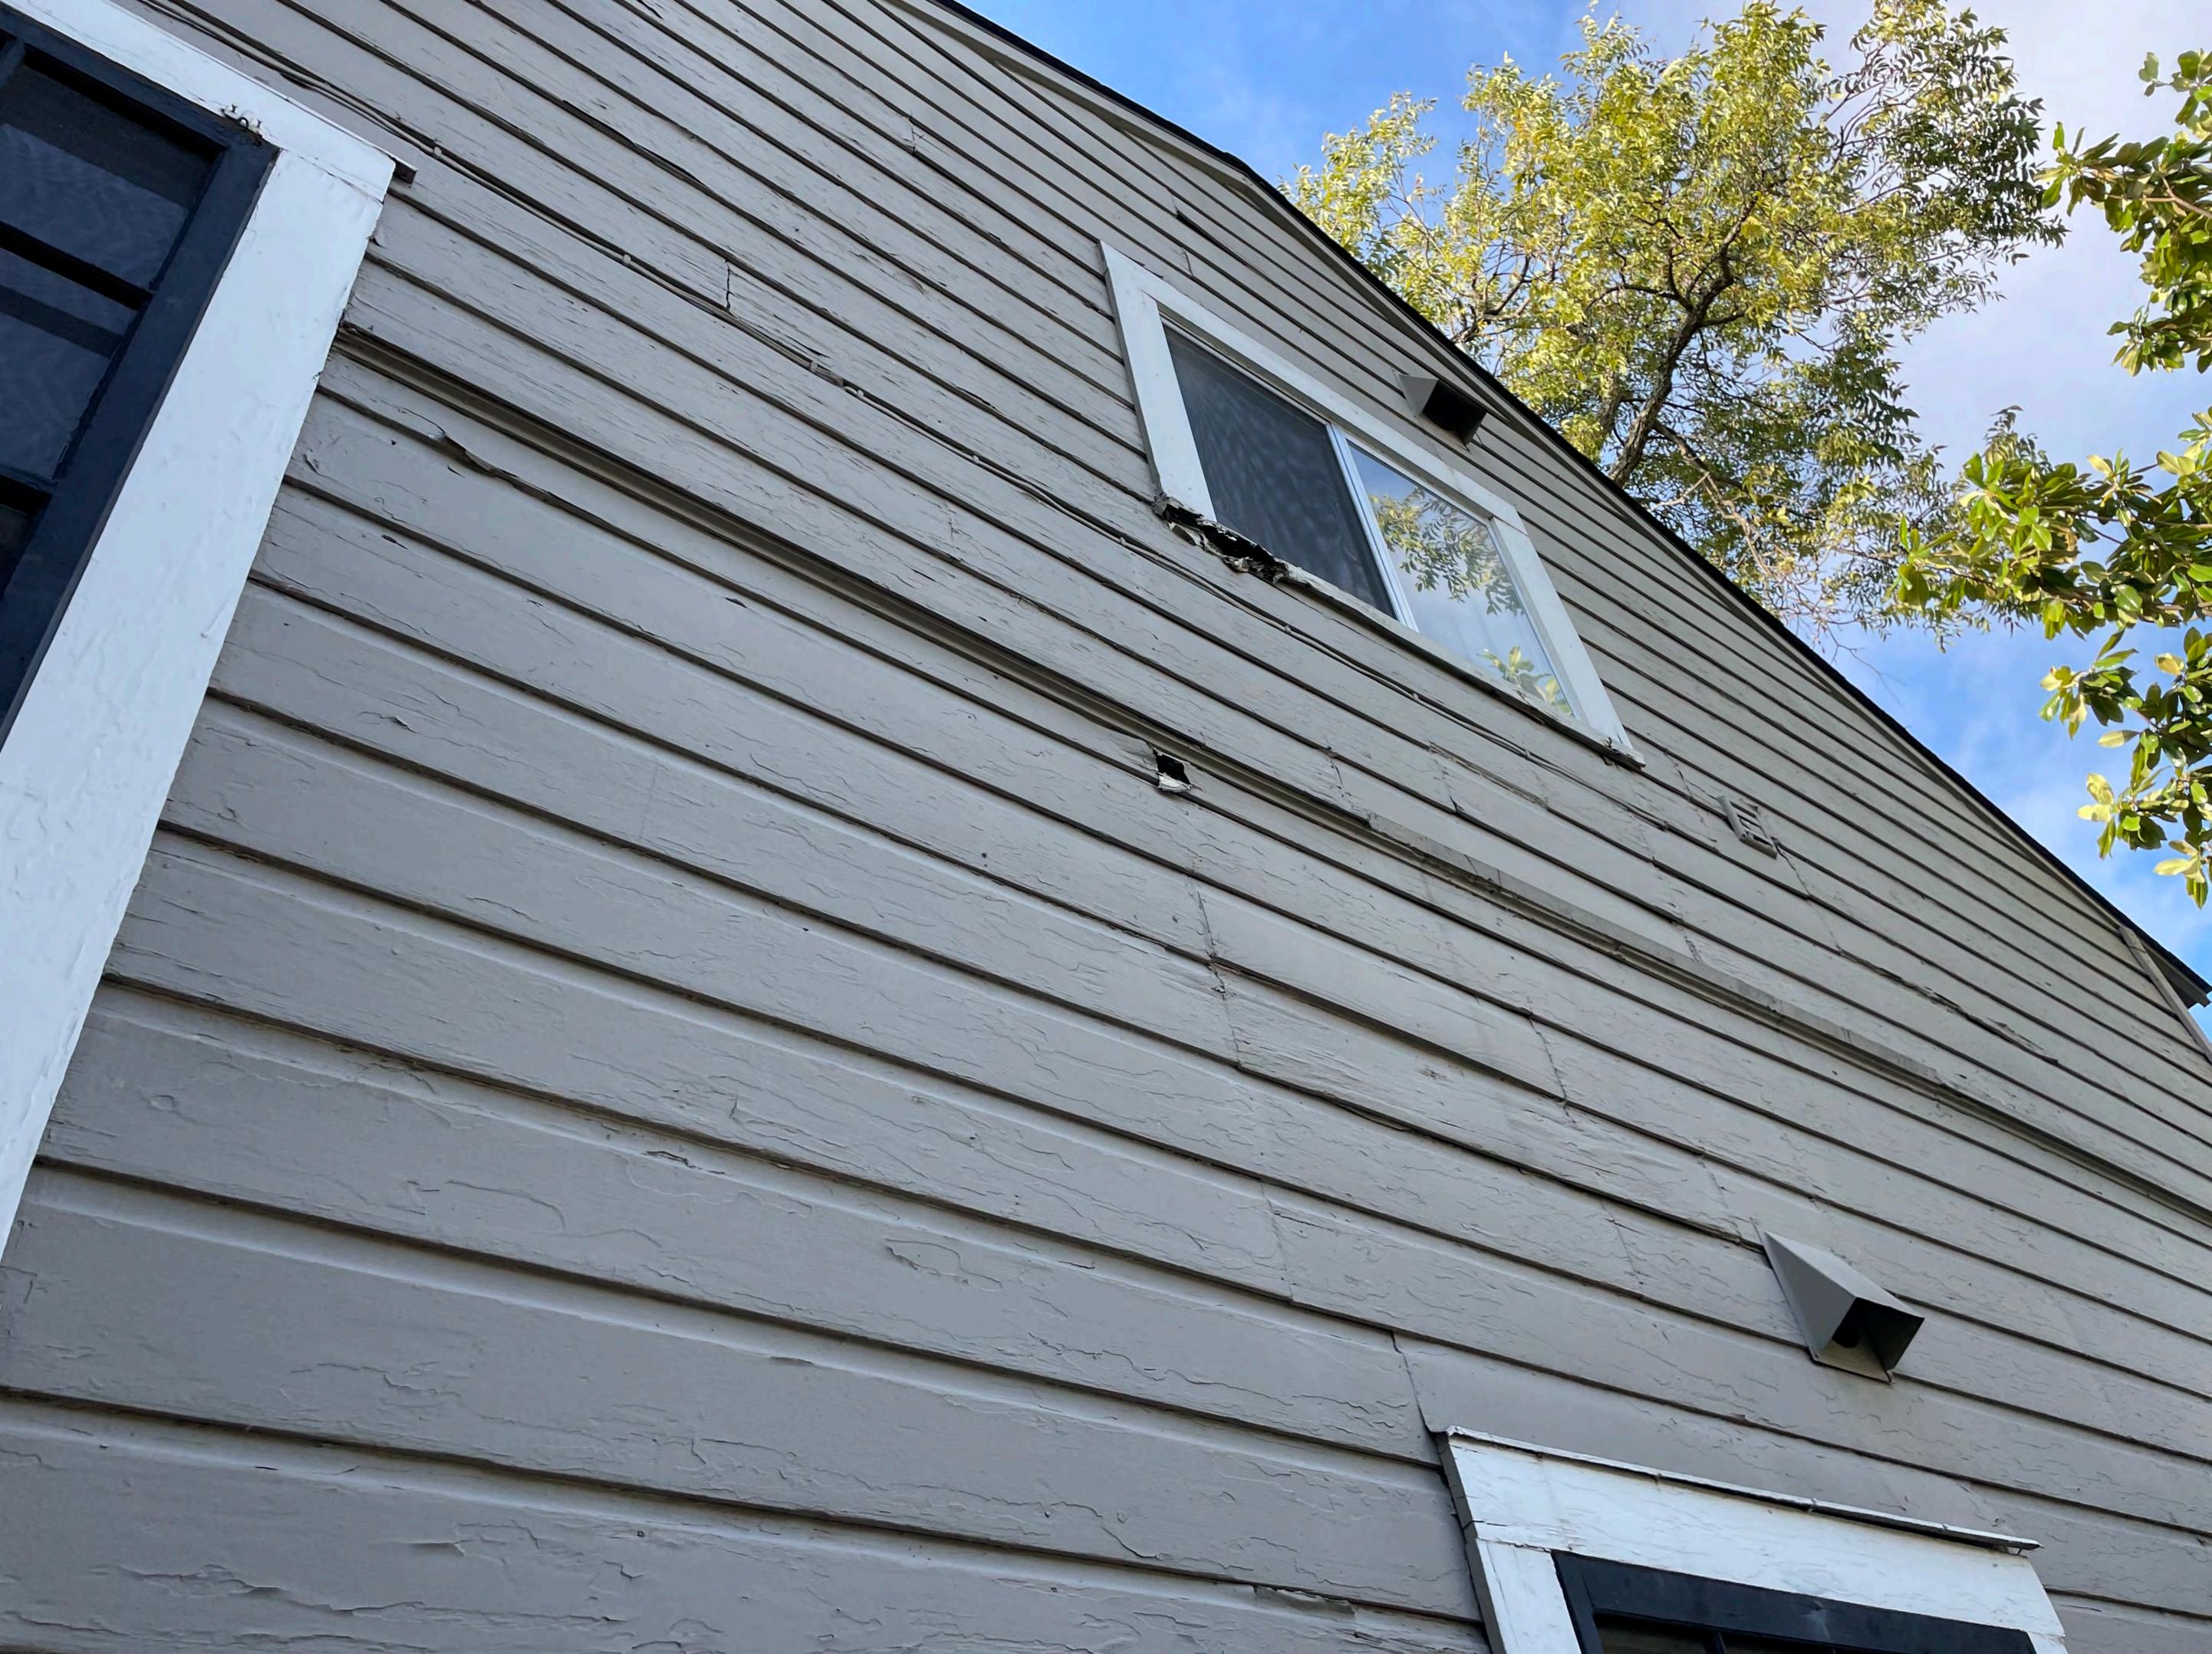
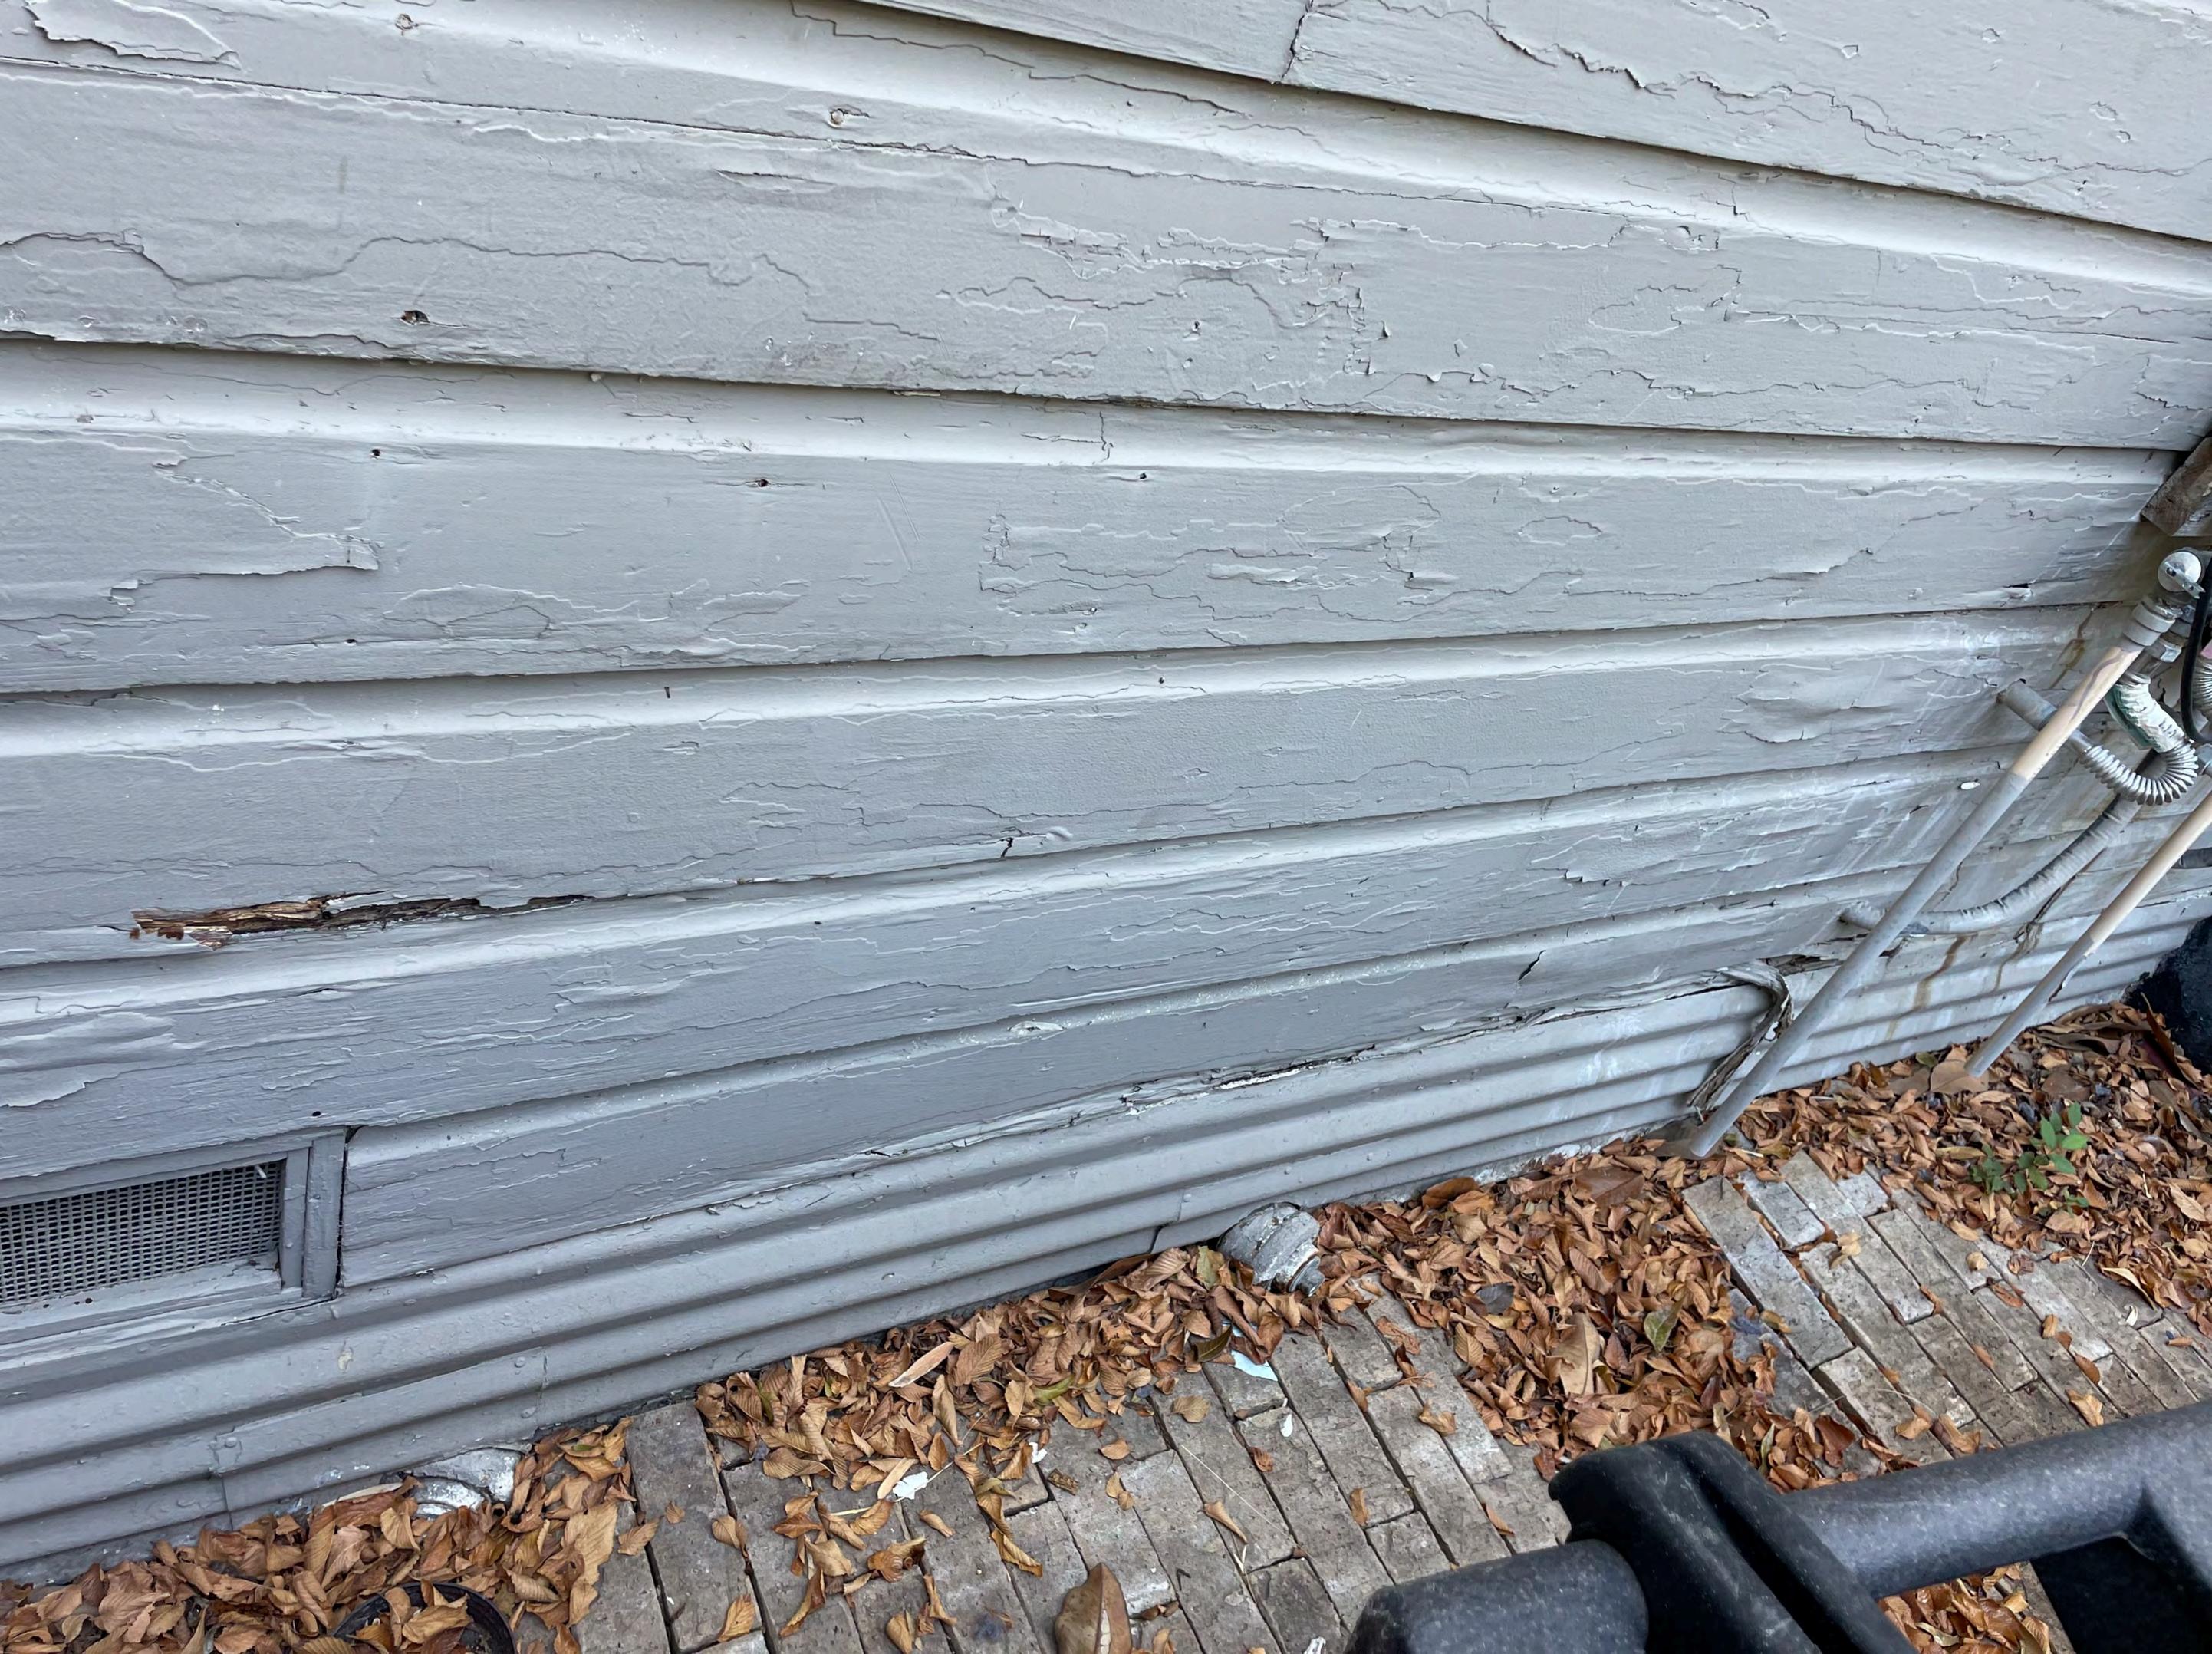
but tends to lack durability and rot resistance when compared to old-growth wood siding. There is evidence that previous patching has occurred on this property, and it further appears that some of the replacement siding has already begun to deteriorate. In 2018, the siding on the front facade was replaced with approval and has experienced some warping and deterioration. According to the Guidelines, wholesale siding replacement should be avoided in favor of spot replacement and repair. Composite or artificial siding is typically not approved as a replacement to wood siding. The applicant has proposed a composite product this is visually similar to the existing drop siding. Staff finds that the applicant has begun to make a case for an alternative material, but it remains unclear how visually similar the proposed hardie product will be to the original.

Staff does not recommend approval at this time. Prior to approval, the applicant must demonstrate the following:

- i. That the existing wood siding is deteriorated to a point which would warrant wholesale replacement over the recommend spot treatment; and
- ii. That the proposed hardie product will be visually similar to the historic wood siding profile to a point which would be indistinguishable from the right of way.
