## HISTORIC AND DESIGN REVIEW COMMISSION

September 18, 2024

**HDRC CASE NO:** 2024-267  
**ADDRESS:** 2619 MCCULLOUGH AVE  
**LEGAL DESCRIPTION:** NCB 1704 BLK 12 LOT N1-2 OF 12 & 13  
**ZONING:** O-1, H  
**CITY COUNCIL DIST.:** 1  
**DISTRICT:** Monte Vista Historic District  
**APPLICANT:** Matthew Gilbert/Ortiz McKnight PLLC  
**OWNER:** ZUNIGA LAW PLLC  
**TYPE OF WORK:** Requesting a waiver, fenestration modifications  
**APPLICATION RECEIVED:** July 19, 2024  
**60-DAY REVIEW:** Waived by applicant  
**CASE MANAGER:** Claudia Espinosa

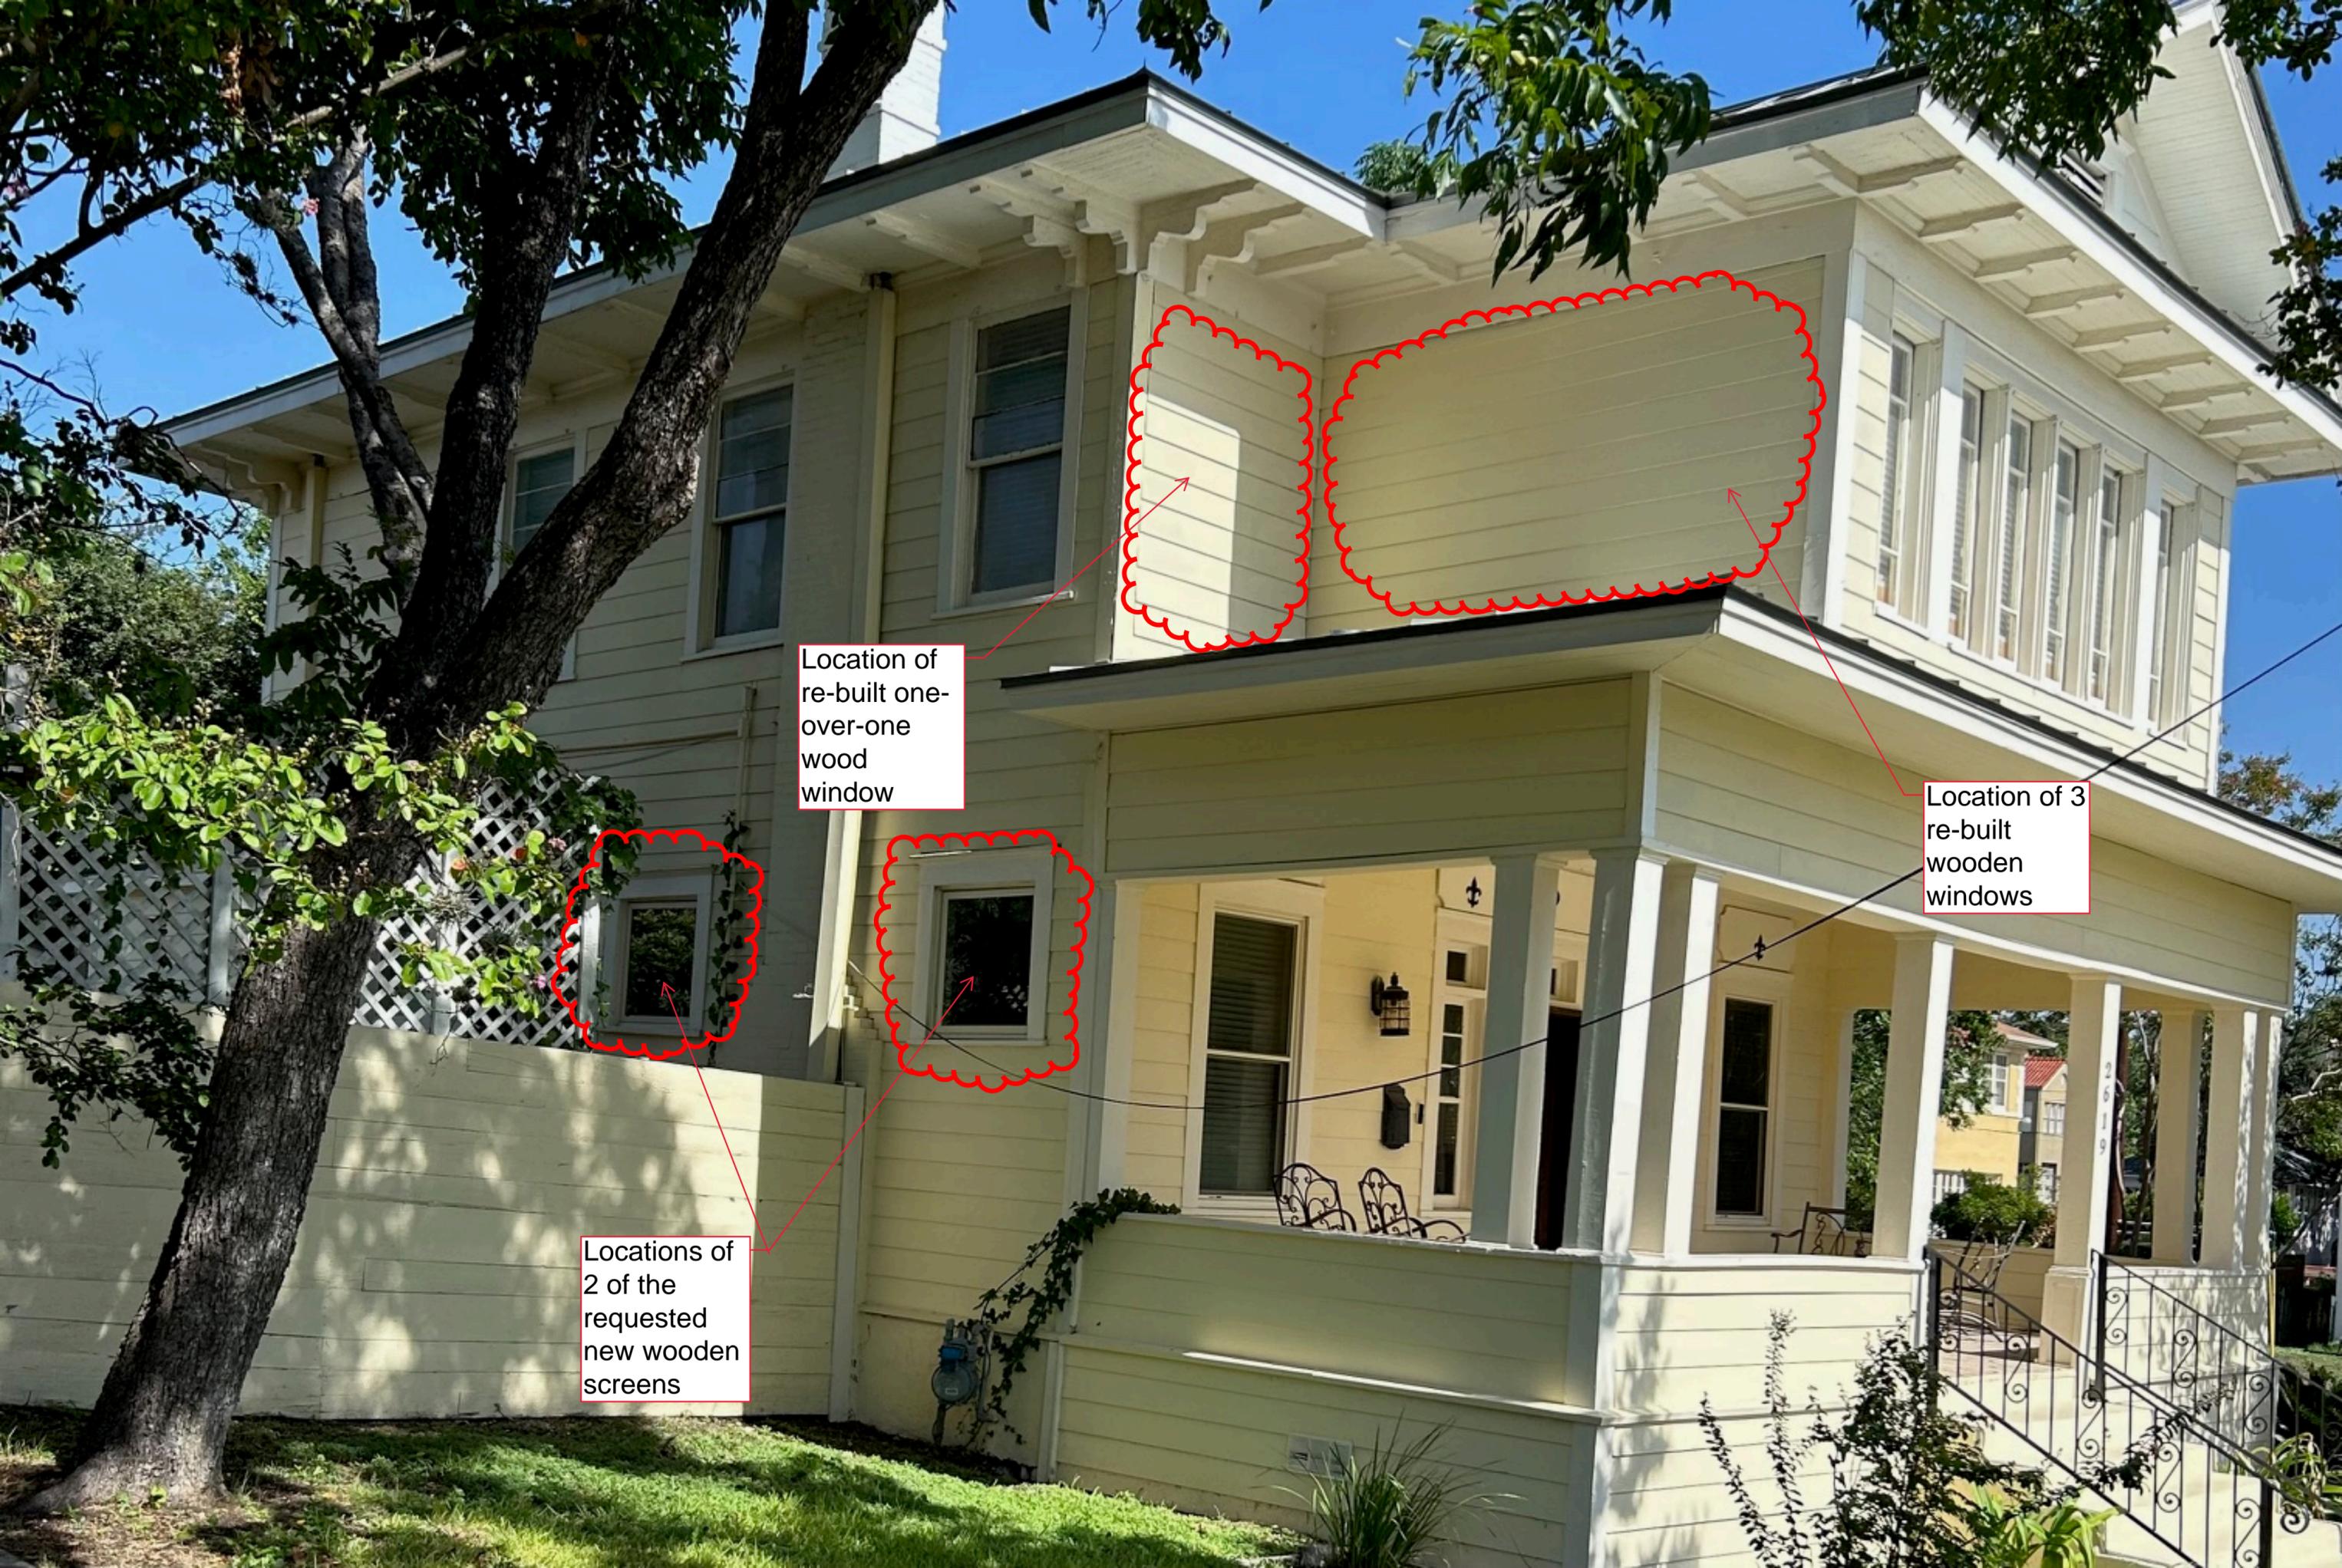
Location of re-built one-over-one wood window

Location of 3 re-built wooden windows

Locations of 2 of the requested new wooden screens

Location of  
re-built  
wood  
window

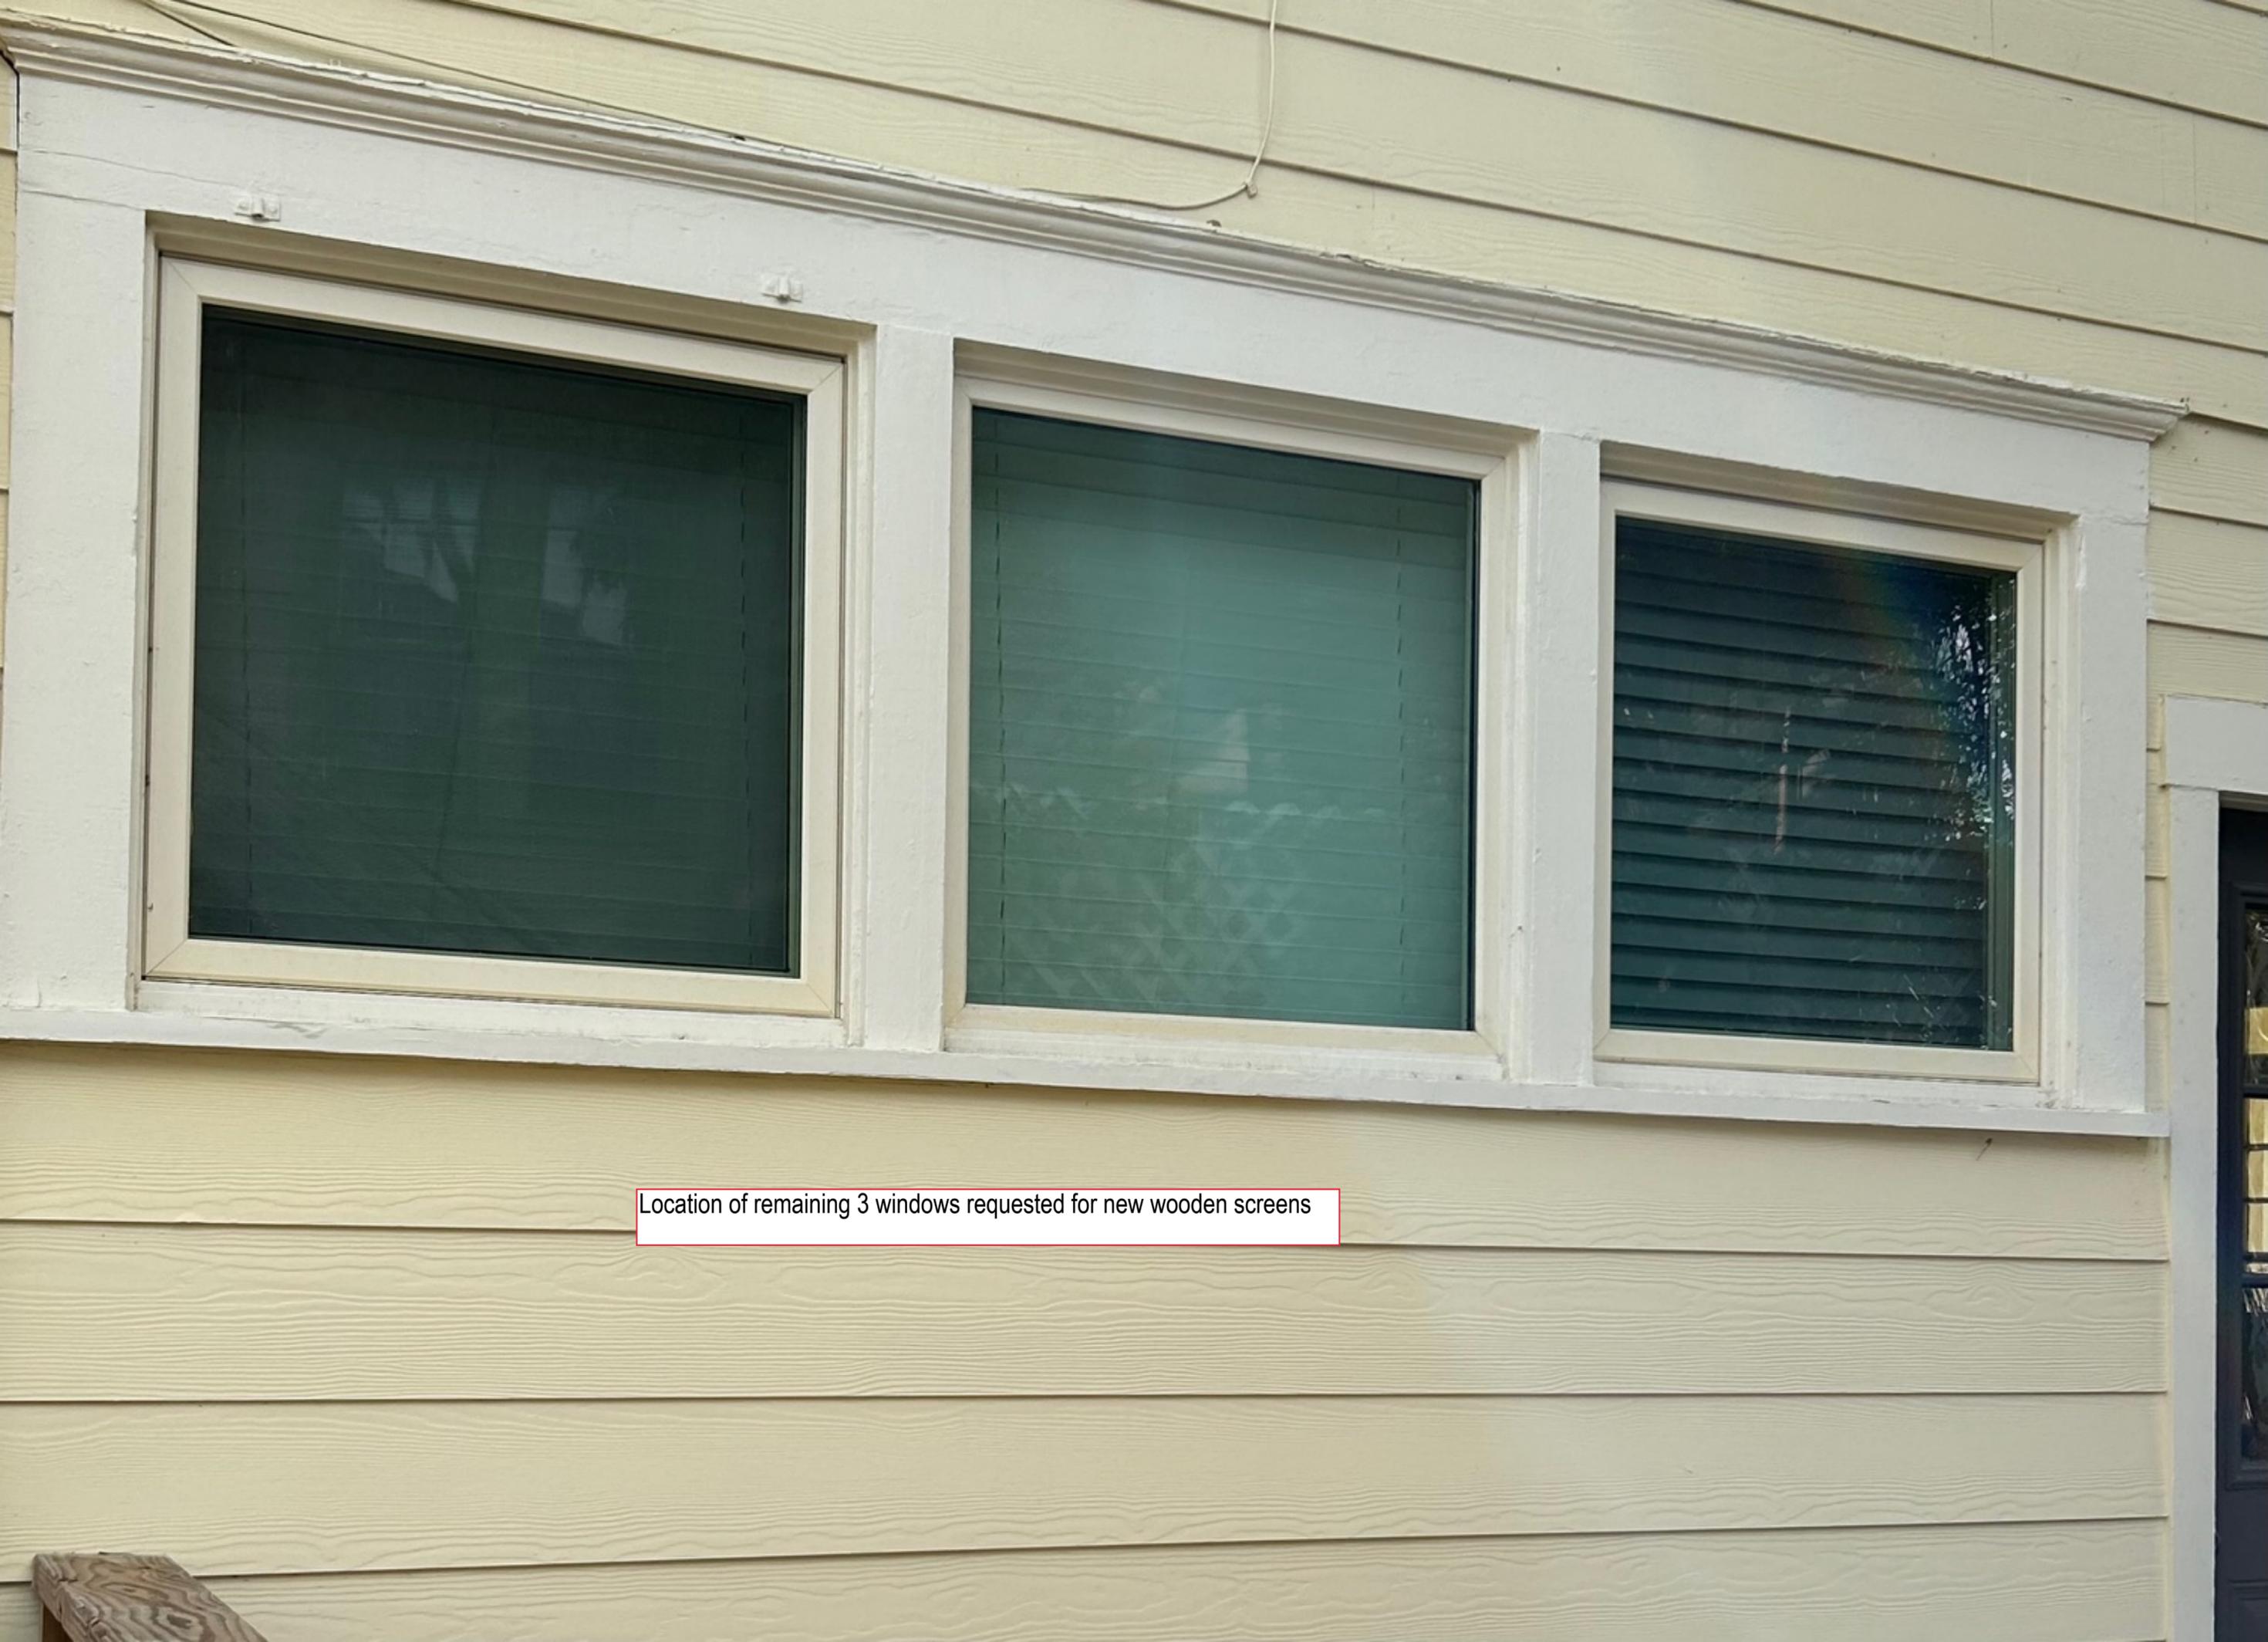
Location of remaining 3 windows requested for new wooden screens

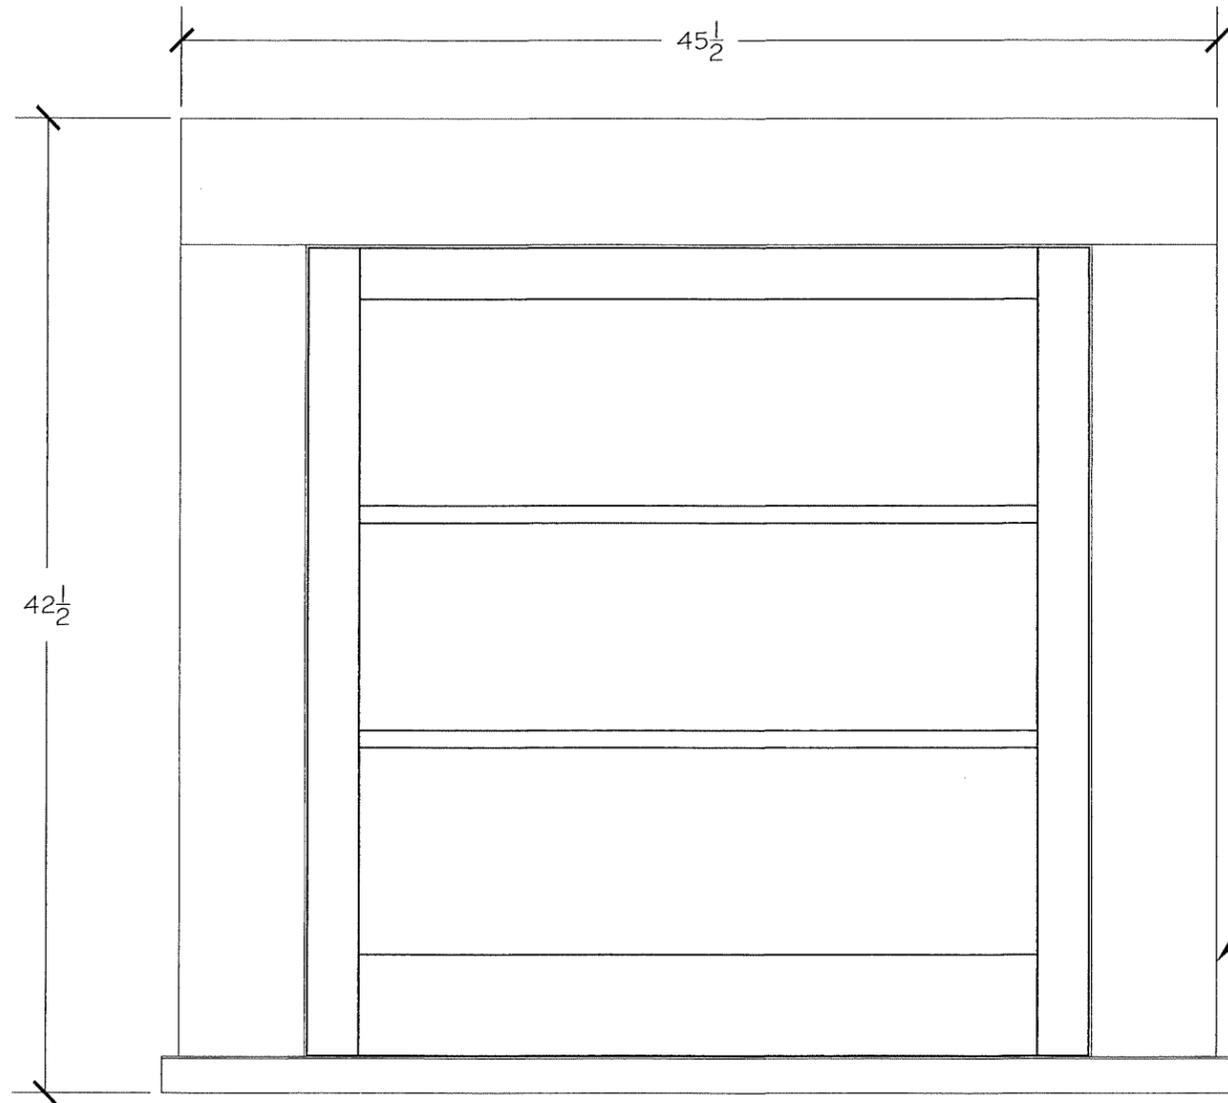
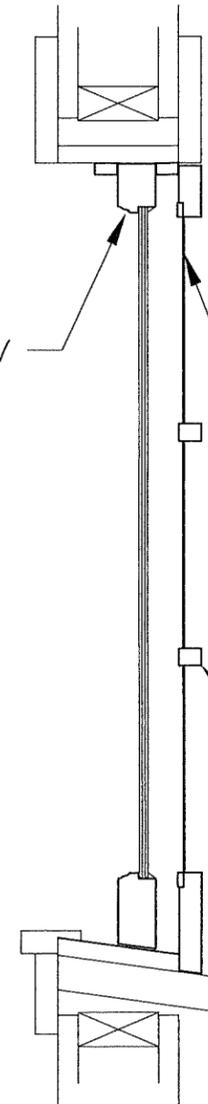
3

EXISTING REPLACEMENT WINDOW

NEW WOOD WINDOW SCREEN.  
INSTALLED TO CONCEAL WINDOW
