**HISTORIC AND DESIGN REVIEW COMMISSION
COMPLIANCE AND TECHNICAL ADVISORY BOARD**

HDRC CASE NO:	2024-278
ADDRESS:	705 E EVERGREEN
LEGAL DESCRIPTION:	NCB 399 BLK 27 LOT 12B
ZONING:	R-6
CITY COUNCIL DIST.:	1
DISTRICT:	Tobin Hill Historic District
APPLICANT:	Doris Blanco/MARTINEZ JUAN JOSE JR
OWNER:	Juan Martinez/MARTINEZ JUAN JOSE JR
TYPE OF WORK:	Siding replacement
APPLICATION RECEIVED:	July 23, 2024
60-DAY REVIEW:	
CASE MANAGER:	Bryan Morales

Investigation Report

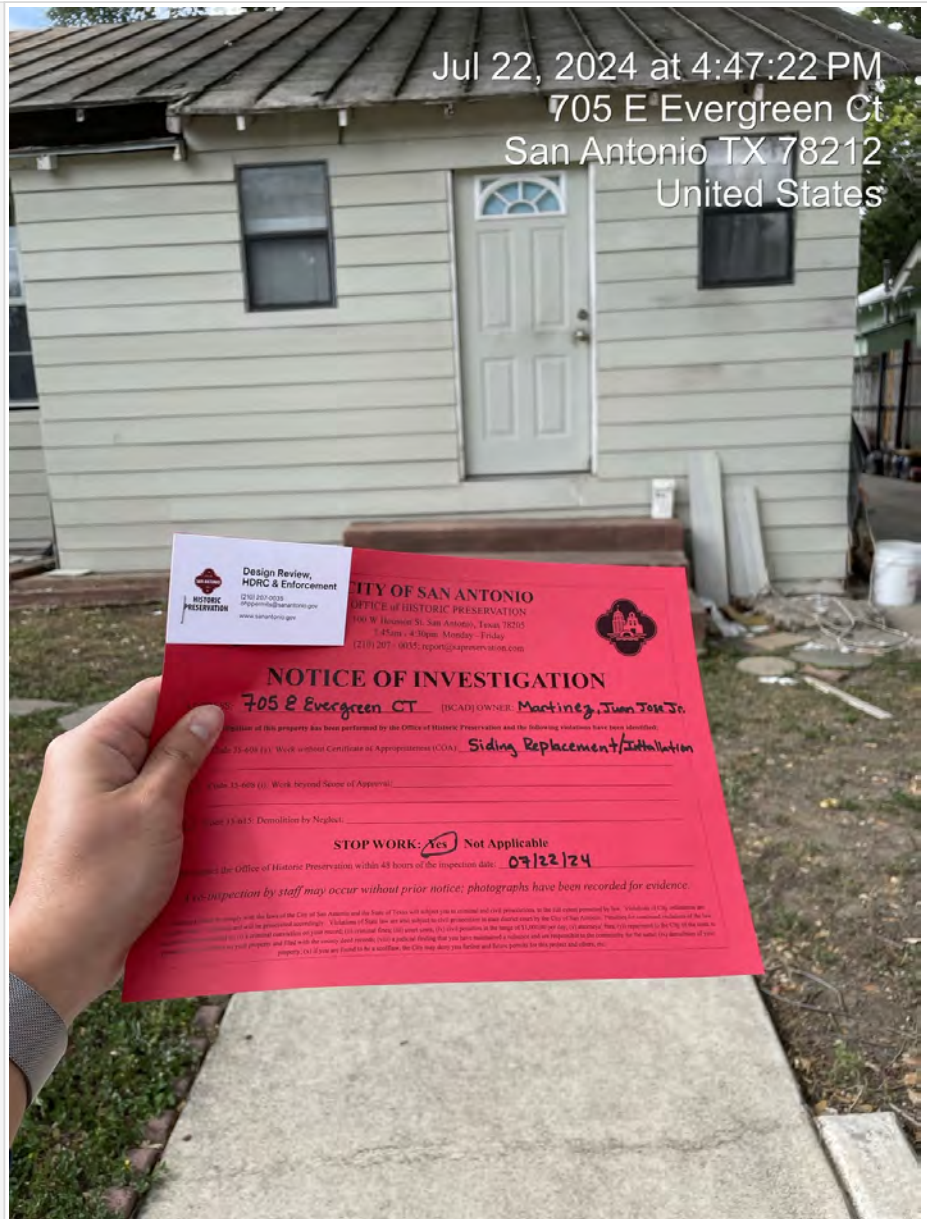
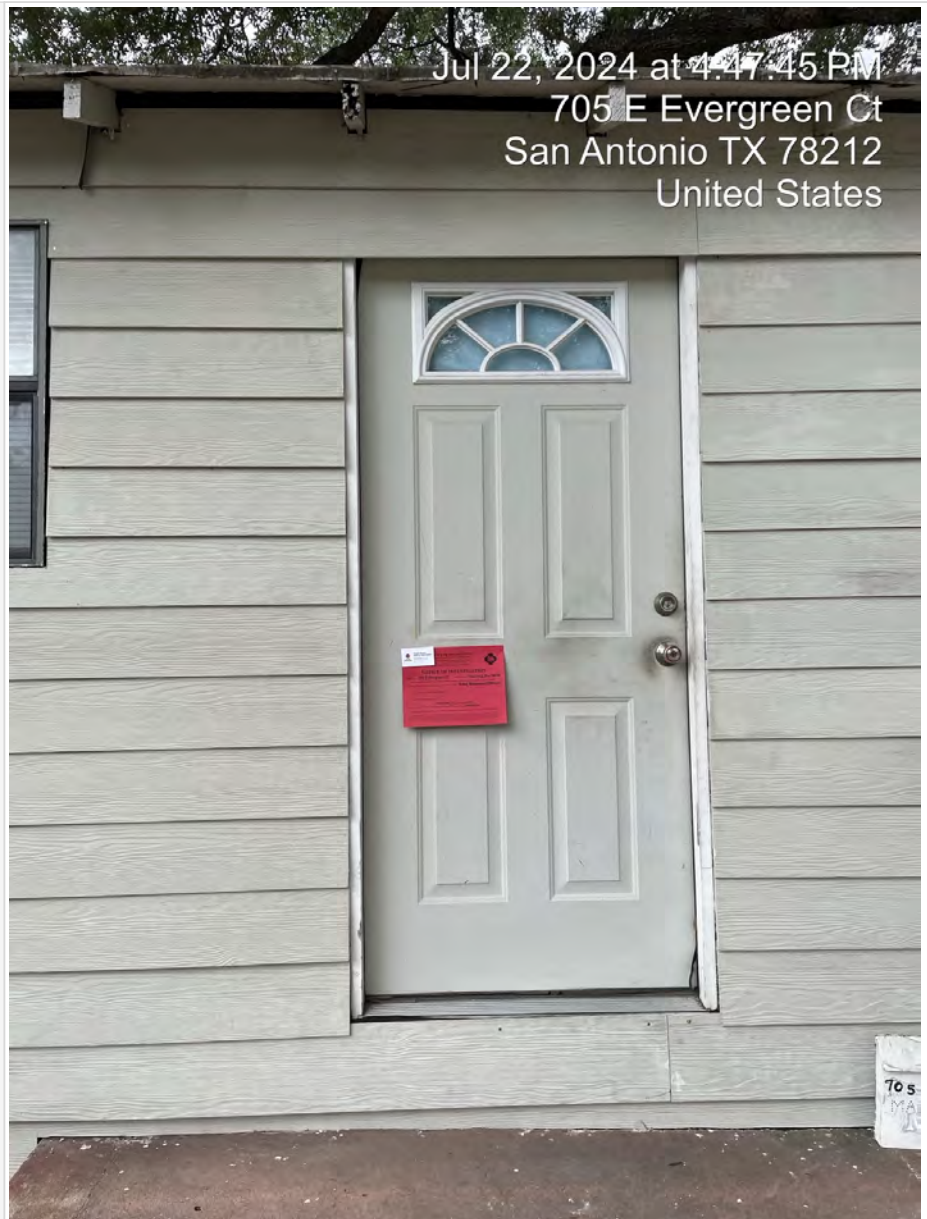
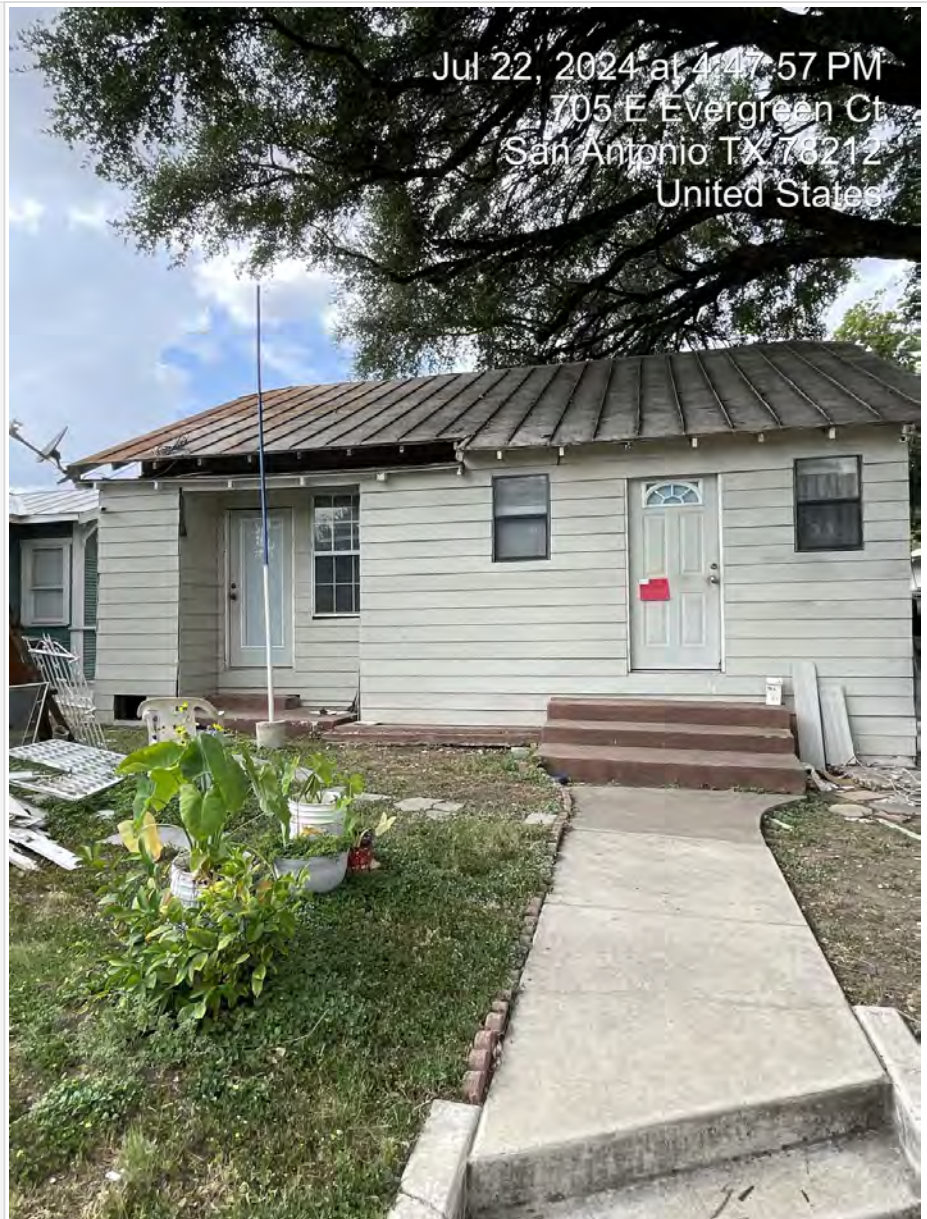
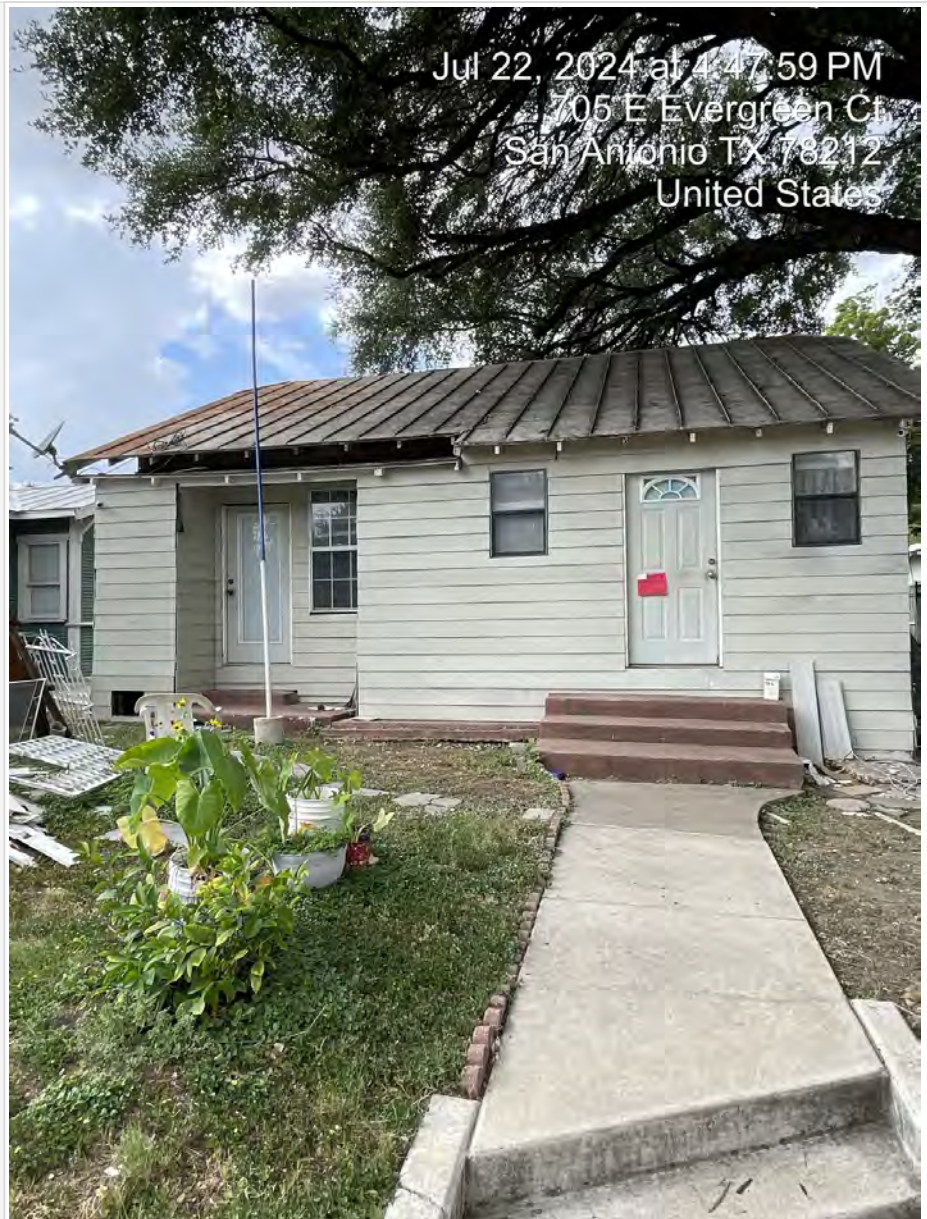
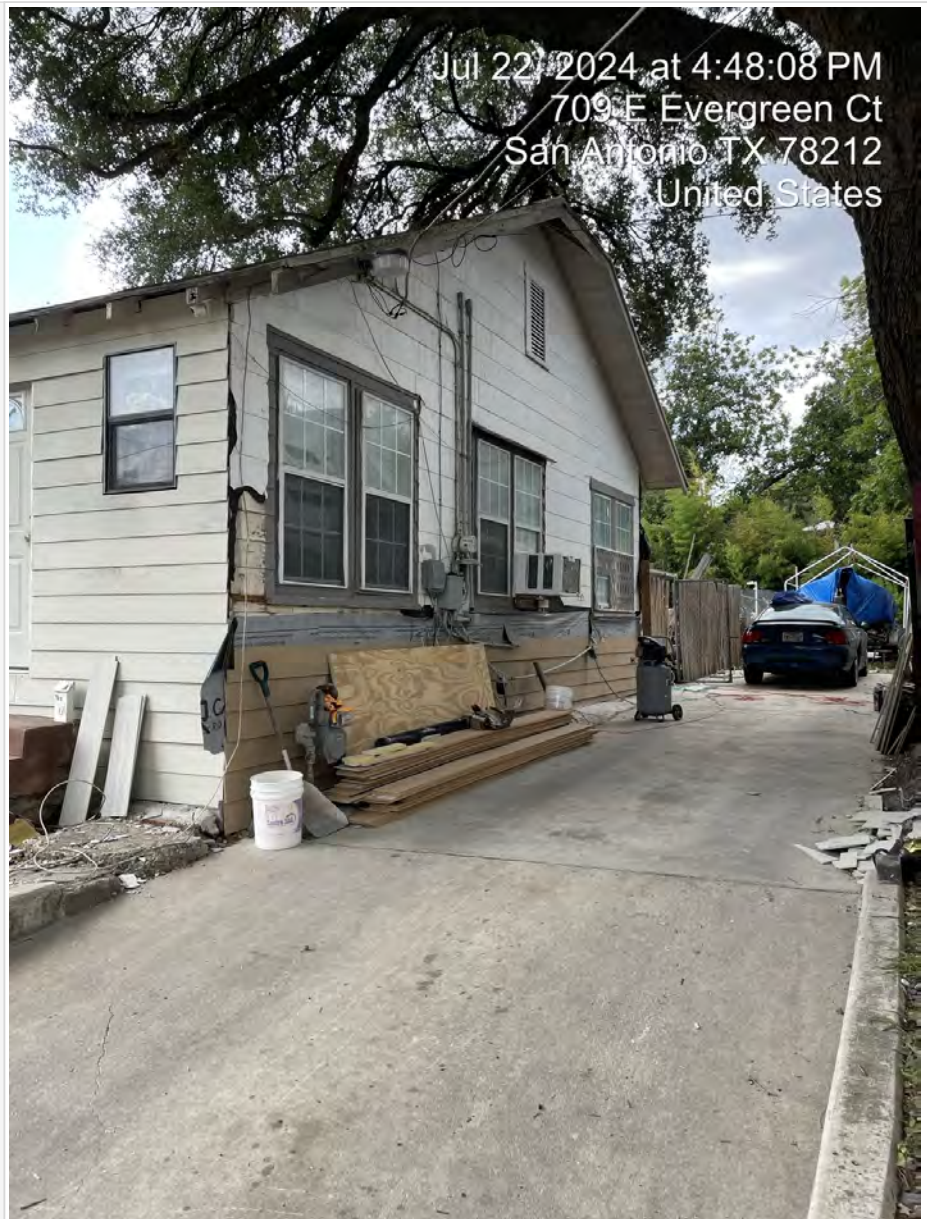
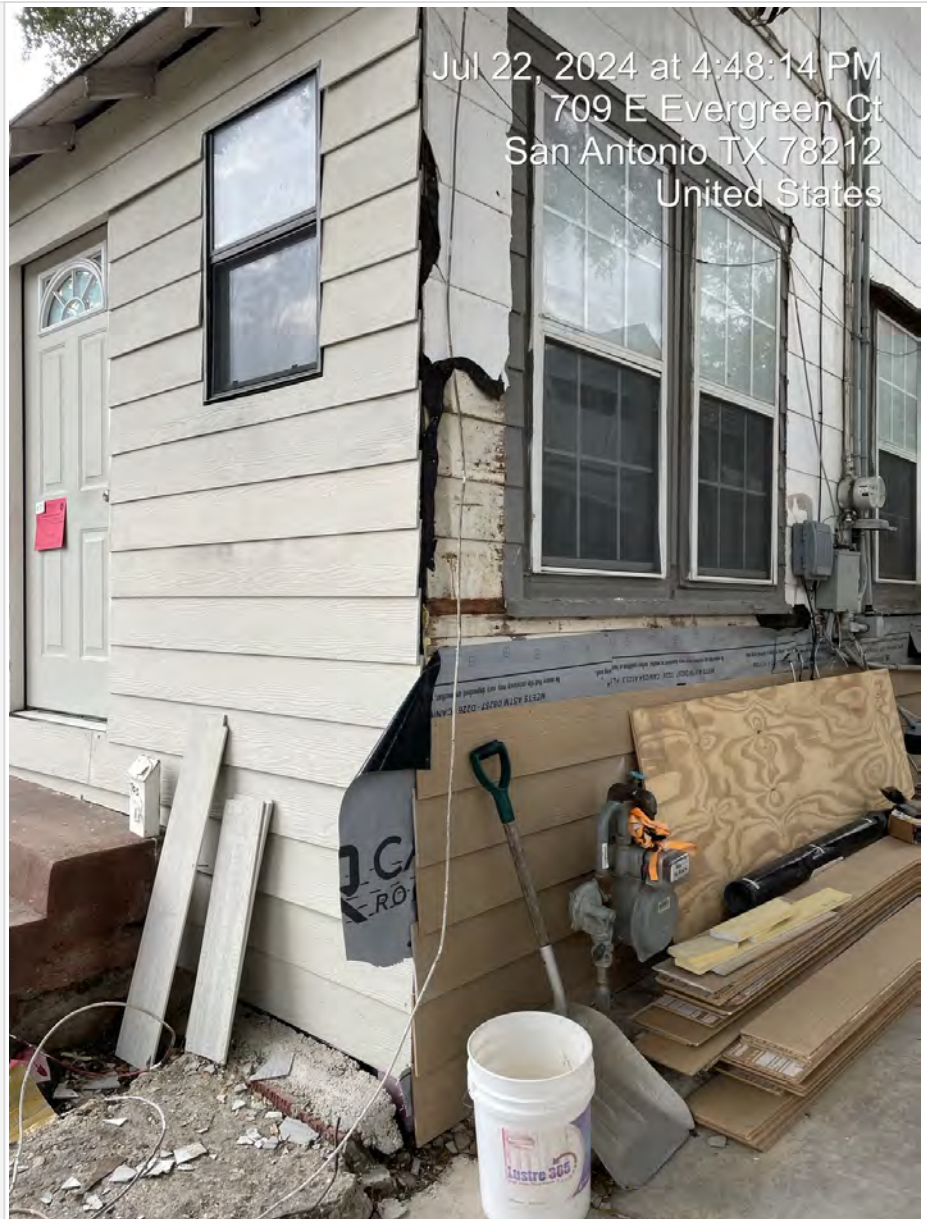
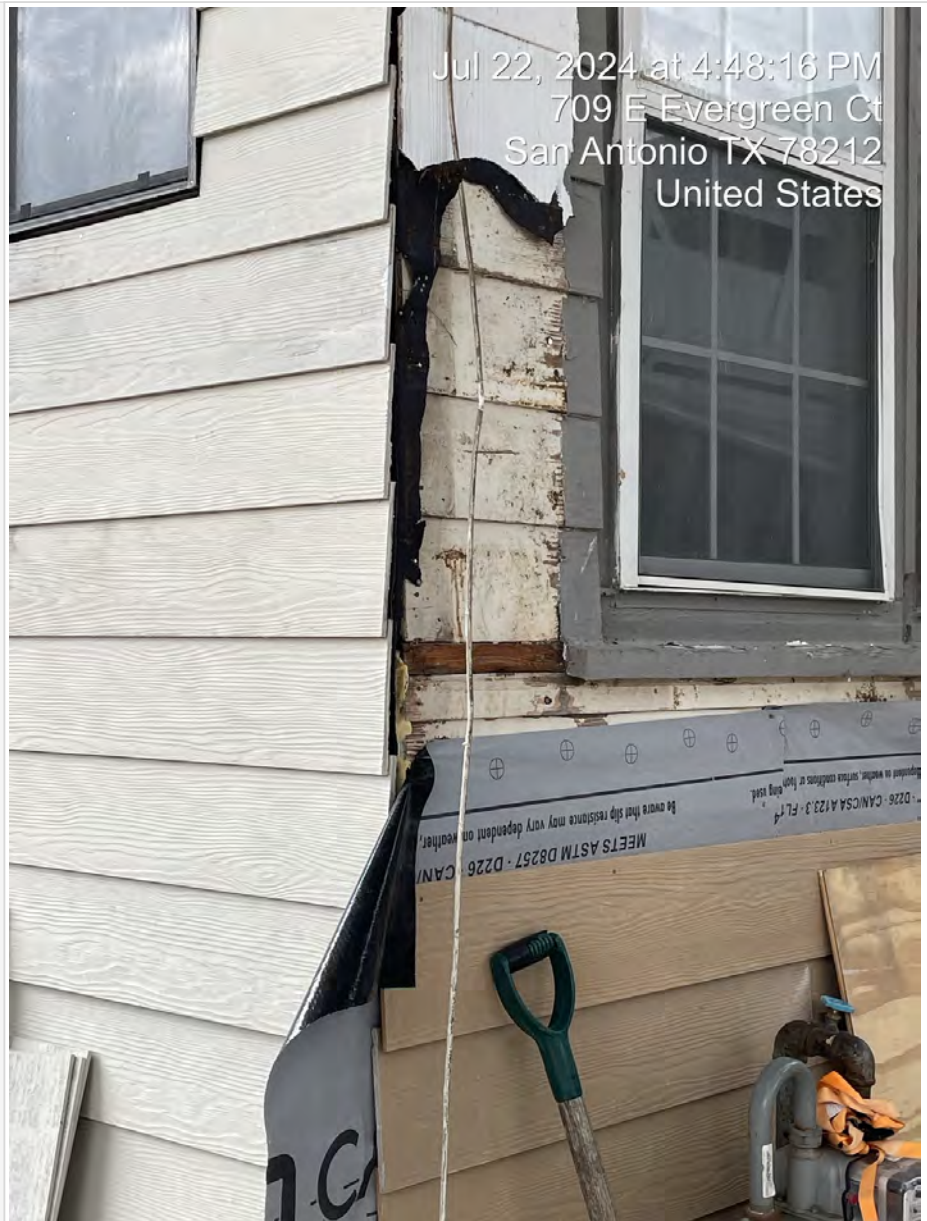
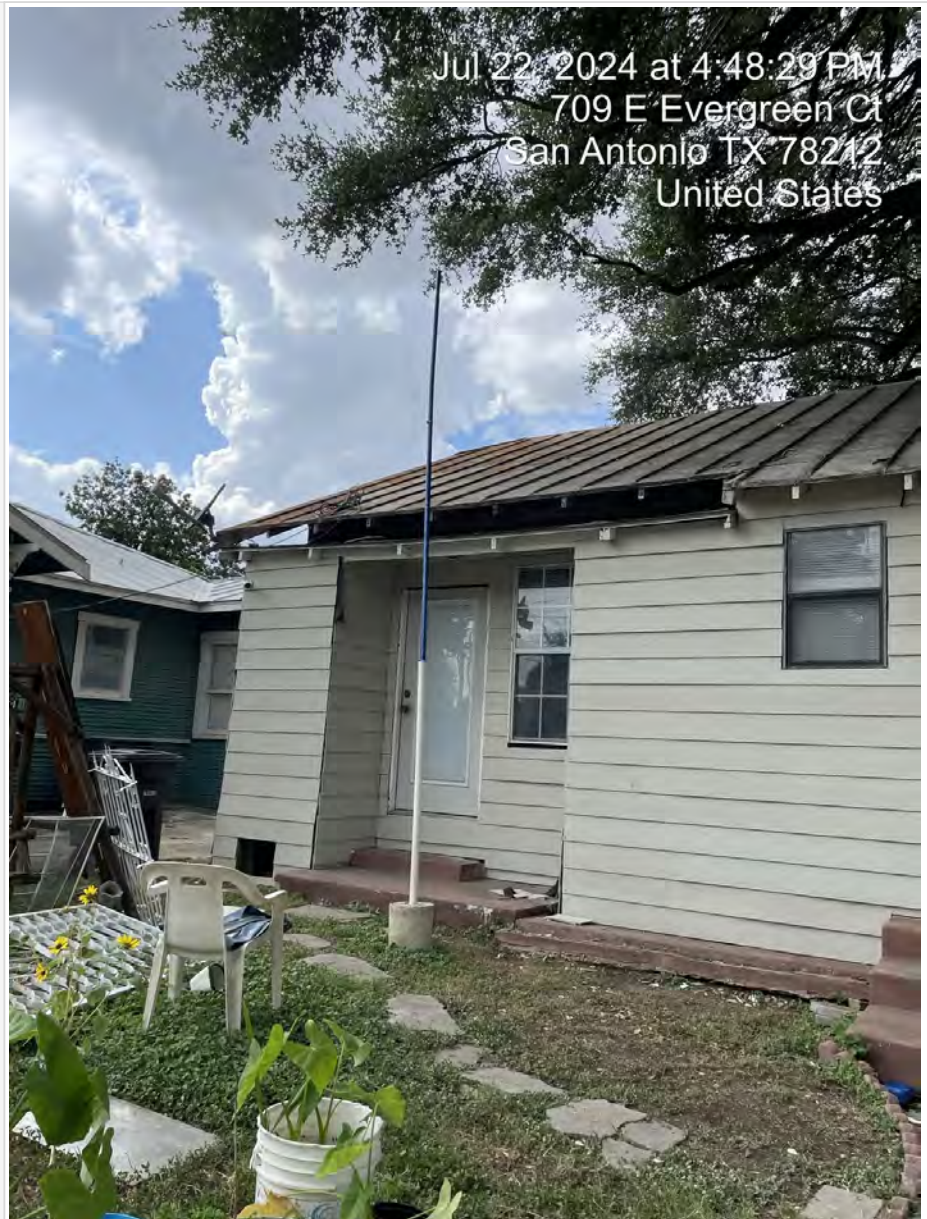
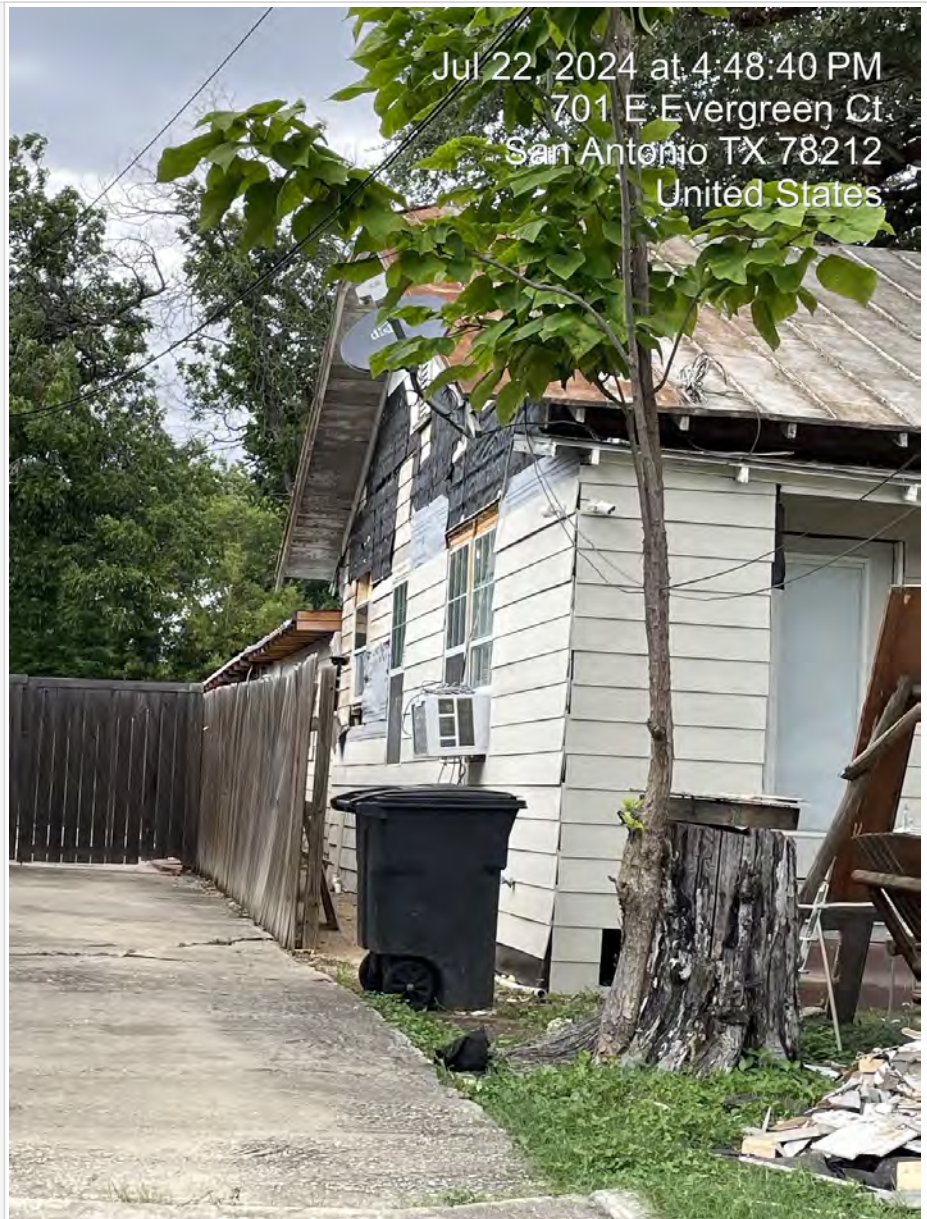
Photographs

Date	07/22/2024
Time	04:50 PM (-5 GMT)
Context	citizen report
Present Staff	Bryan Morales
Present Individuals	Family/Tenant
Contractor/Realtor Companies	N/A
Types of Work Observed	Exterior Maintenance and Alterations
Amount of Work Completed	50%
Description of work	Removal of existing siding and installation of cement fiber board lapped siding.
Description of interaction	Knocked on door and daughter answered. Property owner was not home.

Violation Type	No Certificate of Appropriateness (Code 35-451a)
OHP Action	Spoke with neighbor/family/tenant, Posted "Notice of Investigation"
Will post-work application fee apply?	To be determined
