HISTORIC AND DESIGN REVIEW COMMISSION

February 21, 2025

HDRC CASE NO: 2025-027
ADDRESS: 210 HERMINE BLVD
LEGAL DESCRIPTION: NCB 9008 BLK 4 LOT 44 THRU 46
ZONING: R-4, H
CITY COUNCIL DIST.: 1
DISTRICT: Olmos Park Terrace Historic District
APPLICANT: Yolanda Jimenez/NEISD
OWNER: Yolanda Jimenez/BSS FINANCIAL LLC
TYPE OF WORK: Driveway and apron installation; and apron modifications
APPLICATION RECEIVED: February 07, 2025
60-DAY REVIEW: April 8, 2025
CASE MANAGER: Bryan Morales

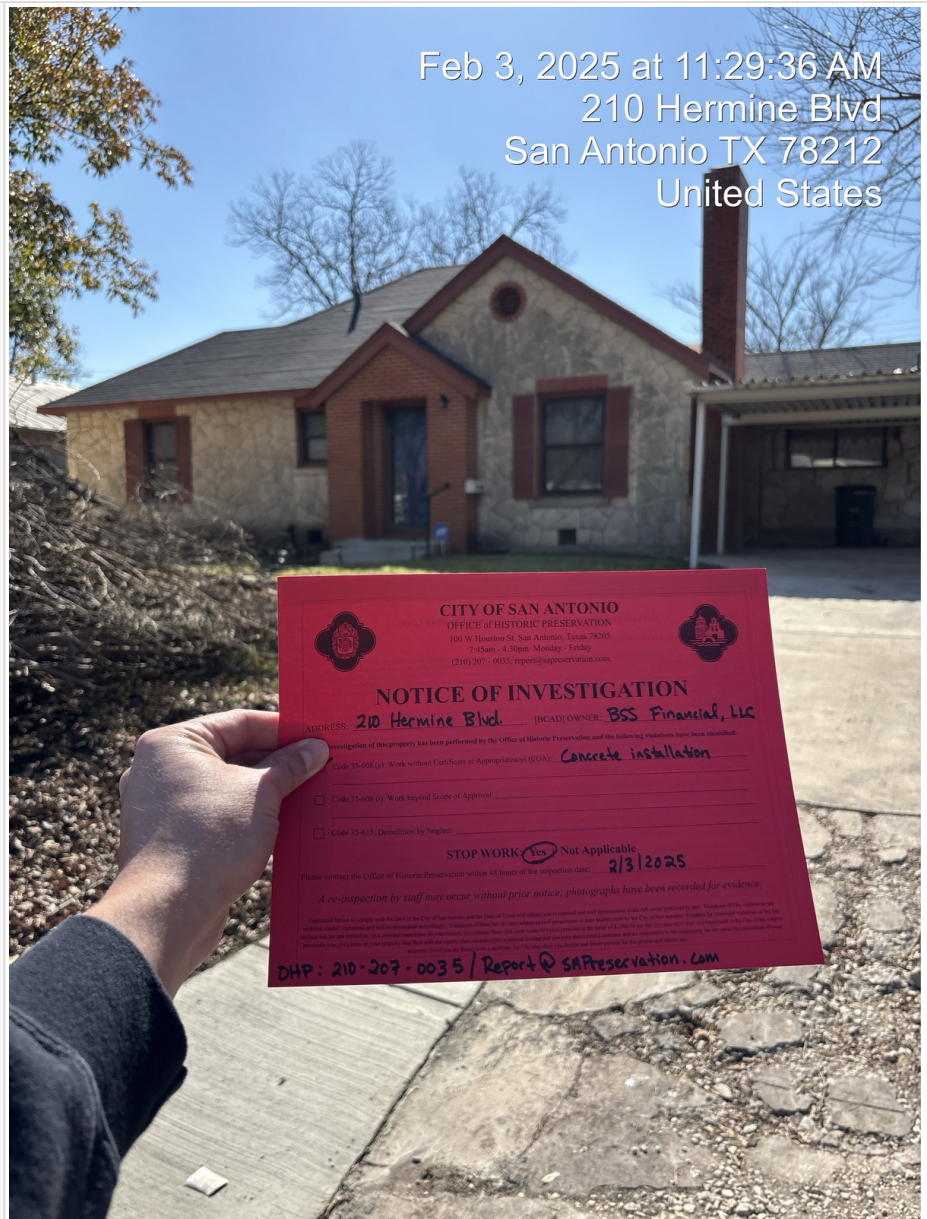
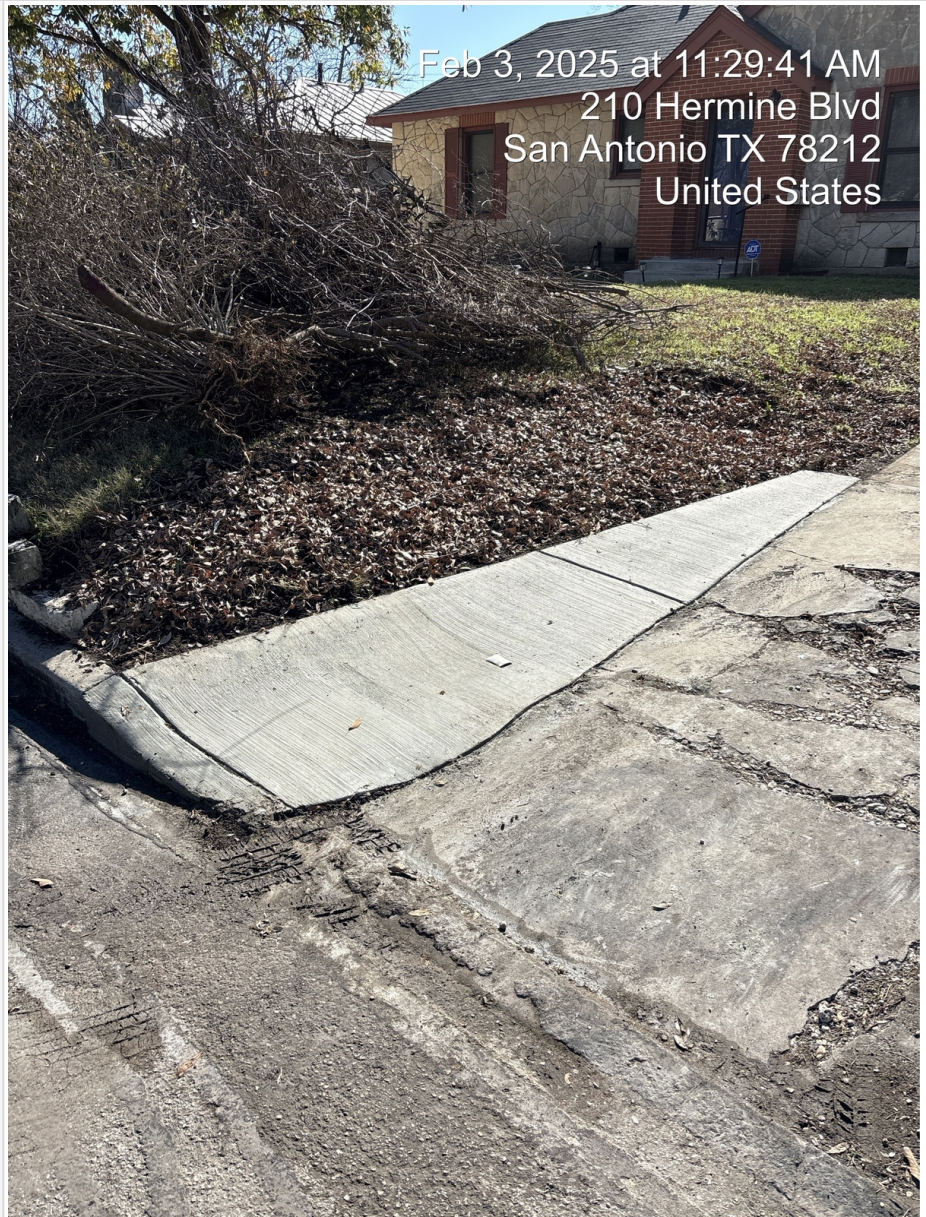
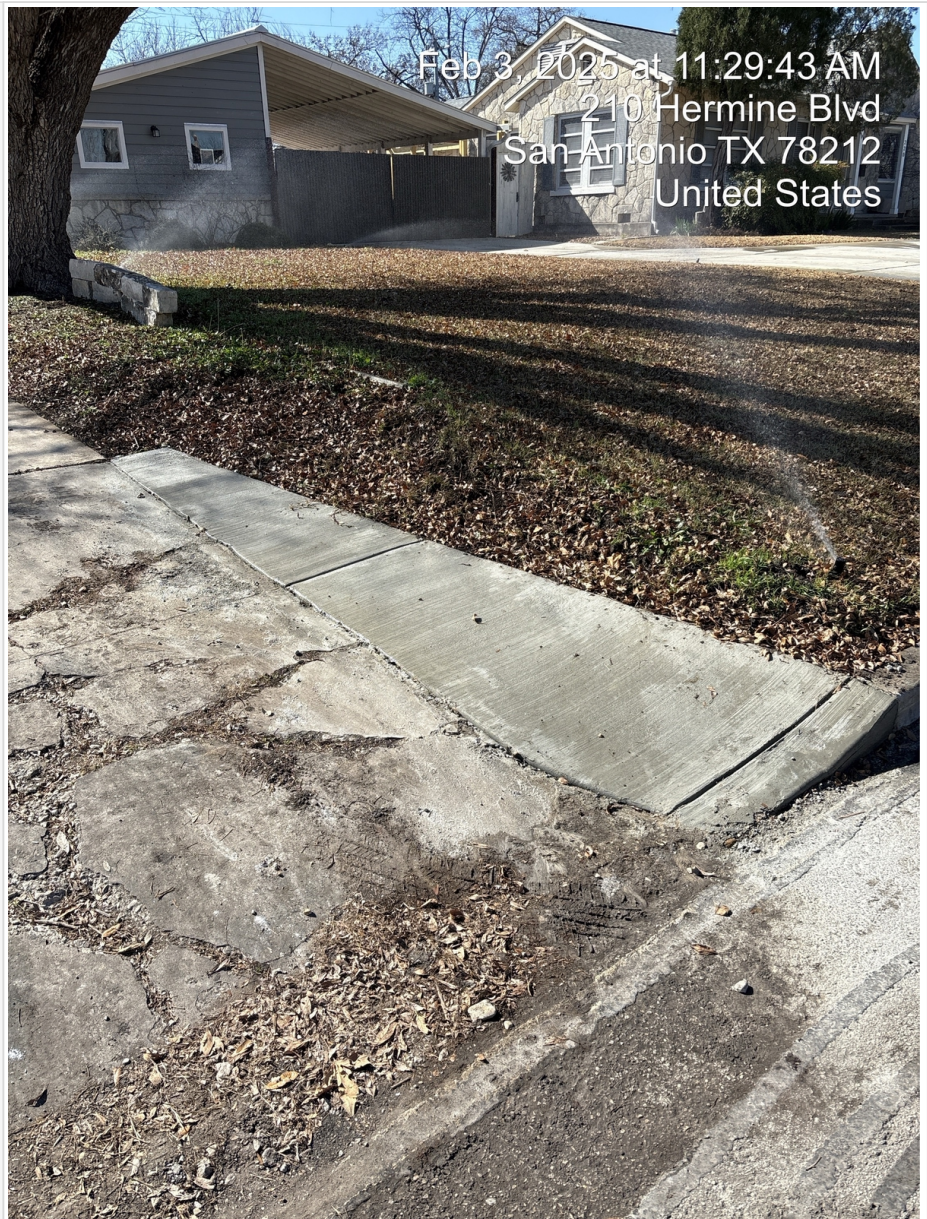
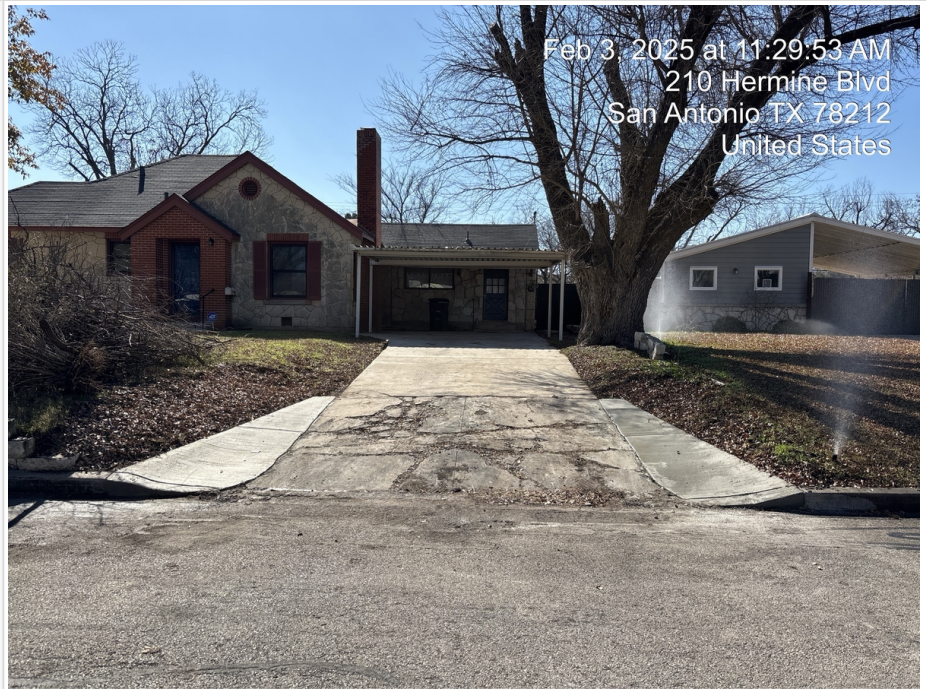
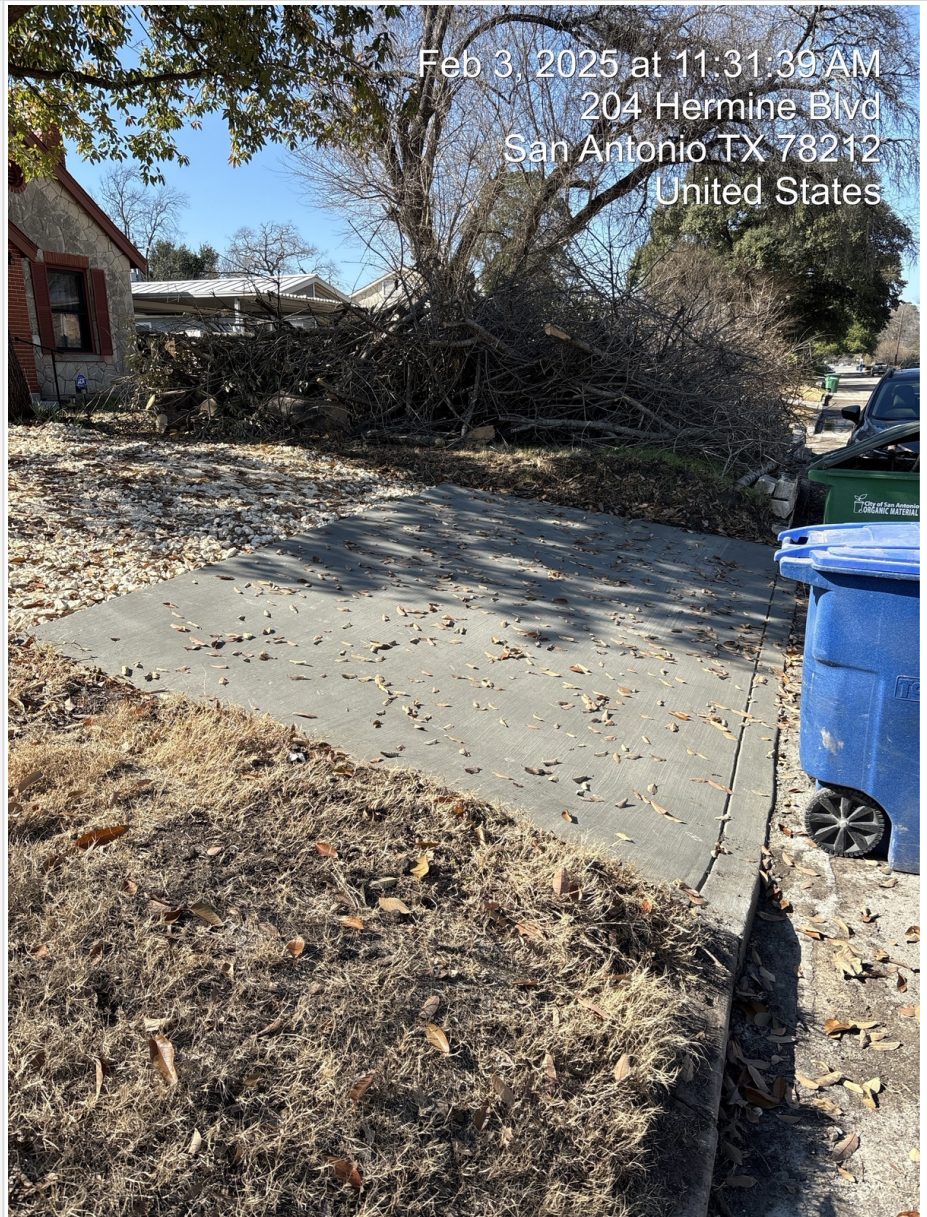
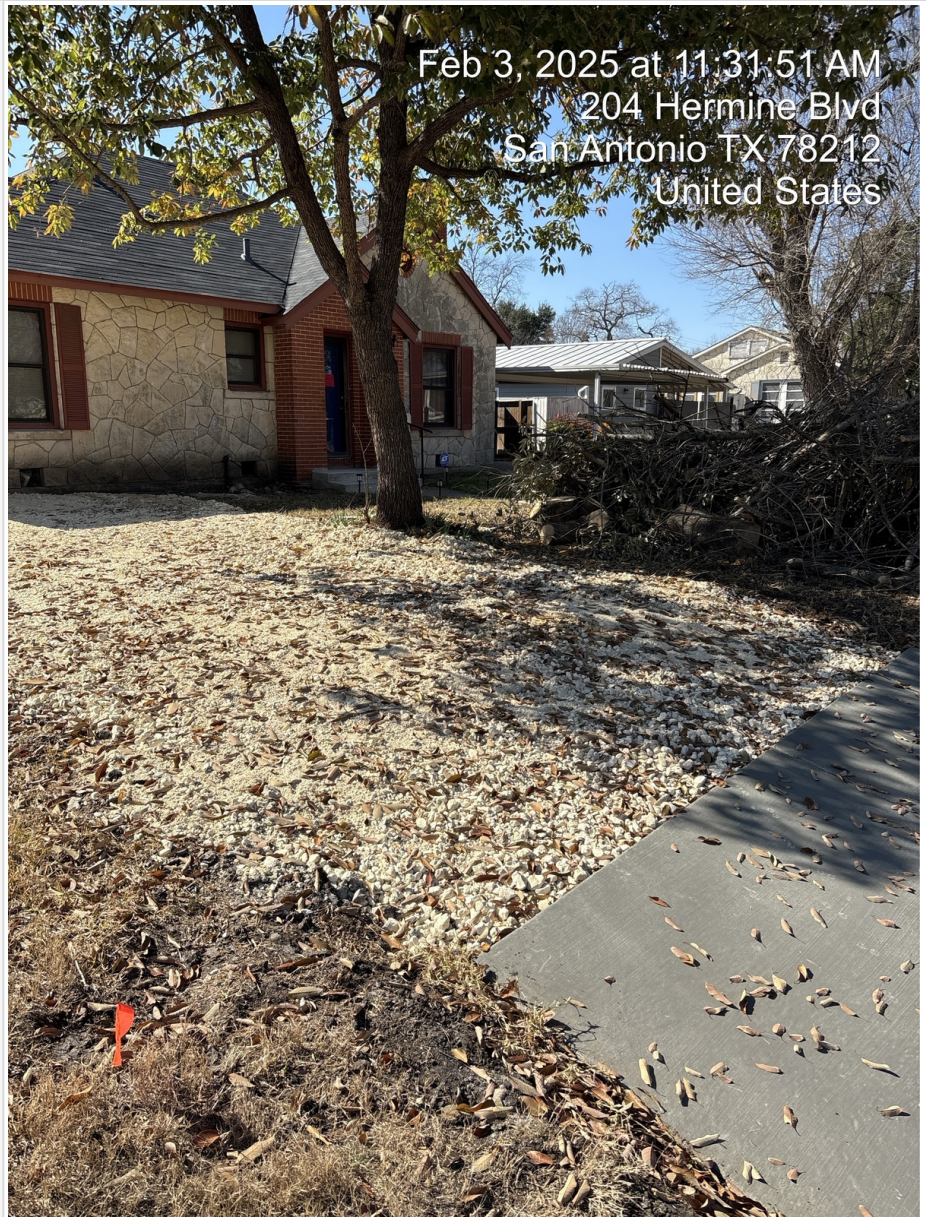
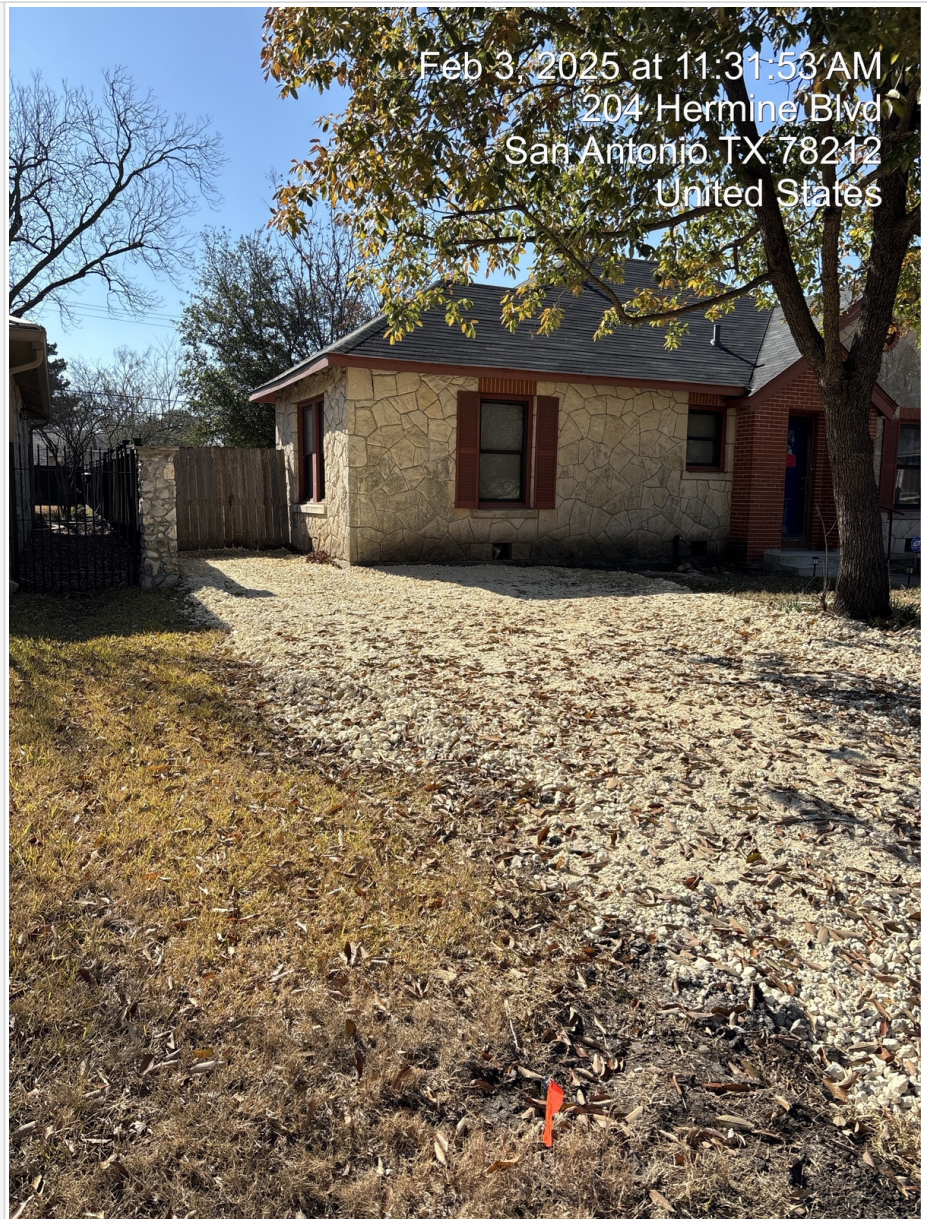
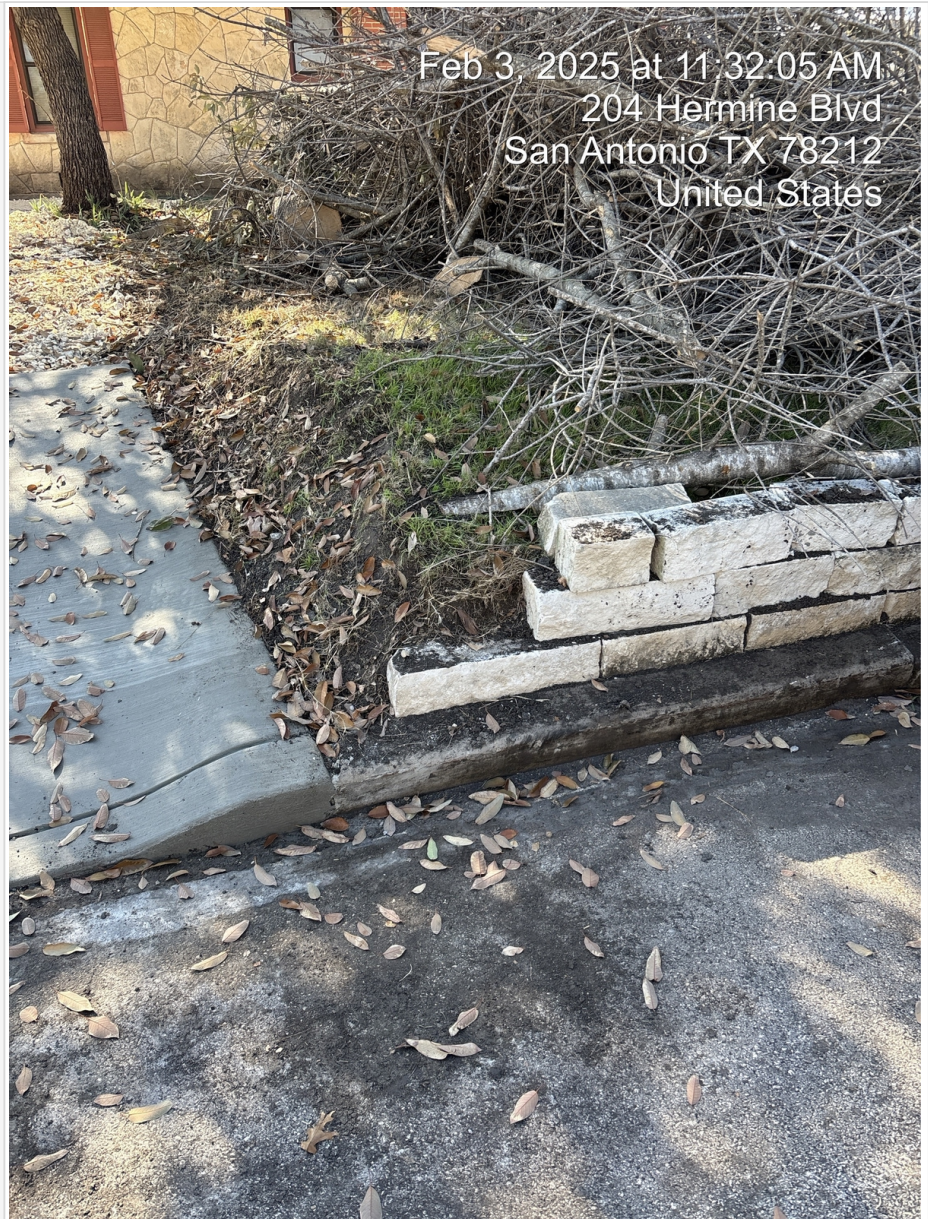
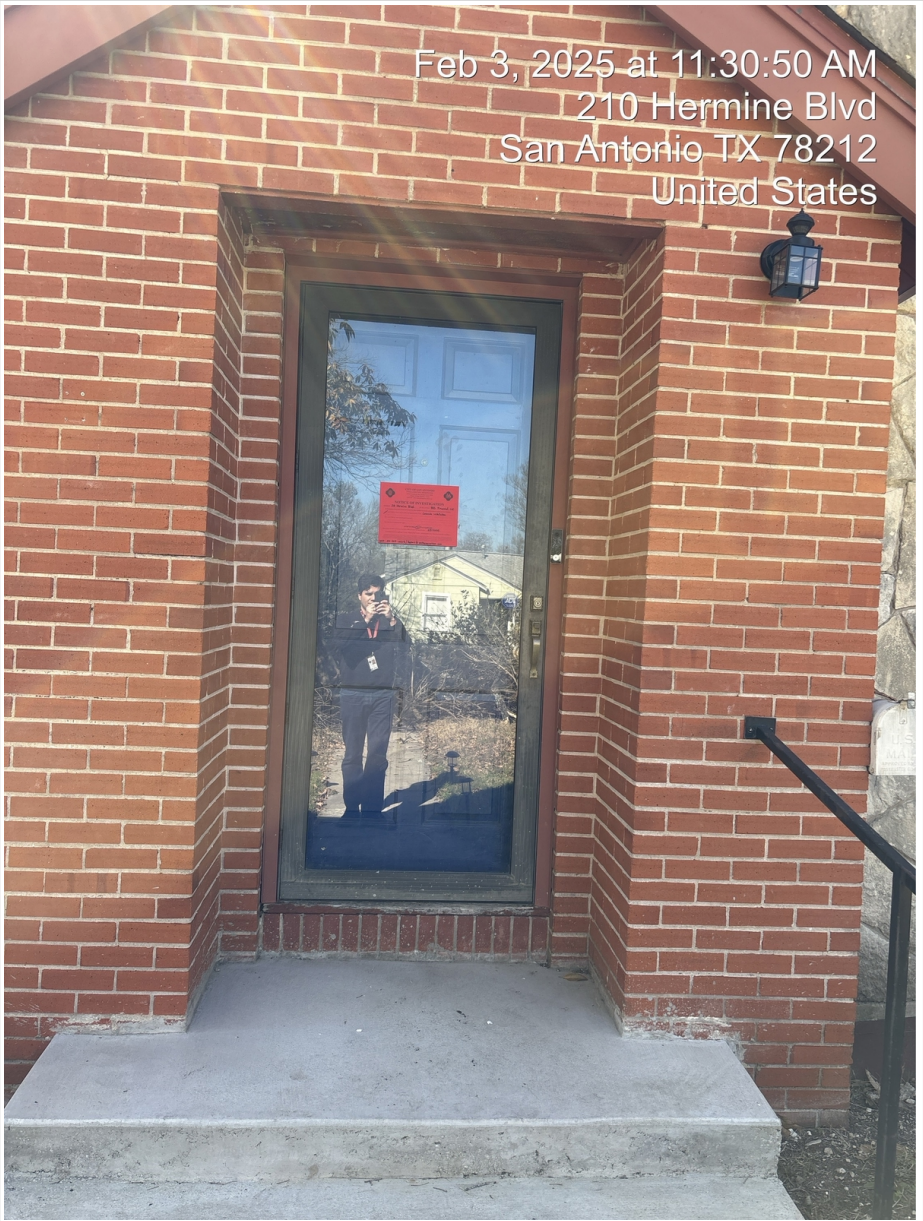
Date	02/03/2025
Time	11:44 AM (-6 GMT)
Context	citizen report
Present Staff	Bryan Morales
Present Individuals	Neighbor
Types of Work Observed	Site Elements
Amount of Work Completed	Completed
Description of work	Installation of a curb cut and apron, gravel driveway.
Description of interaction	Talked with neighbor who reached out via 311. Concerned about work without a COA or permits.

Staff does not recommend approval of items 2 and 3, based on findings a through d. Staff recommends the applicant remove the new curb cut and driveway and install landscaping based on Guidelines.

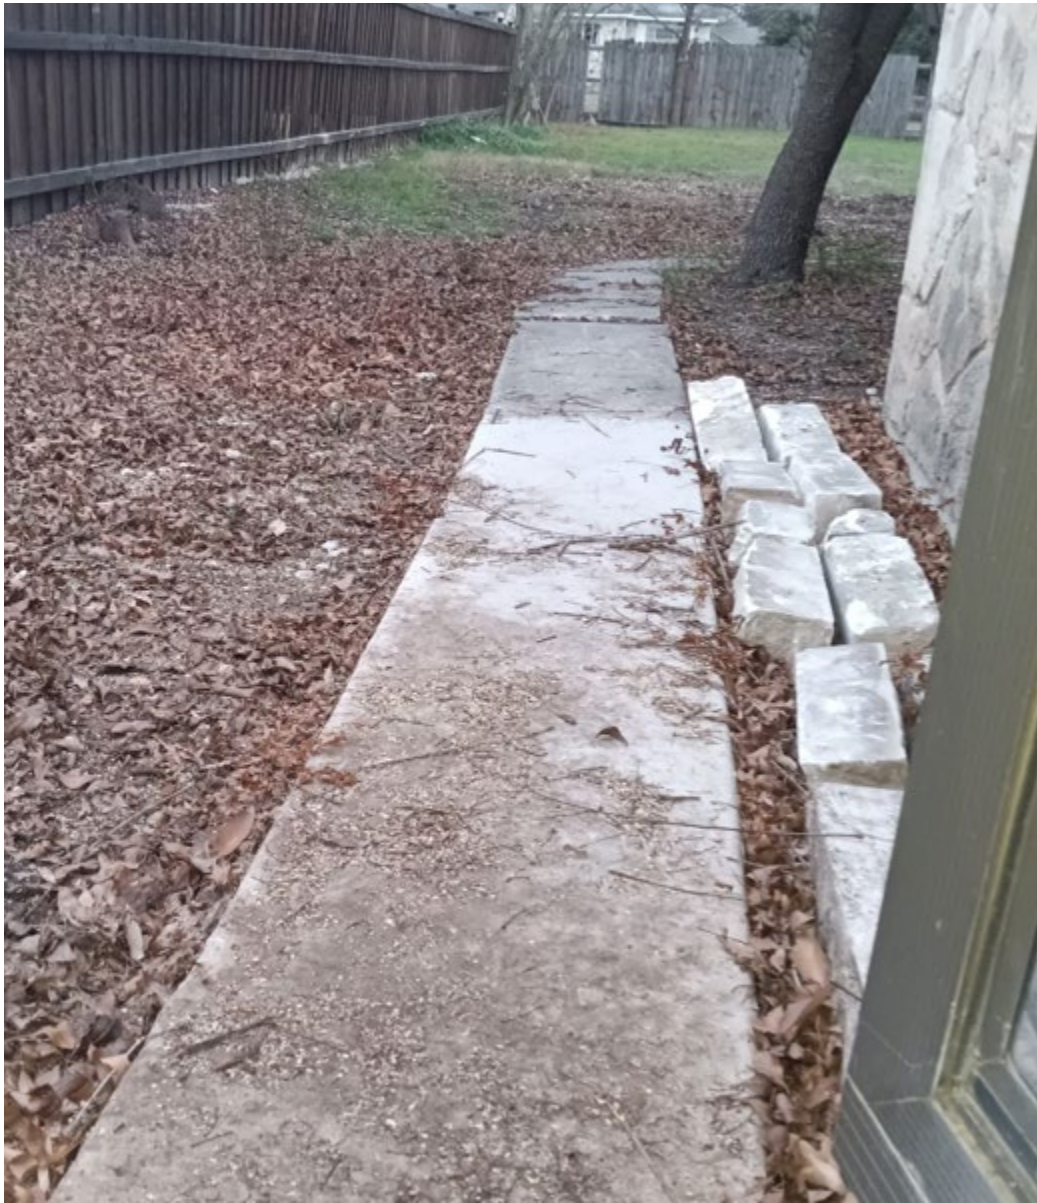
Sidewalks broken & slanted towards the house from the left side of the house

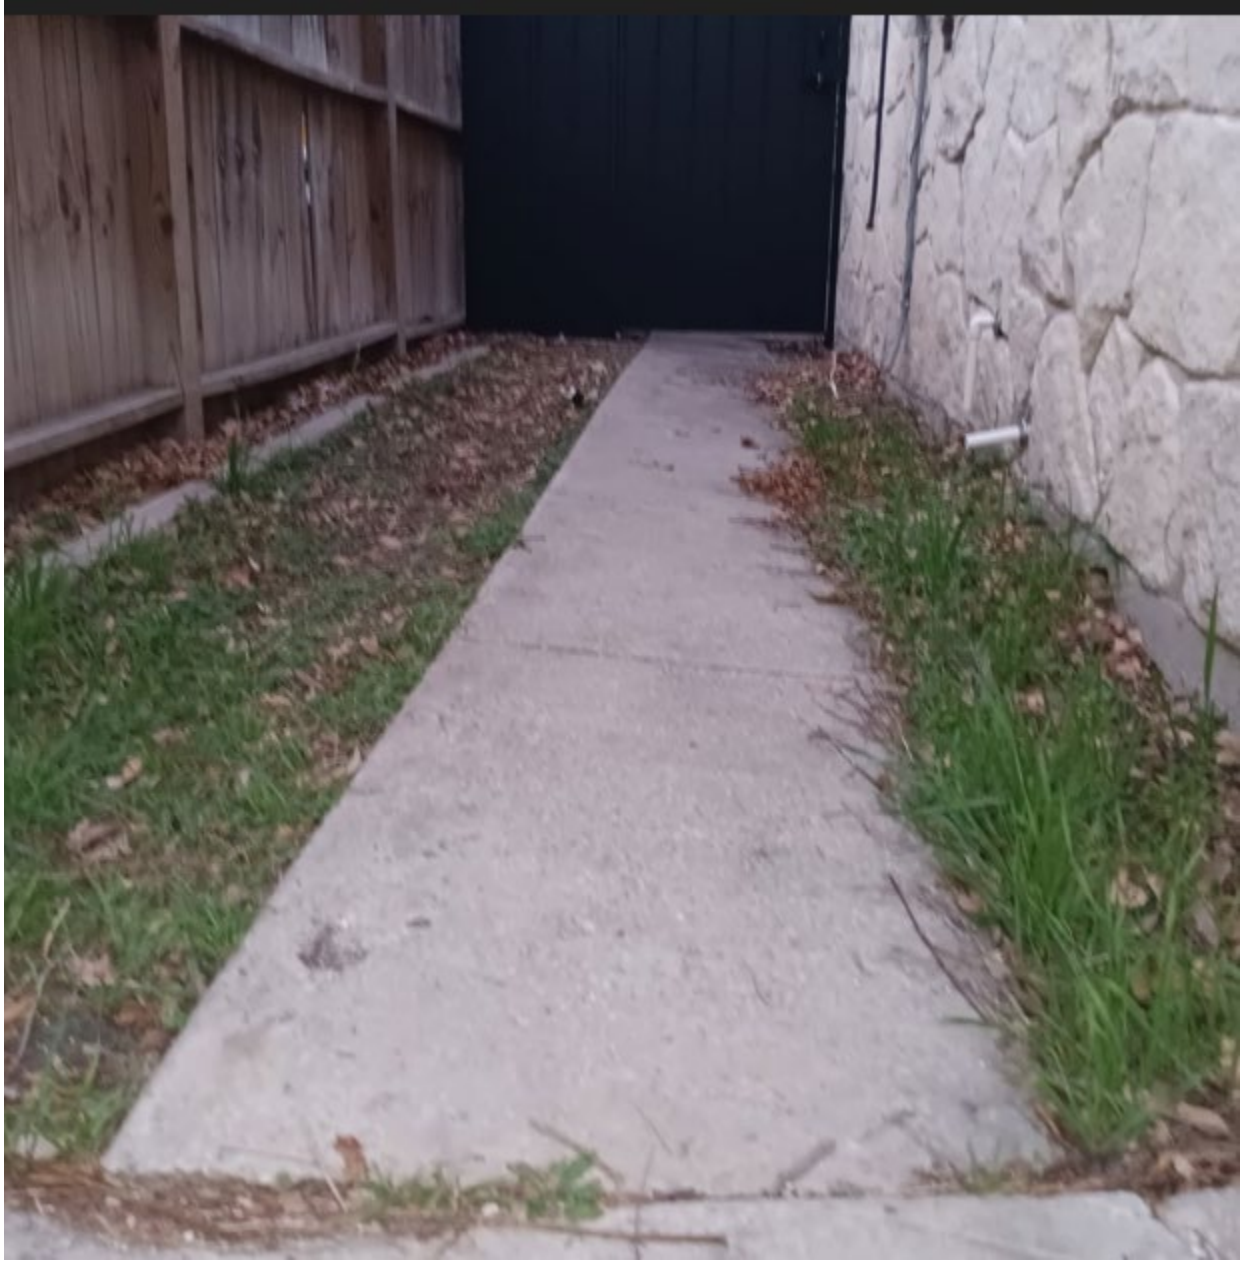
Sidewalk broken & slanted from the right side of the house backyard view

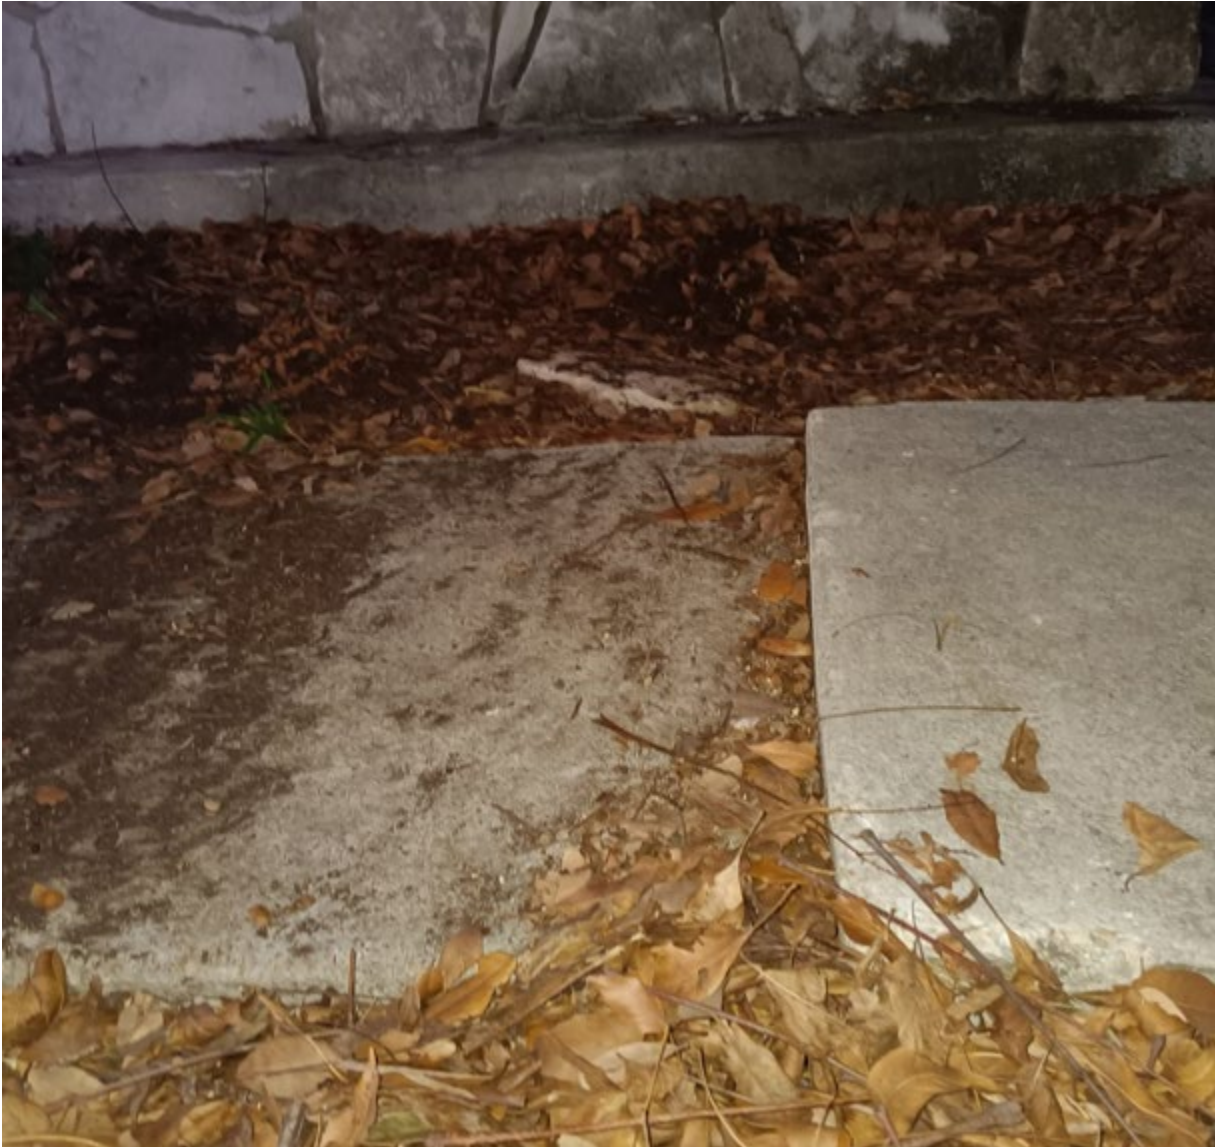
Uneven side walk damaged

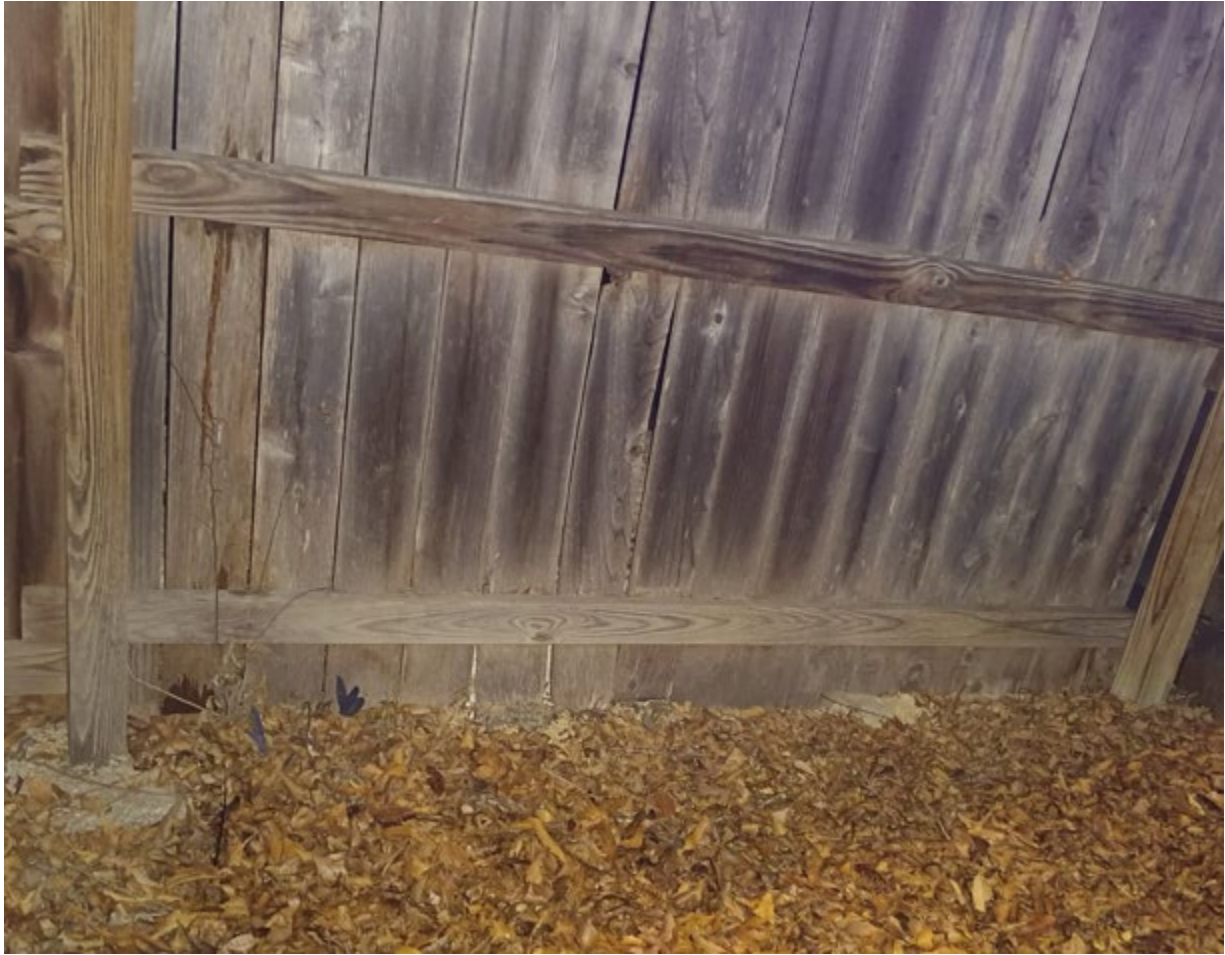
Front left fence blocking the flow of water
