HISTORIC AND DESIGN REVIEW COMMISSION

August 21, 2024

HDRC CASE NO: 2024-267
ADDRESS: 2619 MCCULLOUGH AVE
LEGAL DESCRIPTION: NCB 1704 BLK 12 LOT N1-2 OF 12 & 13
ZONING: O-1, H
CITY COUNCIL DIST.: 1
DISTRICT: Monte Vista Historic District
APPLICANT: Matthew Gilbert/Ortiz McKnight PLLC
OWNER: ZUNIGA LAW PLLC
TYPE OF WORK: Requesting a waiver, fenestration modifications
APPLICATION RECEIVED: July 19, 2024
60-DAY REVIEW: September 17, 2024
CASE MANAGER: Claudia Espinosa

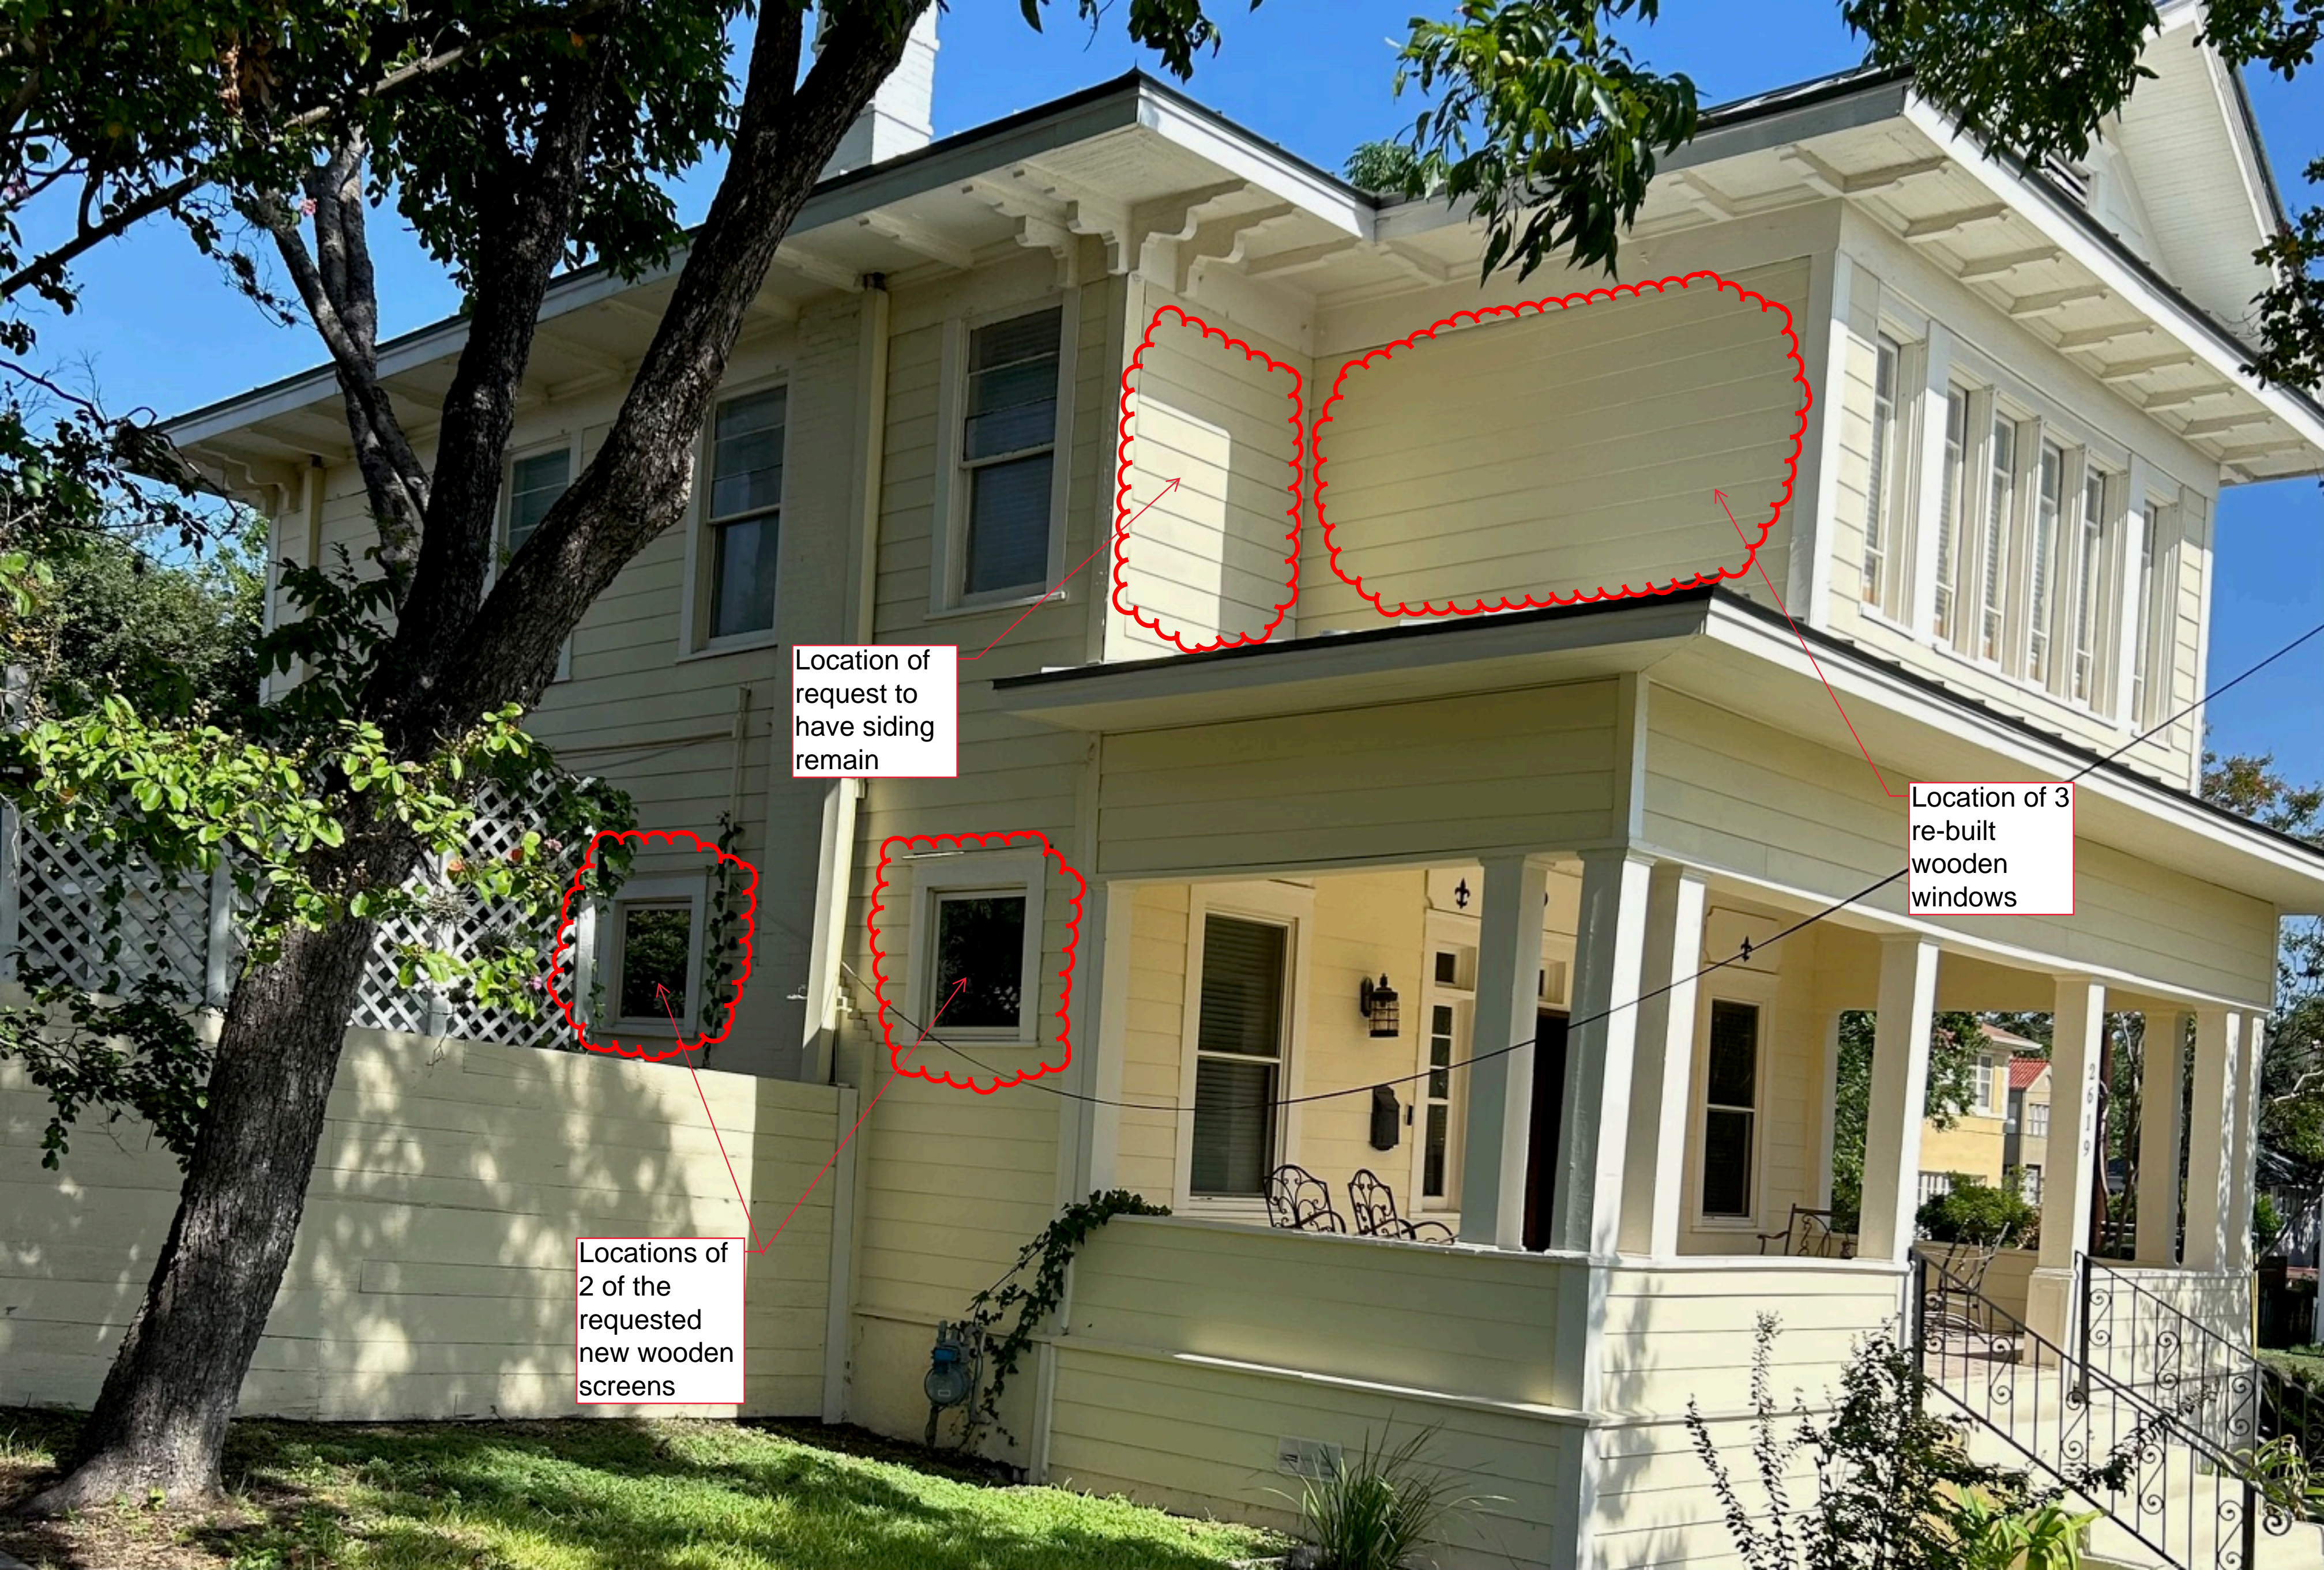
Location of
request to
have siding
remain

Location of 3
re-built
wooden
windows

Locations of
2 of the
requested
new wooden
screens

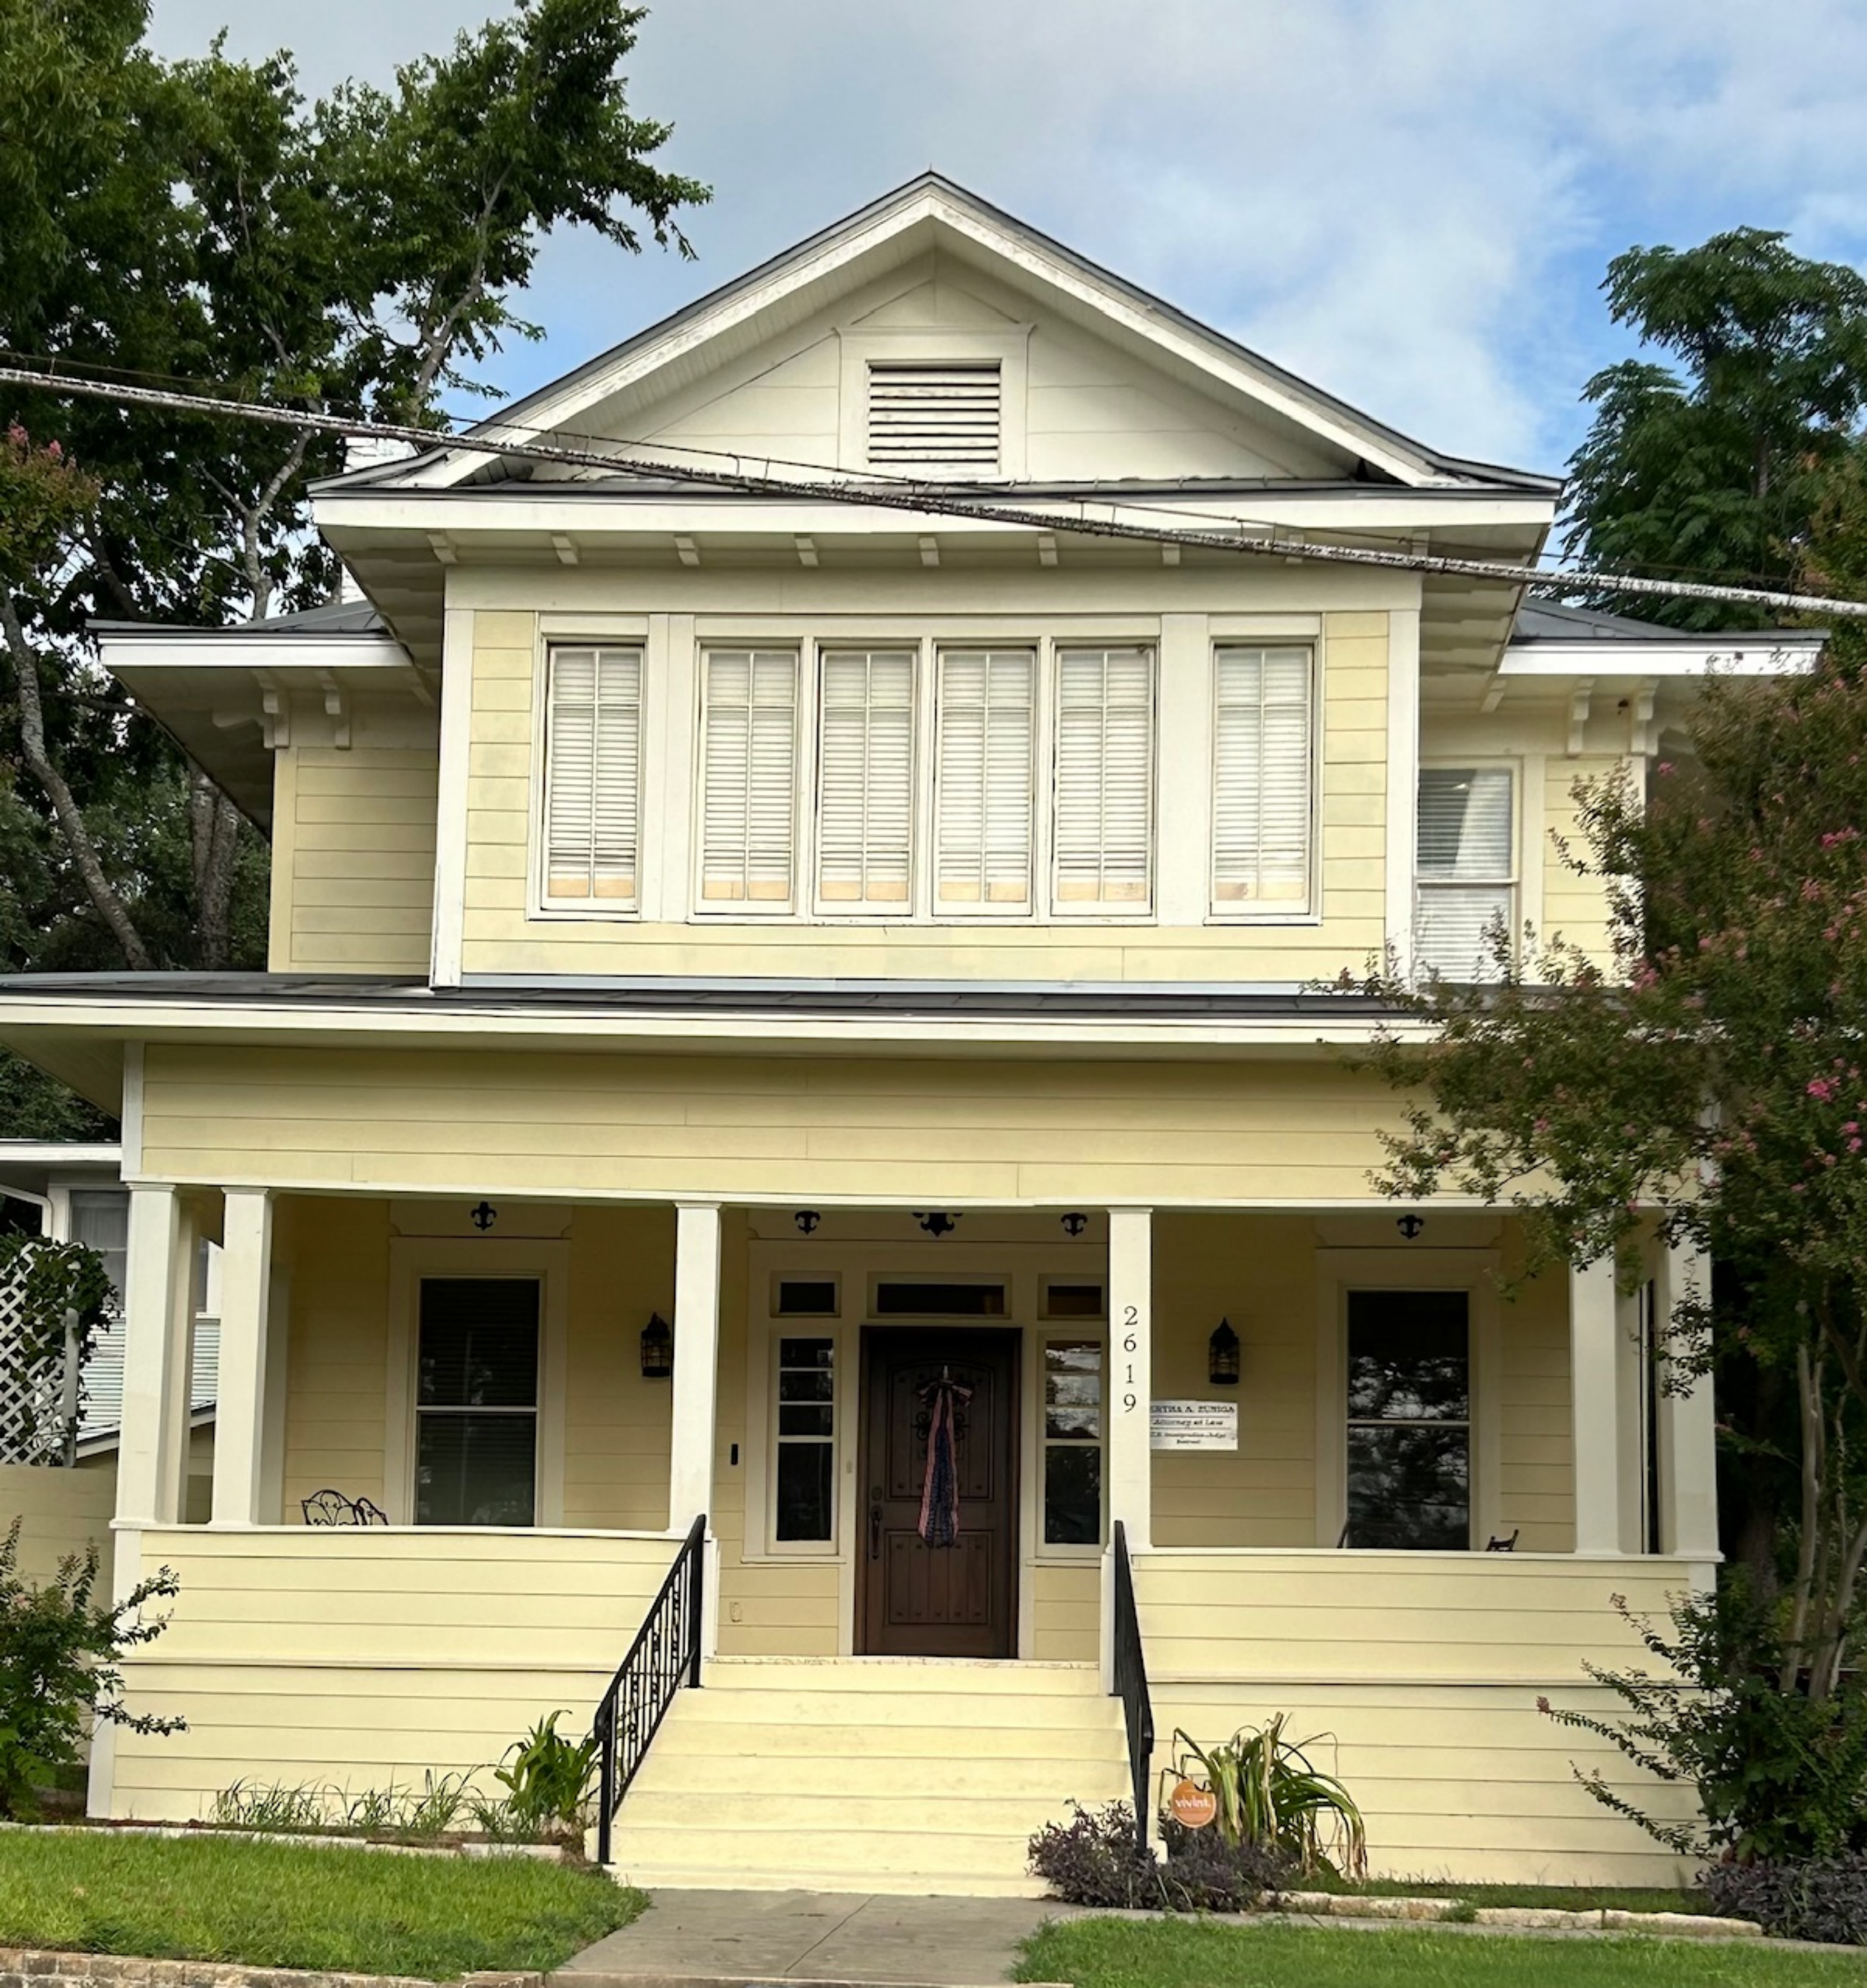
vinyl

Location of 3
re-built
wooden
windows

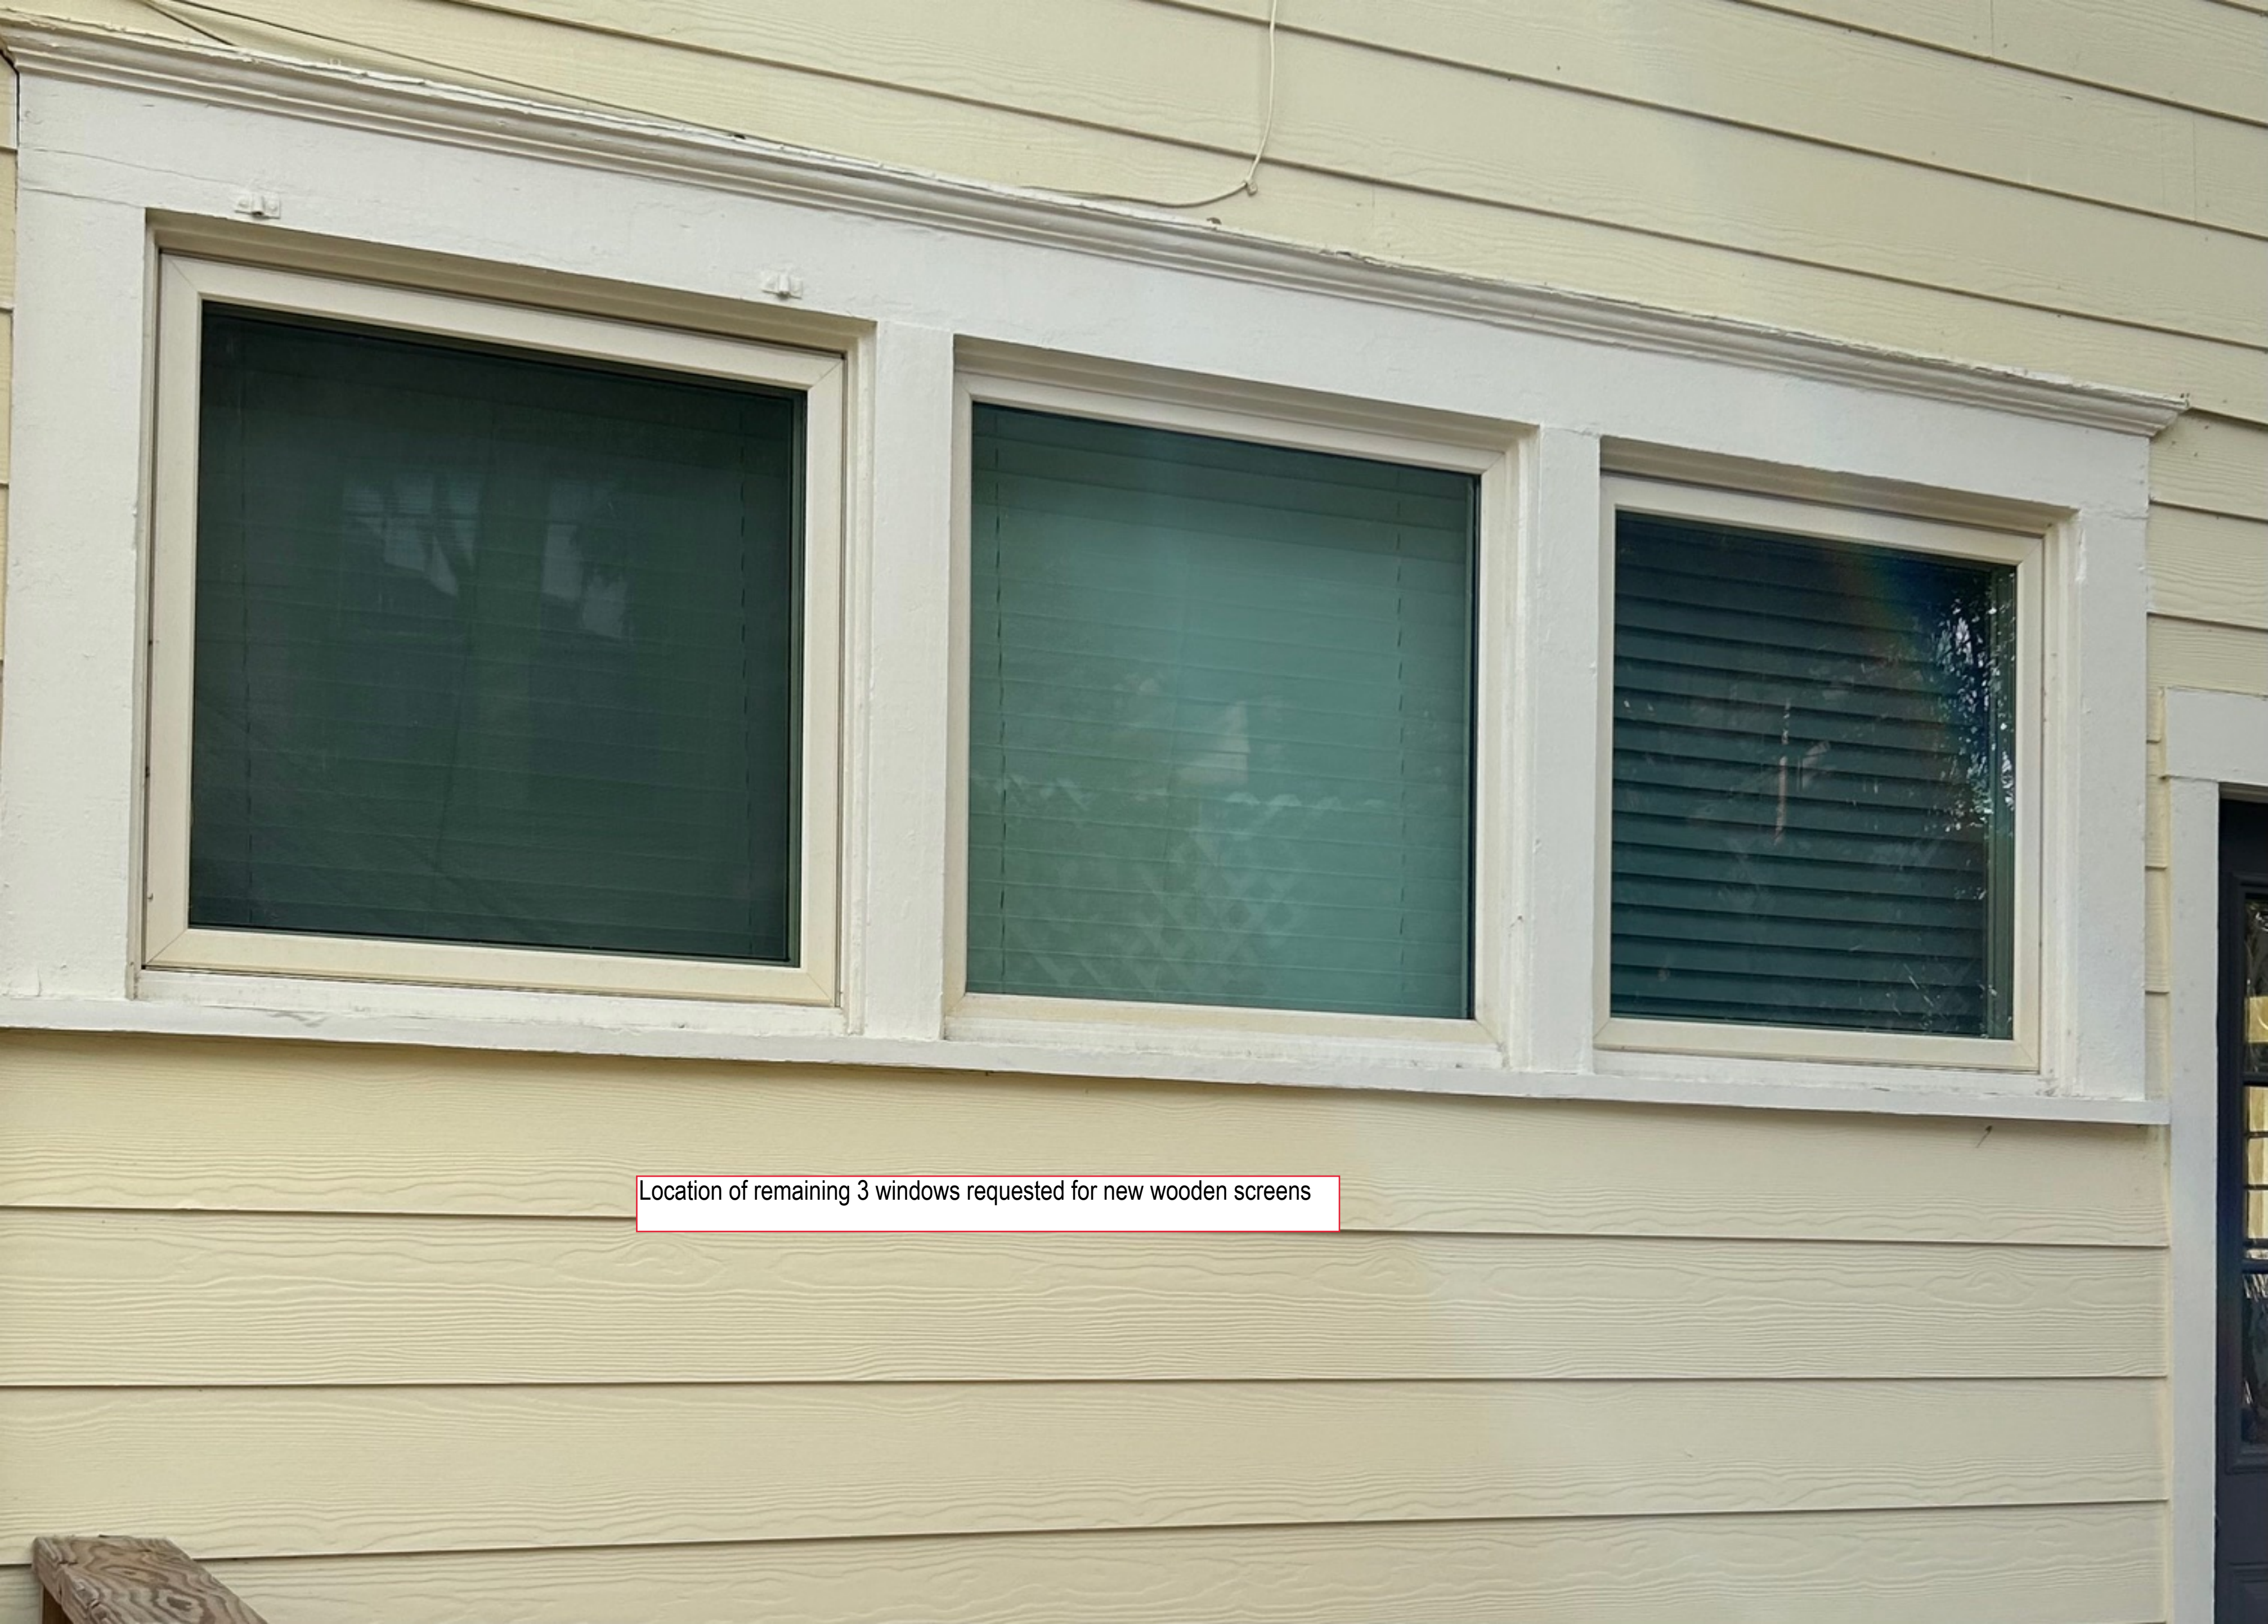
Location of remaining 3 windows requested for new wooden screens

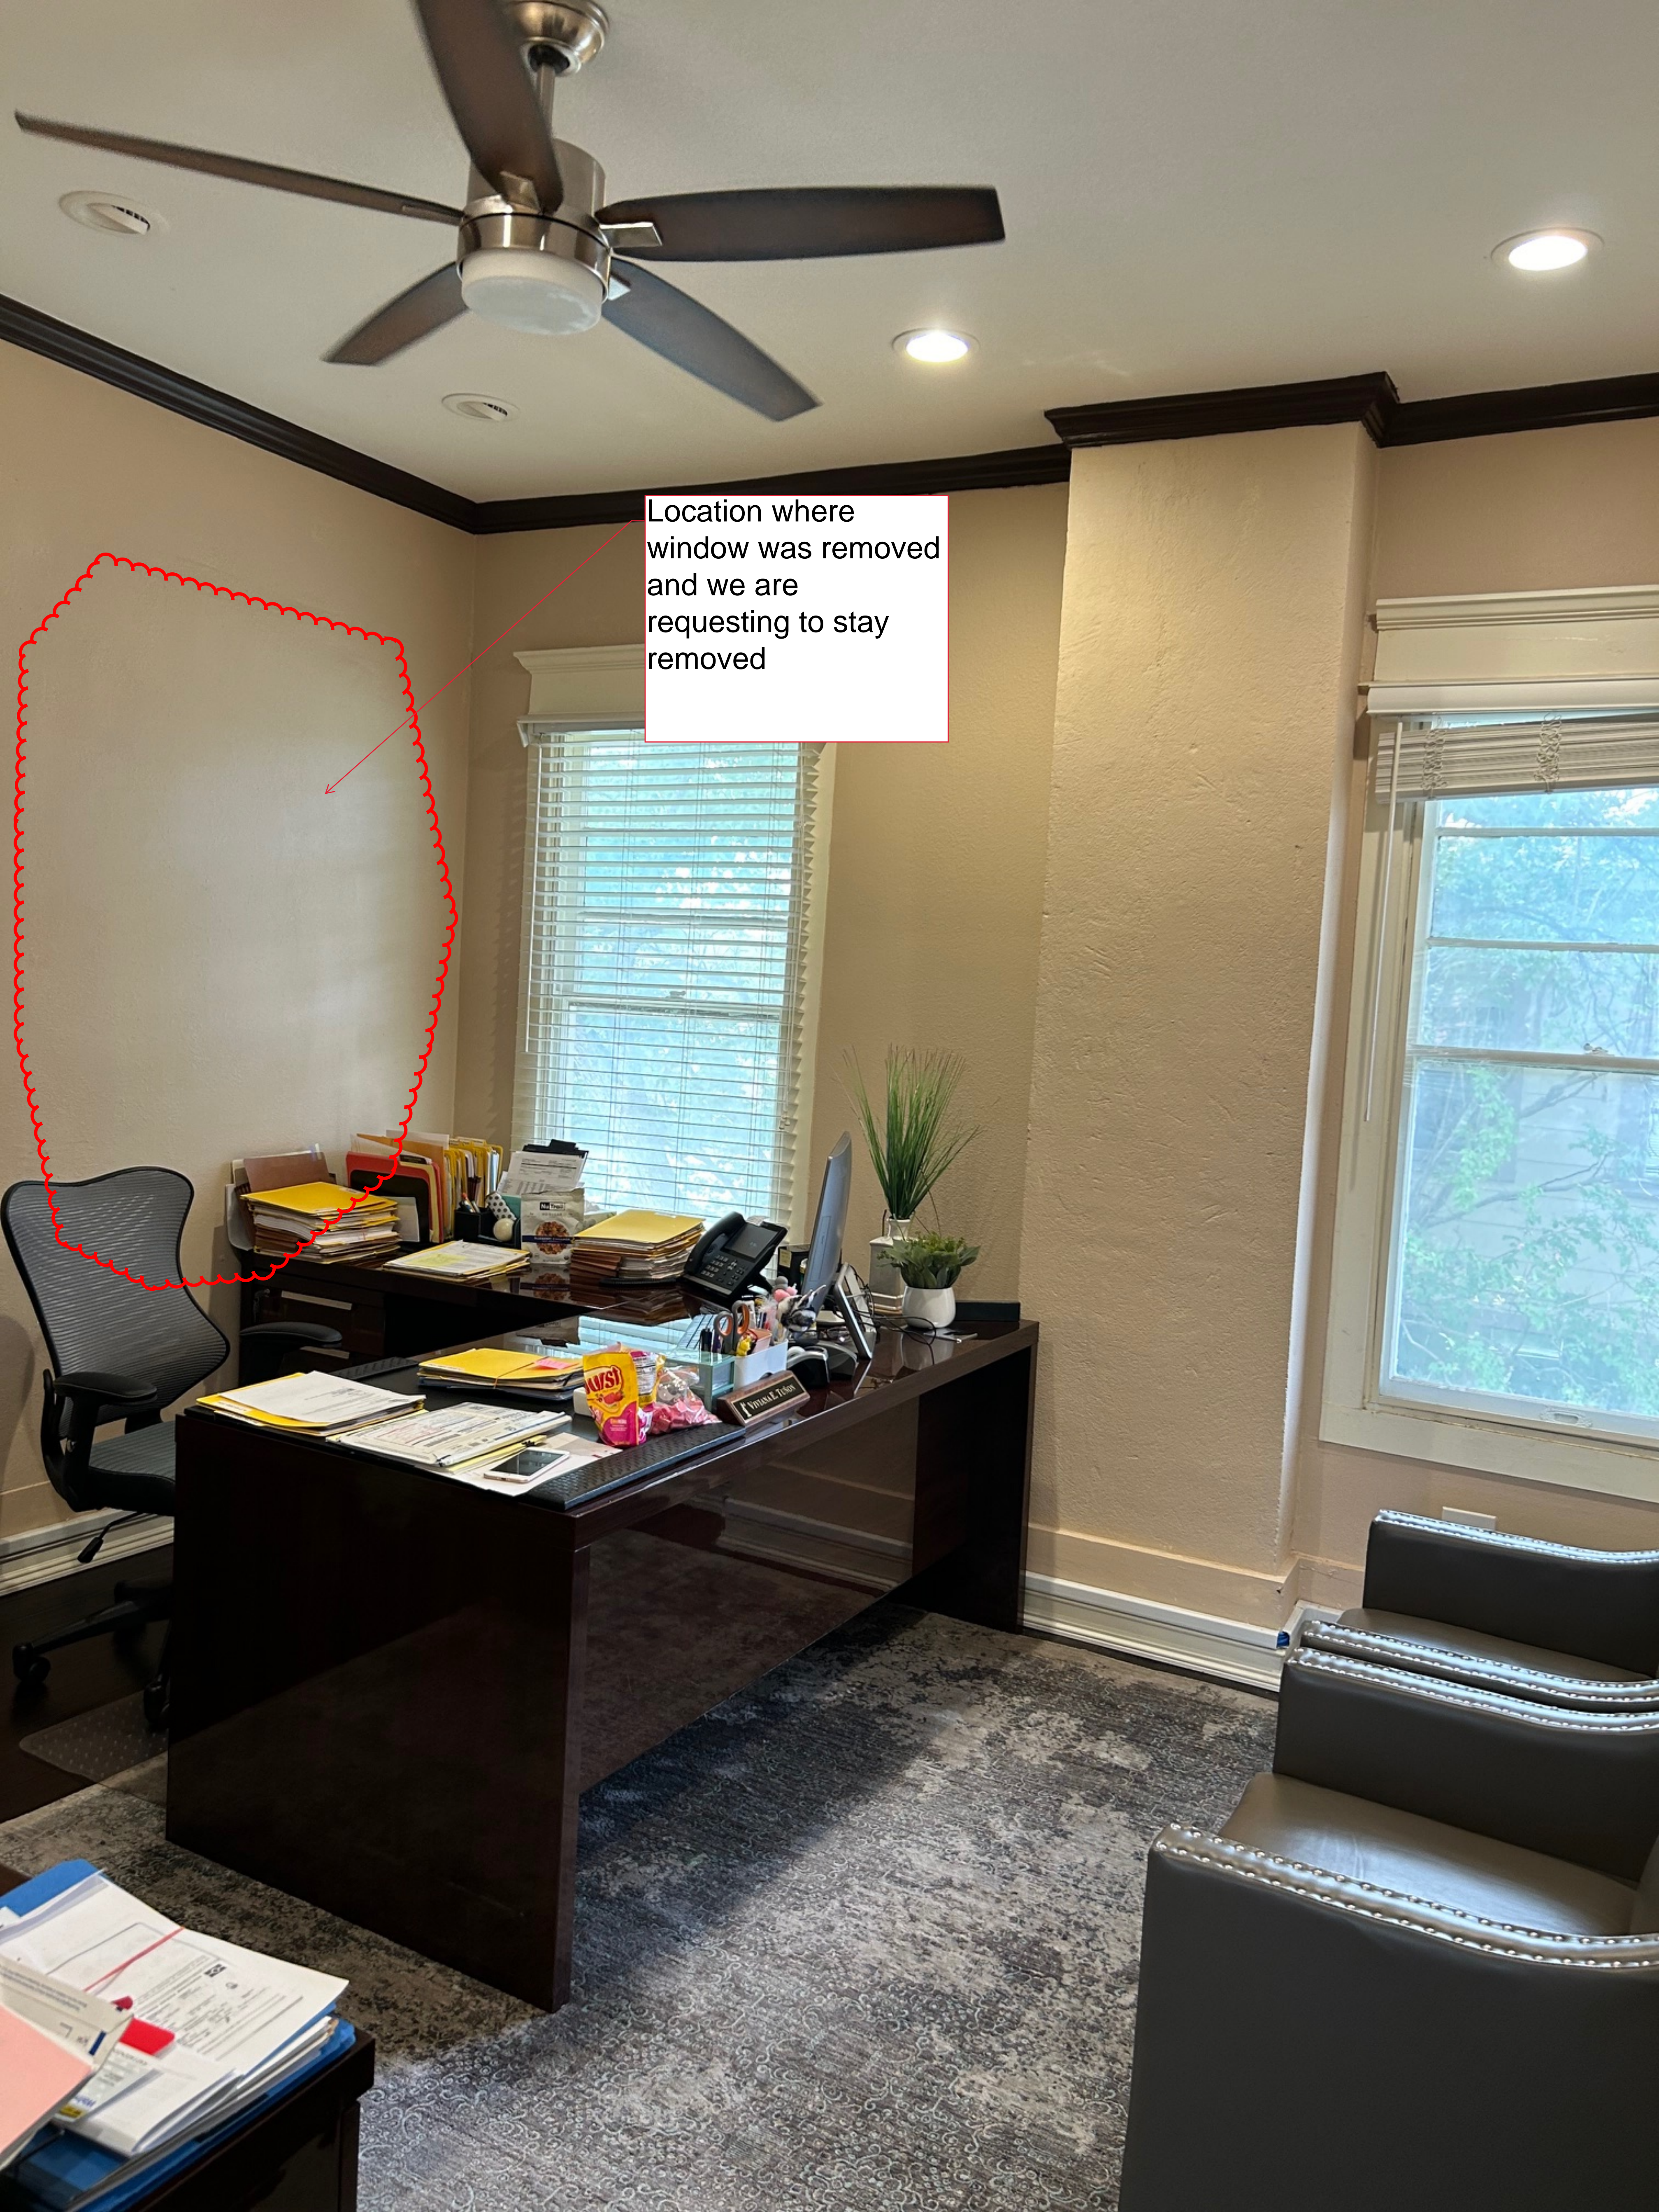
Location where
window was removed
and we are
requesting to stay
removed

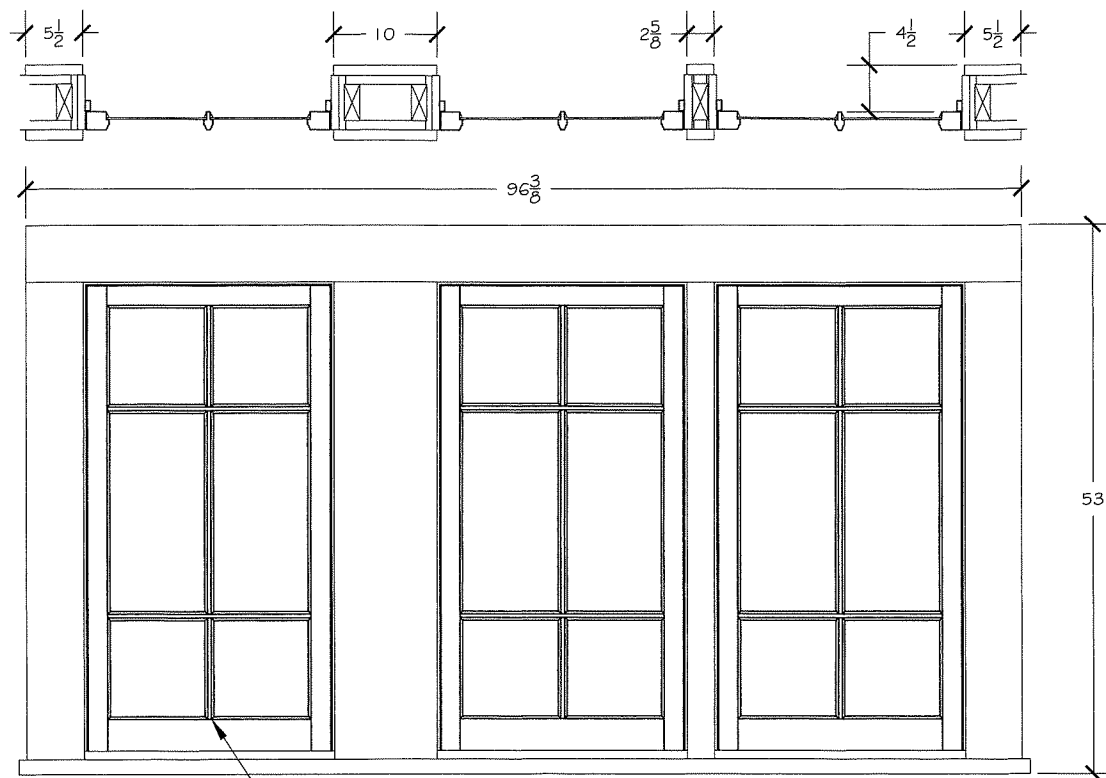
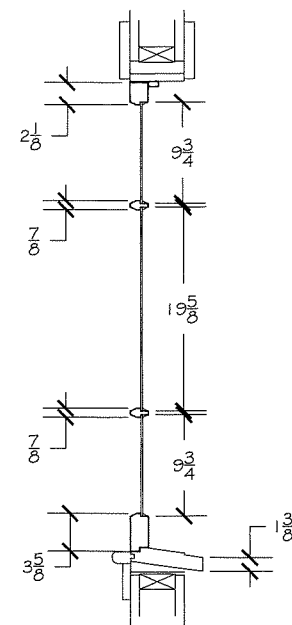
CK BY:
07-12-24
SHEET
3

NEW WOOD CASEMENT WINDOW. SIZE, PROFILE, AND CONFIGURATION CONSISTENT WITH ORIGINAL CONSTRUCTION. PUTTY GLAZED WITH 1/8" CLEAR ANNEALED GLASS.MADE FROM SPANISH CEDAR.

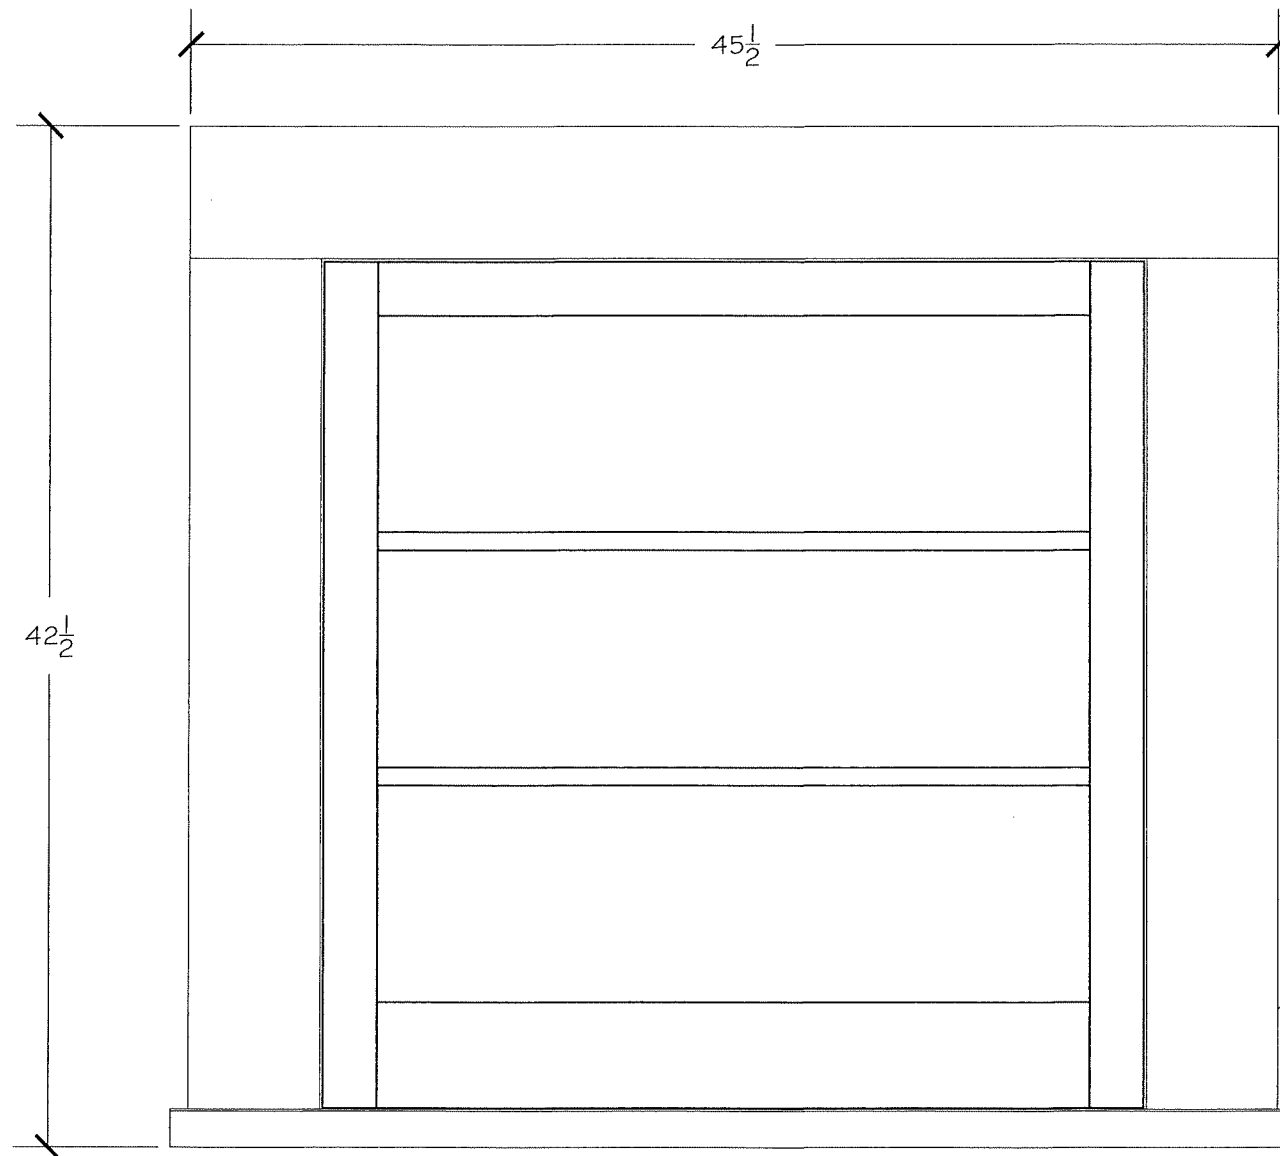
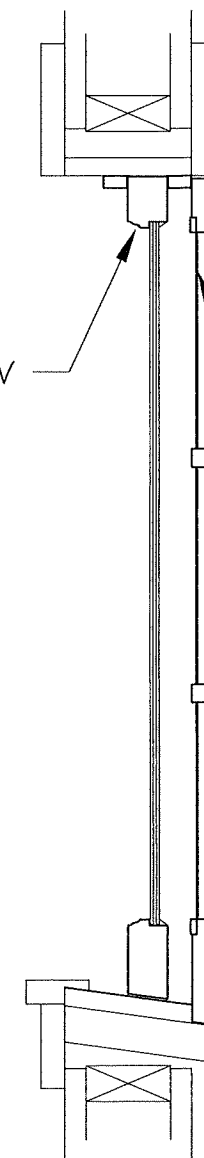
EXISTING REPLACEMENT WINDOW

EXISTING ORIGINAL TRIM

NEW WOOD WINDOW SCREEN.
INSTALLED TO CONCEAL WINDOW

3/4" HORIZONTAL MUNTINS

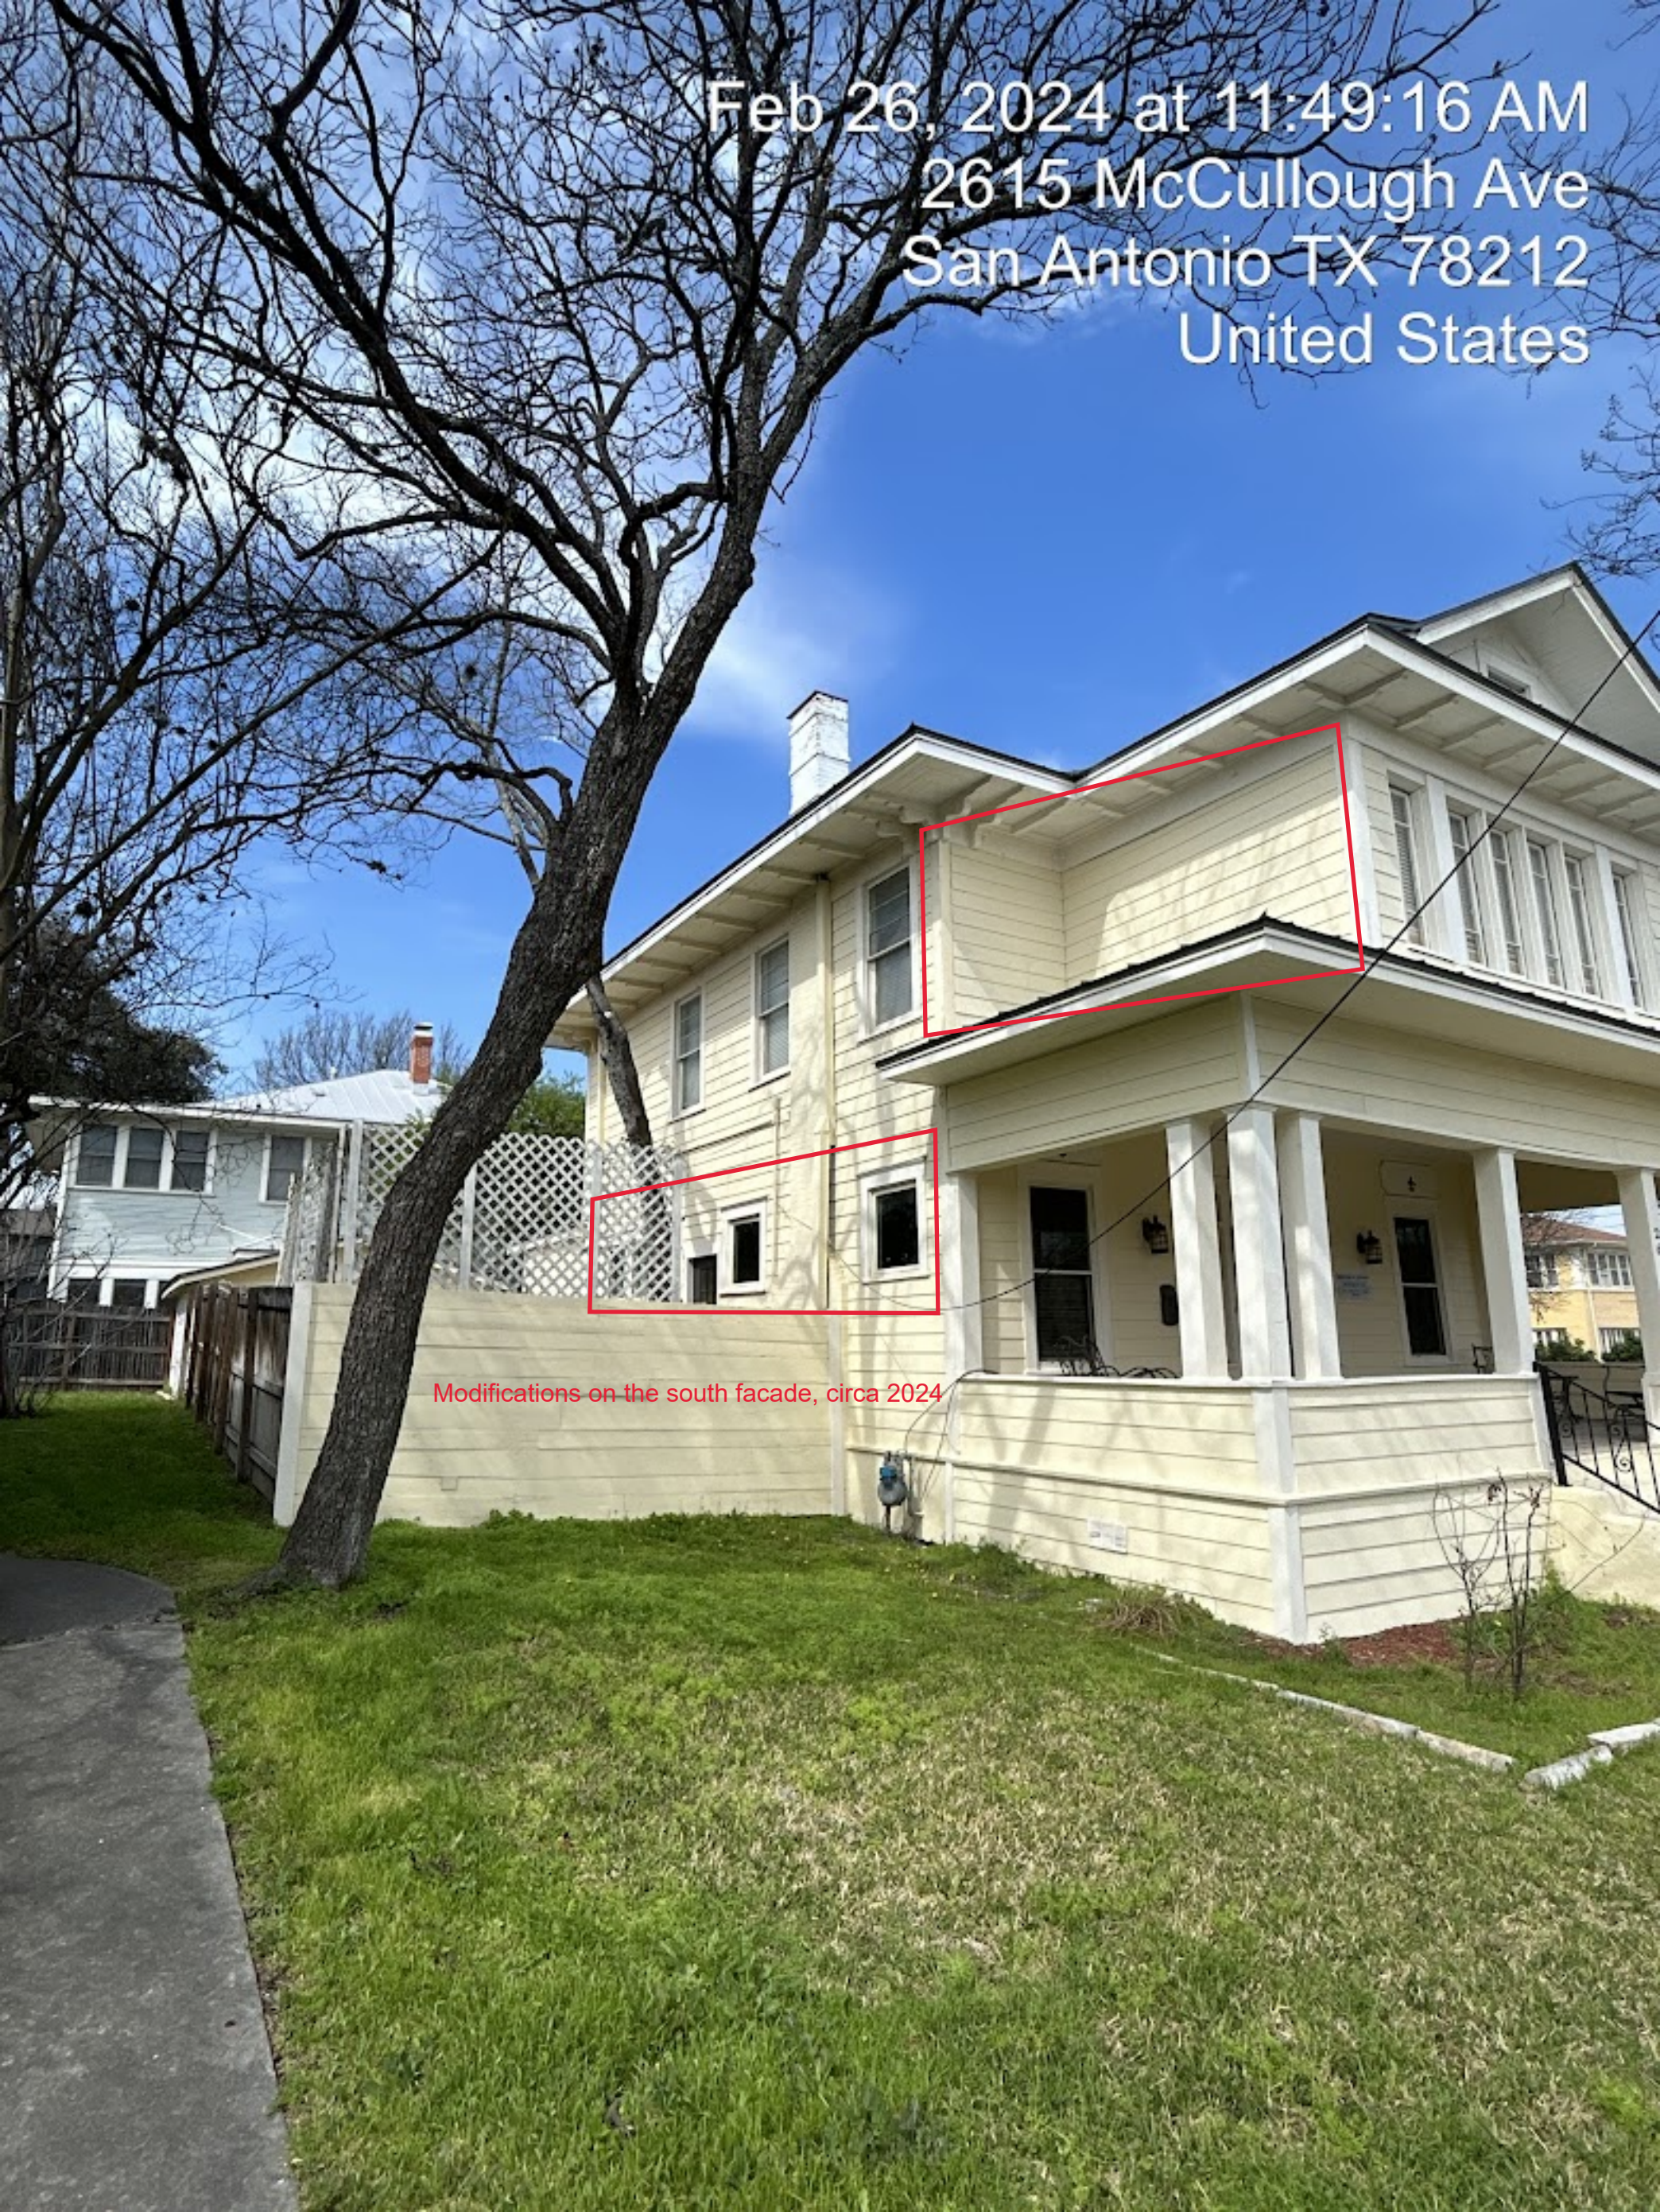
Modifications on the south facade, circa 2024
