Environmental Variance Exception Review

Re: Vida San Antonio Phase 1A/1B, TRE-APP-APP22-38800306
UDC Sec. 35-523 (h) – 100-Year Floodplain(s) and Environmentally Sensitive Areas

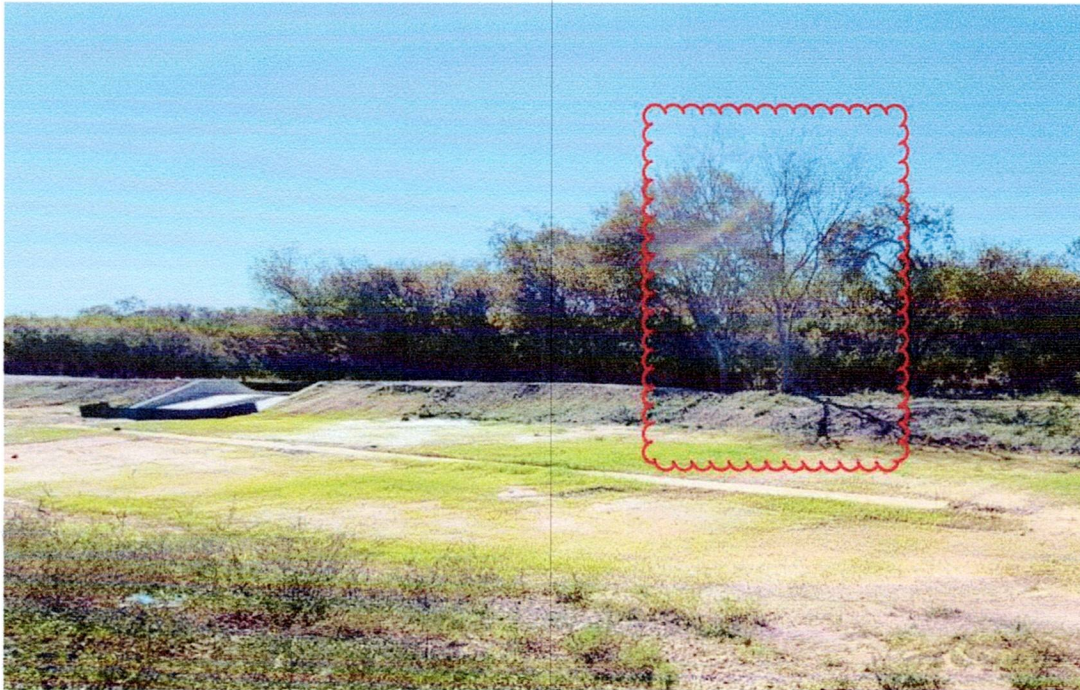
The tree preservation plan for the Vida Phase 1A/1B Master Tree Plan (the "Project") was originally approved with all Tree ordinance requirements being met. Tree Tag #13004 (15" Hackberry) within the 30 foot Riparian Buffer stood within the vicinity of a proposed detention basin. To ensure and protect the integrity of the root protection zone and preserve this ESA Tree, a retaining wall was proposed and constructed (See figure 3 below). Through the progression of the construction on this site, it was noted how the proposed basin was not constructed accordingly and that tree tag #13004 was not being protected as called out on the construction plan set (See figure 1 and figure 2 below). This construction mishap caused tree tag# 13004 to have its trunk buried at least 4 feet within the proposed basin berm, consequently inducing stress and declining its' overall health.

Figure 1 Initial Basin Construction Update with Tree Tag# 13004 Red Clouded (Dated: 11/8/21)

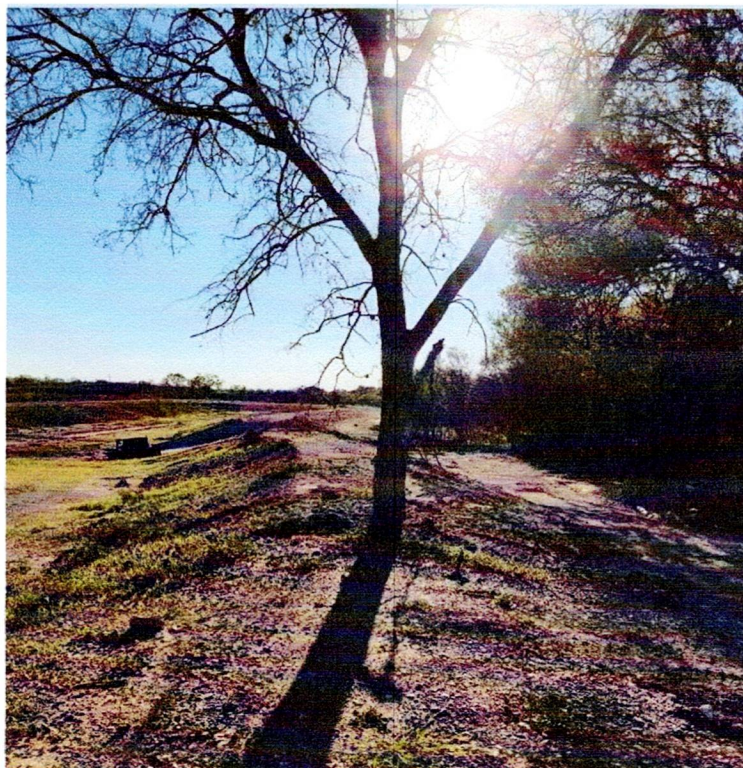
Figure 2: Construction Update Tree Tag# 13004 (Dated: 11/8/21)

Southstar notified the contractor of these discrepancies and requested the construction be revised quickly to avoid further impact and stress on tree tag #13004. By the following field construction update (12/28/21), the requested updates had been completed. The proposed wall fenced around tree tag# 13004 can be seen below on figure 3. In addition to illustrating the proposed wall, figure 3 demonstrates the declining health of this tree species after enduring stress for an extended period. This species was categorized as a significant tree (10" – 23.5") within the 30 ft Riparian Buffer. This Tree species categorization had a total preservation total of 100%. With the reclassification of this tree from preserved to removed, the preservation percentage has declined from 100% to 68% preservation, consequently going below the minimum preservation requirements for trees in the Floodplain Buffer/ESA.

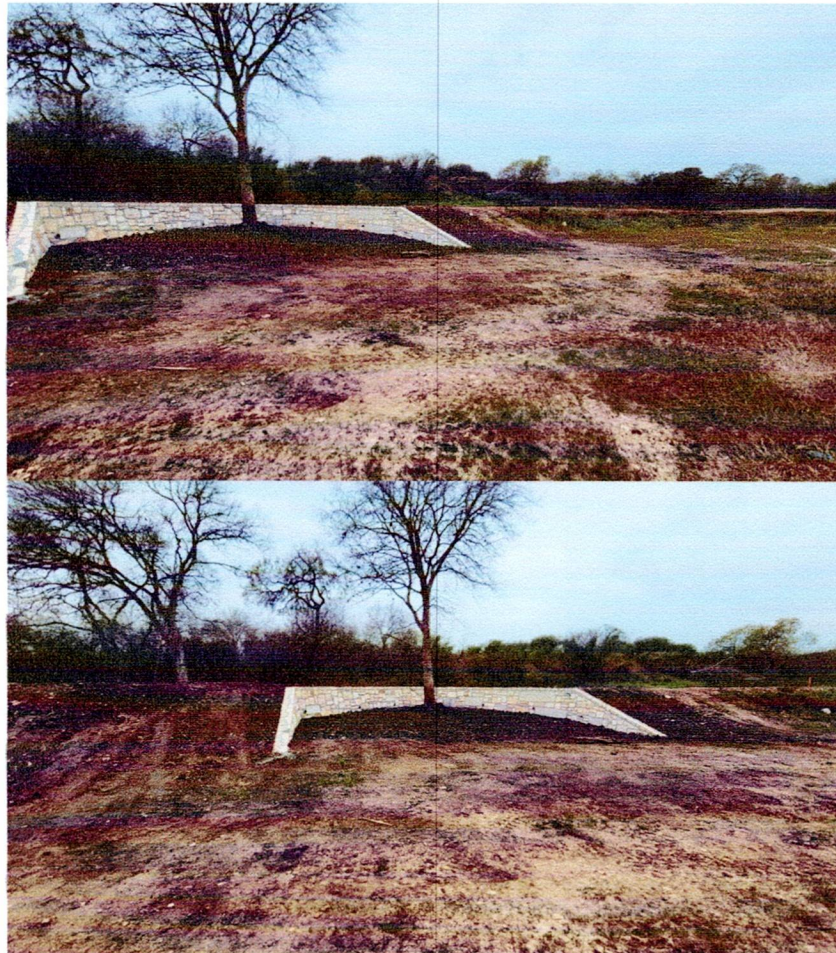
Figure 3: Images of Tree Tag #13004 Taken (12/28/21)

Overall required mitigation for falling below 80% preservation within the Environmental Sensitive Area totals 6.0 inches. Mitigation within the Project surpasses the overall requirement by 149.50 inches. The excess mitigation has been accomplished through the planting of two large species at 2.5 inches at each residential lot (266 lots), and 1 – 3" species tree added to each townhome lot. In addition to these proposed mitigations measures, Southstar has proactively implemented a landscaping plan for the entirety of the tract with the sole purpose of promoting the welfare and overall health of the Vida San Antonio Community. This landscaping plan includes the addition of 231.5 inches. Per the previous amendment, TPV 23-150, this landscaping plan entered maintenance agreement services with the city as part of Southstar commitment and dedication to the community and the City of San Antonio. In total, the proposed mitigation for this site is 796.50 inches. Beyond the proposed mitigation, Southstar has surveyed undersized species within the last undeveloped tract of the Project, the Amenity Center.
