HISTORIC AND DESIGN REVIEW COMMISSION
December 20, 2023

HDRC CASE NO: 2023-330
ADDRESS: 919 MASON ST
LEGAL DESCRIPTION: NCB 1267 BLK 3 LOT S 105 FT OF 6
ZONING: R-6, H
CITY COUNCIL DIST.: 2
DISTRICT: Government Hill Historic District
APPLICANT: Juan M Guajardo | By Grace Floors and Construction LLC
OWNER: Rose Galindo
TYPE OF WORK: Wholesale wood window replacement
APPLICATION RECEIVED: August 8, 2023
60-DAY REVIEW: January 14, 2024
CASE MANAGER: Bryan Morales

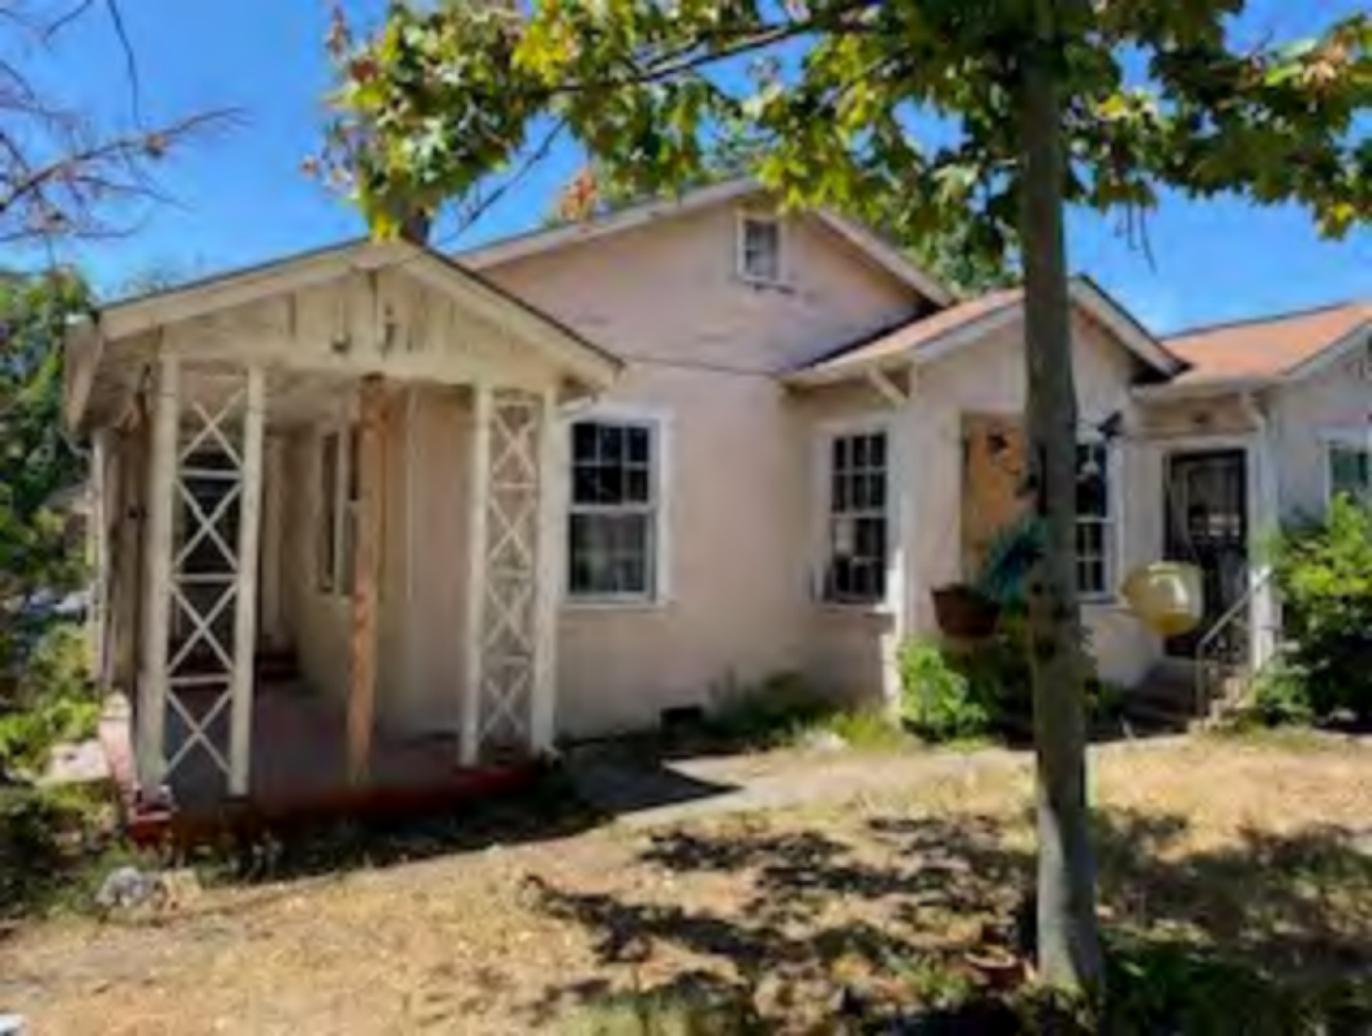
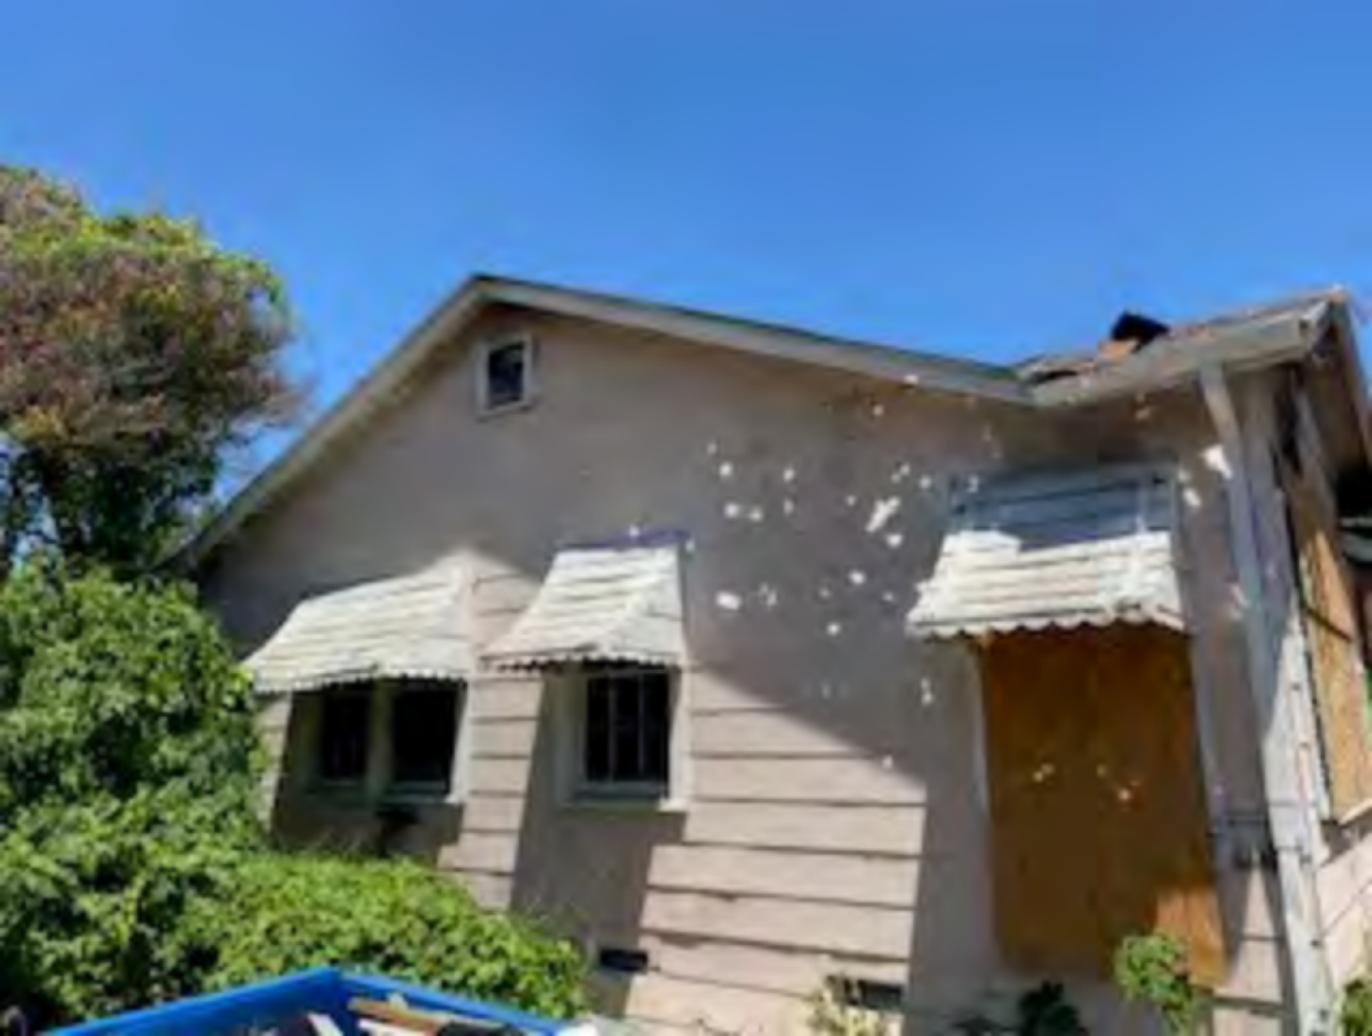
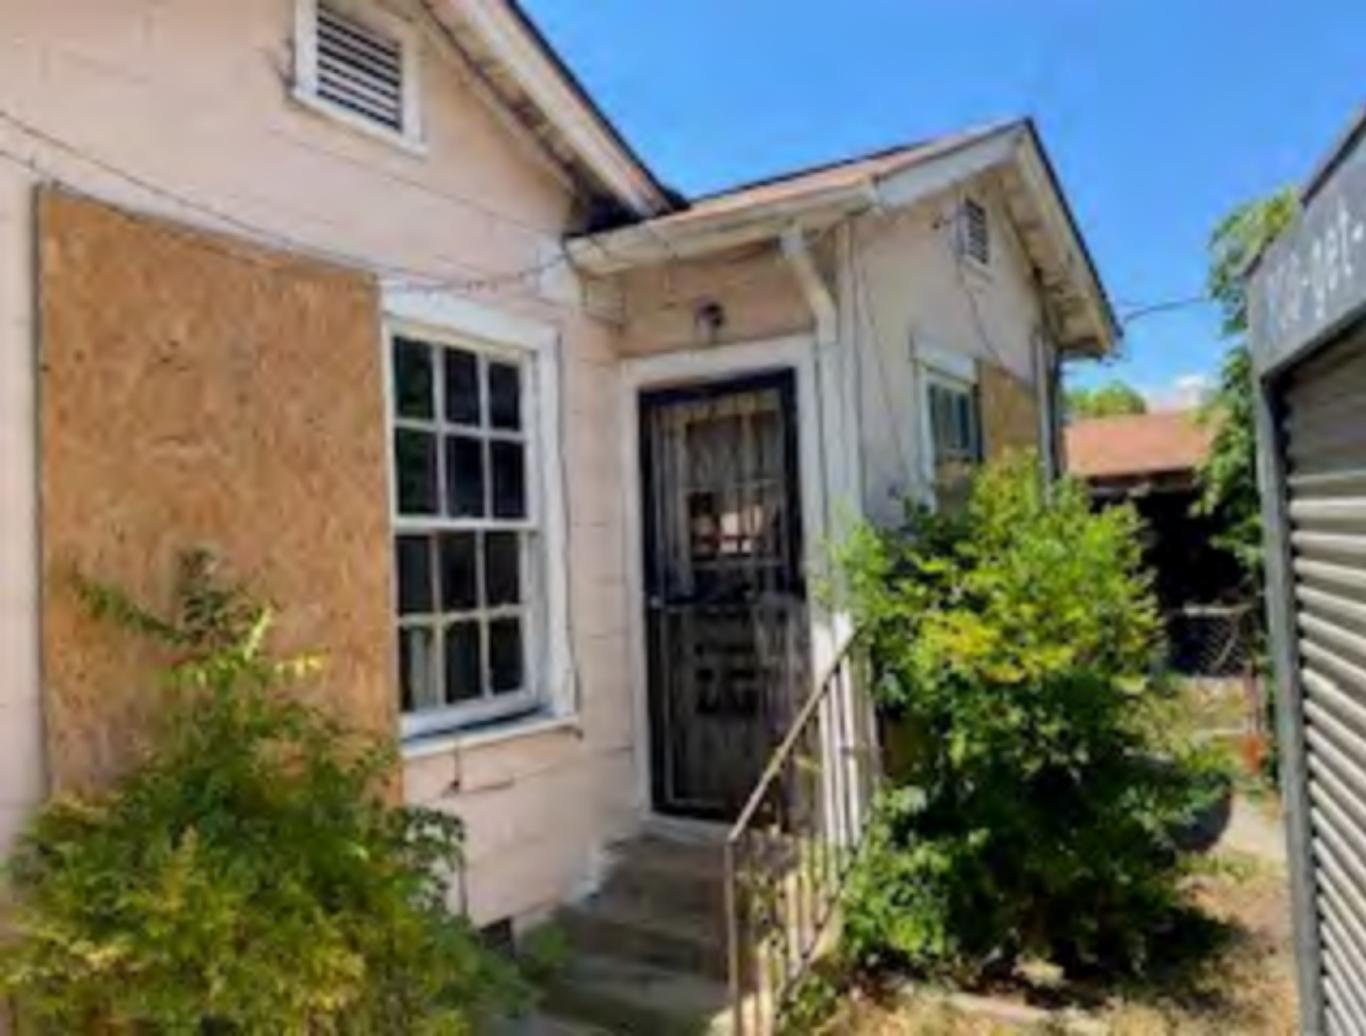
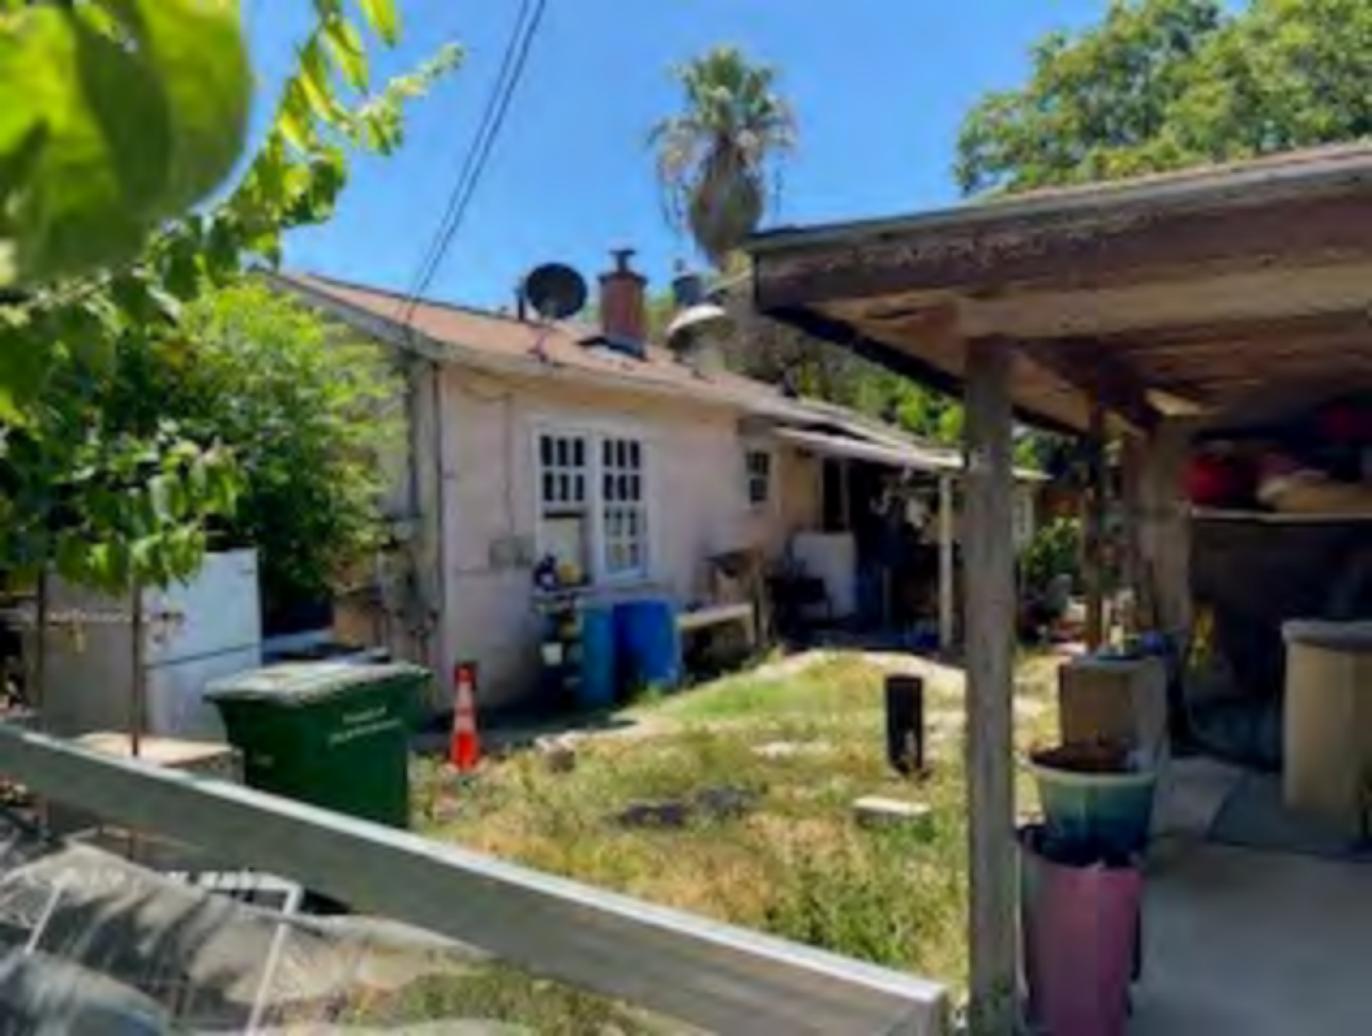
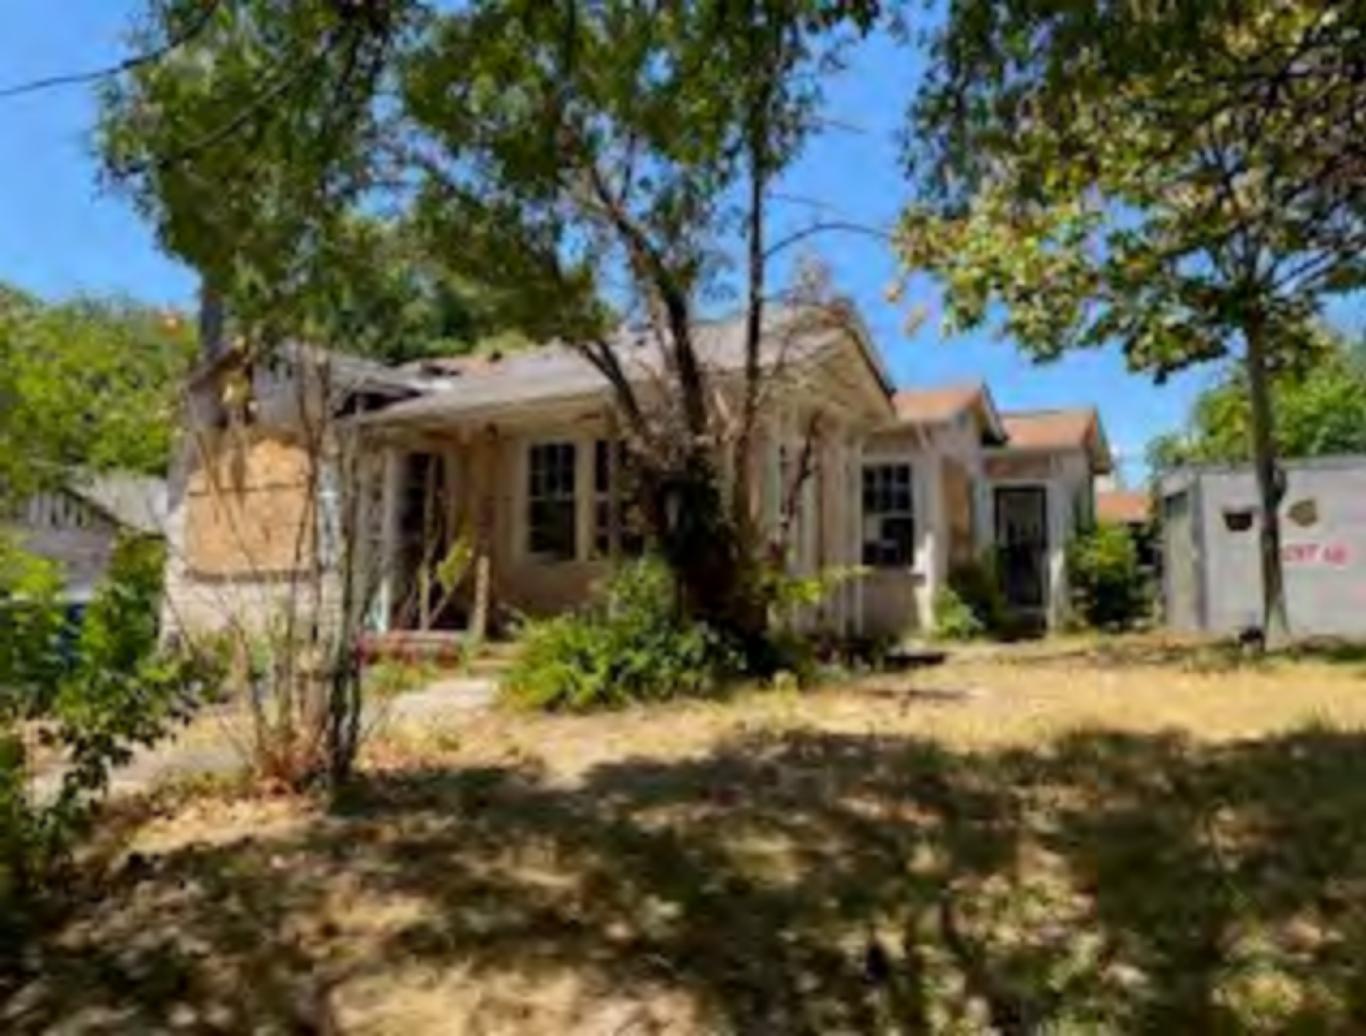
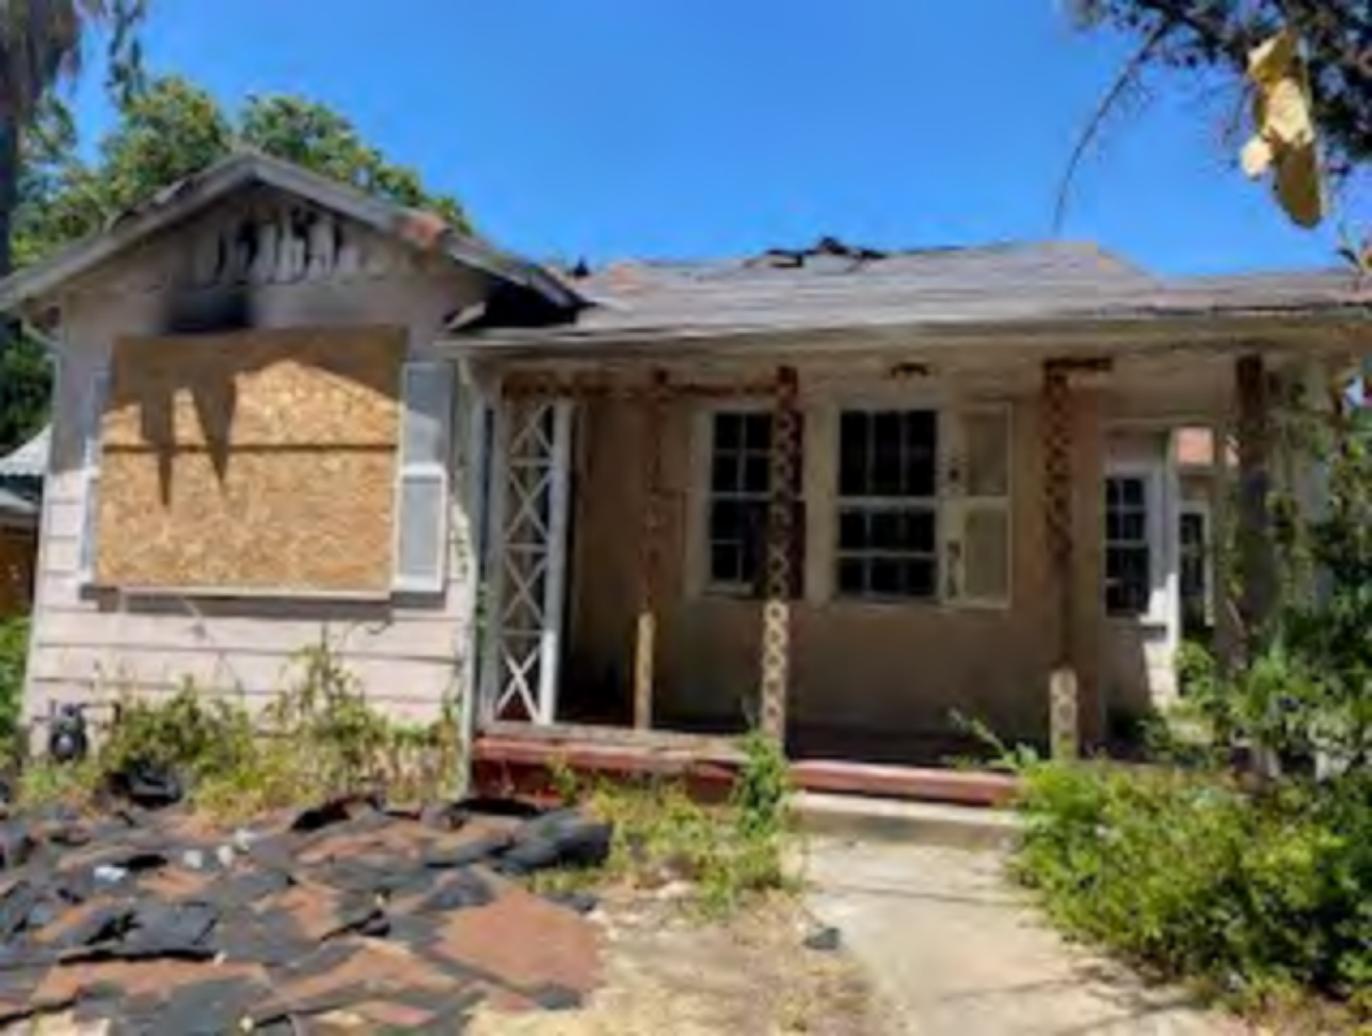
December 14, 2023

- b. **SITE VISIT** – On December 8, 2023, staff conducted a site visit to assess the window conditions at 919 Mason St. Staff was able to observe the exterior of windows 1-8 and 14-19.

- c. **WINDOW REPLACEMENT: EXISTING CONDITION** – Staff has observed evidence of paint stripping and flaking, deteriorated glazing, and some areas where the bottom rail has begun separating at the joint. However, with the exception of windows 17-19, almost all of the original wood is intact in all cases with very limited evidence of irreversible rot or damage. The joints of the top sashes are in excellent condition with no evidence of slipping or separation. Staff finds windows 1-16 are in repairable condition, with most requiring minimal repair and intervention like re-glazing and painting, along with refitting into the trim and frames.

Staff does not recommend approval of the request, based on findings a through f. Staff recommends the applicant work with staff concerning the repair of windows 1-16 and replacement of windows 17-19 in-kind for administrative approval.
