HISTORIC AND DESIGN REVIEW COMMISSION

October 16, 2024

HDRC CASE NO: 2024-355
ADDRESS: 1223 VIRGINIA BLVD
LEGAL DESCRIPTION: NCB 3886 BLK 2 LOT 18
ZONING: RM-4, H
CITY COUNCIL DIST.: 2
DISTRICT: Knob Hill Historic District
APPLICANT: SHAUN CANE/GREATEST NATION EQUITY LLC
OWNER: SHAUN CANE/GREATEST NATION EQUITY LLC
TYPE OF WORK: Fenestration modifications
APPLICATION RECEIVED: September 27, 2024
60-DAY REVIEW: November 26, 2024
CASE MANAGER: Bryan Morales

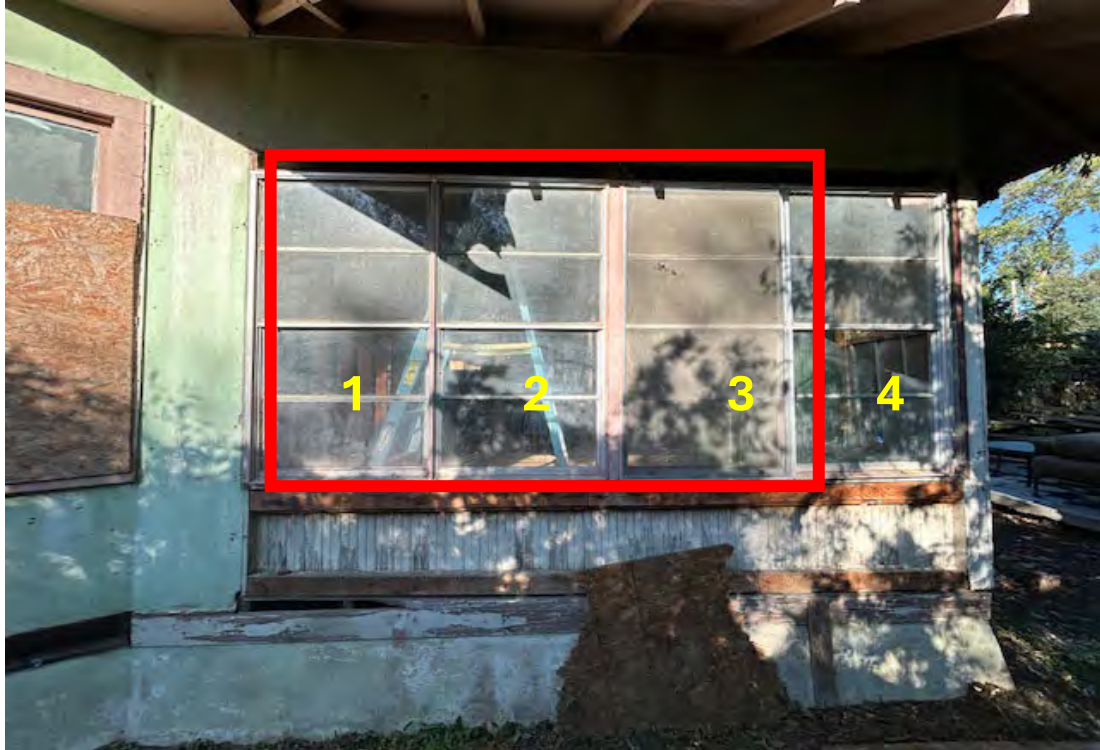
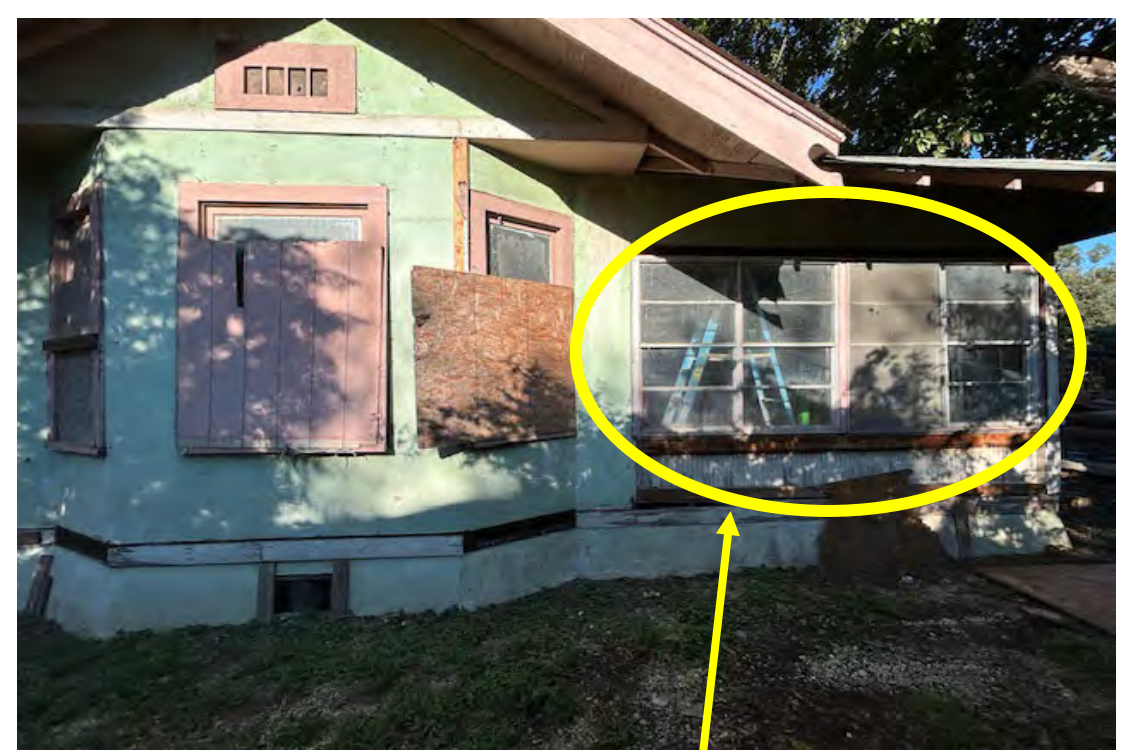
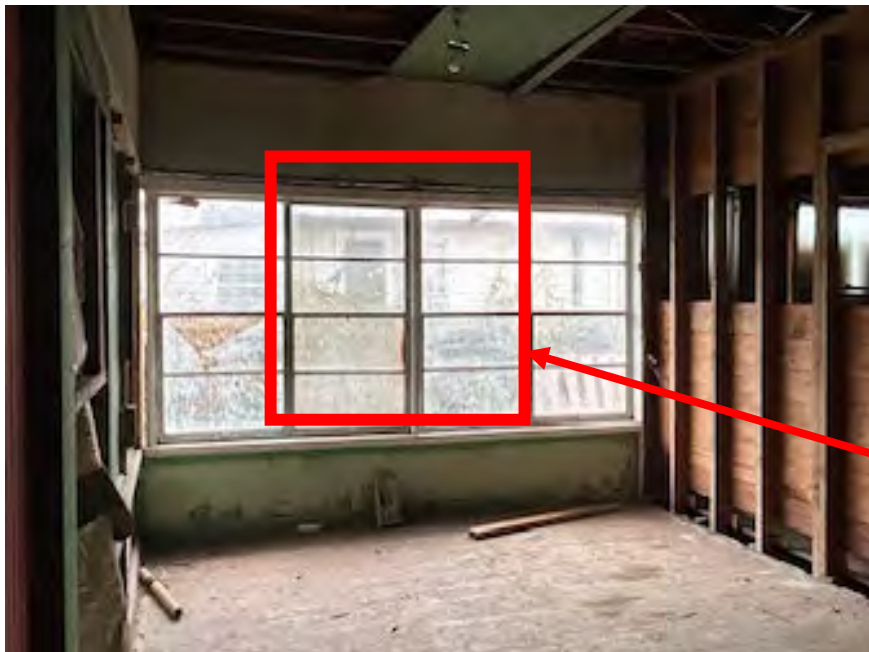
RIGHT SIDE (Facing house from street)

- rear window section IS NOT original to house
- current windows are not wood or historic in design or material.

-**REQUEST:** replace with 3 Salvaged wood windows (see sketch with dimensions). Use same elevation as existing wood windows on east and west side of house.

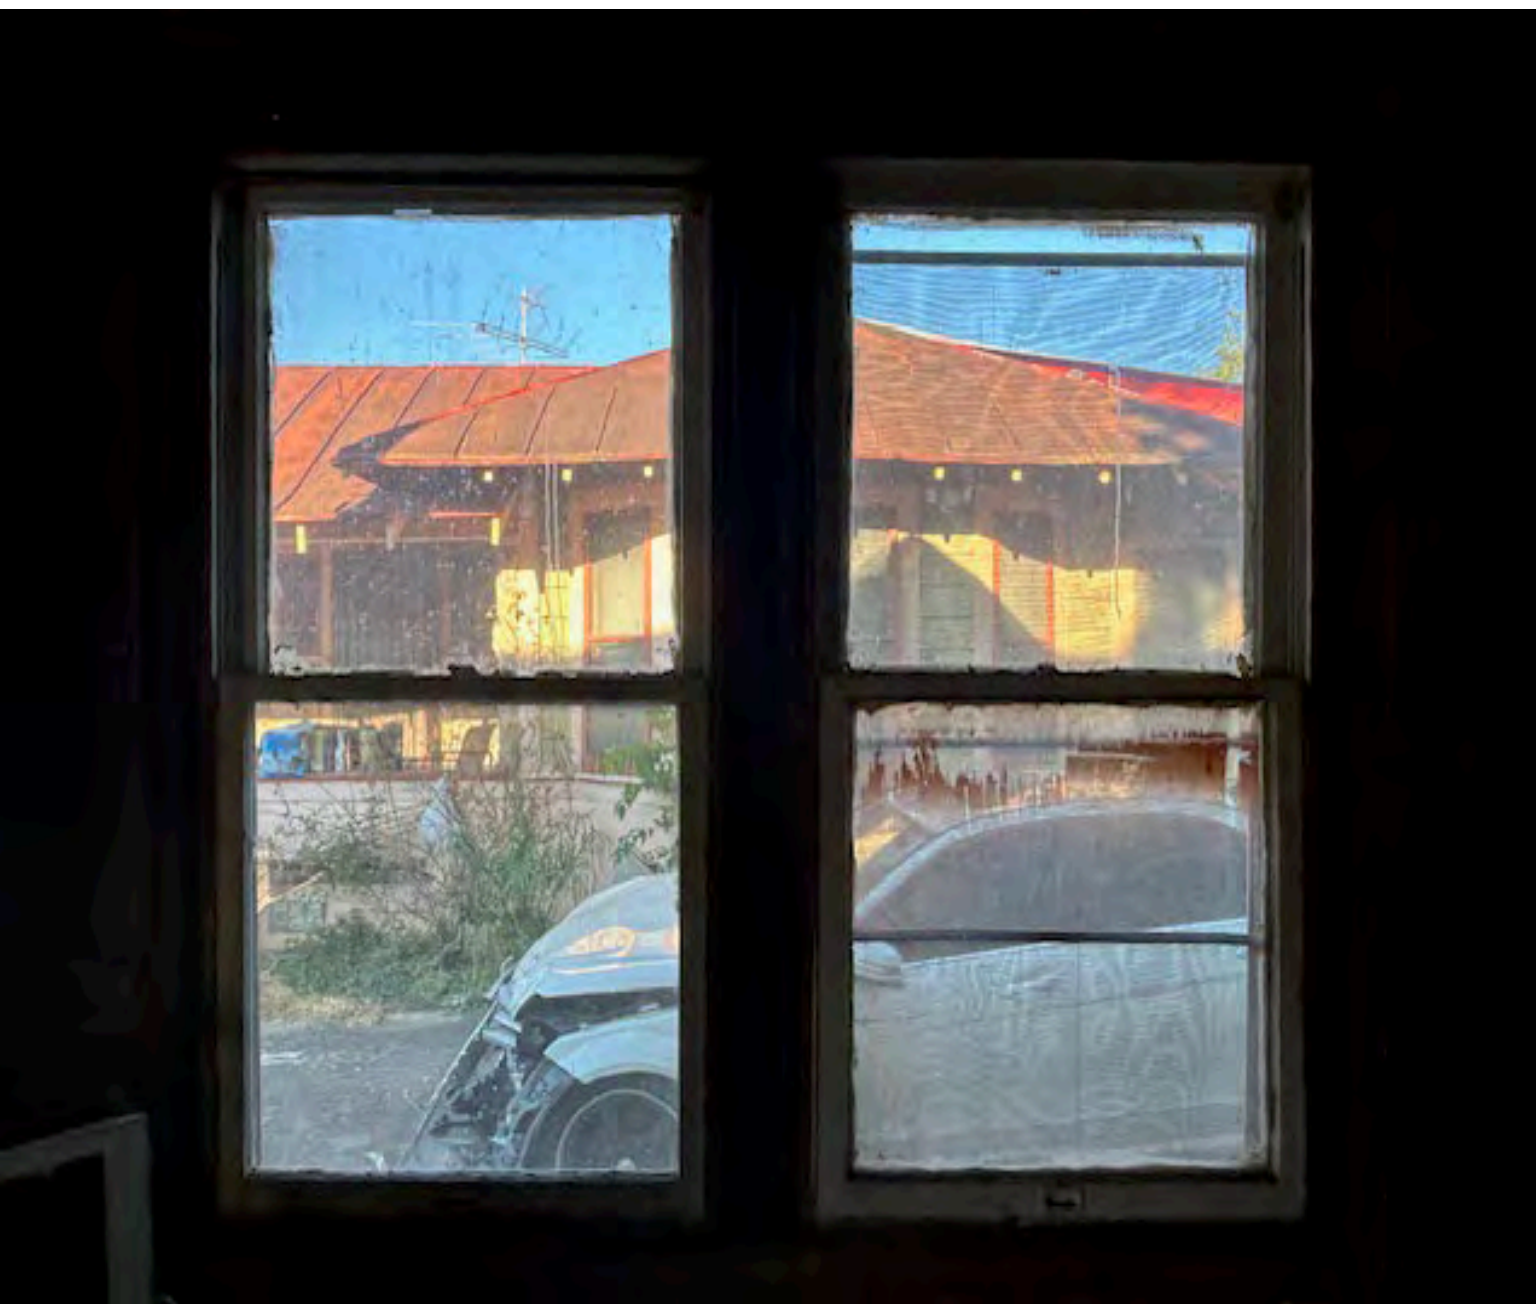
This is the current windows in bed room on West side. This is the same type of double window design we are requesting to replace in the room on the East side where currently there are 4 non-historic windows added at some point to this house.
