HISTORIC AND DESIGN REVIEW COMMISSION

August 07, 2024

HDRC CASE NO: 2024-229
ADDRESS: 1514 W LYNWOOD
LEGAL DESCRIPTION: NCB 2759 BLK 65 LOT 11
ZONING: R-4, H
CITY COUNCIL DIST.: 1
DISTRICT: Keystone Park Historic District
APPLICANT: ELENA ANGELES SANCHEZ/MOVEHOUSE INVESTMENT CORP
OWNER: ELENA ANGELES SANCHEZ/MOVEHOUSE INVESTMENT CORP
TYPE OF WORK: Demolition of a historic landmark (accessory) and front porch column modifications
APPLICATION RECEIVED: May 30, 2024
60-DAY REVIEW: September 27, 2024
CASE MANAGER: Rachel Rettaliata

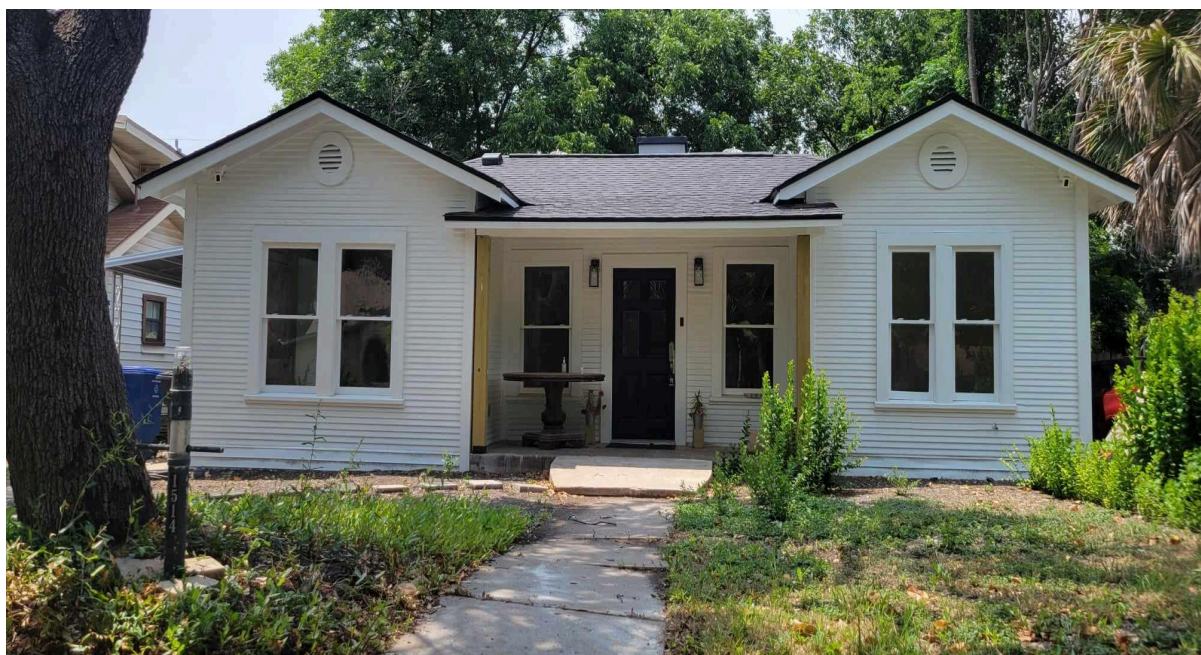
FRENTE DE LA CASA

- h. **FRONT PORCH COLUMN REPLACEMENT** – The applicant has proposed to replace four (4) non-original decorative metal front porch columns with two (2) square wood columns installed flush with the front façade at the outer corners on the inset front porch. Guideline 7.B.iii for Exterior Maintenance and Alterations states that porches and related elements should be replaced in-kind when such features are deteriorated beyond repair. When in-kind replacement is not feasible, the design should be compatible in scale, massing, and details. Additionally, Guideline 7.B.iv for Exterior Maintenance and Alterations states that replacement elements should be designed to be simple so as to not distract from the historic character of the building. Do not add new elements and details to create a false historic appearance. Simple wood columns are appropriate for the architectural style of the structure; however, staff finds that columns should be more centrally located along the awning of the porch in a location that columns were traditionally installed on historic homes, similar to the locations of the previous decorative metal replacement columns. Installing square wood columns with a capital and base and chamfered corners in the approximate location of the previous metal columns would be appropriate.

- i. That the applicant installs fully wood front porch columns that are no wider than 6" square, featuring both capital and base trim and chamfered corners, in the approximate location of the previously existing metal columns. Updated material specifications and an updated elevation drawing must be submitted to staff for review and approval prior to the issuance of a Certificate of Appropriateness.

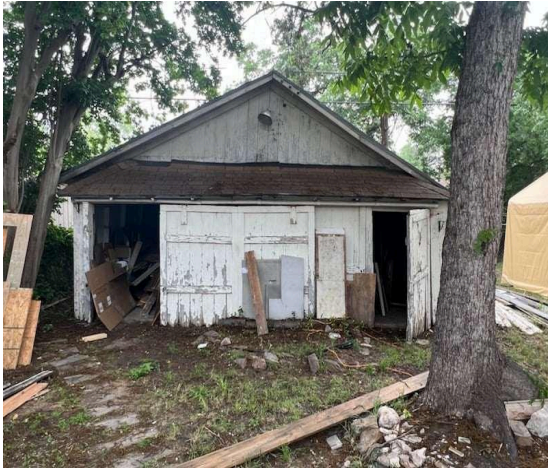
For this we ask Eng. Faraklas to give us his opinion. He inspected it and told us that the garage represents a danger to people's lives and that neither their insurance nor ours together it would cover the damages to those affected. The garage has severe damage from the passage of

years, including a broken ceiling beam, another bent, the bases of the walls rotten, broken or cracked. He can give us the letter if requested by you.

GARAJE FOTO FRONTAL

The proposal is to dismantle the garage and try to recover some of the wood from the ceiling (which as possible), since the other parts are seriously damaged. For this stage that is the most delicate and time-consuming, I would like to have your permission to begin disassembling the garage since we will try to recover what we can of wood and we would do it ourselves themselves to avoid damage to third parties.

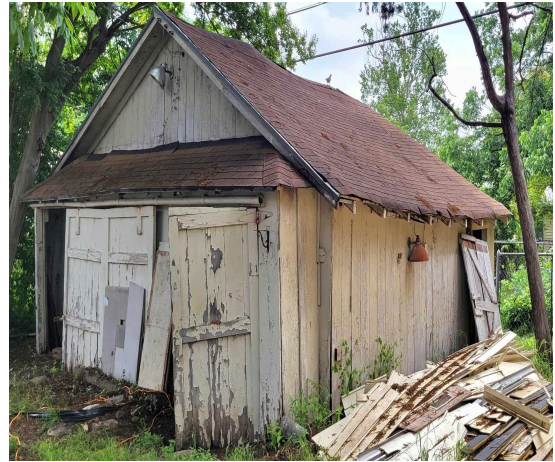
GARAJE LADO LATERAL DERECHO

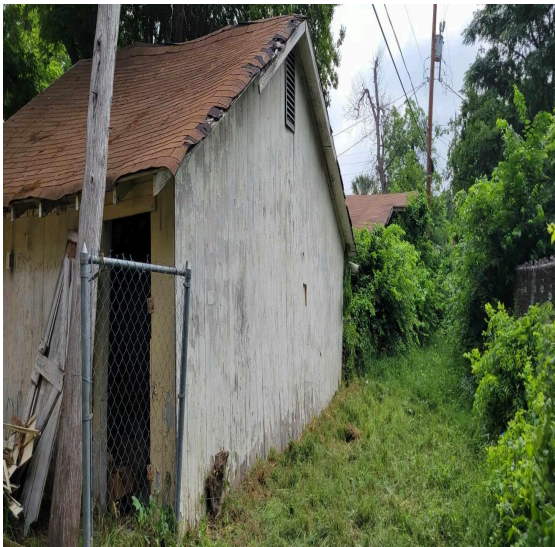
LADO POSTERIOR

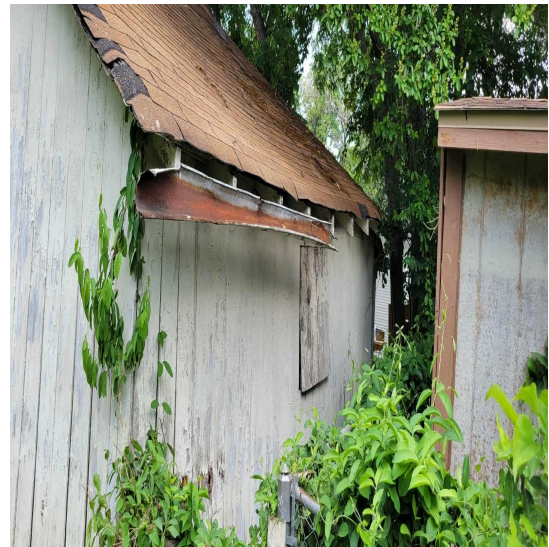
LADO LATERAL IZQUIERDO

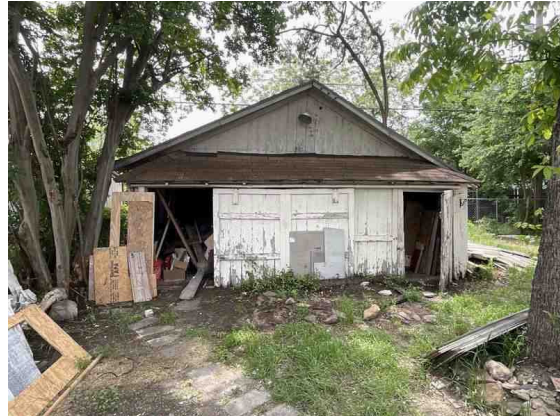
Detached Garage

During my site visit, I noted the walls and roof frame to be in poor condition and is in need of extensive removal and replacement of its structural members. The foundation supporting this structure is a concrete "slab-on-grade" foundation system which has grade beams which transfers gravitational and lateral loads from the wood framed walls and roof into the ground supporting this foundation system. The foundation has numerous cracks throughout the surface of the slab and is also in need of repair.

Based on the current condition of the foudnation and wood framed structure of this detached garage, it is my professional opinion this structure, it is current condition, presents danger to the public and should be demolished, removing all debris from the site.

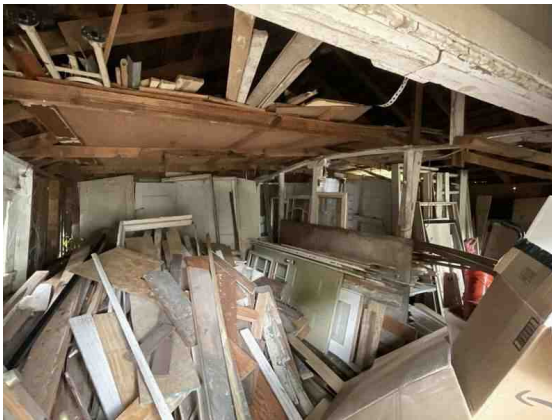
Detached Garage Interior

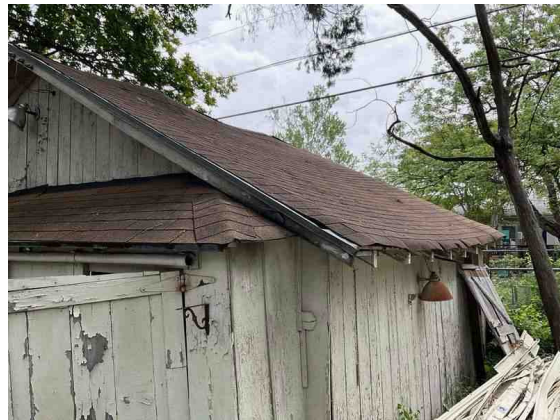
Garage Roof
