**HISTORIC AND DESIGN REVIEW  
COMPLIANCE AND TECHNICAL ADVISORY BOARD  
May 17, 2024**

**HDRC CASE NO:** 2024-163  
**ADDRESS:** 271 W WILDWOOD  
**LEGAL DESCRIPTION:** NCB 9013 BLK 7 LOT 82 83 AND 84  
**ZONING:** R-4, H  
**CITY COUNCIL DIST.:** 1  
**DISTRICT:** Olmos Park Terrace Historic District  
**APPLICANT:** Julia Castillo/CASTILLO JULIA A  
**OWNER:** Julia Castillo/CASTILLO JULIA A  
**TYPE OF WORK:** Fenestration modification to the existing garage structure  
**APPLICATION RECEIVED:** April 10, 2024  
**60-DAY REVIEW:** June 10, 2024  
**CASE MANAGER:** Claudia Espinosa

## Investigation Report

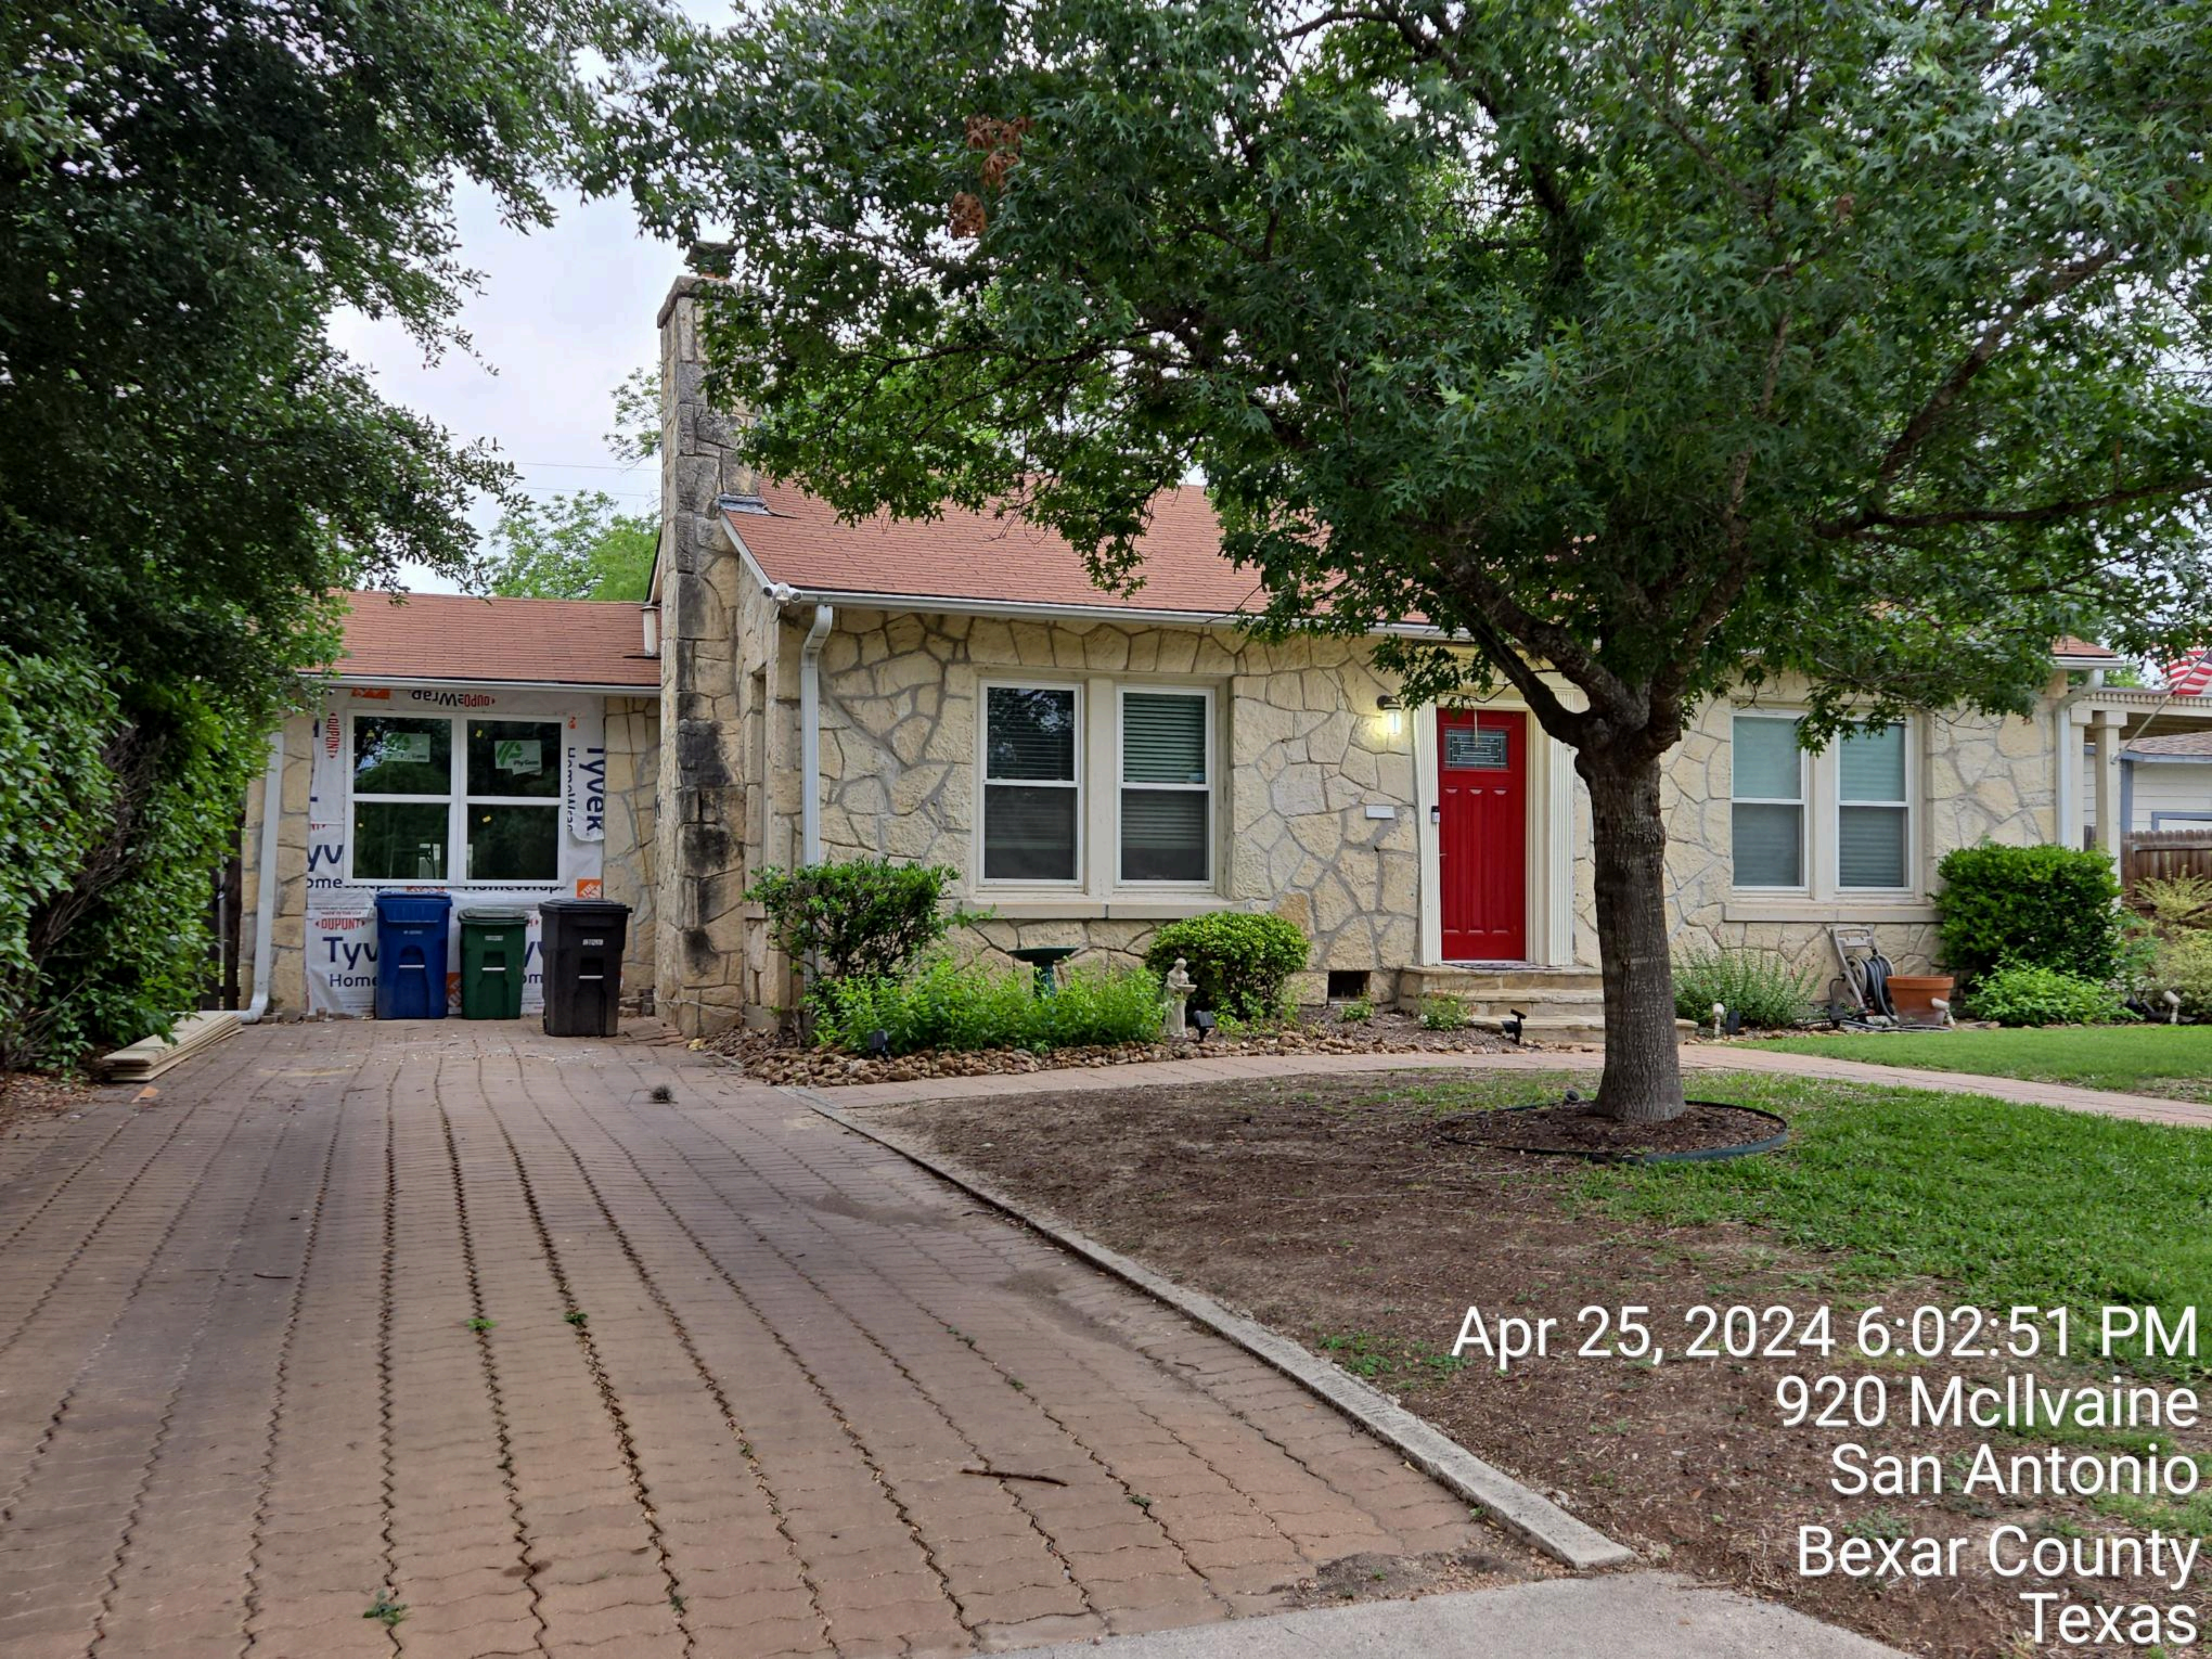
Apr 25, 2024 6:02:51 PM  
920 McIlvaine  
San Antonio  
Bexar County  
Texas

- b. VIOLATION – On Friday, April 26, 2024, while staff was placing the public notice sign, staff noticed the garage infill and window installation were in process. No one was on site to speak with regarding the modifications. Staff contacted the property owner to discuss the ongoing work, gave them a verbal stop work order, and referred the case from the May 1, 2024, HDRC agenda to the May 15, 2024, CTAB agenda.

- c. GARAGE DOOR (INFILL) – The accessory structure currently features a single-bay garage with a metal garage door. While the door itself has been replaced over time, this configuration is original. The applicant has proposed to remove the door and enclose the opening with horizontal lap siding with the installation of two, ganged vinyl windows. The Historic Design Guidelines for Exterior Maintenance and Alterations state that the original window and door opening should be preserved. Any infill at this location should result in a condition that is visually similar and reads as a garage door.

- d. INFILL (MATERIALS) – The applicant requests approval to remove the existing metal garage door and infill the opening with horizontal Hardie lap siding and a set of ganged one-over-one vinyl windows. The Guidelines for Additions 3.A.i, state to use materials that match in type, color, and texture and include an offset or reveal to distinguish the addition from the historic structure whenever possible. Any new materials introduced to the site as a result of an addition must be compatible with the architectural style and materials of the original structure. The proposed siding is not a compatible material with this structure and results in an appearance that is dissimilar from the original garage door configuration.

Staff recommends approval of the removal of the garage doors and infill, based on findings b-d with the following stipulations:

- i. That alternative cladding materials be proposed, namely a paneling that mimic the appearance of a garage door based on finding b and c.
- ii. That the applicant revise the proposed fenestration pattern to propose window opening that conform with windows that might normally be found on a garage door based on finding d.
- iii. That window materials be consistent with staff's standards for new windows including installation depth based on finding d.

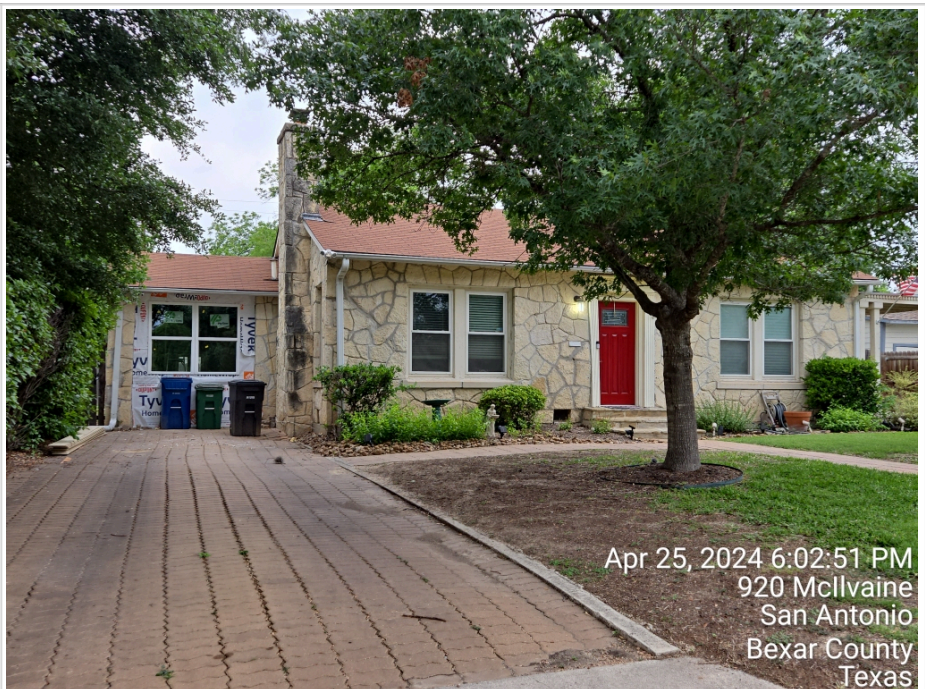
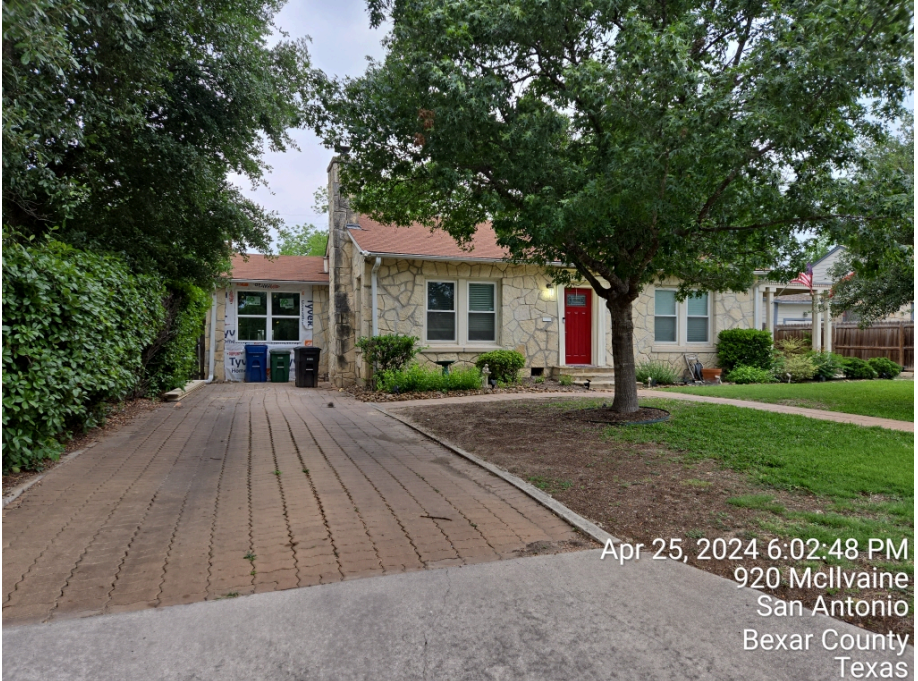
Date	04/25/2024
Time	06:09 PM (-5 GMT)
Context	drive-by
Present Staff	Jessica Anderson
Present Individuals	None
Types of Work Observed	Exterior Maintenance and Alterations
Amount of Work Completed	75%
Description of work	Garage infill
Description of interaction	No interaction. Photos only.

Violation Type	No Certificate of Appropriateness (Code 35-451a)
OHP Action	No Action Taken/Photos Only
Will post-work application fee apply?	To be determined
