**HISTORIC AND DESIGN REVIEW  
COMPLIANCE AND TECHNICAL ADVISORY BOARD**

**November 22, 2024**

**HDRC CASE NO:** 2024-377  
**ADDRESS:** 443 DONALDSON AVE  
**LEGAL DESCRIPTION:** NCB 6695 BLK 4 LOT 11  
**ZONING:** R-6, H  
**CITY COUNCIL DIST.:** 7  
**DISTRICT:** Monticello Park Historic District  
**APPLICANT:** Clarke Coleman/Masters Construction Inc.  
**OWNER:** SHANANTONIO ENTERPRISES LLC  
**TYPE OF WORK:** Exterior masonry painting  
**APPLICATION RECEIVED:** October 29, 2024  
**60-DAY REVIEW:** December 28, 2024  
**CASE MANAGER:** Bryan Morales

The applicant is requesting a Certificate of Appropriateness for approval to paint the exterior masonry.

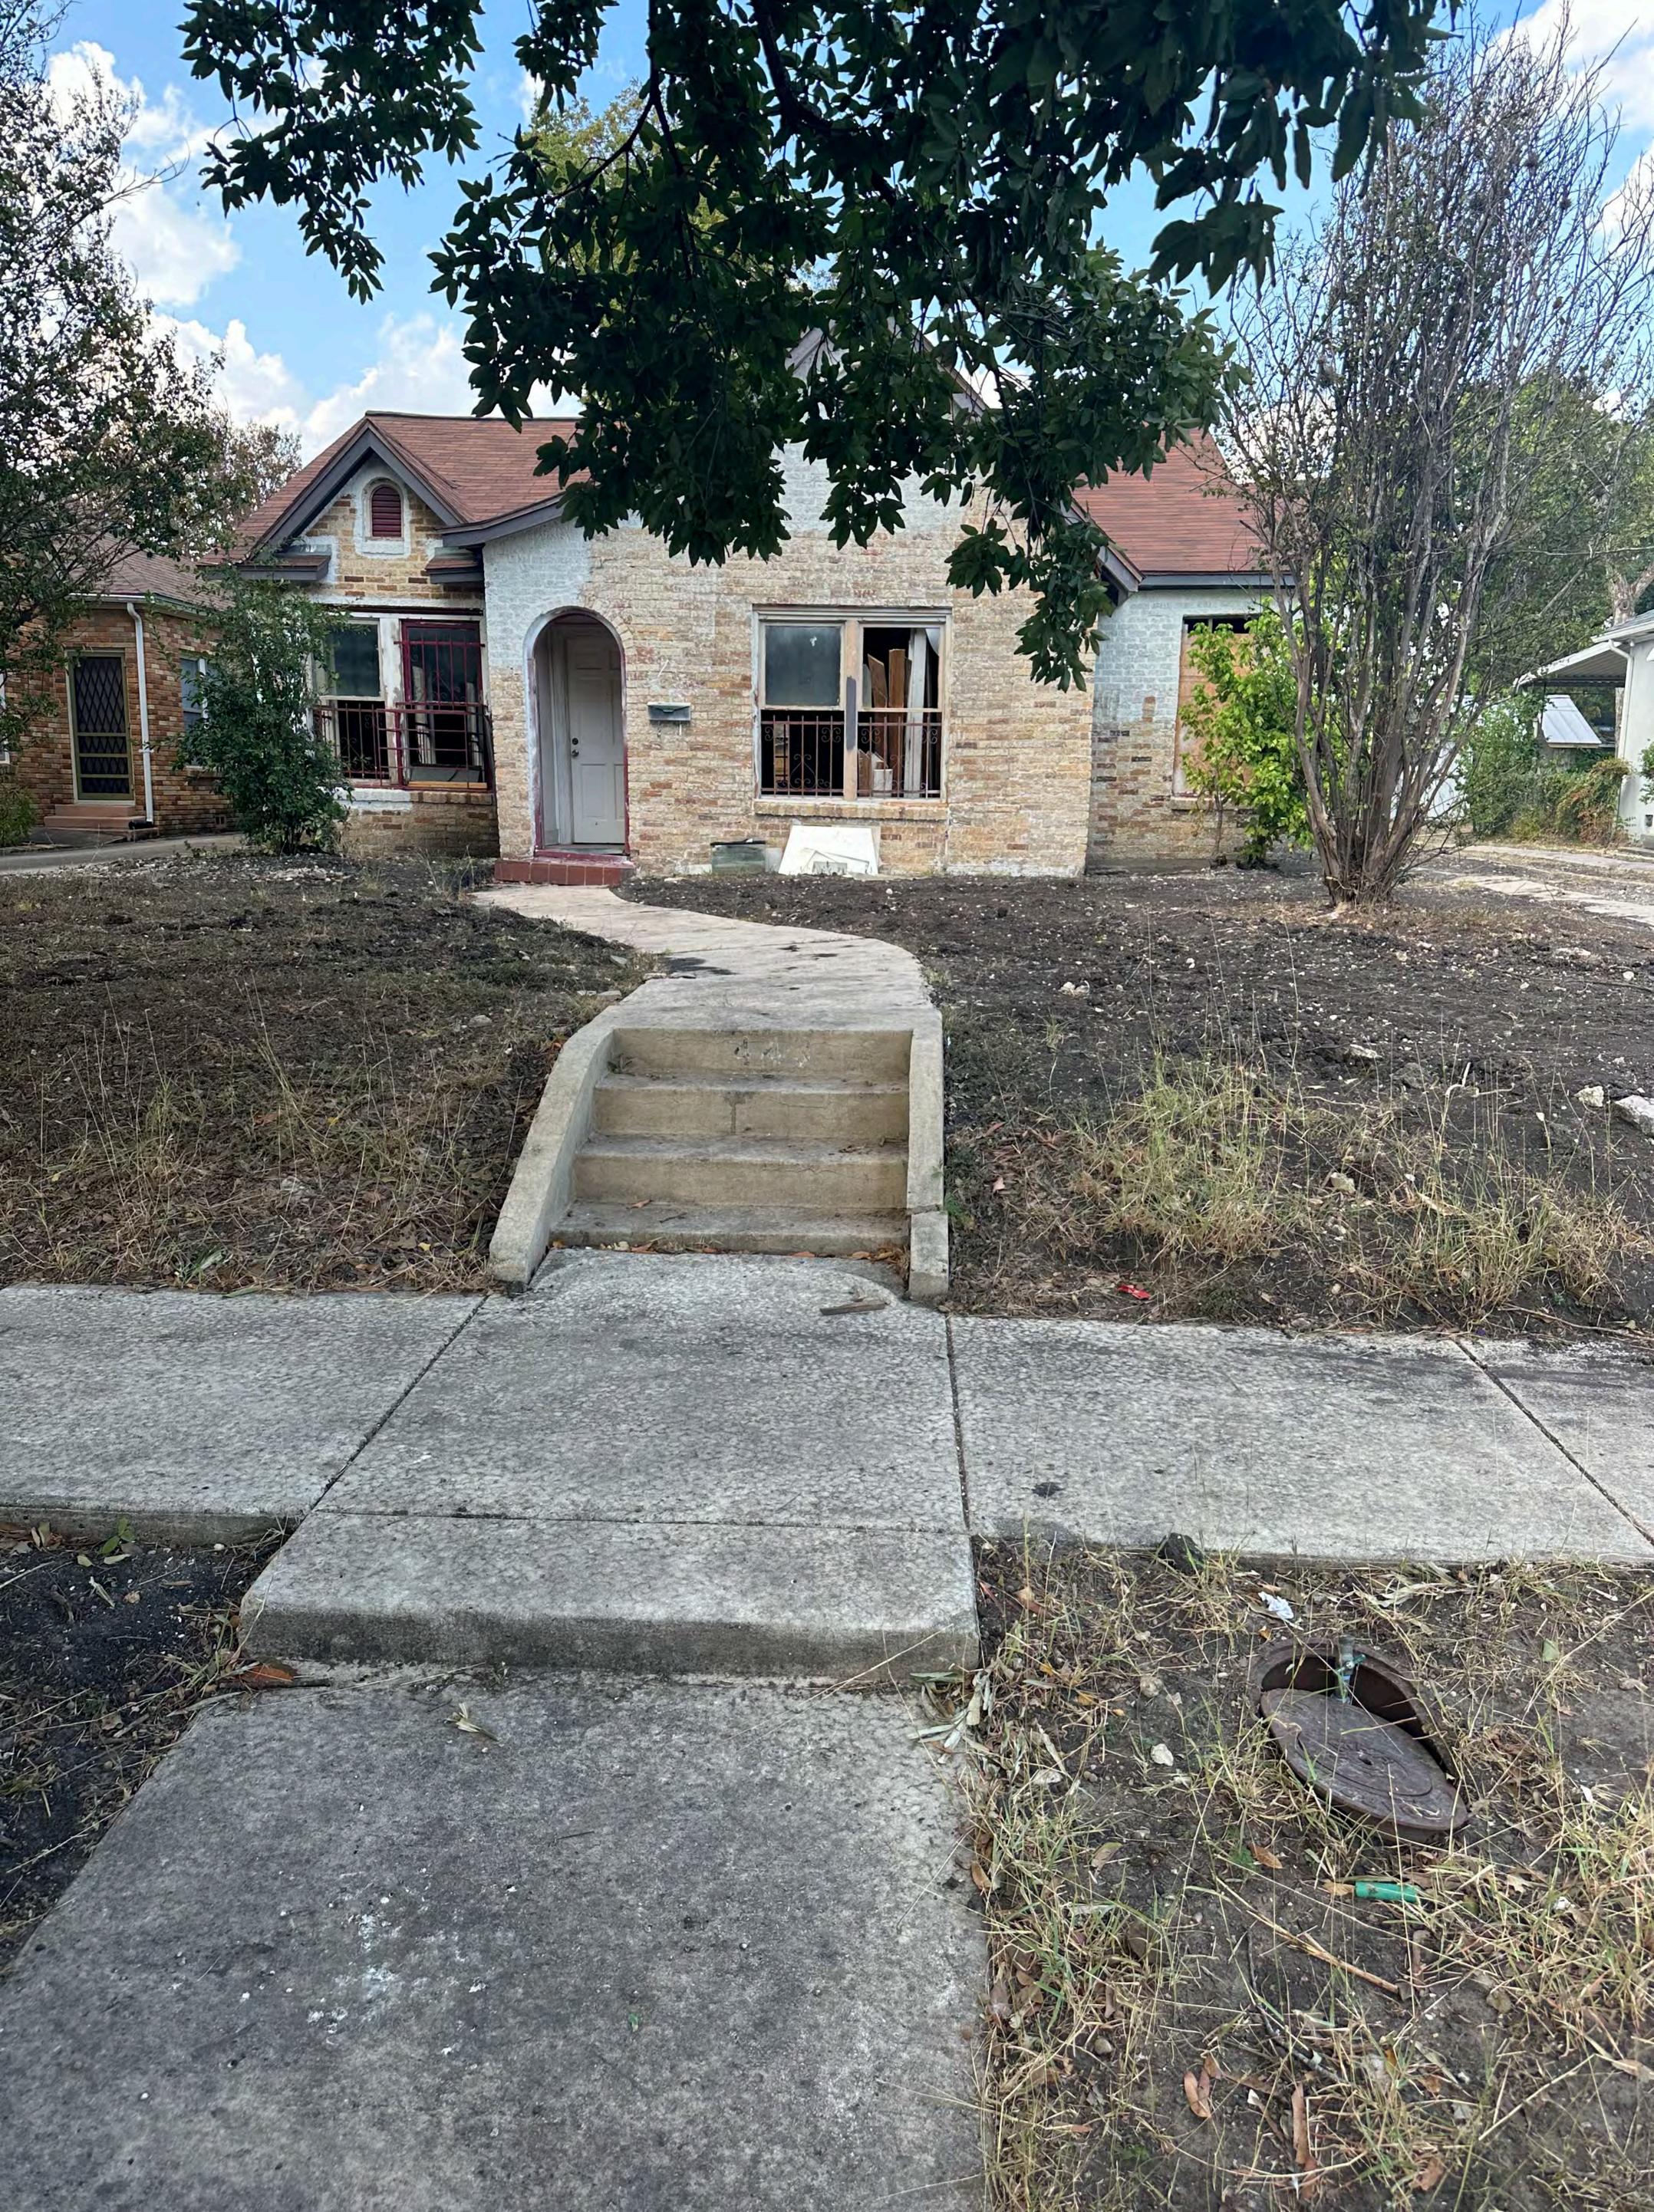
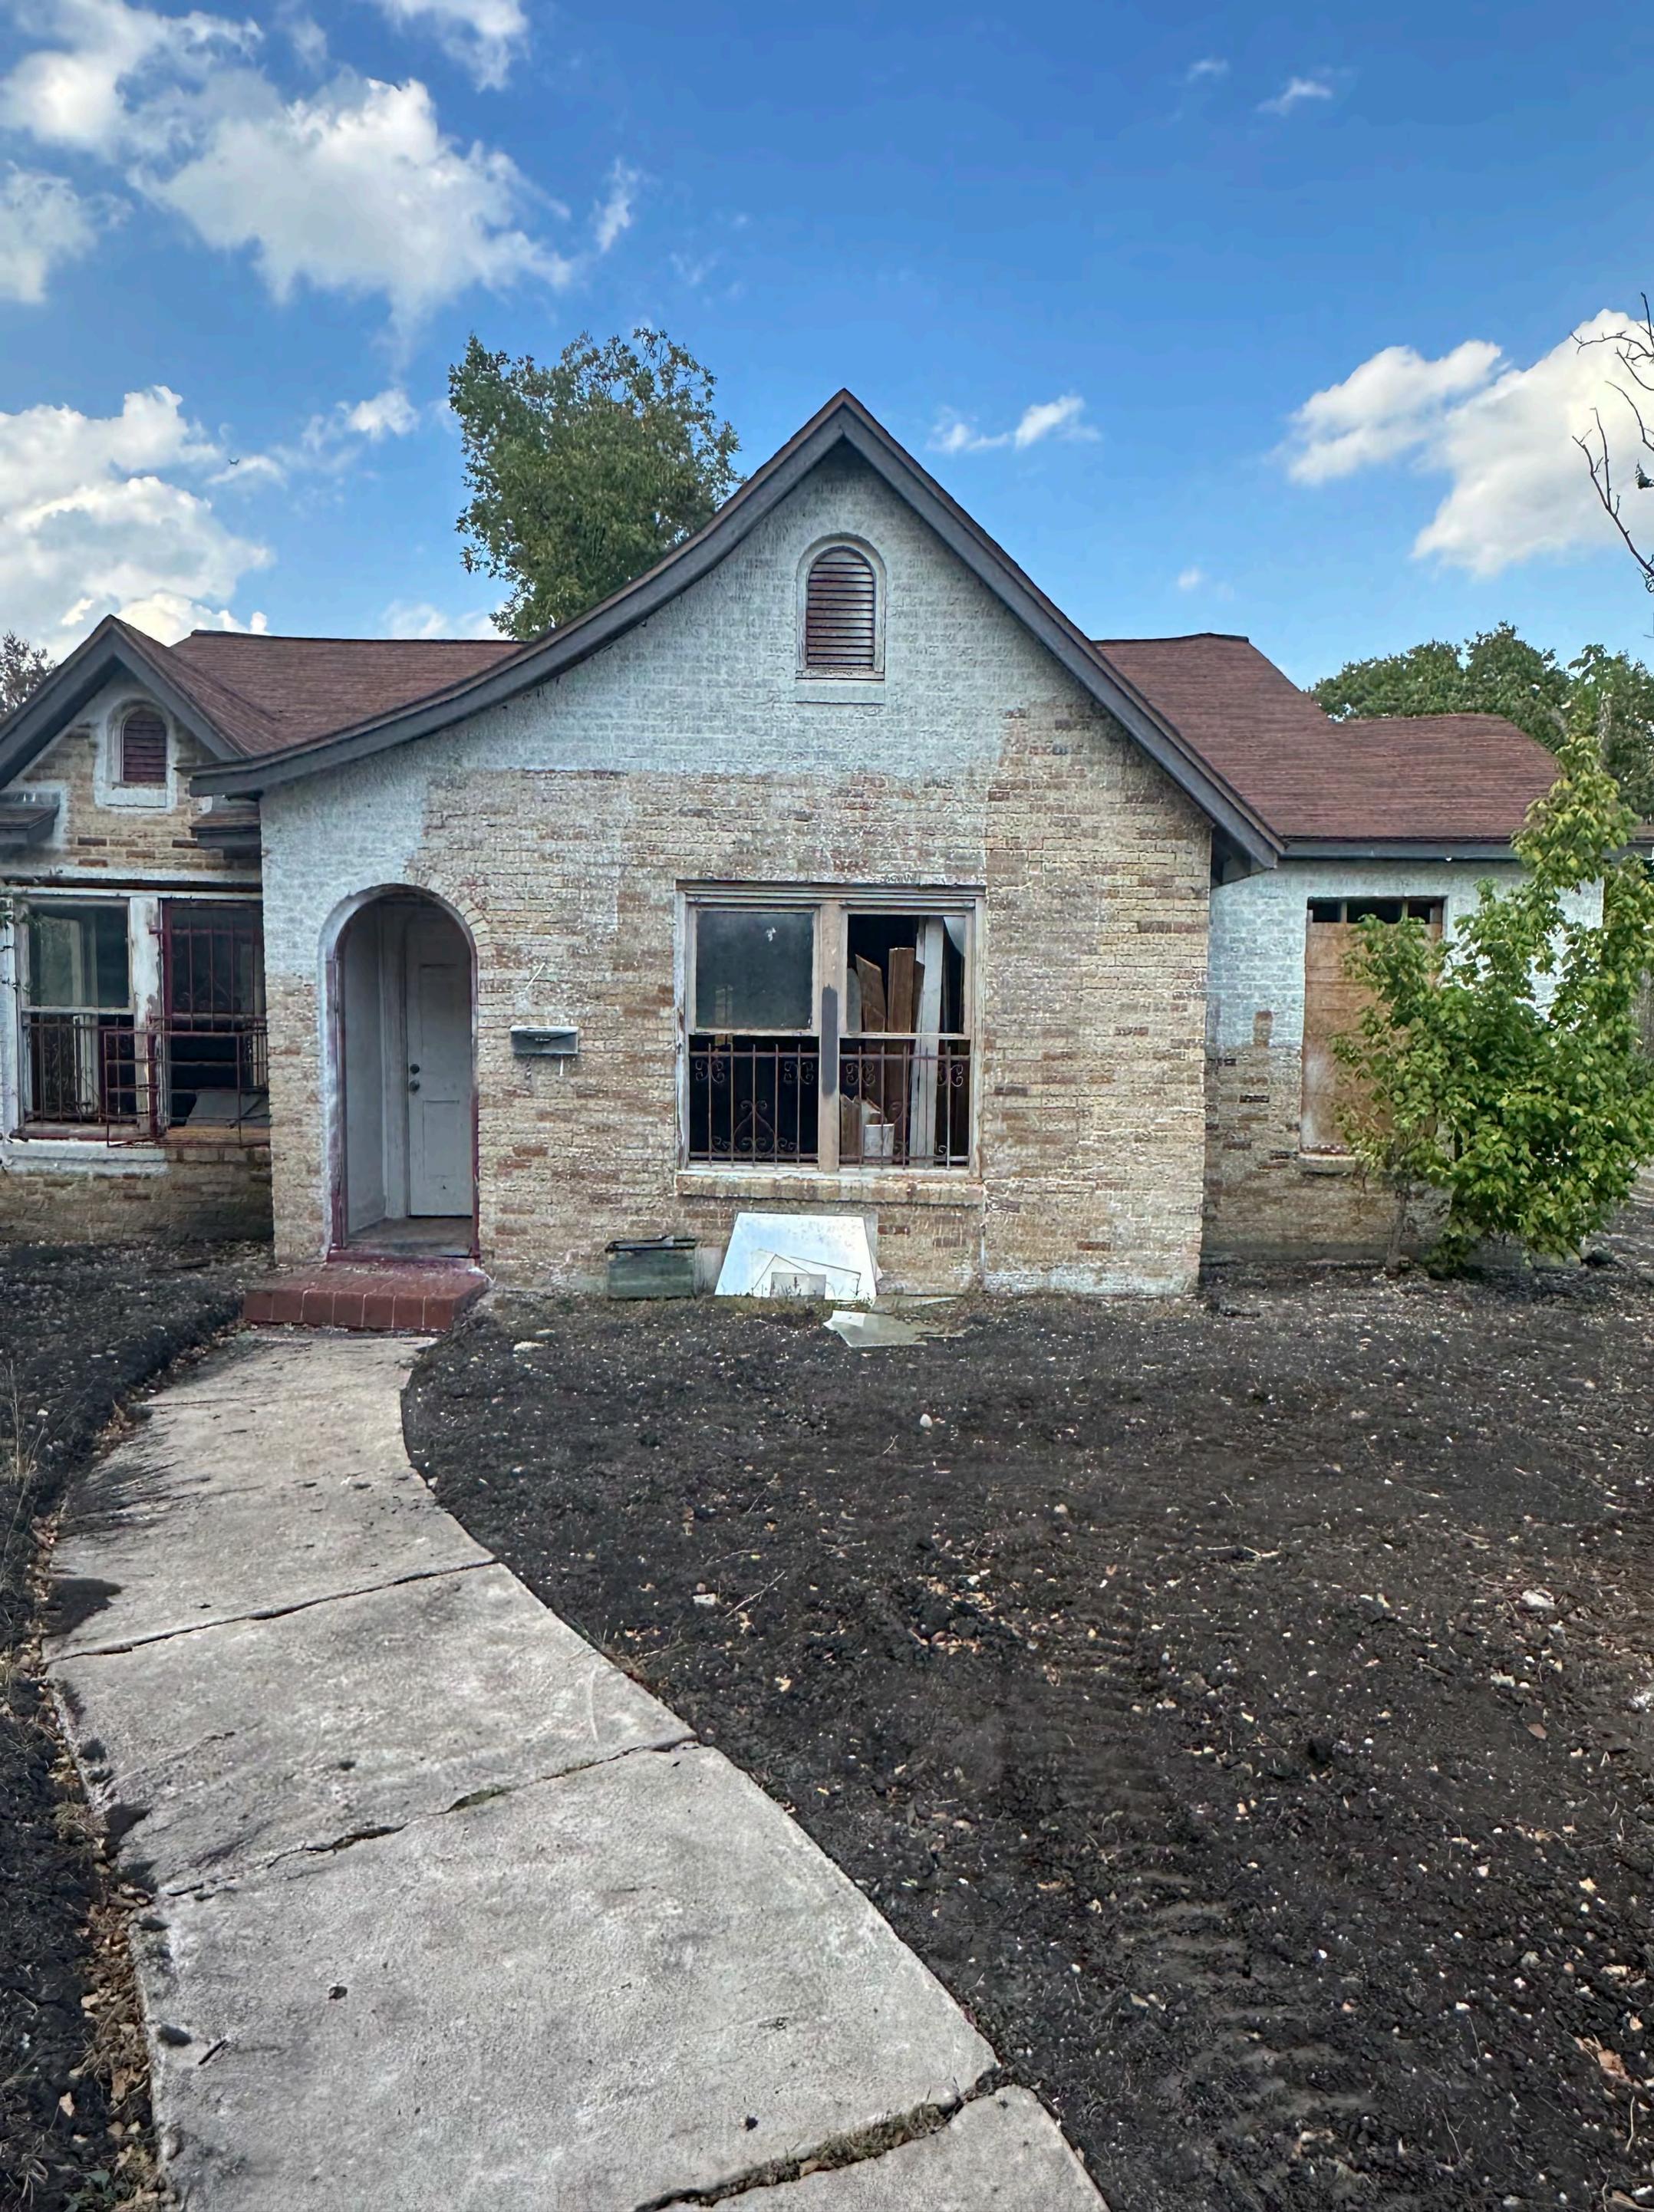
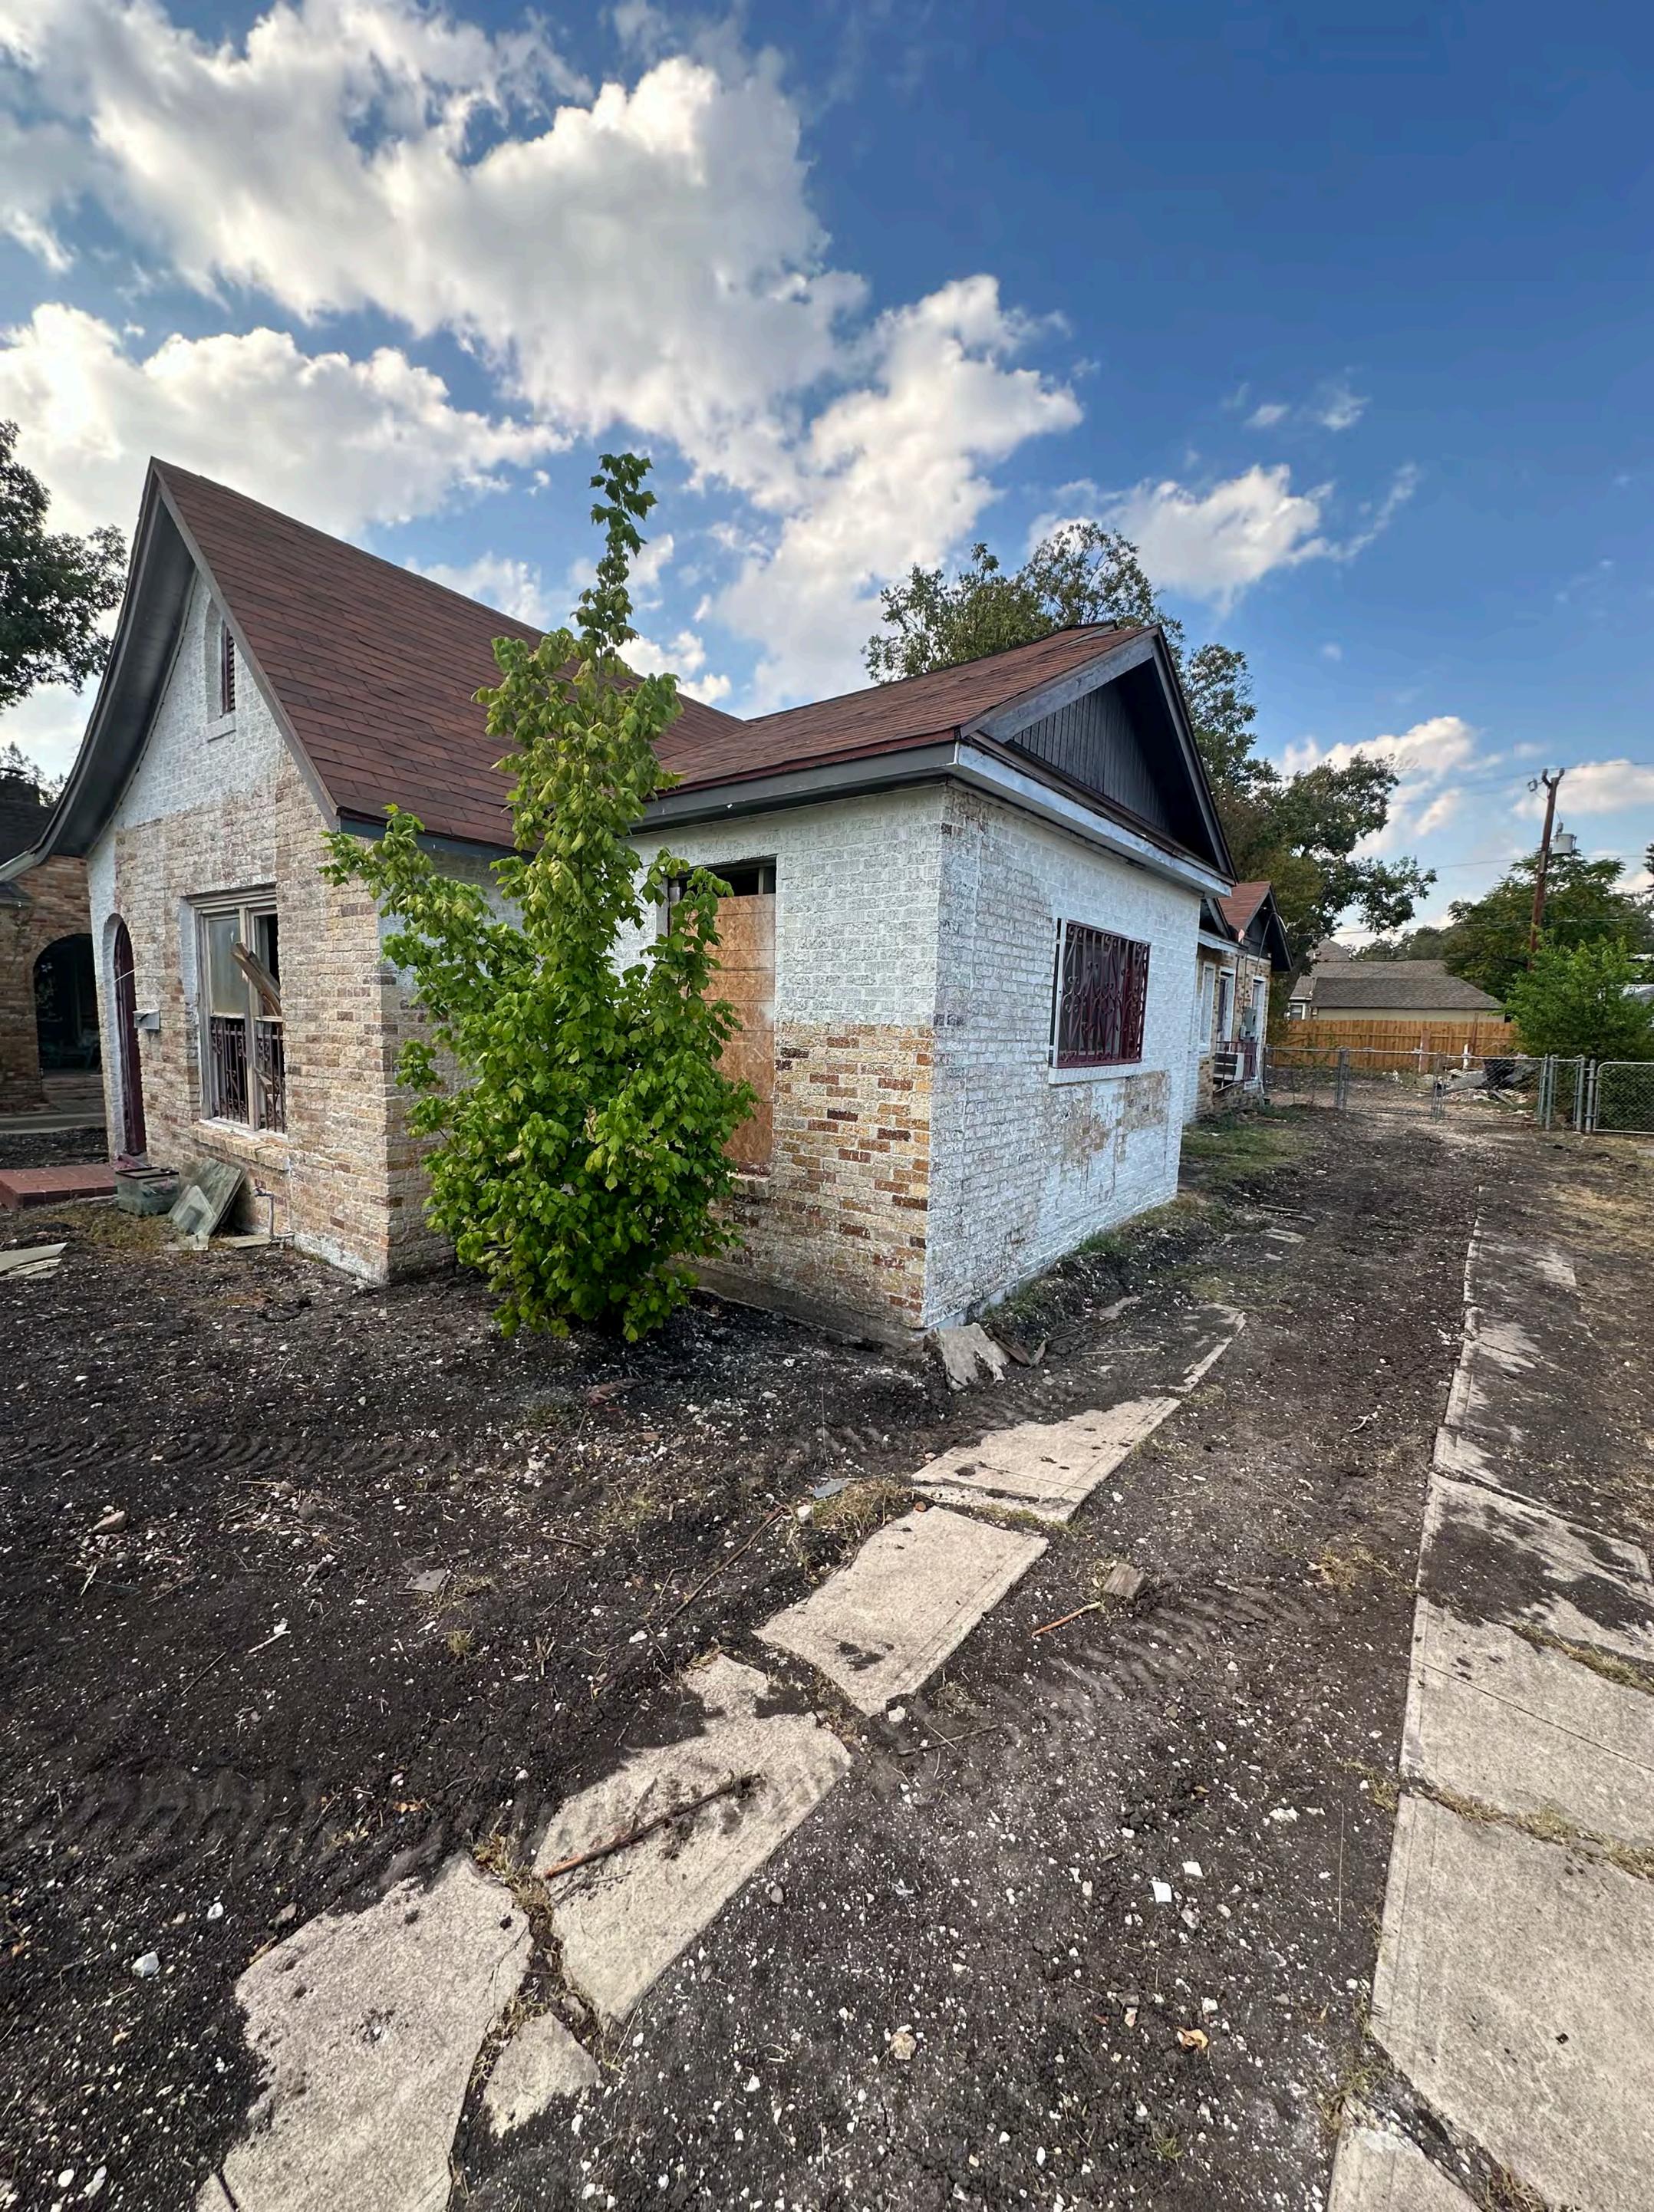
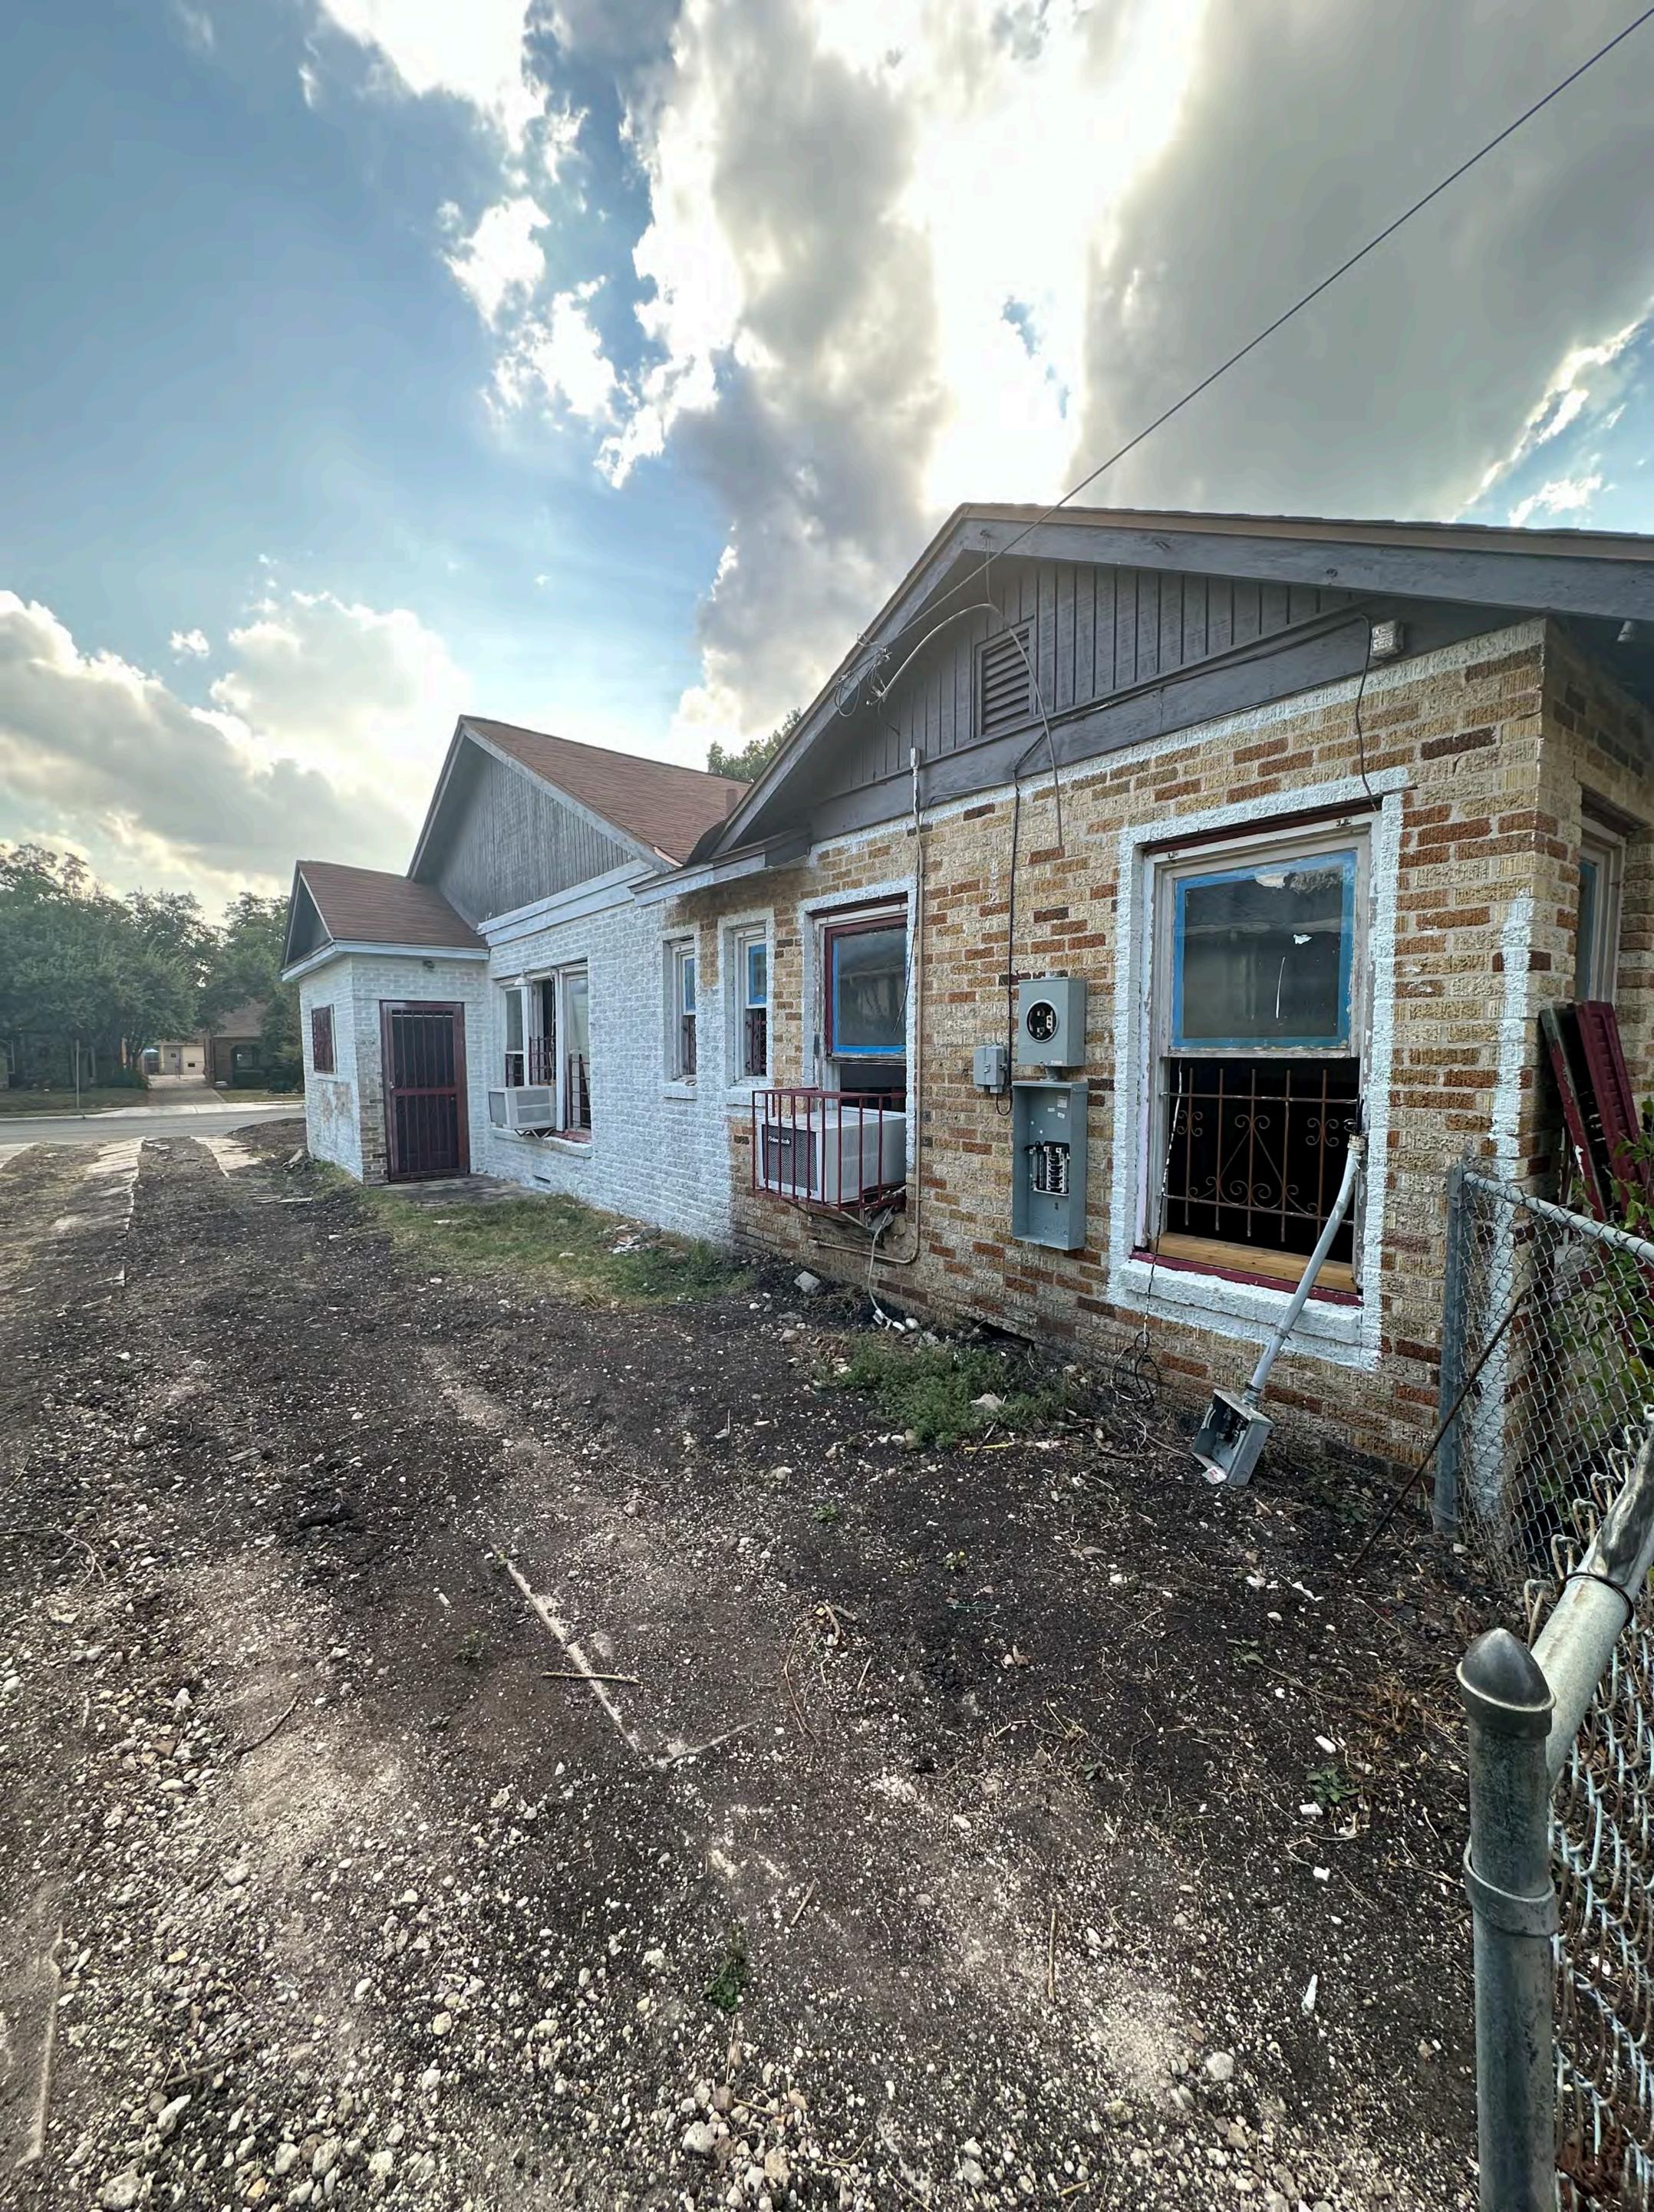
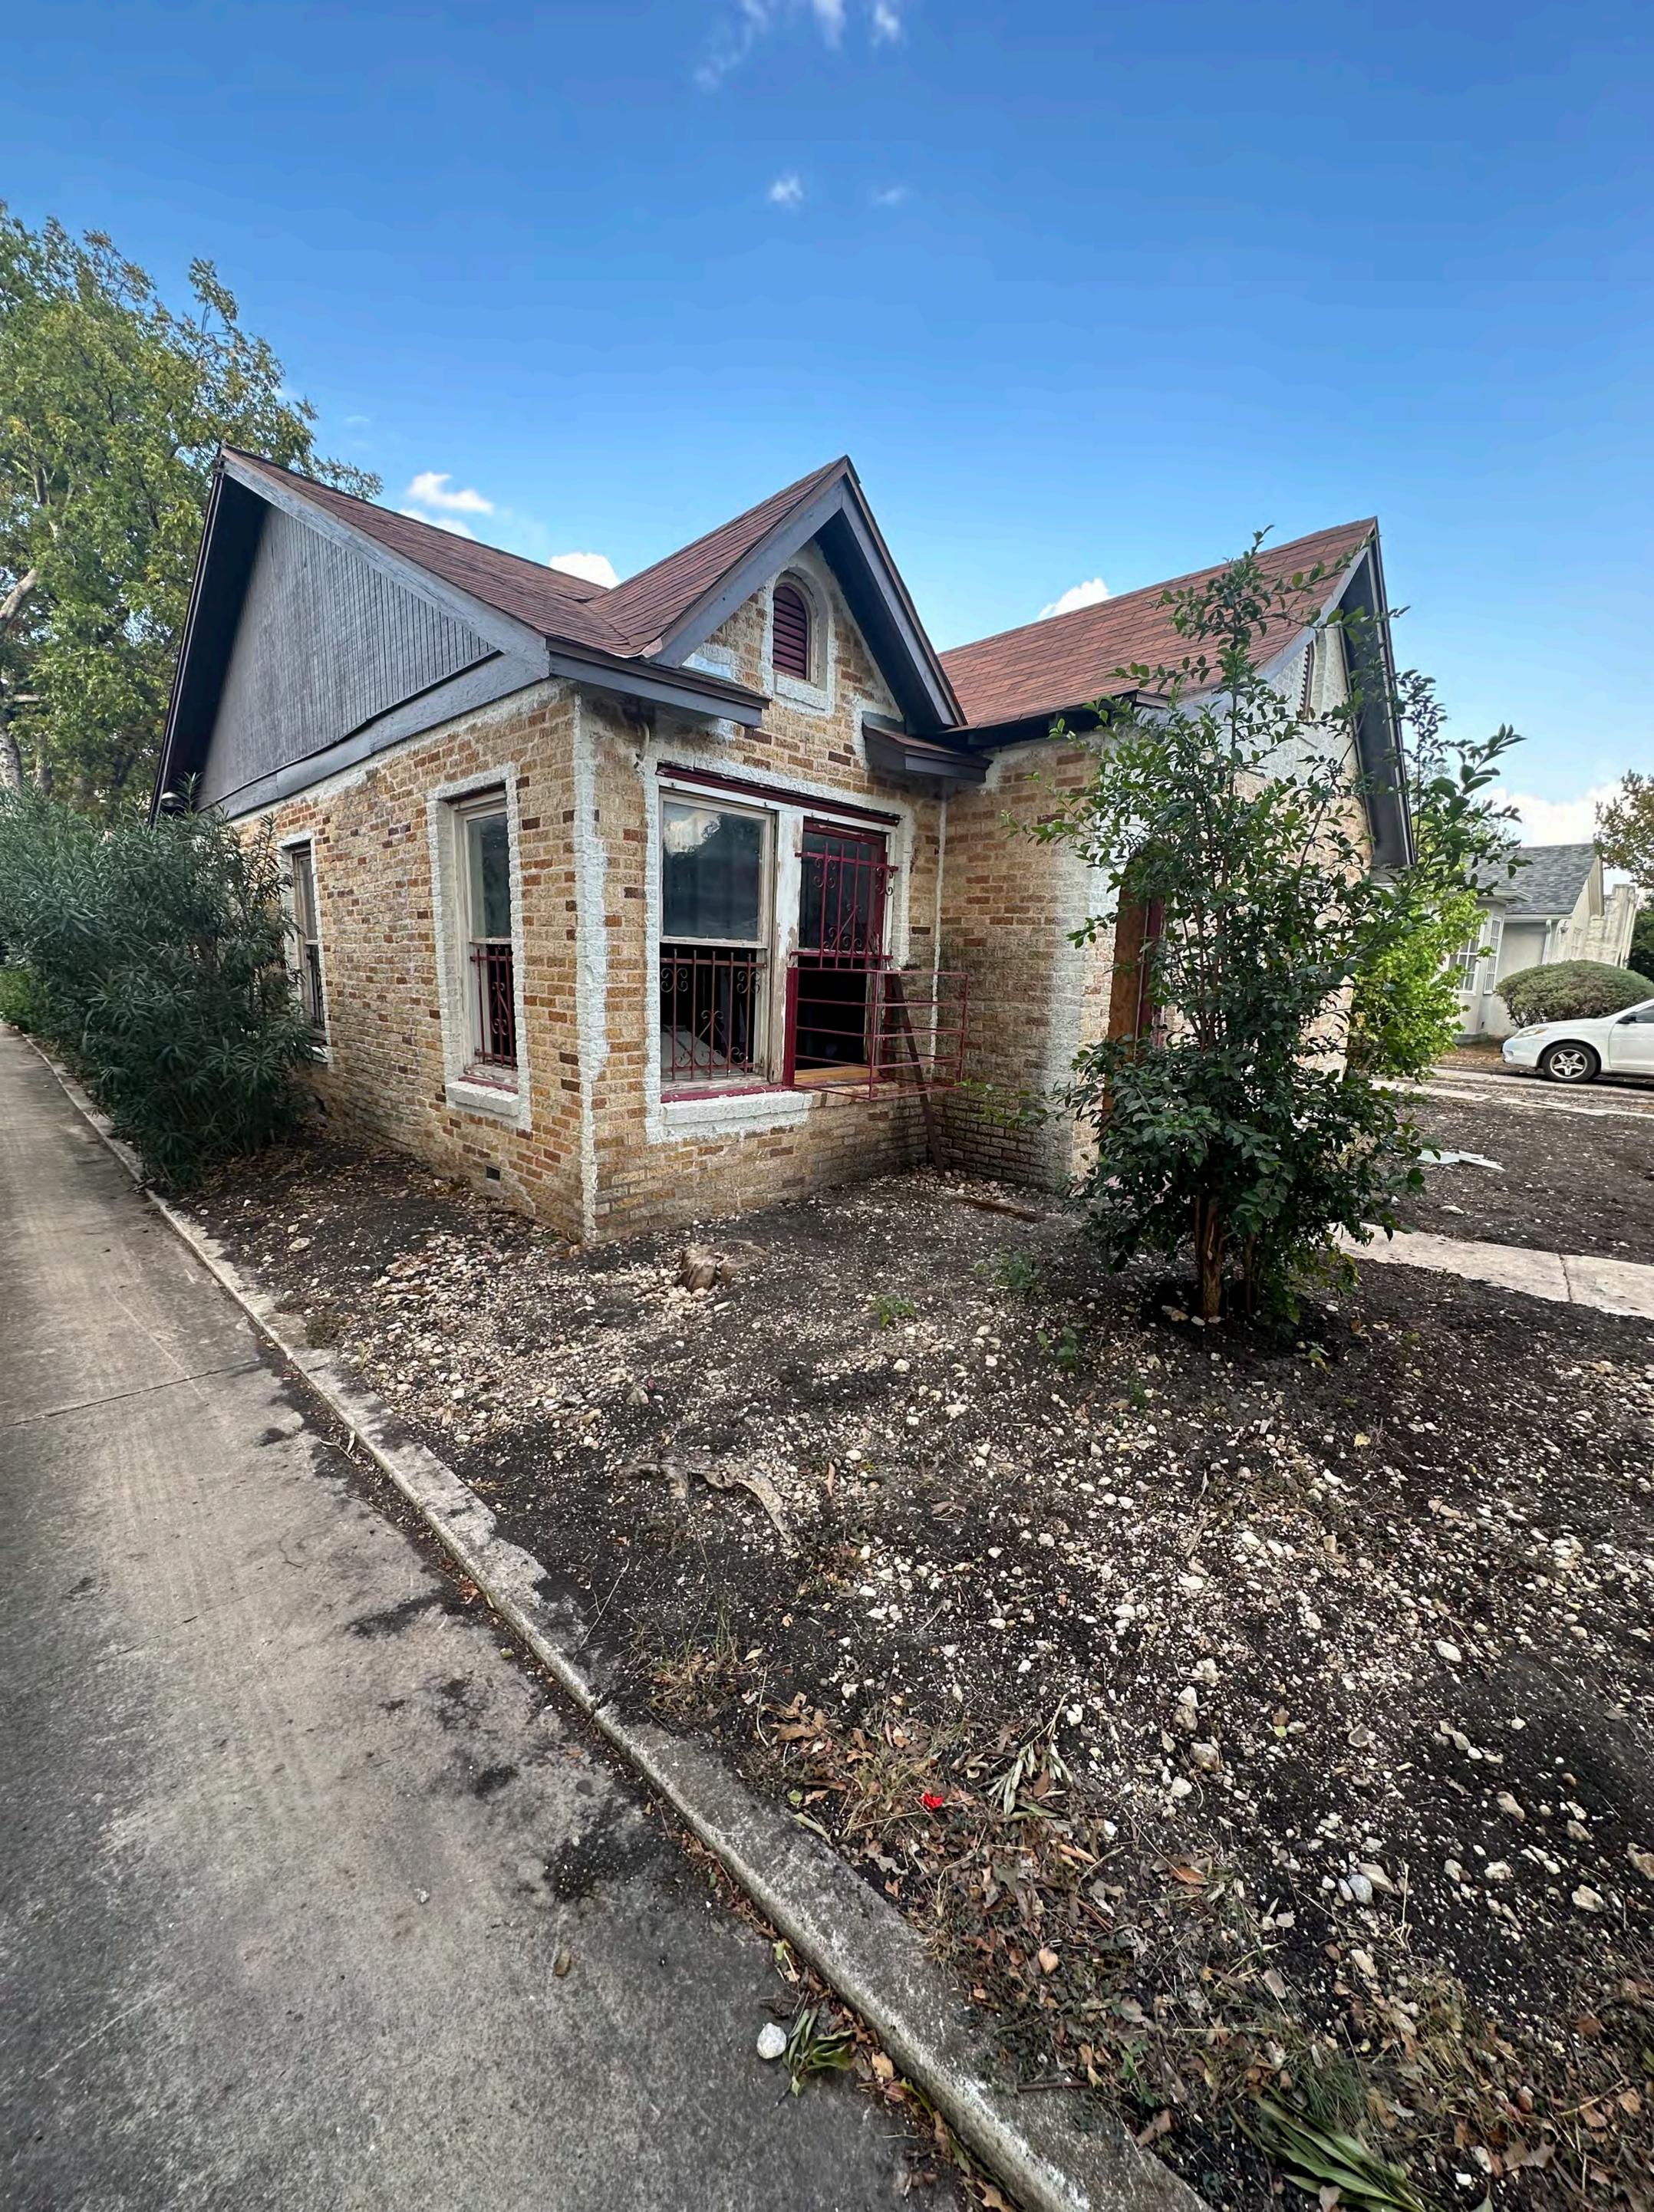
sold the property to the current owner. Currently, the property has undergone some paint removal to rectify the standing violation.

- c. MASONRY PAINTING – The applicant is requesting approval to paint the historic exterior masonry. The Historic Design Guidelines for Exterior Maintenance and Alterations 2.A.i. states to avoid painting historically unpainted surfaces. Staff finds the request to paint the masonry exterior does not conform to Guidelines.

We have been working with historical to try to get the paint off. We have tried the coal slag, sand, pressure washing. We are awaiting a decision from historical on the 20th if we can just paint it.

Staff does not recommend approval of the request, based on the findings. Staff recommends the applicant remove the existing exterior paint without damage to historic masonry onsite.
