**HISTORIC AND DESIGN REVIEW  
COMPLIANCE AND TECHNICAL ADVISORY BOARD**

**November 22, 2024**

**HDRC CASE NO:** 2024-377  
**ADDRESS:** 443 DONALDSON AVE  
**LEGAL DESCRIPTION:** NCB 6695 BLK 4 LOT 11  
**ZONING:** R-6, H  
**CITY COUNCIL DIST.:** 7  
**DISTRICT:** Monticello Park Historic District  
**APPLICANT:** Clarke Coleman/Masters Construction Inc.  
**OWNER:** SHANANTONIO ENTERPRISES LLC  
**TYPE OF WORK:** Exterior masonry painting  
**APPLICATION RECEIVED:** October 29, 2024  
**60-DAY REVIEW:** December 28, 2024  
**CASE MANAGER:** Bryan Morales

The applicant is requesting a Certificate of Appropriateness for approval to paint the exterior masonry.

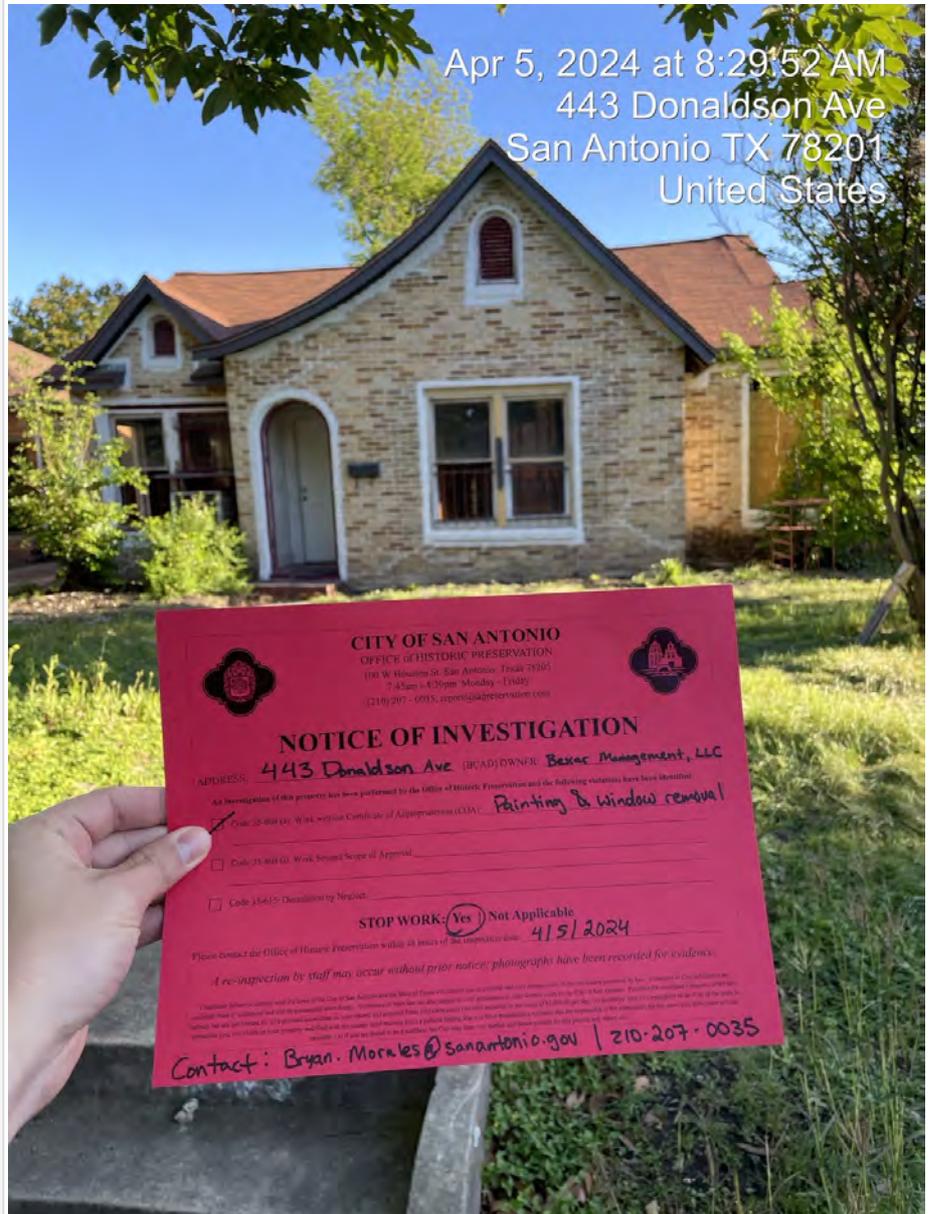
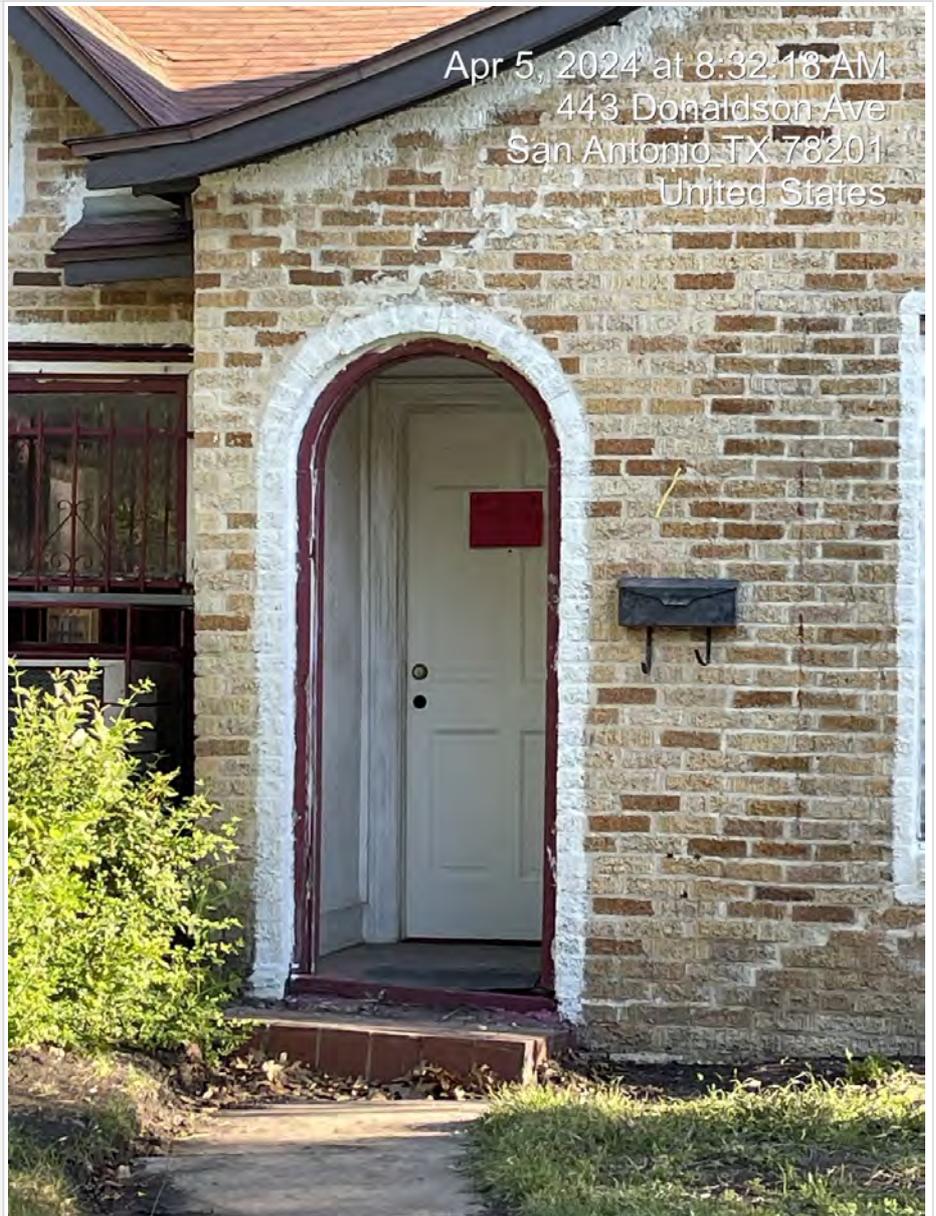
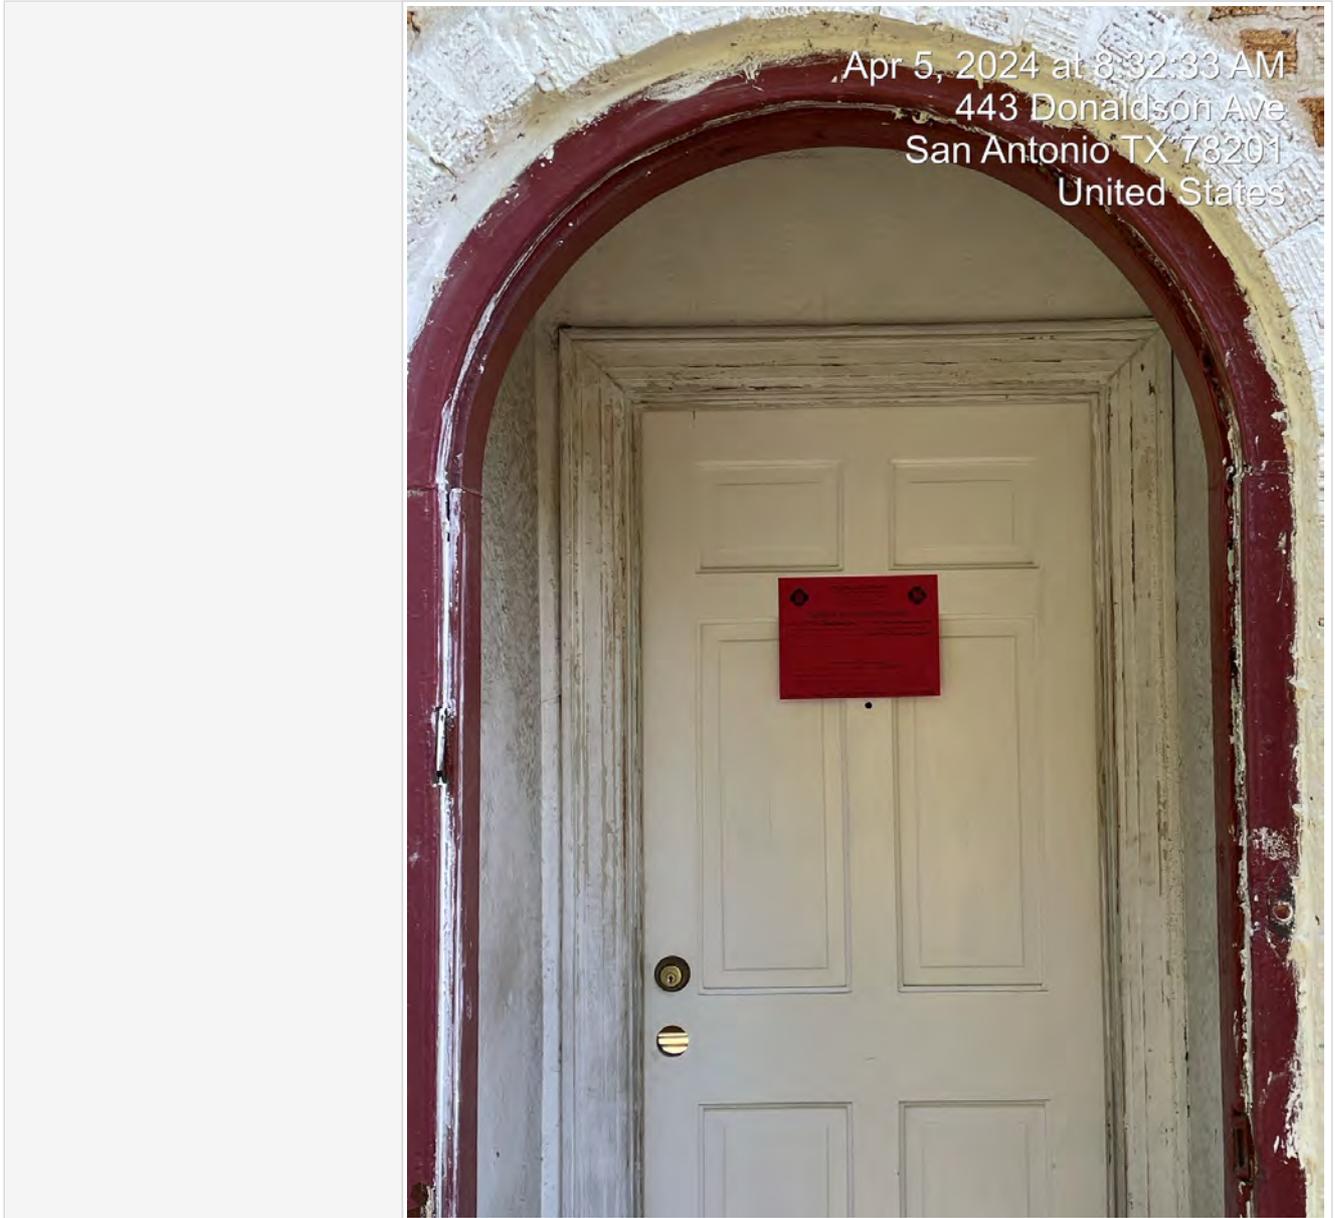
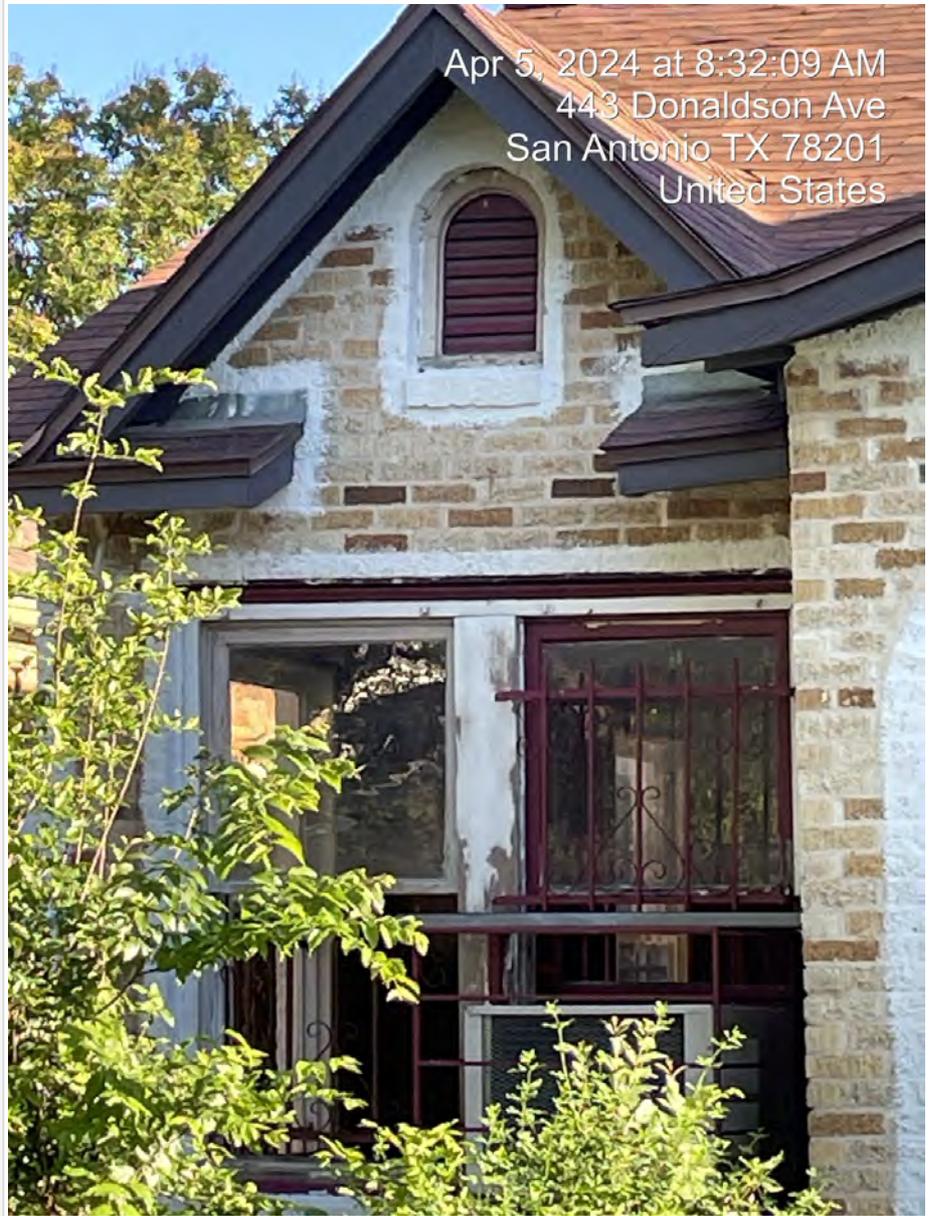
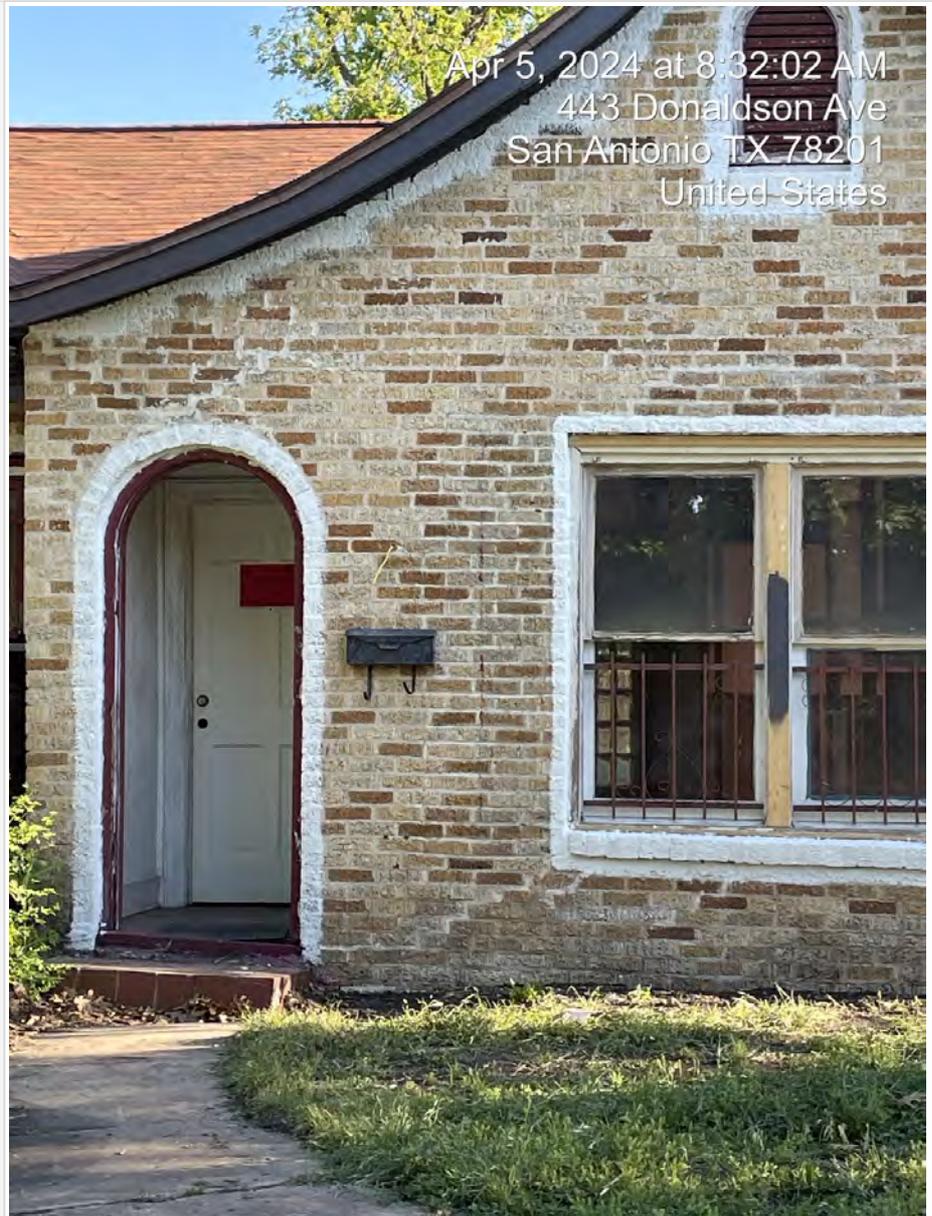
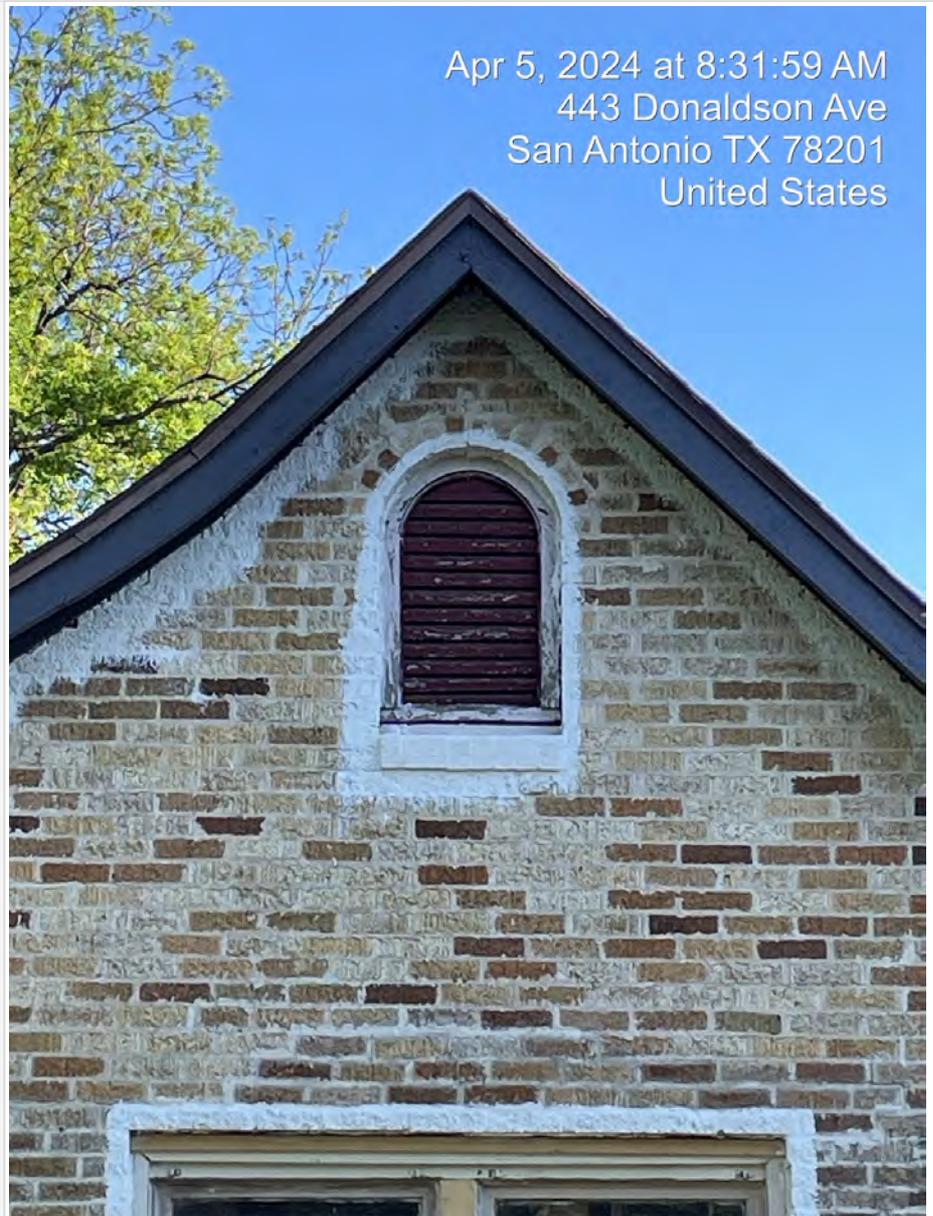
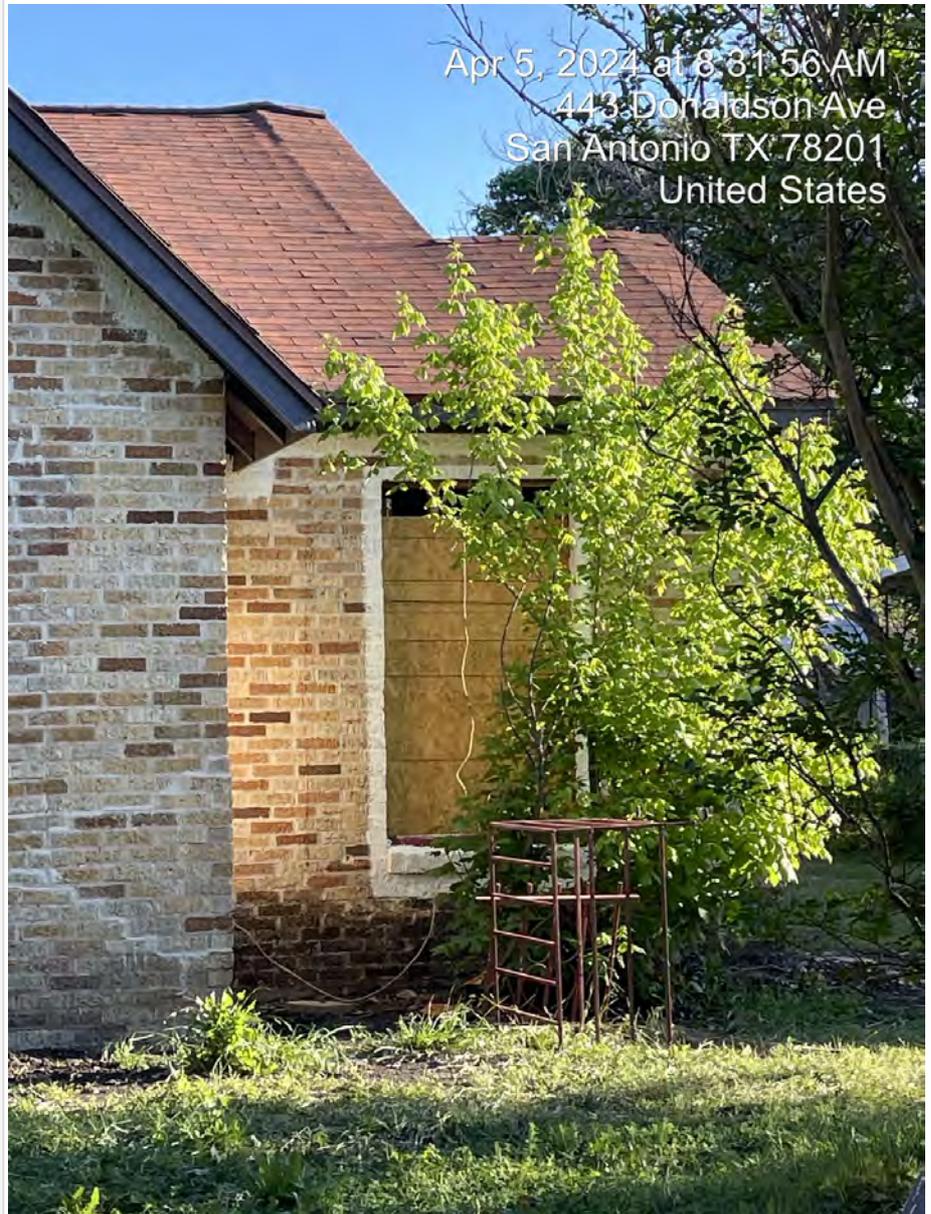
Date	04/05/2024
Time	08:32 AM (-5 GMT)
Context	citizen report
Present Staff	Bryan Morales
Present Individuals	None
Types of Work Observed	Exterior Maintenance and Alterations
Amount of Work Completed	25%
Description of work	Removal of one window visible from ROW. Painting of trim without COA and painting/prep painting historic masonry.
Description of interaction	N/A
