# HISTORIC AND DESIGN REVIEW COMMISSION

June 21, 2024

**HDRC CASE NO:** 2024-188  
**ADDRESS:** 509 NOLAN ST  
**LEGAL DESCRIPTION:** NCB 546 BLK 19 LOT W 51.08 FT OF 12  
**ZONING:** R-6, H  
**CITY COUNCIL DIST.:** 2  
**DISTRICT:** Dignowity Hill Historic District  
**APPLICANT:** john moreno/jeveconst  
**OWNER:** Mary Martin/JEVE CONSTRUCTION LLC  
**TYPE OF WORK:** Front porch column replacement, fenestration modifications  
**APPLICATION RECEIVED:** May 13, 2024  
**60-DAY REVIEW:** July 12, 2024  
**CASE MANAGER:** Edward Hall

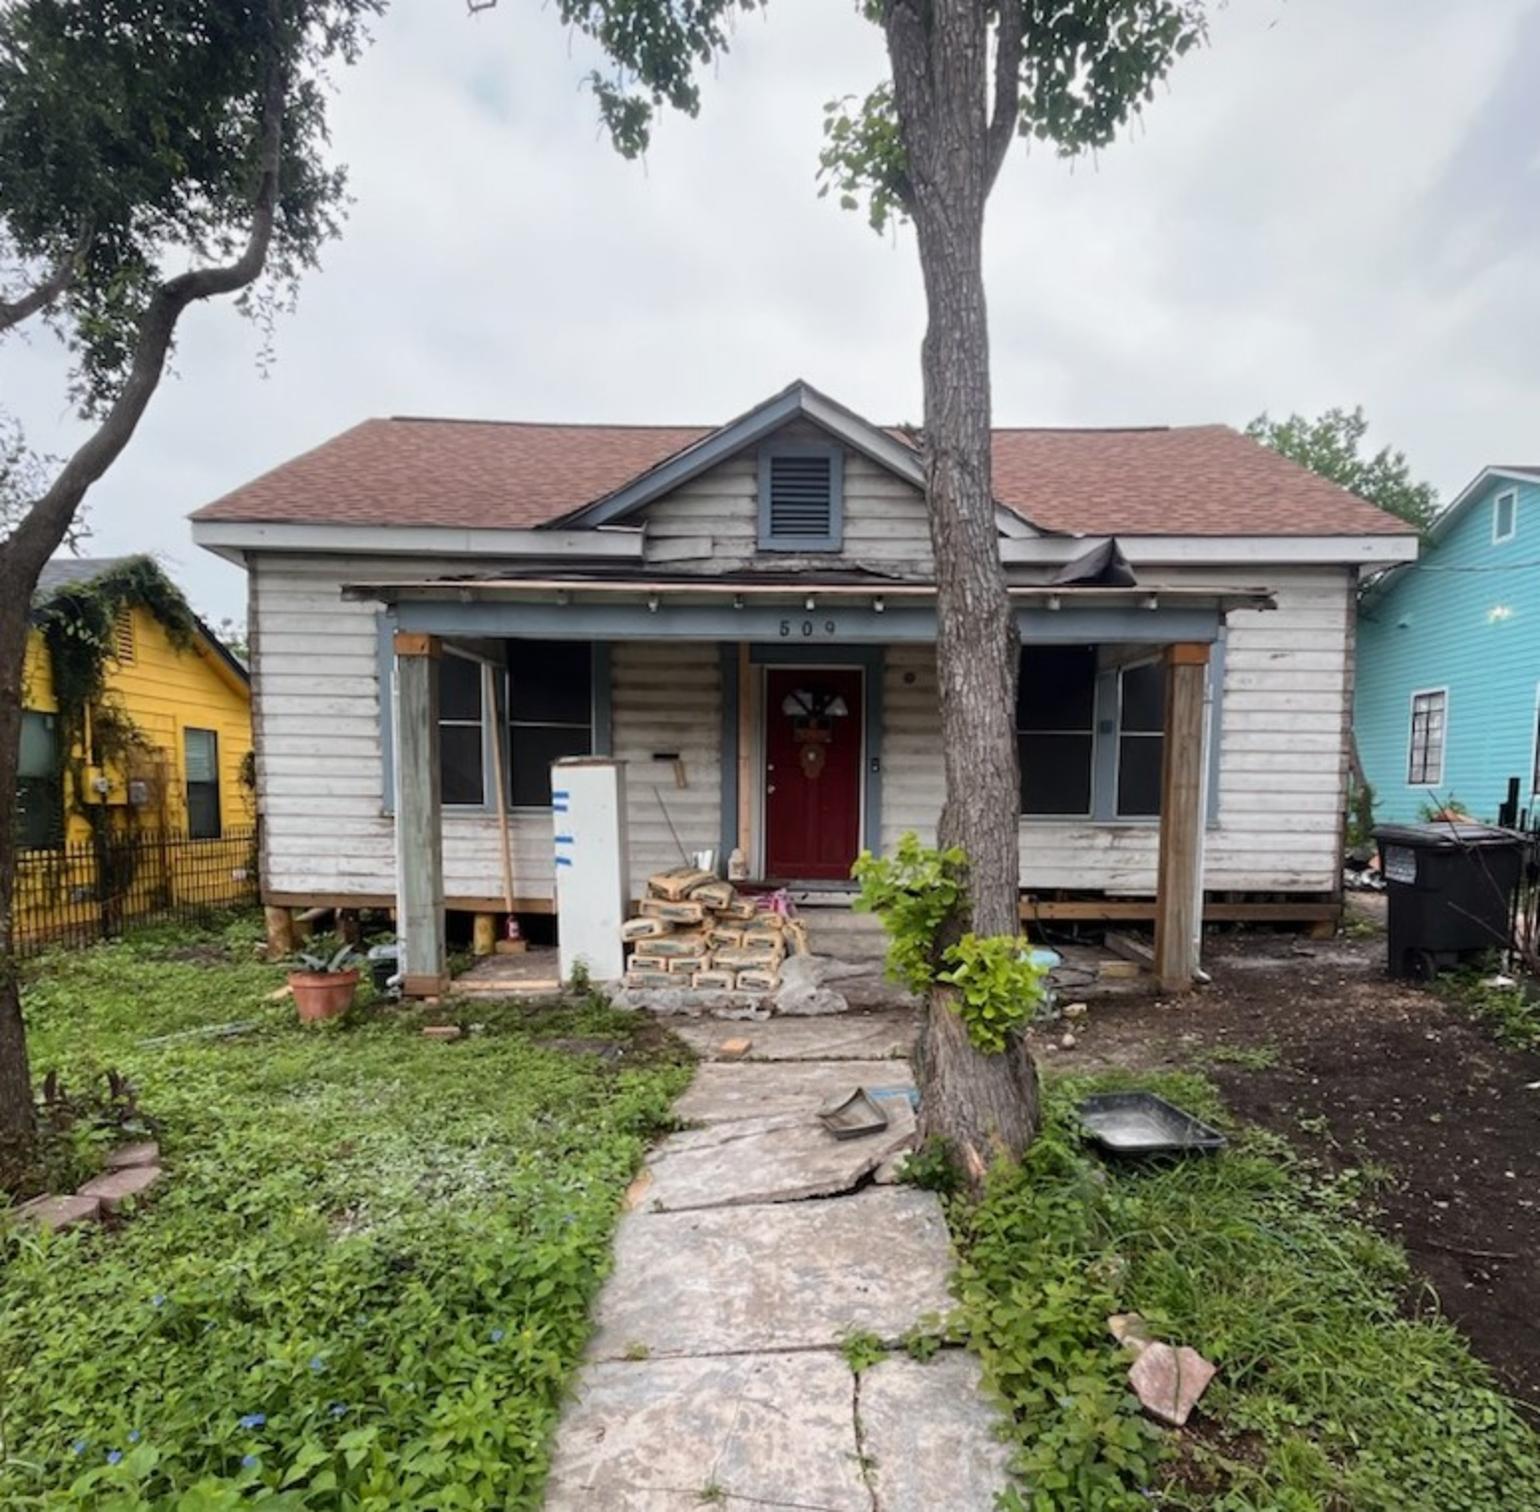
**EXAMPLE OF PROPOSED COLUMNS - PROVIDED BY APPLICANT**

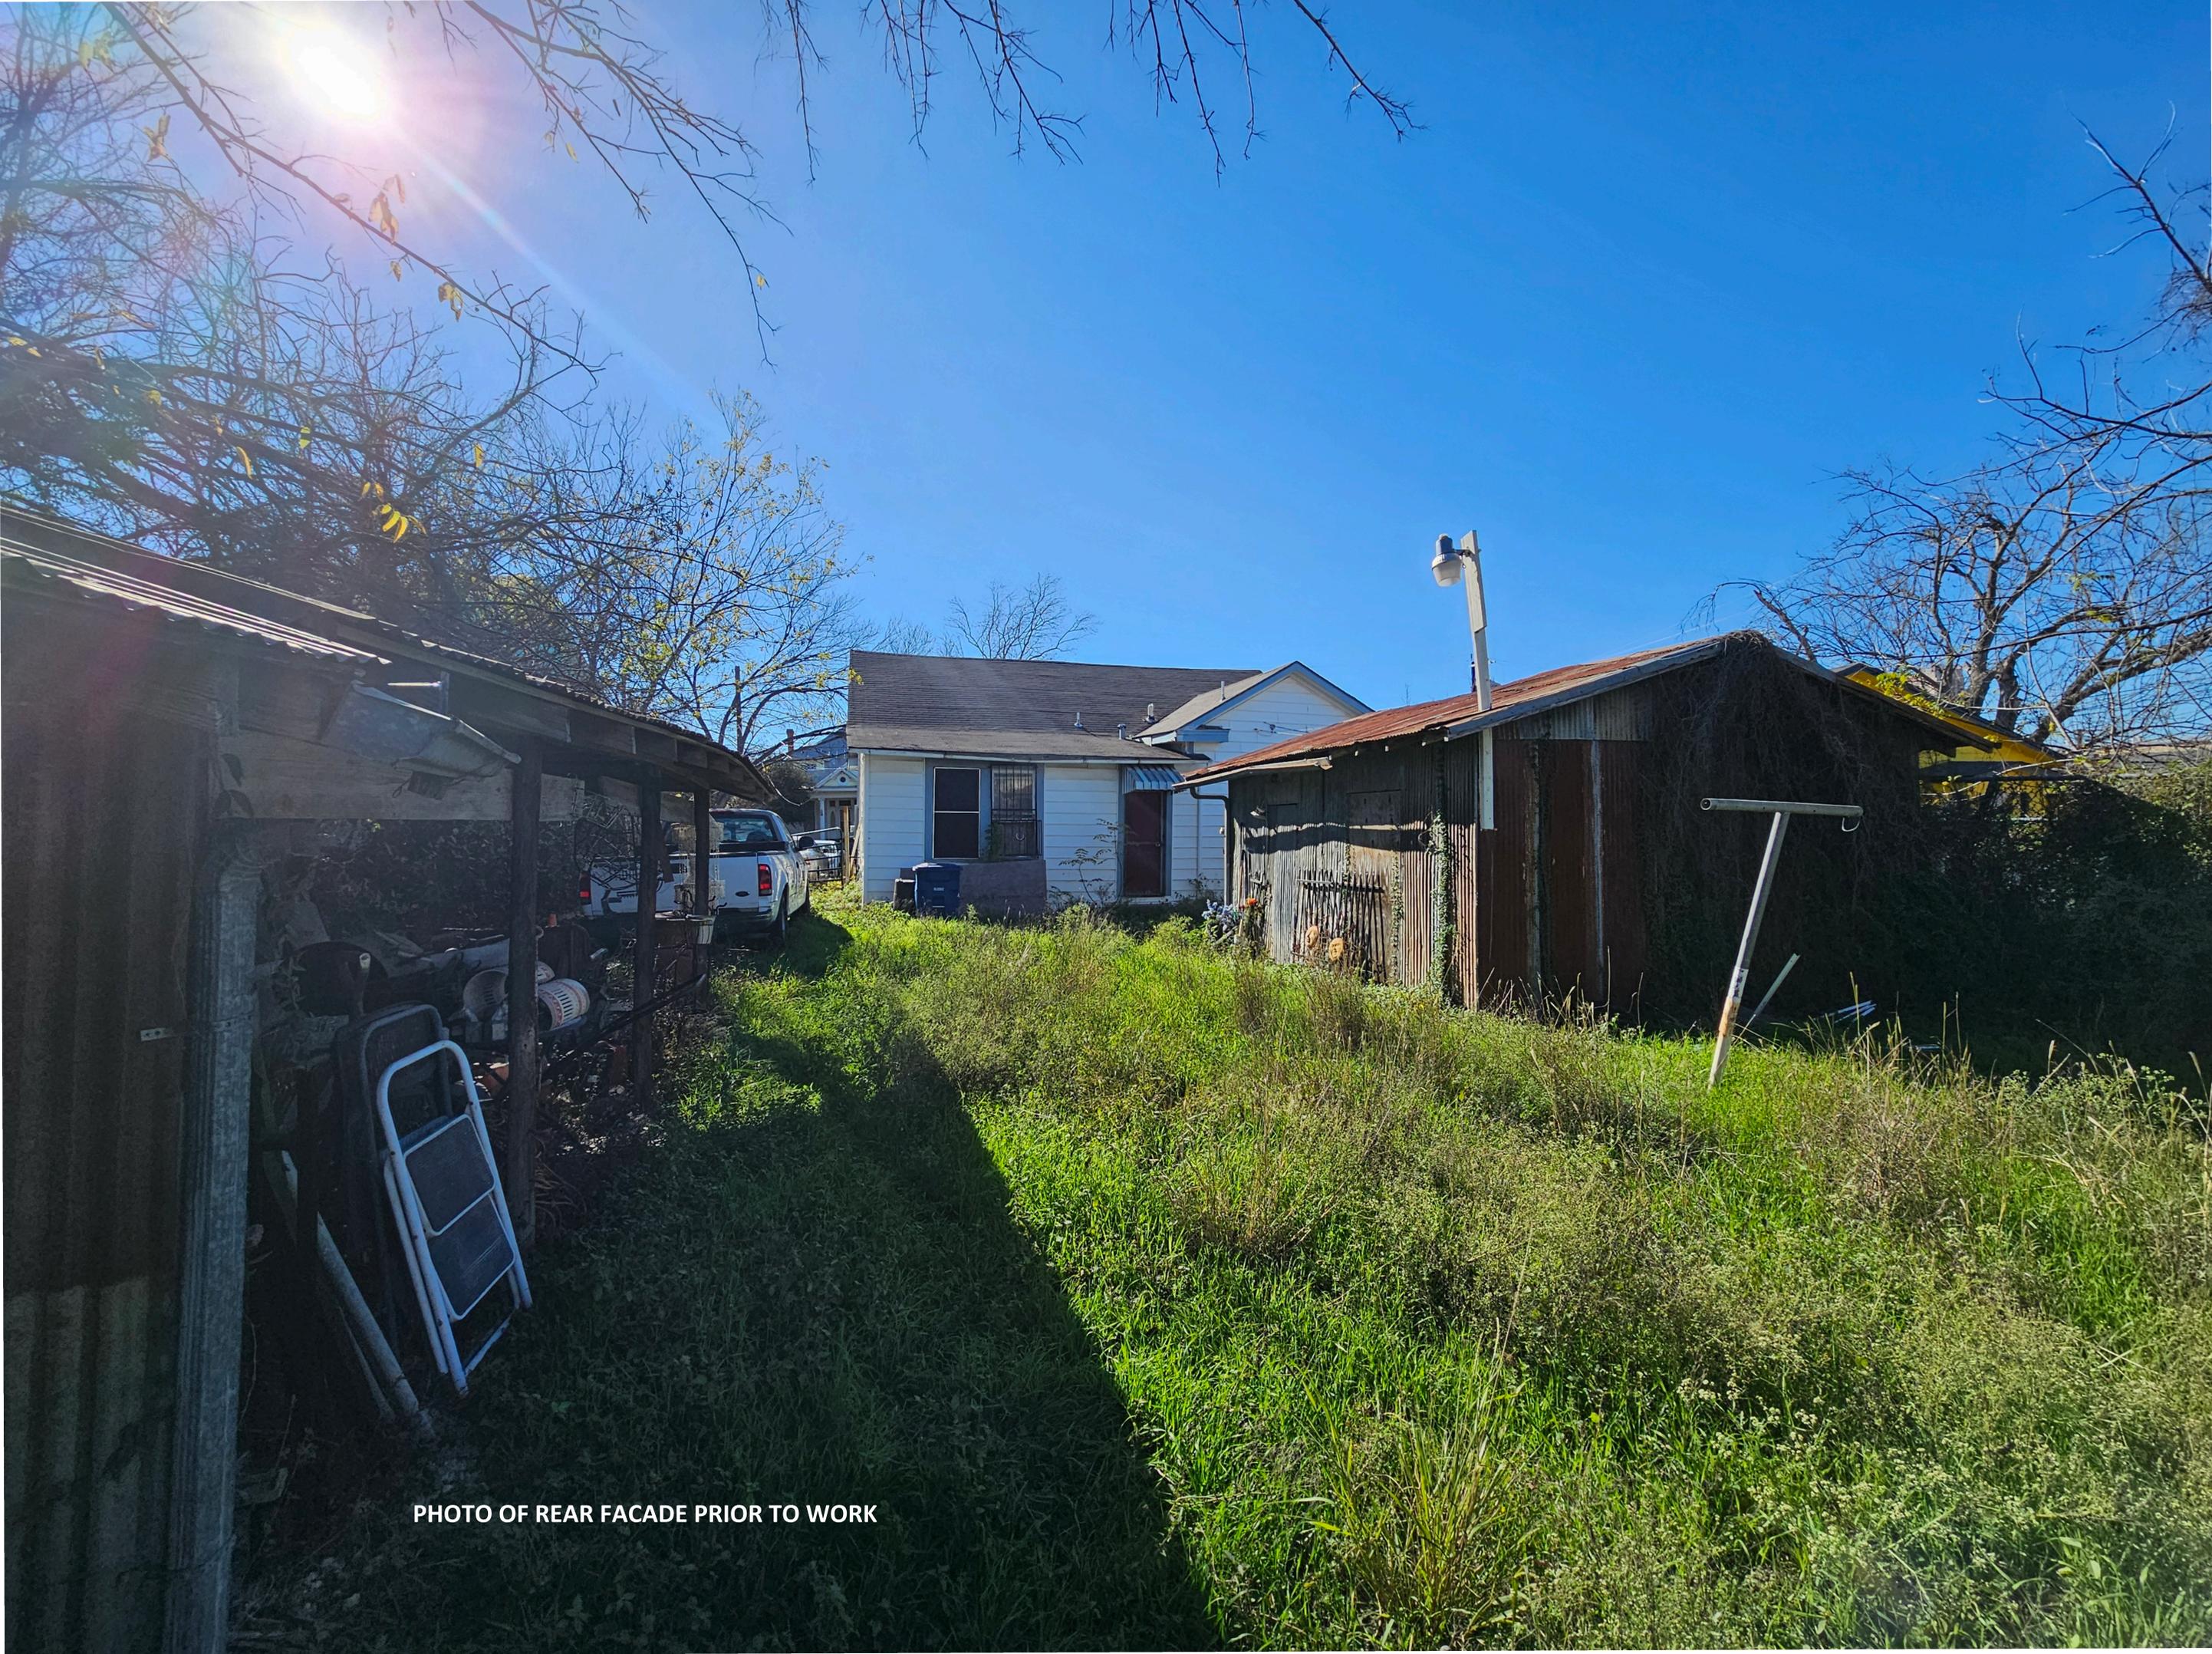
PHOTO OF REAR FACADE PRIOR TO WORK

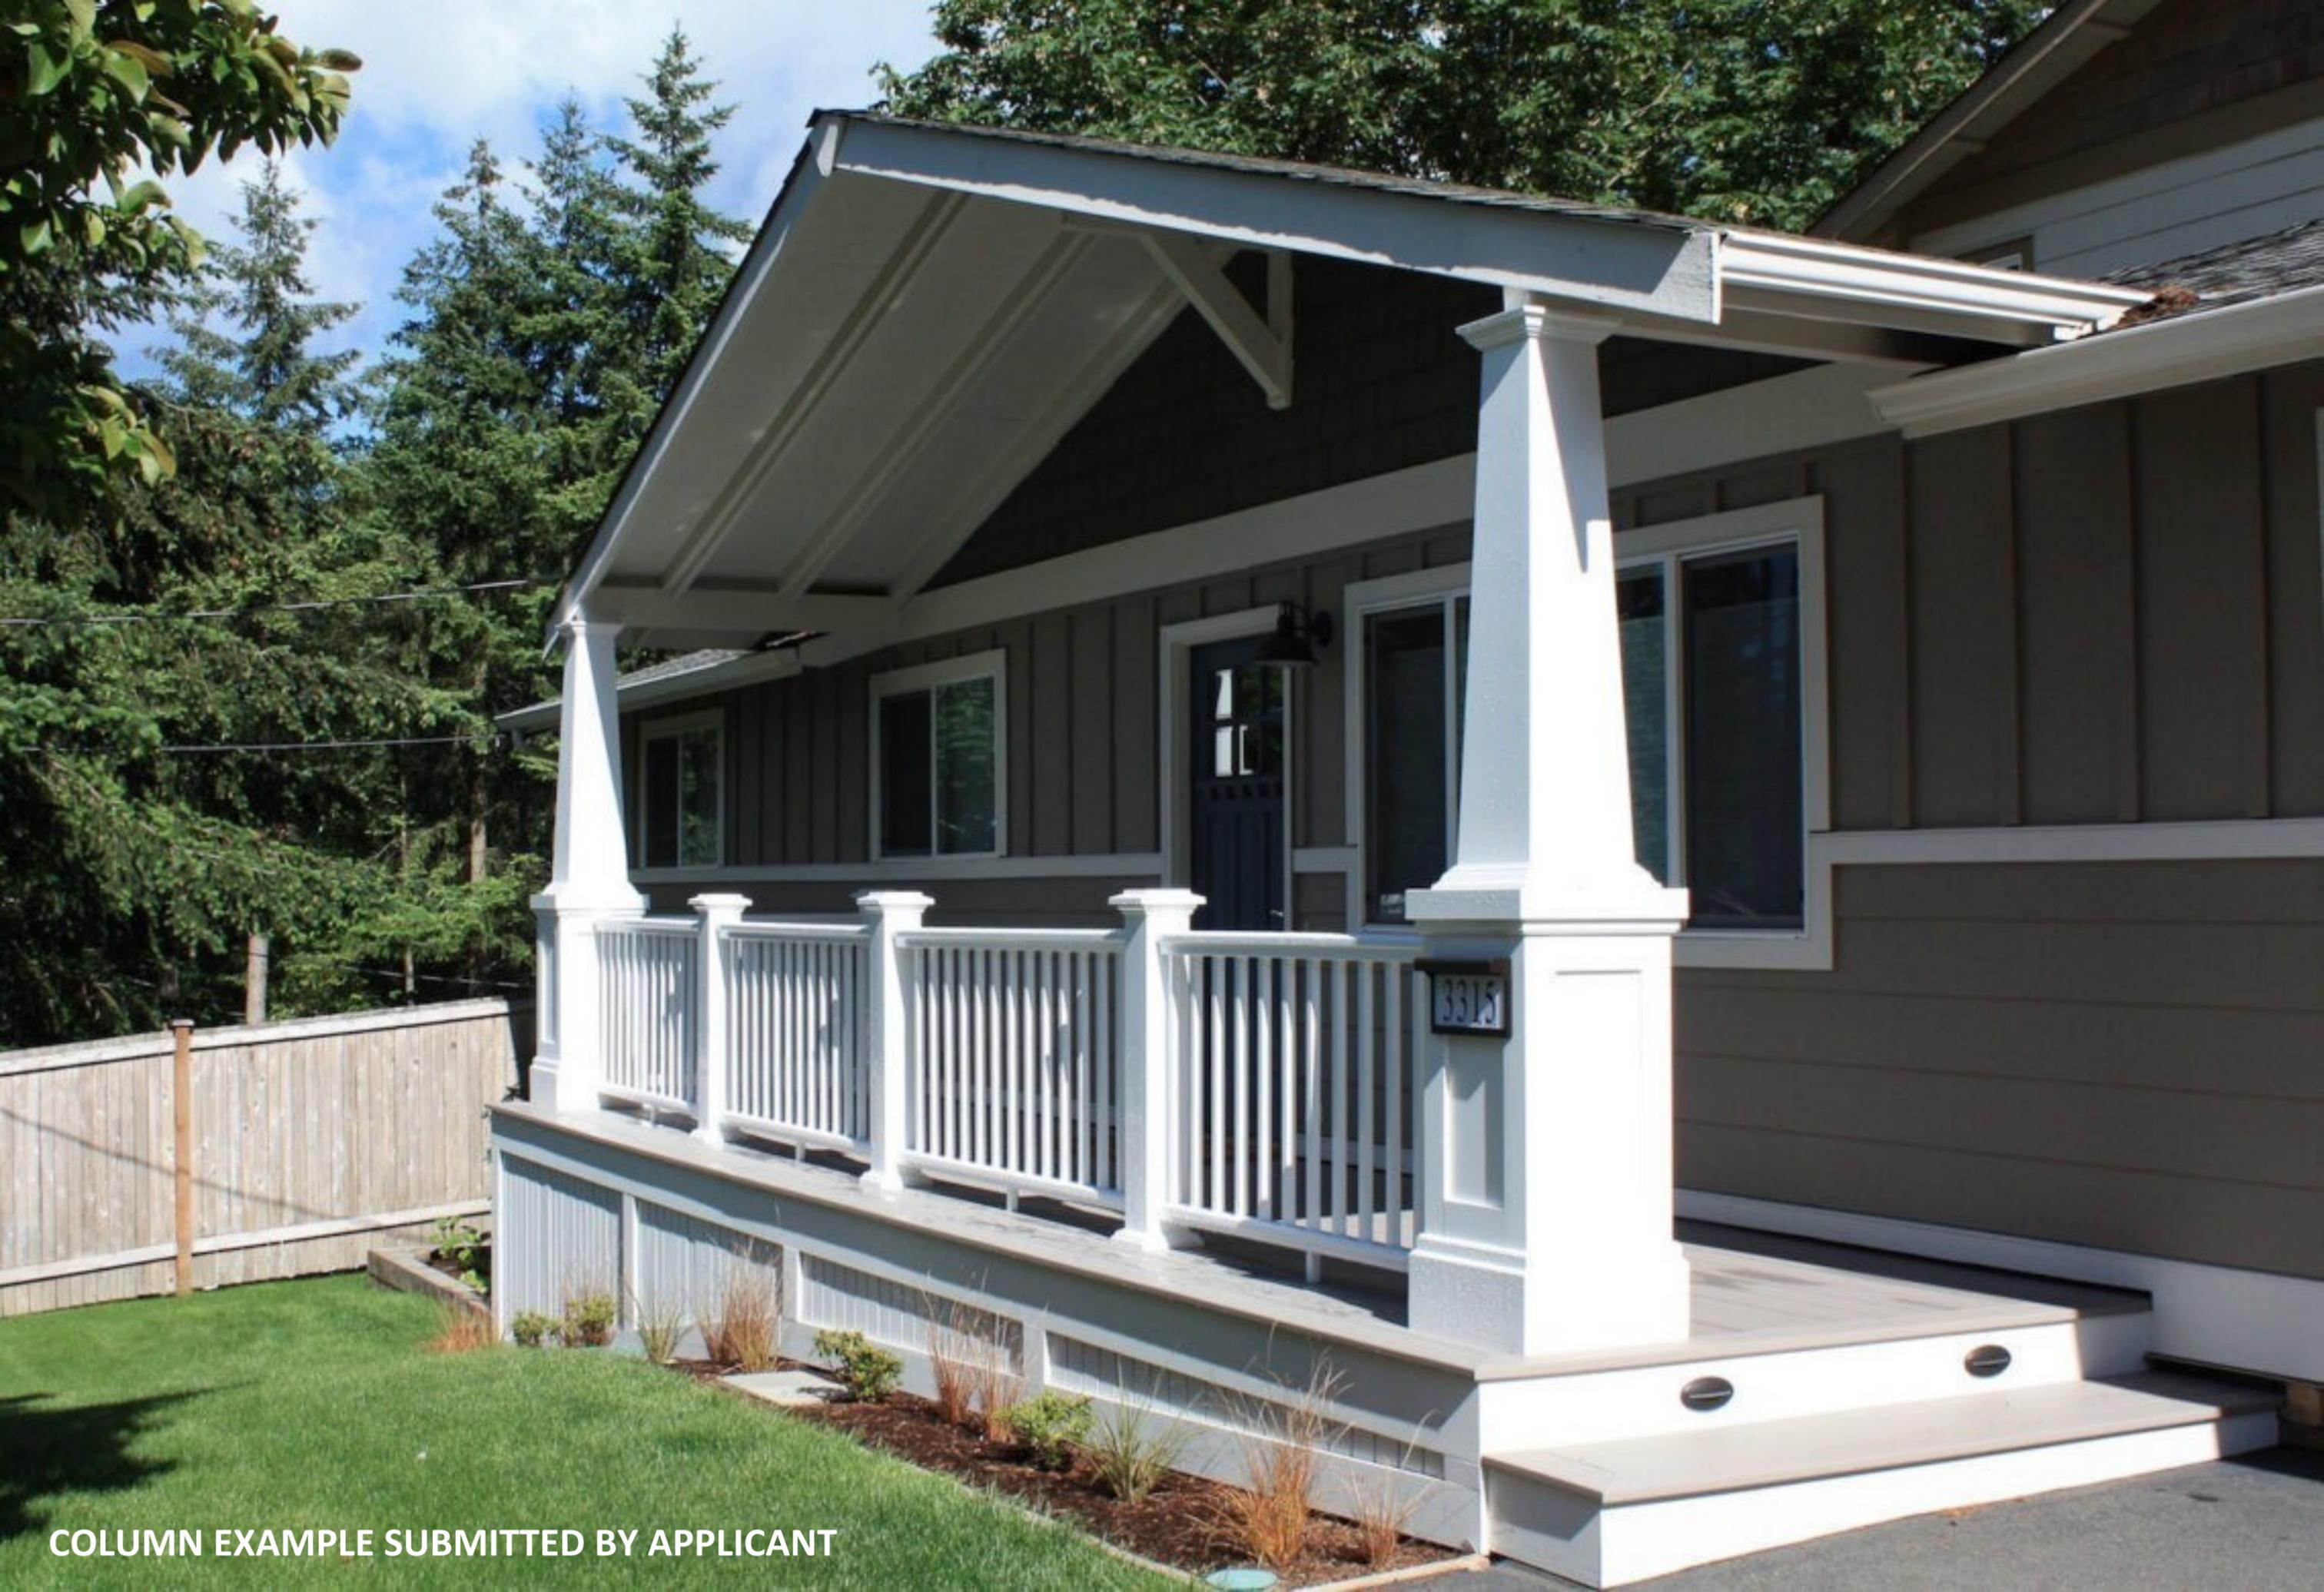
COLUMN EXAMPLE SUBMITTED BY APPLICANT

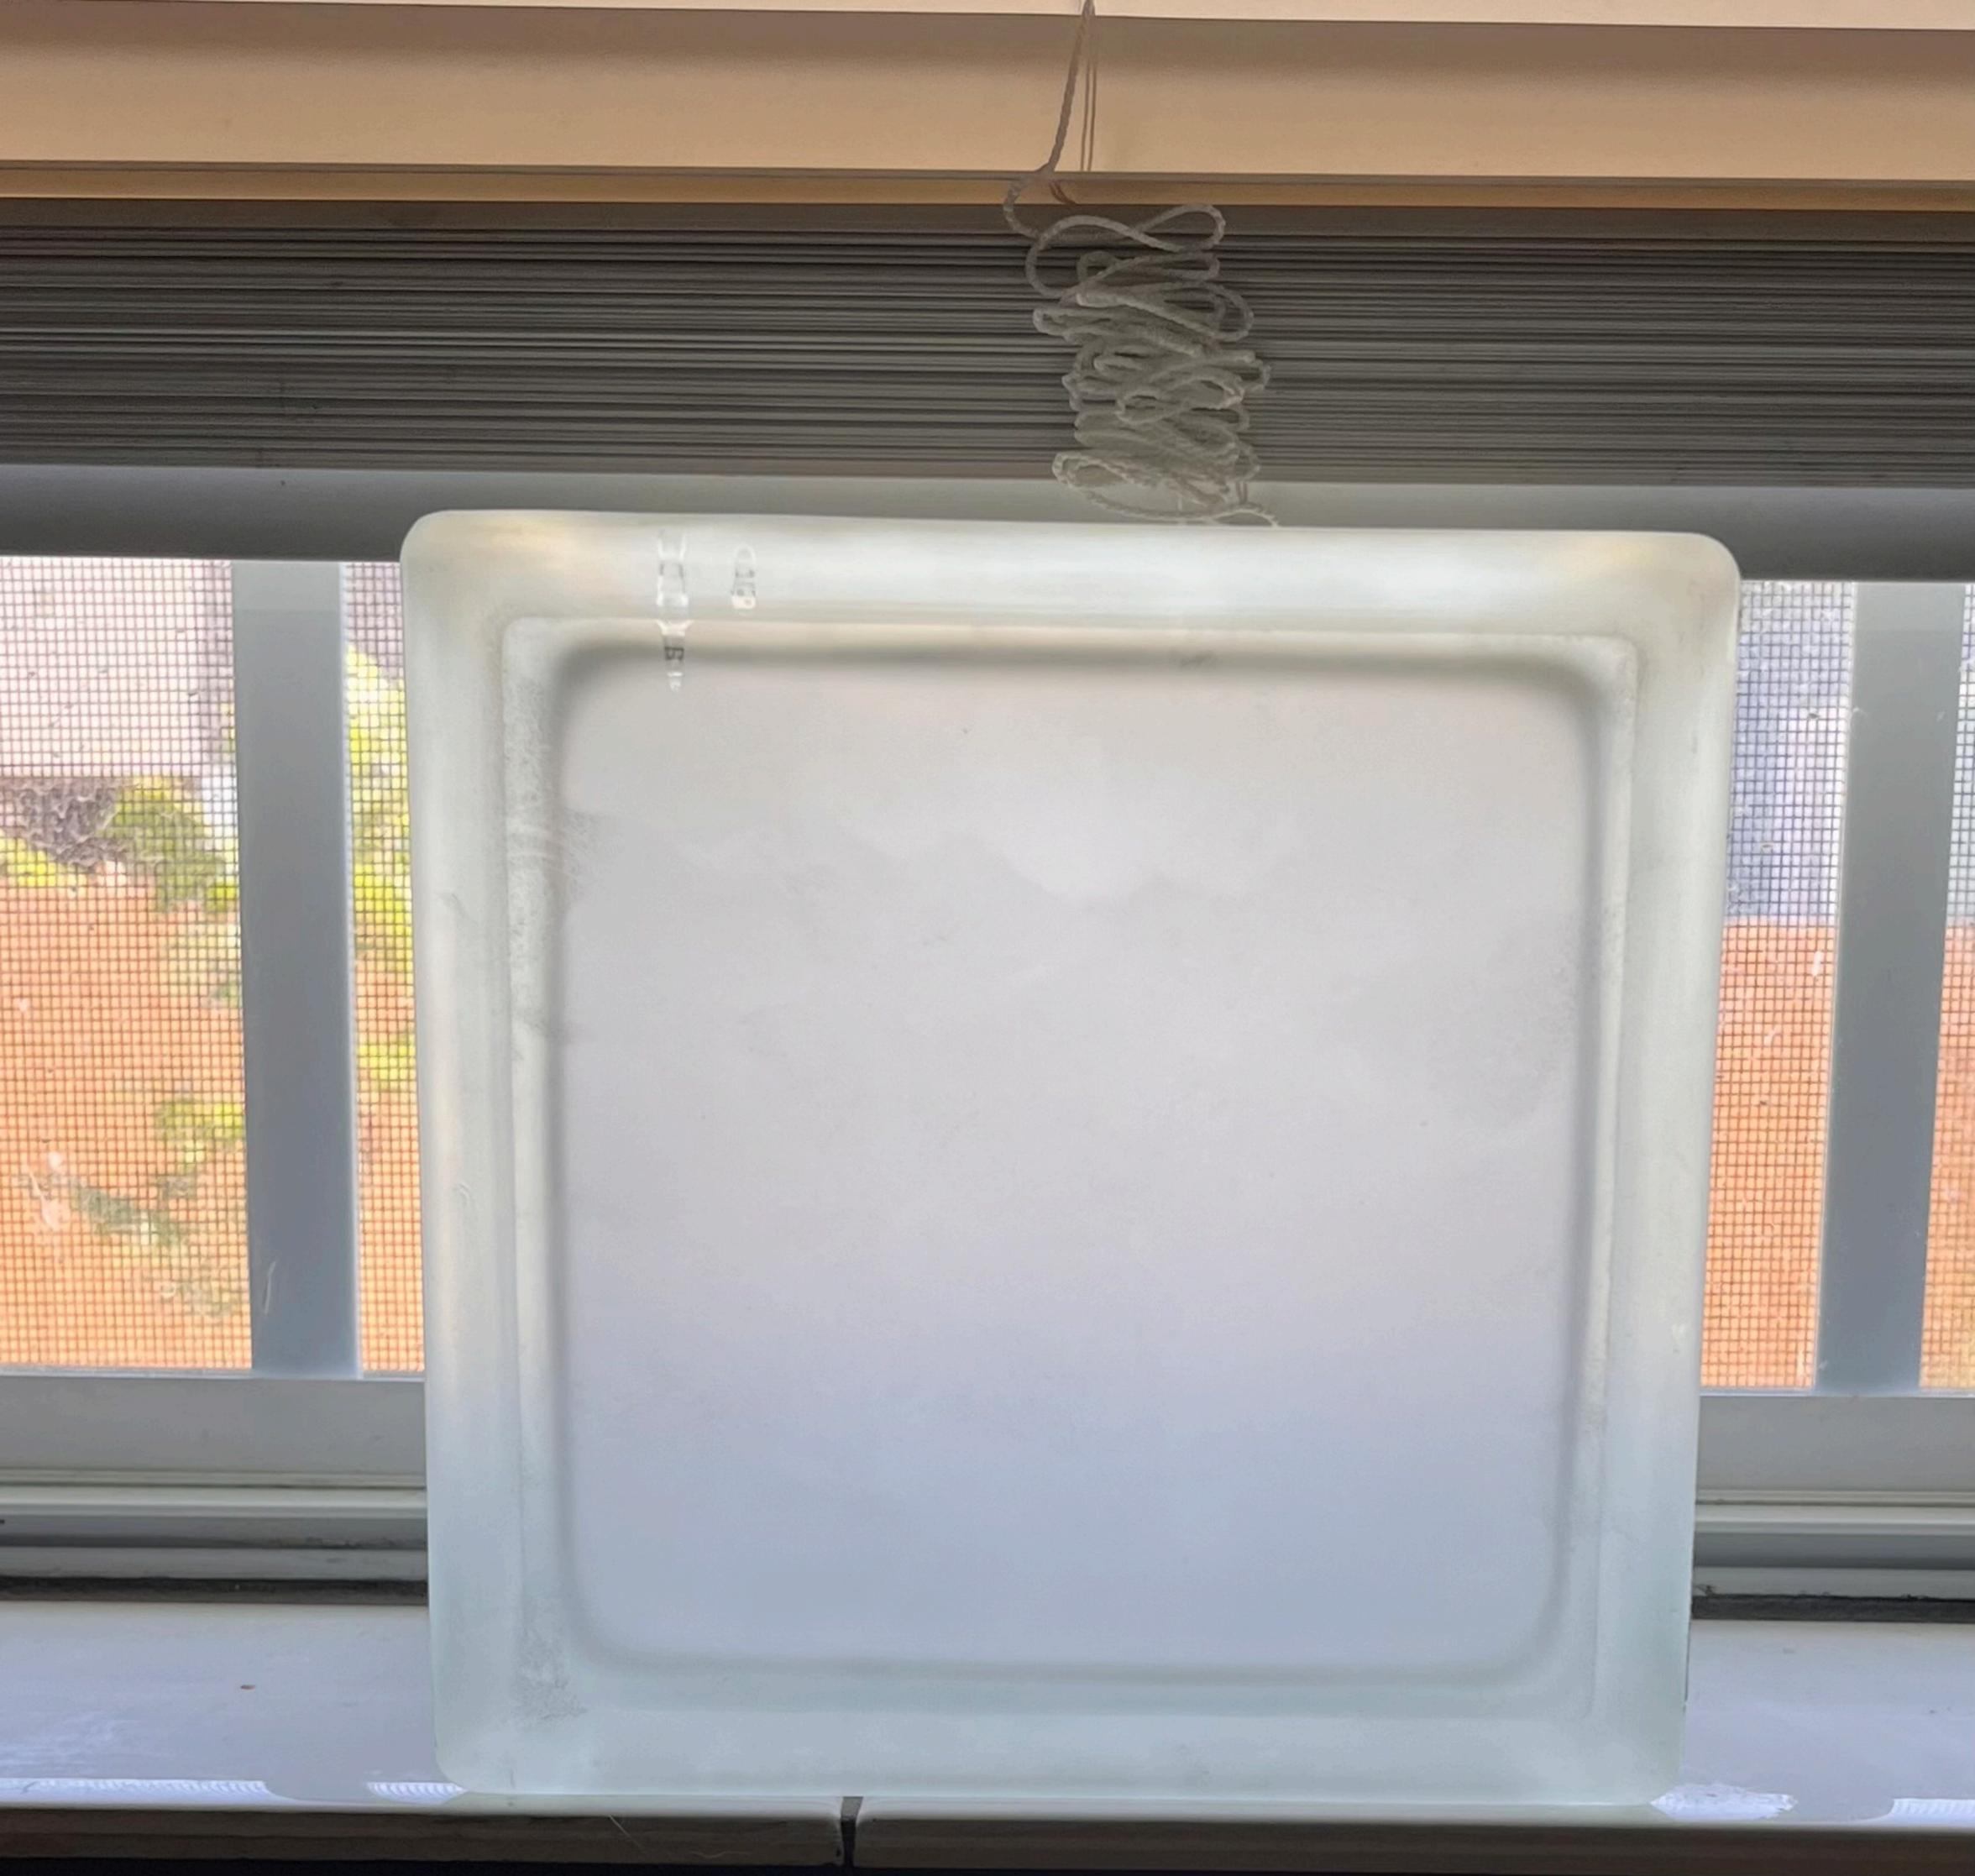
GLASS BLOCK EXAMPLE SUBMITTED BY APPLICANT
