**HISTORIC AND DESIGN REVIEW COMMISSION
COMPLIANCE AND TECHNICAL ADVISORY BOARD**

June 20, 2025

HDRC CASE NO:	2025-134
ADDRESS:	617 E GUENTHER ST
LEGAL DESCRIPTION:	NCB 940 BLK 3 LOT 7&8
ZONING:	RM-4, H
CITY COUNCIL DIST.:	1
DISTRICT:	King William Historic District
APPLICANT:	Jorgeluis Espinoza/Blue Hammer Construction LLC
OWNER:	EM INVESTMENT GROUP LLC & THREE OAKS REALTY LLC
TYPE OF WORK:	Wood window replacement
APPLICATION RECEIVED:	May 08, 2025
60-DAY REVIEW:	July 07, 2025
CASE MANAGER:	Bryan Morales

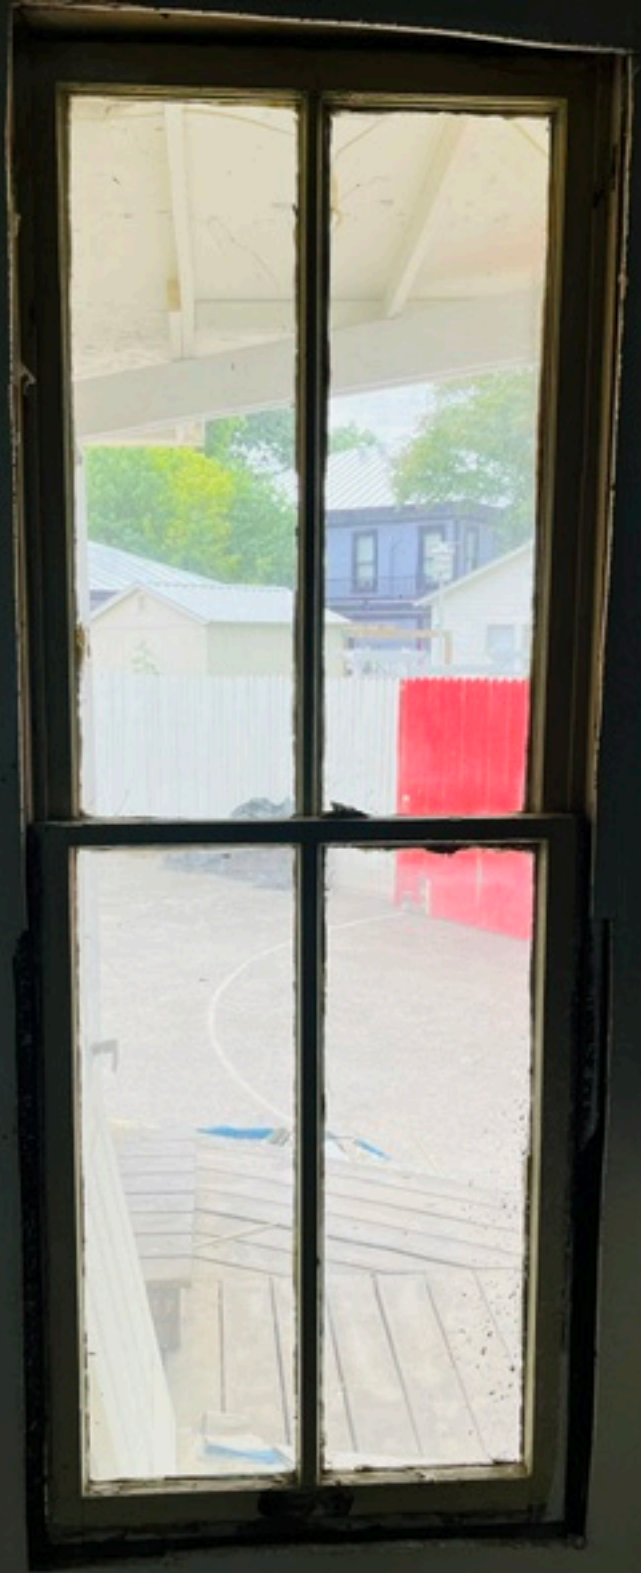
Jun 12, 2025 at 8:30:57 AM
617 E Guenther St
San Antonio TX 78210
United States

- b. WINDOW REPLACEMENT: EXISTING CONDITION – Staff conducted a site visit on June 12, 2025, to assess the existing window condition and found that the first-floor's two-over-two wood window proposed for replacement is a good candidate for in-kind repair. The two one-over-one wood windows located on the second floor are missing their bottom halves and are eligible for replacement with an in-kind window product meeting staff's standard stipulation. Staff does not recommend replacement of the first-floor window. Staff may administratively approve replacement of the two one-over-one wood windows on the second floor provided the applicant replaces the

Staff does not recommend approval of the request, based on the findings. Staff recommends the applicant repair the first-floor wood window in-kind and replace the two one-over-one wood windows on the second floor with a salvaged wood window or a new fully wood window conforming to Guidelines.

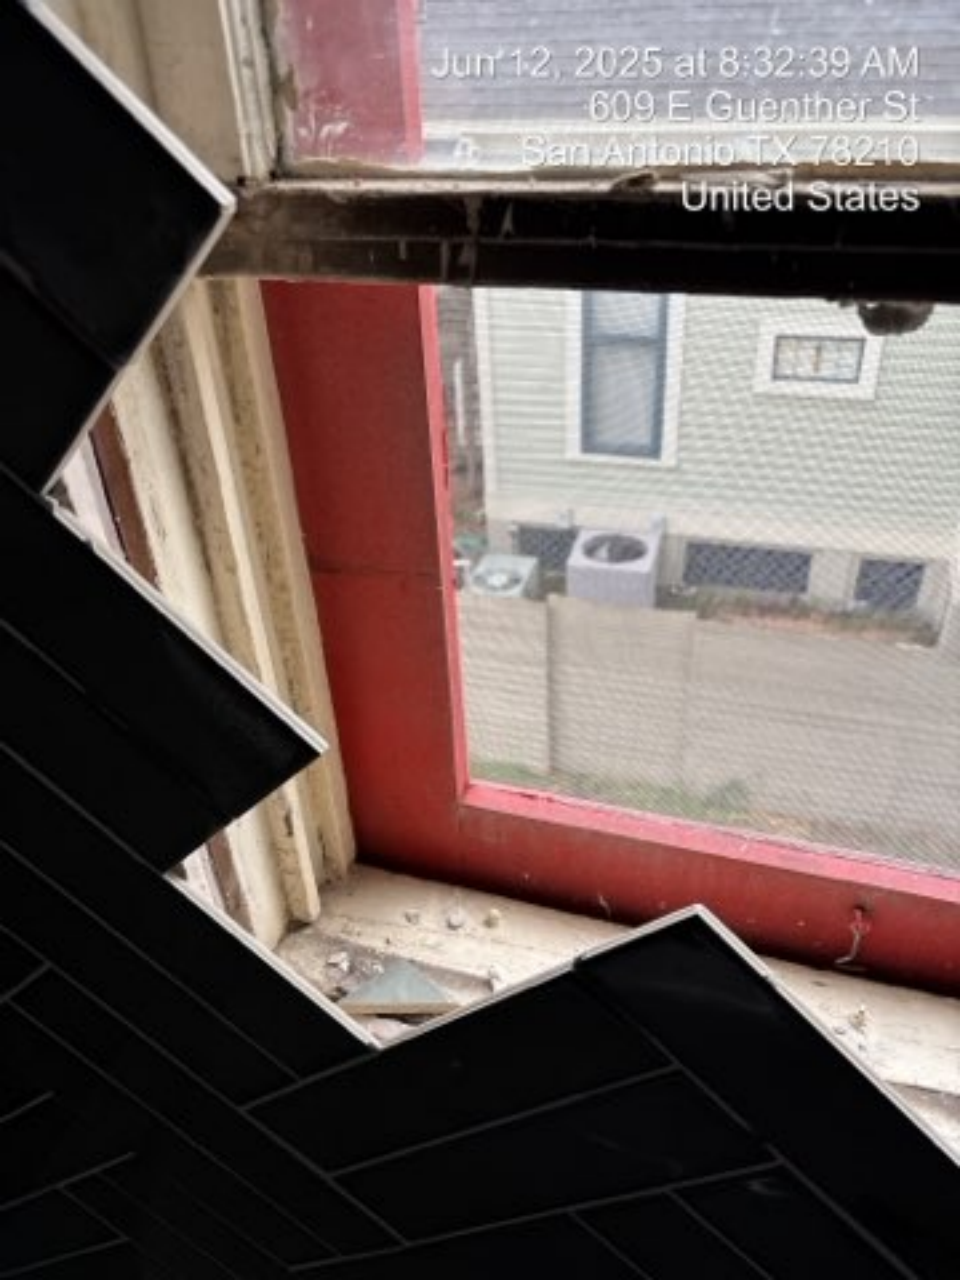
Jun 12, 2025 at 8:35:27 AM
617 E Guenther St
San Antonio TX 78210
United States

windows in-kind. Staff finds the replacement of three wood windows onsite with an aluminum window product to match previously replaced windows does not conform to Guidelines.
