HISTORIC AND DESIGN REVIEW COMMISSION

February 16, 2022

HDRC CASE NO: 2022-093
ADDRESS: 715 LABOR ST
LEGAL DESCRIPTION: NCB 729 BLK 3 LOT N 46.31 FT OF 8 & N IRRG 45.3 FT OF 9
ZONING: R-6, H
CITY COUNCIL DIST.: 1
DISTRICT: Lavaca Historic District
APPLICANT: Shawa Walker/ROC Acquisitions LLC
OWNER: Shawa Walker/ROC Acquisitions LLC
TYPE OF WORK: Historic Tax Verification
APPLICATION RECEIVED: February 04, 2022
60-DAY REVIEW: Not applicable due to City Council Emergency Orders
CASE MANAGER: Rachel Rettaliata

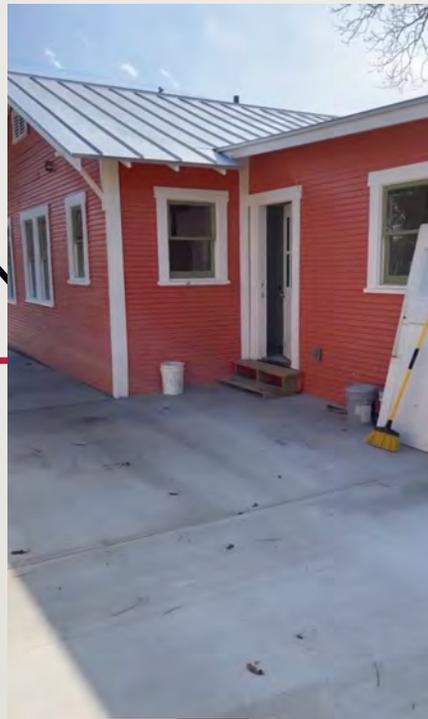
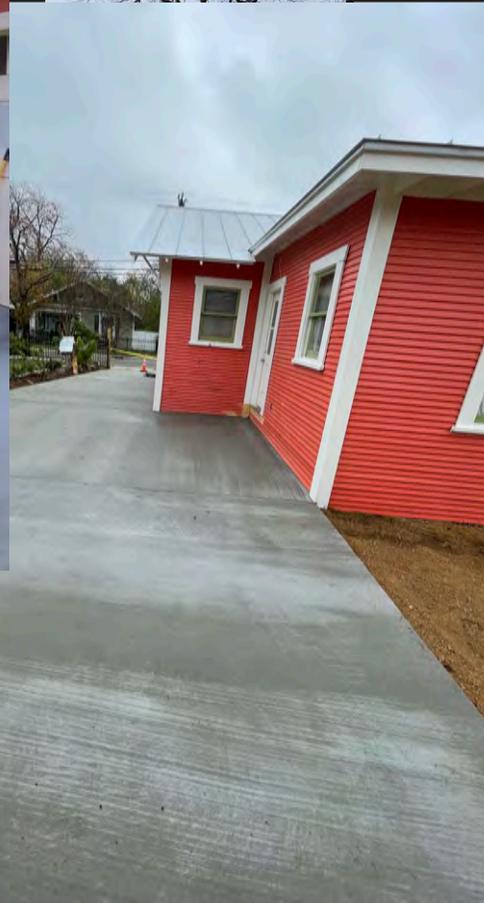
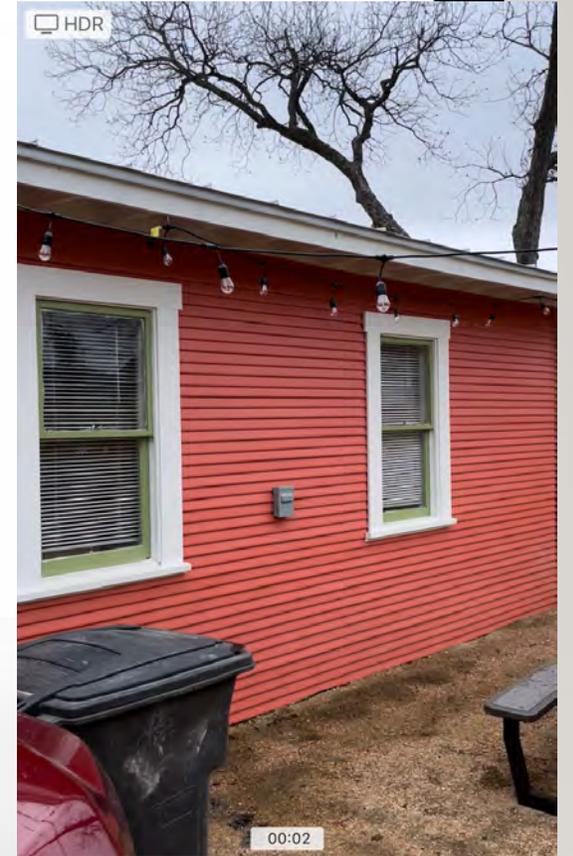
EXTERIOR RESTORATION PLAN

- [REDACTED] Completely redo the foundation – all the cedar piers and wood beams underneath were rotten and need to be replaced with new wood concrete piers. Siding will continue down to the ground.
- [REDACTED] Exterior roof is beyond repair. Add a new standing-seam metal roof (if approved) or use composition shingles which are what is on the house now
- [REDACTED] Repair and repaint the exterior wood siding, front door and windows. We will keep the original wood pattern on the house. Rotten wood around windows will be replaced. Repainted with Sherwin Williams Exterior Satin finish paint.

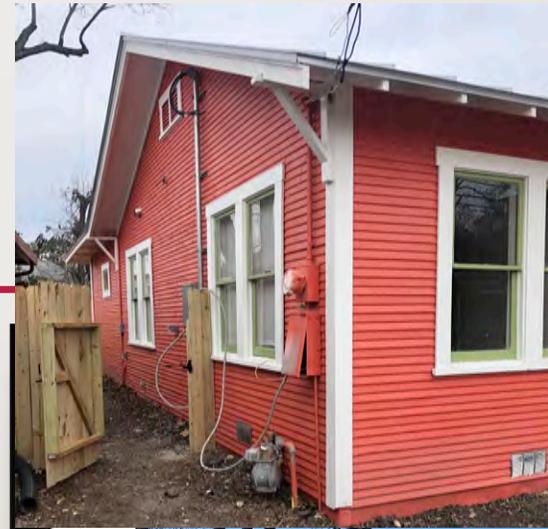
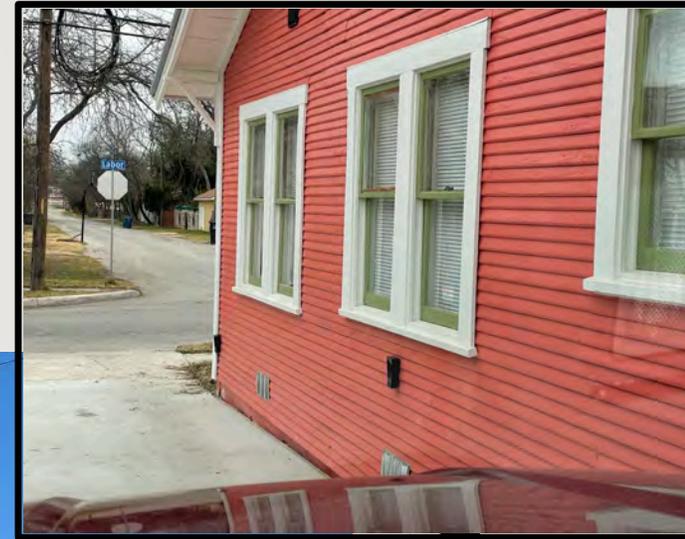
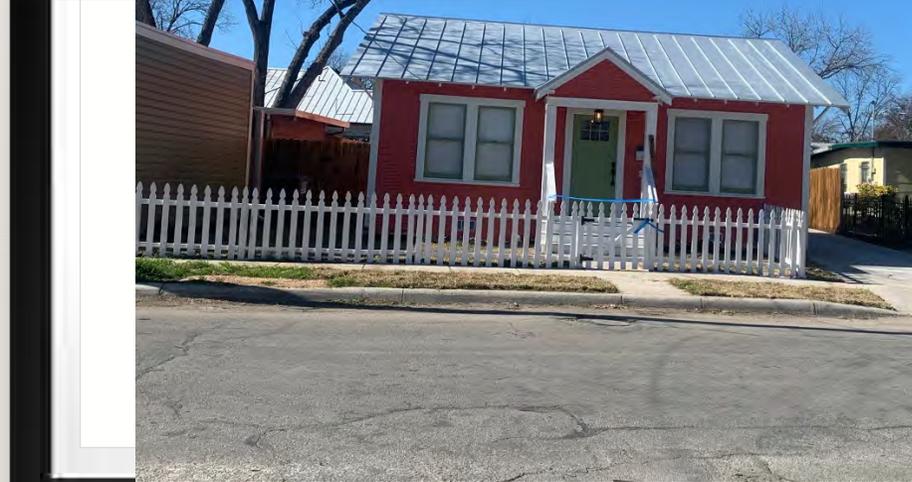
EXTERIOR RESTORATION CONTINUED

- [redacted] New fence around the property either a wood picket or a wrought iron like the neighbors on either side (see photos)
