# HISTORIC AND DESIGN REVIEW COMMISSION

**HDRC CASE NO:** 2022-095  
**ADDRESS:** 205 OSTROM  
**LEGAL DESCRIPTION:** NCB 6938 BLK LOT 1&2  
**ZONING:** R-4 CD, H  
**CITY COUNCIL DIST.:** 1  
**DISTRICT:** River Road Historic District  
**OWNER:** Stapleton Design & Build LLC, Stapleton Design & Build LLC  
**TYPE OF WORK:** Historic Tax Certification  
**APPLICATION RECEIVED:** February 04, 2022  
**60-DAY REVIEW:** Not applicable due to City Council Emergency Orders  
**CASE MANAGER:** Rachel Rettaliata  
**REQUEST:**

The applicant is requesting Historic Tax Certification for the property at 205 Ostrom.

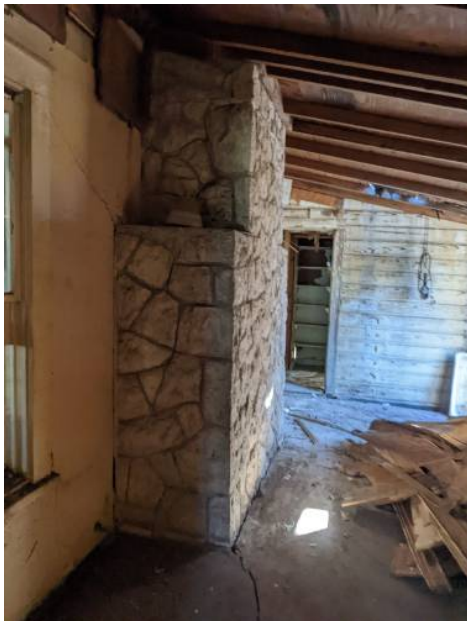
(3)

Rear porch behind Fireplace slab cracked in multiple places.

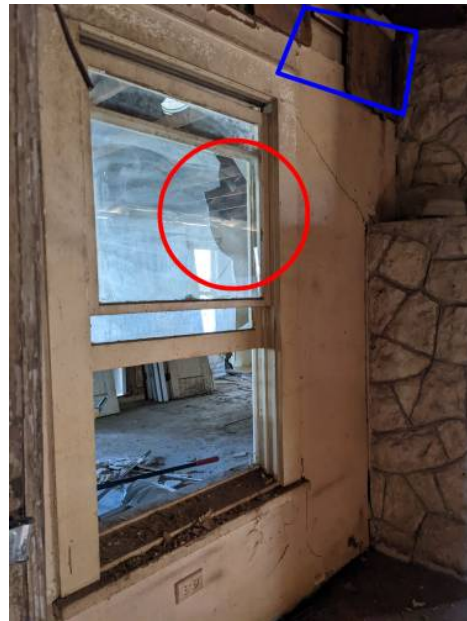
(4)

Rear of fireplace see floor cracks.

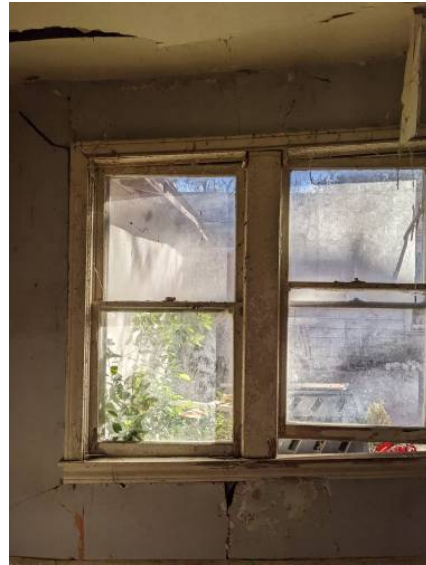
(26)

Most North western room. Walls failing floor failed, windows racked out of plumb open for years. No foundation support anymore here joists sitting on dirt

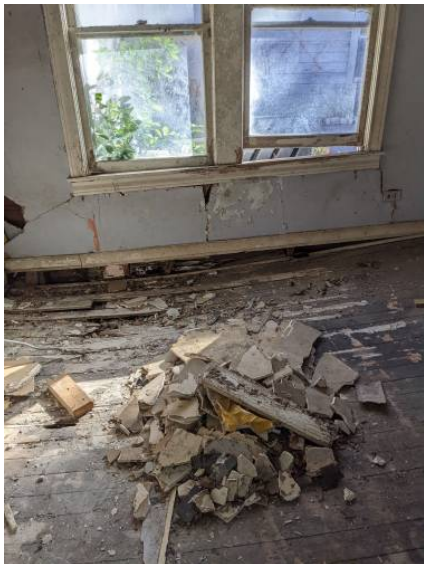
(27)

Most North western room. windows racked out of plumb due to total foundation collapse.

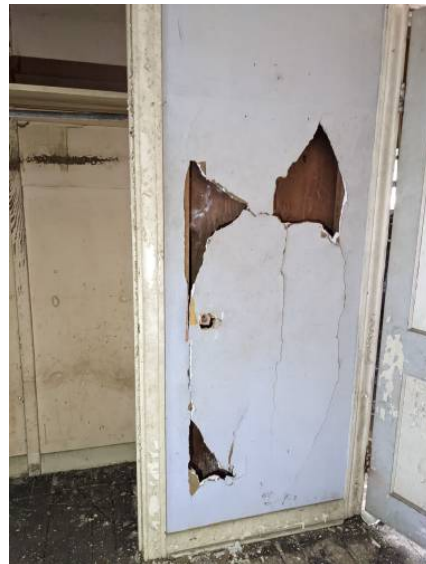
(28)

Most North western room. Walls failing floor failed, windows racked out of plumb open for years. No foundation support anymore here joists sitting on dirt

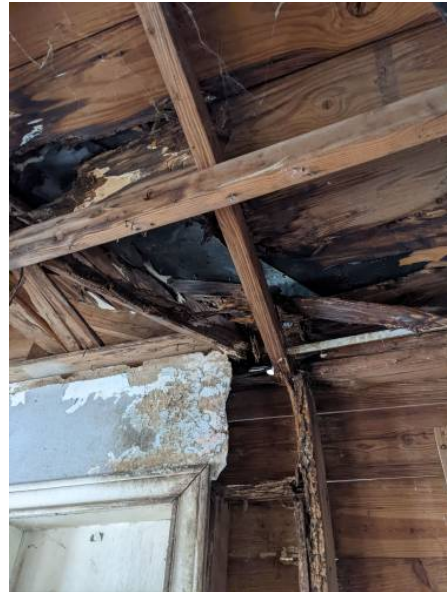
(30)

Most North western room. Roof structure failed.

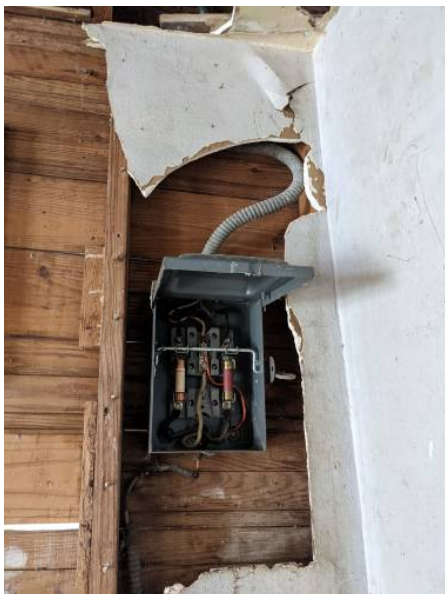
(31)

Most North western room. Walls failing floor failed, windows racked out of plumb open for years. No foundation support anymore here joists sitting on dirt. ROOF JOISTS FAILED

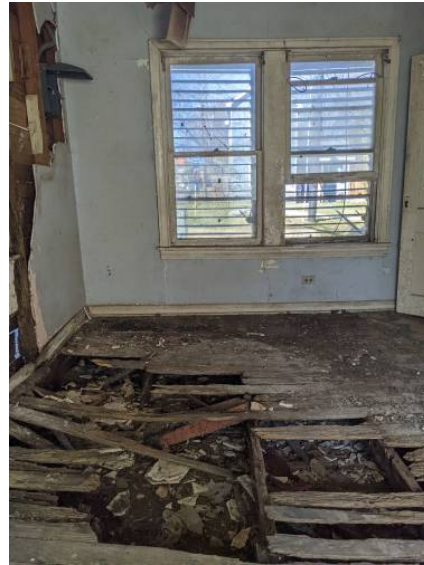
(34)

Most North western room. Walls failing floor failed, windows racked out of plumb open for years. No foundation support anymore here joists sitting on dirt

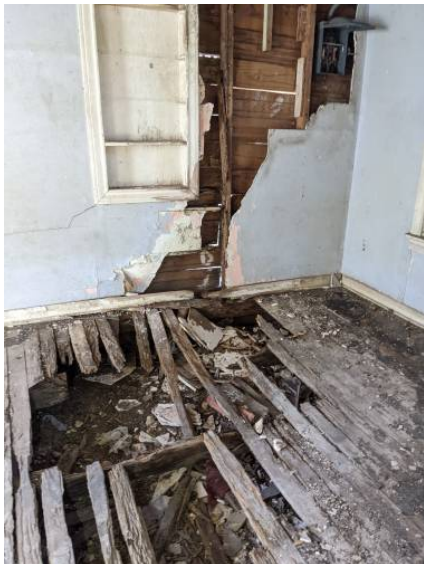
(35)

Most North western room. Walls failing floor failed, windows racked out of plumb open for years. No foundation support anymore here joists sitting on dirt

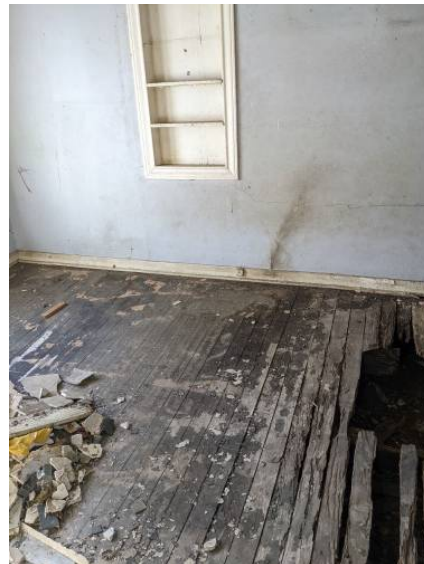
(36)

Most North western room. Walls failing floor failed, windows racked out of plumb open for years. No foundation support anymore here joists sitting on dirt

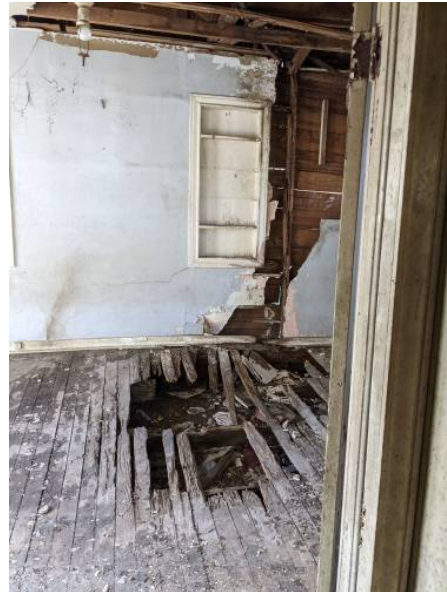
(38)

Most North western room. Walls failing floor failed, windows racked out of plumb open for years. No foundation support anymore here joists sitting on dirt

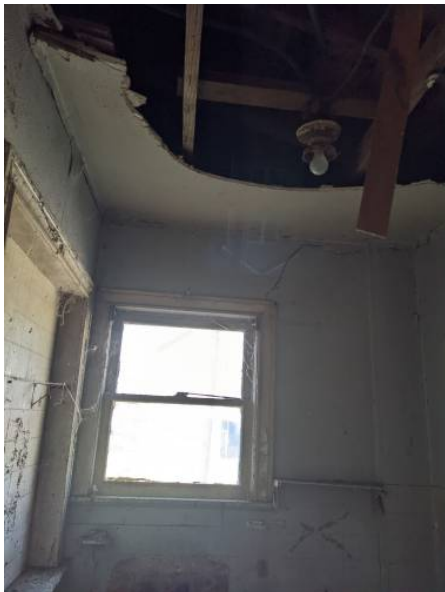
(39)

Most North western room. Walls failing floor failed, windows racked out of plumb open for years. No foundation support anymore here joists sitting on dirt

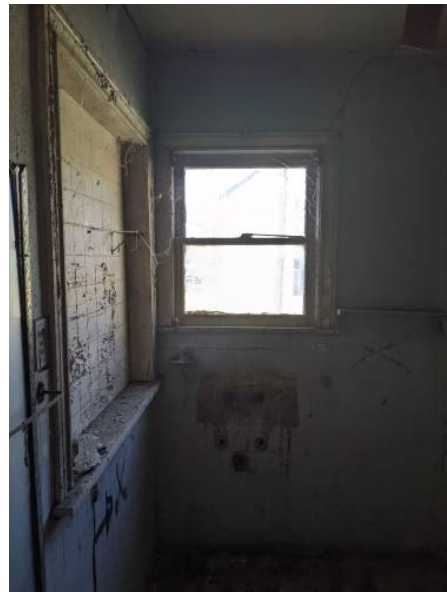
(40)

Northern bathroom floor ceiling and walls all failing or failed

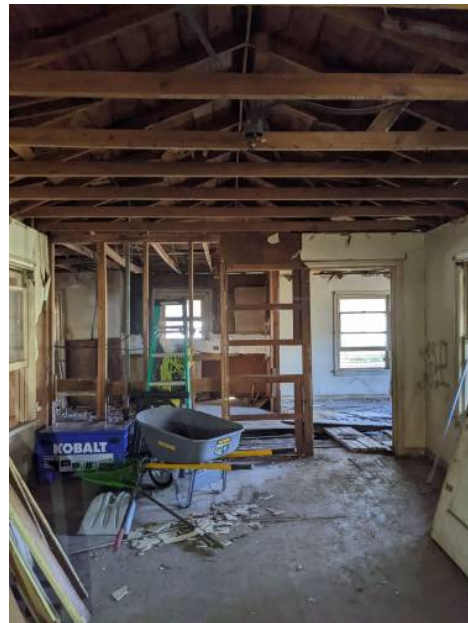
(72)

Fireplace surround missing old trim stacked up for recycling

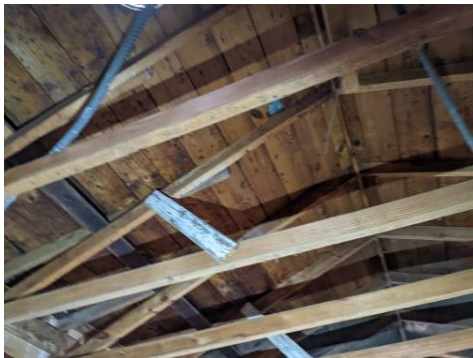
(83)

Floor in south easterly wing rotten and collapsed as is ceiling and roof. Walls cracking.

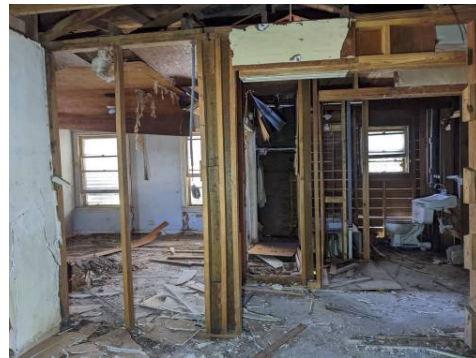
(84)

Floor in south easterly wing rotten and collapsed as is ceiling and roof. Walls cracking.

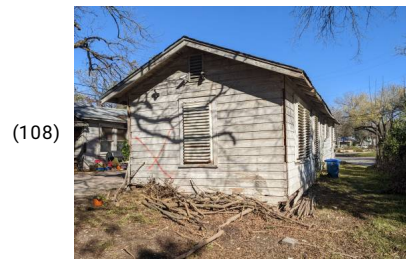
Northern facade of carport joists failing and roof.

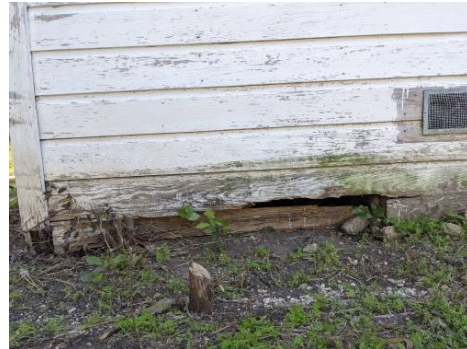
(116)

Foundation on northern facade facing Magnolia  
failed in areas

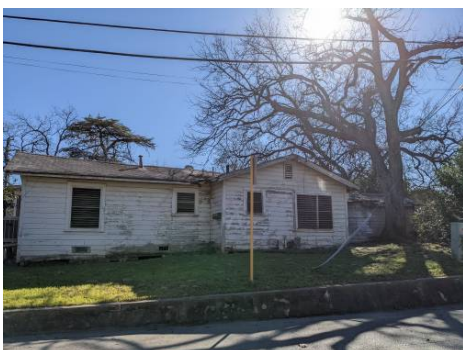
(117)

Foundation on northern facade facing Magnolia  
failed in areas

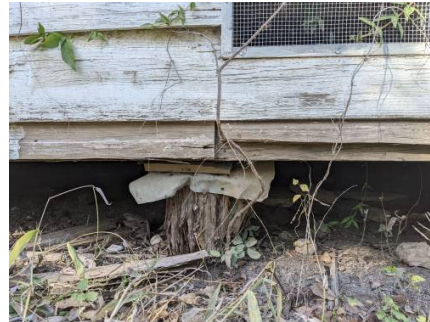
(136)

Southern facade foundation and wall compromised.

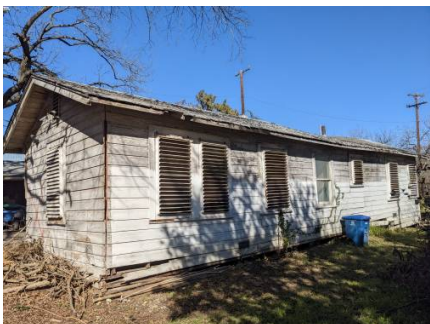
(137)

Southern facade foundation and wall compromised.
