HISTORIC AND DESIGN REVIEW COMMISSION

April 20, 2022

HDRC CASE NO: 2022-221
ADDRESS: 329 CLUB DR
LEGAL DESCRIPTION: NCB 6704 BLK 14 LOT W 32 FT OF 7 & E 25 FT OF 8
ZONING: R-6 H
CITY COUNCIL DIST.: 7
HIST. DIST. NAME: Monticello Park
APPLICANT: Mike Garcia
OWNER: Manuel Garcia/CENTEX REI LLC
TYPE OF WORK: Exterior alterations, repair and maintenance, window replacement
APPLICATION RECEIVED: March 22, 2022
60-DAY REVIEW: Not applicable due to City Council Emergency Orders
CASE MANAGER: Jessica Anderson

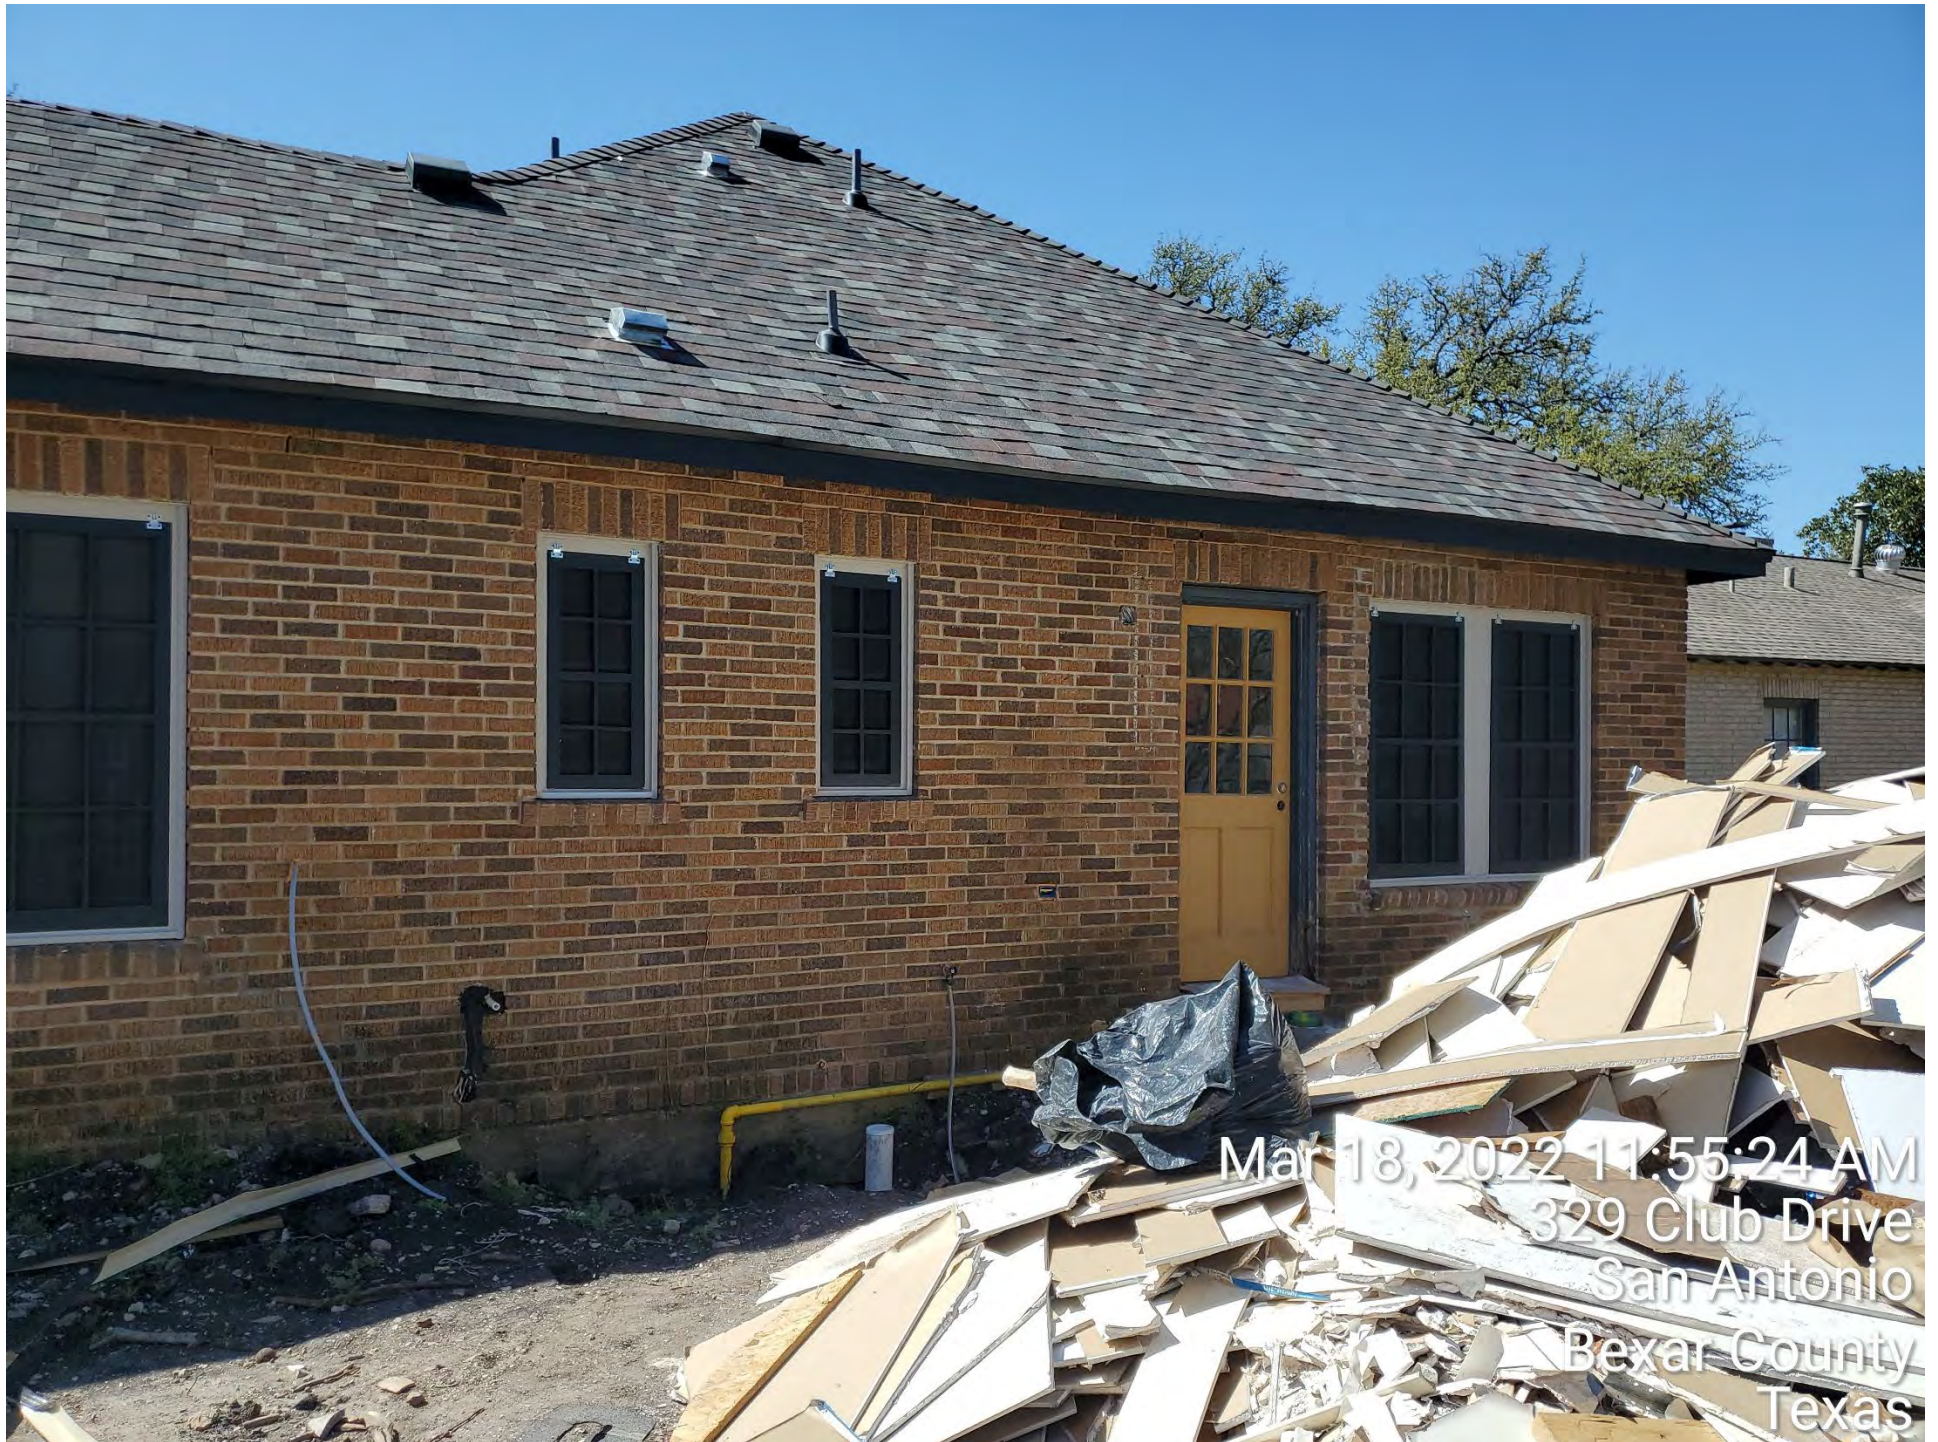
Mar 18, 2022 11:55:24 AM
329 Club Drive
San Antonio
Bexar County
Texas

- c. VIOLATION: Office of Historic Preservation staff performed a site visit on March 18, 2022, and observed that the following scopes of work were performed without a Certificate of Appropriateness: replacement of front concrete porch, replacement of second-story windows, removal of a window in the front east gable, replacement of existing window screens, addition of shingles to front gables, and front walkway modification. OHP staff issued a stop work order at that time. No permits were issued by Development Services Department.

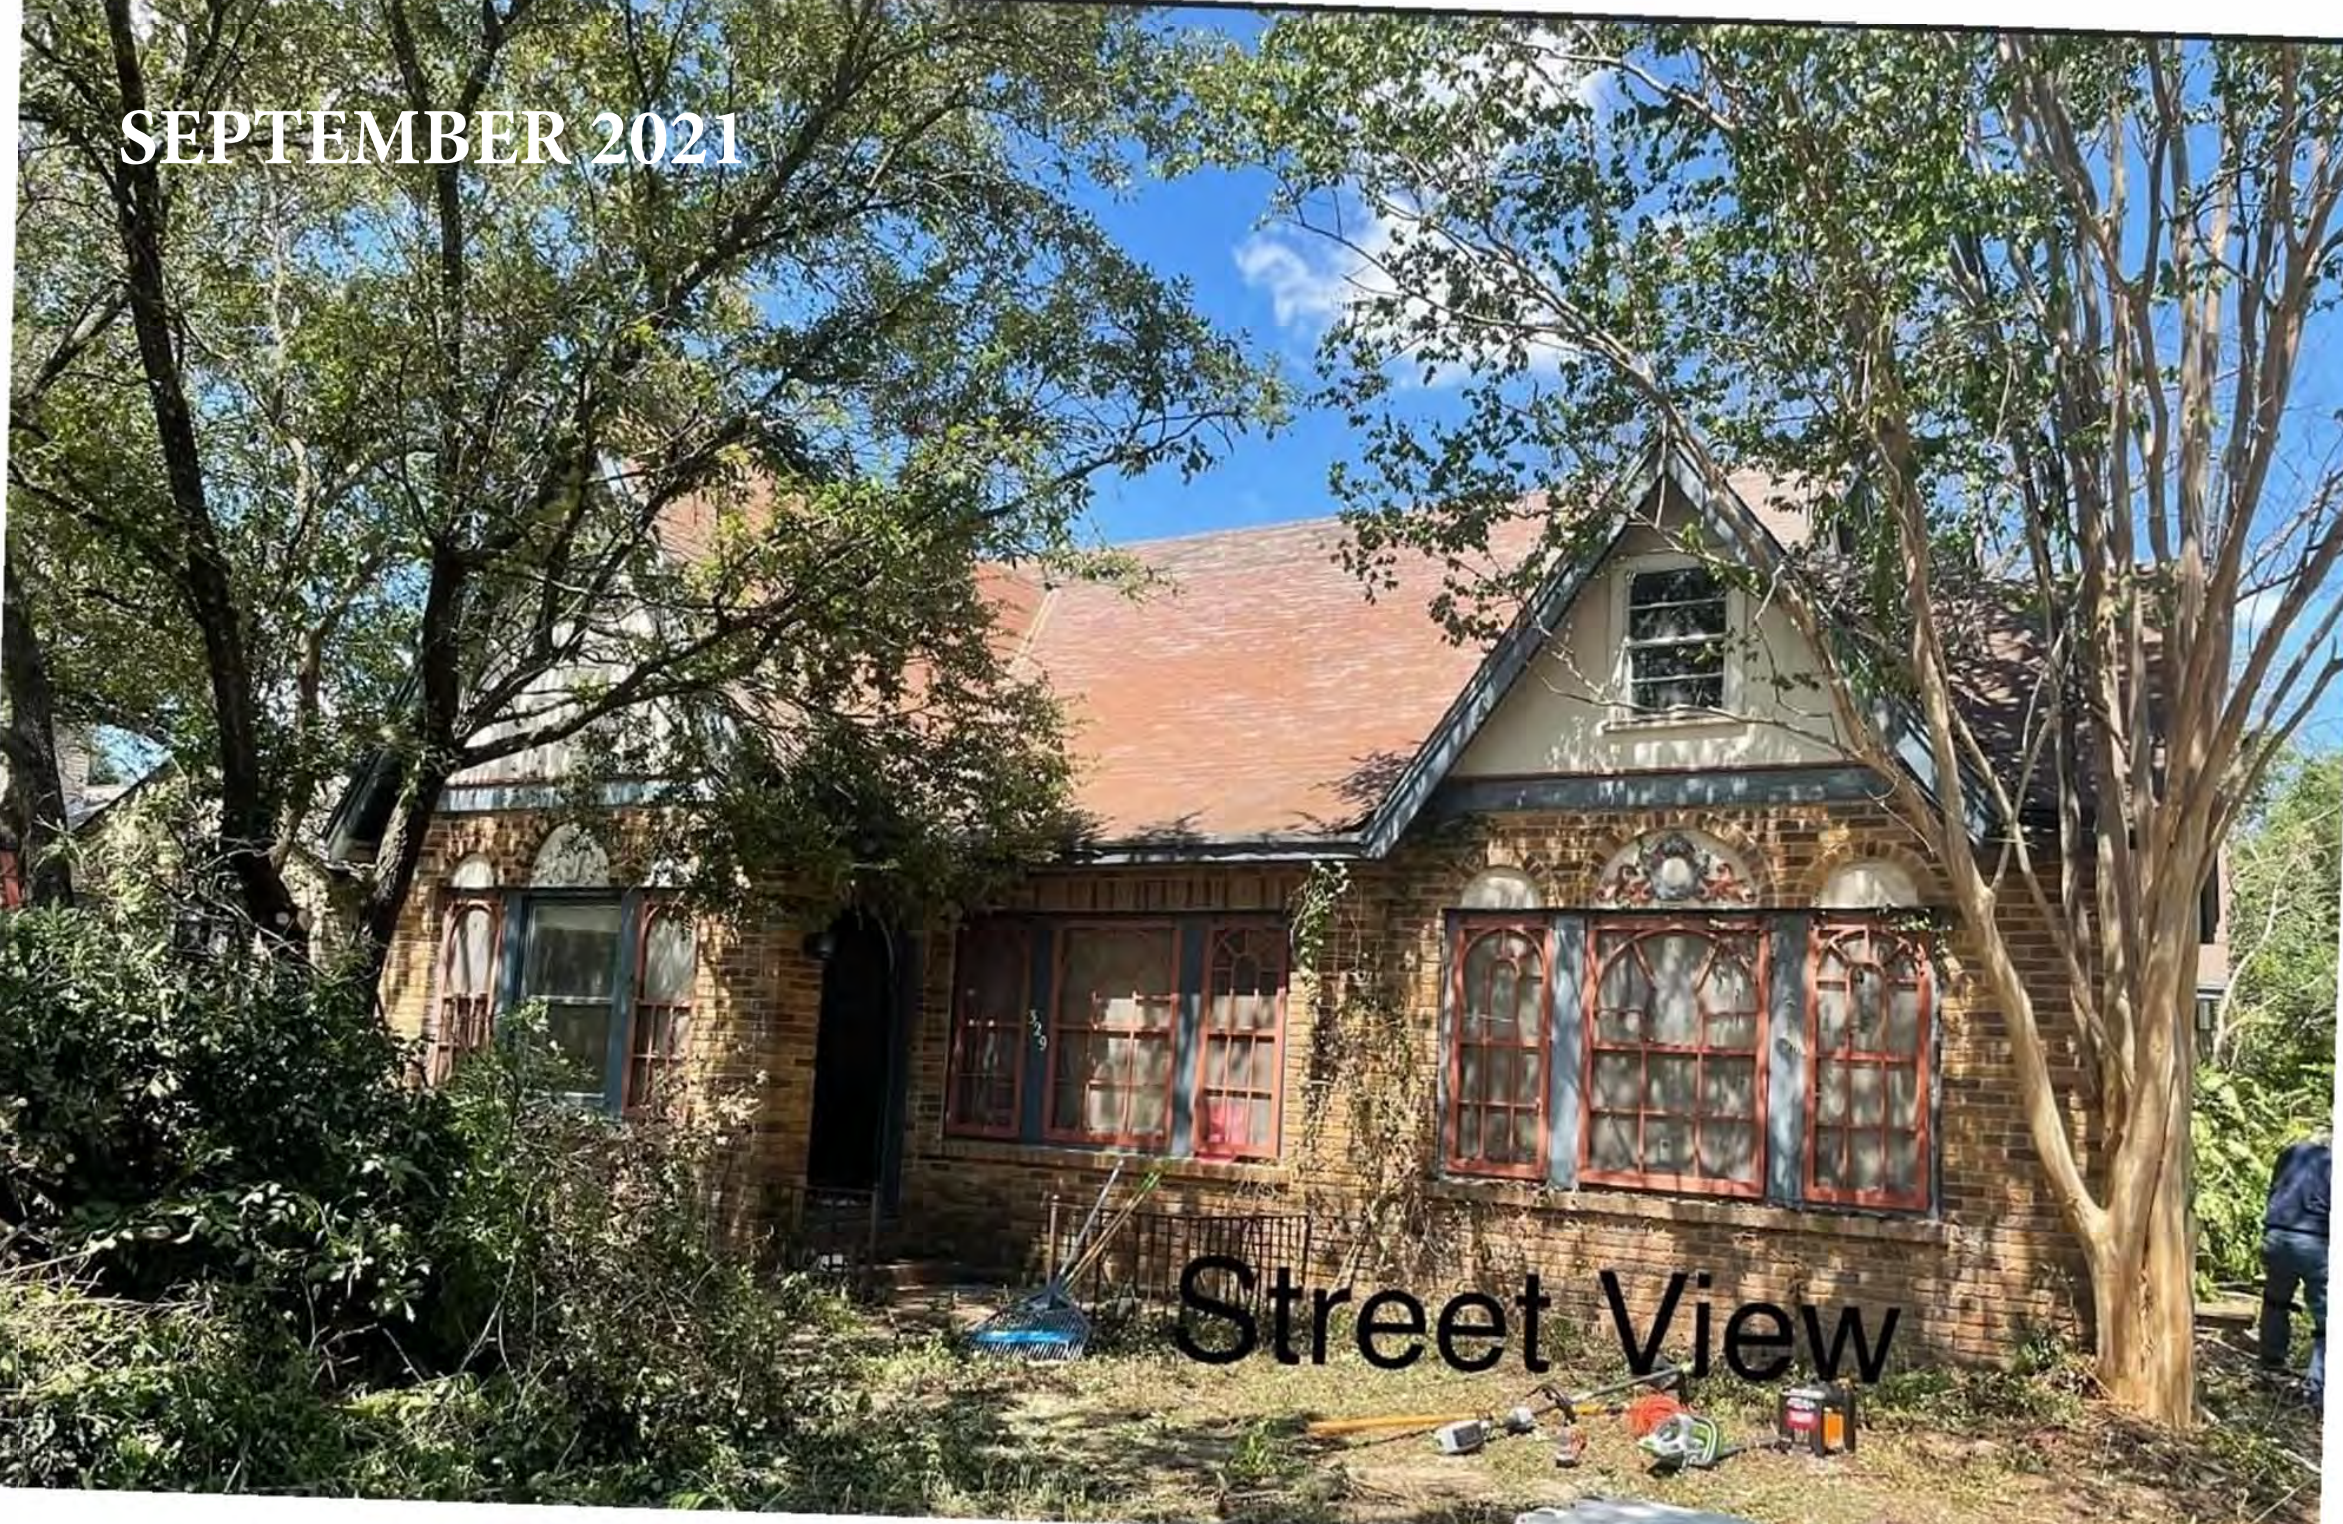
Street View

- e. PORCH: Per images submitted by the applicant in September 2021, the front porch included a scored concrete design with two lengths of metal railing at the porch edge. The replacement porch observed by staff at the site visit on March 18, 2022, was smooth with no pattern, and the metal railings had been removed. Staff finds that the applicant should score the front concrete porch and return the metal railings to match conditions shown in the September 2021 photos.

- i. **GABLE DESIGN:** Per photos submitted by the applicant in September 2021, the primary gables were clad in wood paneling to match non-primary gables. The applicant has since installed wood singles in the primary gables. Staff finds this to be inappropriate and finds that the previous condition should be returned.

1. Staff recommends approval of item #1, replacement of the front concrete porch, with the following stipulations:
 - i. That the new concrete patio be scored to match previous conditions.

- ii. That the metal railings are reinstalled or replicated.
2. Staff does not recommend approval of item #2, window replacement, as installed. Staff recommends the applicant install windows consistent with staff's standards for replacement windows. Window product specifications should be submitted to OHP staff for review and approval.

5. Staff does not recommend approval of item #5, gable design modification. Staff recommends returning the gables on the primary elevation to their previous condition.
6. Staff does not recommend approval of item #6, modification of front walkway based on finding j. Staff recommends the front walkway be returned to its previous condition.
7. Staff recommends approval of item #8, modifications to the accessory structure, with the following stipulation:
 - i. That the applicant submit more detailed drawings of proposed changes to the accessory structure prior to the issuance of a COA.

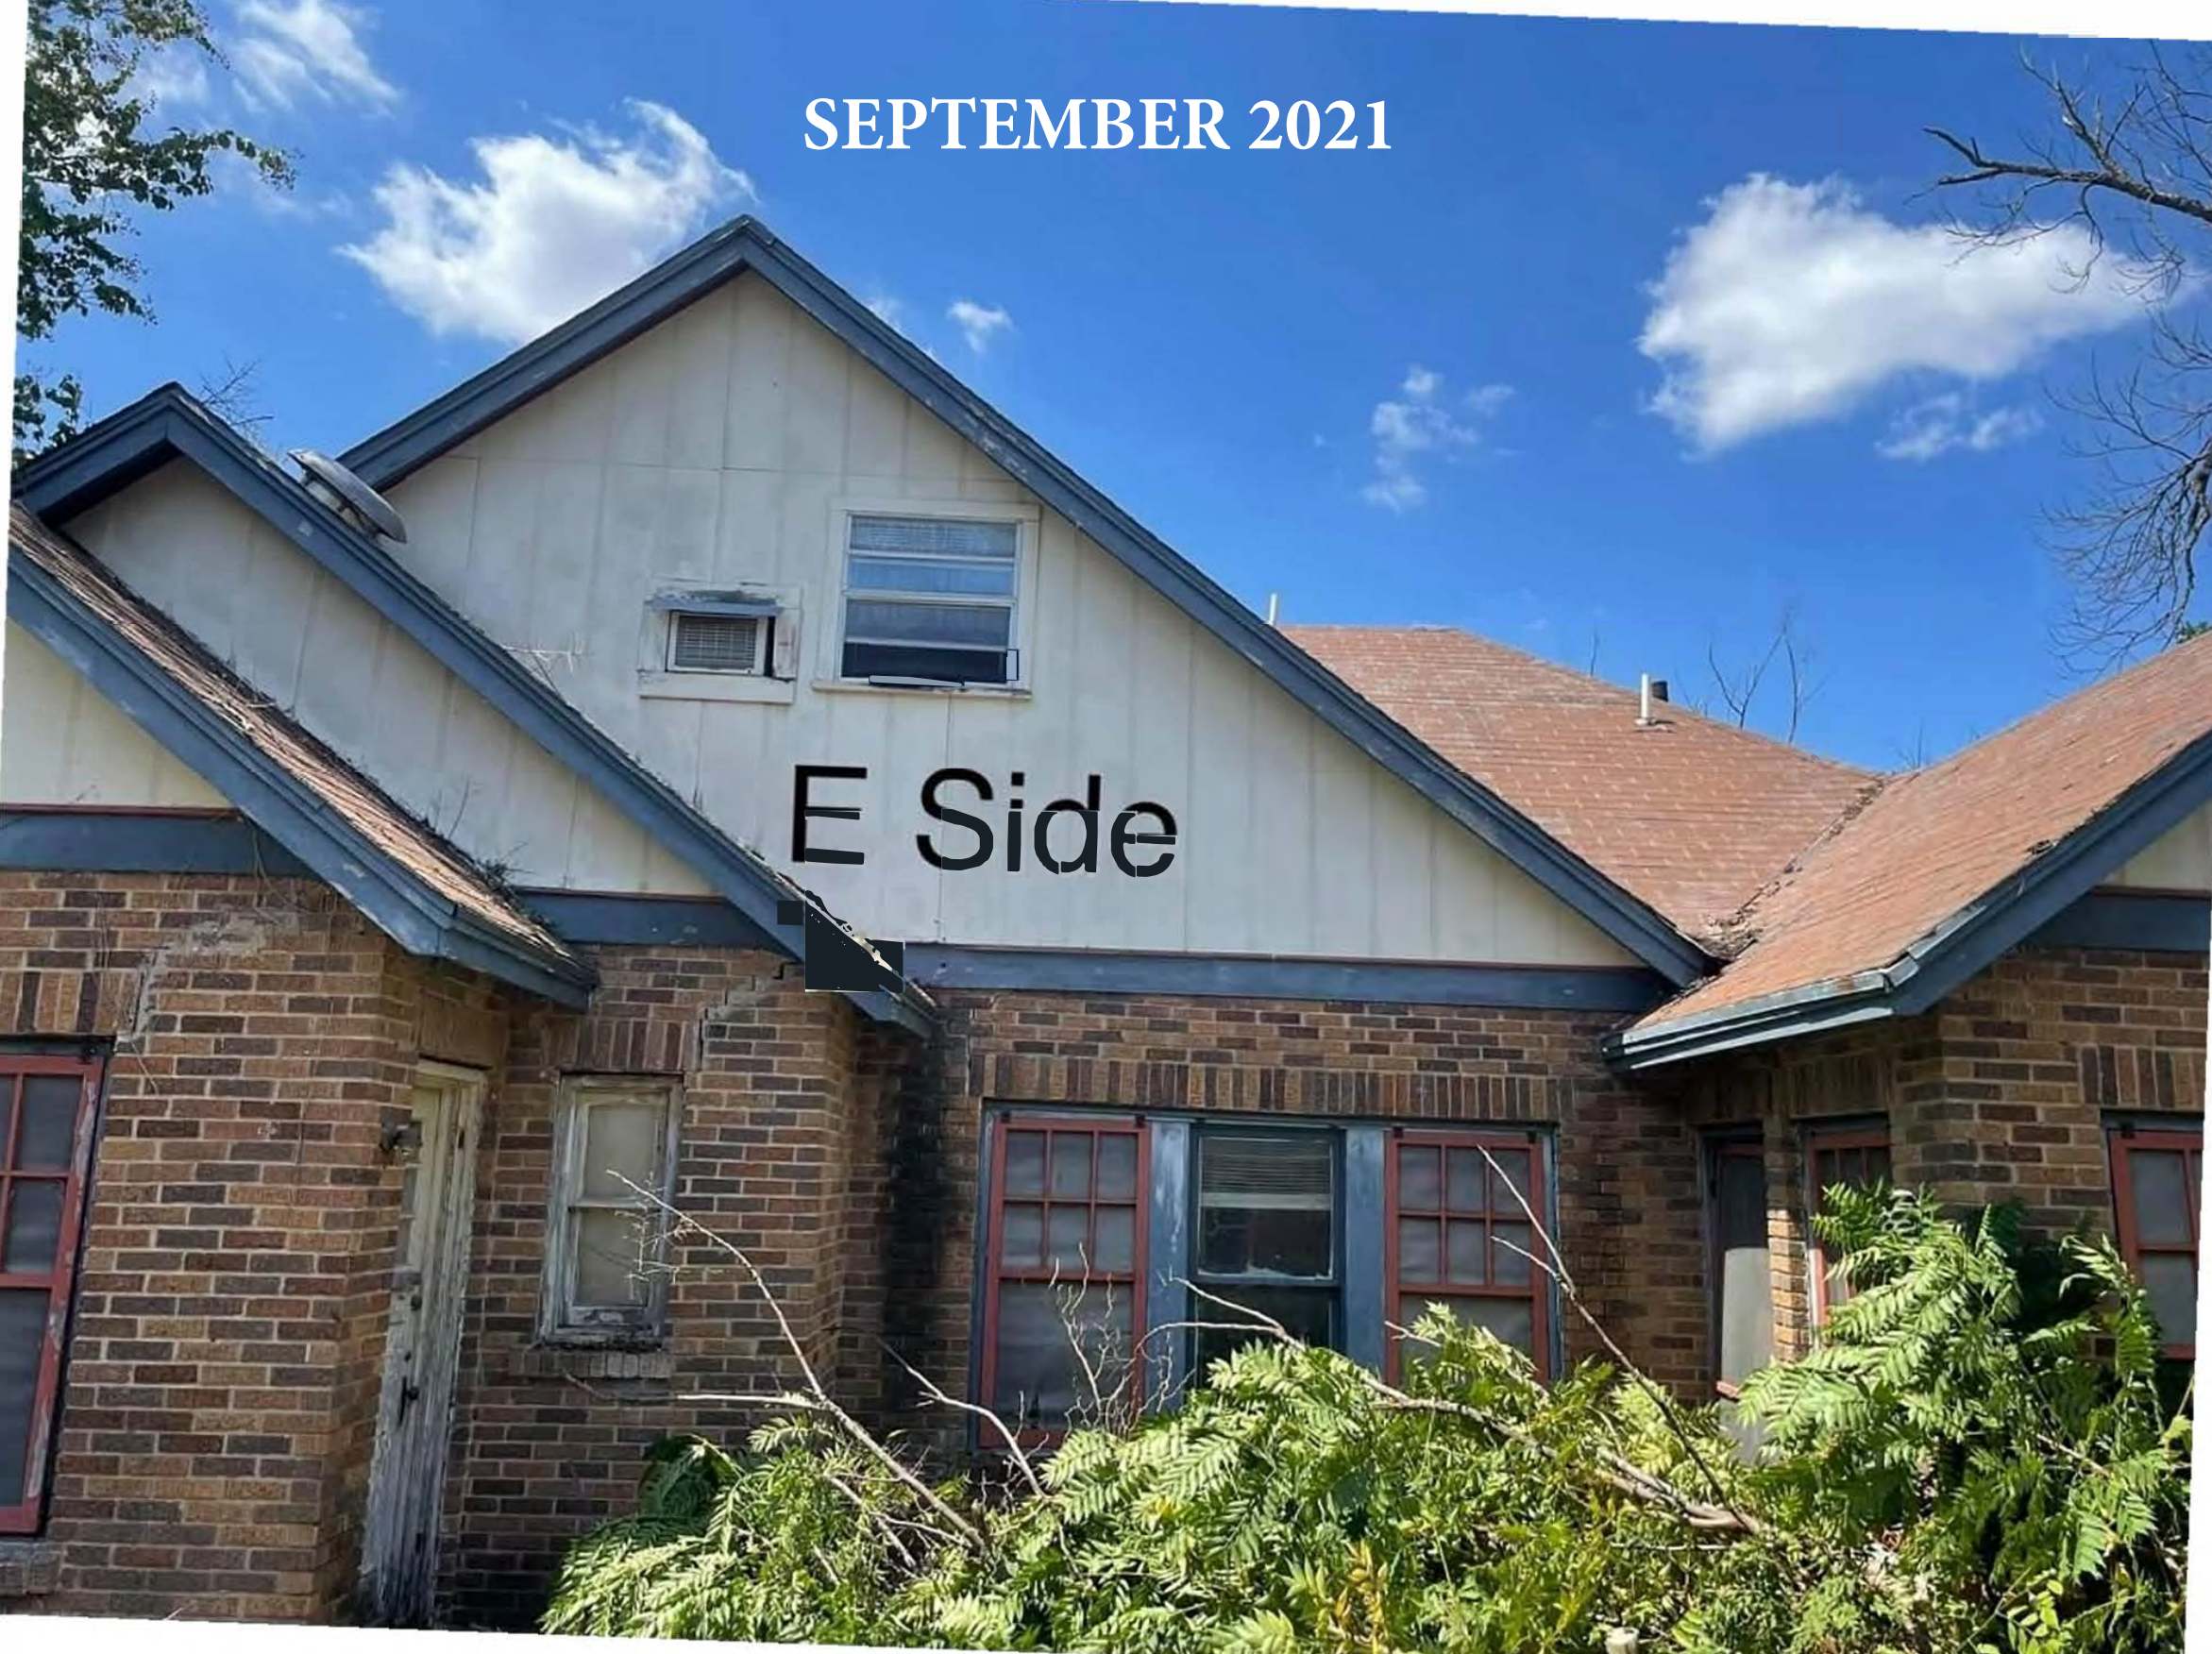
E Side

- g. **FENESTRATION CHANGES:** Per images submitted by the applicant in September 2021, and in addition to the change in size of the second-story east window, a two-over-two metal sash window located in the east gable on the primary elevation has since been removed and replaced by the wood slatted vent. The second-story windows appear to be the result of interior changes over time and are not original to the structure. Staff finds this change appropriate.

3. Staff recommends approval of item #3, removal of a window in the front east gable, based on finding g.
4. Staff does not recommend approval of item #4, wood screen replacement, based on finding h. Staff recommends the original first-story screens be returned and repaired or replaced in kind, with lite patterns to match historic configurations, and that where screens were not previously found, the new screens be six-over-one to match previous conditions. If screens are replaced or installed where not previously found, staff recommends use of a screen style that more closely matches previous conditions and does not recommend the use of solar screen.

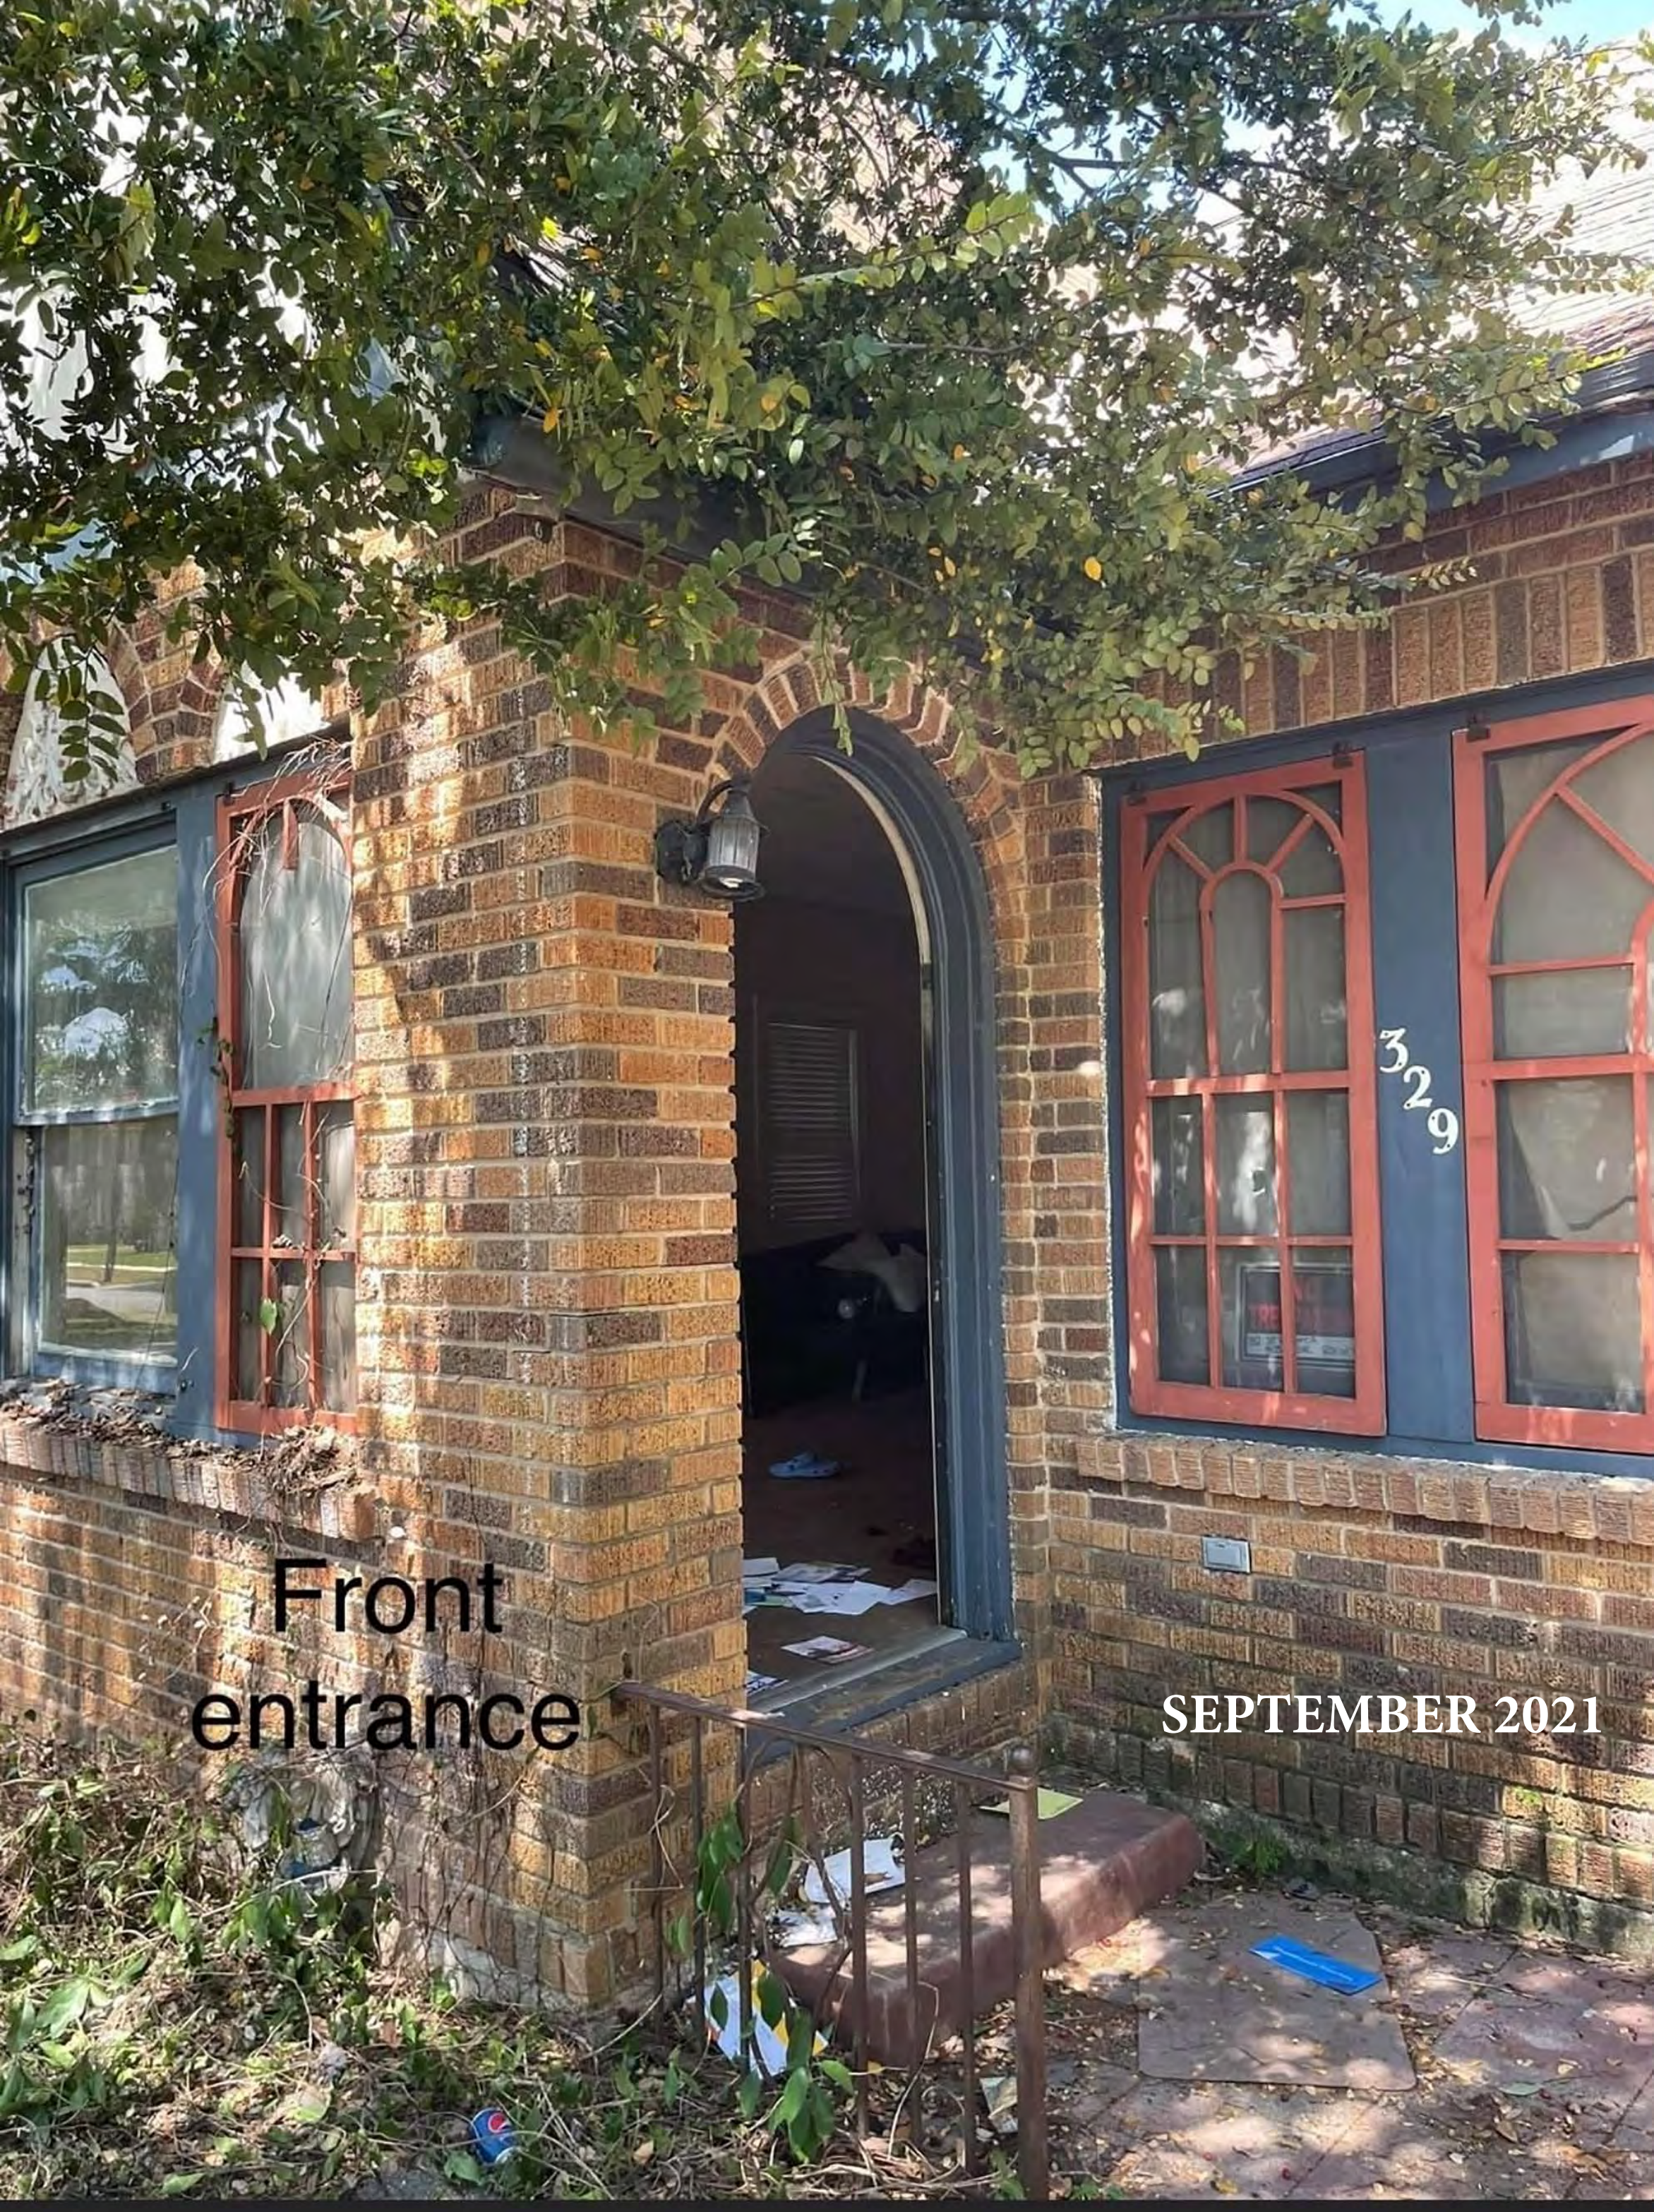
Front
entrance

- h. **WOOD SCREEN REPLACEMENT:** On September 21, 2021, staff administratively approved the repair of existing wood window screens. Per images submitted by the applicant at that time, previously existing wood screens were only included on the first floor. Wood screens on the primary elevation were eight-over-six, with the lites in the upper sash of the screen set in an arched pattern. Wood screens on non-primary elevations were six-over-one. The new window screens are six-over-six, are installed on both floors, and are constructed using black solar screen. Staff finds the replacement screens inappropriate in style as they do not match the historic screen designs seen in photos submitted by the applicant in September 2021. Where screens were not previously found, staff finds that following the style of the previous screens found on non-primary elevations by installing six-over-one wood screens is appropriate. Additionally, staff finds the use of solar screen materials in the wood screens inappropriate and finds that a screen style that more closely matches what is seen in the September 2021 photos should be installed.

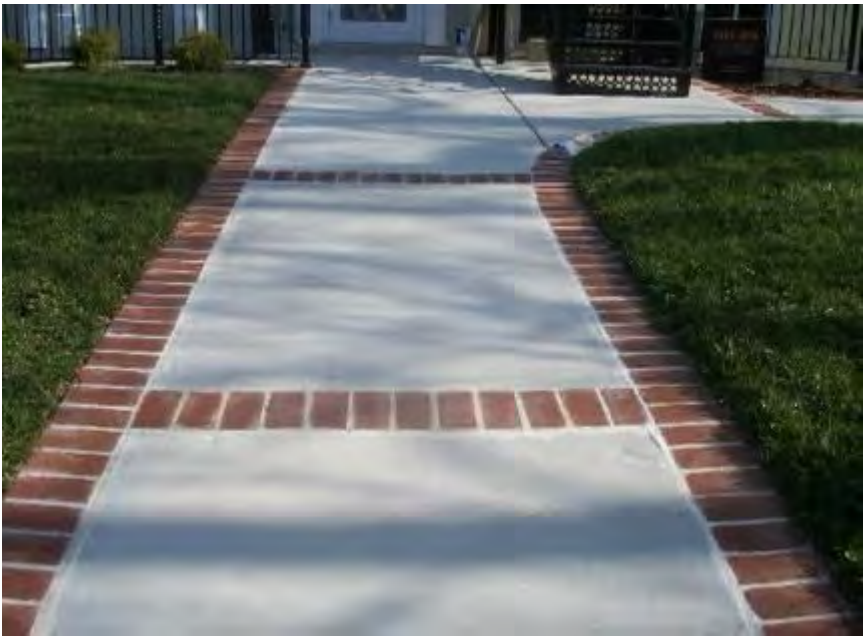
Proposed walkway treatment

- j. **FRONT WALKWAY DESIGN:** The applicant removed short sections of the existing concrete walkway from a staircase to the front porch so that the sidewalk appears as large concrete pavers. The applicant proposes a design for the front walkway that incorporates brick borders separating each concrete paver and along both sides of the path. The Guidelines for Site Elements note that existing concrete walkways should be repaired in-kind. Staff finds the proposed modifications to be inappropriate.

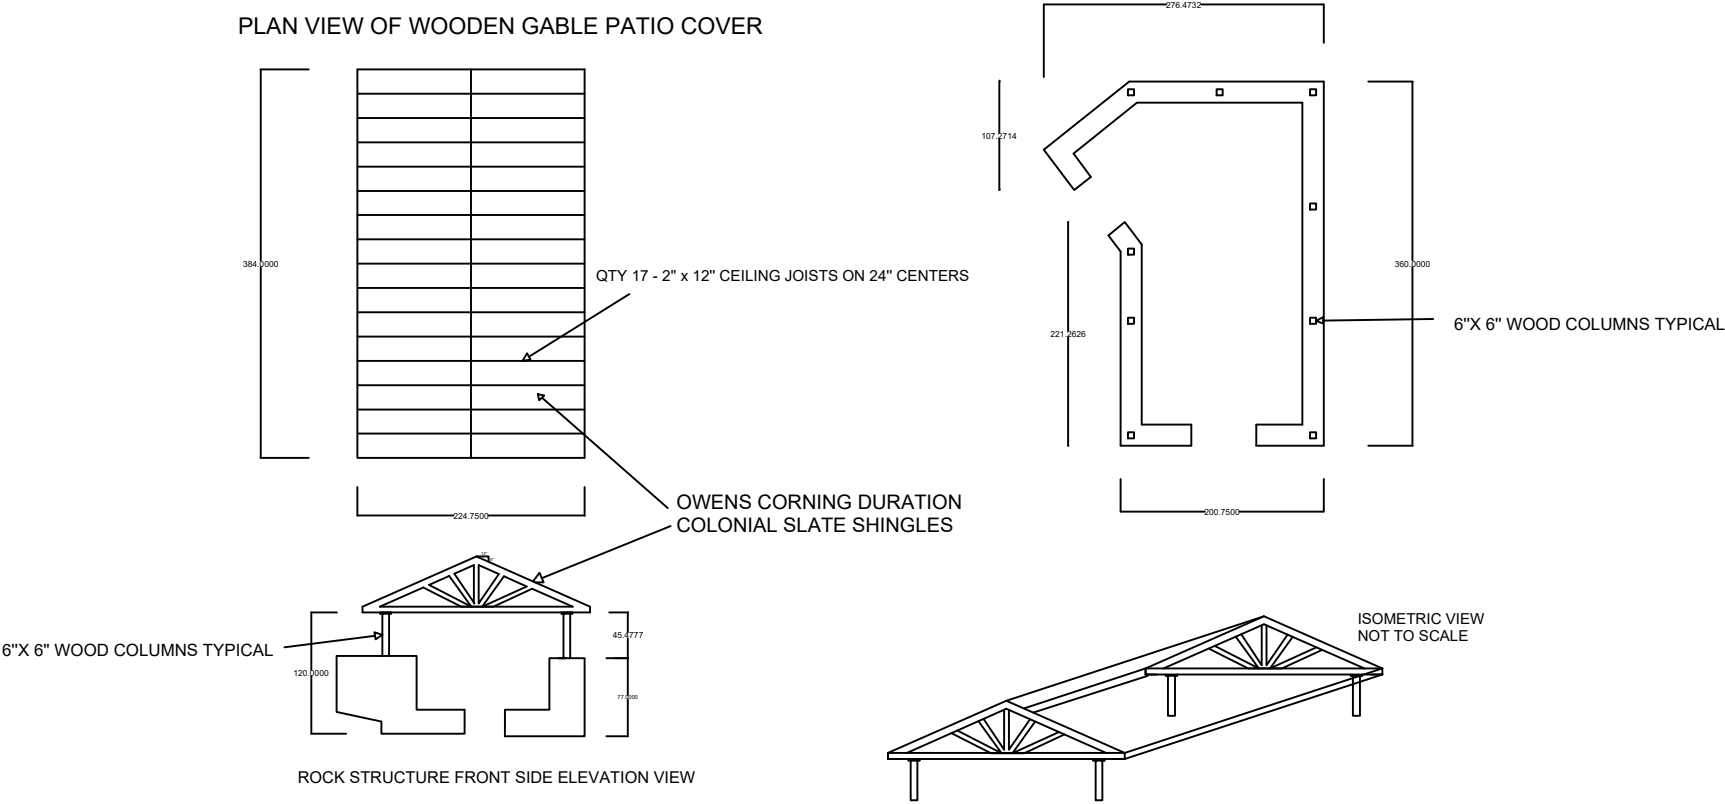
ROCK STRUCTURE WOODEN GABLE PATIO COVER PLANS

- l. **ACCESORY STRUCTURE:** The applicant proposes to add an approximately 600 square foot (18.75'x32') end-gabled roof with composition shingles on 6"x6" wood posts to the top of the existing stone structure in the rear. Generally, staff finds this scope of work to be appropriate; however, the applicant should submit more detailed drawings prior to the issuance of a COA.
