# HISTORIC AND DESIGN REVIEW COMMISSION

**HDRC CASE NO:** 2022-283  
**ADDRESS:** 119 E MAGNOLIA AVE  
**LEGAL DESCRIPTION:** NCB 1703 BLK 8 LOT 18 AND 19  
**ZONING:** R-4, H  
**CITY COUNCIL DIST.:** 1  
**DISTRICT:** Monte Vista Historic District  
**APPLICANT:** Dustin O'Connor/Guido  
**OWNER:** Charles Ramon/RAMON CHARLES  
**TYPE OF WORK:** Window replacement  
**APPLICATION RECEIVED:** May 10, 2022  
**60-DAY REVIEW:** Not applicable due to City Council Emergency Orders  
**CASE MANAGER:** Rachel Rettaliata

The applicant is requesting a Certificate of Appropriateness for approval to replace all existing wood windows and empty openings with aluminum-clad wood windows.

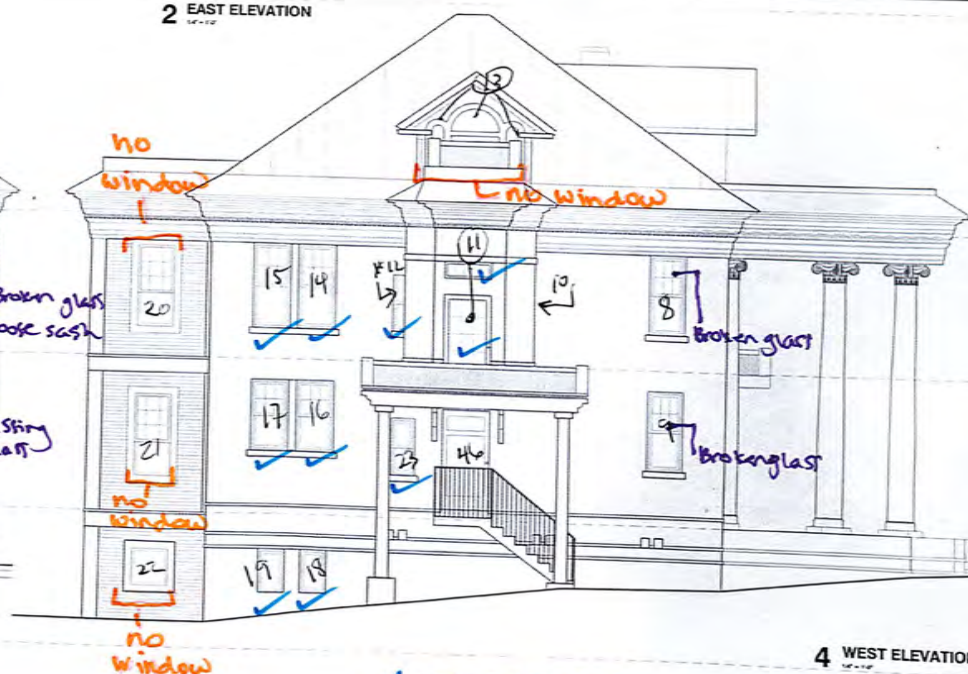
4 WEST ELEVATION

✓ Intact window  
 — no window Sashes  
 ■ missing elements
