HISTORIC AND DESIGN REVIEW COMMISSION

July 20, 2022

HDRC CASE NO: 2022-303
ADDRESS: 226 E HUISACHE AVE
LEGAL DESCRIPTION: NCB 3086 BLK 2 LOT 7
ZONING: R-4 CD, H
CITY COUNCIL DIST.: 1
DISTRICT: Monte Vista Historic District
APPLICANT: Nadav Givoni/GR-226 HUISACHE LLC
OWNER: Nadav Givoni/GR-226 HUISACHE LLC
TYPE OF WORK: Window replacement
APPLICATION RECEIVED: May 01, 2022
60-DAY REVIEW: Not applicable due to City Council Emergency Orders
CASE MANAGER: Hannah Leighner
REQUEST:

The applicant is requesting a Certificate of Appropriateness for approval to replace nineteen (19) existing wood windows with new wood windows.

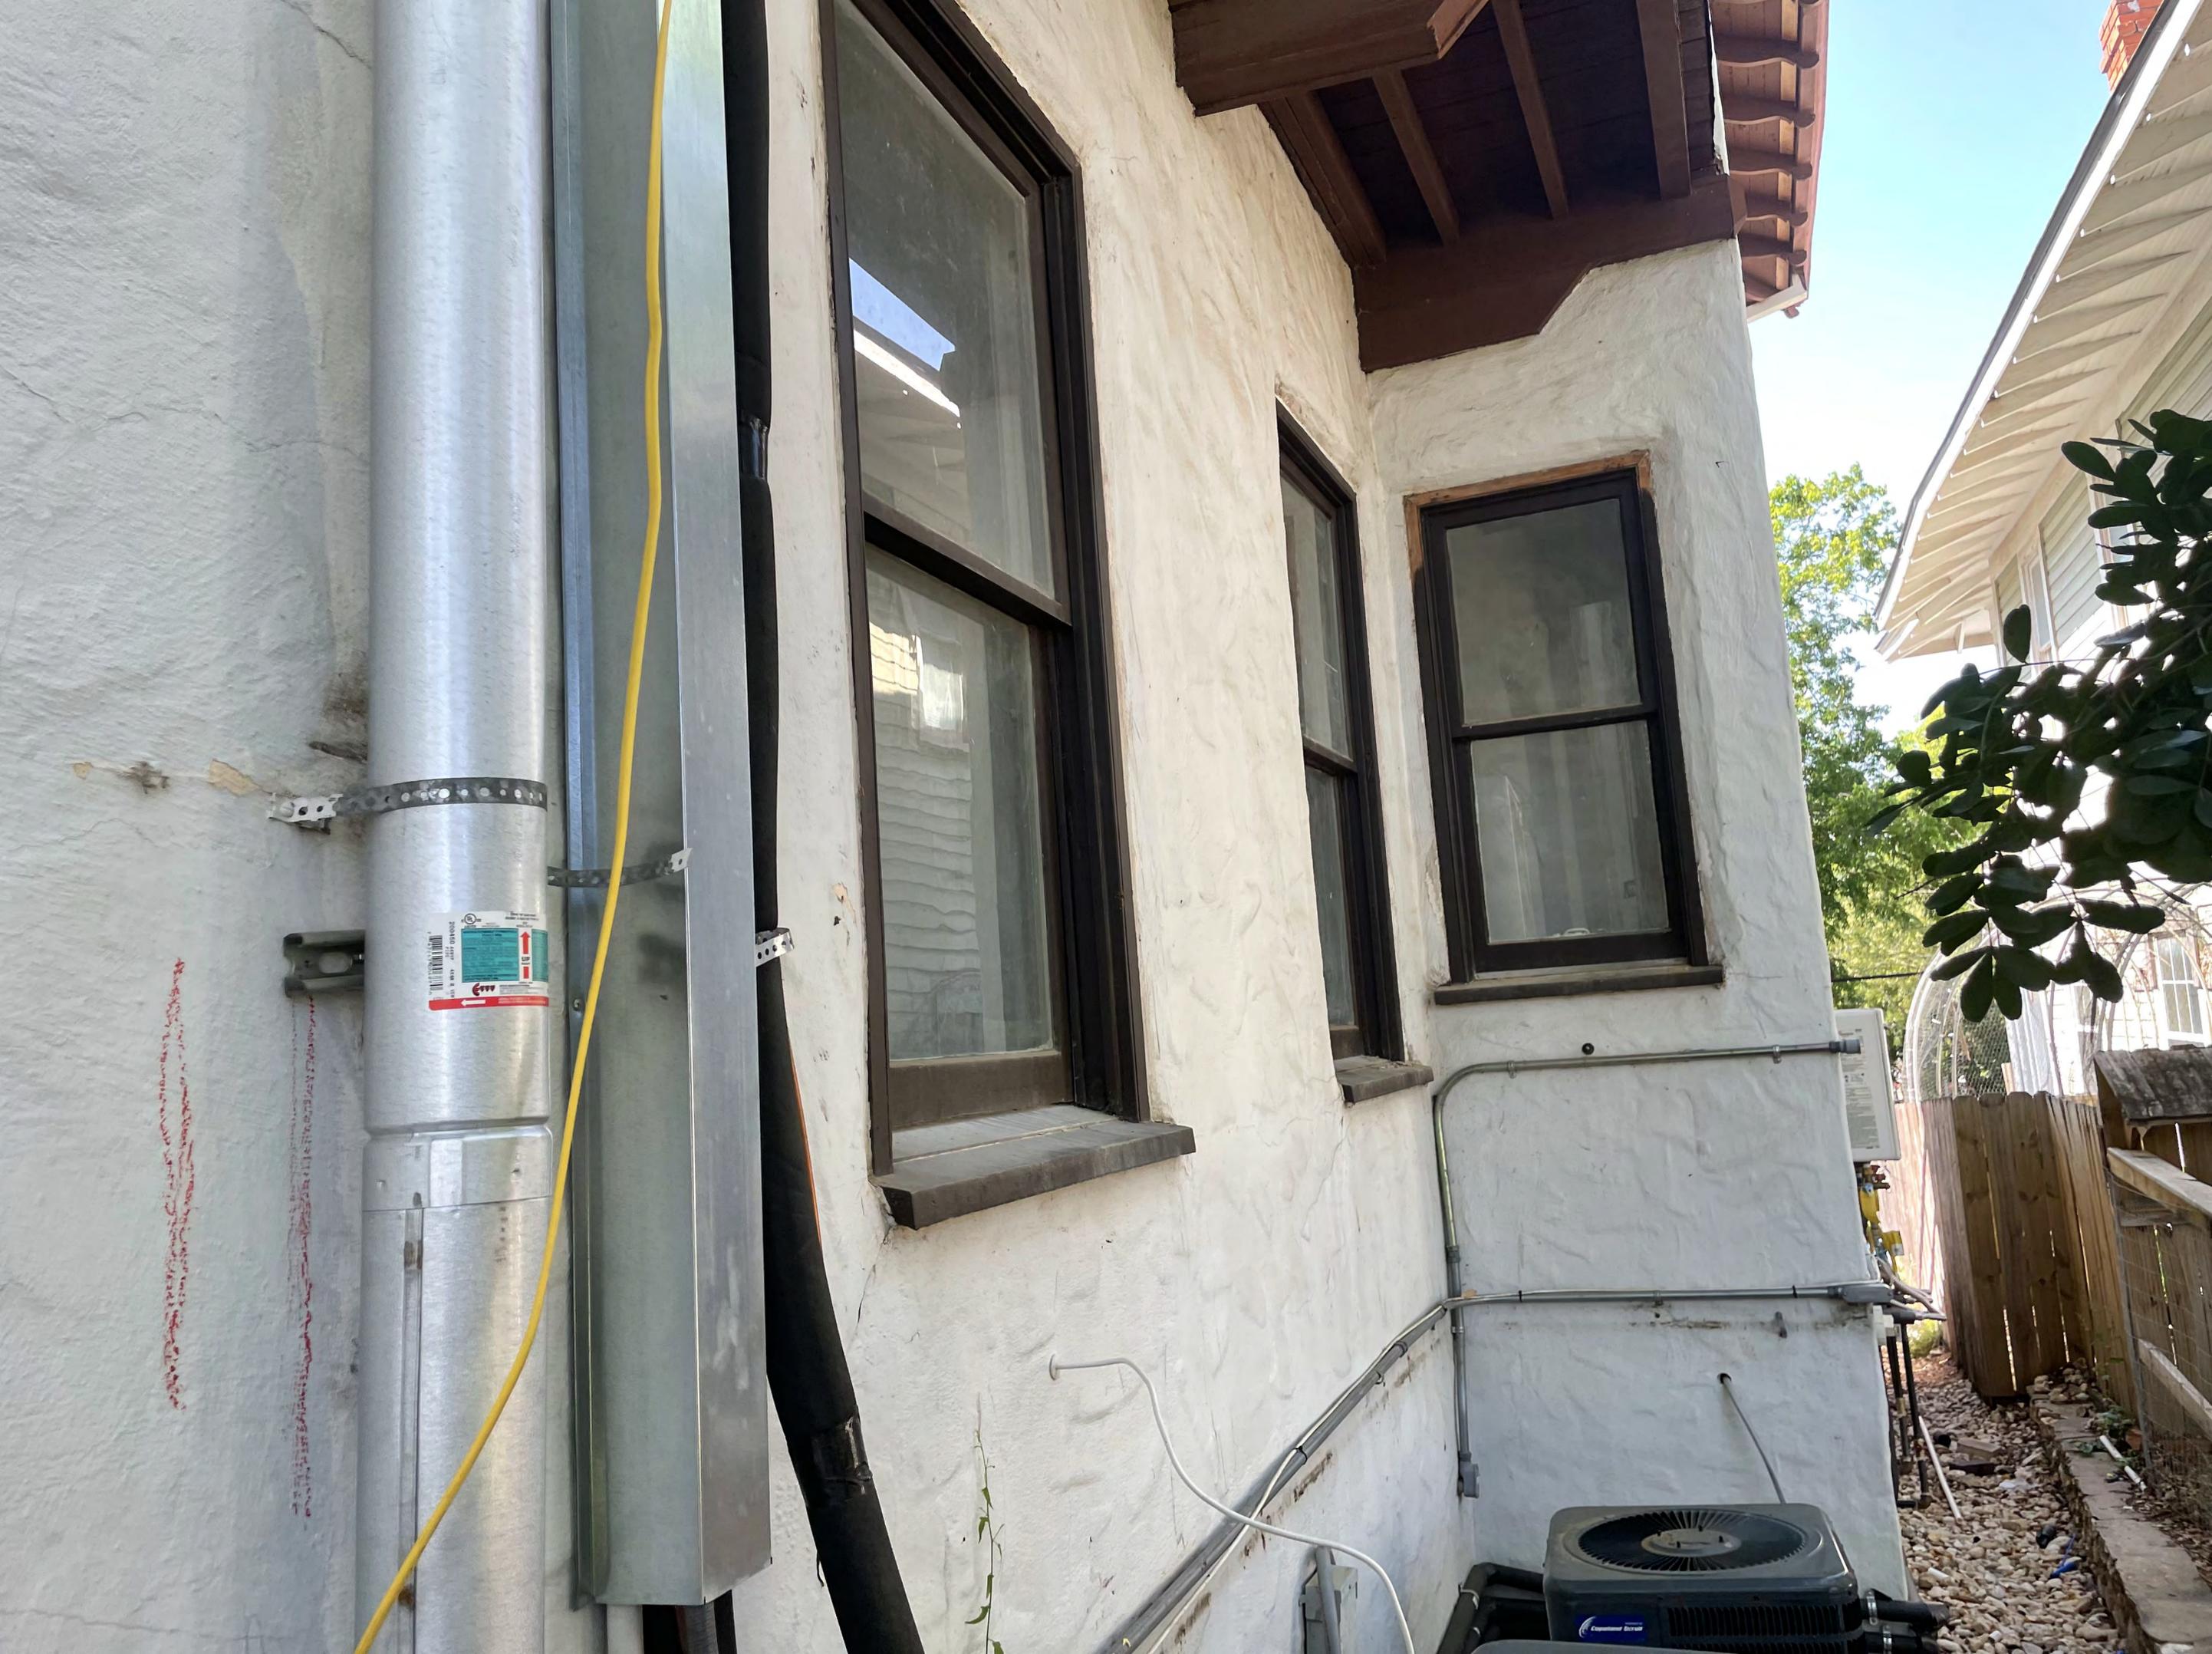
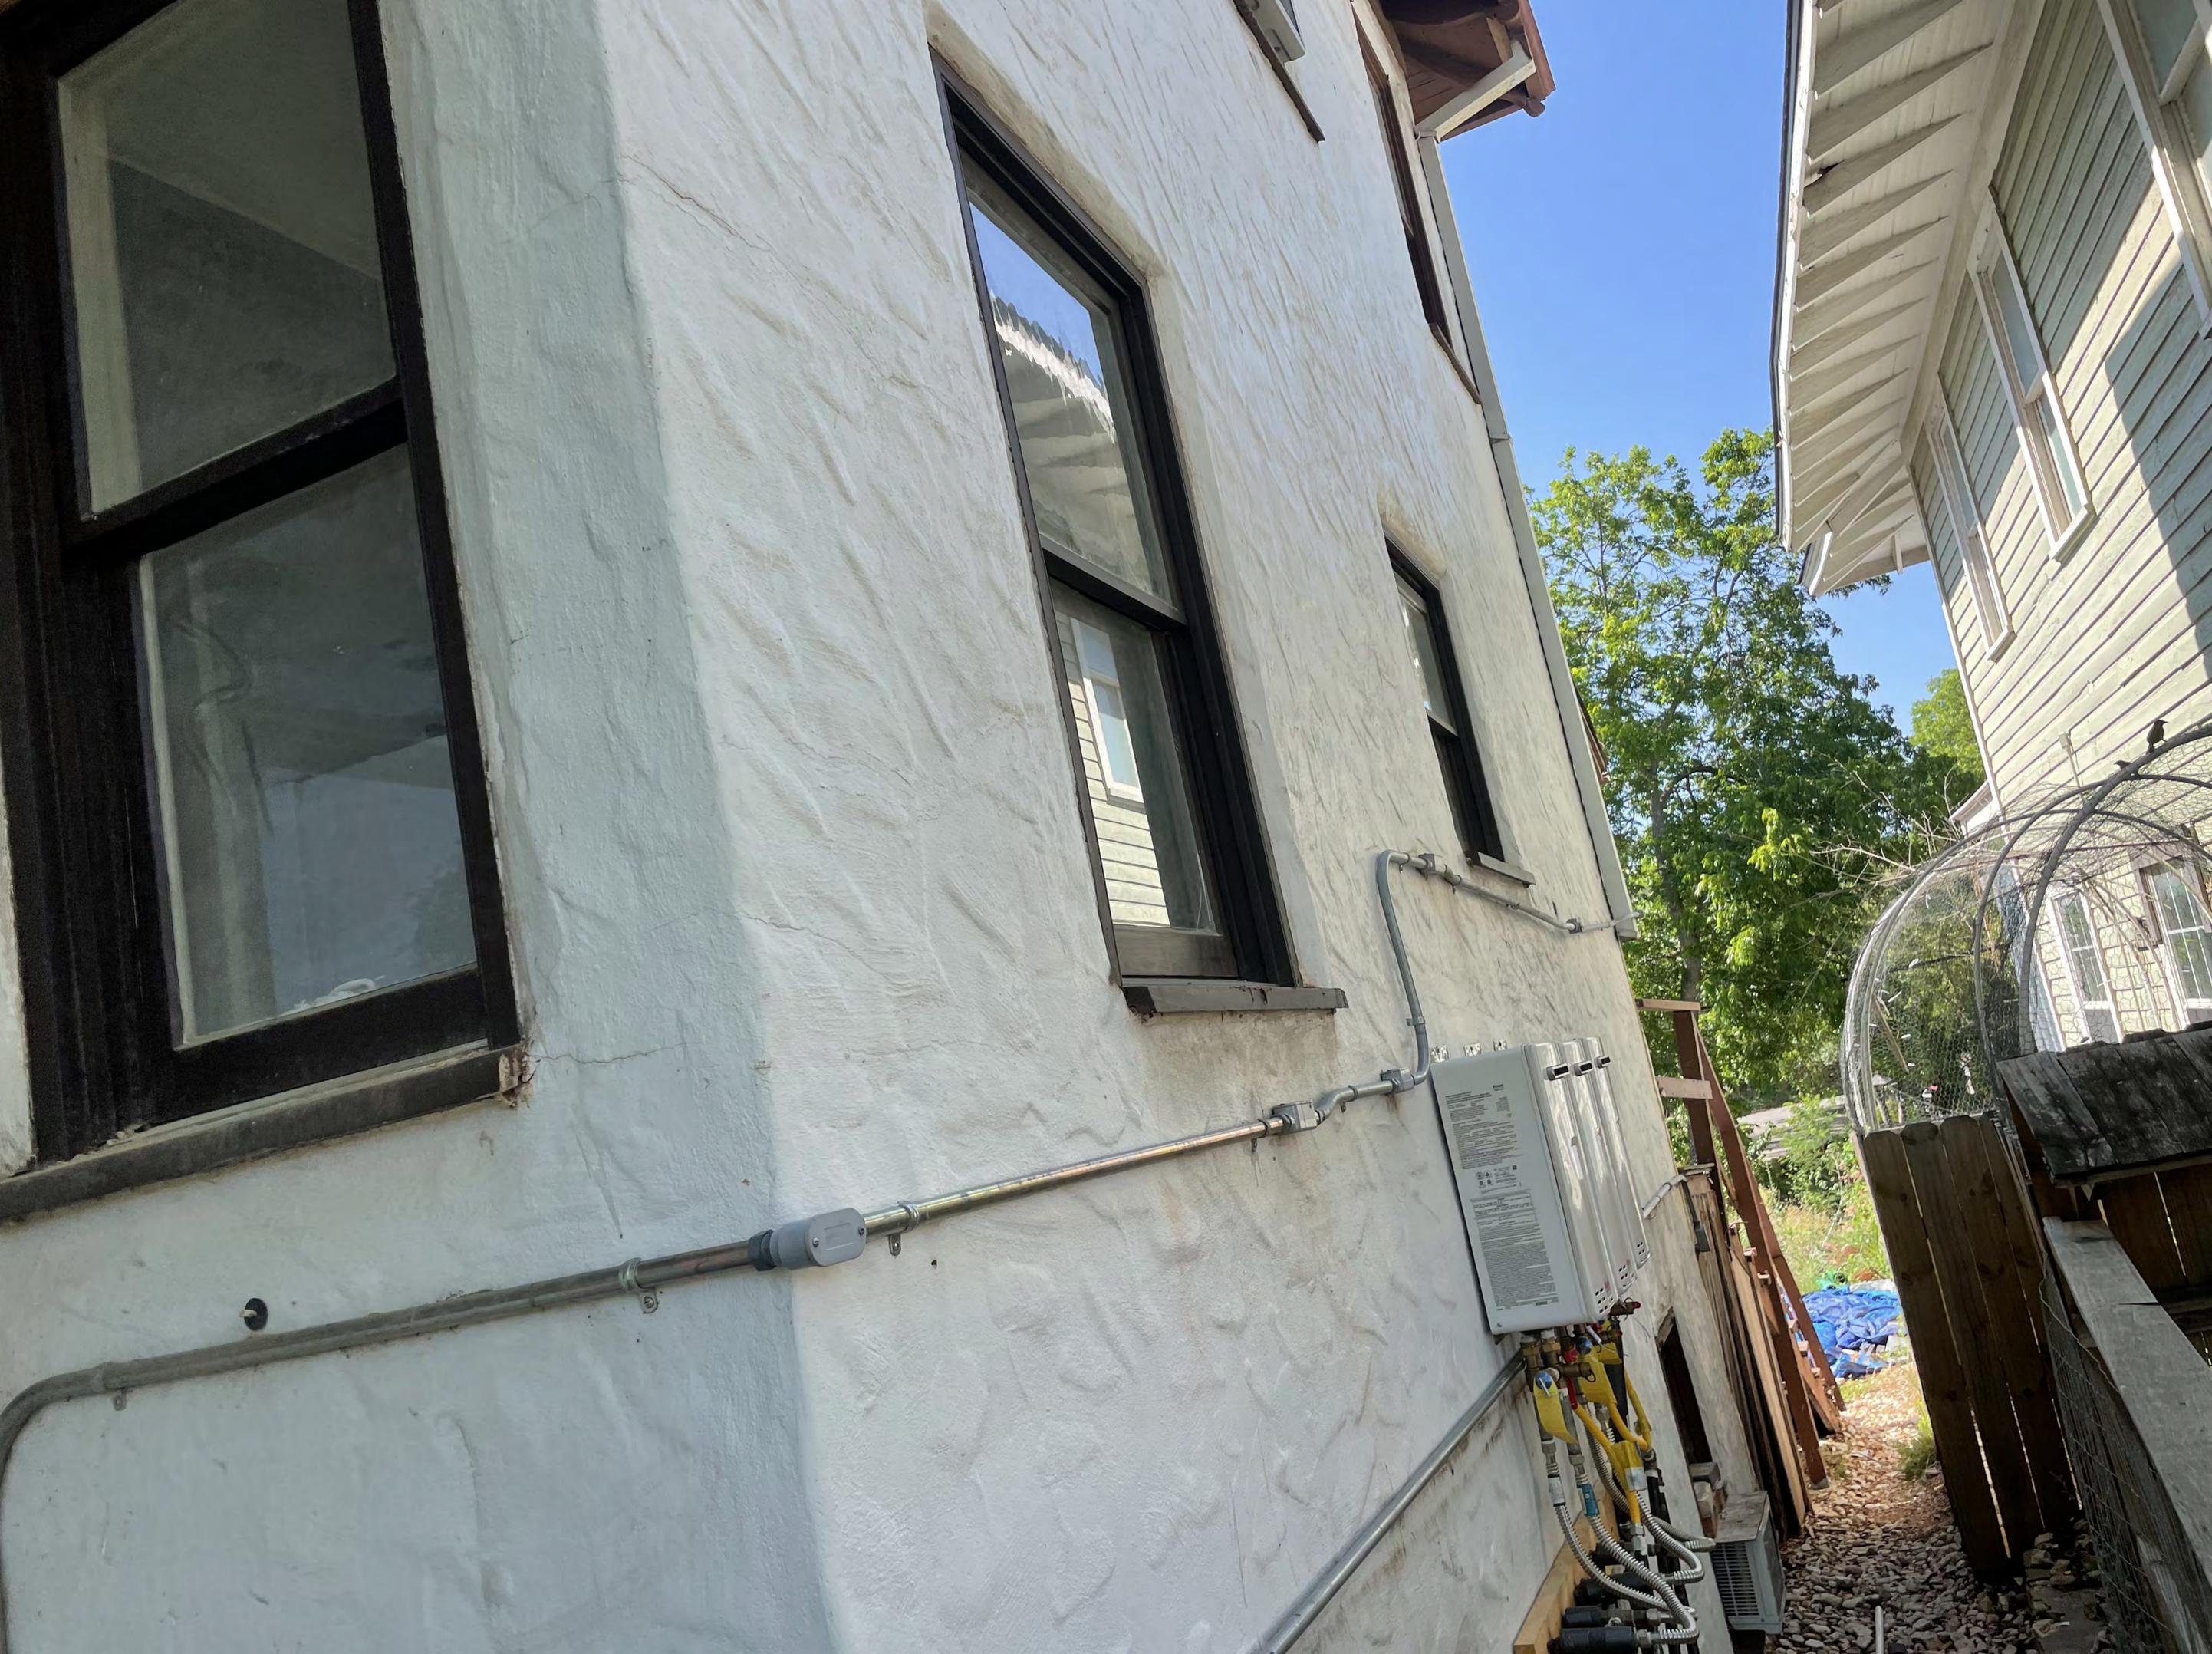
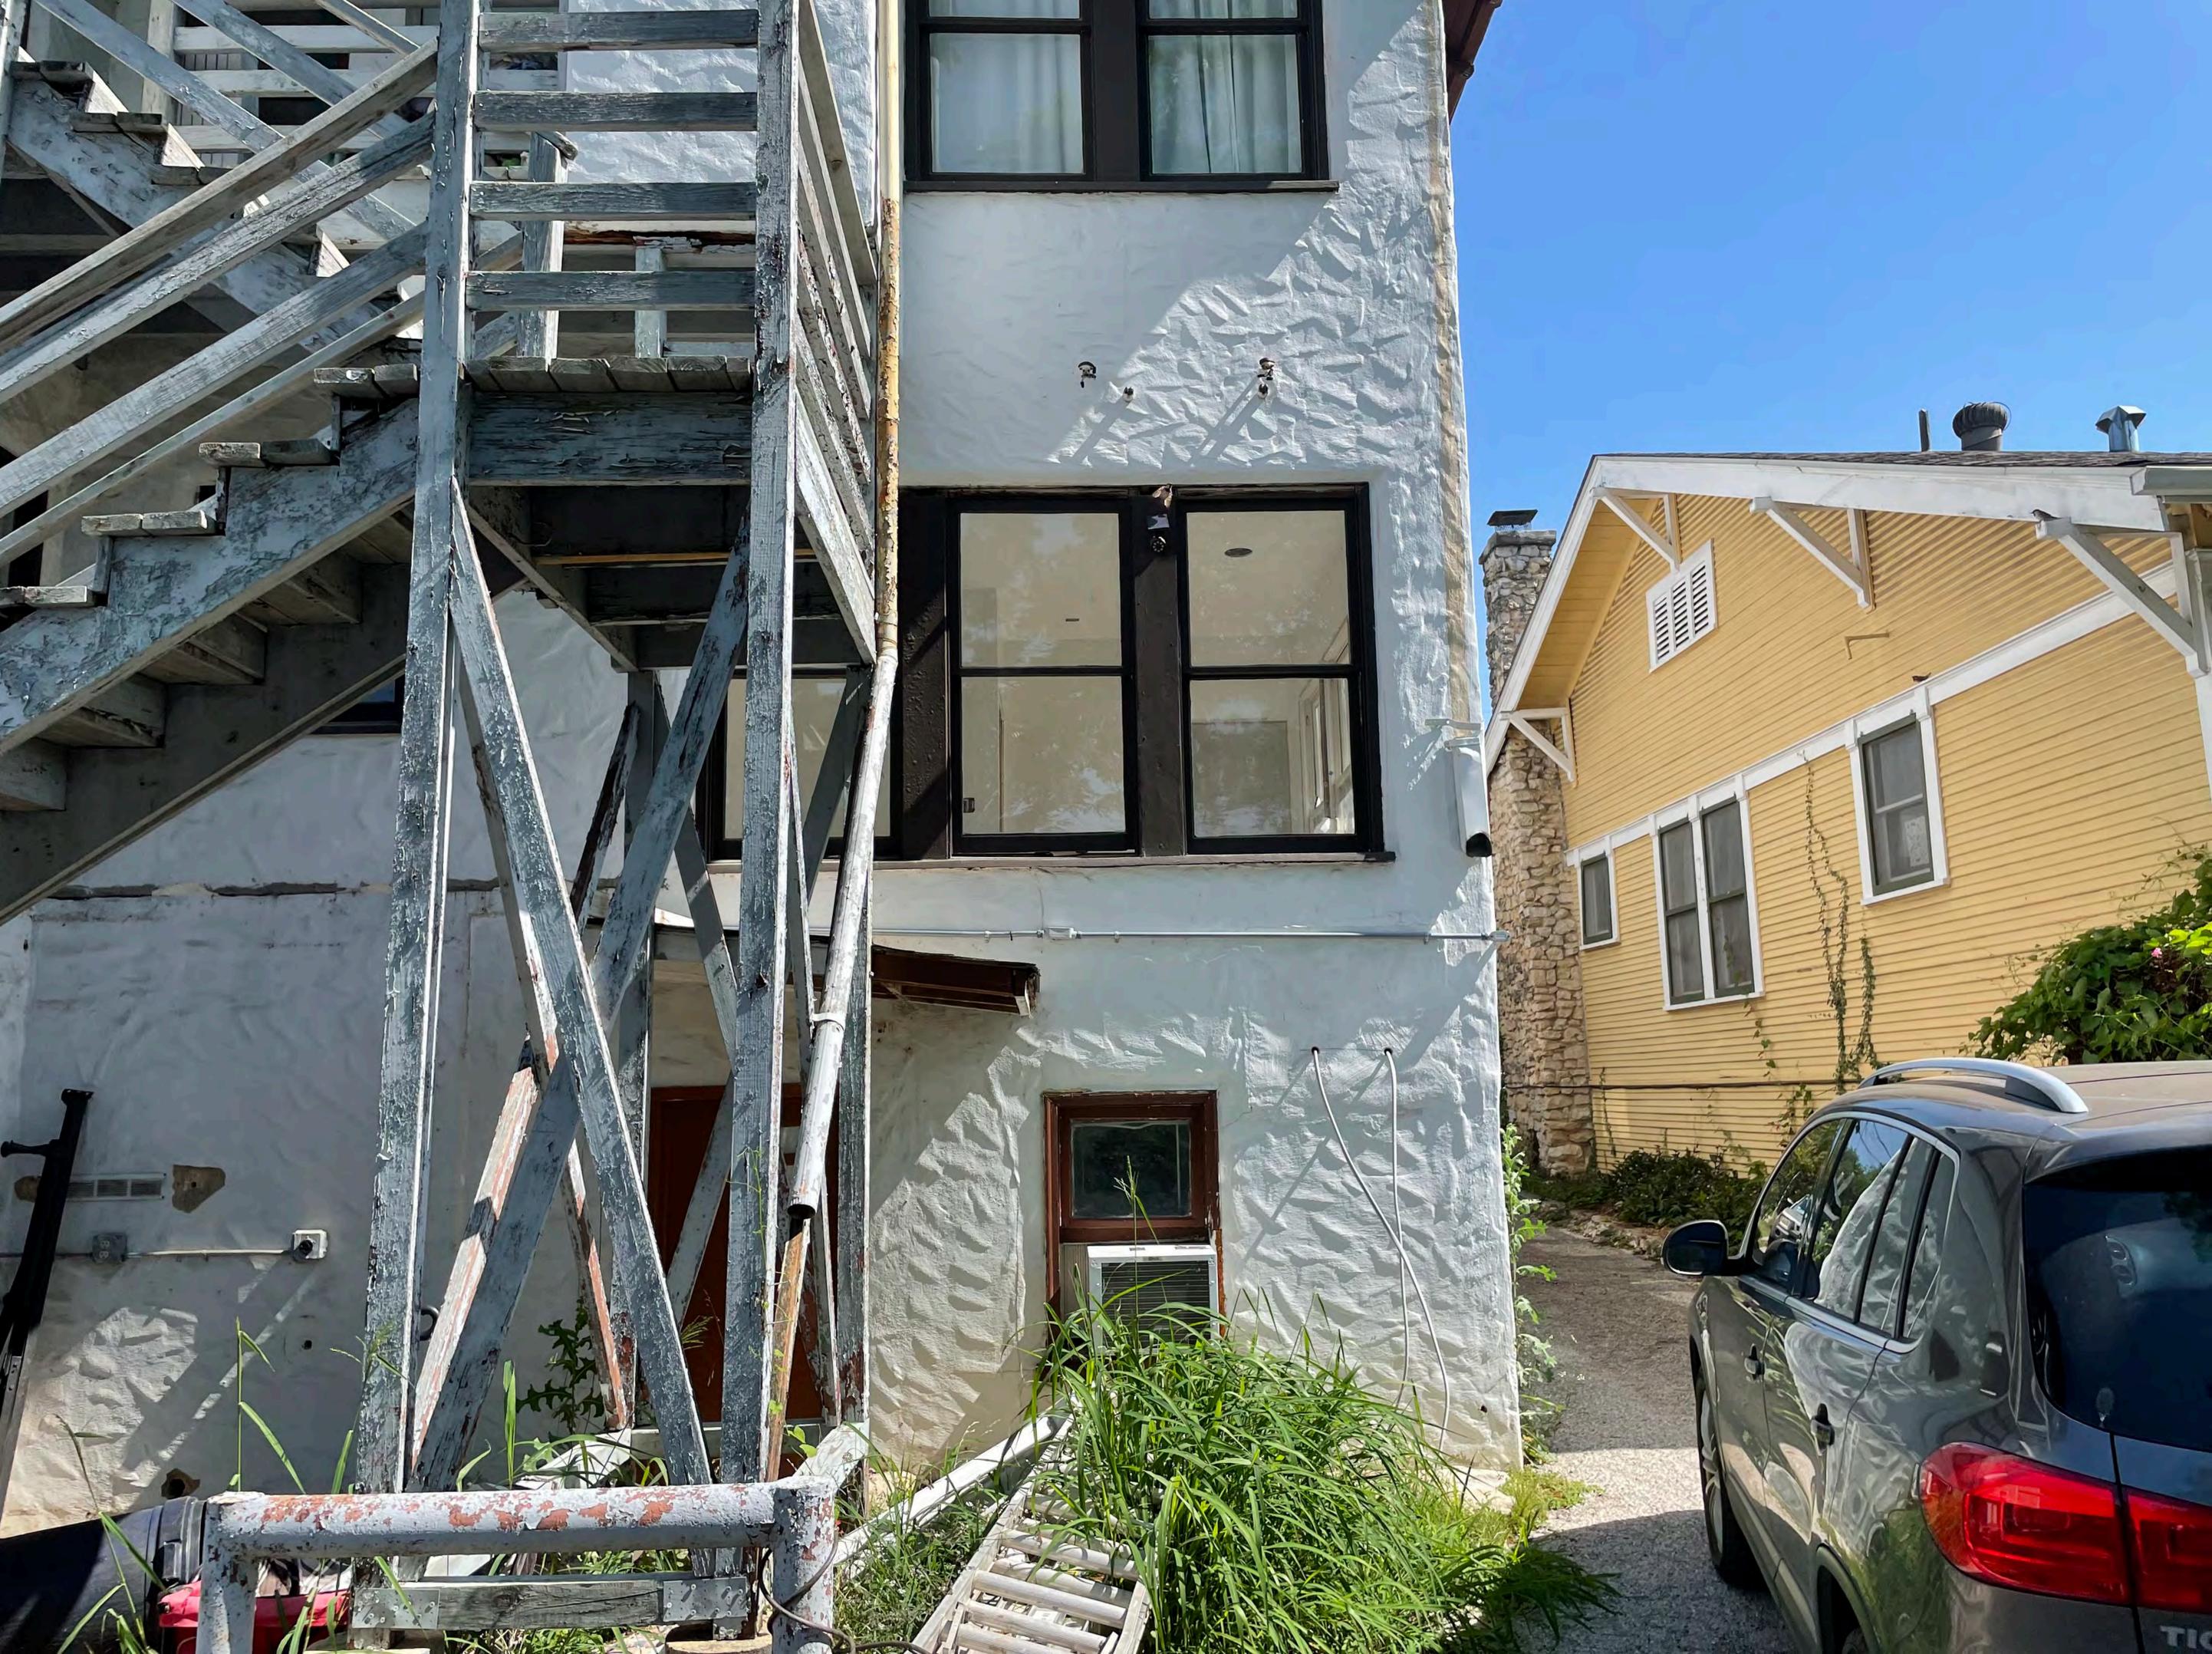
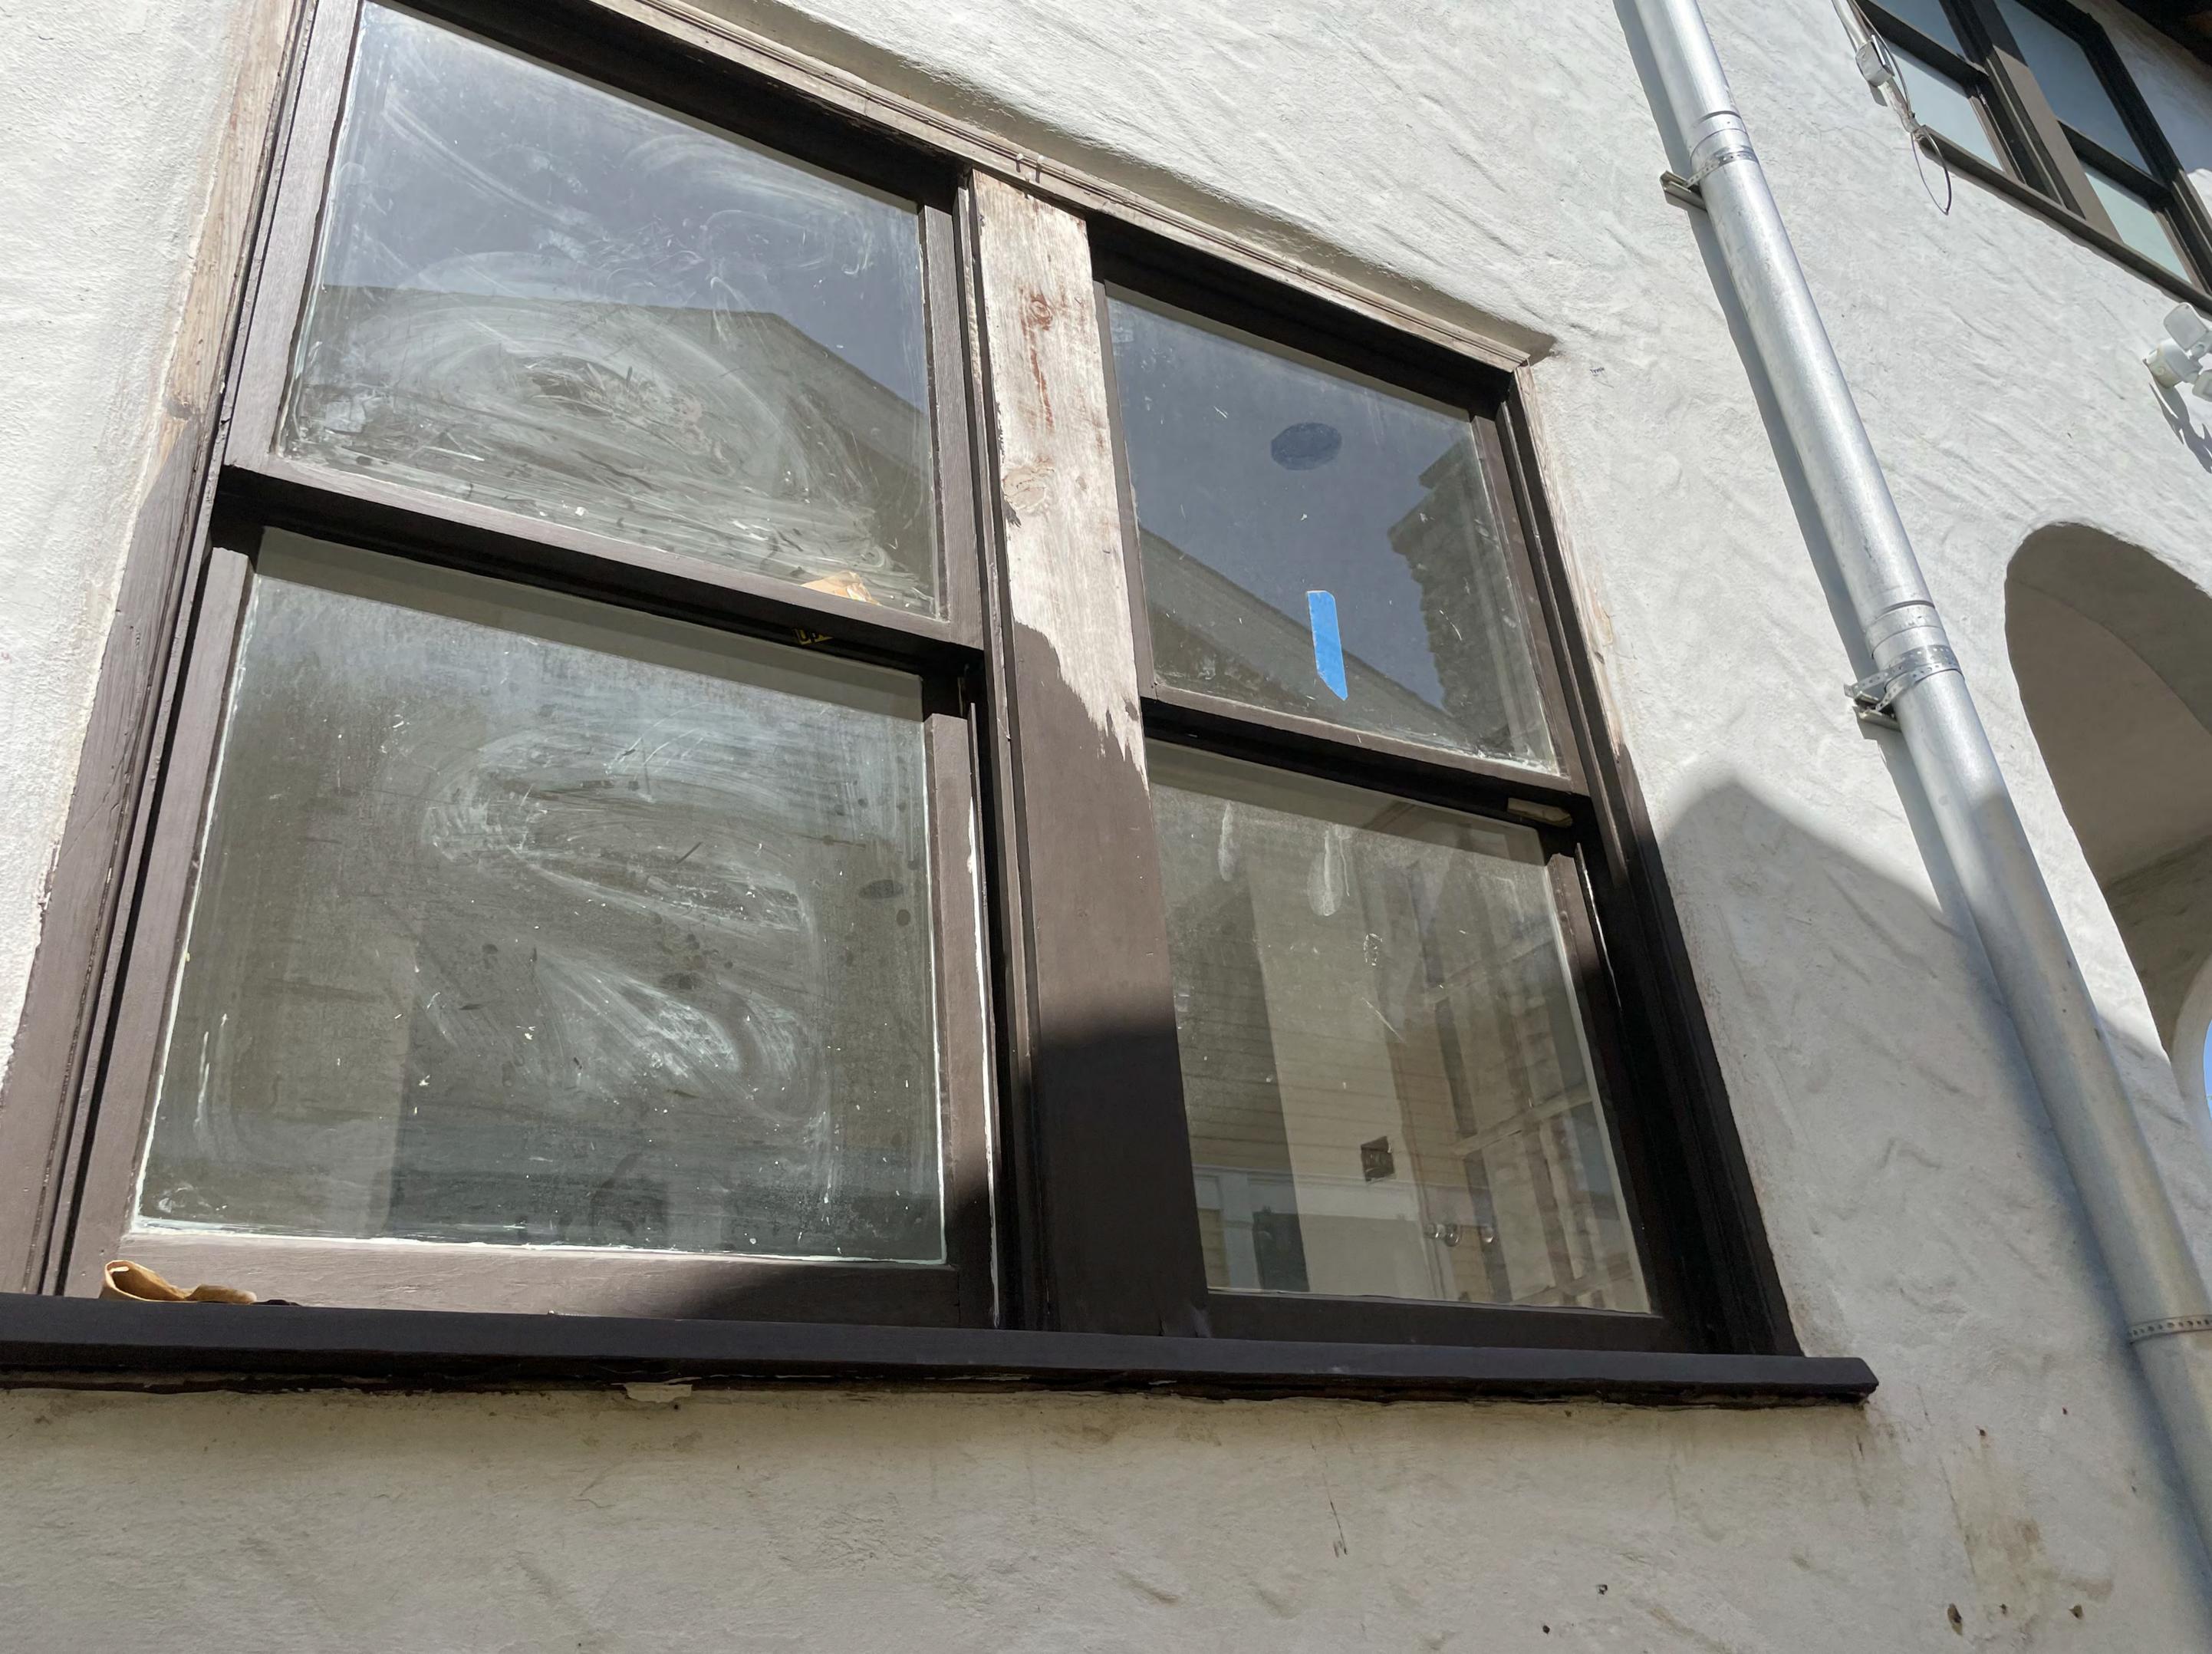
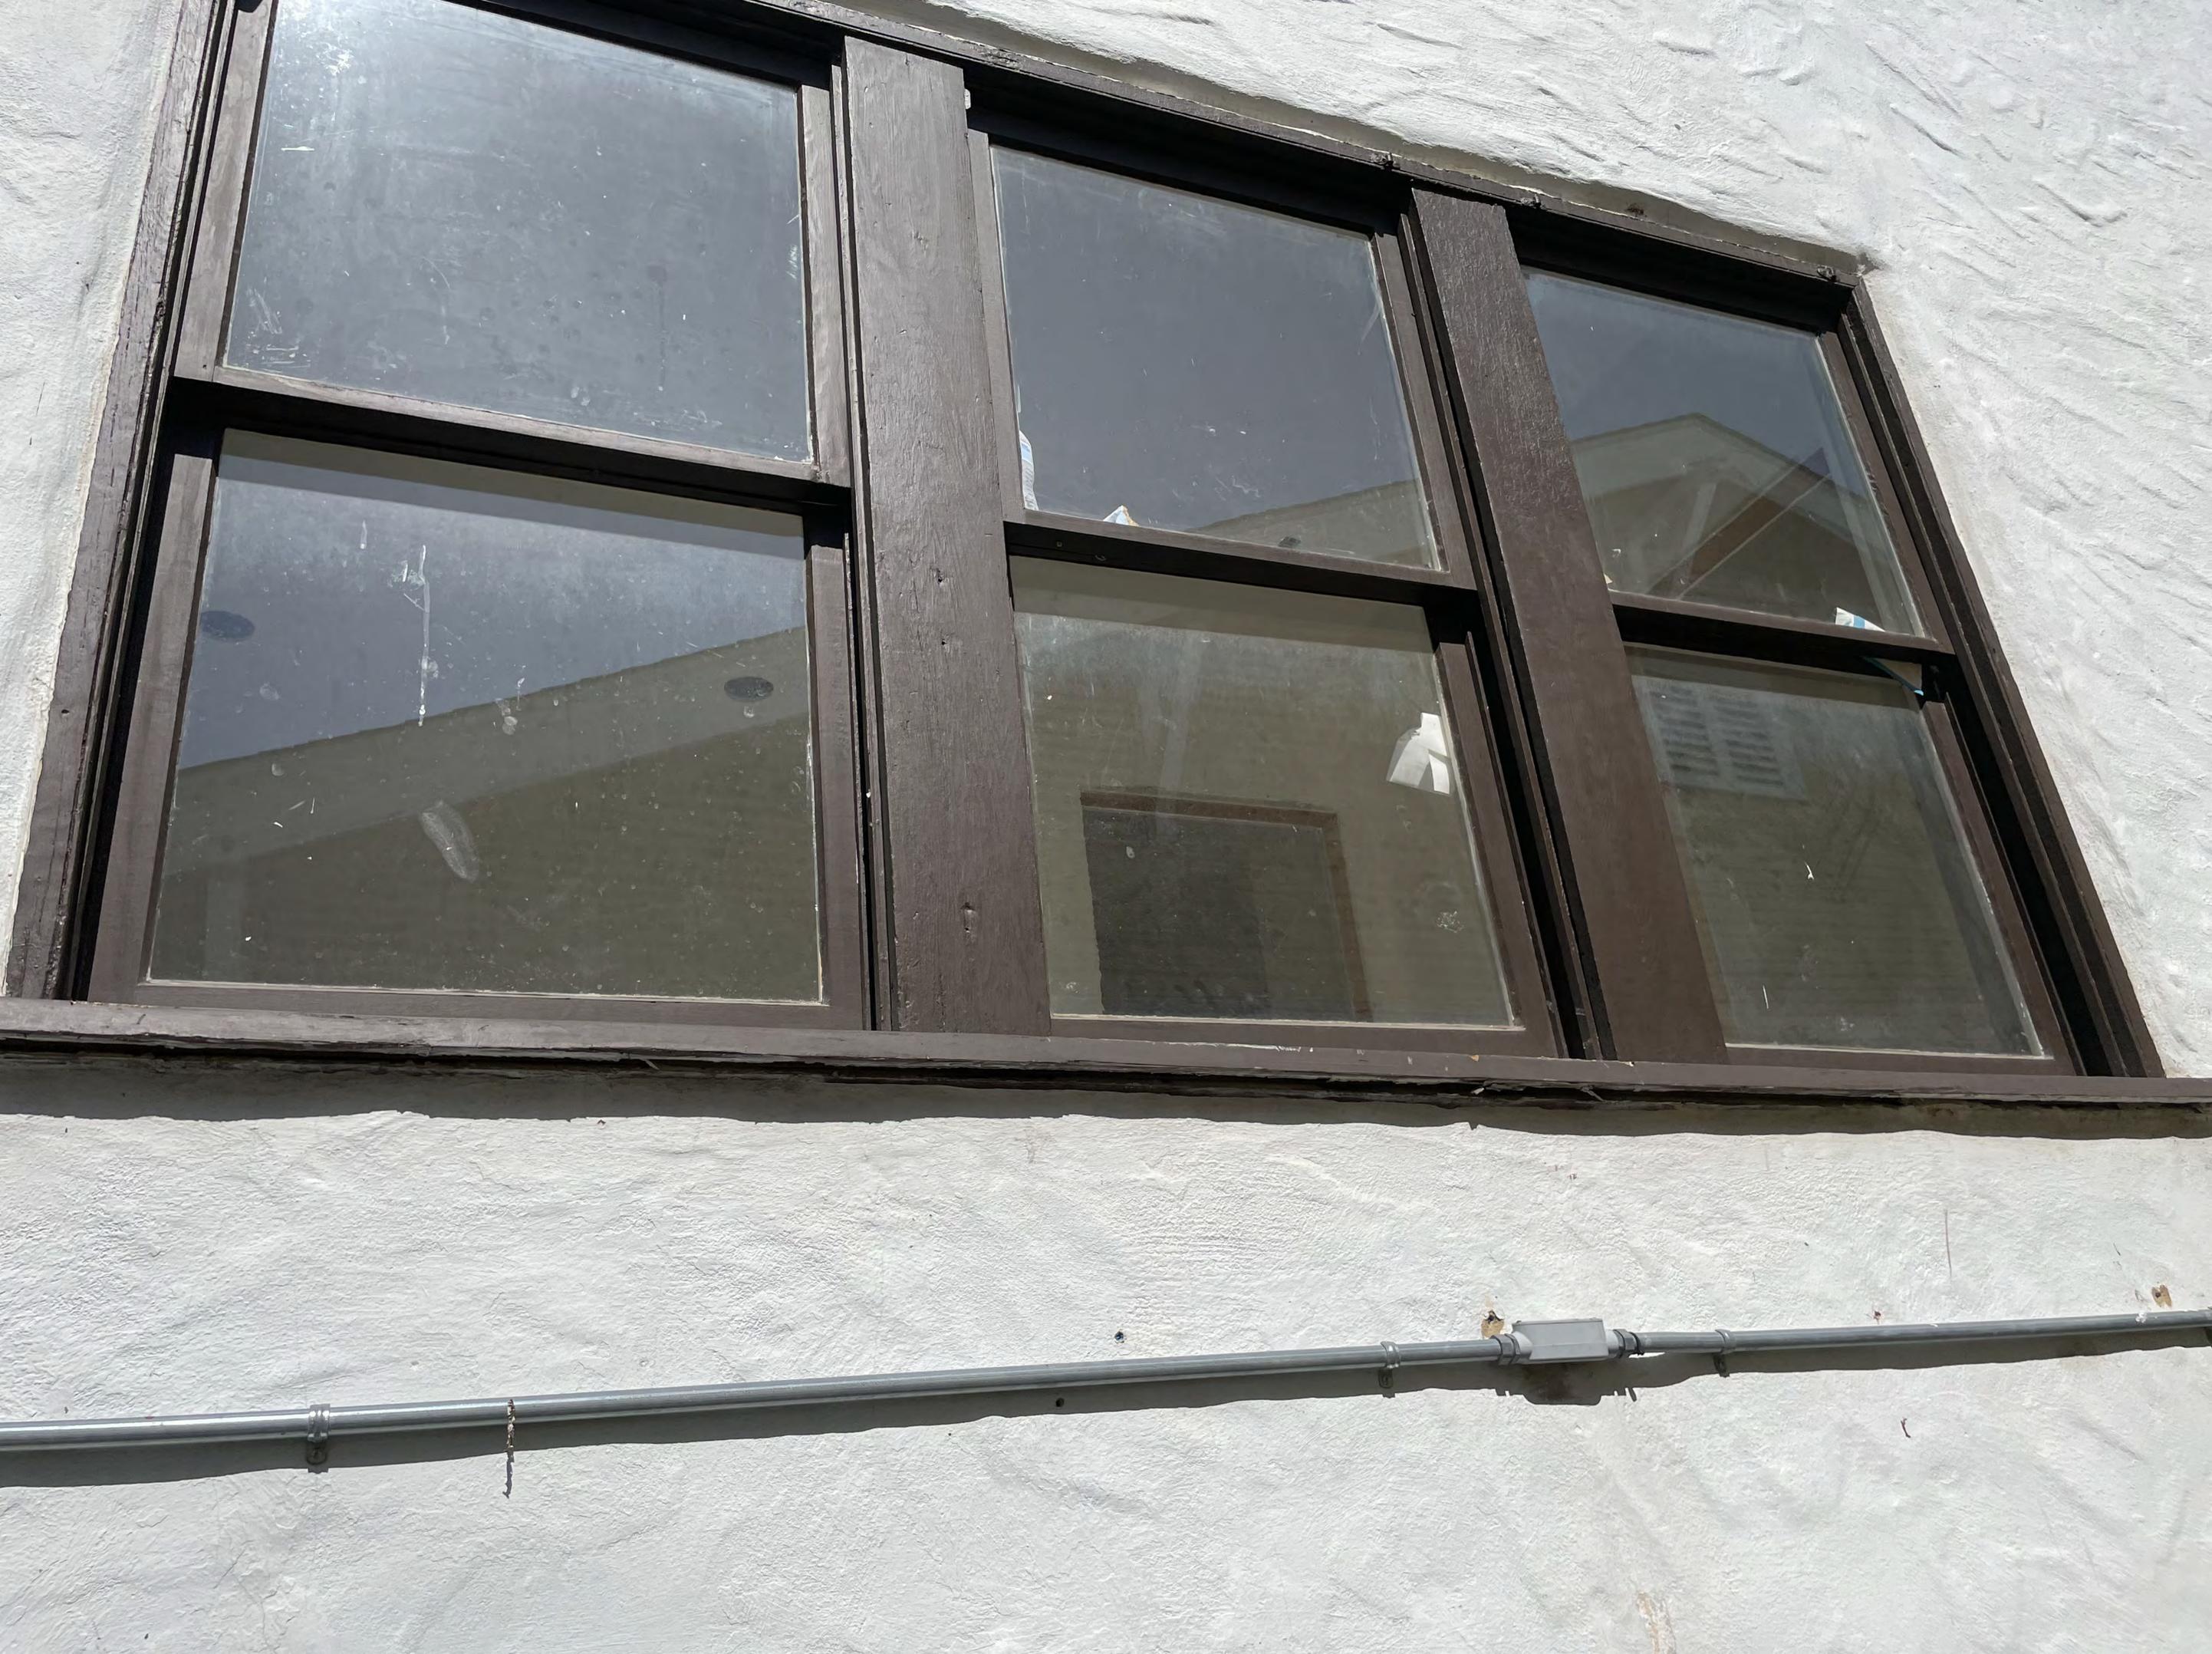
- c. **WINDOW REPLACEMENT: EXISTING CONDITION** – From the photos submitted to date, the wood windows proposed for replacement appear to be of historic-age, fully wood one-over-one windows. The windows do not show signs of significant wood rot, wood damage, or severe deterioration. Staff finds that the wood windows are in repairable condition based on the documentation provided, with most requiring minimal repair and intervention such as the reworking of the sashes and re-glazing, along with refitting into the trim and frames. Staff has scheduled a site visit with the applicant for Monday, May 30 and may be able to report additional information at the hearing.

Staff does not recommend approval based on findings b – e. Staff recommends that the applicant restore the deteriorated wood windows and preserve all original window openings.

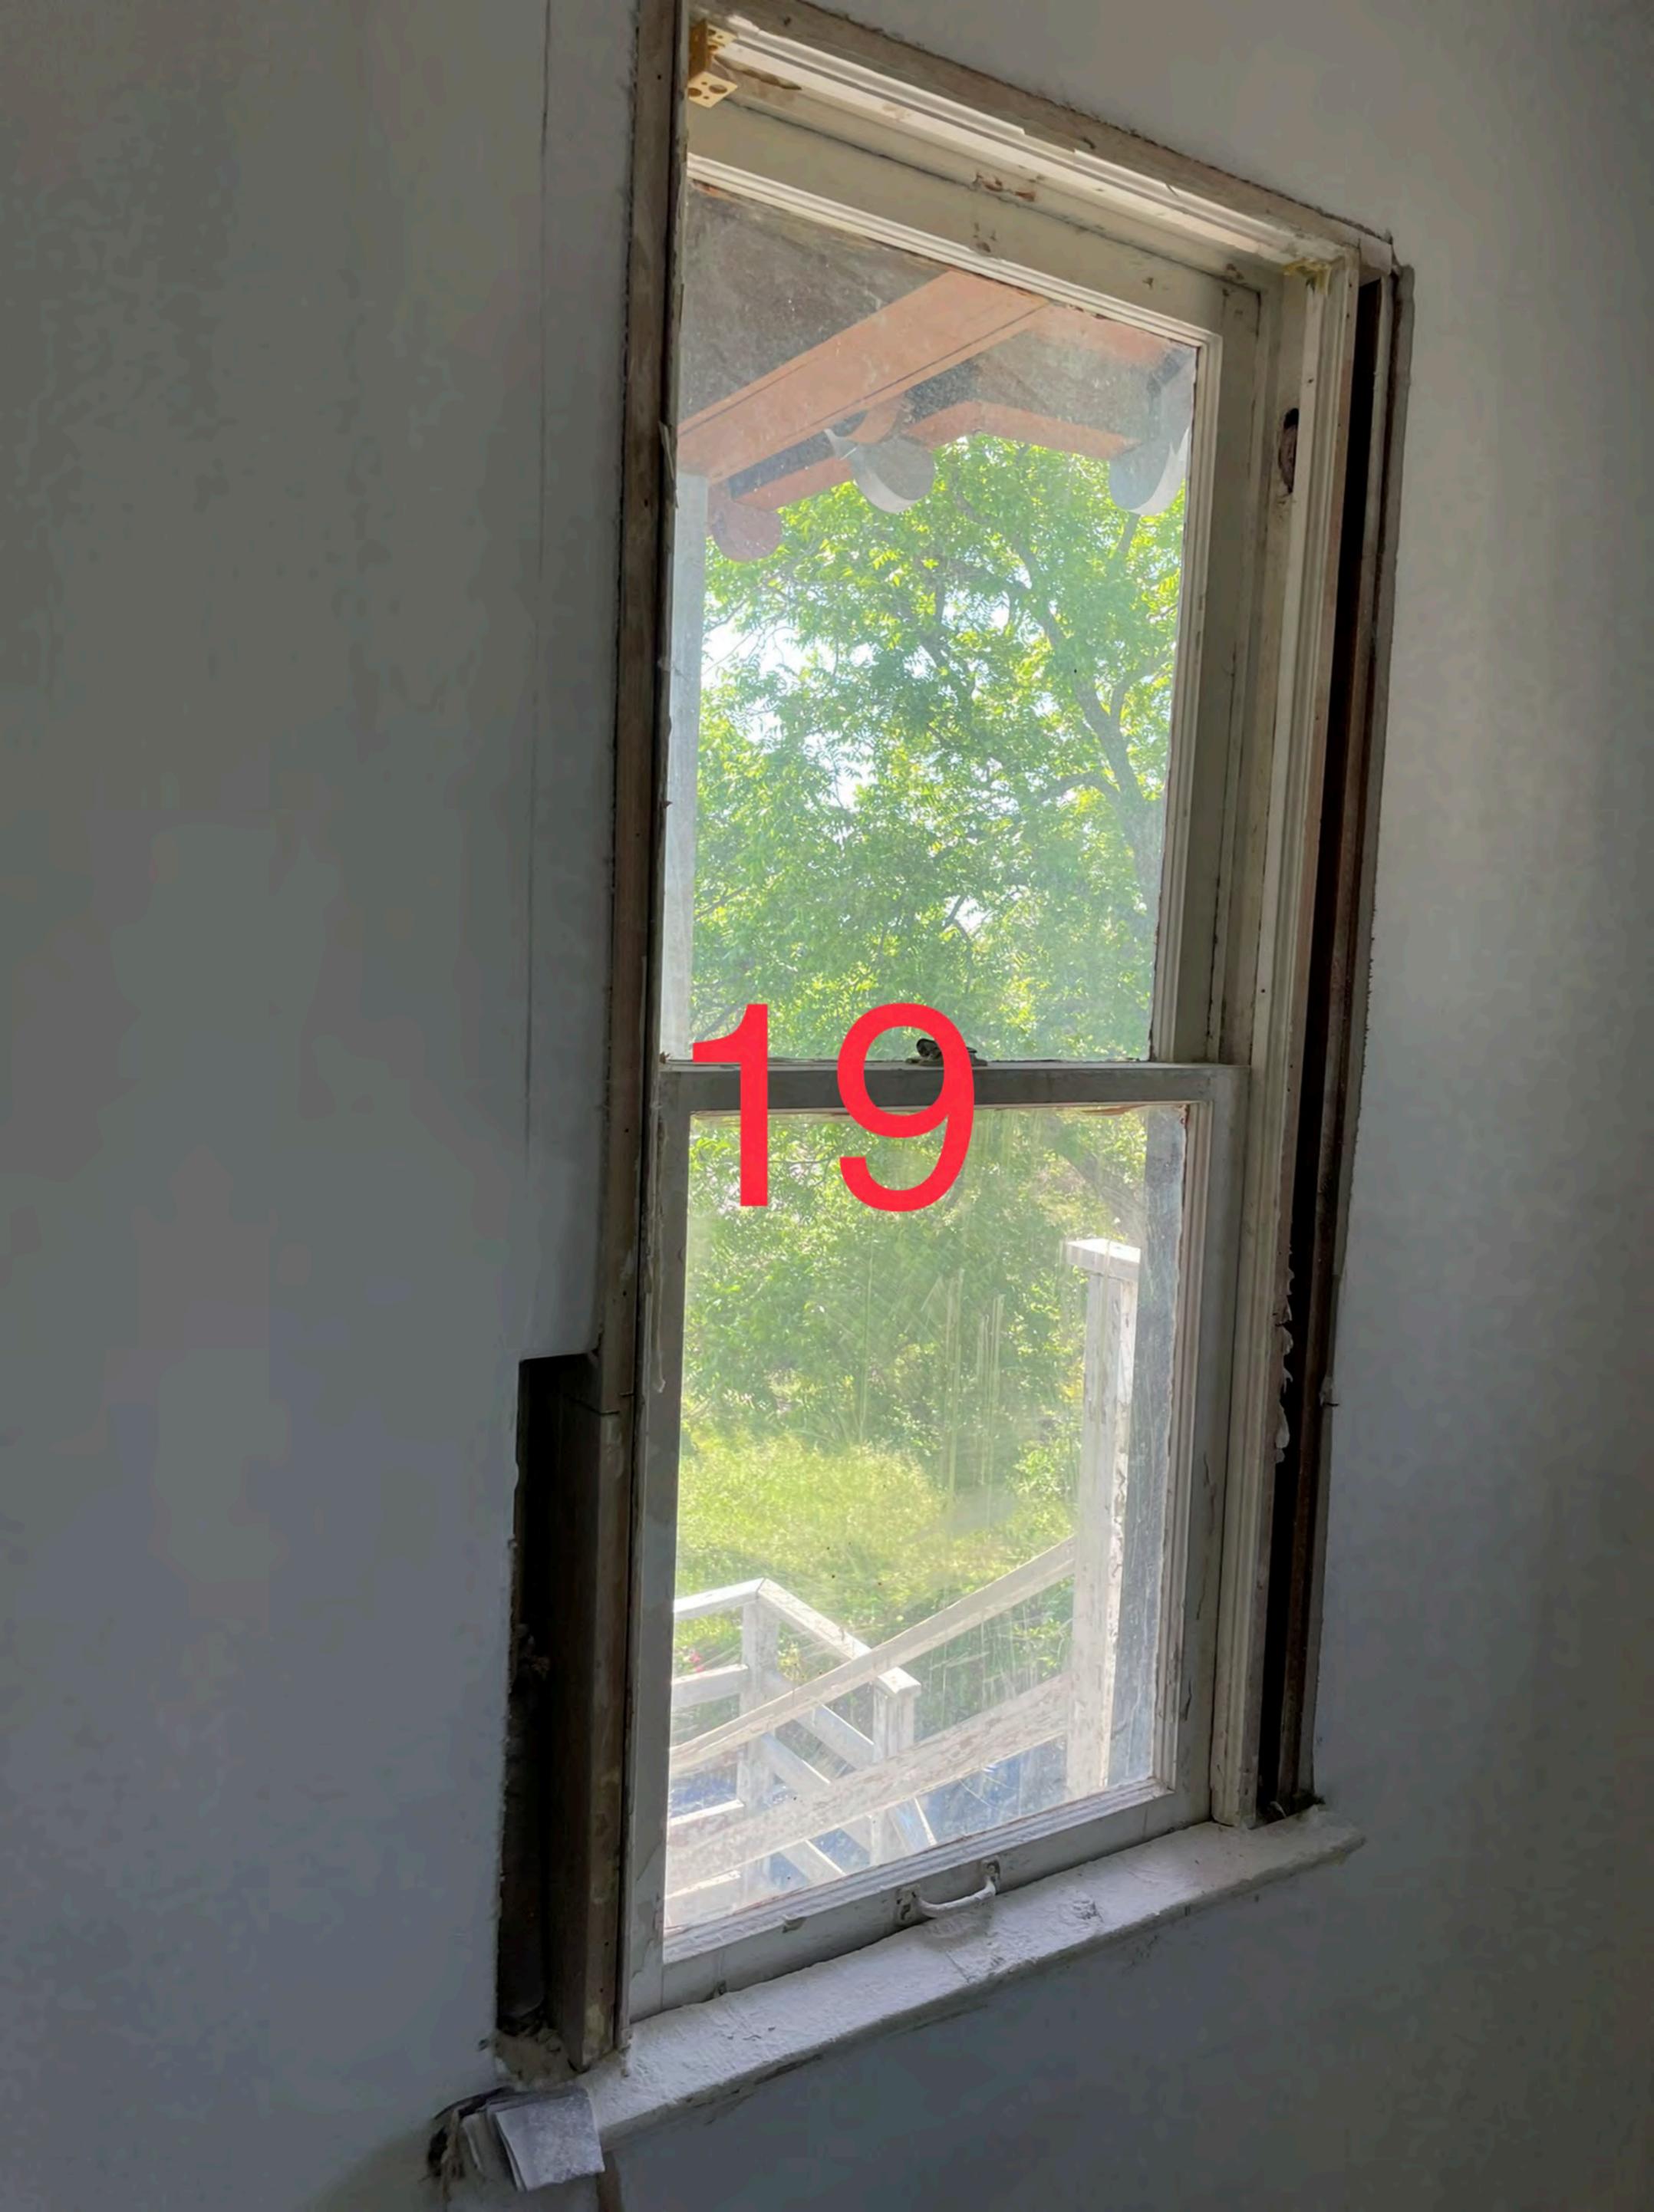
The current condition of the windows is such that many are unrepairable. I've had multiple contractors visit the site and have commented as such. I need to replace them with comparable Marvin windows that are approved for historic window replacement.
