# HISTORIC AND DESIGN REVIEW COMMISSION

August 17, 2022

**HDRC CASE NO:** 2022-418  
**ADDRESS:** 215 W MARIPOSA  
**LEGAL DESCRIPTION:** NCB 9012 BLK 6 LOT 54 & 55  
**ZONING:** R-4, H  
**CITY COUNCIL DIST.:** 1  
**DISTRICT:** Olmos Park Terrace Historic District  
**APPLICANT:** ANA LITOFISKY/ANA LITOFISKY  
**OWNER:** ANA LITOFISKY/ANA LITOFISKY  
**TYPE OF WORK:** Window replacement, chimney removal  
**APPLICATION RECEIVED:** July 14, 2022  
**60-DAY REVIEW:** Not applicable due to City Council Emergency Orders  
**CASE MANAGER:** Rachel Rettaliata

## Investigation Report

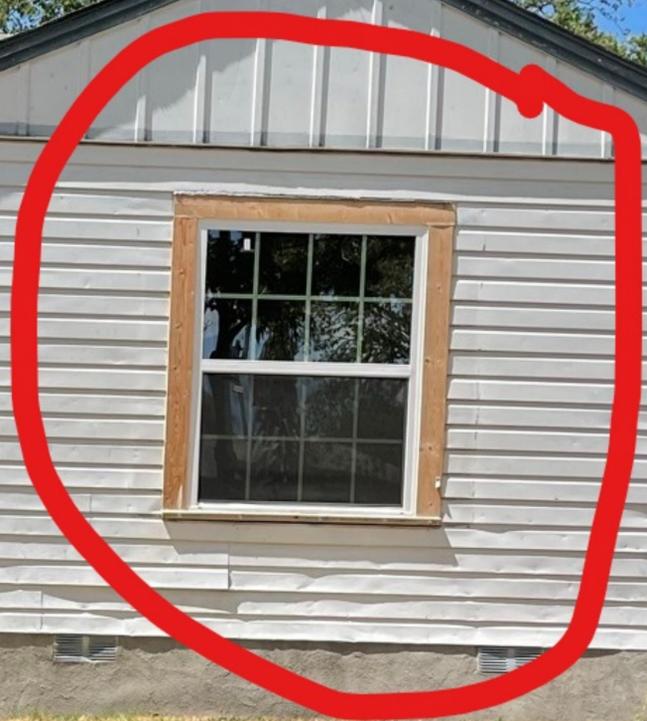
#1

7/20  
 WINDOWS  
 REPLACED  
 NO OTHERS  
 WILL BE  
 REPLACED

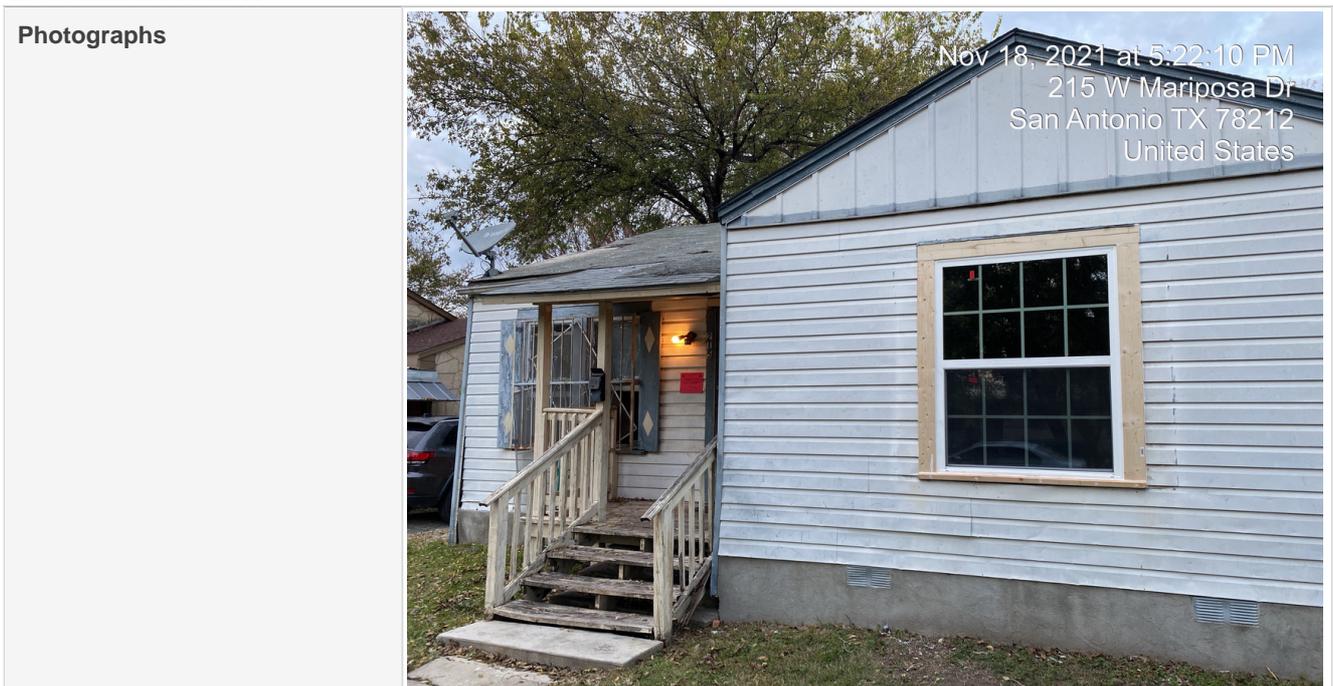
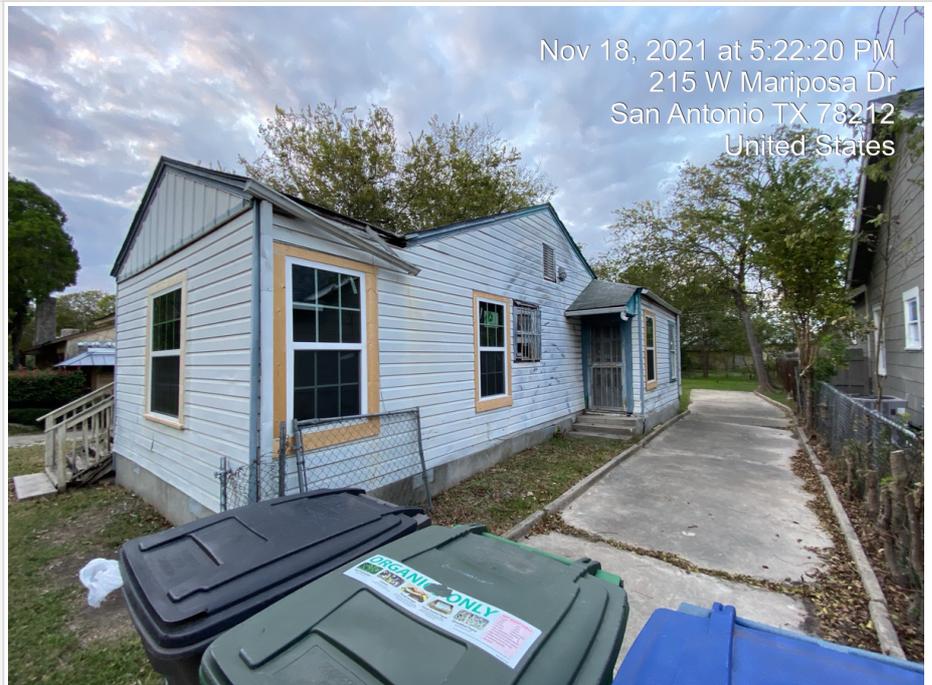
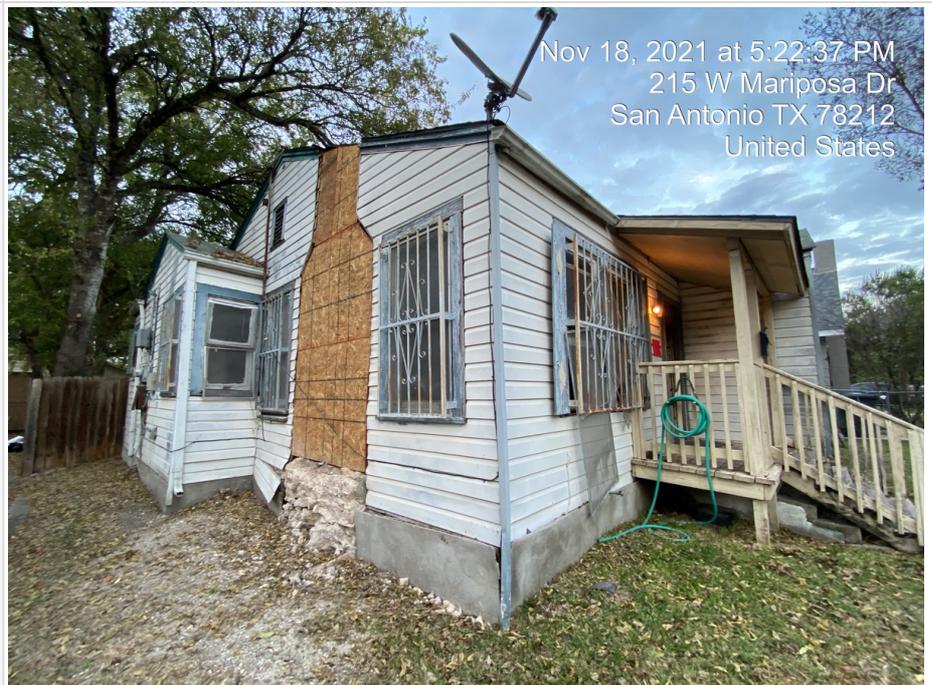
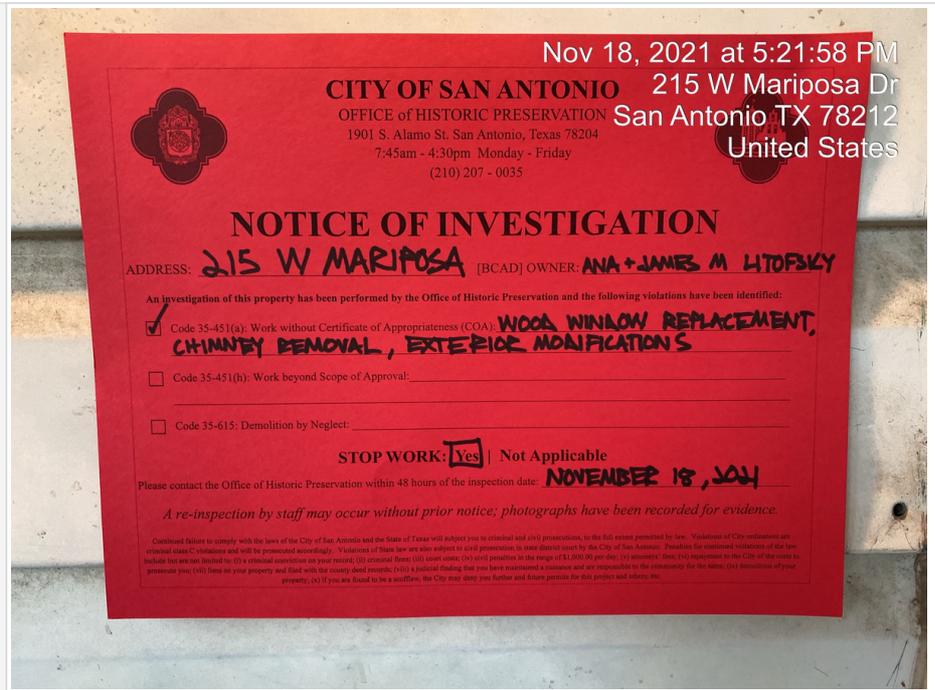
Date	11/18/2021
Time	05:20 PM (-6 GMT)
Context	citizen report
Present Staff	Edward Hall
Present Individuals	None
Types of Work Observed	Exterior Maintenance and Alterations
Amount of Work Completed	50%
Description of work	Removal of masonry chimney, fenestration modifications, exterior modifications, window replacement.
