HISTORIC AND DESIGN REVIEW COMMISSION

October 05, 2022

HDRC CASE NO: 2022-456
ADDRESS: 902 E GRAYSON ST
LEGAL DESCRIPTION: NCB 992 BLK 1 LOT 15
ZONING: R-6, H
CITY COUNCIL DIST.: 2
DISTRICT: Government Hill Historic District
APPLICANT: ERIN OSHAUGHNESSY/OSHAUGHNESSY ERIN E
OWNER: ERIN OSHAUGHNESSY/OSHAUGHNESSY ERIN E
TYPE OF WORK: Construction of a carport, driveway modification
APPLICATION RECEIVED: September 09, 2022
60-DAY REVIEW: Not applicable due to City Council Emergency Orders
CASE MANAGER: Jessica Anderson

The applicant requests a Certificate of Appropriateness for approval to extend the driveway and install a carport.

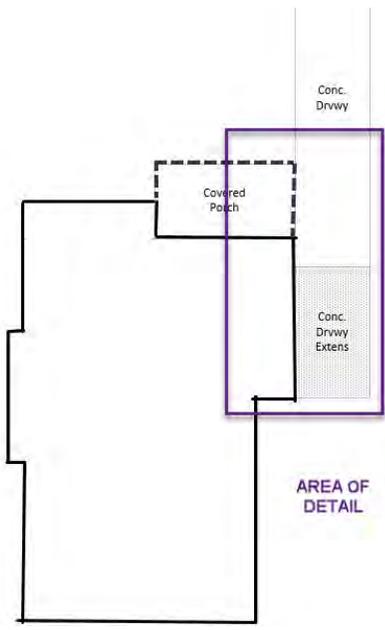
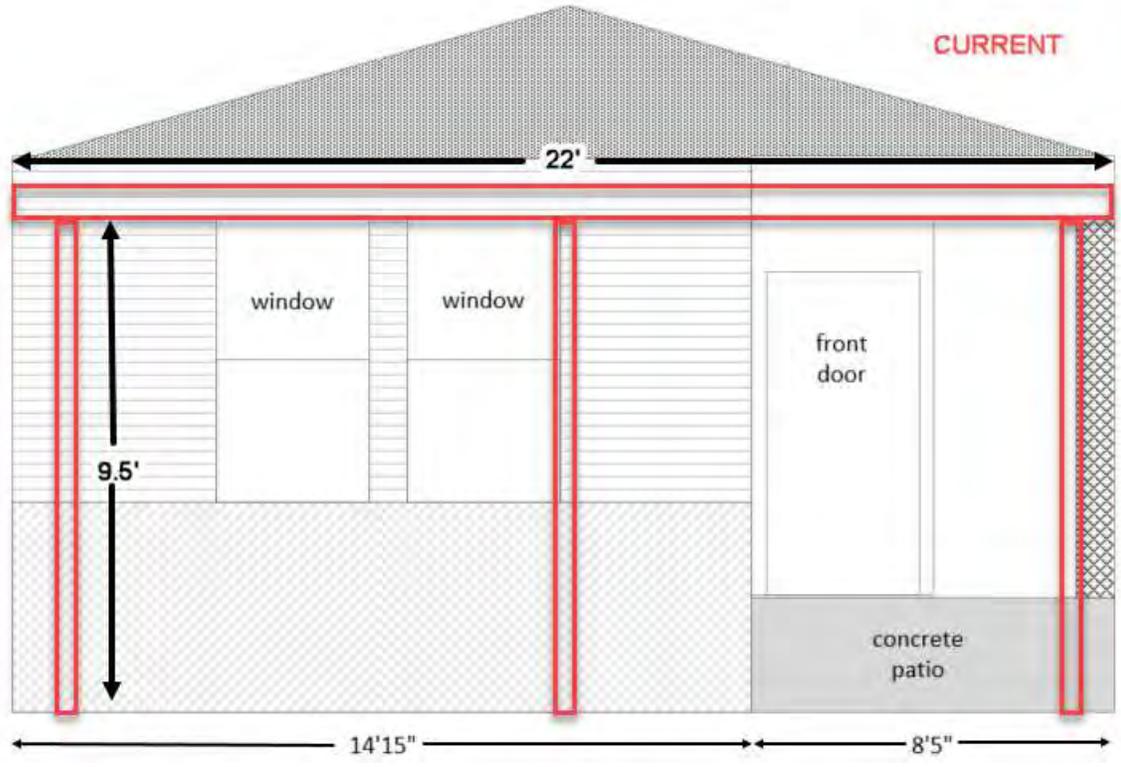
Current carport size = 22' x 10' x 9.5'

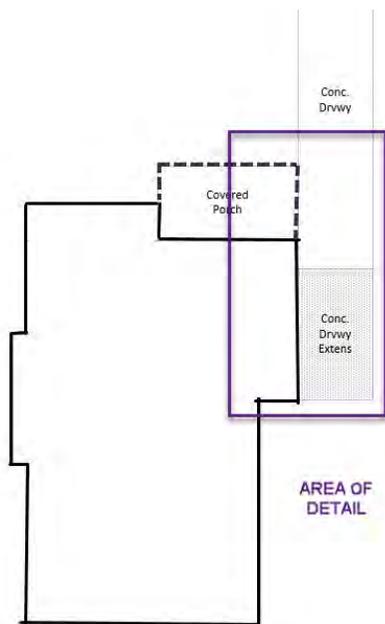
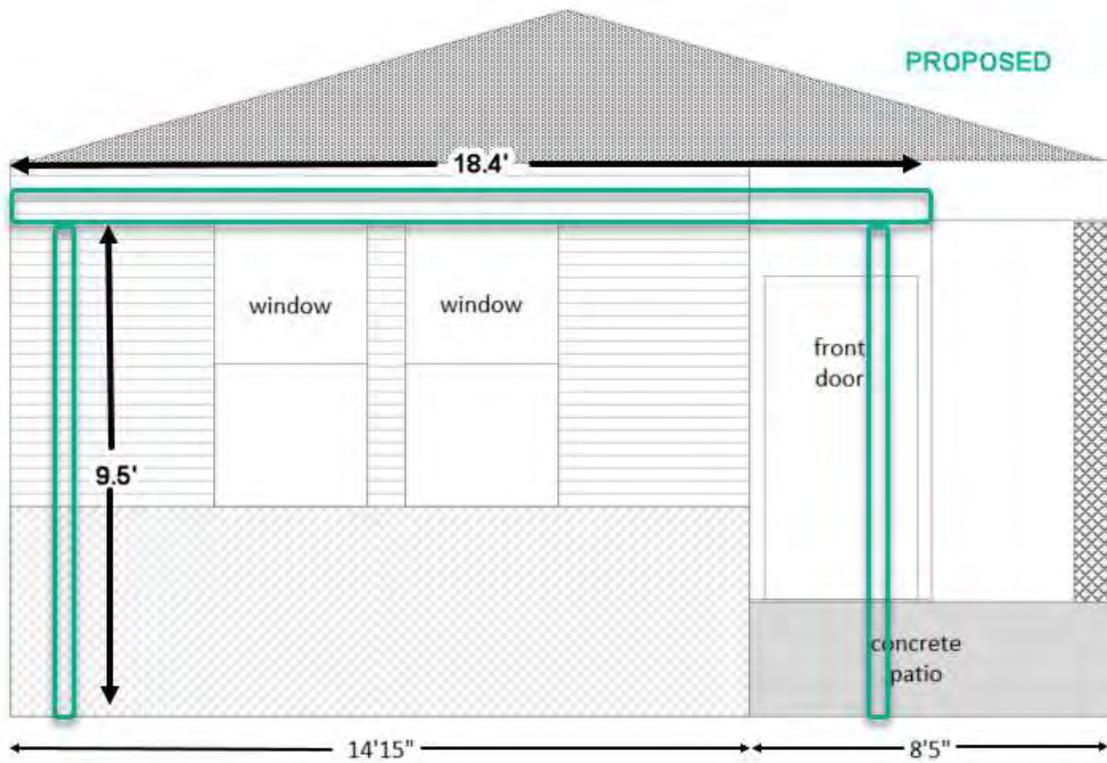
Proposed carport size = 18'4" x 10' x 9.5'

PROPOSED MODIFICATION OF EXISTING LEAN-TO CARPORT – 902 E. GRAYSON:
REMOVE 44" FROM FRONT OF CARPORT.

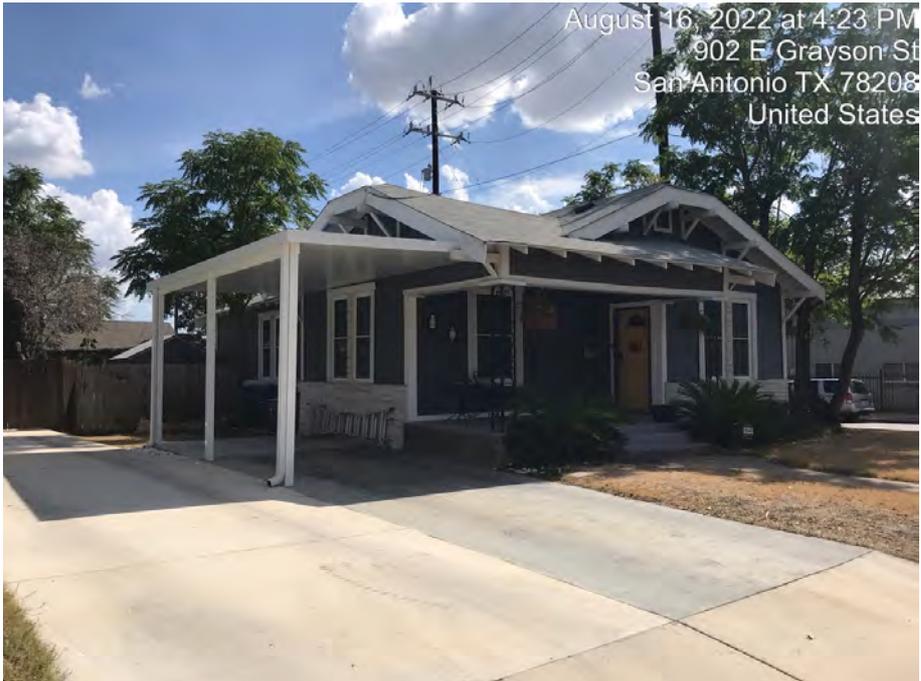
Photographs

Date	08/16/2022
Time	04:15 PM (-5 GMT)
Context	citizen report
Present Staff	Edward Hall
Present Individuals	None
Types of Work Observed	New Construction
Amount of Work Completed	Completed
Description of work	Construction of an attached carport.

Violation Type	No Certificate of Appropriateness (Code 35-451a)
OHP Action	Posted "Notice of Investigation"
Will post-work application fee apply?	To be determined
