HISTORIC AND DESIGN REVIEW COMMISSION

November 02, 2022

HDRC CASE NO: 2022-399
ADDRESS: 363 NORTH DR
LEGAL DESCRIPTION: NCB 7026 BLK 5 LOT 16, E11 FT OF 18
ZONING: R-6, H
CITY COUNCIL DIST.: 7
DISTRICT: Monticello Park Historic District
APPLICANT: Thomas Gandy/GANDY THOMAS R
OWNER: Thomas Gandy/GANDY THOMAS R
TYPE OF WORK: Exterior modifications, fenestration modifications
APPLICATION RECEIVED: July 24, 2022
60-DAY REVIEW: Not applicable due to City Council Emergency Orders
CASE MANAGER: Edward Hall

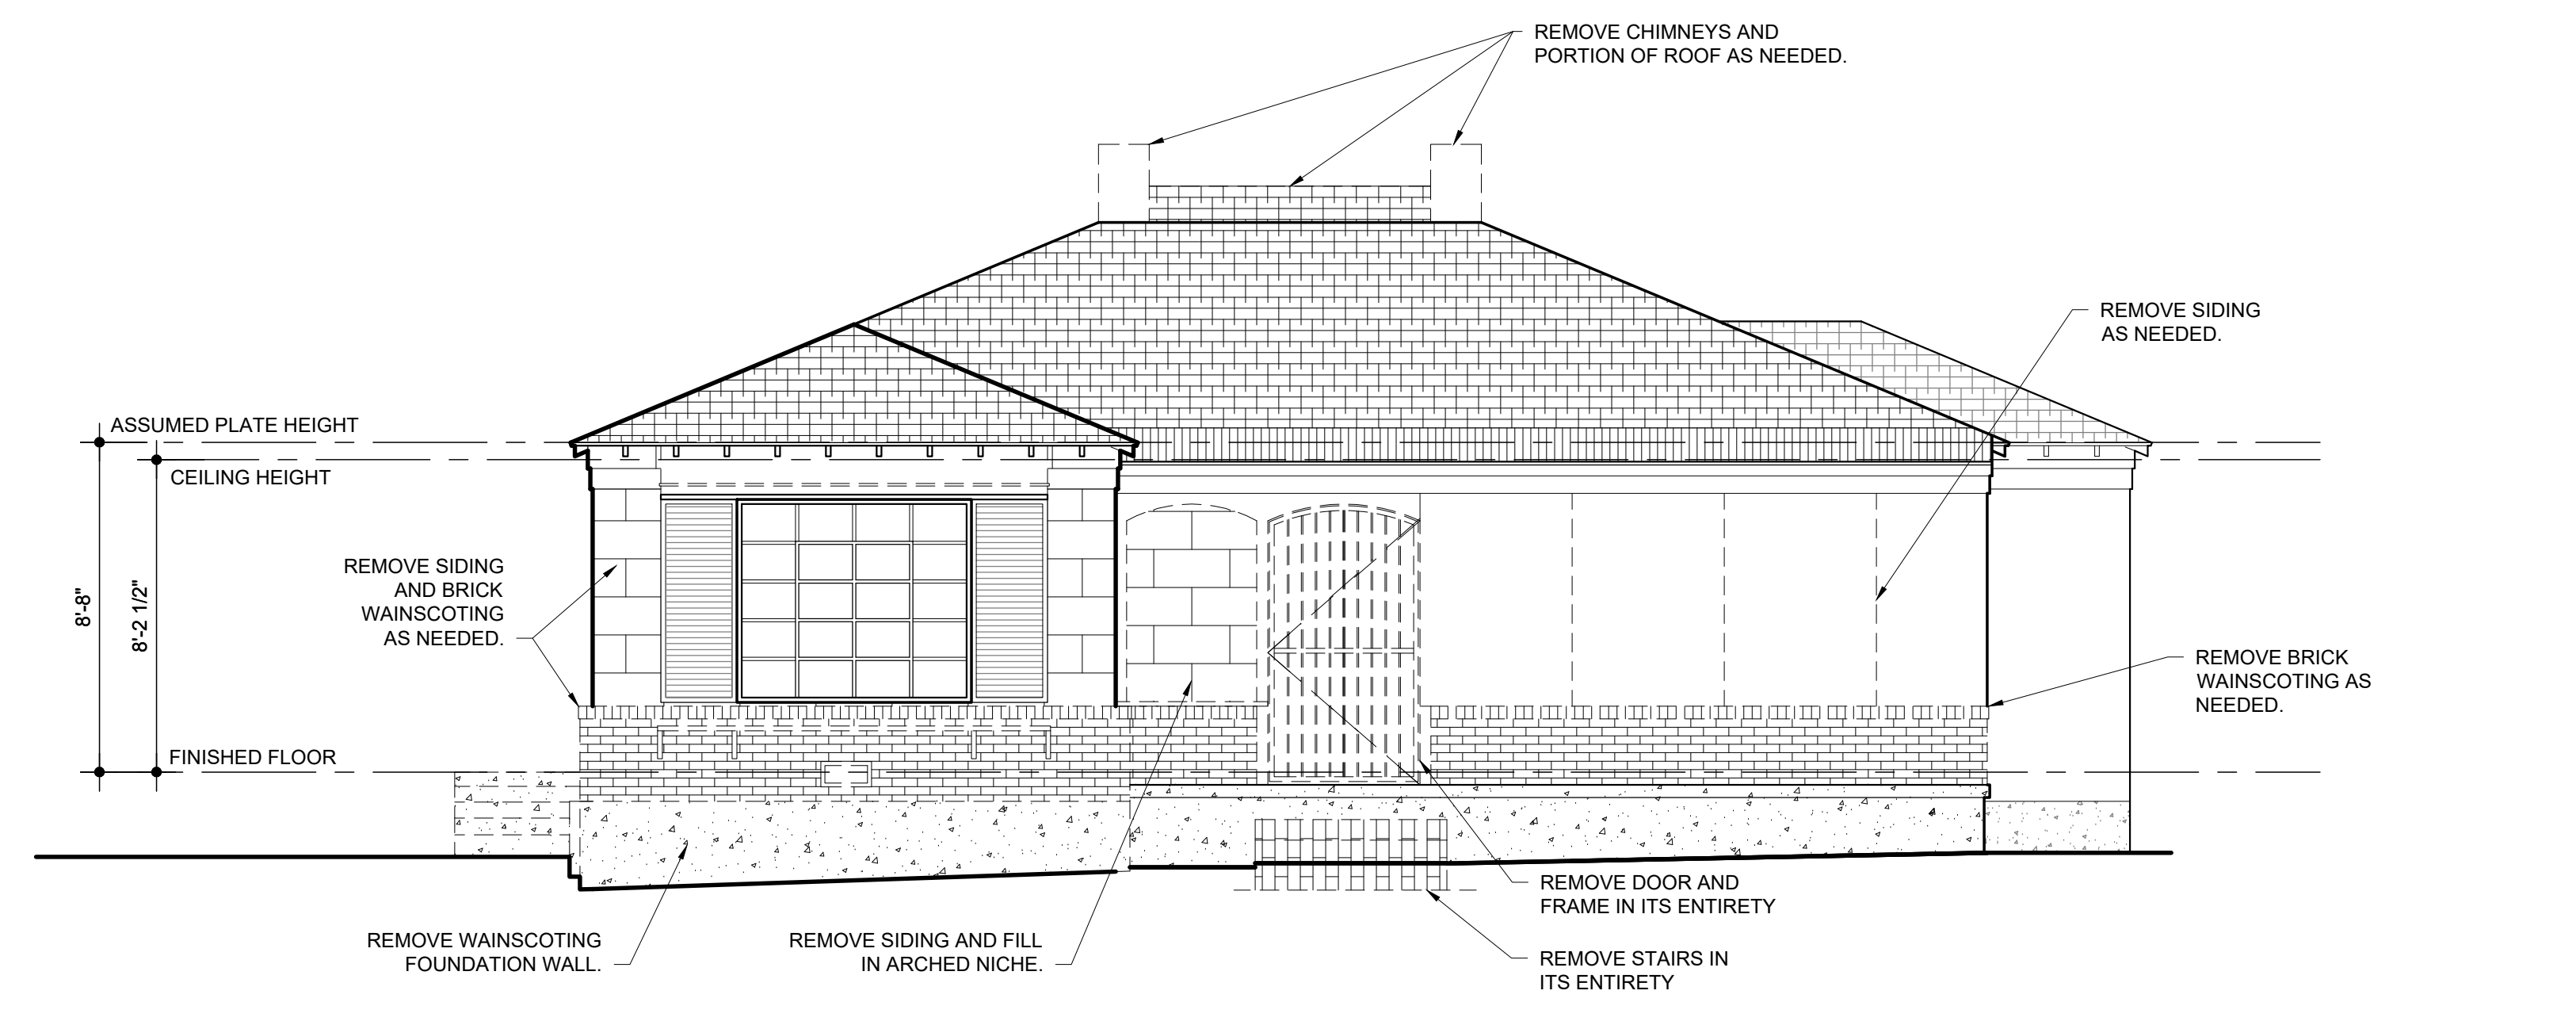
2 FRONT ELEVATION
AD-10 1/4"=1'-0"

- f. EXTERIOR MODIFICATIONS (Front Façade) – The applicant has proposed to perform modifications to the front façade to include the installation of two, one over one windows on the front façade. This wall plane is not original and is the front of a previously enclosed front porch. The Guidelines for Exterior Maintenance and Alterations 7.A and B. note that front porches should not be enclosed. When porches are enclosed, the Guidelines note that they should function and visible read as a porch. Per photos, the front porch has been enclosed with screening elements since 2007, at least. Staff finds that either windows should be added across the entirety of the enclosed porch to read as an open element with visible porch columns, or that the structure should be returned to its previous condition.

2. Staff does not recommend approval of item #2, modifications to the front façade, as noted in finding f. Staff recommends that either windows be added across the entirety of the enclosed porch to read as an open element with visible porch columns or that the structure be returned to its previous condition.

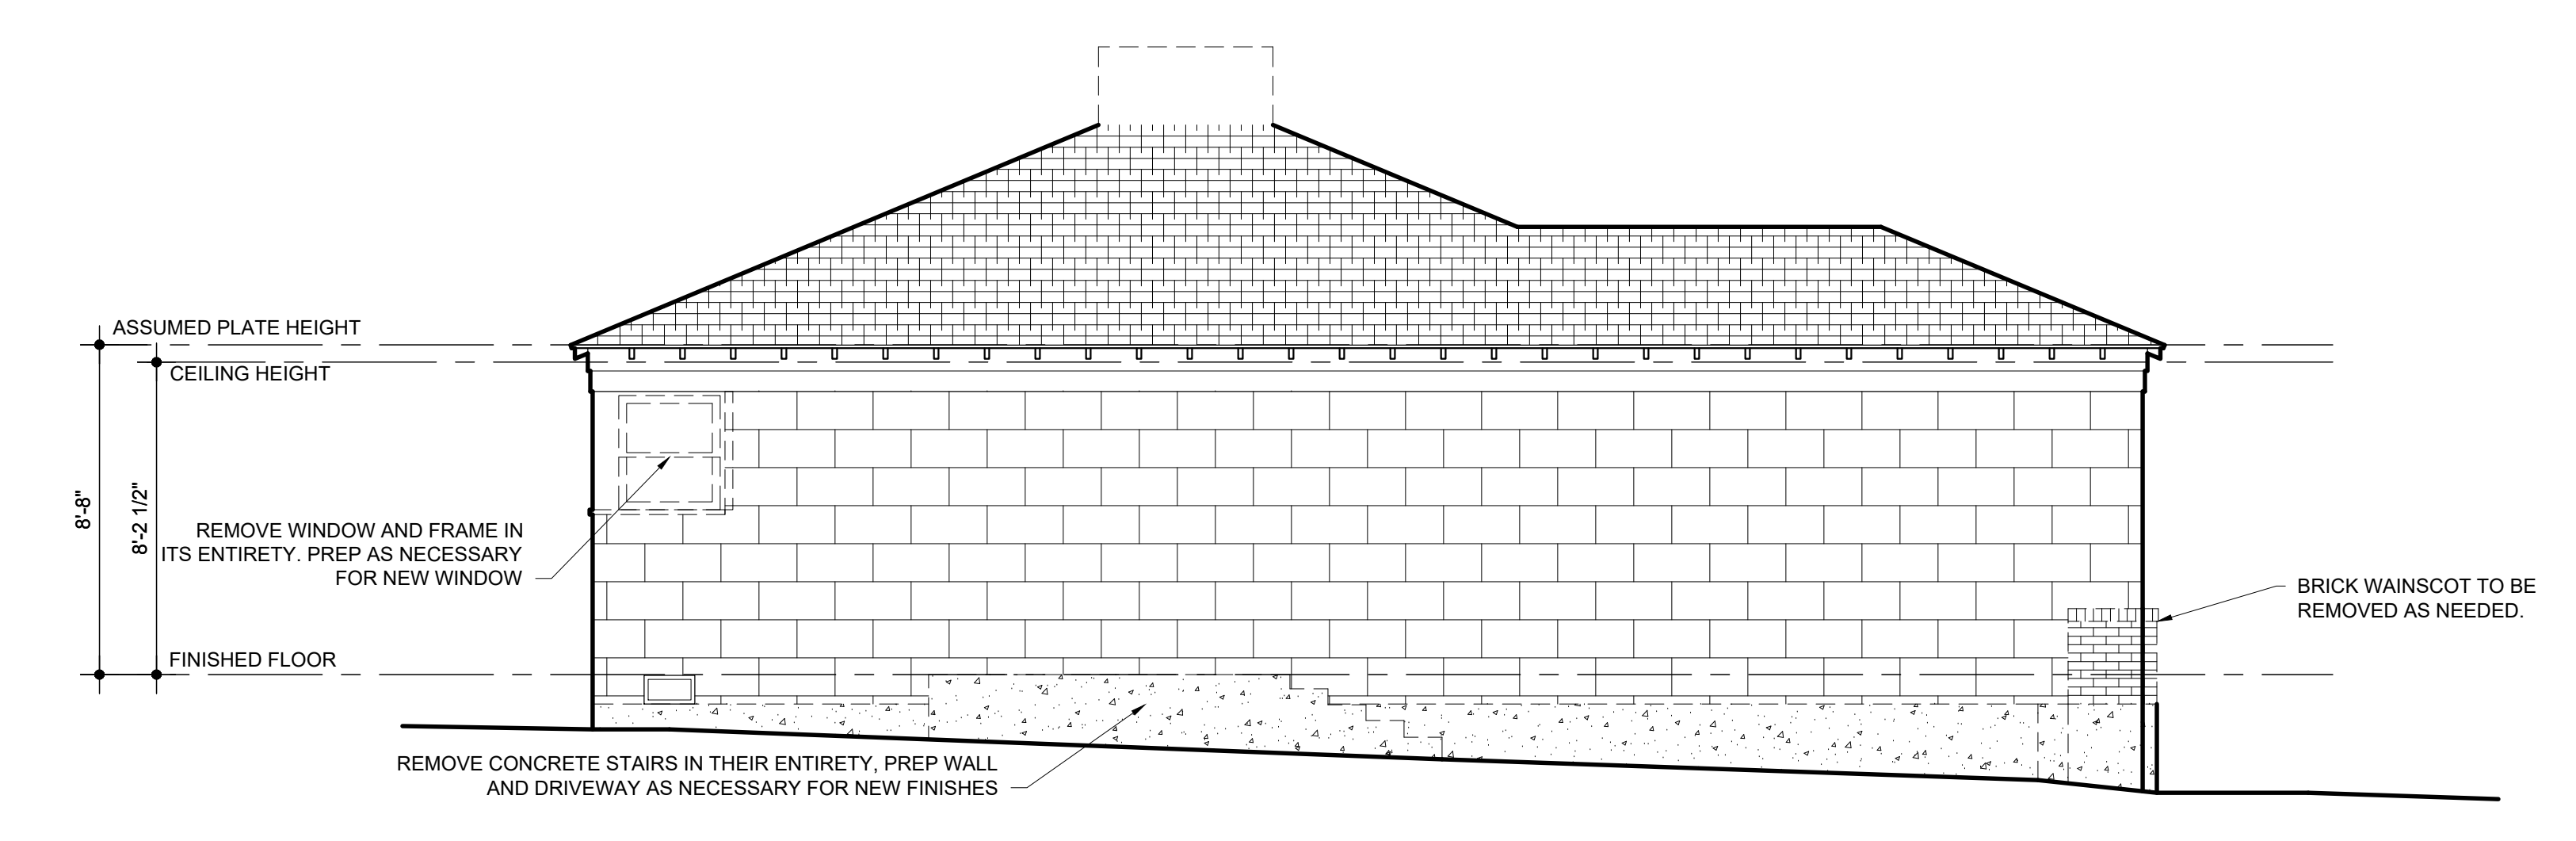
3 LEFT ELEVATION
AD-10 1/4"=1'-0"

- g. EXTERIOR MODIFICATIONS (Side Façade) – The applicant has proposed to perform modifications to the side (west) façade to include the removal of an existing door opening, and the removal of an existing concrete stoop and steps. Per the Guidelines for Exterior Maintenance and Alterations 6.A.i., exiting window and door openings are to be preserved. The proposal to remove the existing, side door is inconsistent with the Guidelines.

Staff finds this door opening should be preserved in its original location. Additionally, staff finds that the side stoop and porch steps are an original element and should be preserved.

3. Staff does not recommend approval of item #3, modifications to the side (west) façade to include the removal of an existing door opening, and the removal of an existing concrete stoop and steps, as noted in finding g. Staff recommends that the door opening, concrete stoop and stairs be preserved.

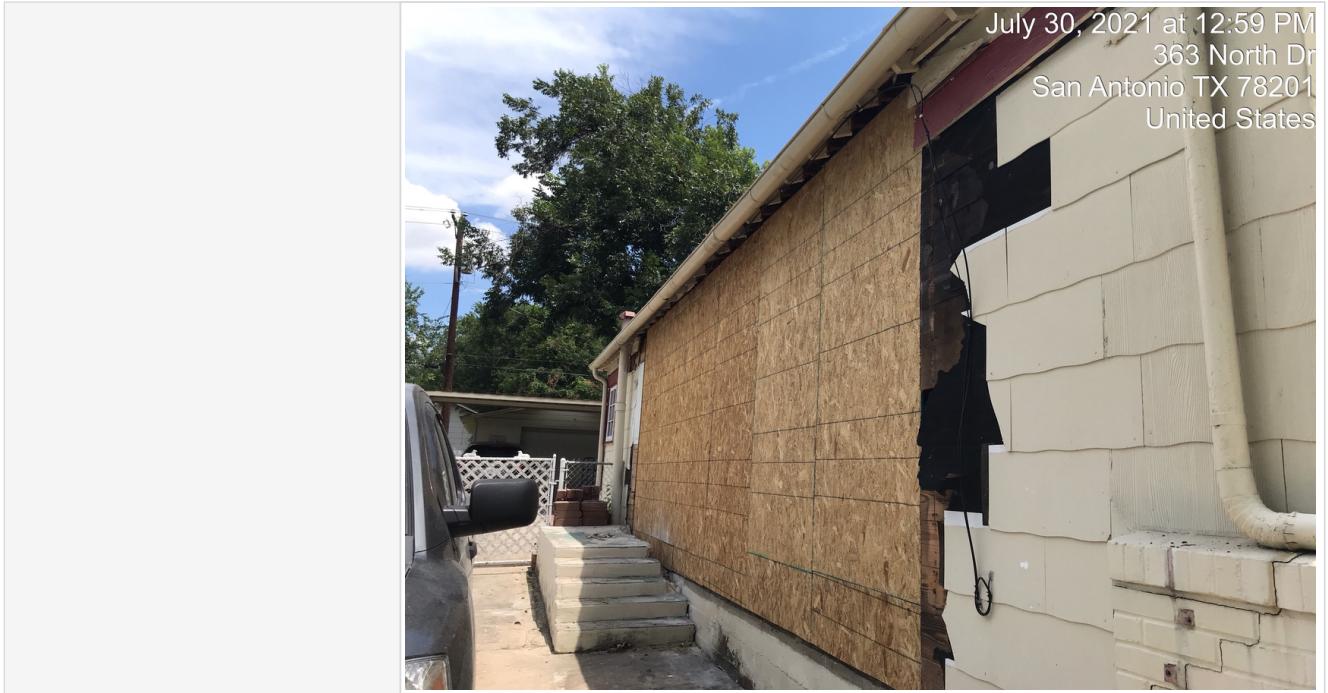
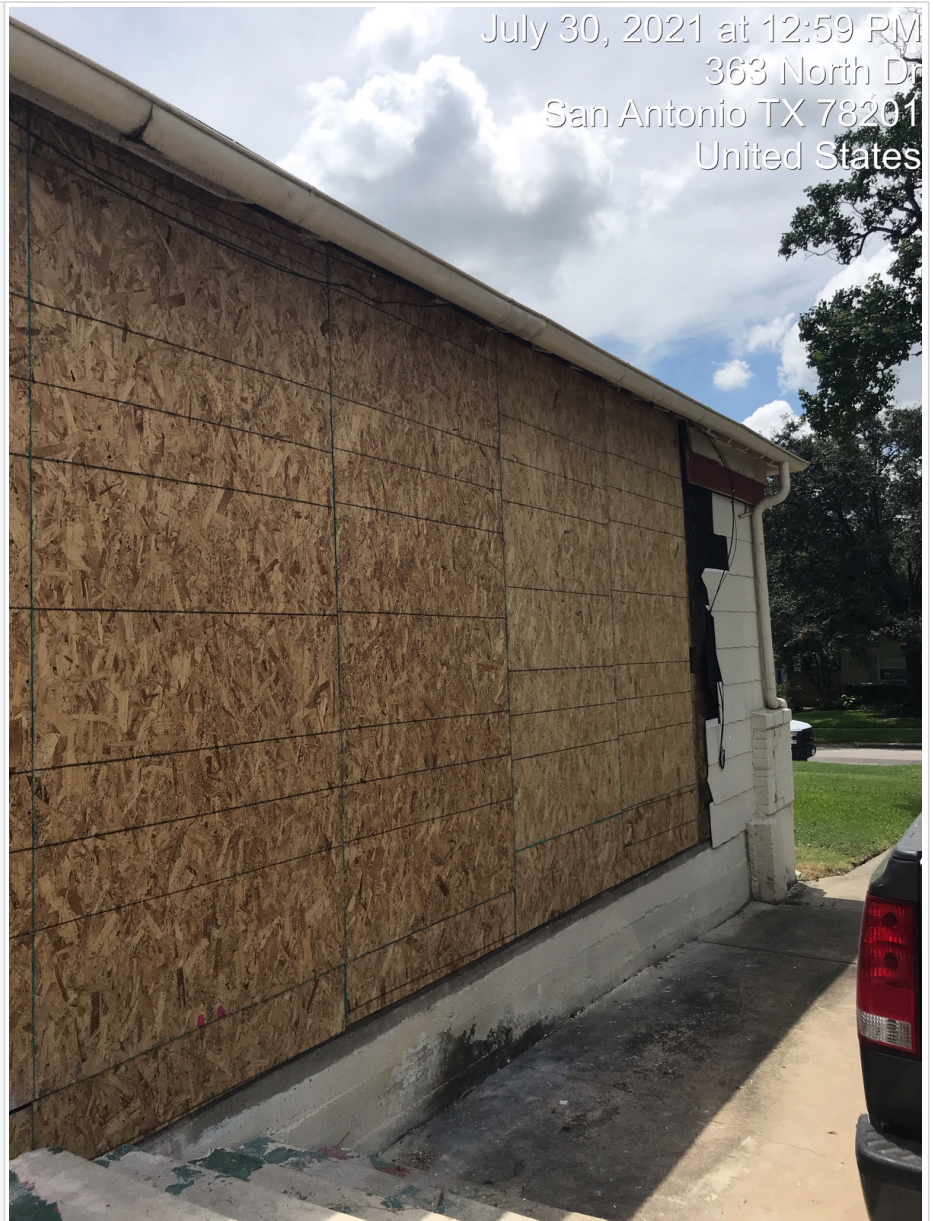
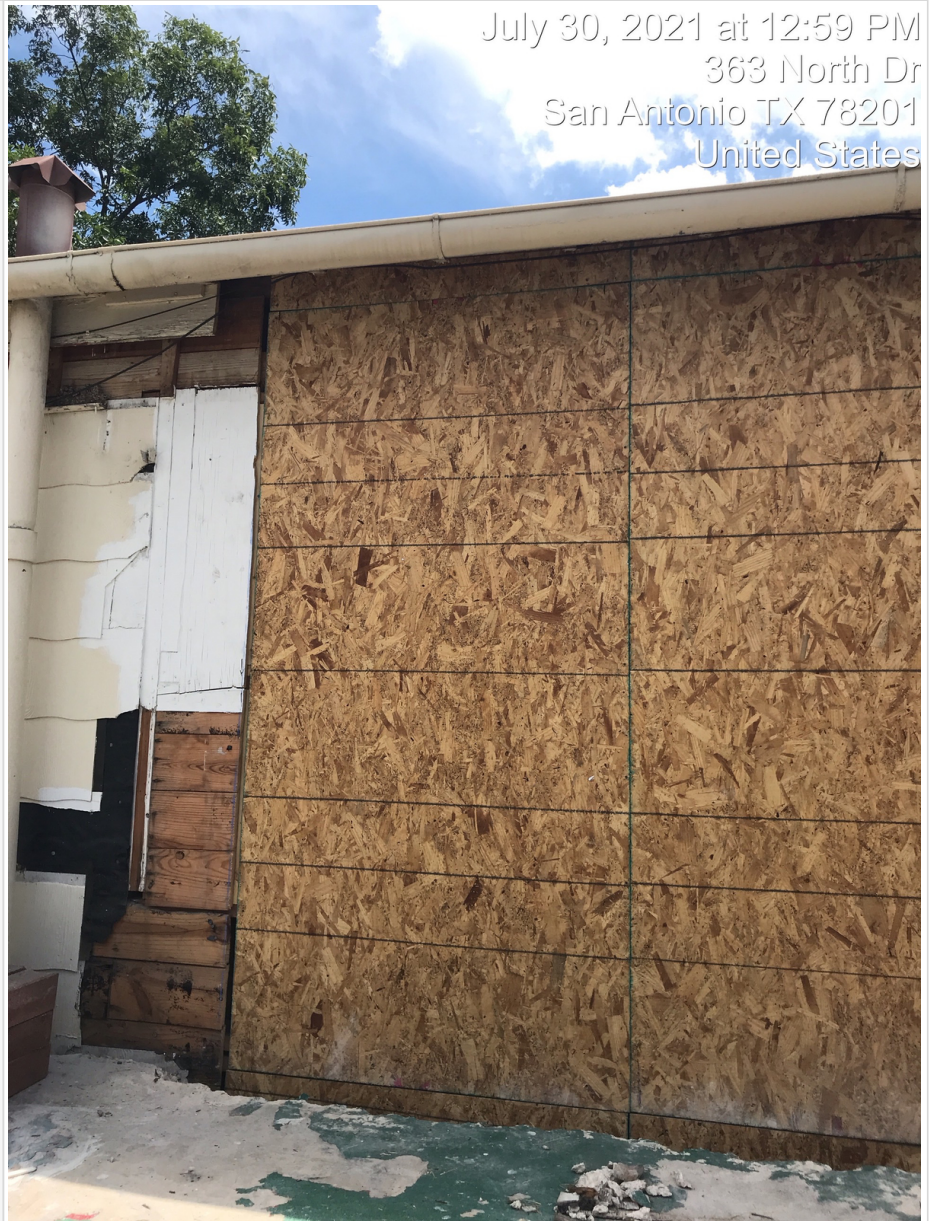
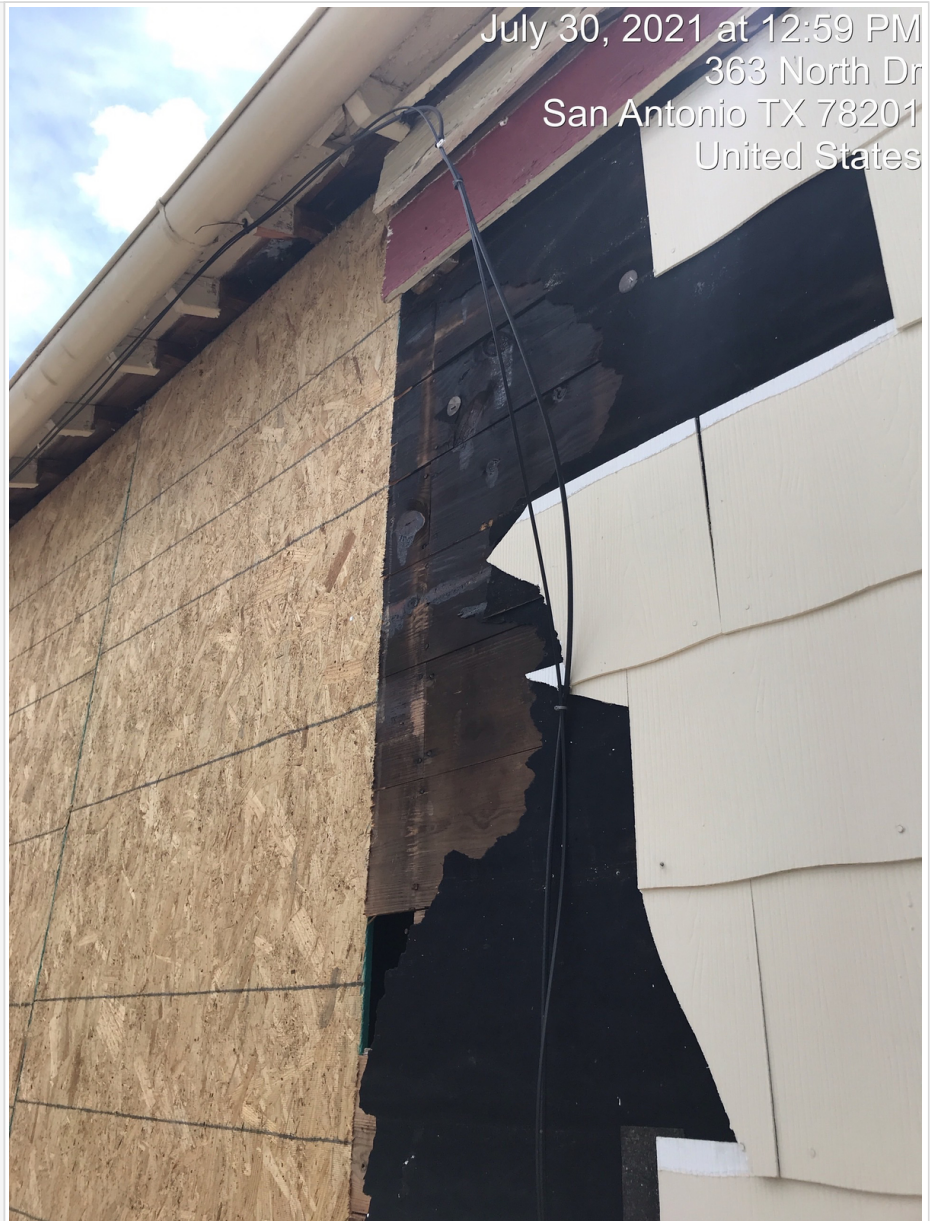
Date	07/30/2021
Time	02:01 PM (-5 GMT)
Context	citizen report
Present Staff	Edward Hall
Present Individuals	Homeowner
Types of Work Observed	Exterior Maintenance and Alterations
Amount of Work Completed	50%
Description of work	Removal of side facade materials and one side door. Installation of new sheathing on side facade.
Description of interaction	OHP staff issued a Stop Work Order and spoke with the property owner. OHP advised that no further work was to occur with the exception of placing building wrap on exposed framing and building materials to prevent water damage and water infiltration into the historic structure.

☒ Code 35-451(a): Work without Certificate of Appropriateness (COA); **EXTENSIVE MODIFICATIONS ON SIDE FRUSTRATE (REMOVAL OF FRUSTRATE MATERIALS)**
