HISTORIC AND DESIGN REVIEW COMMISSION

November 16, 2022

HDRC CASE NO: 2022-399
ADDRESS: 363 NORTH DR
LEGAL DESCRIPTION: NCB 7026 BLK 5 LOT 16, E11 FT OF 18
ZONING: R-6, H
CITY COUNCIL DIST.: 7
DISTRICT: Monticello Park Historic District
APPLICANT: Thomas Gandy/GANDY THOMAS R
OWNER: Thomas Gandy/GANDY THOMAS R
TYPE OF WORK: Exterior modifications, fenestration modifications
APPLICATION RECEIVED: July 24, 2022
60-DAY REVIEW: Not applicable due to City Council Emergency Orders
CASE MANAGER: Edward Hall

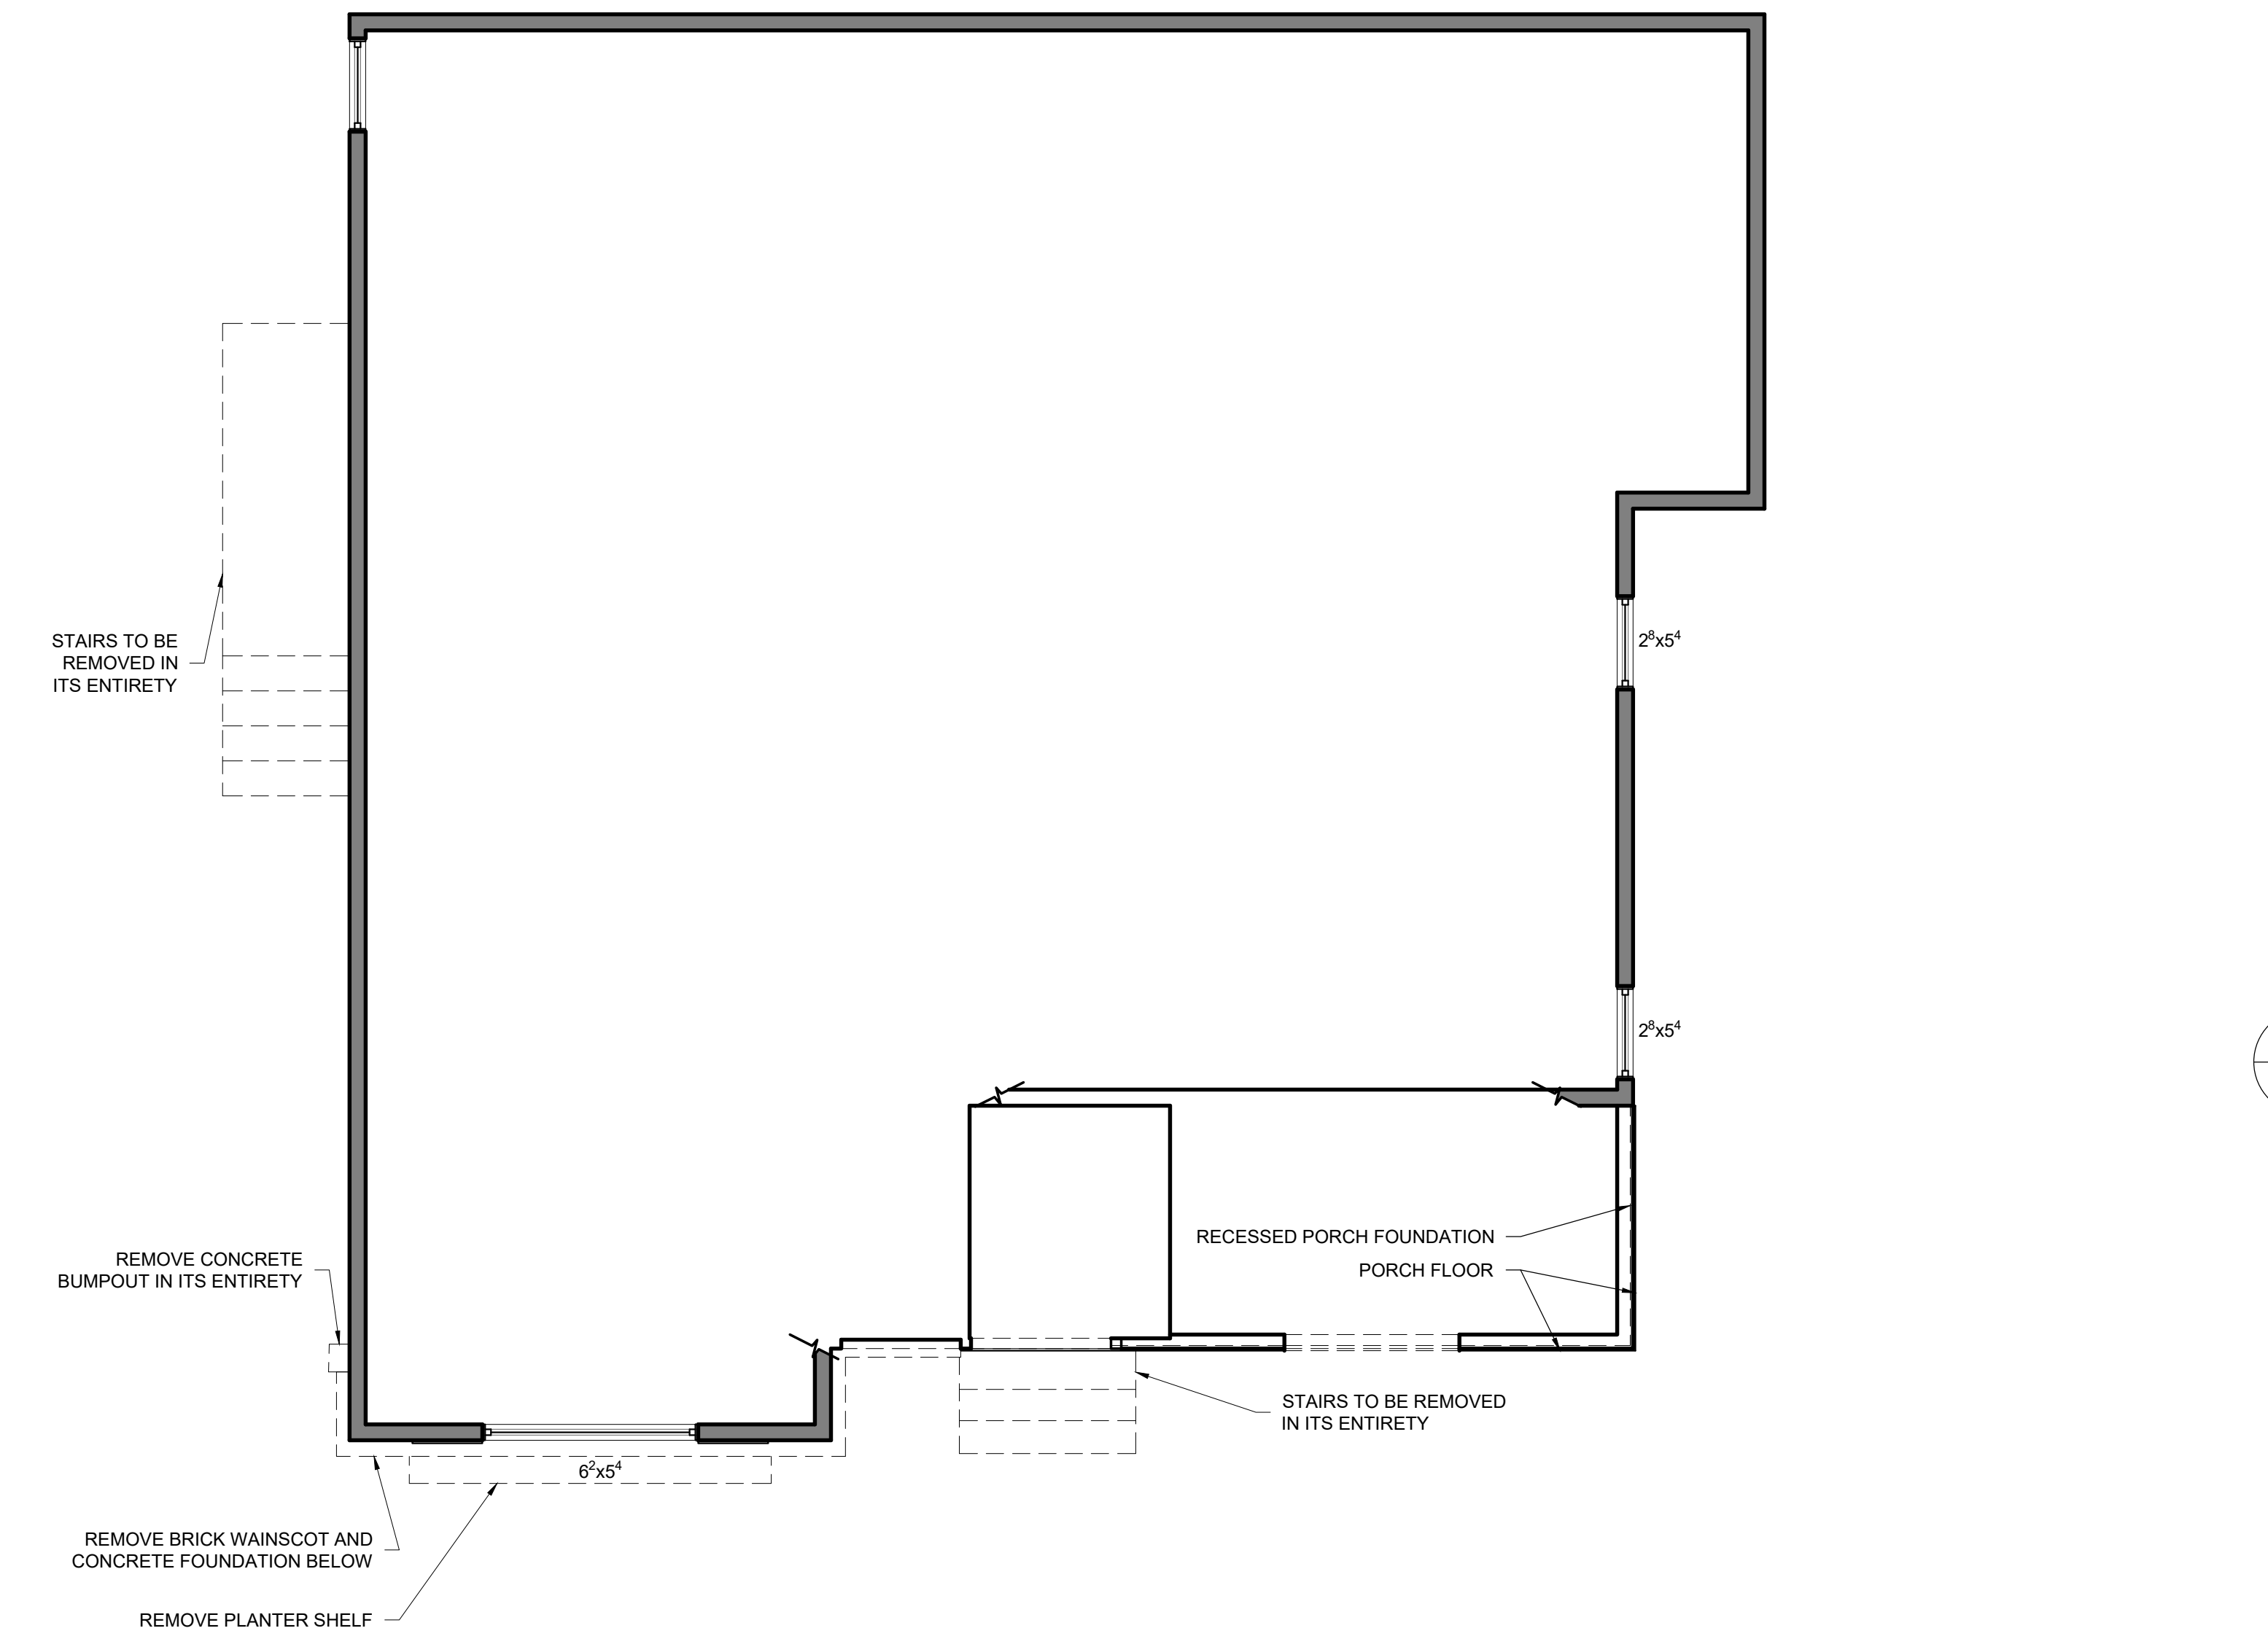
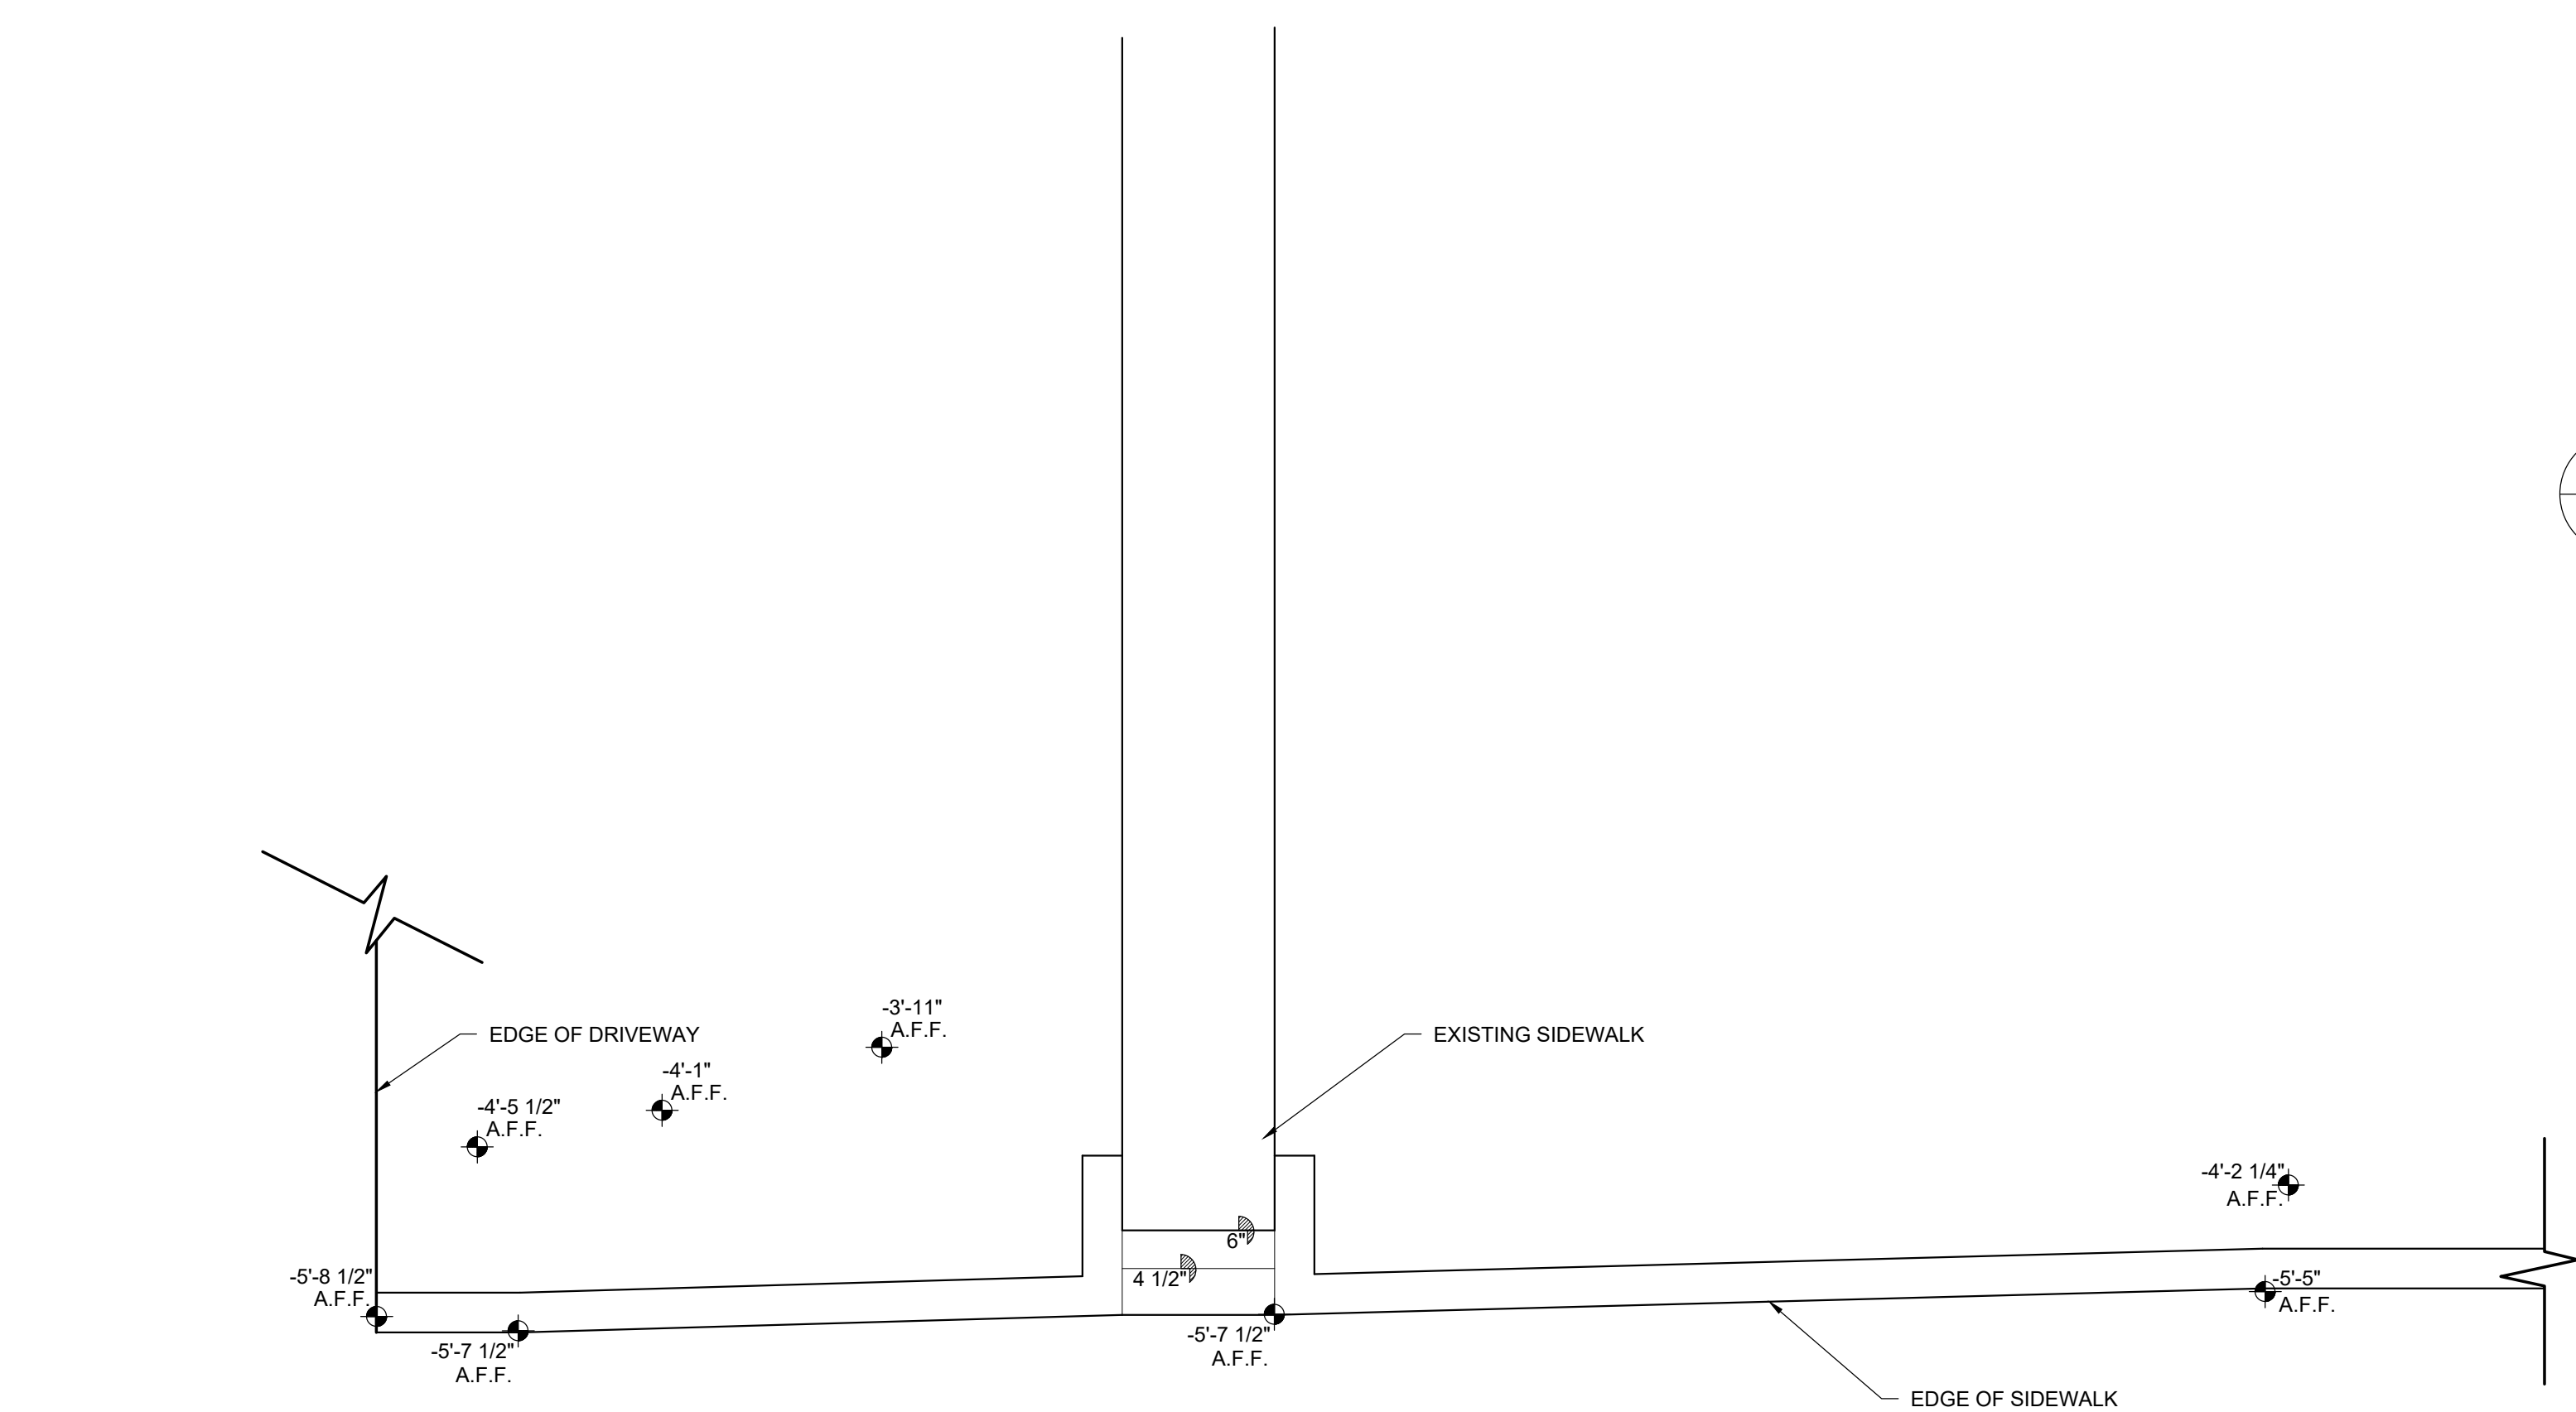
1 FLOOR PLAN WITH SITE INFORMATION
AD-10 1/4"=1'-0"

2 FRONT ELEVATION
AD-10 1/4"=1'-0"

3 LEFT ELEVATION
AD-10 1/4"=1'-0"

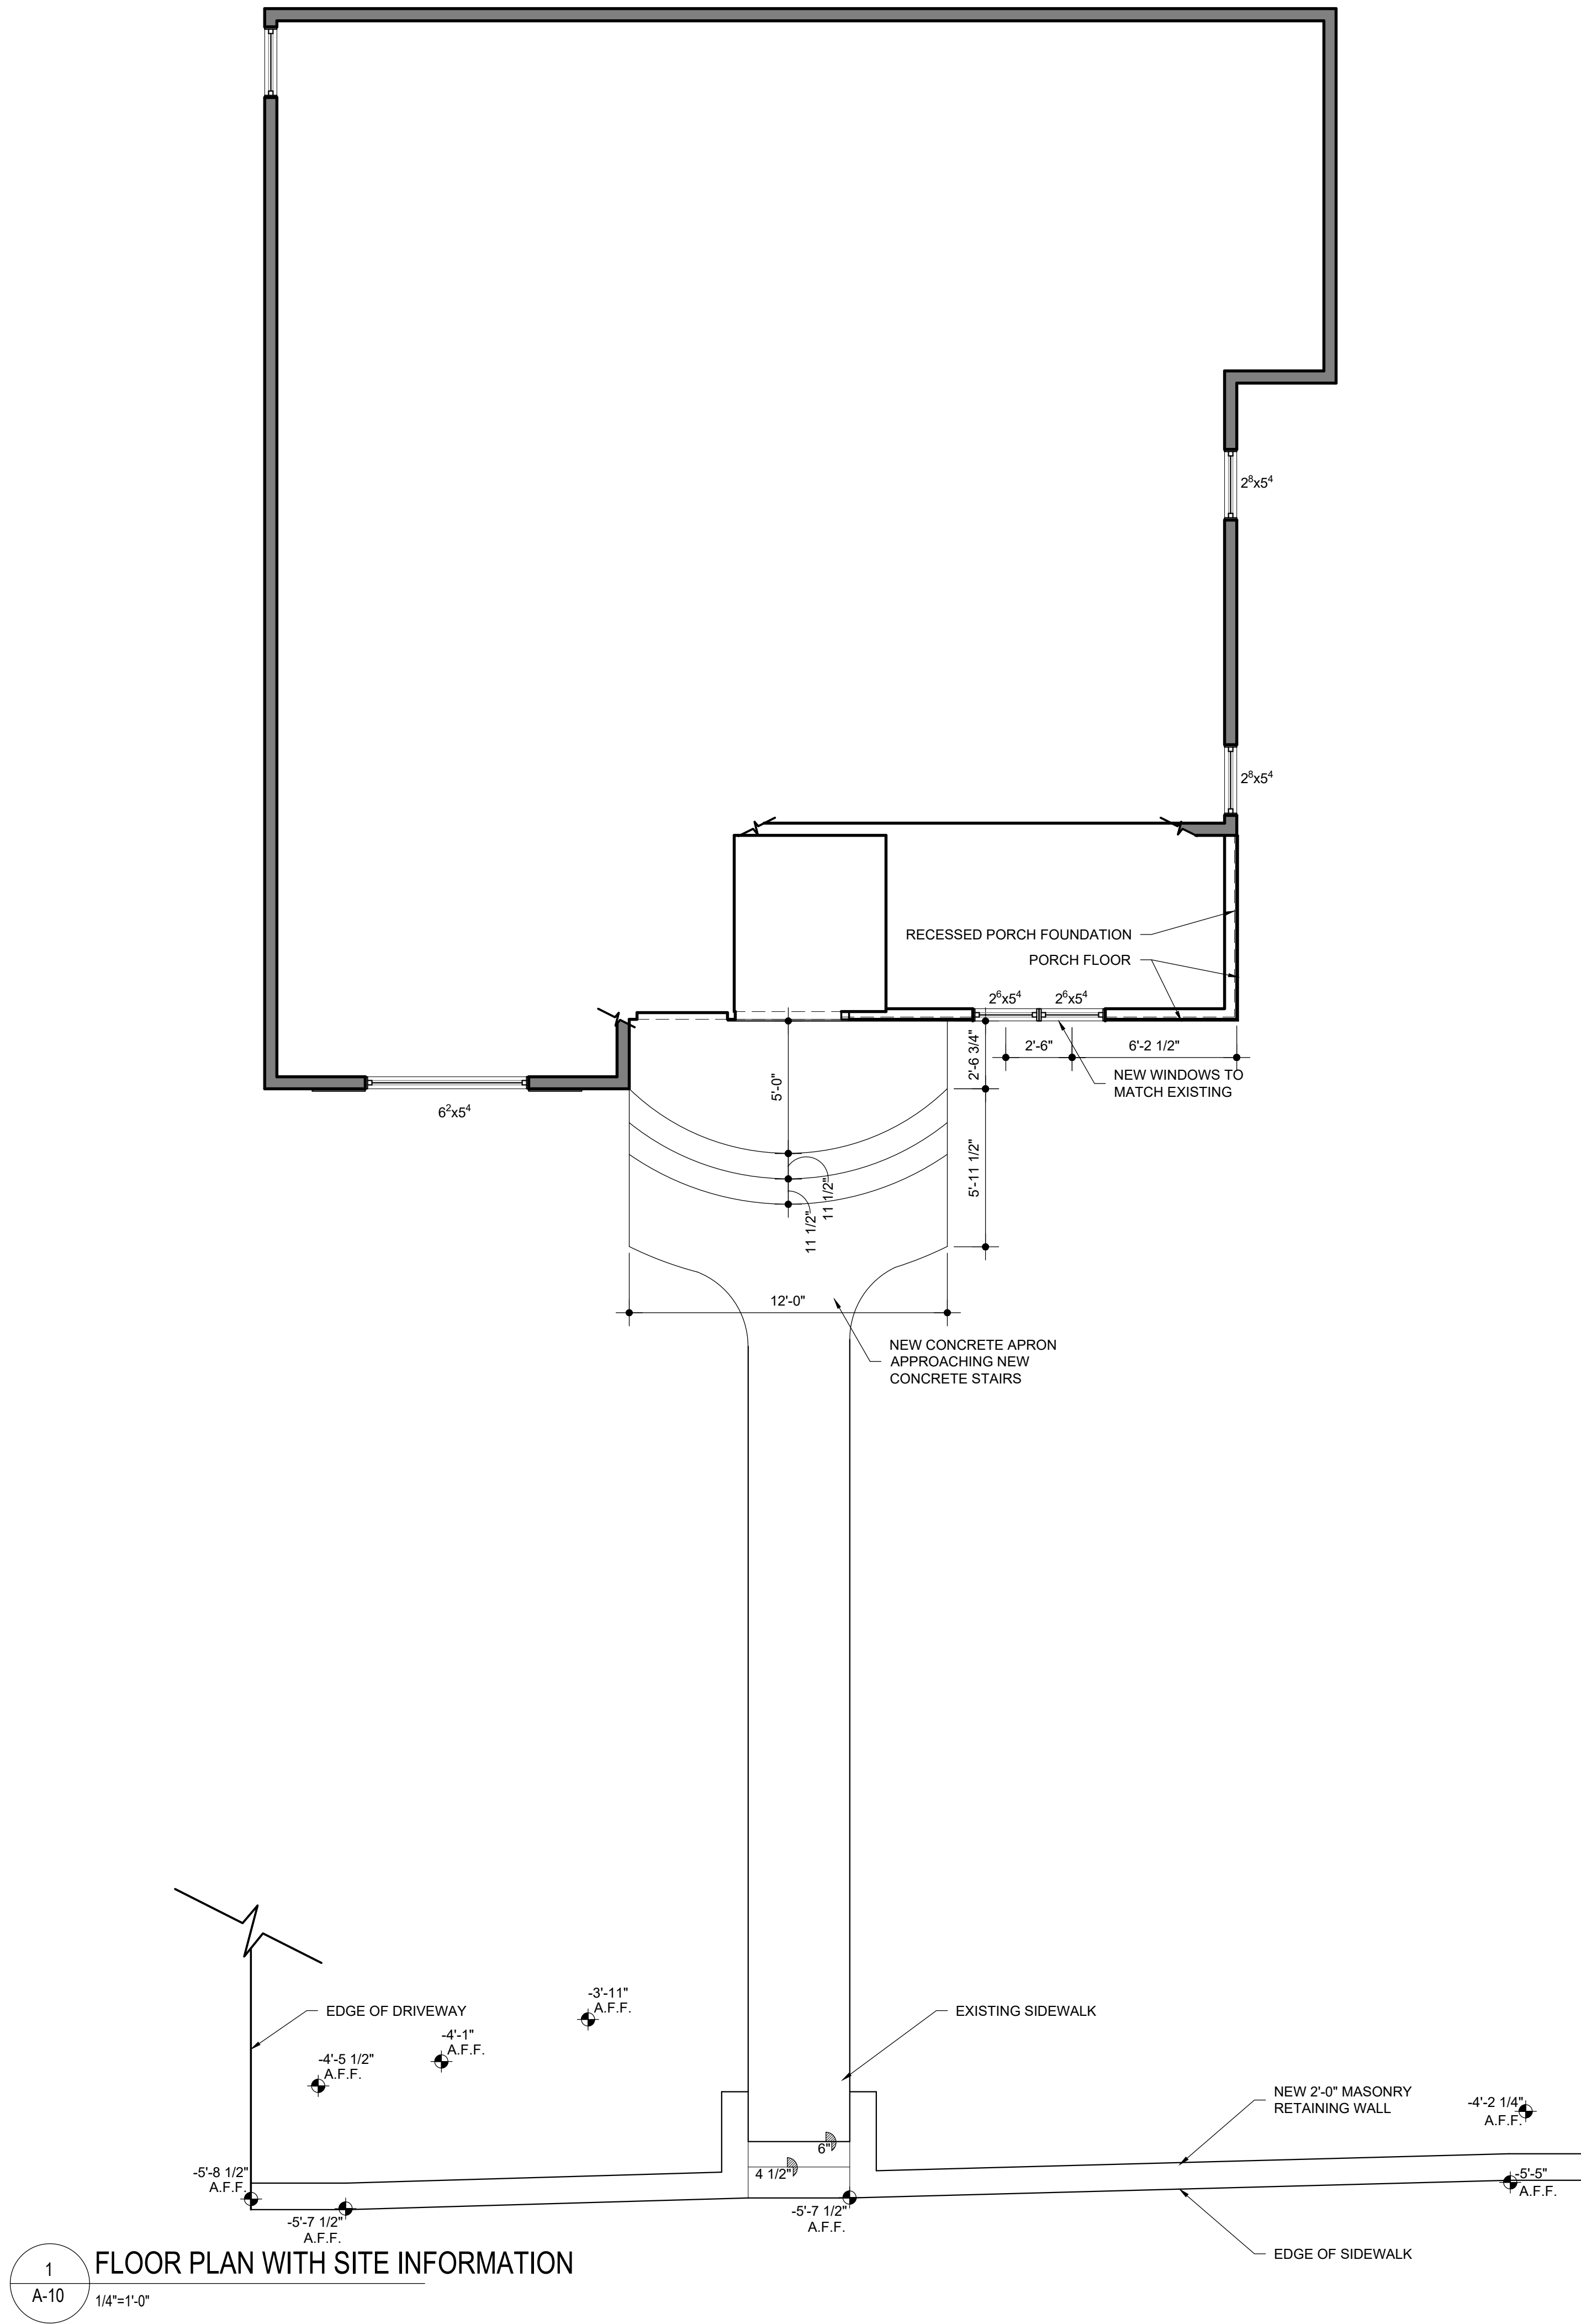
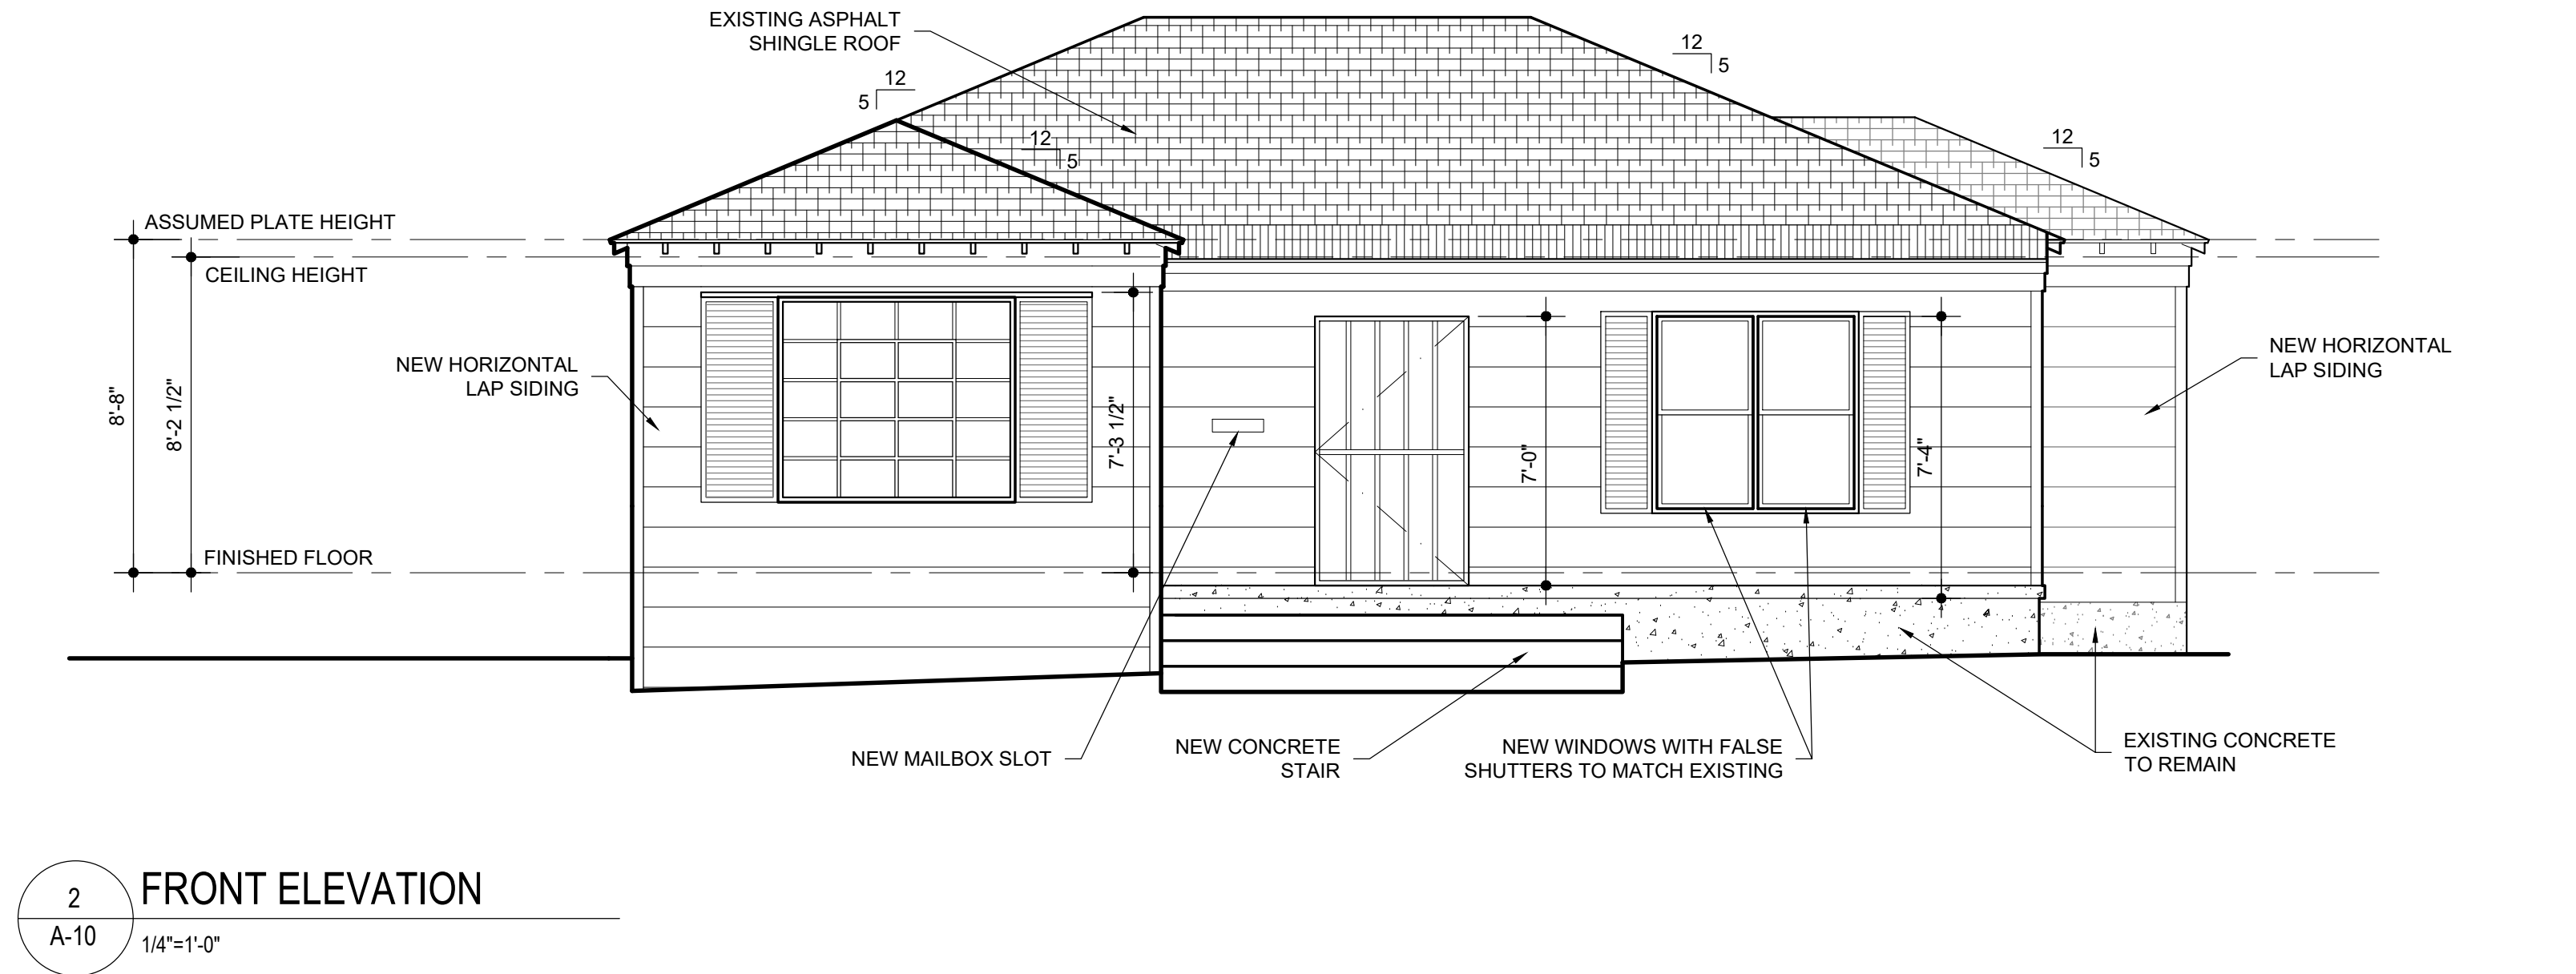
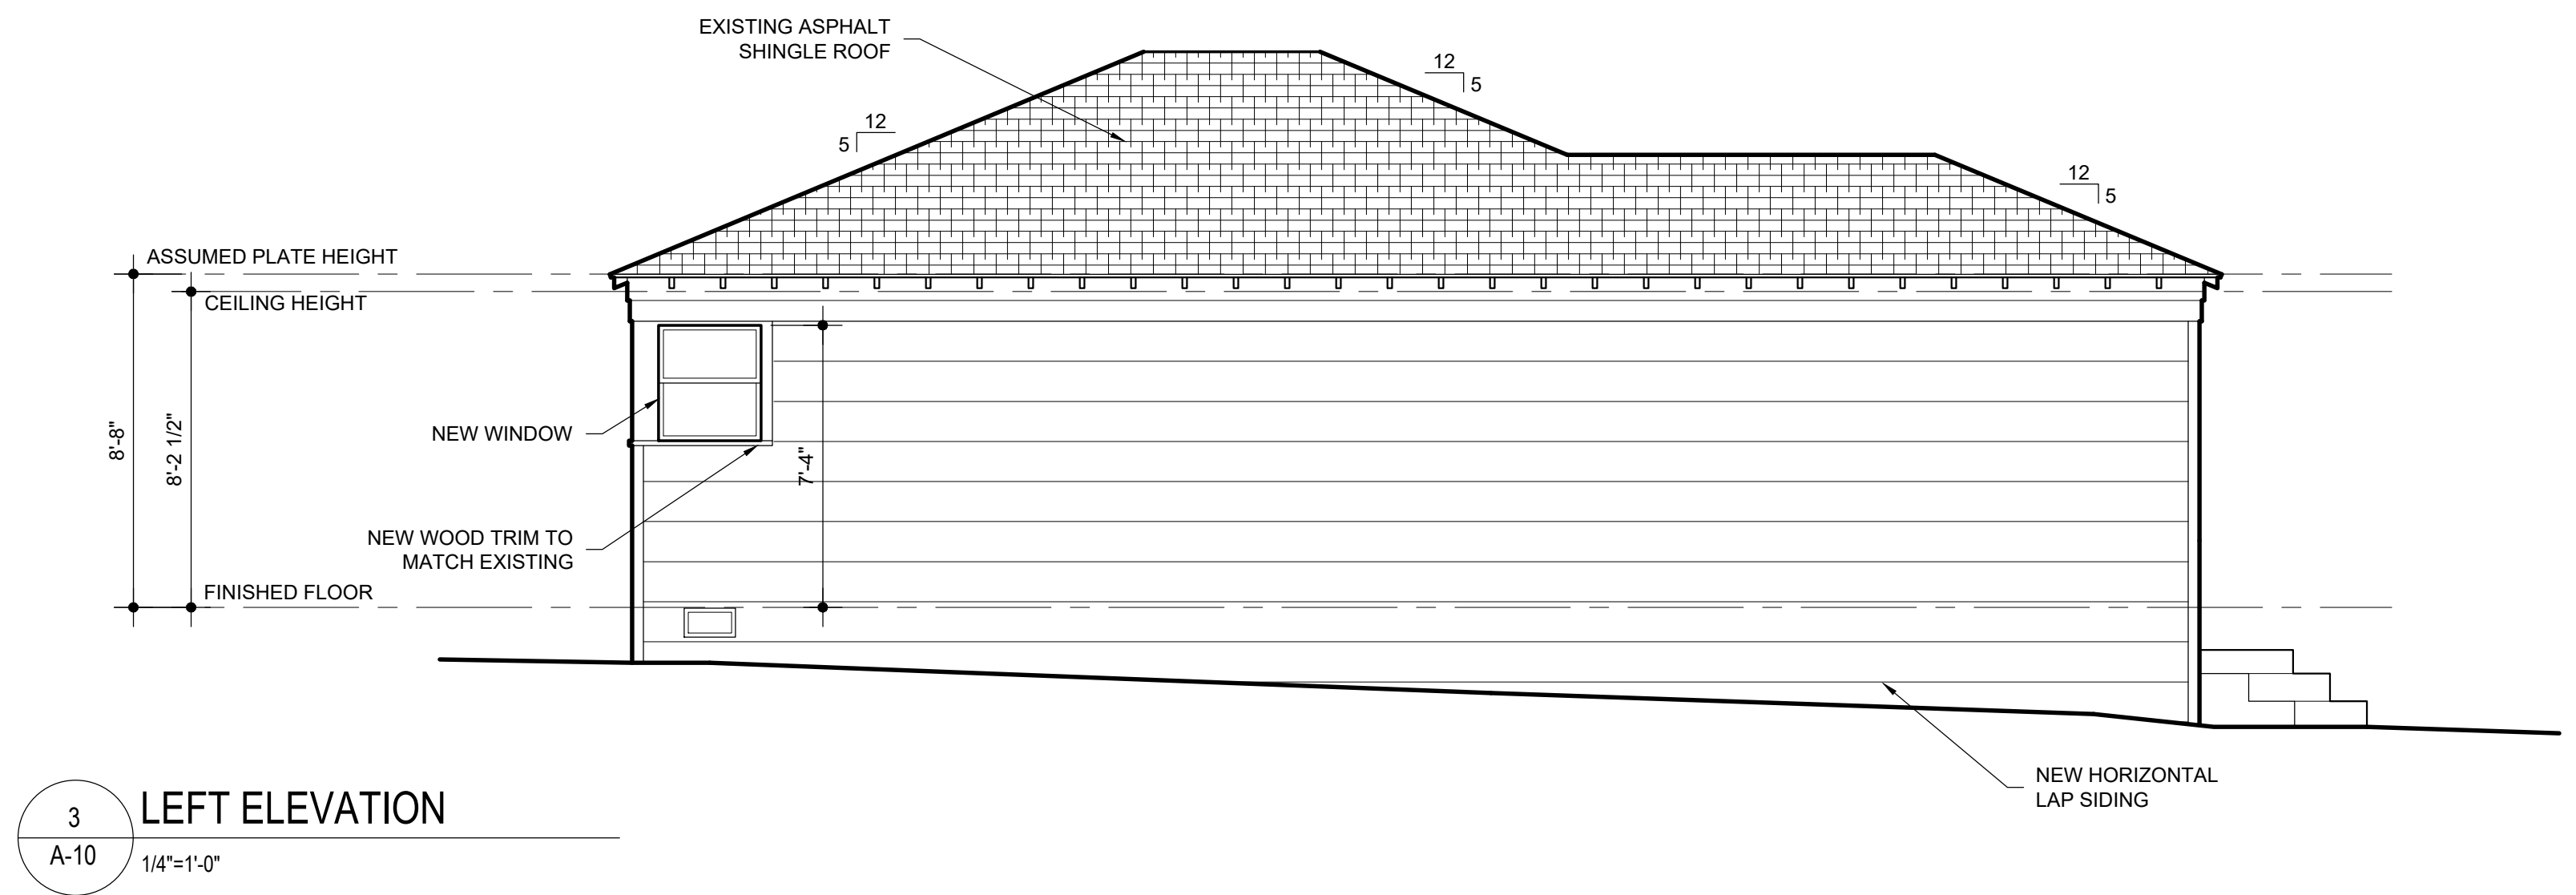
A-10

RENOVATED FLOOR
PLAN AND ELEVATIONS

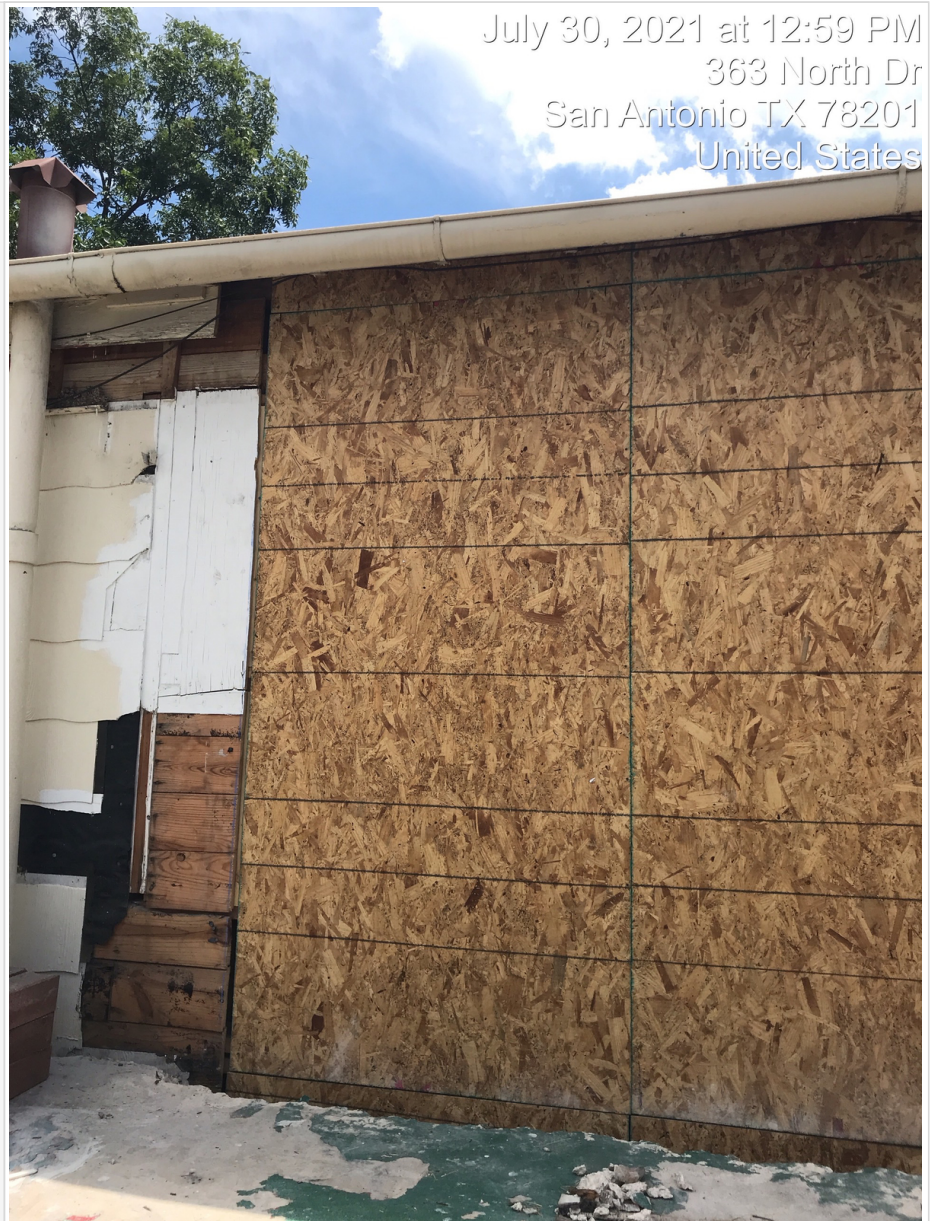
Date	07/30/2021
Time	02:01 PM (-5 GMT)
Context	citizen report
Present Staff	Edward Hall
Present Individuals	Homeowner
Types of Work Observed	Exterior Maintenance and Alterations
Amount of Work Completed	50%
Description of work	Removal of side facade materials and one side door. Installation of new sheathing on side facade.
Description of interaction	OHP staff issued a Stop Work Order and spoke with the property owner. OHP advised that no further work was to occur with the exception of placing building wrap on exposed framing and building materials to prevent water damage and water infiltration into the historic structure.

Violation Type	No Certificate of Appropriateness (Code 35-451a)
OHP Action	Spoke with property owner, Posted additional "Stop Work Notice"
Will post-work application fee apply?	Yes
