HISTORIC AND DESIGN REVIEW COMMISSION

HDRC CASE NO: 2022-548
ADDRESS: 218 WASHINGTON ST
LEGAL DESCRIPTION: NCB 739 BLK 2 LOT 4 5 & 6
ZONING: RM-4, H
CITY COUNCIL DIST.: 1
DISTRICT: King William Historic District
APPLICANT: Anne Toxey
OWNER: Anne Toxey
TYPE OF WORK: Repair and reconstruction of the rear accessory structure
APPLICATION RECEIVED: October 24, 2022
60-DAY REVIEW: Not applicable due to City Council Emergency Orders
CASE MANAGER: Rachel Rettaliata

REQUEST:

The applicant is requesting a Certificate of Appropriateness for approval to replace the original barrel tile metal roof with a galvalume standing seam metal roof.

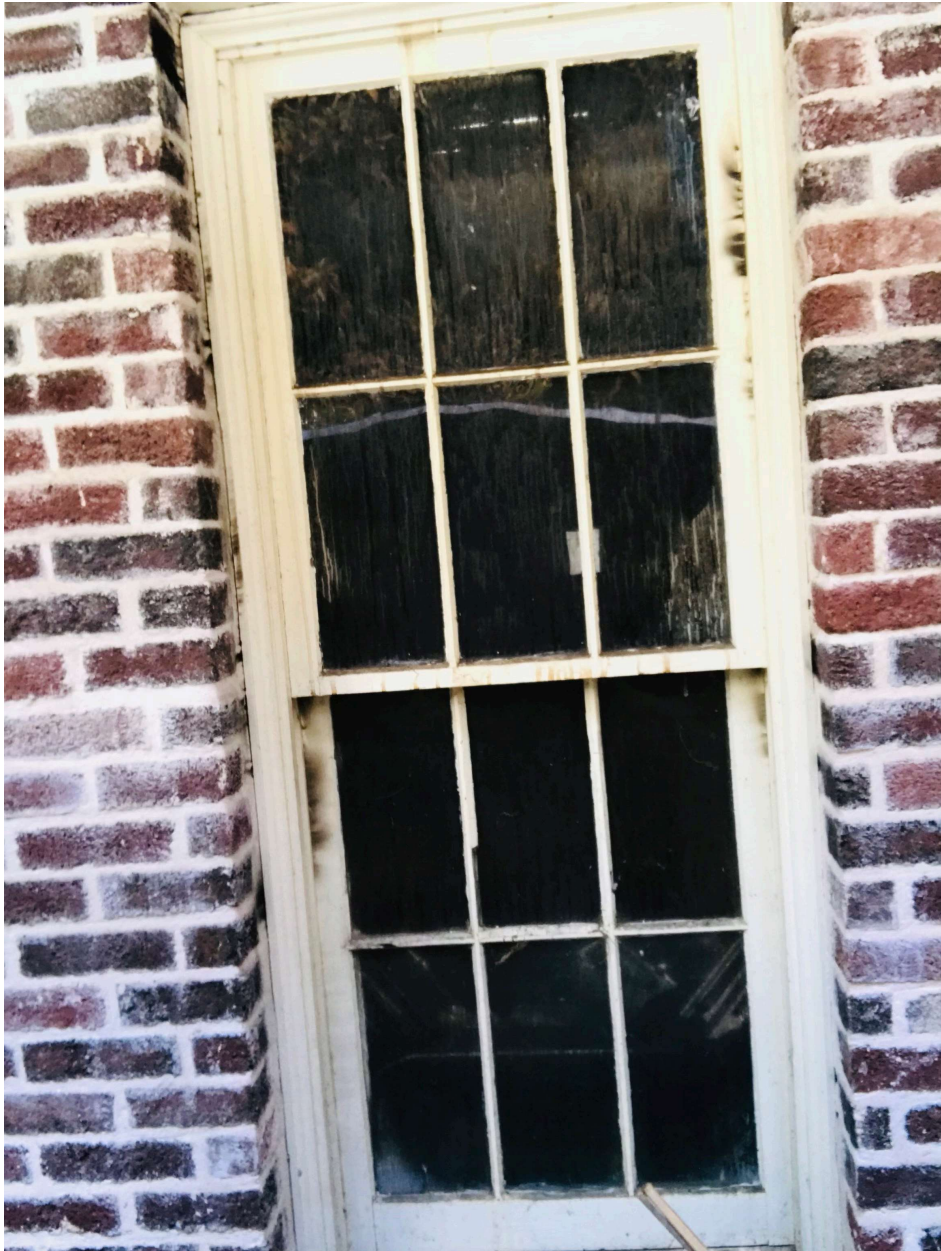
Window 1 will not be replaced.

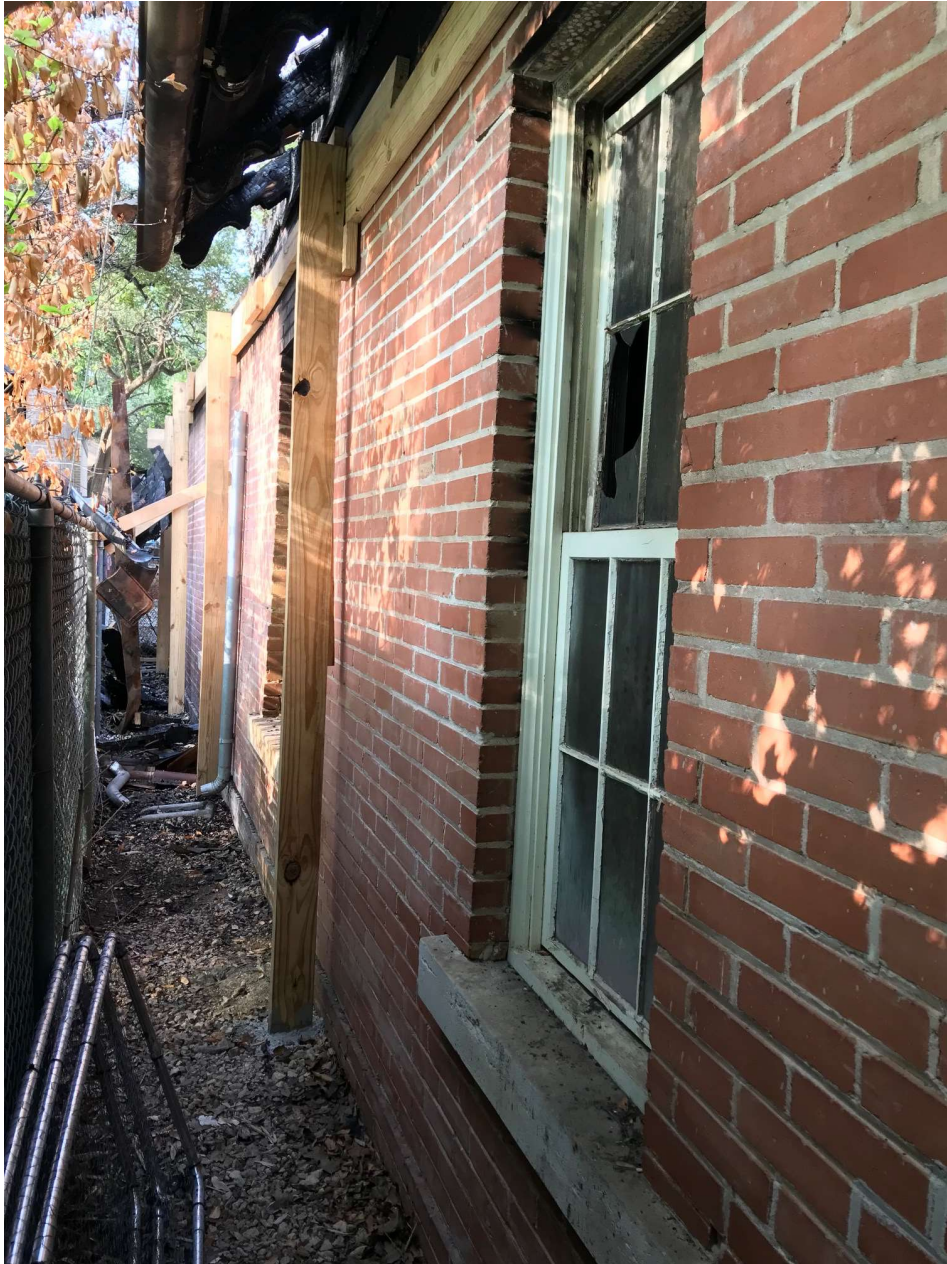
Window 2 will not be replaced.

(difficult to photograph since southeast wall is so close to property line)

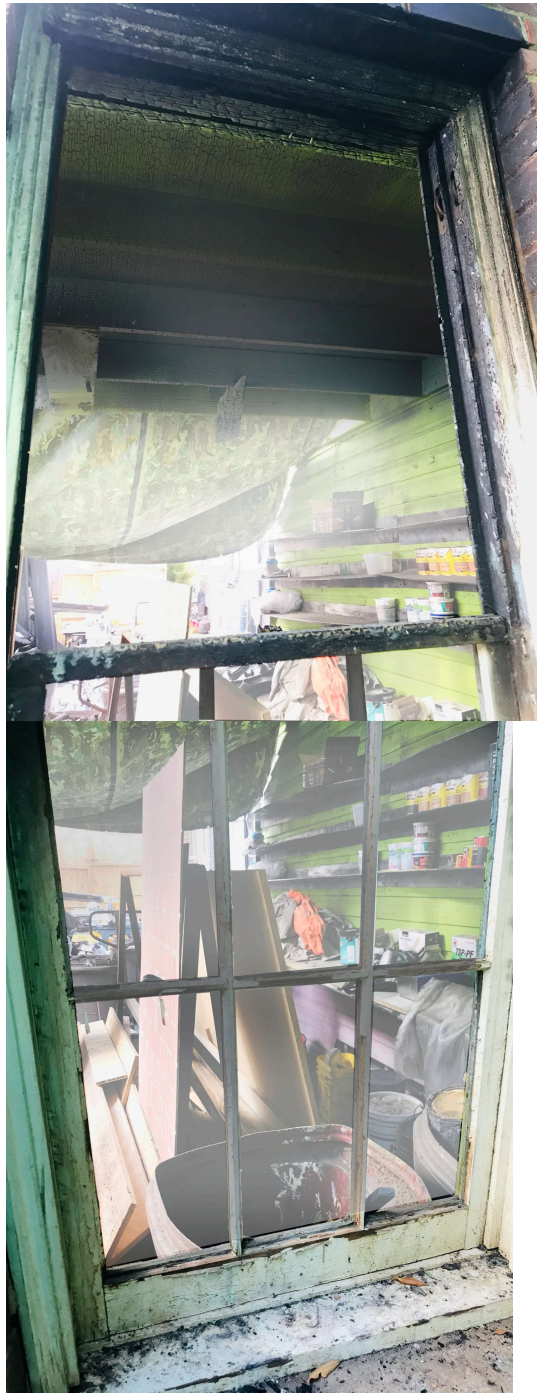
(difficult to photograph since southeast wall is so close to property line)

Window 3 will be replaced, using original weights and possibly original lower sash and frame, if salvageable.

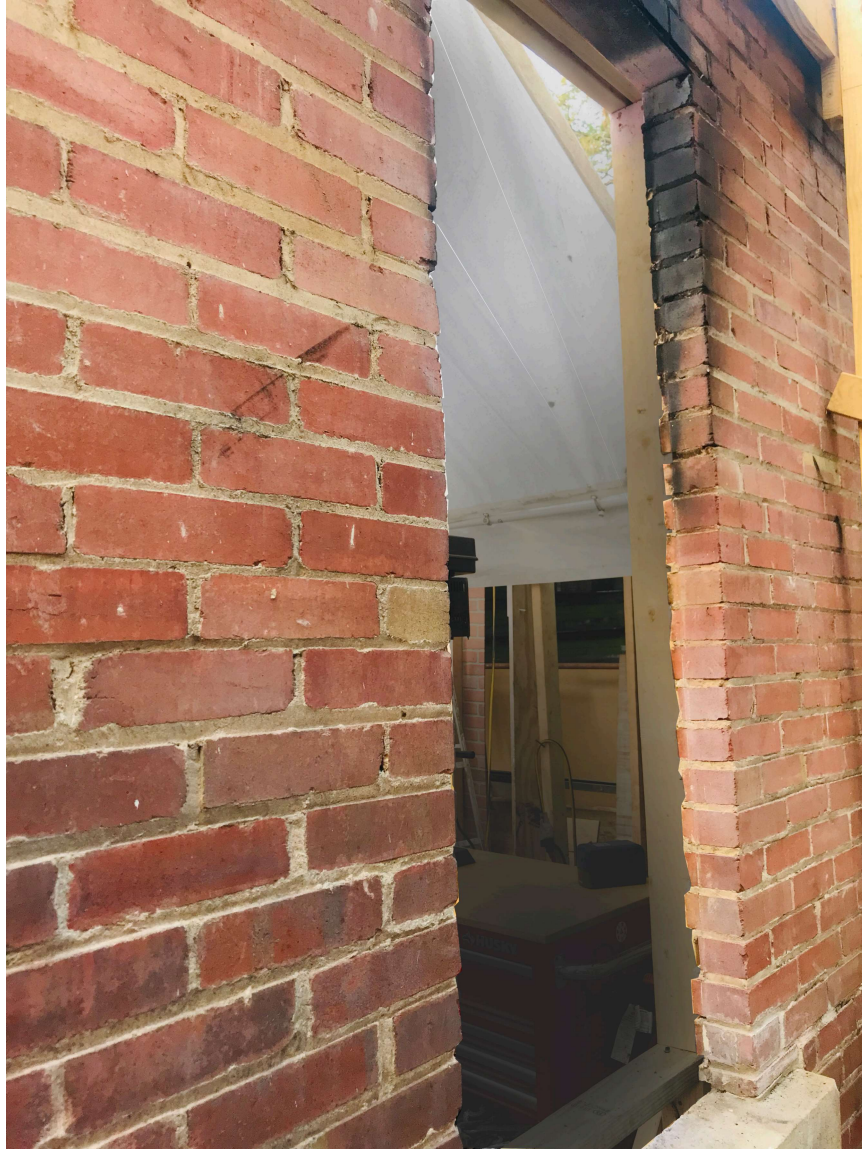
(difficult to photograph since southeast wall is so close to property line)

Window 4 will be replaced, using original weights.

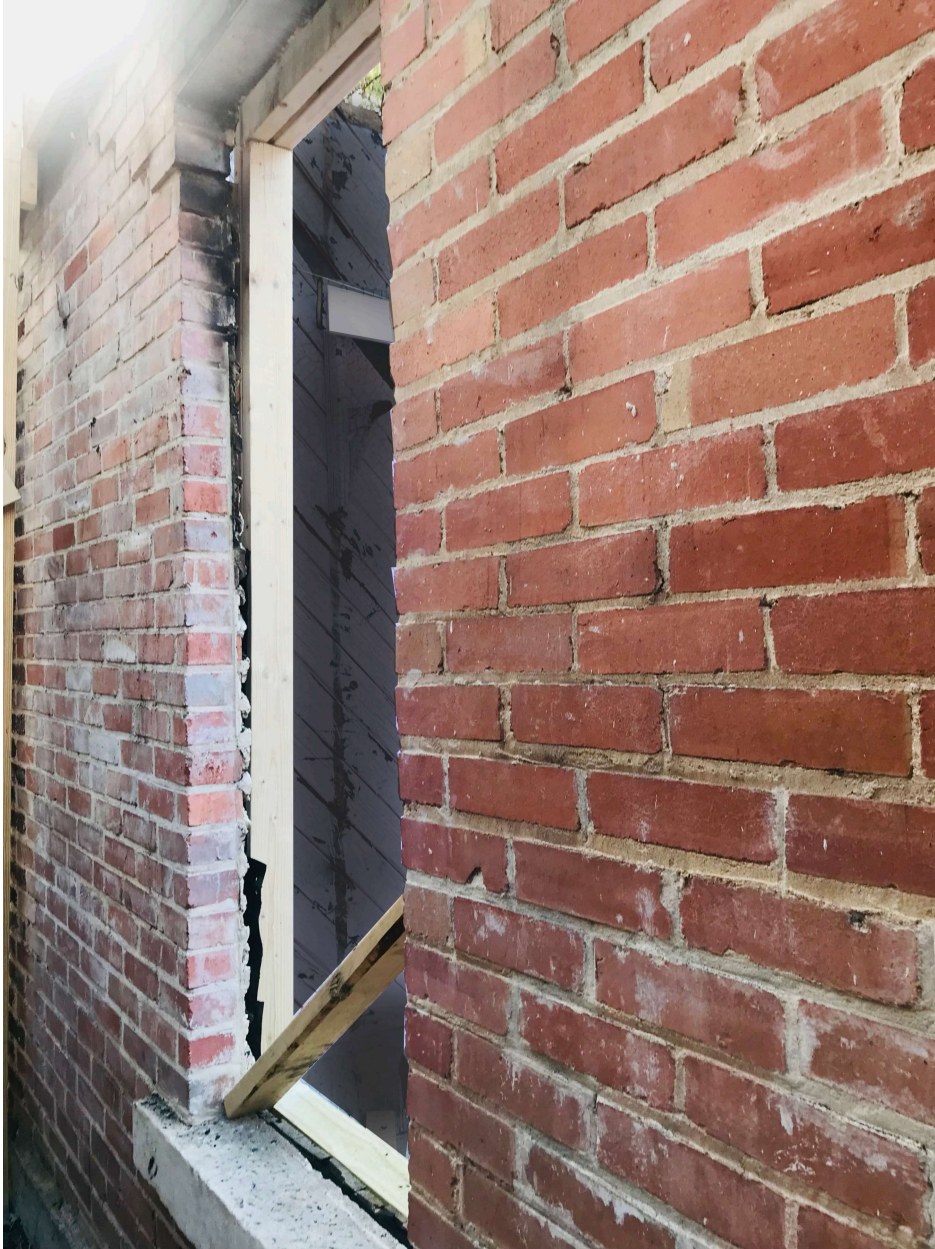
(difficult to photograph since southeast wall is so close to property line)

Window 5 will be replaced, using original weights.
