HISTORIC AND DESIGN REVIEW COMMISSION

April 19, 2023

HDRC CASE NO: 2023-106
ADDRESS: 501 E LOCUST
LEGAL DESCRIPTION: NCB 1736 BLK 10 LOT 1
ZONING: MF-33, H
CITY COUNCIL DIST.: 1
HIST. DIST. NAME: Tobin Hill Historic District
APPLICANT: Matthew Carson/Pella South Texas
OWNER: WOHLRABE SHANE & IRENE
TYPE OF WORK: Window replacement
APPLICATION RECEIVED: March 01, 2023
60-DAY REVIEW: Not applicable due to City Council Emergency Orders
CASE MANAGER: Jessica Anderson

The applicant requests a Certificate of Appropriateness for approval to replace 18 one-over-one wood windows with aluminum-clad wood windows.

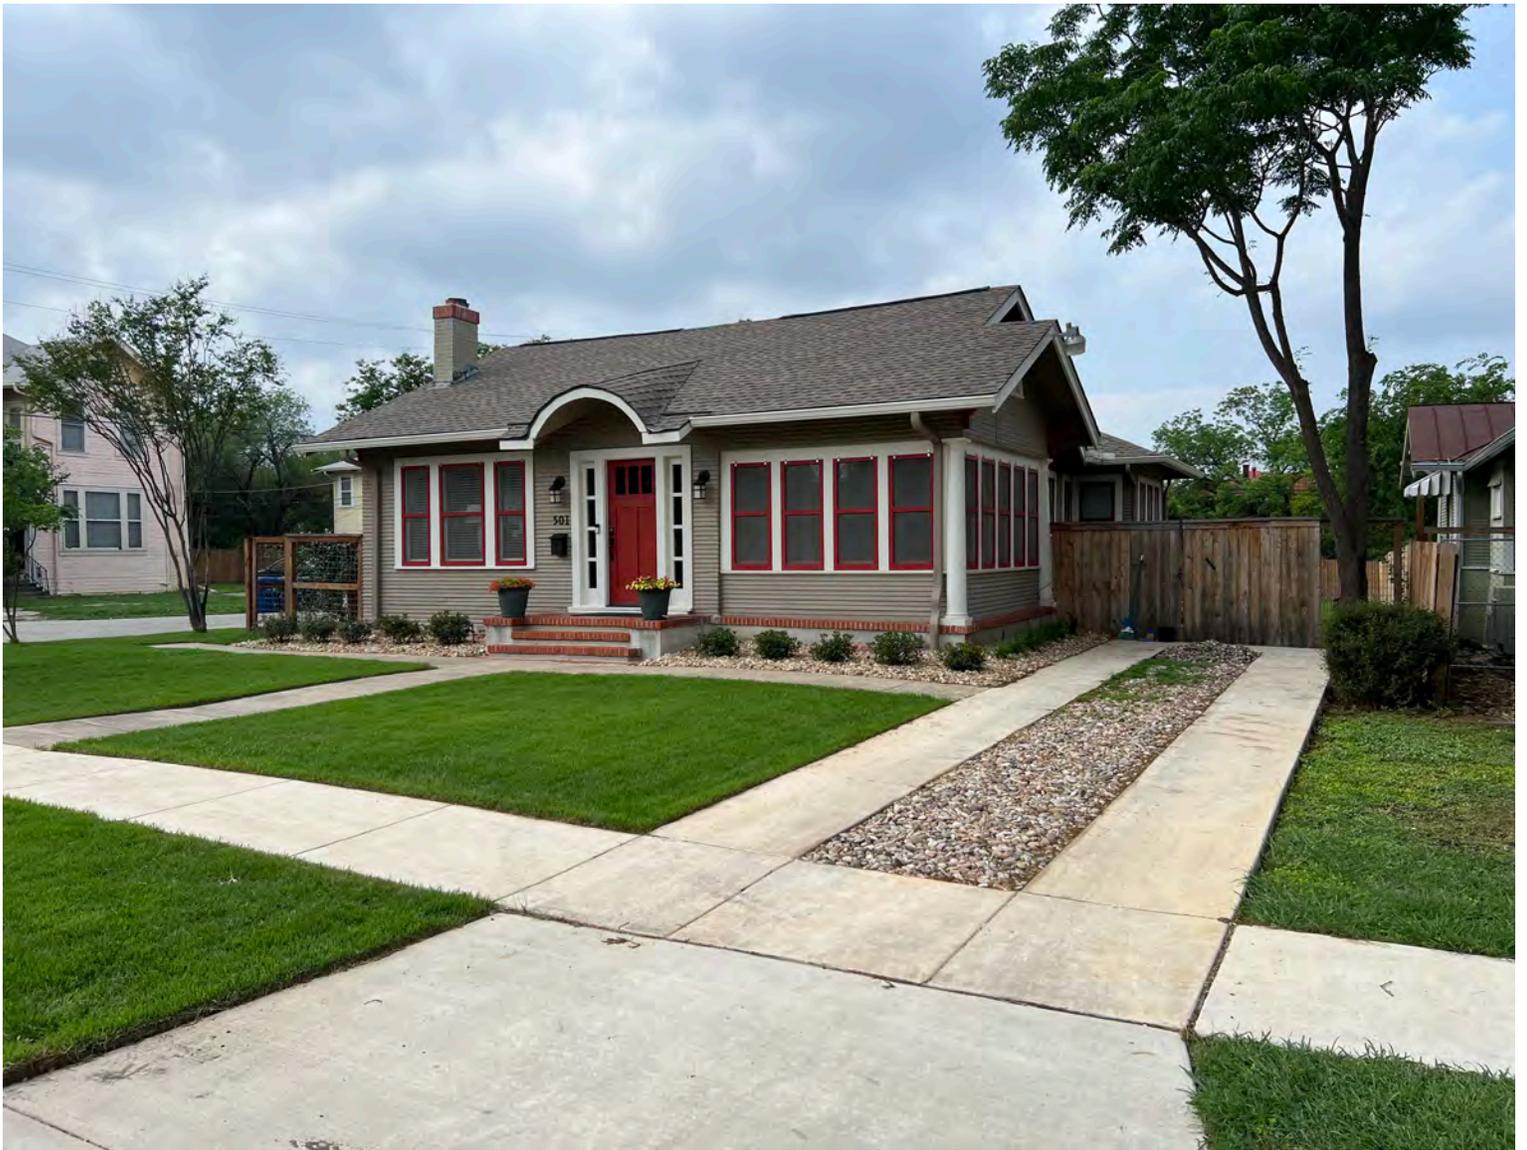
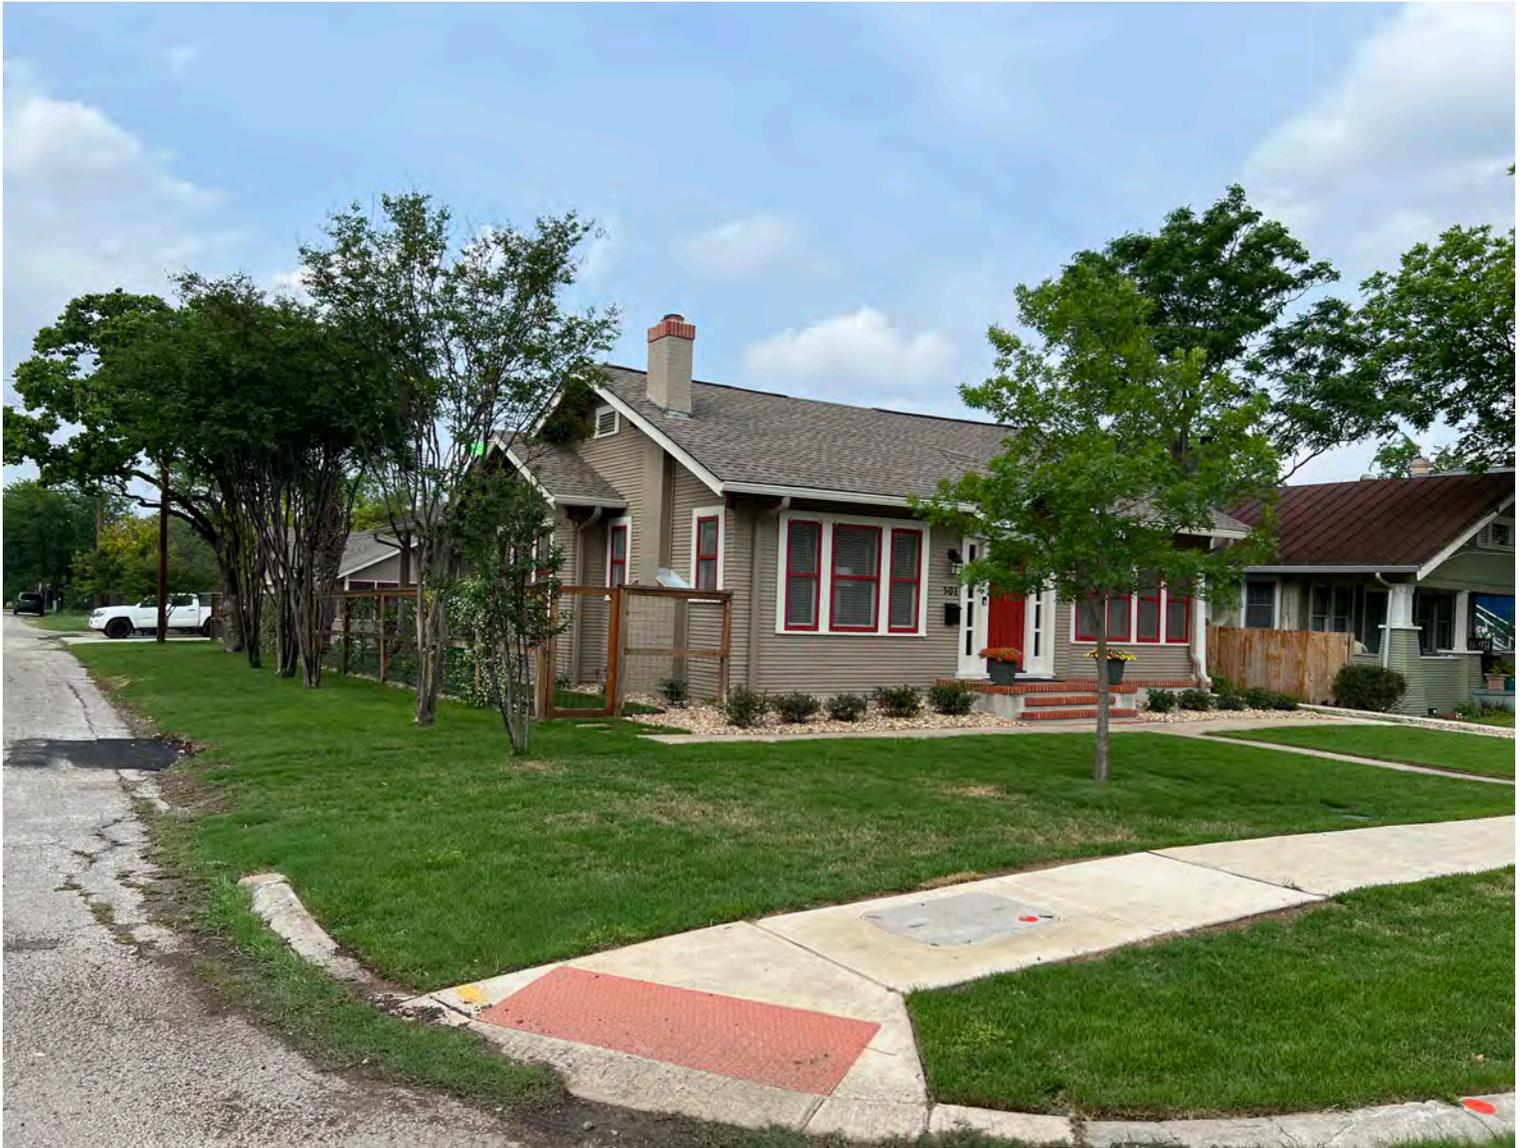
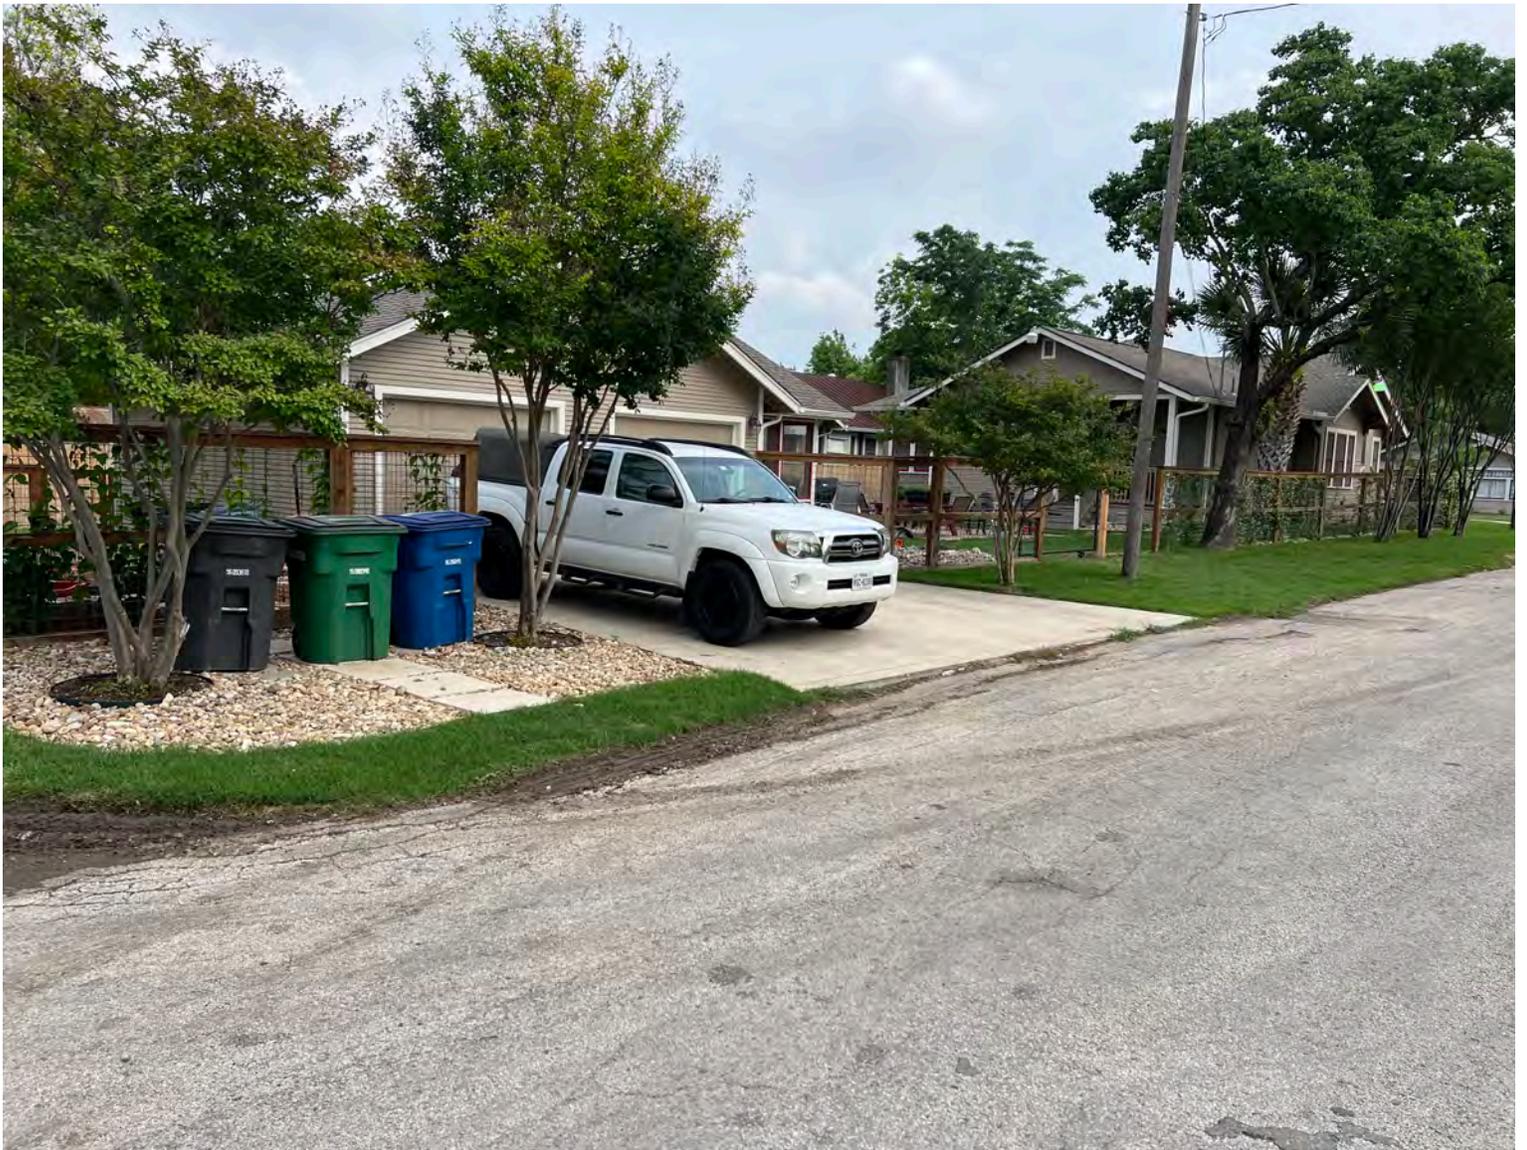
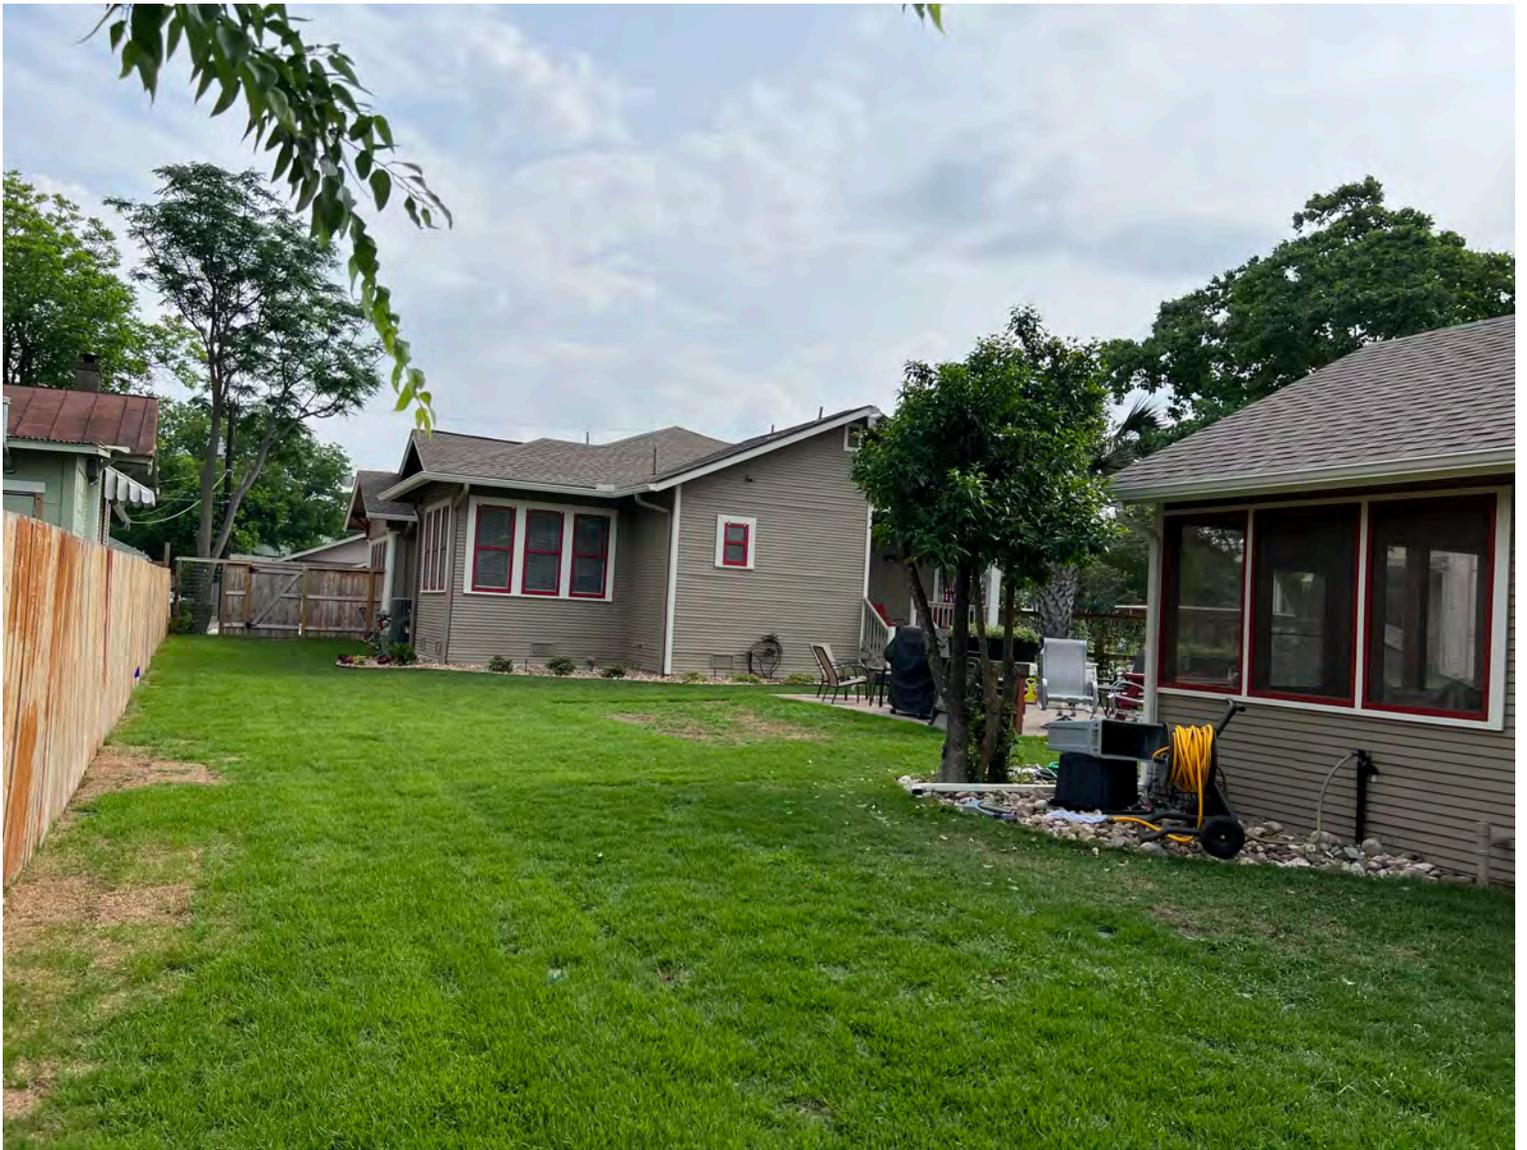
Staff site visit
23 March 2023 9 AM

Wood windows requested for replacement; all appear in reparable condition.

Staff does not recommend approval based on findings c through f. Staff recommends that all existing wood windows are retained and repaired.

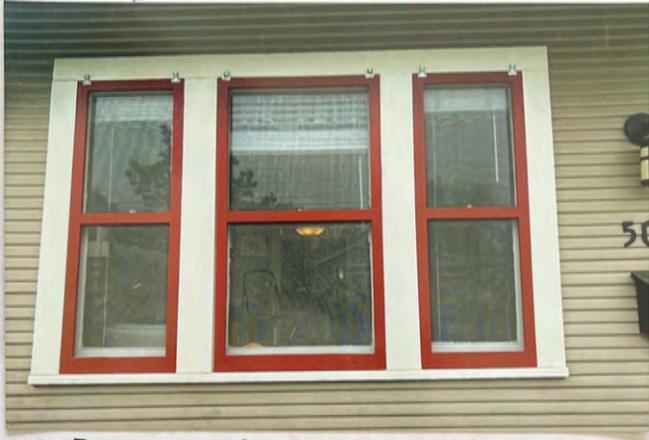
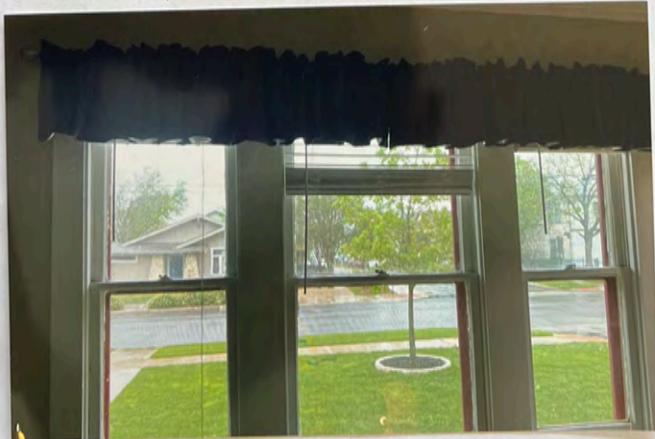
#3 #2 #1

1-3 will
be replaced

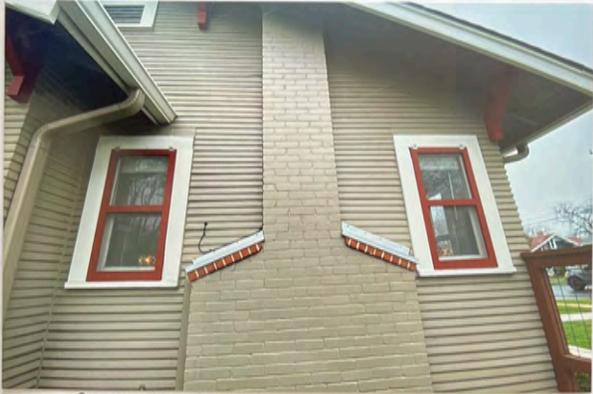
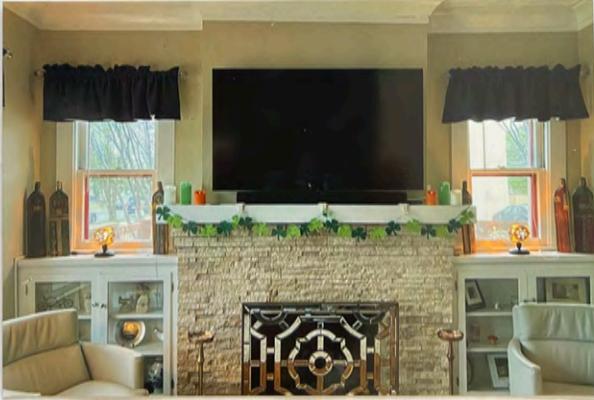
4-5 will be replaced

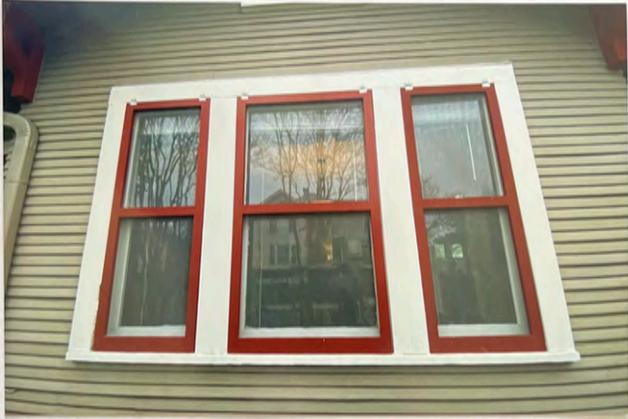
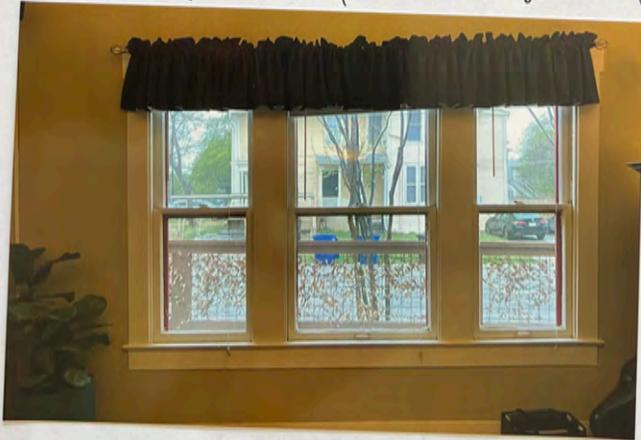
8 # 7 # 6 (Exterior)

6-8 will
be replaced

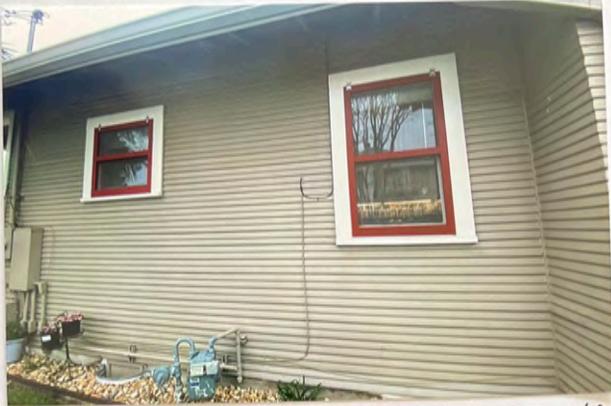
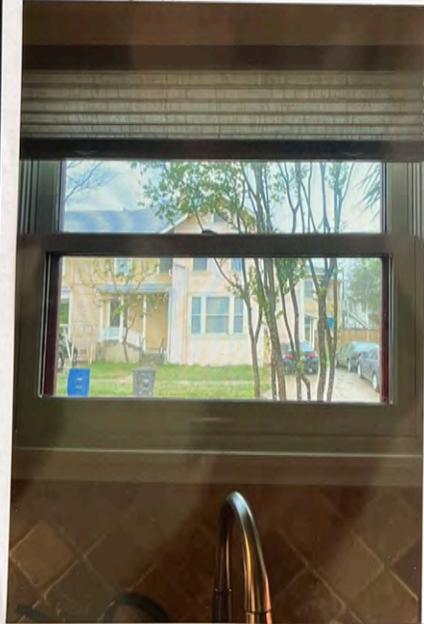
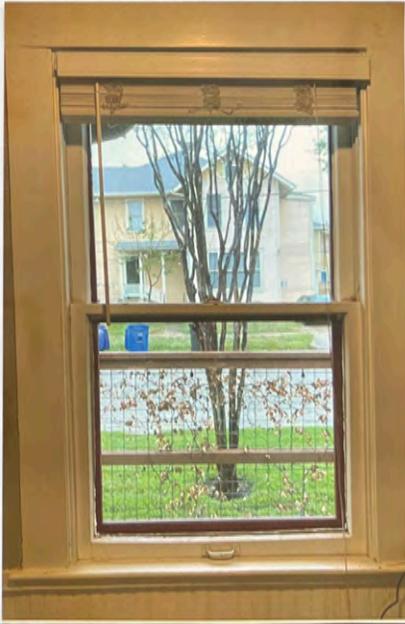
#9 ~~is~~ will be
replace

#10 will ~~not~~
be replaced

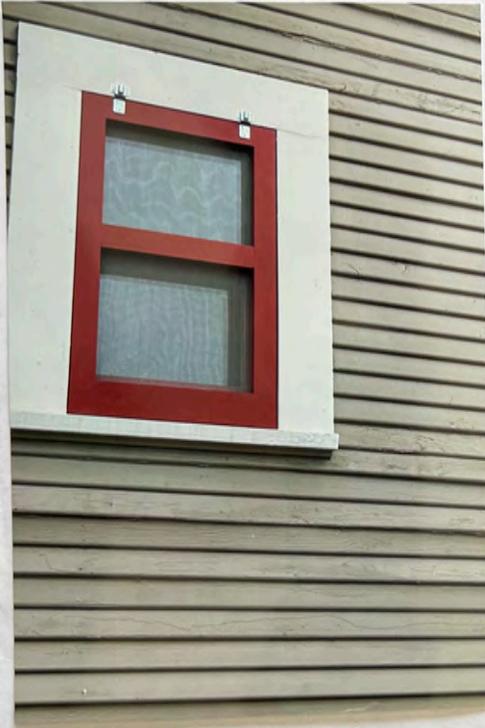
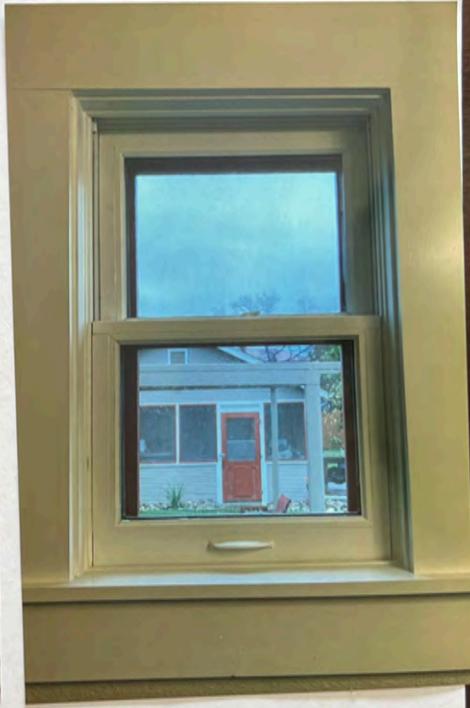
Window # 11 will not be replaced

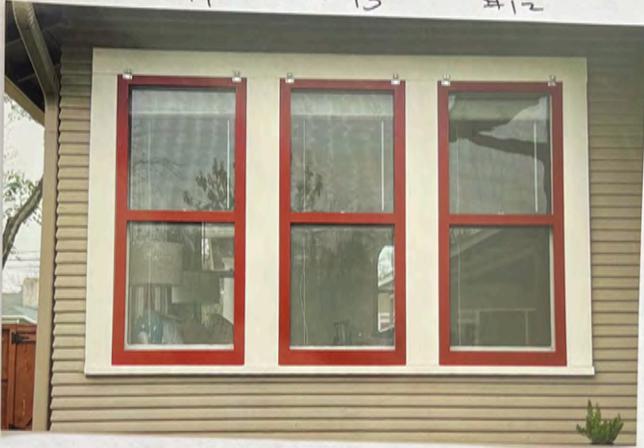
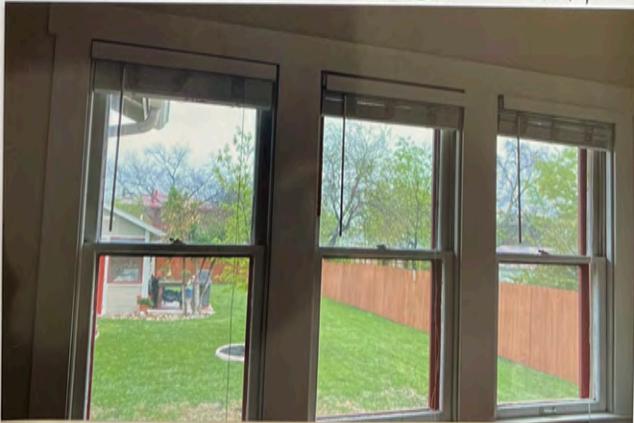
12-14 will
be replaced

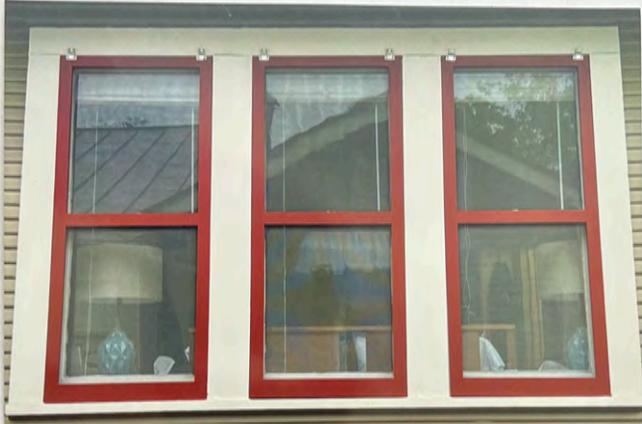
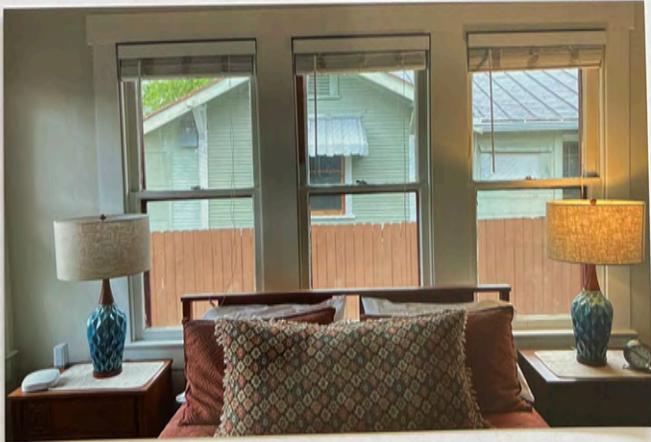
#15-17
will be
replaced

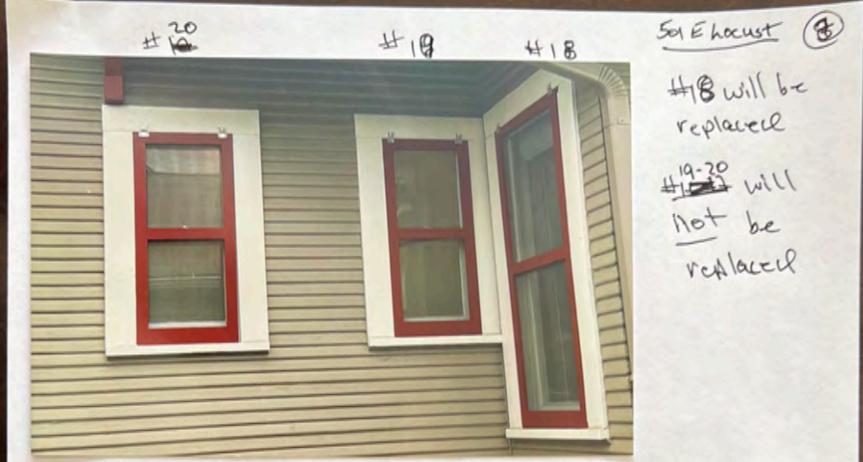
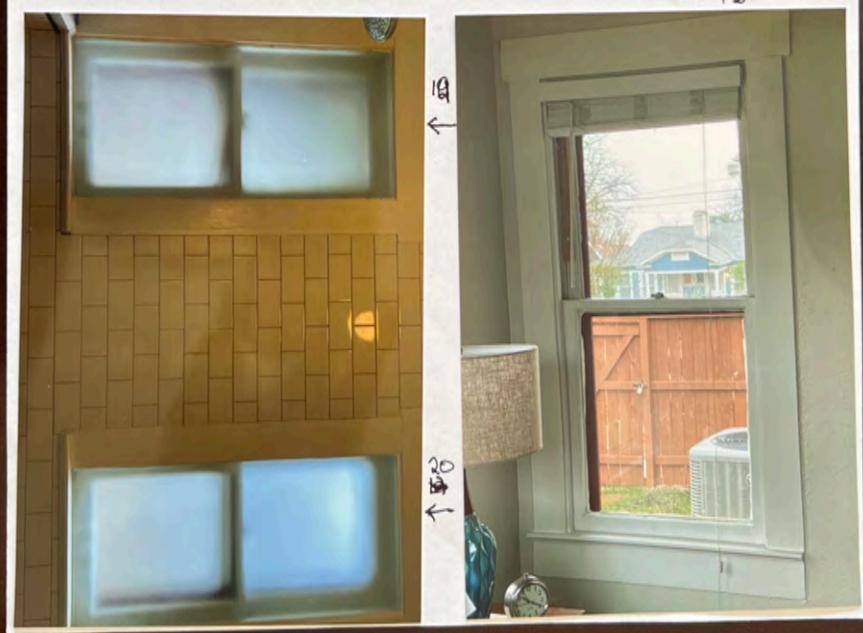
#18 will be replaced

#19-20 will not be replaced

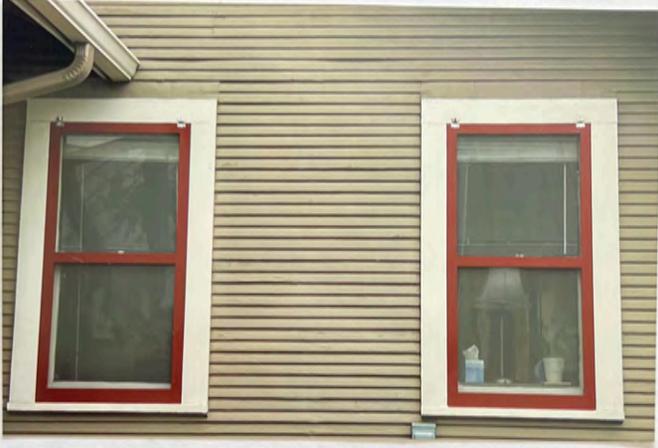
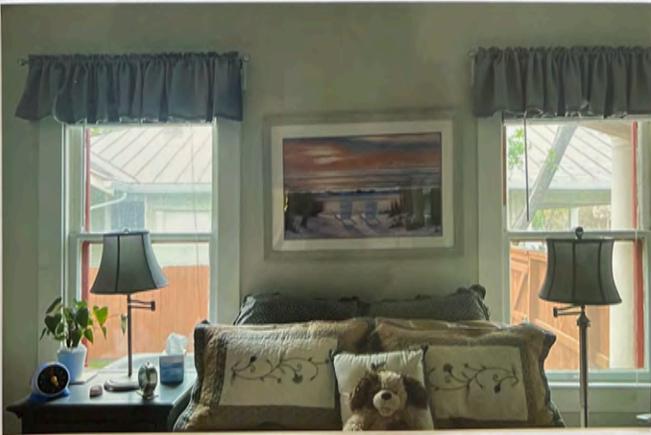
21-22 will
be replaced

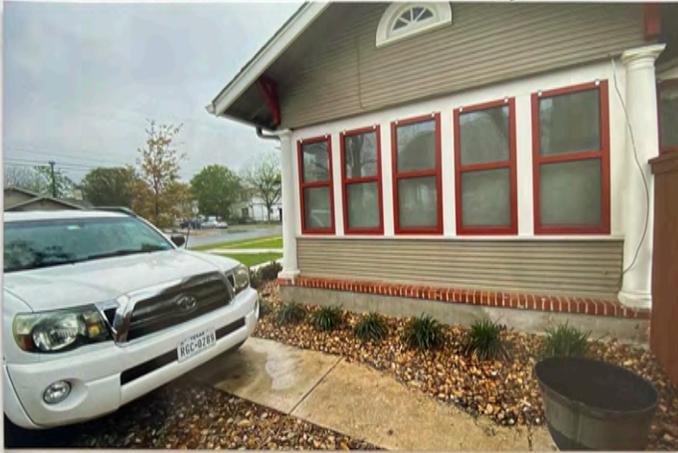
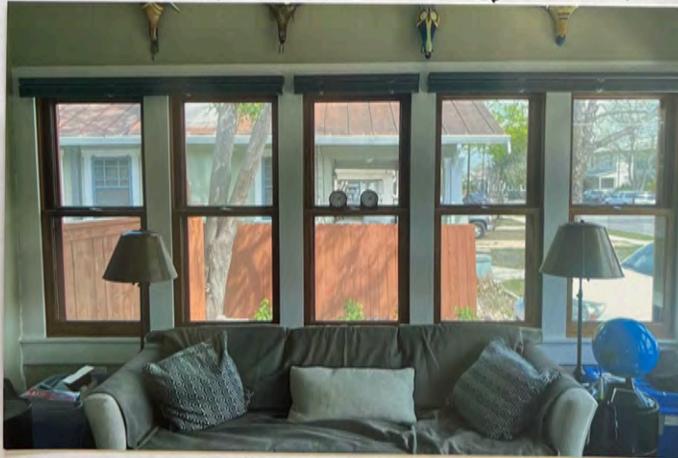
23-27
Will NOT
be Replaced

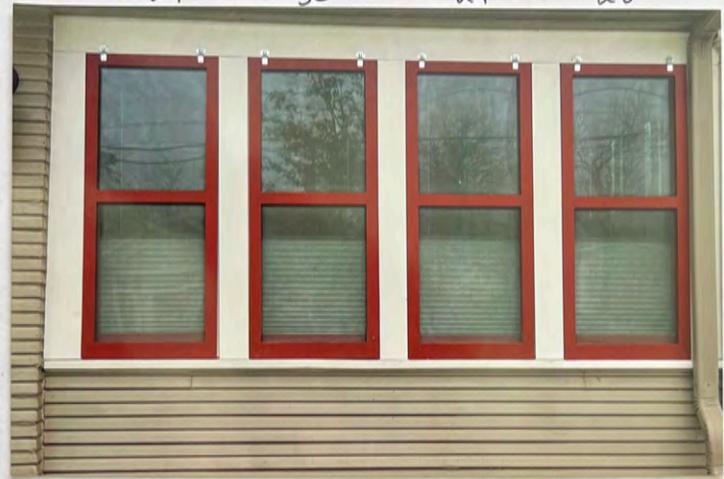
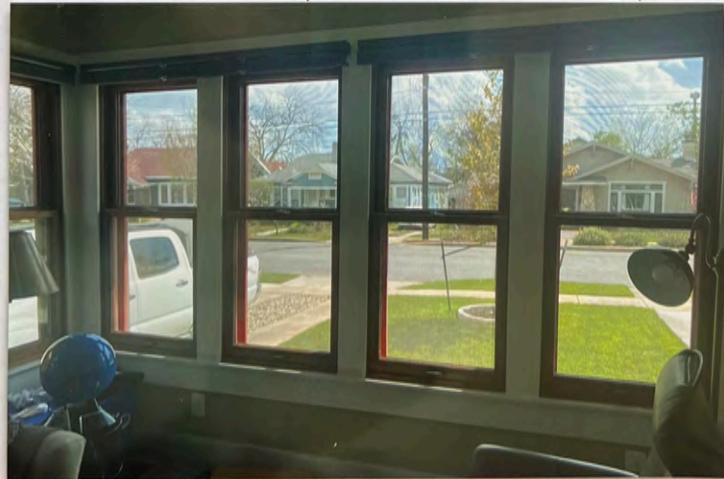
28-31 will
NOT be
replaced
