HISTORIC AND DESIGN REVIEW COMMISSION

April 19, 2023

HDRC CASE NO: 2022-091
COMMON NAME: Brackenridge Park, Lambert Beach
ADDRESS: 3700 N ST MARYS ST
LEGAL DESCRIPTION: NCB A49 PART OF A-2, A-4, A-52 (208 AC)
ZONING: R-6,HS
CITY COUNCIL DIST.: 2
LANDMARK: Individual Landmark
APPLICANT: Jamaal Moreno/City of San Antonio, PWD
OWNER: City of San Antonio
TYPE OF WORK: Phase 1 of FY17 Bond Improvements to Lambert Beach Area
APPLICATION RECEIVED: April 04, 2023
60-DAY REVIEW: Not applicable due to City Council emergency orders
CASE MANAGER: Cory Edwards
REQUEST:

The applicant is requesting a Certificate of Appropriateness for approval to construct improvements to the Lambert Beach area in Brackenridge Park as Phase I of the FY17 Bond Project. Request items include:

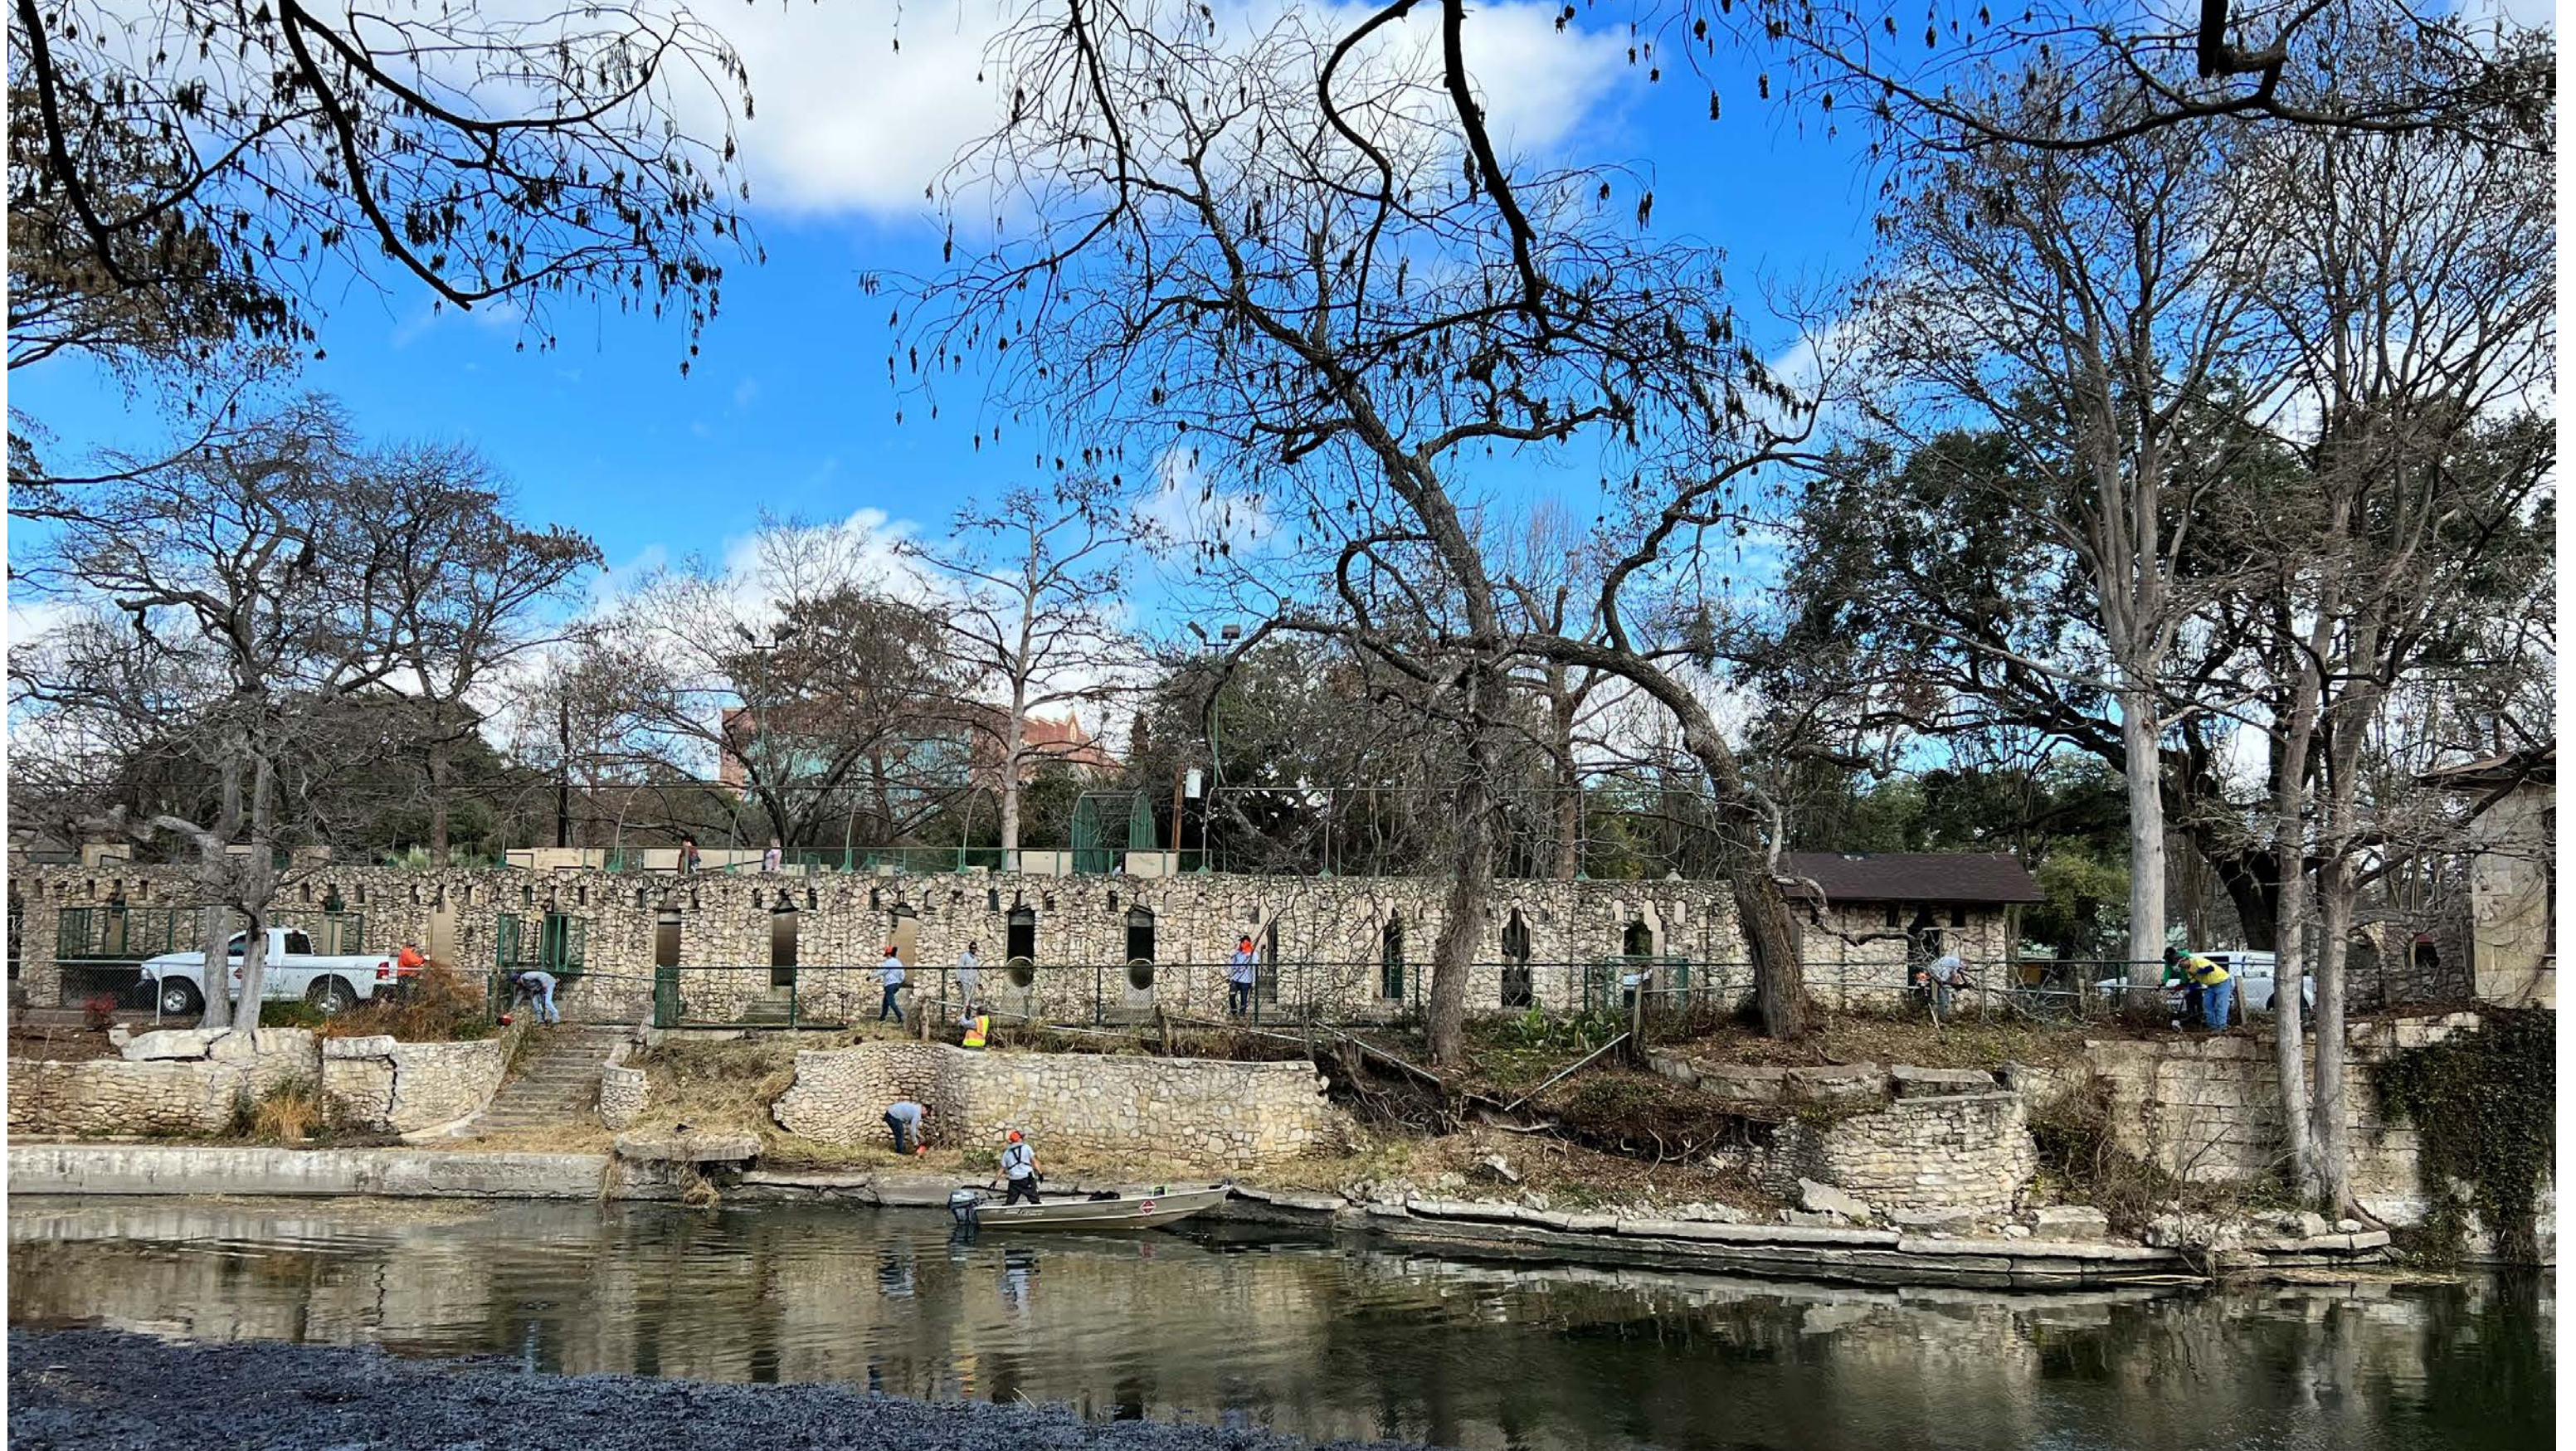
EXISTING CONDITIONS : LAMBERT BEACH NORTH WALLS

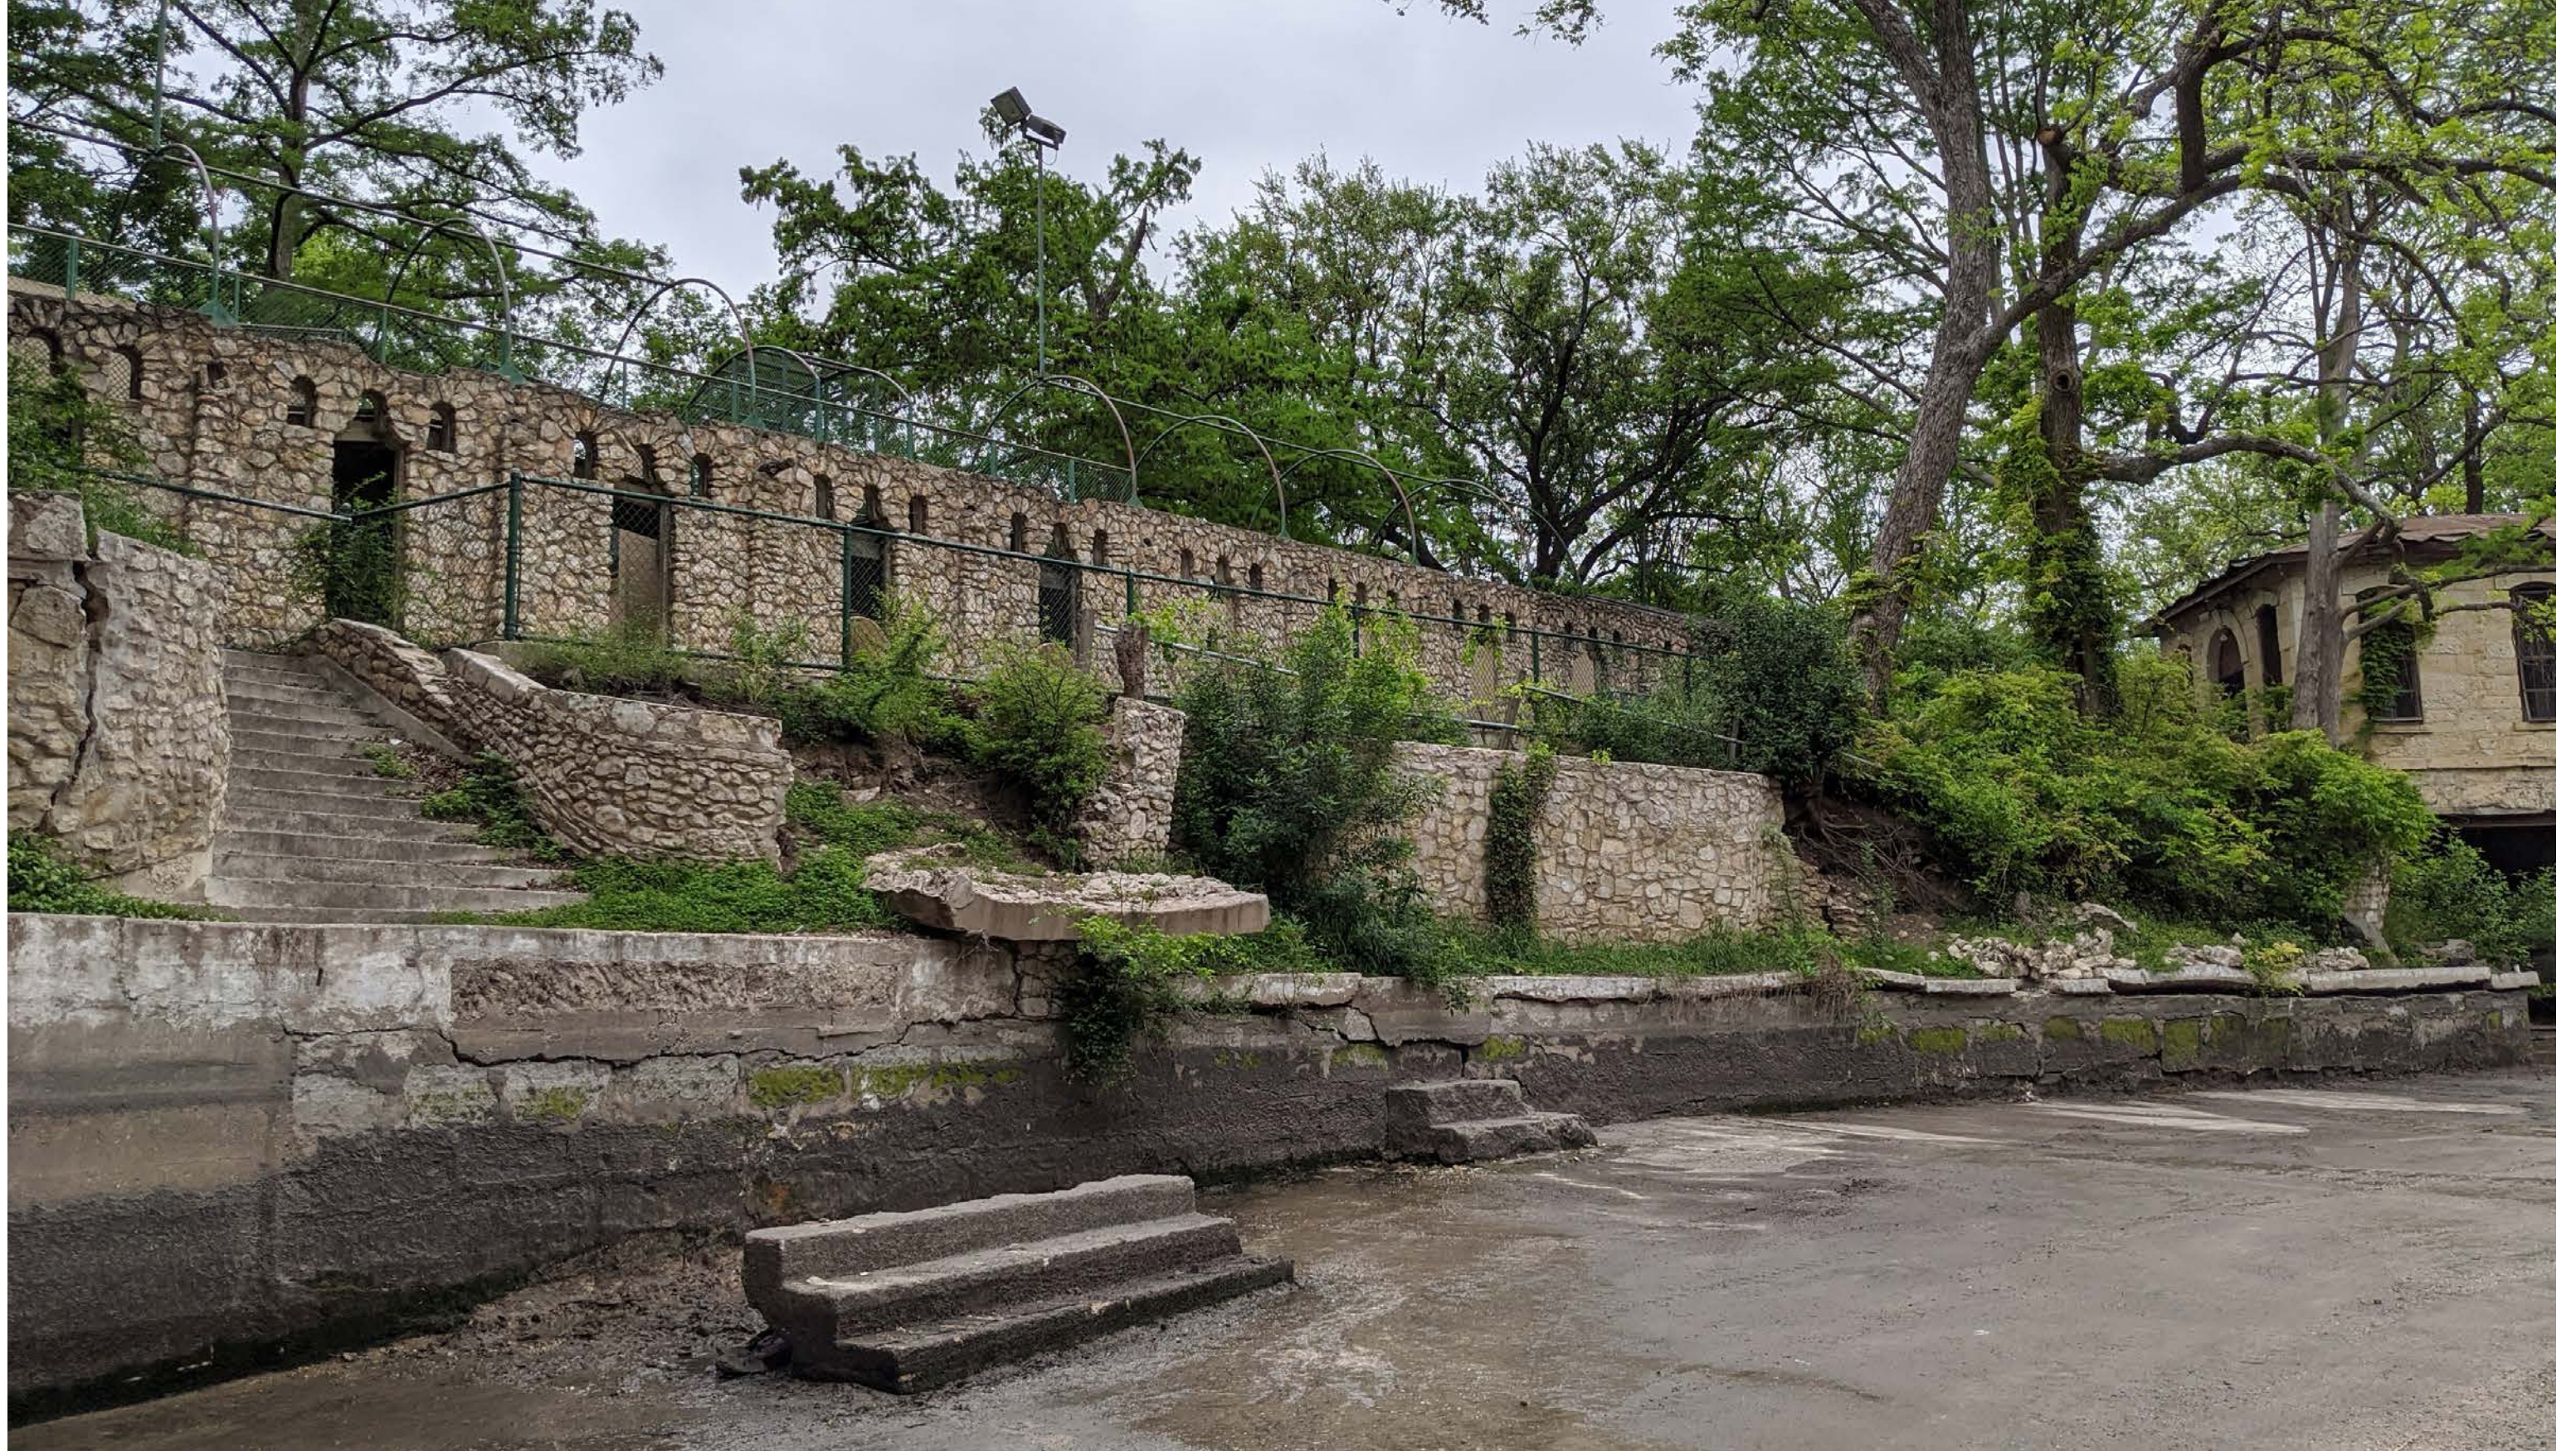
EXISTING CONDITIONS : DEWATERED RIVER CHANNEL WALL AND WALK AT PUMP HOUSE

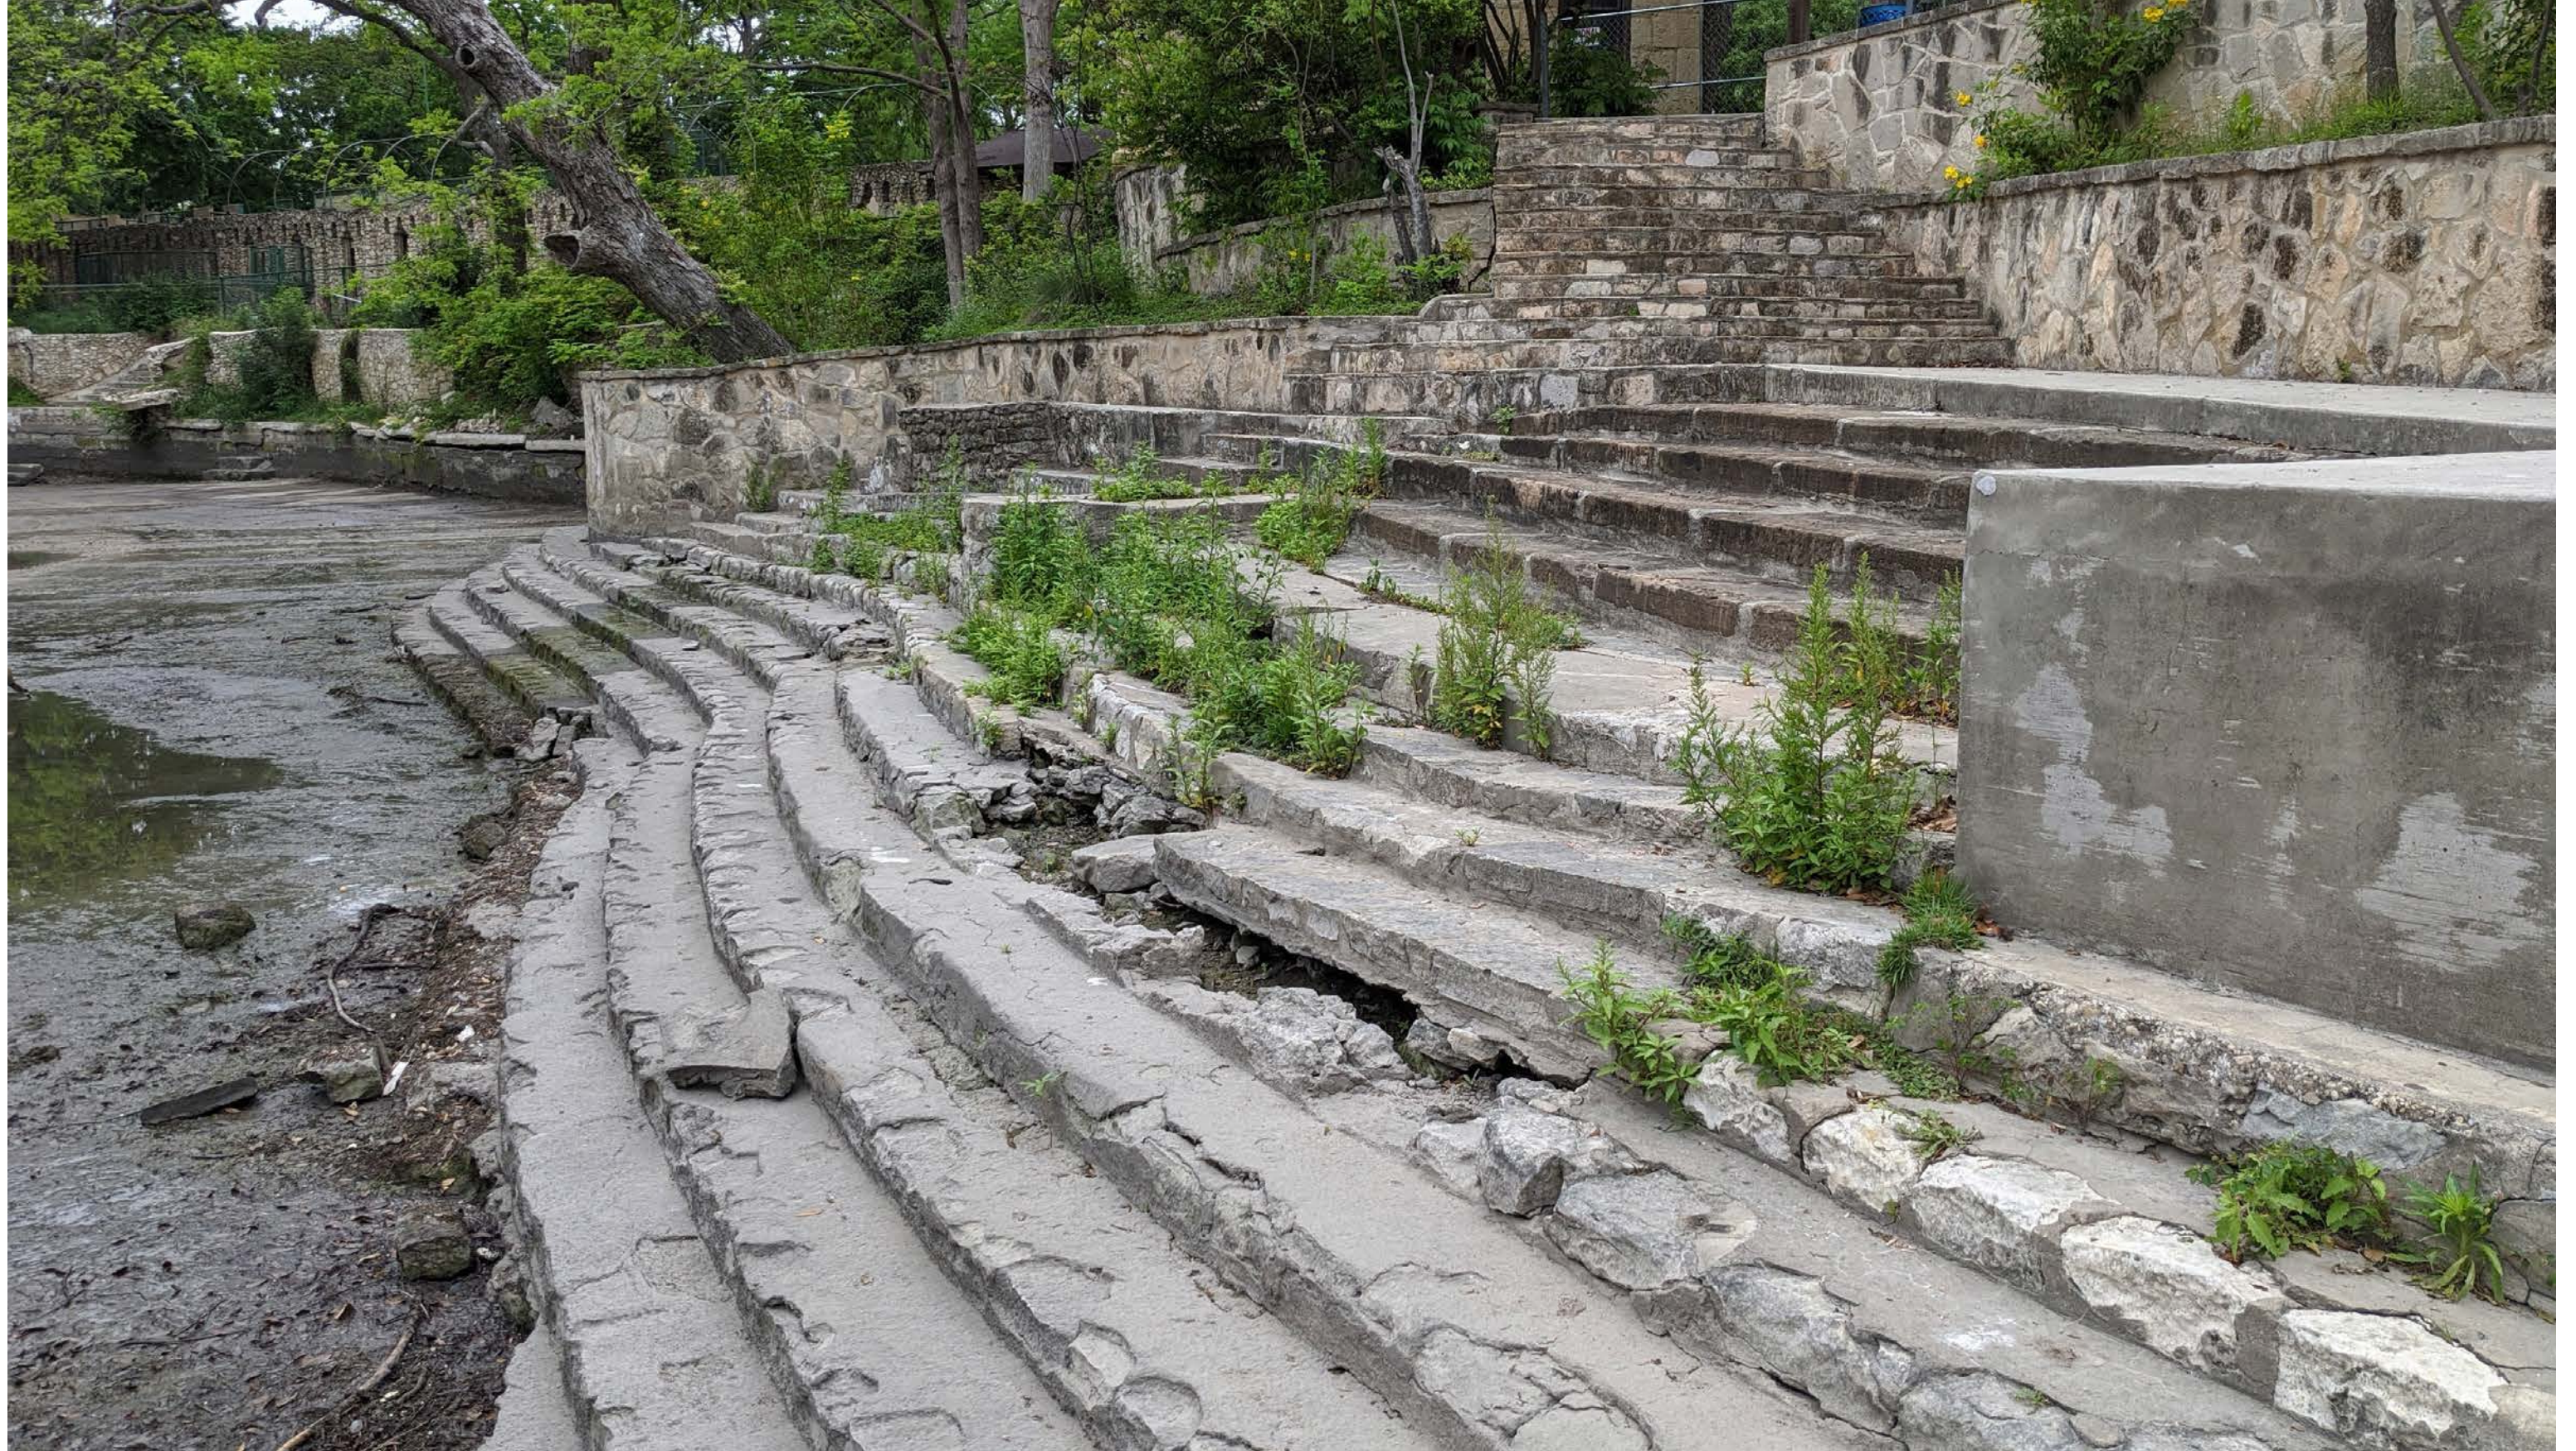
EXISTING CONDITIONS : DEWATERED LAMBERT BEACH GRAND STAIR

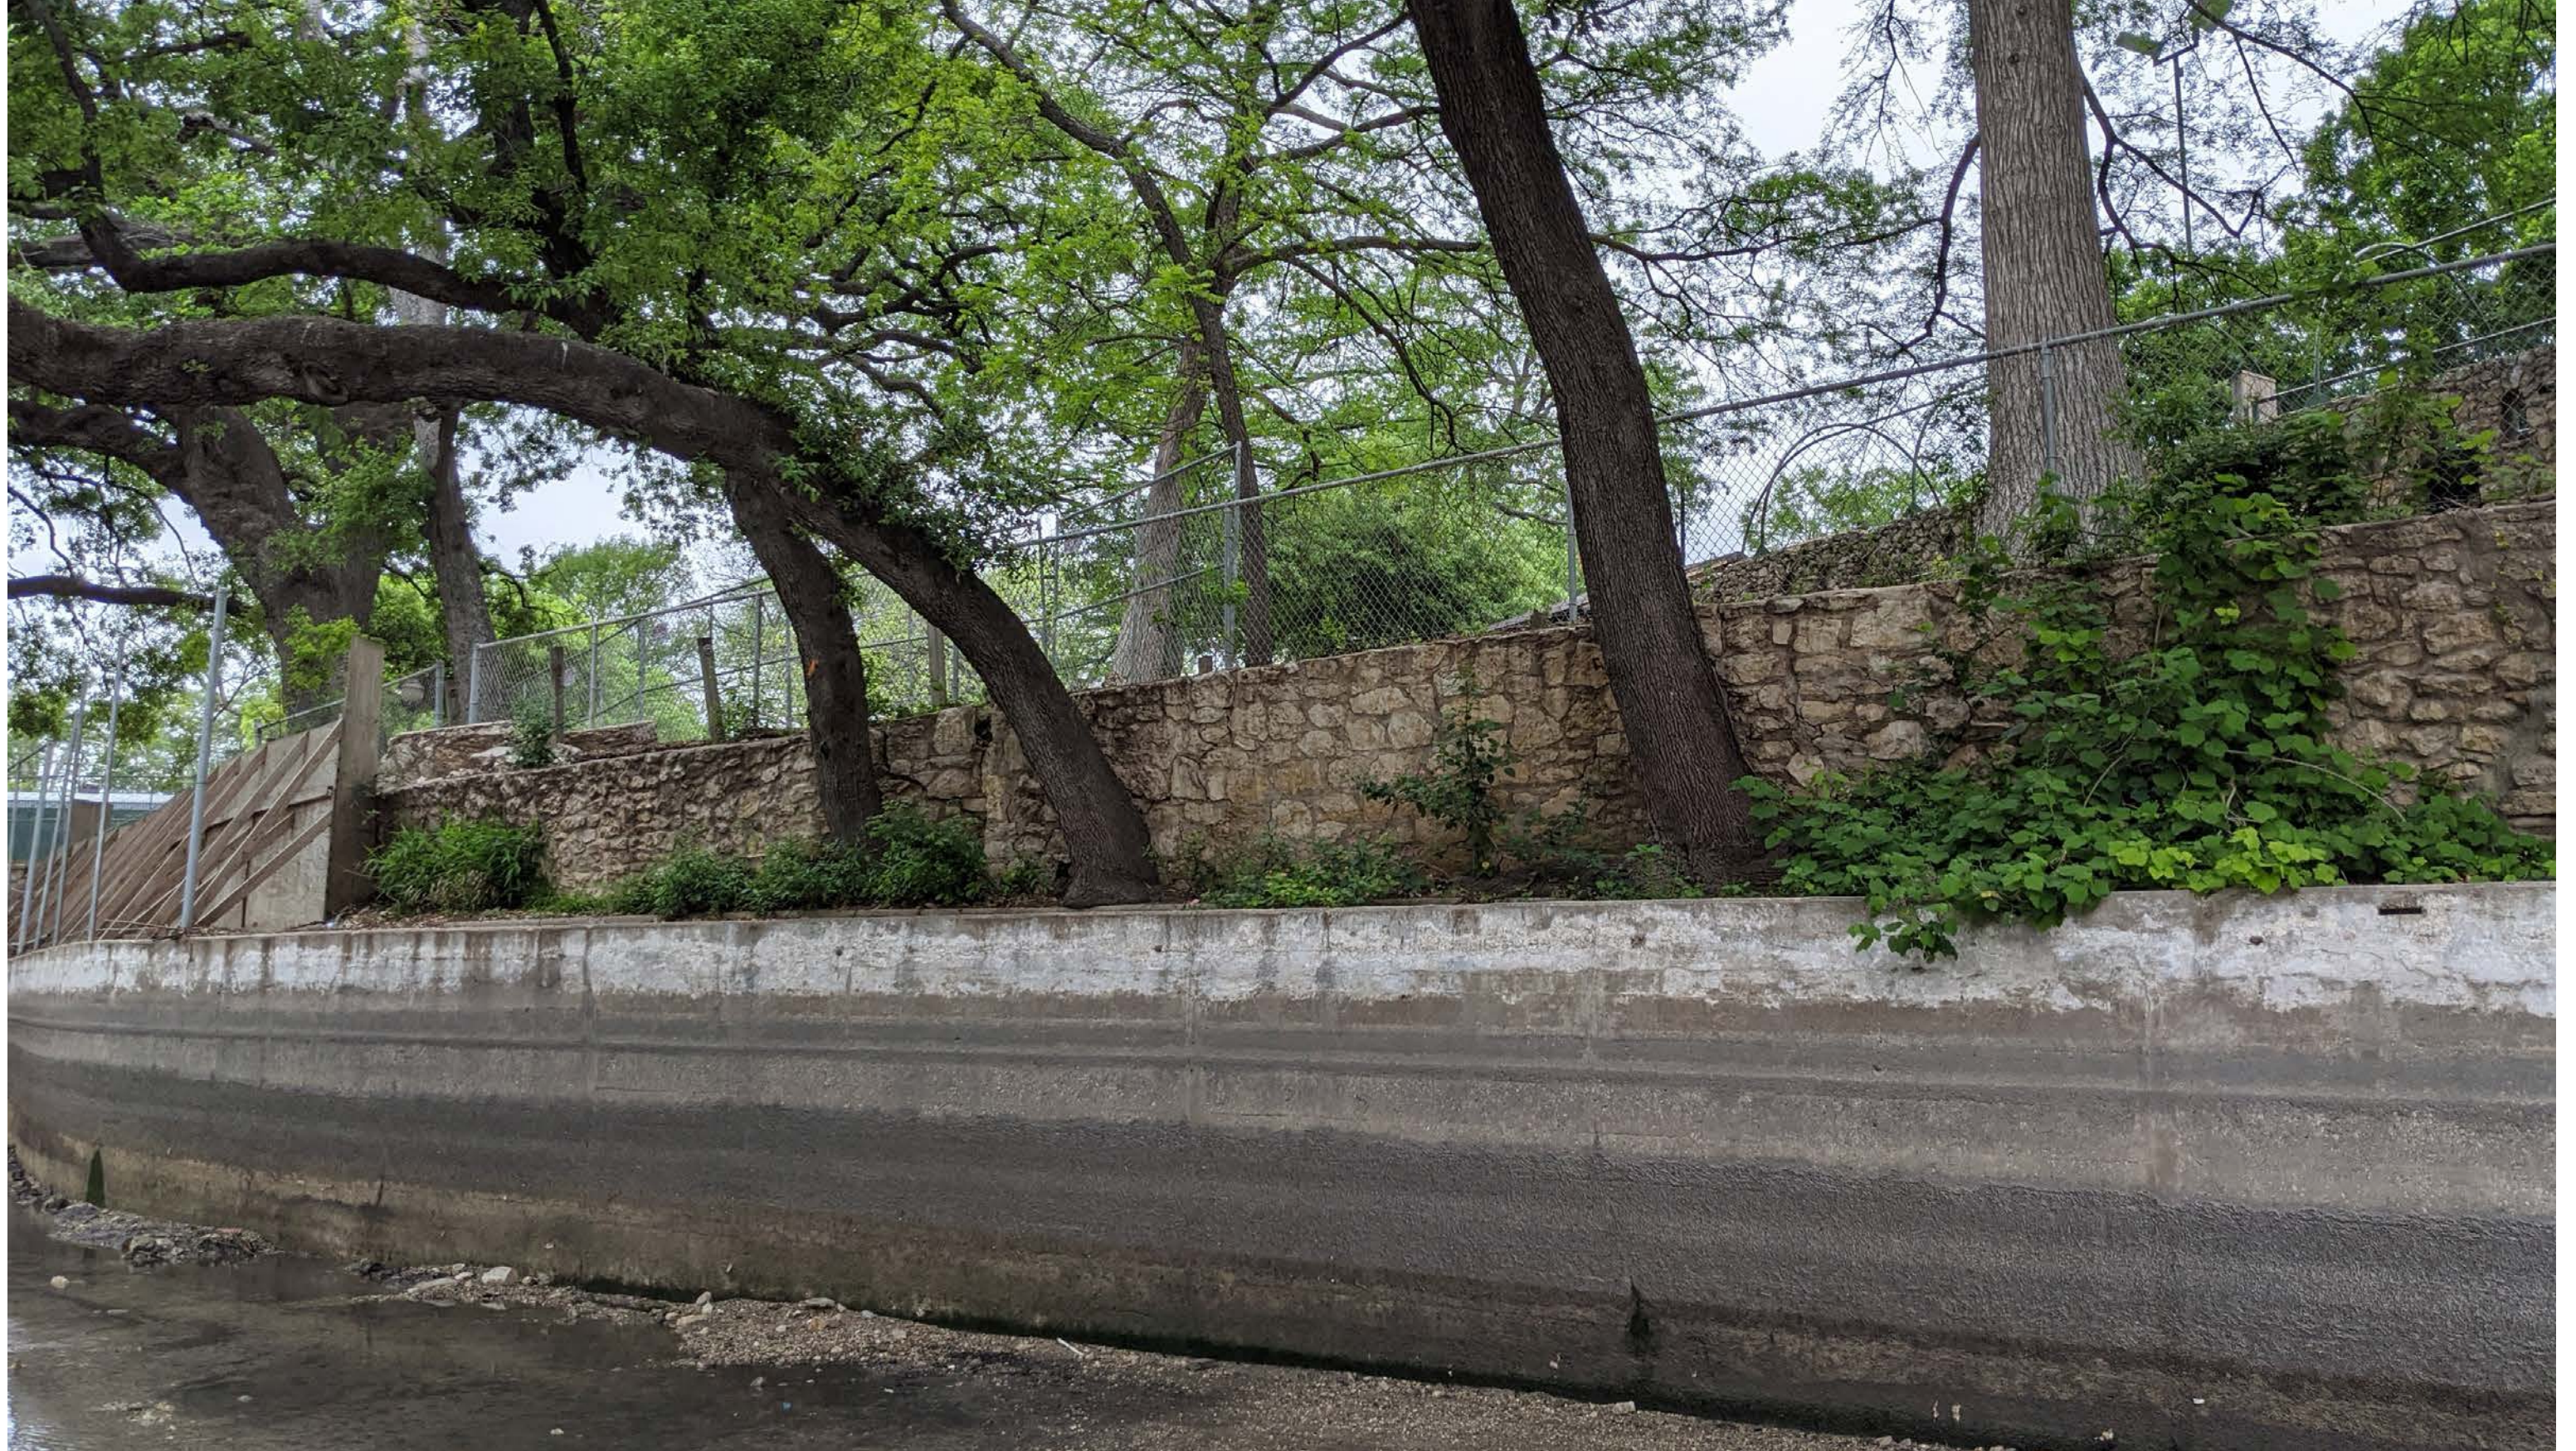
EXISTING CONDITIONS : VOLUNTEER TREES AT BASE OF DEWATERED LAMBERT BEACH WALL

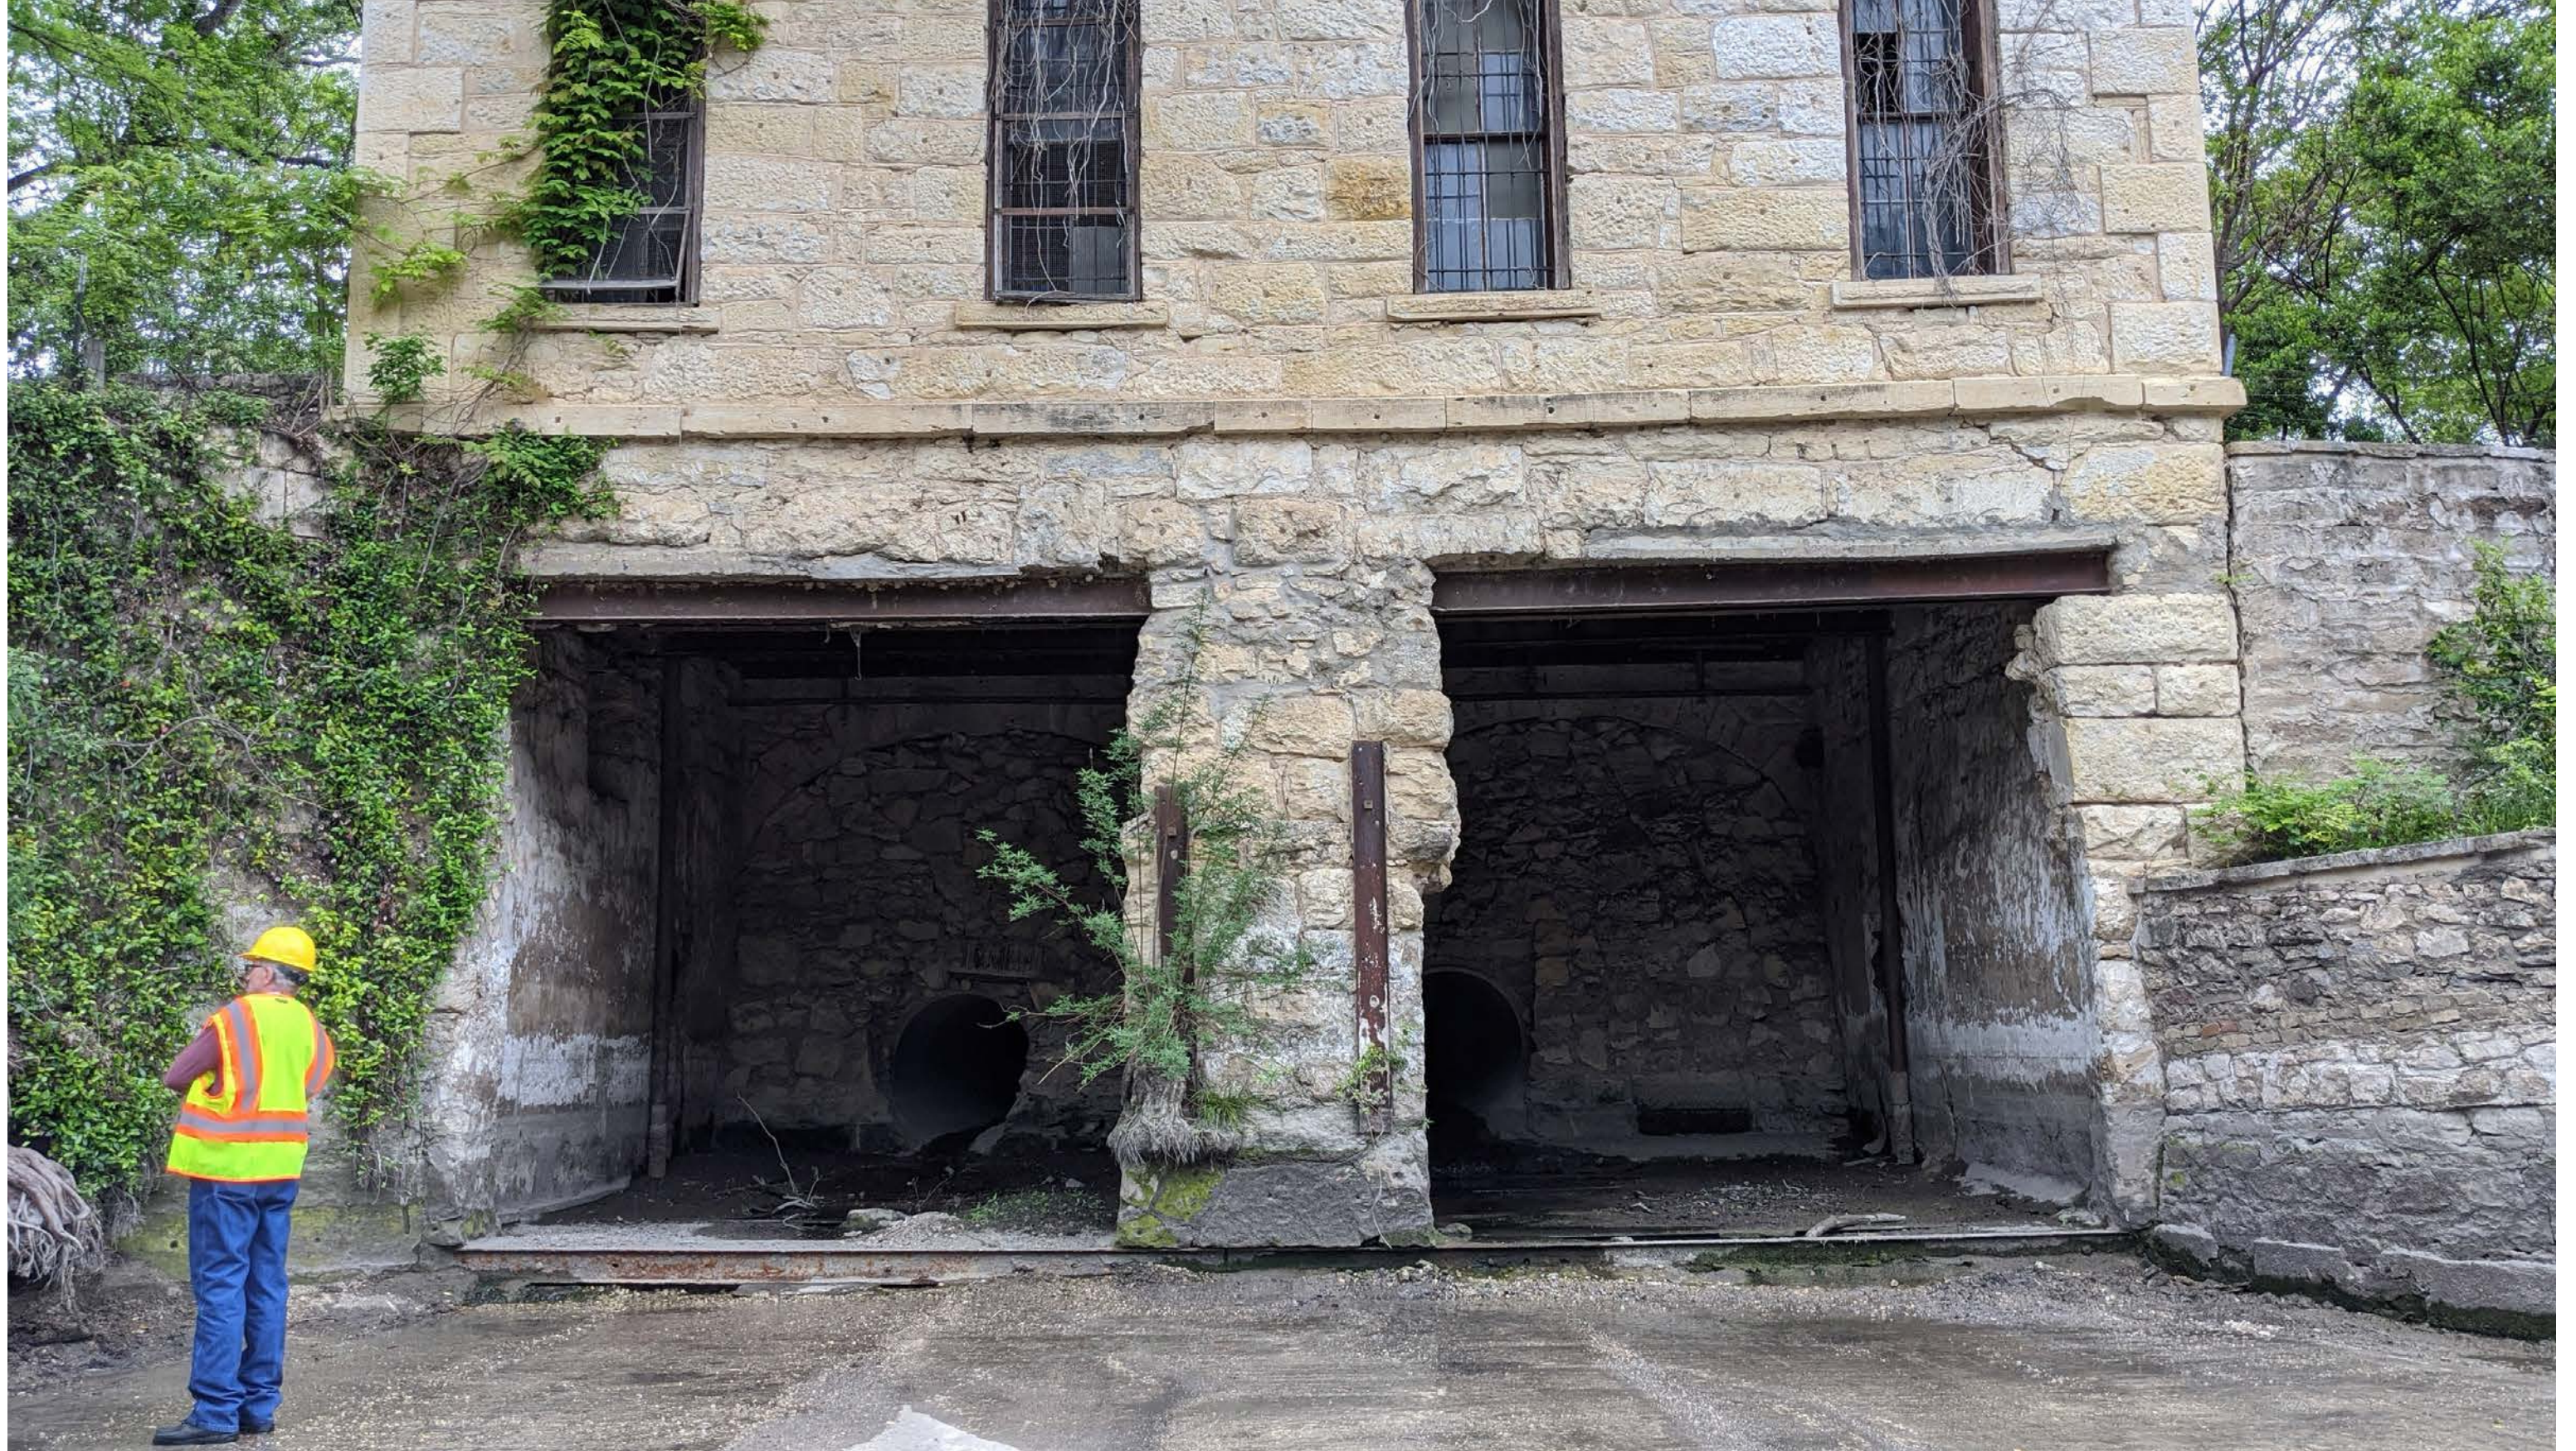
EXISTING CONDITIONS : DEWATERED RIVER LEVEL FLOOR OF PUMP HOUSE

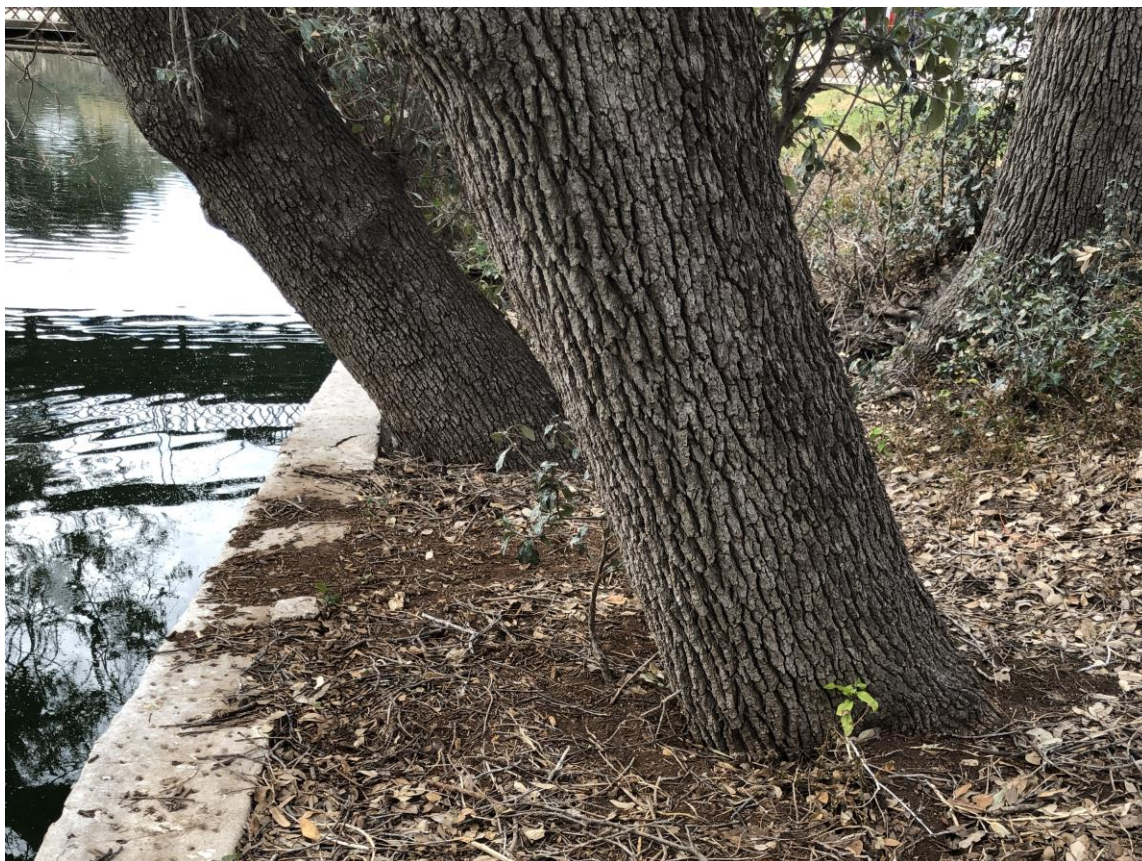
Figure 4: Foreground - Tree 98, 18-inch Live Oak proposed to be removed. Proximity to Cultural Resource: 18 inches. Background Left – Tree No. 97 proposed to be removed, Background Right – Tree No. 96 proposed to be preserved.

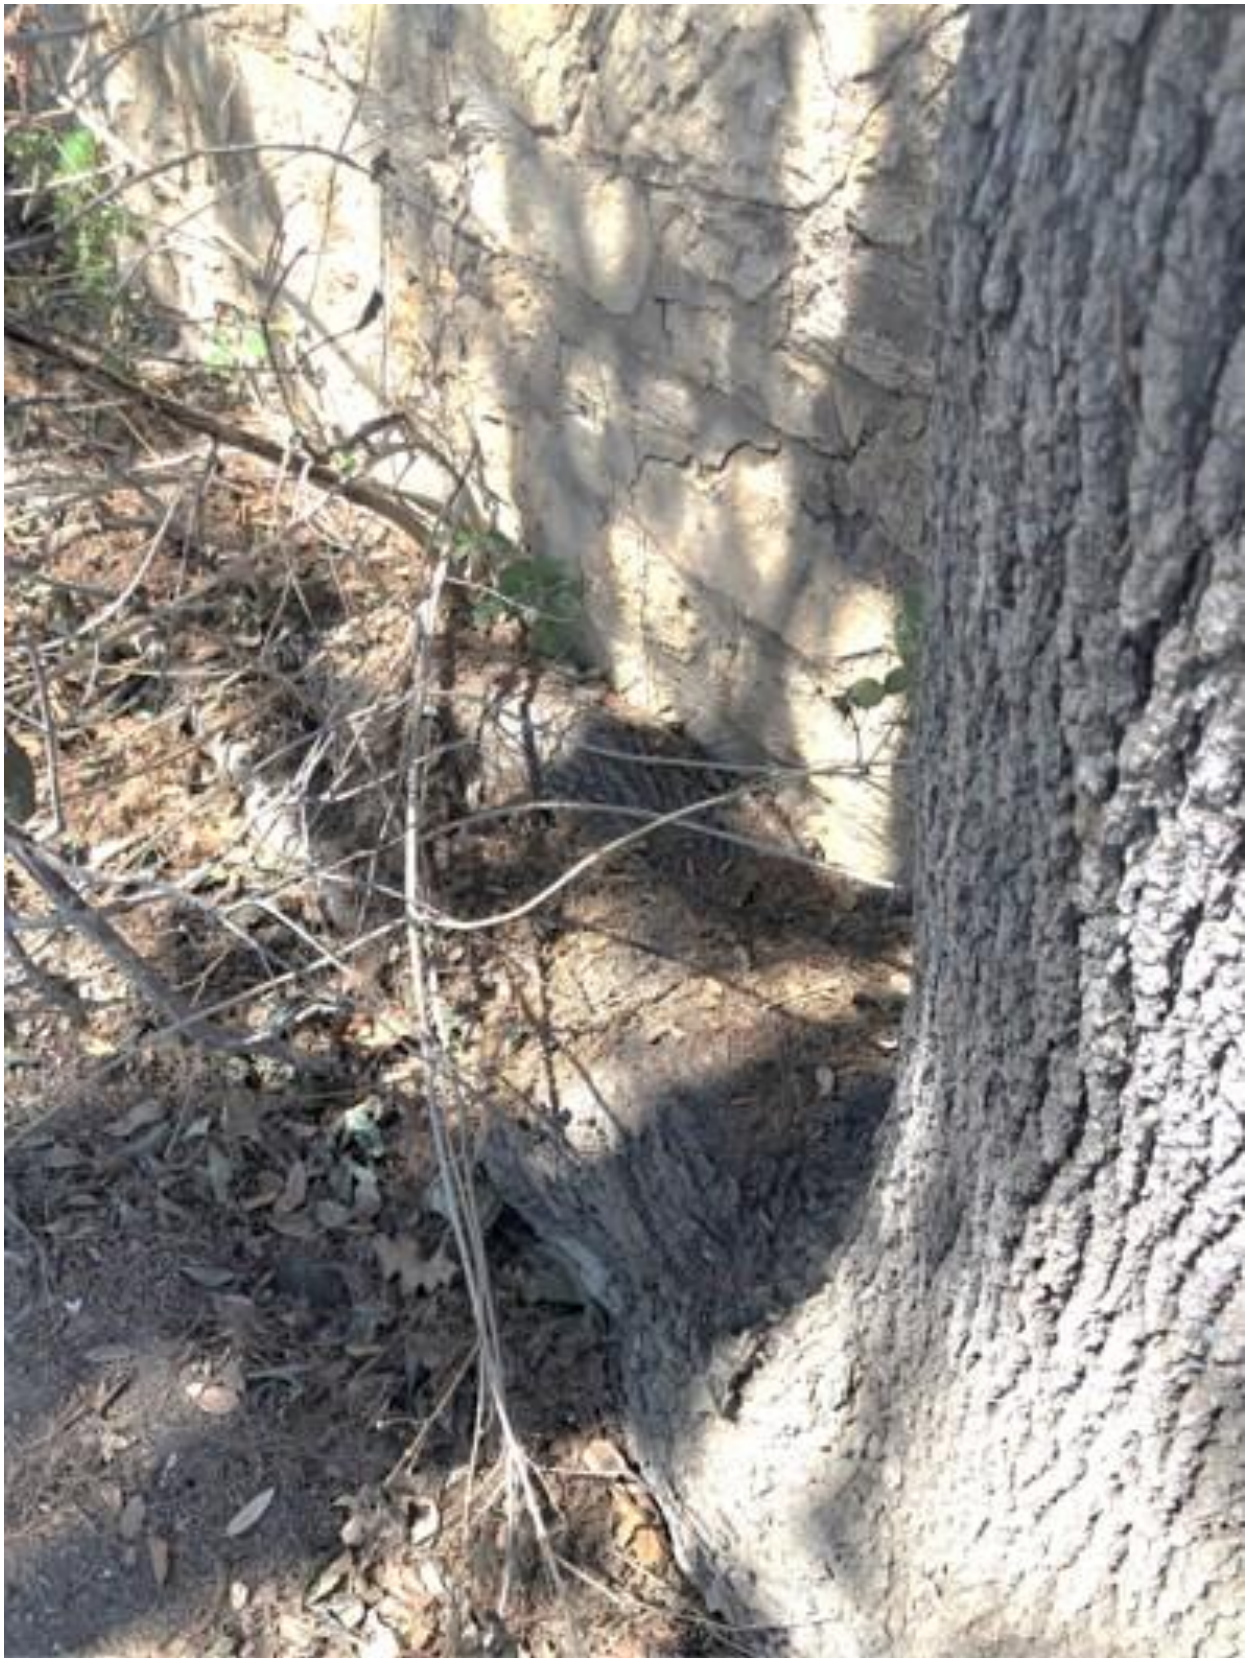
Figure 14: Tree No. 136, 20-inch Live Oak proposed to be removed. Proximity to Cultural Resource: 0 inches.

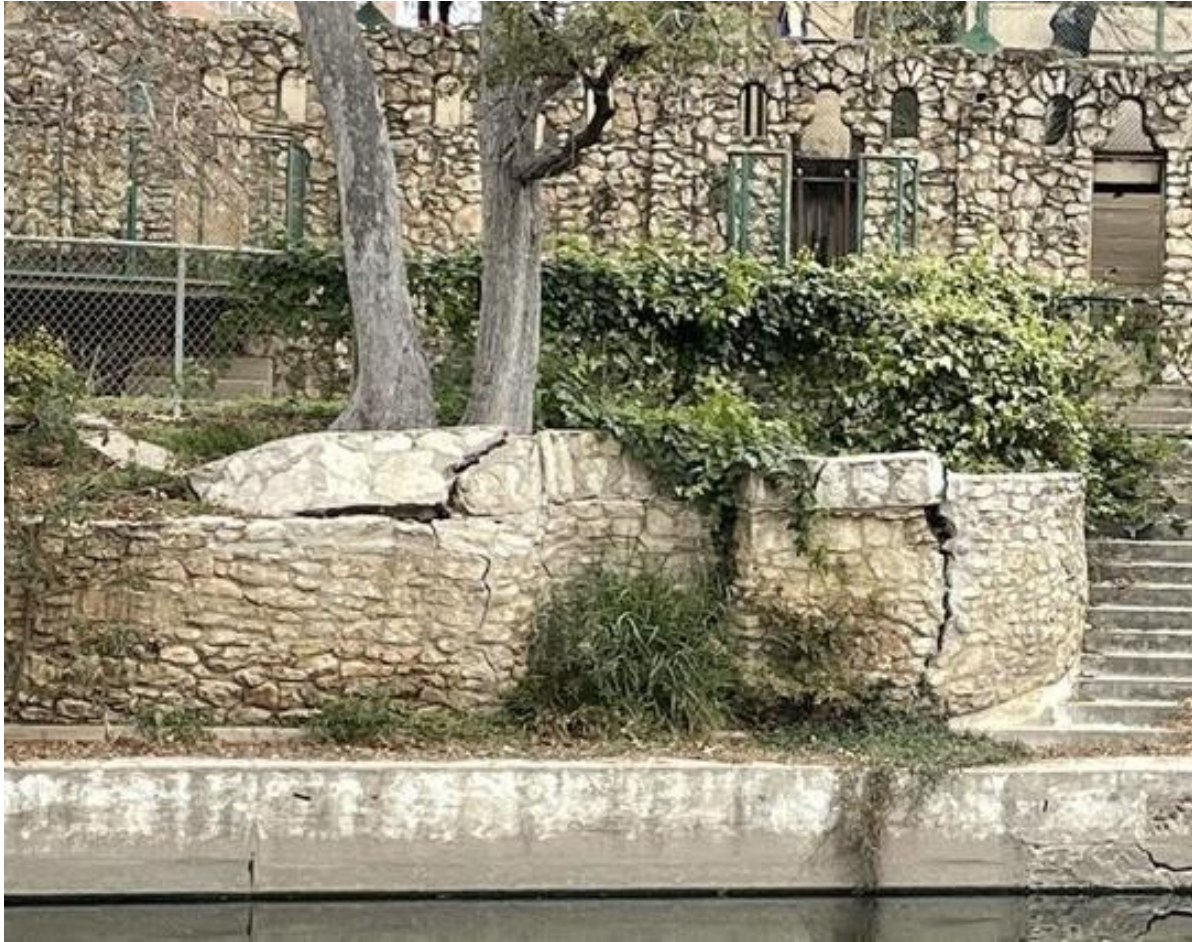
Figure 15: (L to R) Tree Nos. 137, 17-inch Cedar Elm, and 138, a 16-inch Cedar Elm, proposed to be removed. Proximity to Cultural Resource: 1-3 inches.
