HISTORIC AND DESIGN REVIEW COMMISSION

April 19, 2023

HDRC CASE NO: 2022-091
COMMON NAME: Brackenridge Park, Lambert Beach
ADDRESS: 3700 N ST MARYS ST
LEGAL DESCRIPTION: NCB A49 PART OF A-2, A-4, A-52 (208 AC)
ZONING: R-6,HS
CITY COUNCIL DIST.: 2
LANDMARK: Individual Landmark
APPLICANT: Jamaal Moreno/City of San Antonio, PWD
OWNER: City of San Antonio
TYPE OF WORK: Phase 1 of FY17 Bond Improvements to Lambert Beach Area
APPLICATION RECEIVED: April 04, 2023
60-DAY REVIEW: Not applicable due to City Council emergency orders
CASE MANAGER: Cory Edwards
REQUEST:

The applicant is requesting a Certificate of Appropriateness for approval to construct improvements to the Lambert Beach area in Brackenridge Park as Phase I of the FY17 Bond Project. Request items include:

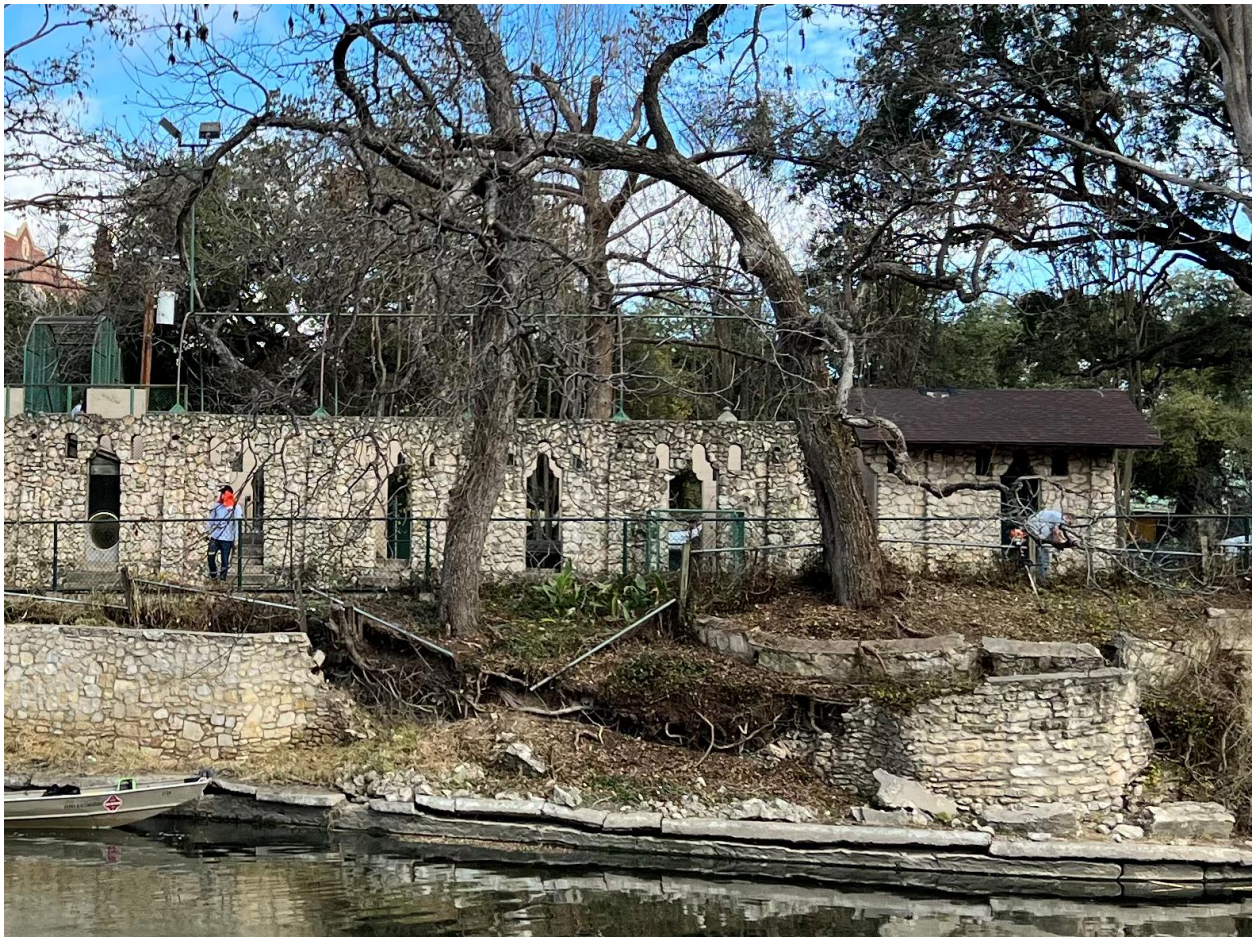
Figure 17: (L to R) Tree Nos. 139, a 26-inch Pecan, and 140, a 24-inch Pecan, proposed to be removed. Proximity to original position of cultural resource (partially demolished): less than 2 feet.

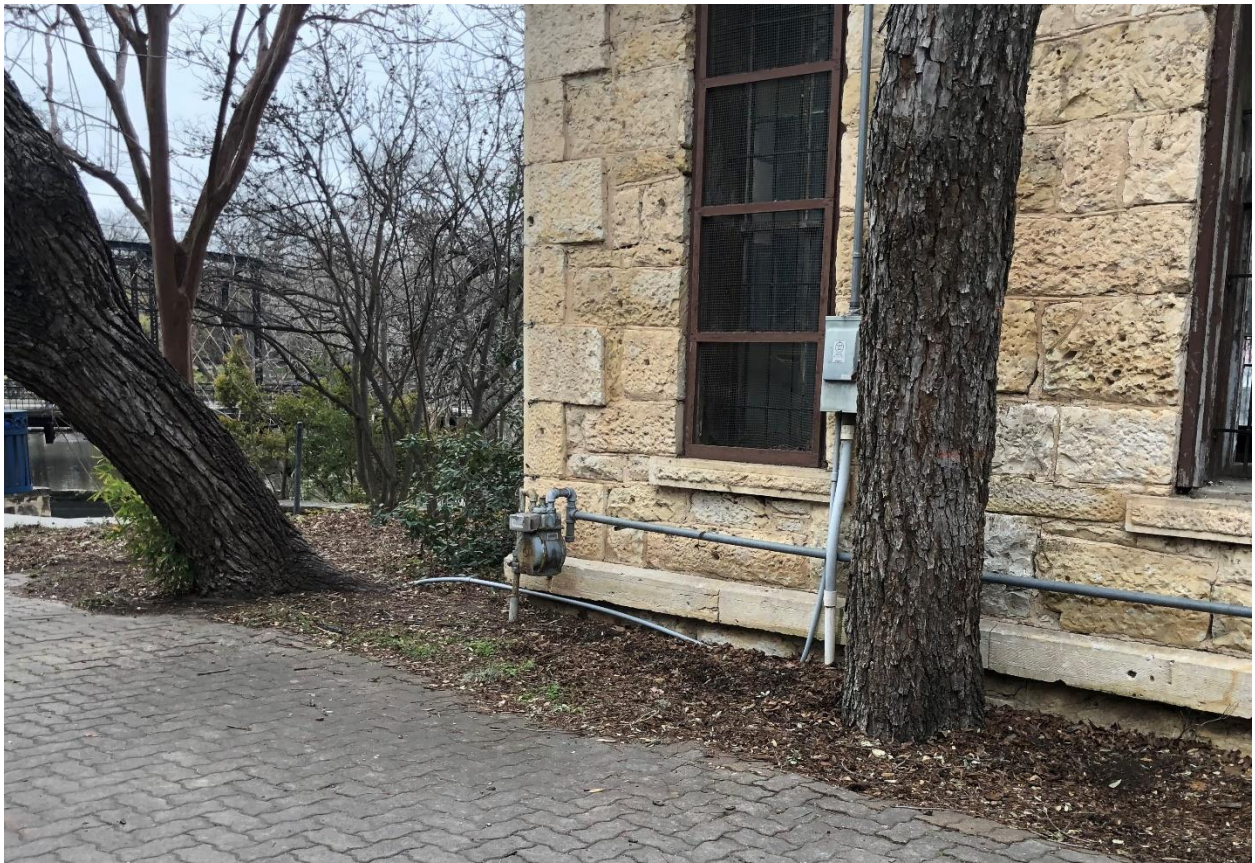
Figure 23: (L to R) Tree Nos. 108, 22-inch Black Walnut, and 107, 18-inch Black Walnut, both proposed to be removed. Proximity to Cultural Resource: 3 to less than 24 inches.

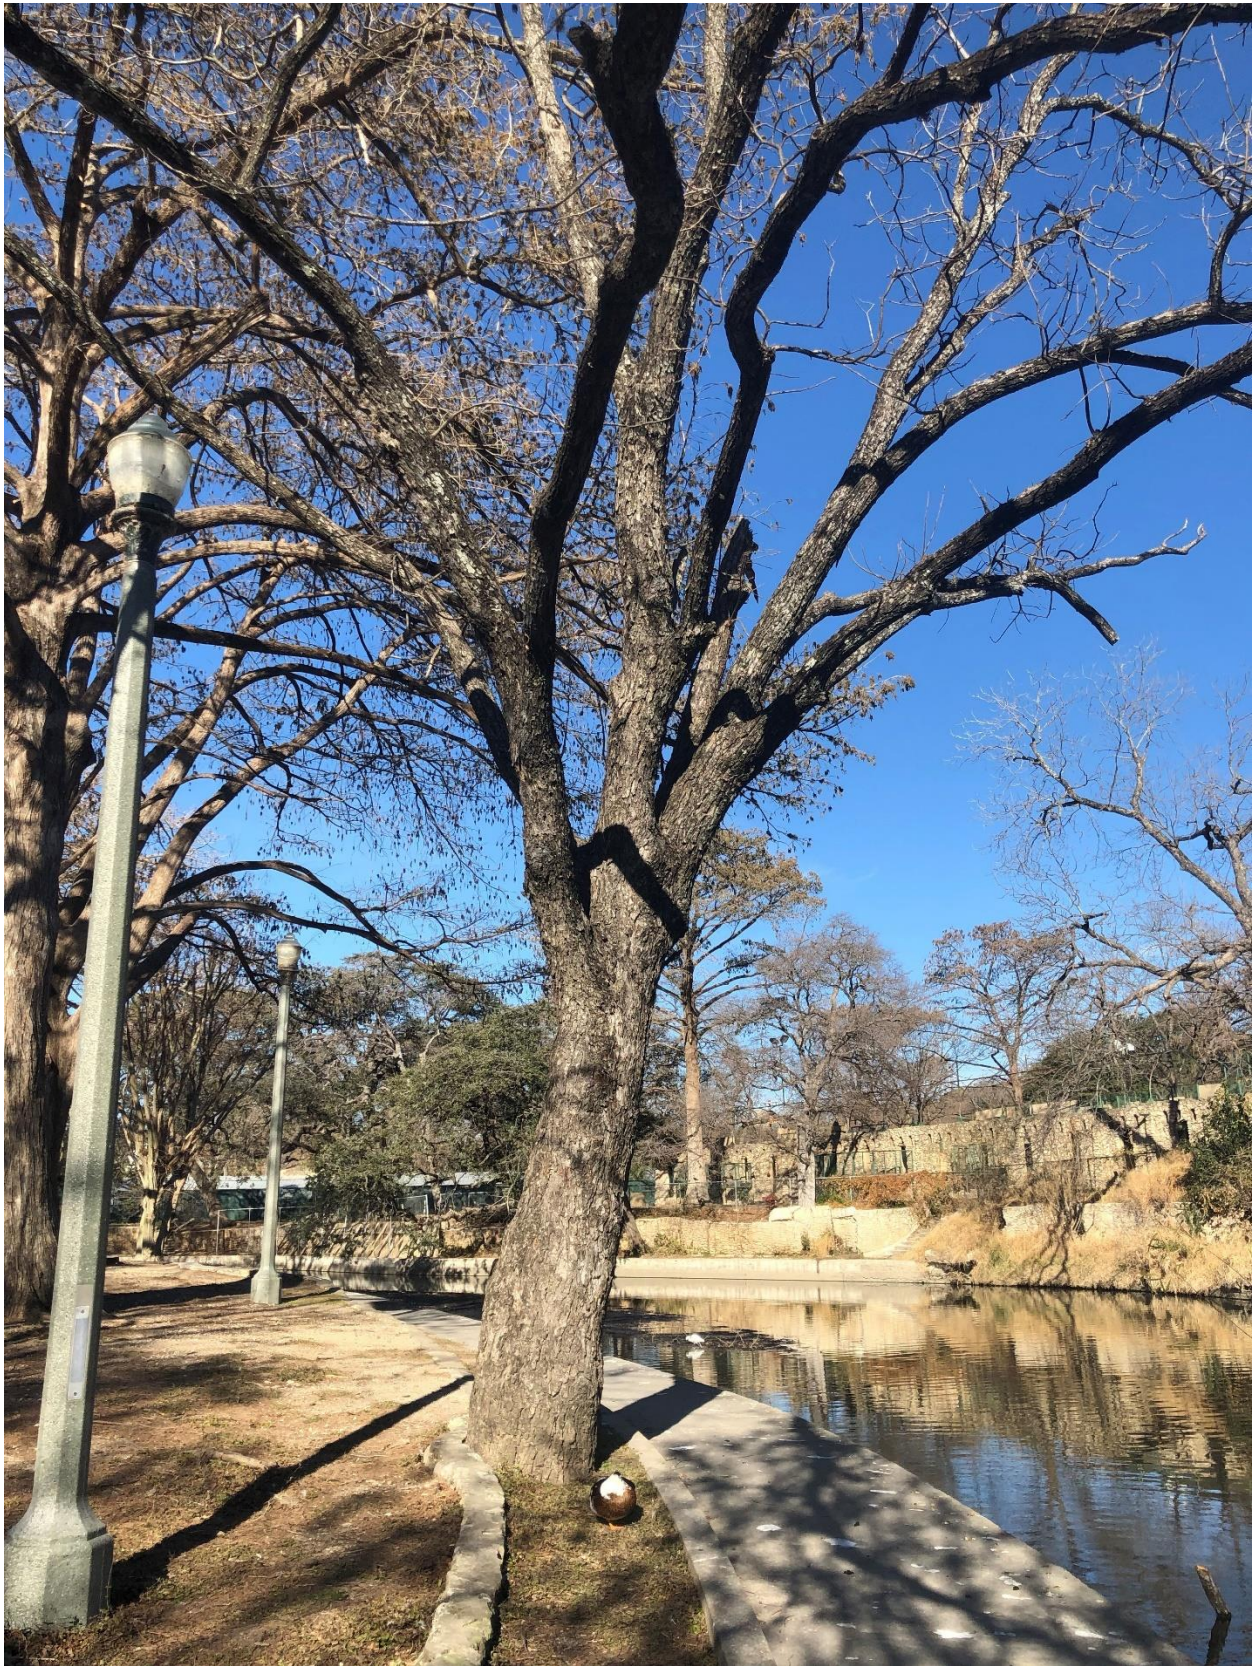
Figure 25: Tree No. 122, 22-inch Pecan proposed to be removed. Proximity to Cultural Resources, 0 inches to 8 inches.

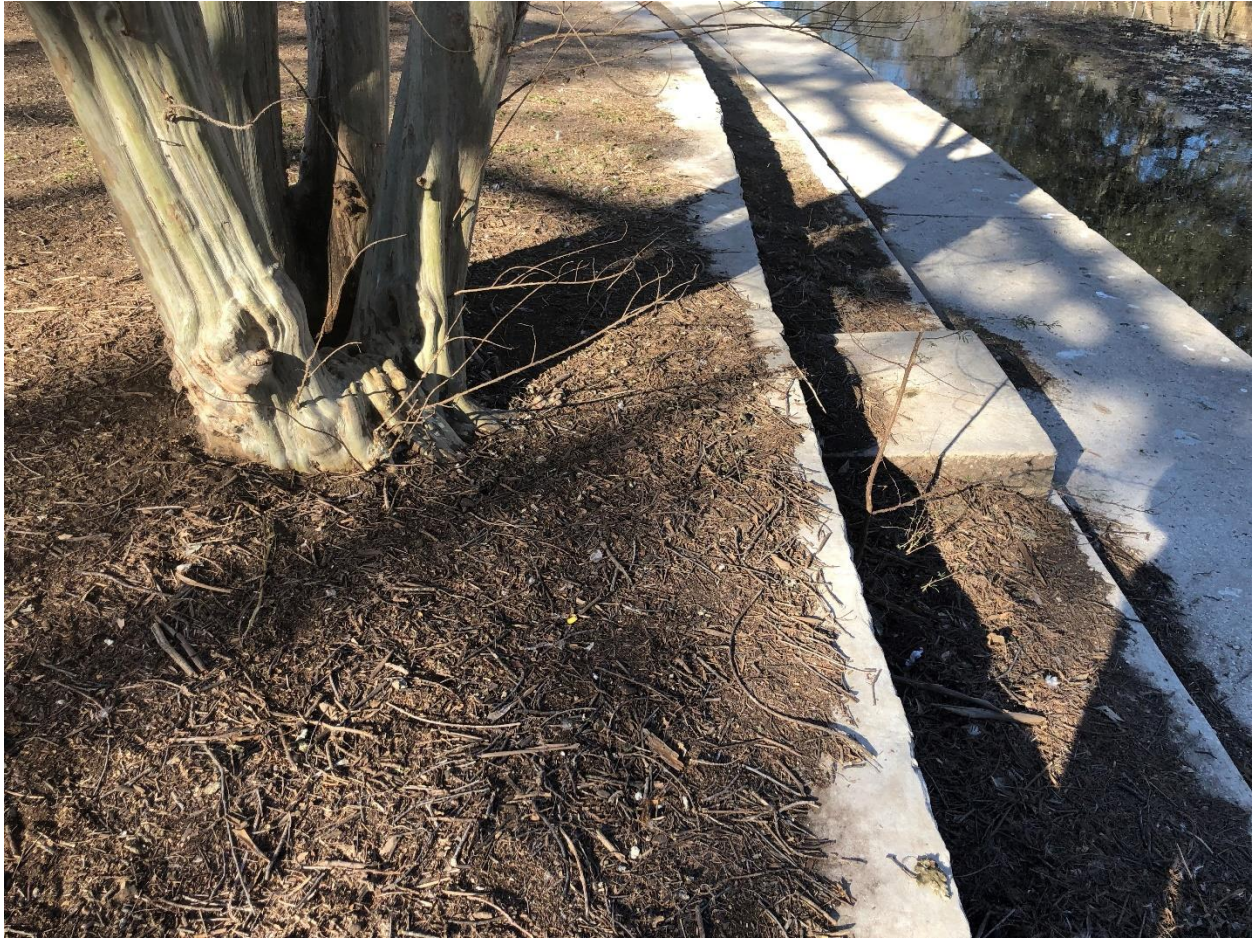
Figure 26: Tree No. 125, 27-inch Crepe Myrtle proposed to be removed. Proximity to Cultural Resource: Less than 1 foot.

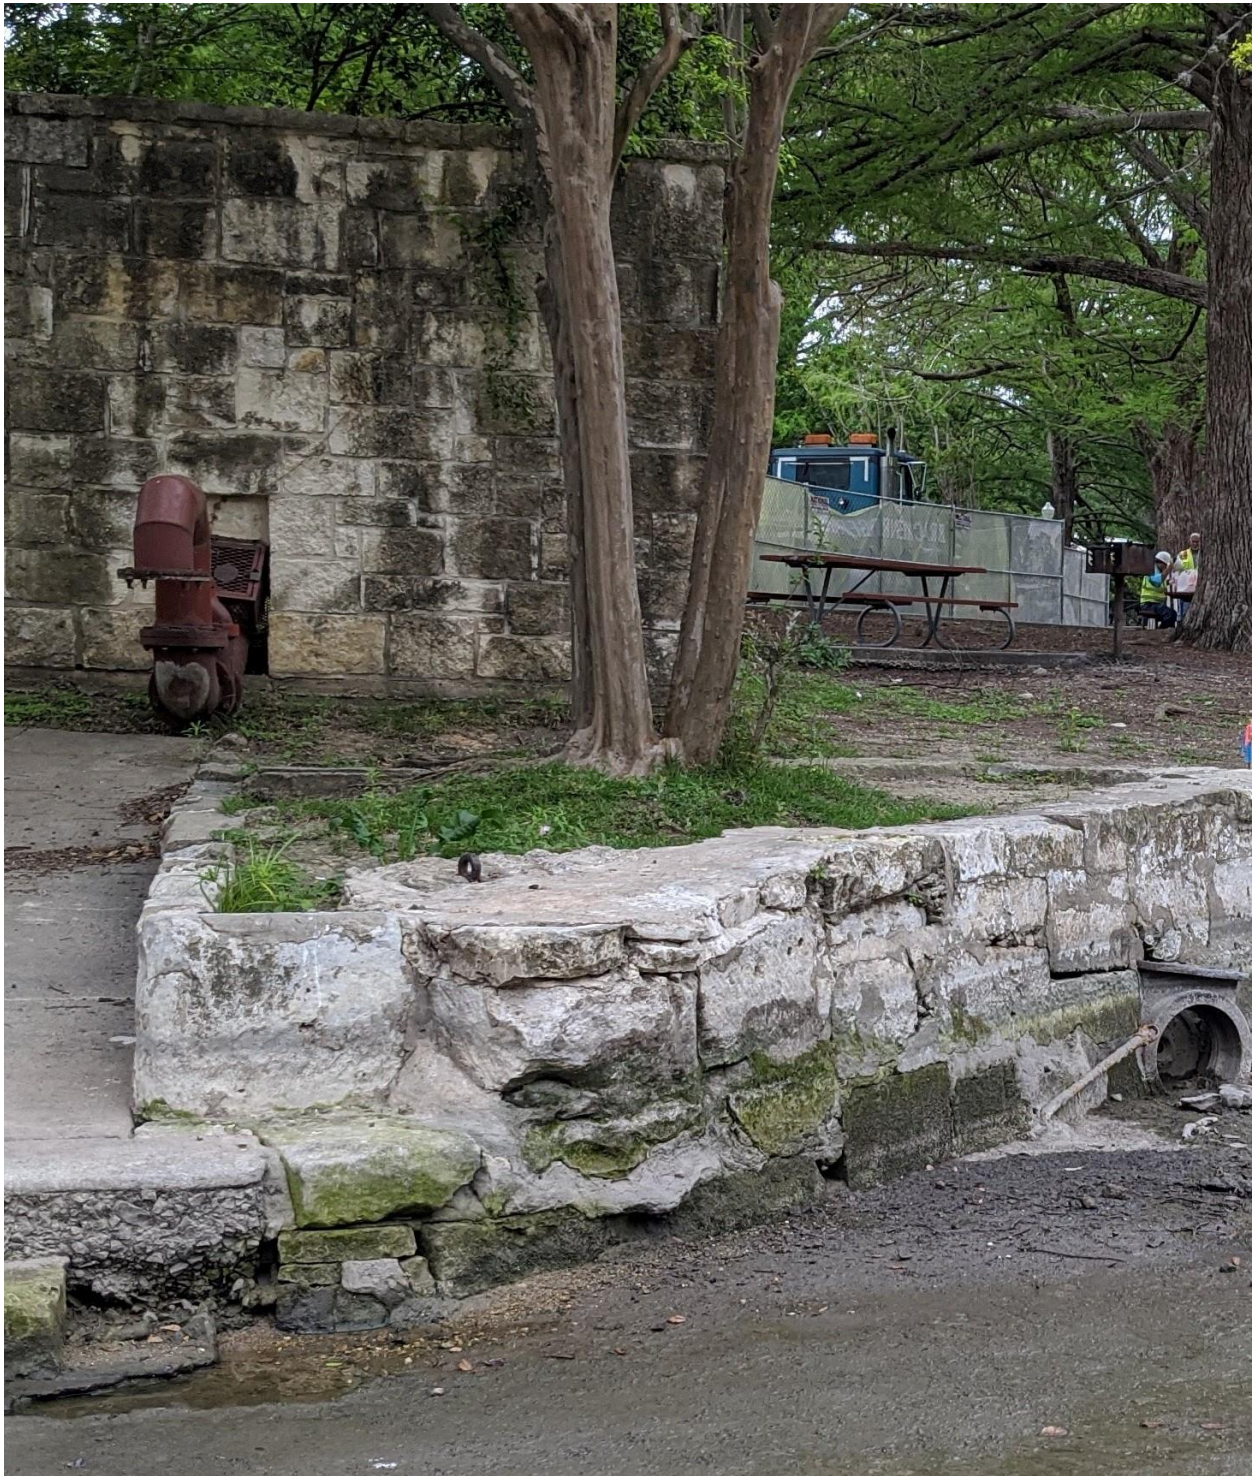
Figure 27: Tree No. 215, 19-inch Crepe Myrtle proposed to be removed. Proximity to Cultural Resources: Less than 3 feet.
