HISTORIC AND DESIGN REVIEW COMMISSION

April 19, 2023

HDRC CASE NO: 2022-091
COMMON NAME: Brackenridge Park, Lambert Beach
ADDRESS: 3700 N ST MARYS ST
LEGAL DESCRIPTION: NCB A49 PART OF A-2, A-4, A-52 (208 AC)
ZONING: R-6,HS
CITY COUNCIL DIST.: 2
LANDMARK: Individual Landmark
APPLICANT: Jamaal Moreno/City of San Antonio, PWD
OWNER: City of San Antonio
TYPE OF WORK: Phase 1 of FY17 Bond Improvements to Lambert Beach Area
APPLICATION RECEIVED: April 04, 2023
60-DAY REVIEW: Not applicable due to City Council emergency orders
CASE MANAGER: Cory Edwards
REQUEST:

The applicant is requesting a Certificate of Appropriateness for approval to construct improvements to the Lambert Beach area in Brackenridge Park as Phase I of the FY17 Bond Project. Request items include:

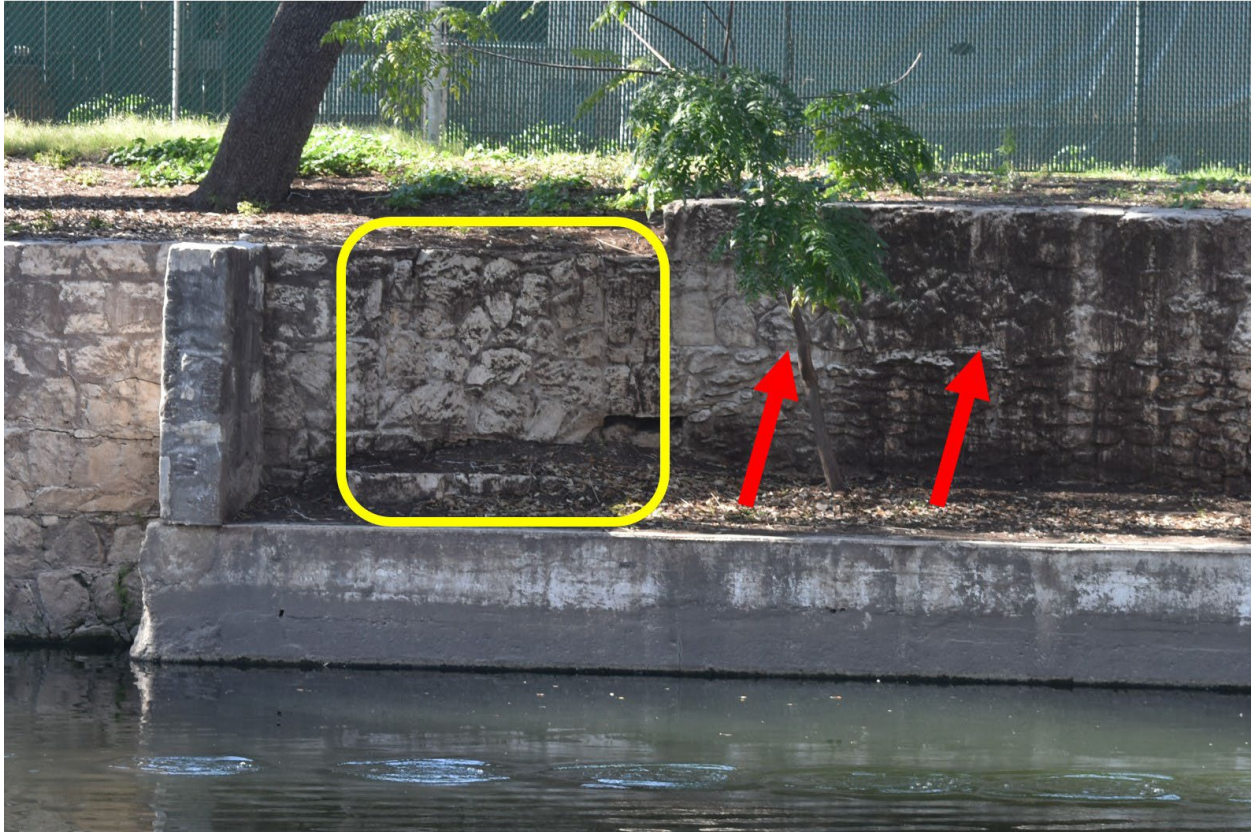
and filled (see Image 7, upper right), both at unknown times. An approximately 50-foot-long section of wall appears to have collapsed and the riverbank is held back by a temporary wood wall. Project-related construction documents indicate the two northernmost stairways extend into the river channel, but they are not visible above water. The river channel wall is constructed of concrete and appears to be in good condition. Modifications and the partial collapse of the riverbank retaining wall diminish its integrity of design and materials. Nevertheless, the resources retain sufficient physical and historical integrity under Criterion A in the area of Entertainment/Recreation for its association with the development and design of Brackenridge Park to communicate their historical significance. Their contributing status to the Brackenridge Park Historic District is affirmed.

Image 14. Resource B1-71/73 modifications as annotated by CMEC. Yellow area is the filled section corresponding with the staircase in Image 7 where bottom step is visible. Red arrows indicate where the wall's height has been raised. Photograph by CMEC, 2022.

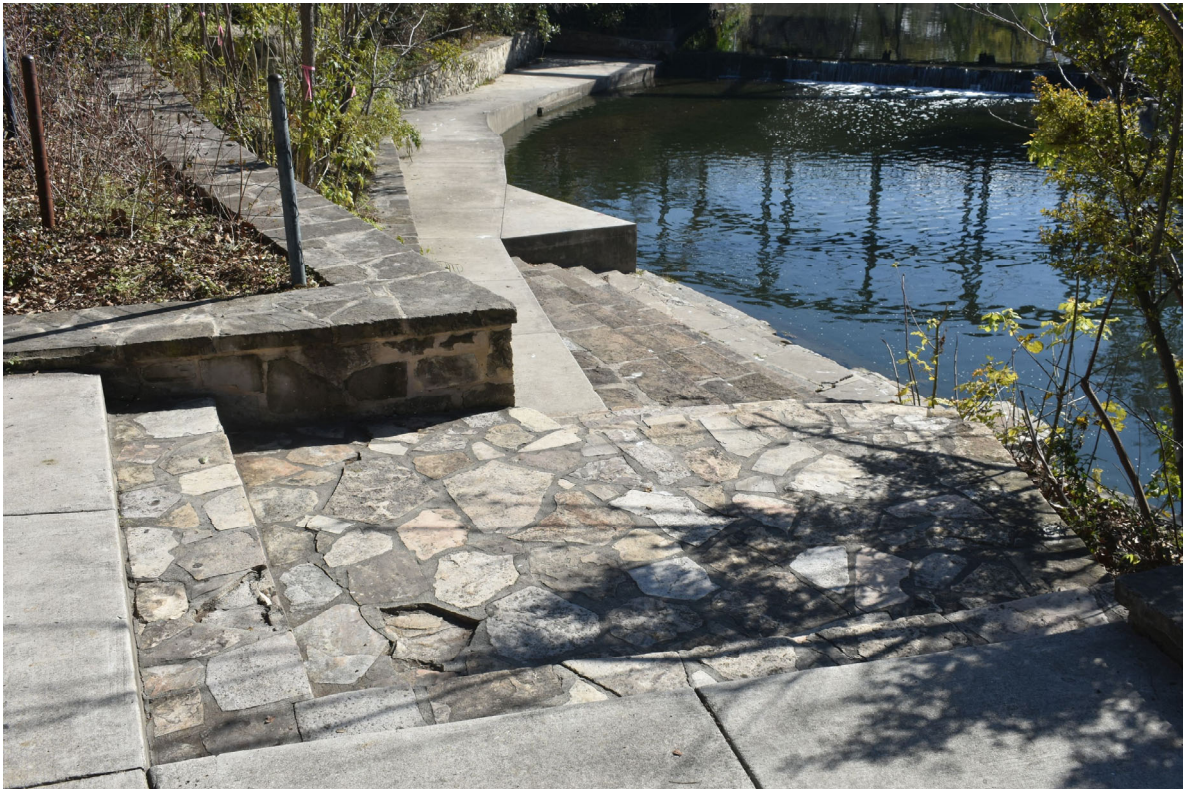
The staircase has experienced at least six phases of modification, one of which occurred outside the period of significance. These alterations diminish the resource's design integrity. In terms of Lambert Beach's entirety, the staircase and walkway are defining features that maintain strong relationships with the surrounding historic resources. Materials and workmanship of subsequent modifications and repair have been consistent with the original, and the facility is still actively used by park-goers, especially for recreational fishing. The resource retains sufficient integrity of location, setting, workmanship, feeling, and association to communicate its historical significance under Criterion A in the area of Entertainment/Recreation for its association with the development and design of Brackenridge Park to communicate its historical significance. Its contributing status to the Brackenridge Park Historic District is affirmed.

Development phases A, B,
and C; stone rubble platform
addition D, modified wall E,
modified walkway F, and
approximate extents of
submerged steps G; view
facing north

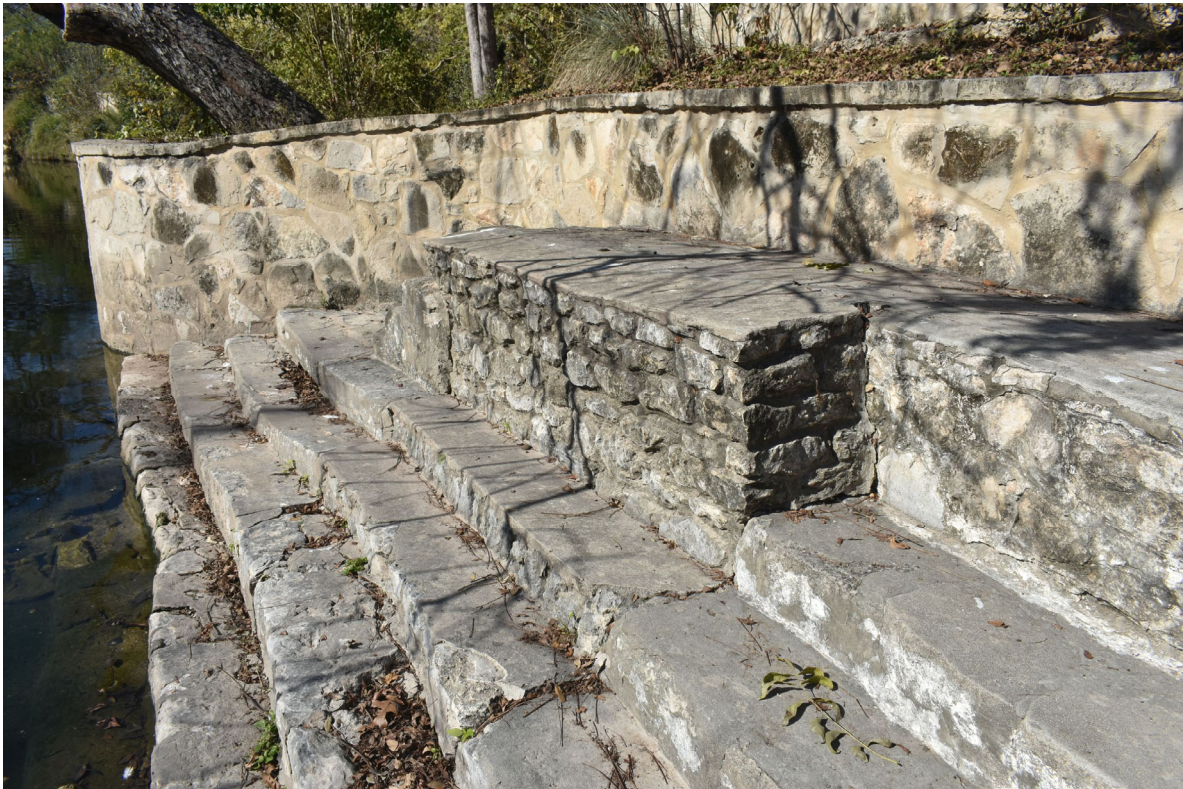
Detail of submerged steps (G) and concrete platform addition (F); view facing northwest

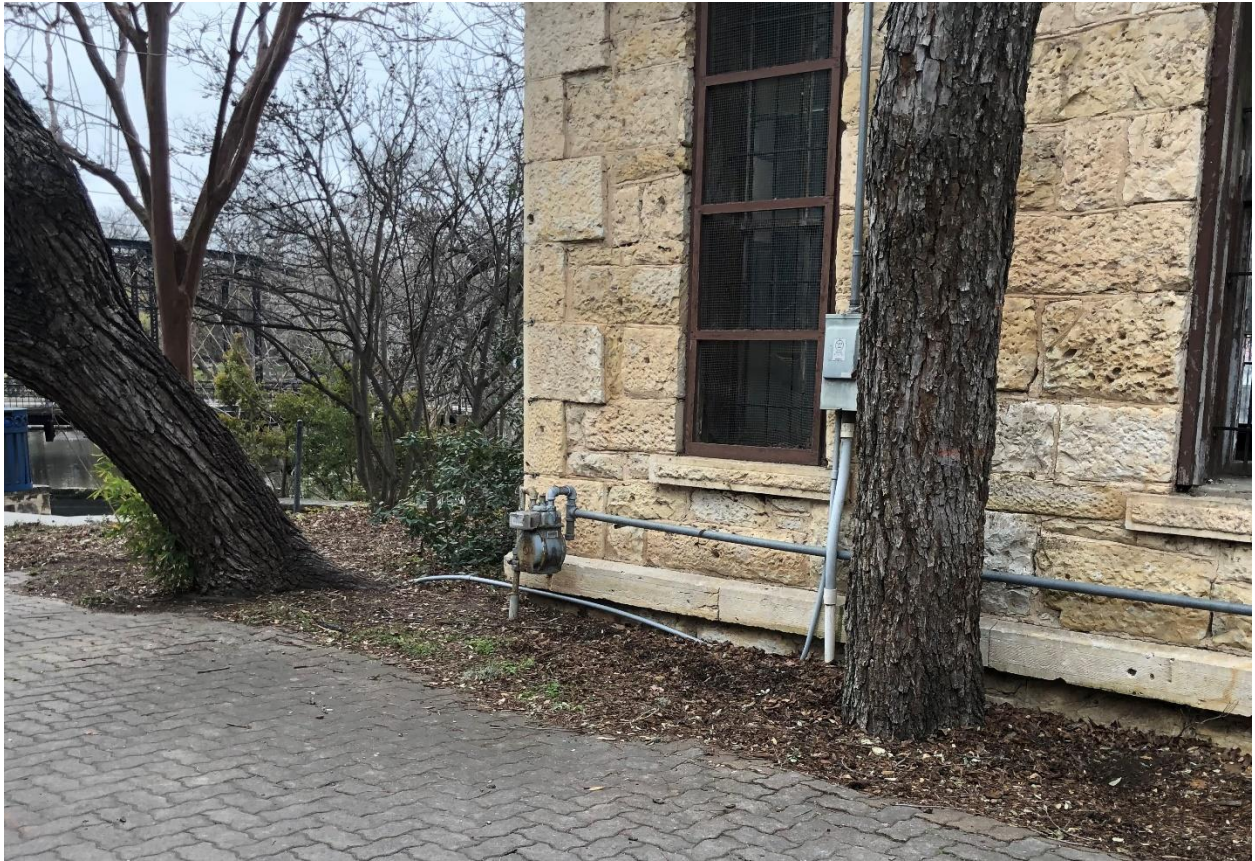
Figure 23: (L to R) Tree Nos. 108, 22-inch Black Walnut, and 107, 18-inch Black Walnut, both proposed to be removed. Proximity to Cultural Resource: 3 to less than 24 inches.
