HISTORIC AND DESIGN REVIEW COMMISSION

October 18, 2023

HDRC CASE NO:	2023-400
ADDRESS:	927 N OLIVE ST
LEGAL DESCRIPTION:	NCB 530 BLK 14 LOT E158. 33FT OF S 50FT OF A3 ARB A17 AT 927 N OLIVE
ZONING:	R-5, H
CITY COUNCIL DIST.:	2
DISTRICT:	Dignowity Hill Historic District
APPLICANT:	arturo lopez/A.L.E trucking
OWNER:	arturo lopez/A.L.E trucking
TYPE OF WORK:	Porch column modification
APPLICATION RECEIVED:	September 21, 2023
60-DAY REVIEW:	November 20, 2023
CASE MANAGER:	Claudia Espinosa

The applicant is requesting a Certificate of Appropriateness for approval to clad the existing wooden columns, capitals, and base with 1x8 softwood boards.

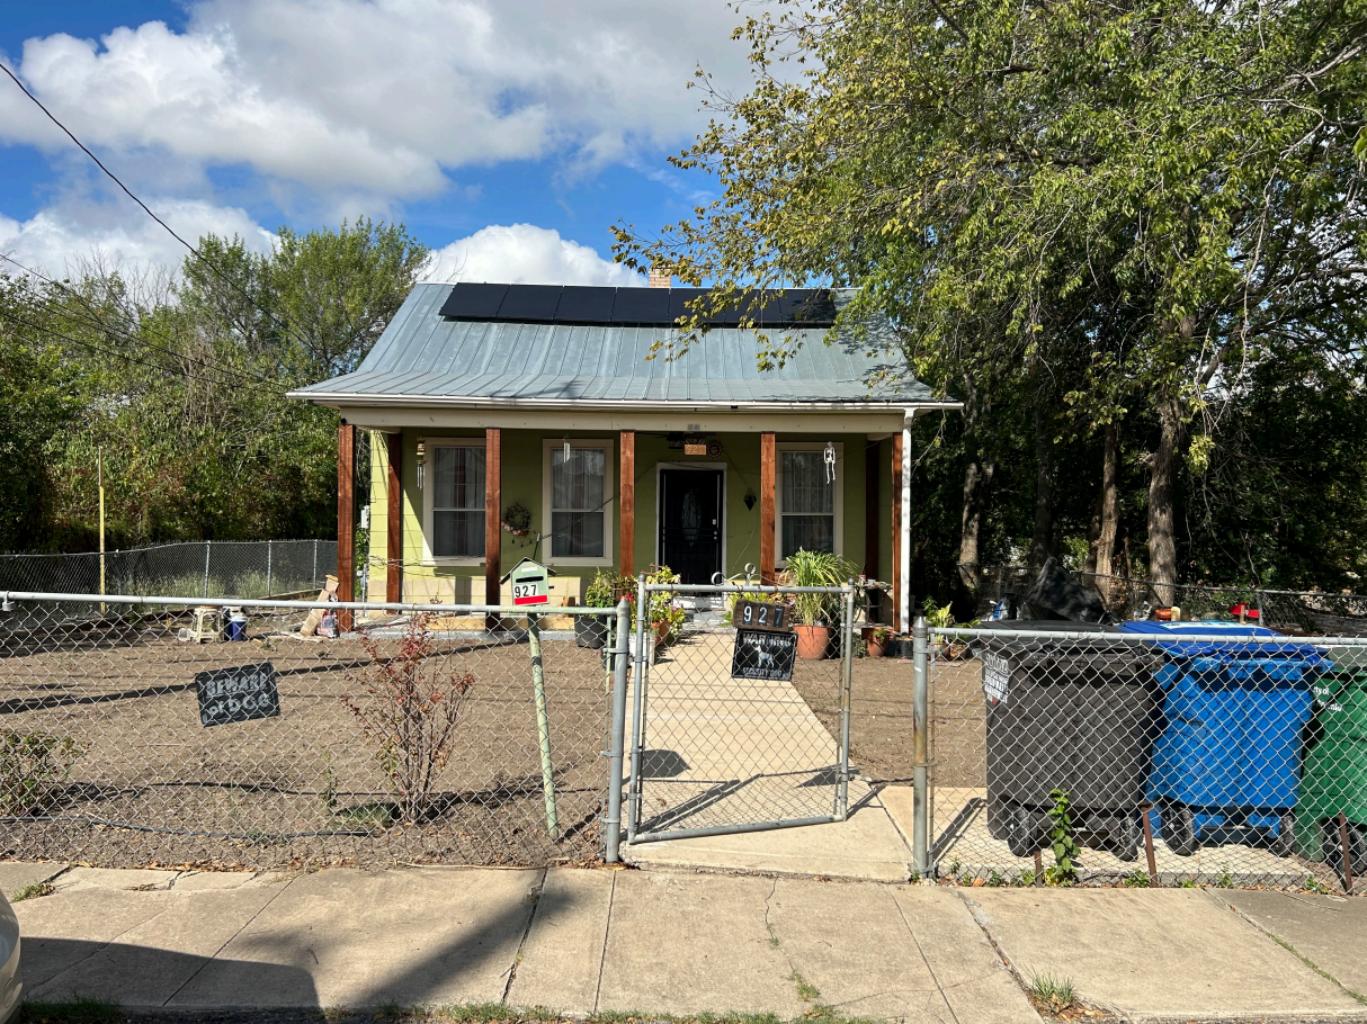
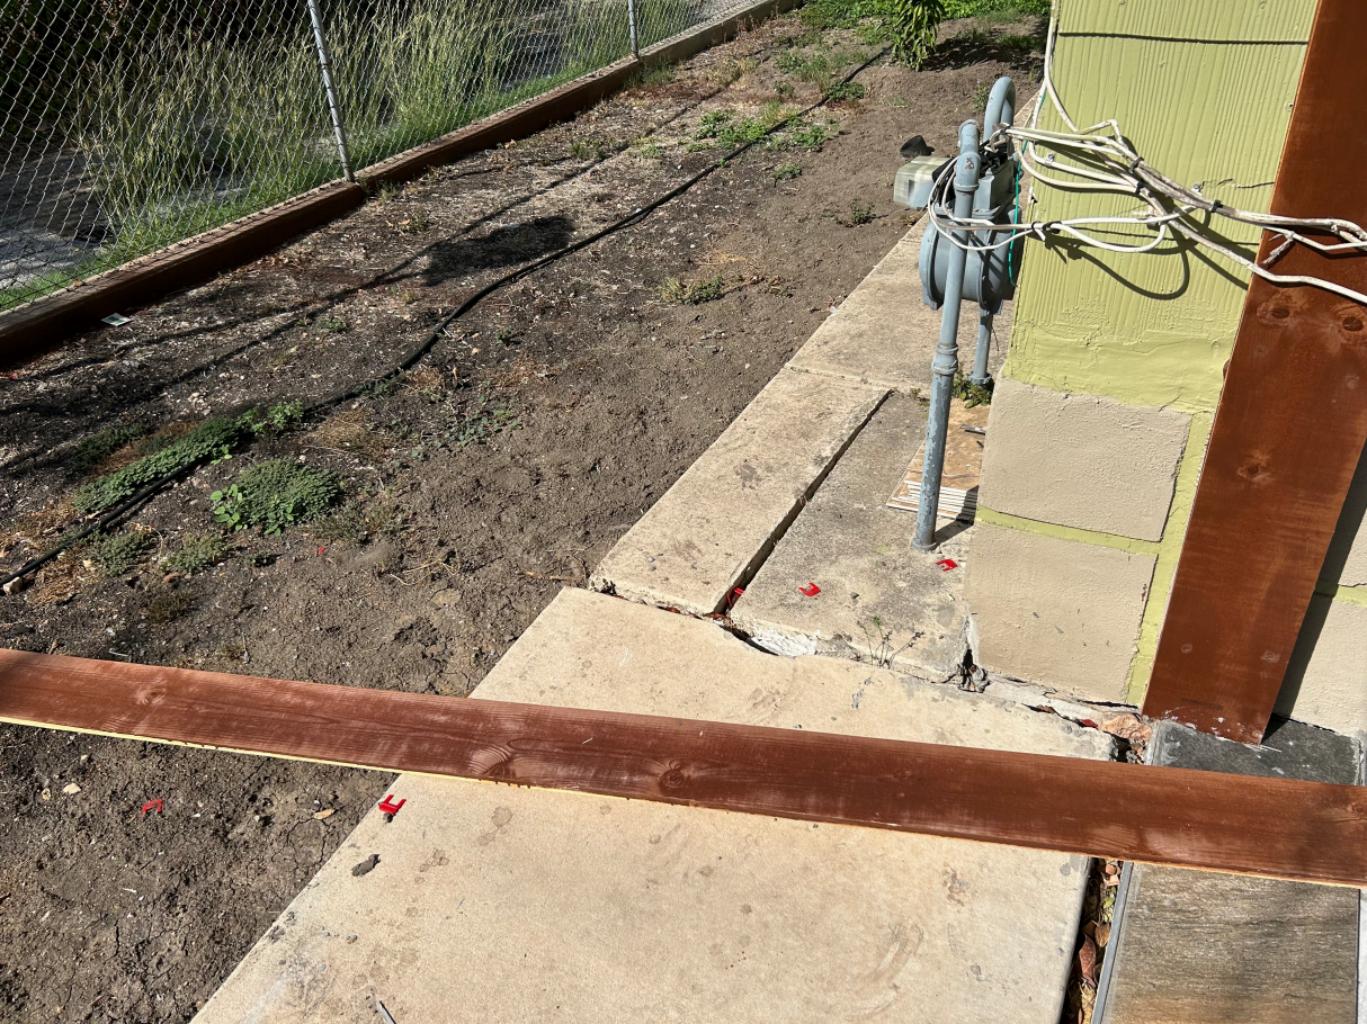
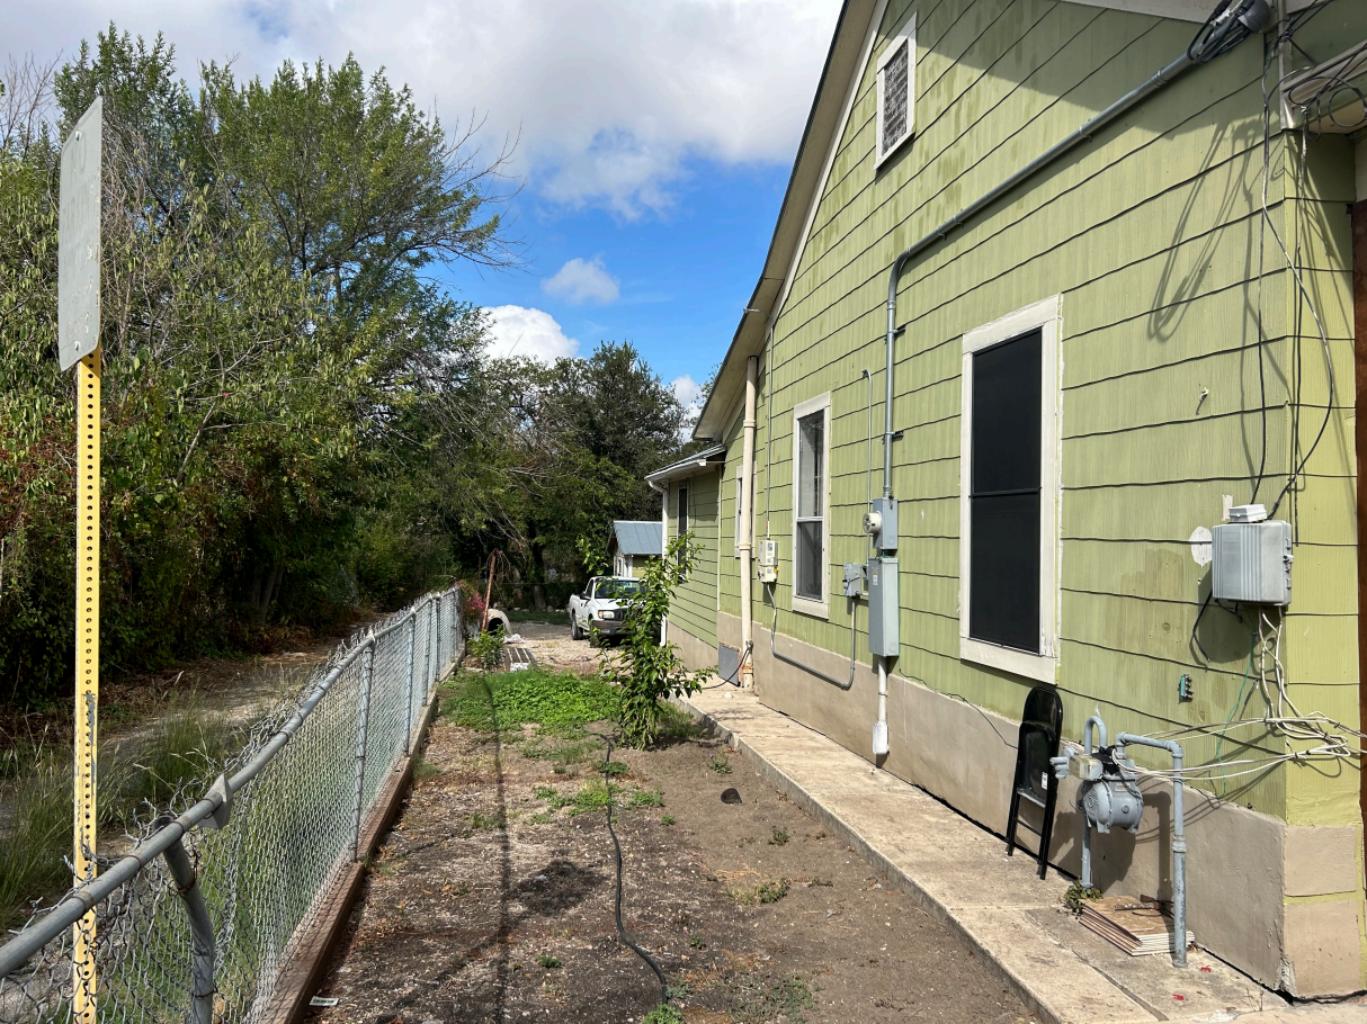
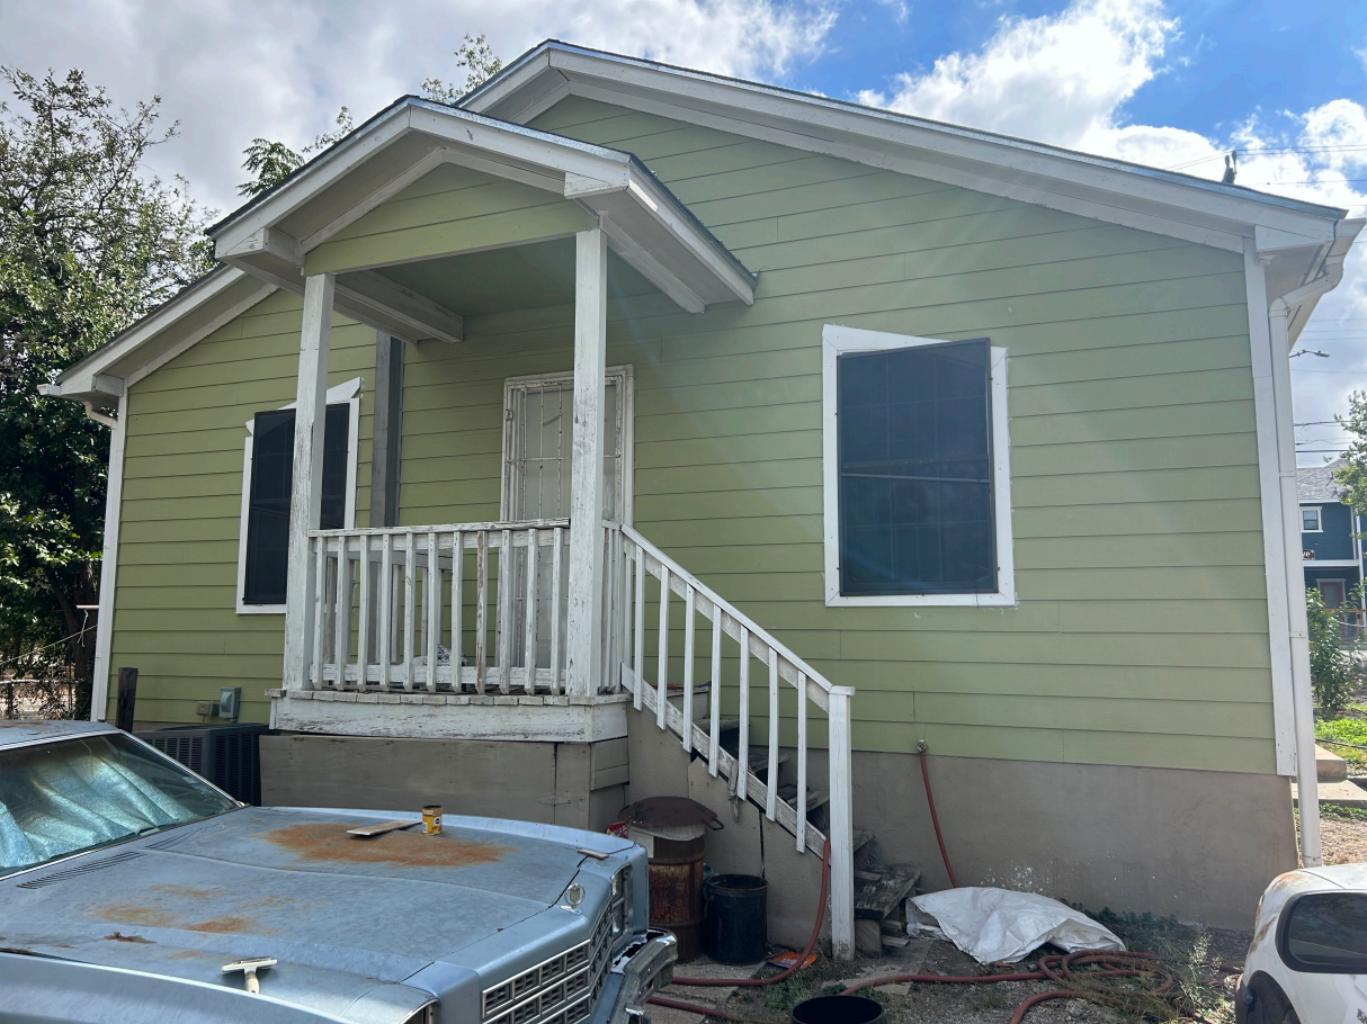
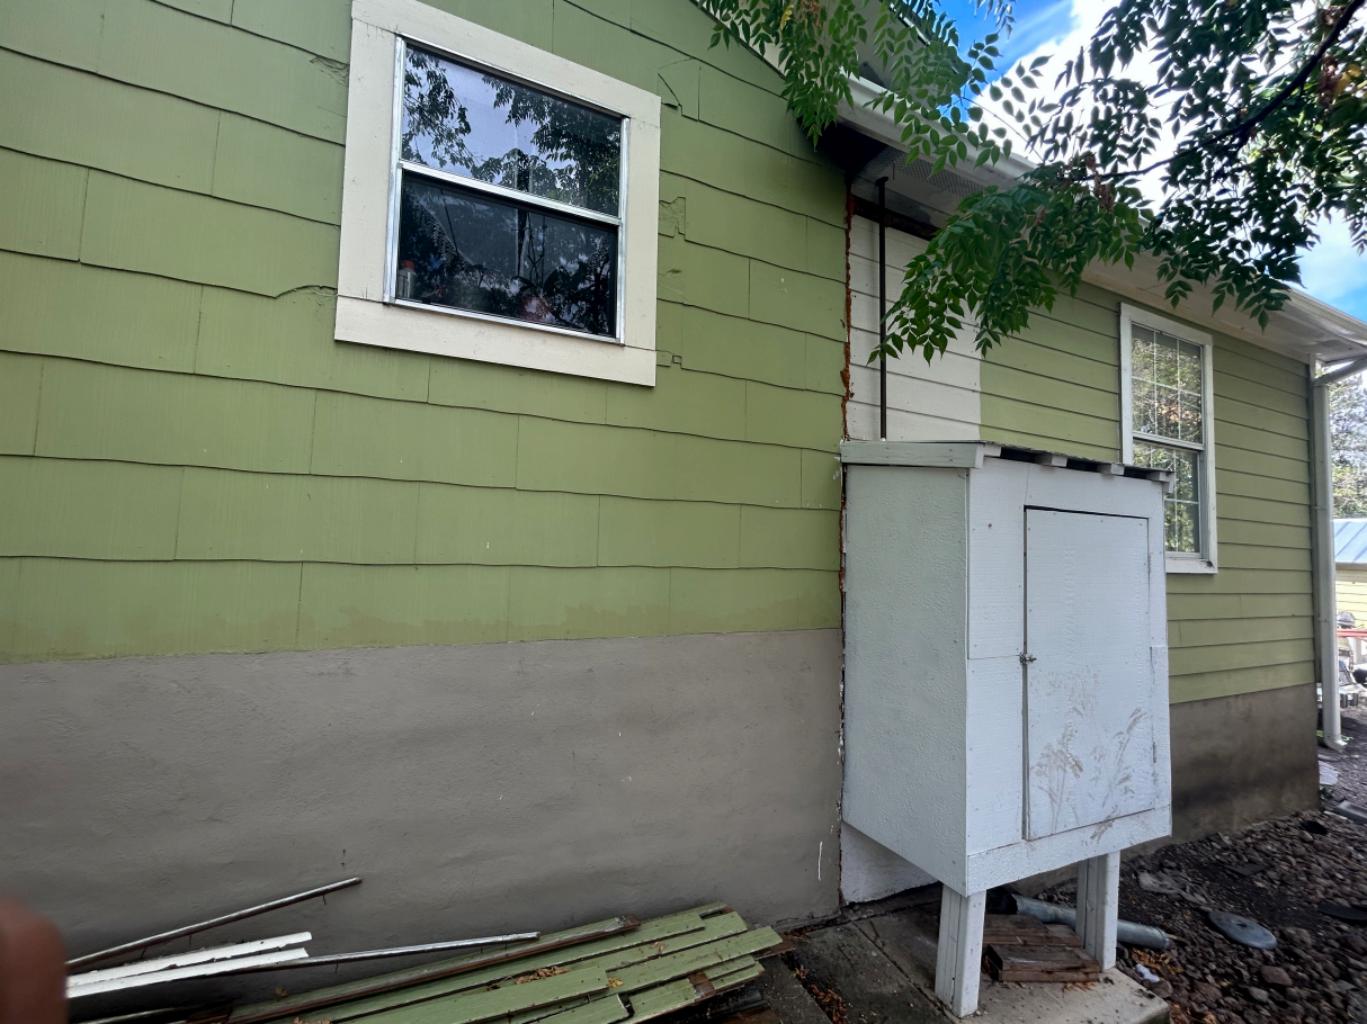
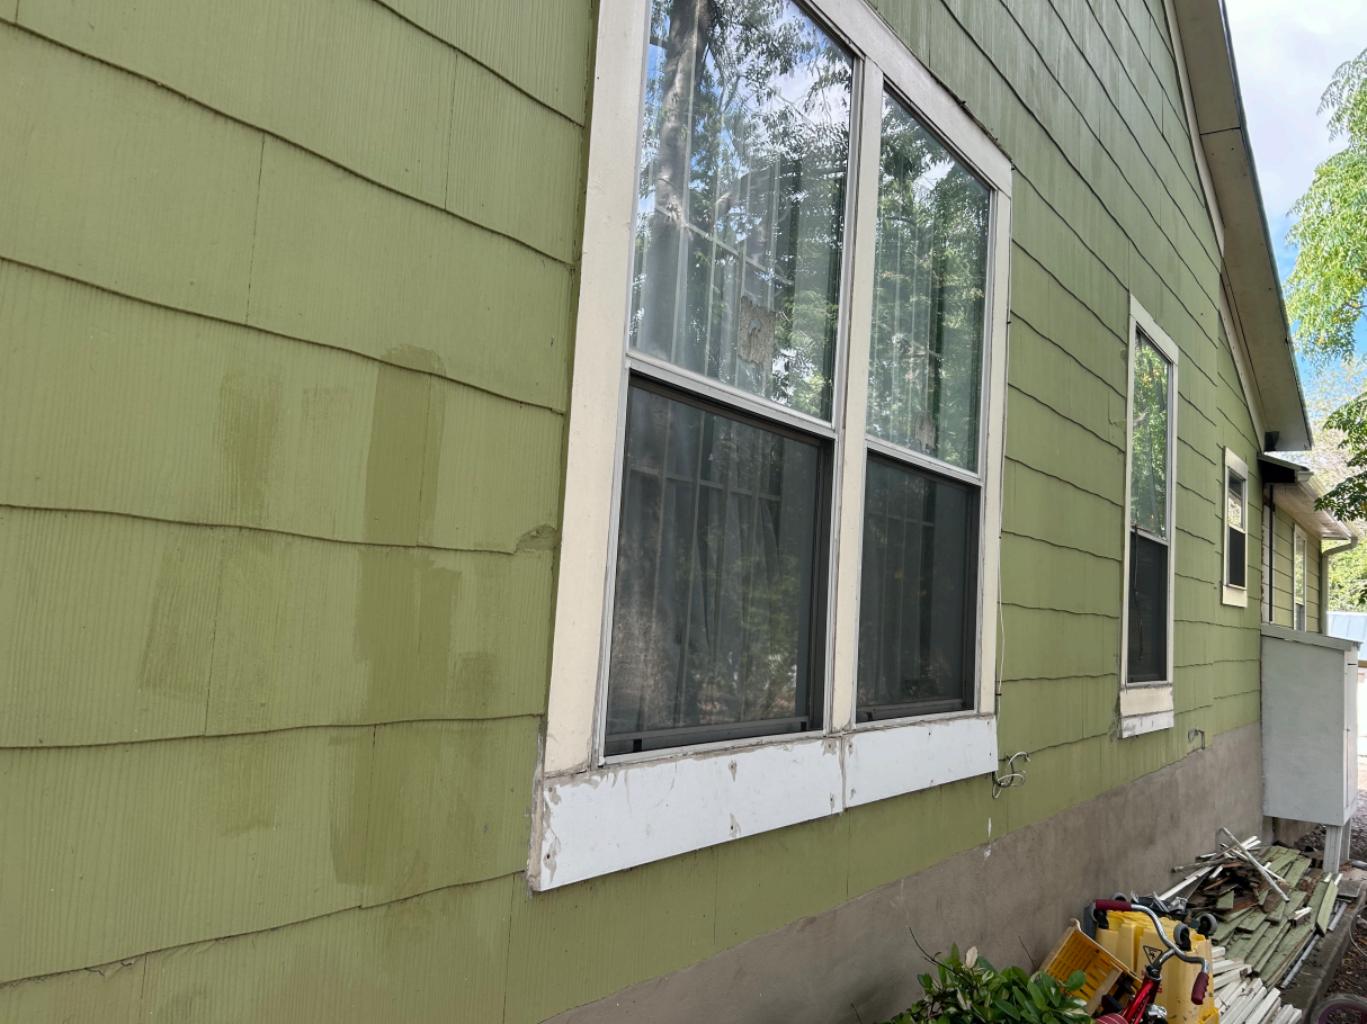
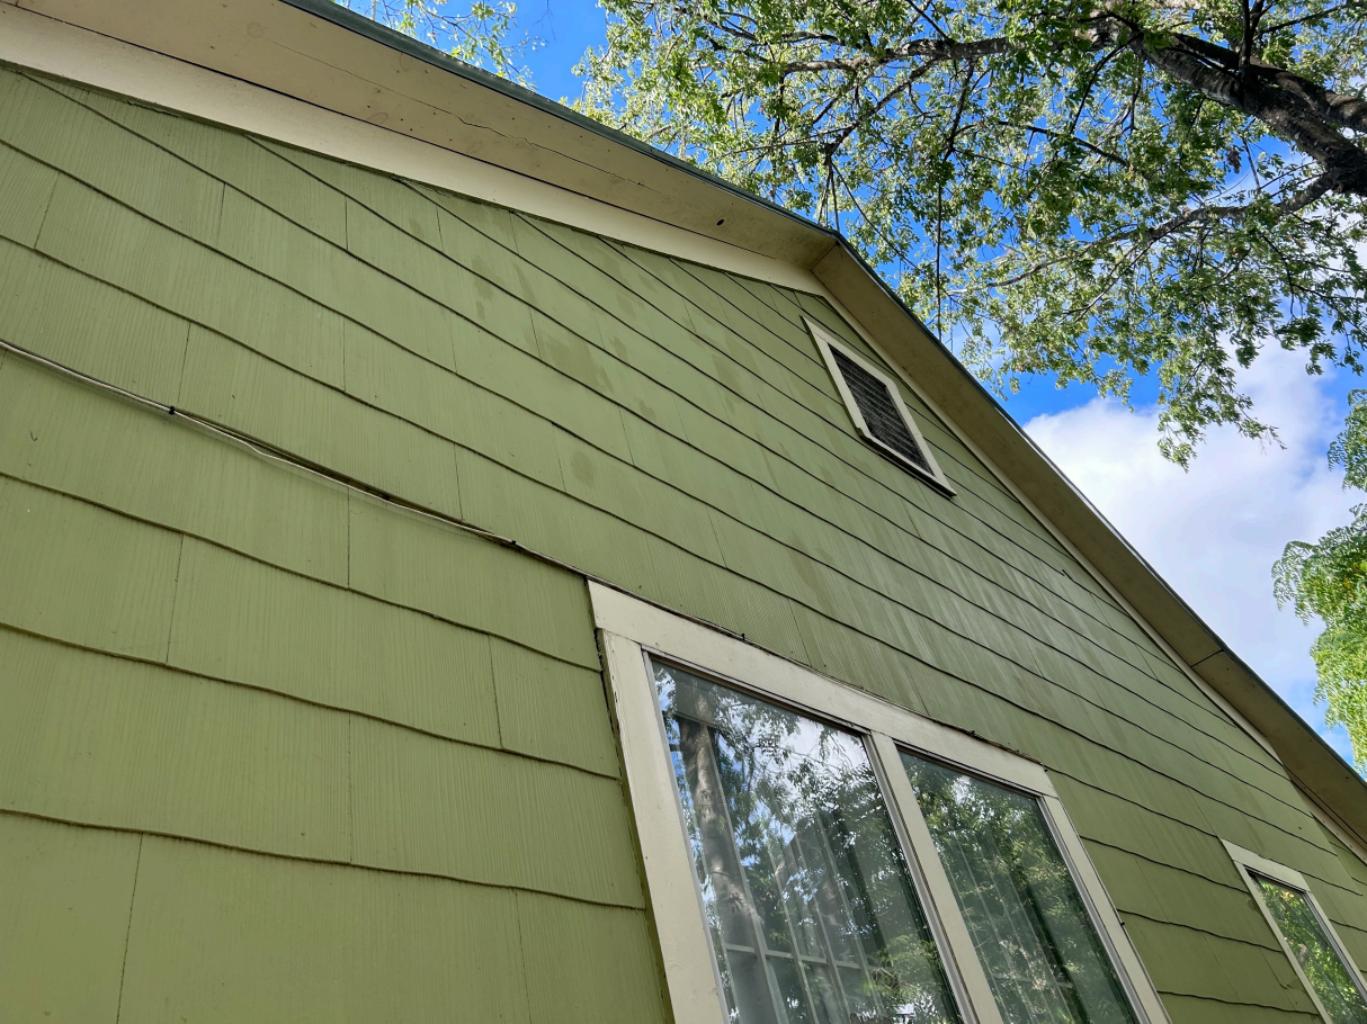
- b. PORCH MODIFICATIONS – The applicant has proposed to wrap the existing columns with 1x8 softwood boards (photos submitted indicate a very thin veneer being added.) According to the Historic Design Guidelines, porches should be reconstructed based on accurate evidence of the original, such as photographs. If no such evidence exists, the design should be based on the architectural style of the building and historic patterns. The proposed column modification is appropriate in terms of materials, but do not conform to the Guidelines which require a traditional column base and cap as well as chamfered corners.

Staff does not recommend approval of the porch column modifications based on finding b. Staff recommends that the applicant install a replacement column that meets the Guidelines with the following stipulations: The proposed wood columns should be no wider than 6" square, feature both capital and base trim and chamfered corners.
