HISTORIC AND DESIGN REVIEW COMMISSION

HDRC CASE NO: 2023-327
ADDRESS: 1023 N PINE ST
LEGAL DESCRIPTION: NCB 522 BLK 15 LOT 1 TO 18
ZONING: RM-4, H
CITY COUNCIL DIST.: 2
DISTRICT: Dignowity Hill Historic District
APPLICANT: Brian Sowell/WestEast Design Group, LLC
OWNER: Cathleen Crabb/CITY OF SAN ANTONIO
TYPE OF WORK: Demolition of one (1) structure and conceptual review of schematic replacement plans
APPLICATION RECEIVED: October 11, 2023
60-DAY REVIEW: December 2, 2023
CASE MANAGER: Rachel Rettaliata

1. A Certificate of Appropriateness for approval to demolish one (1) structure at the Ella Austin campus.
2. Conceptual approval of schematic replacement plans.

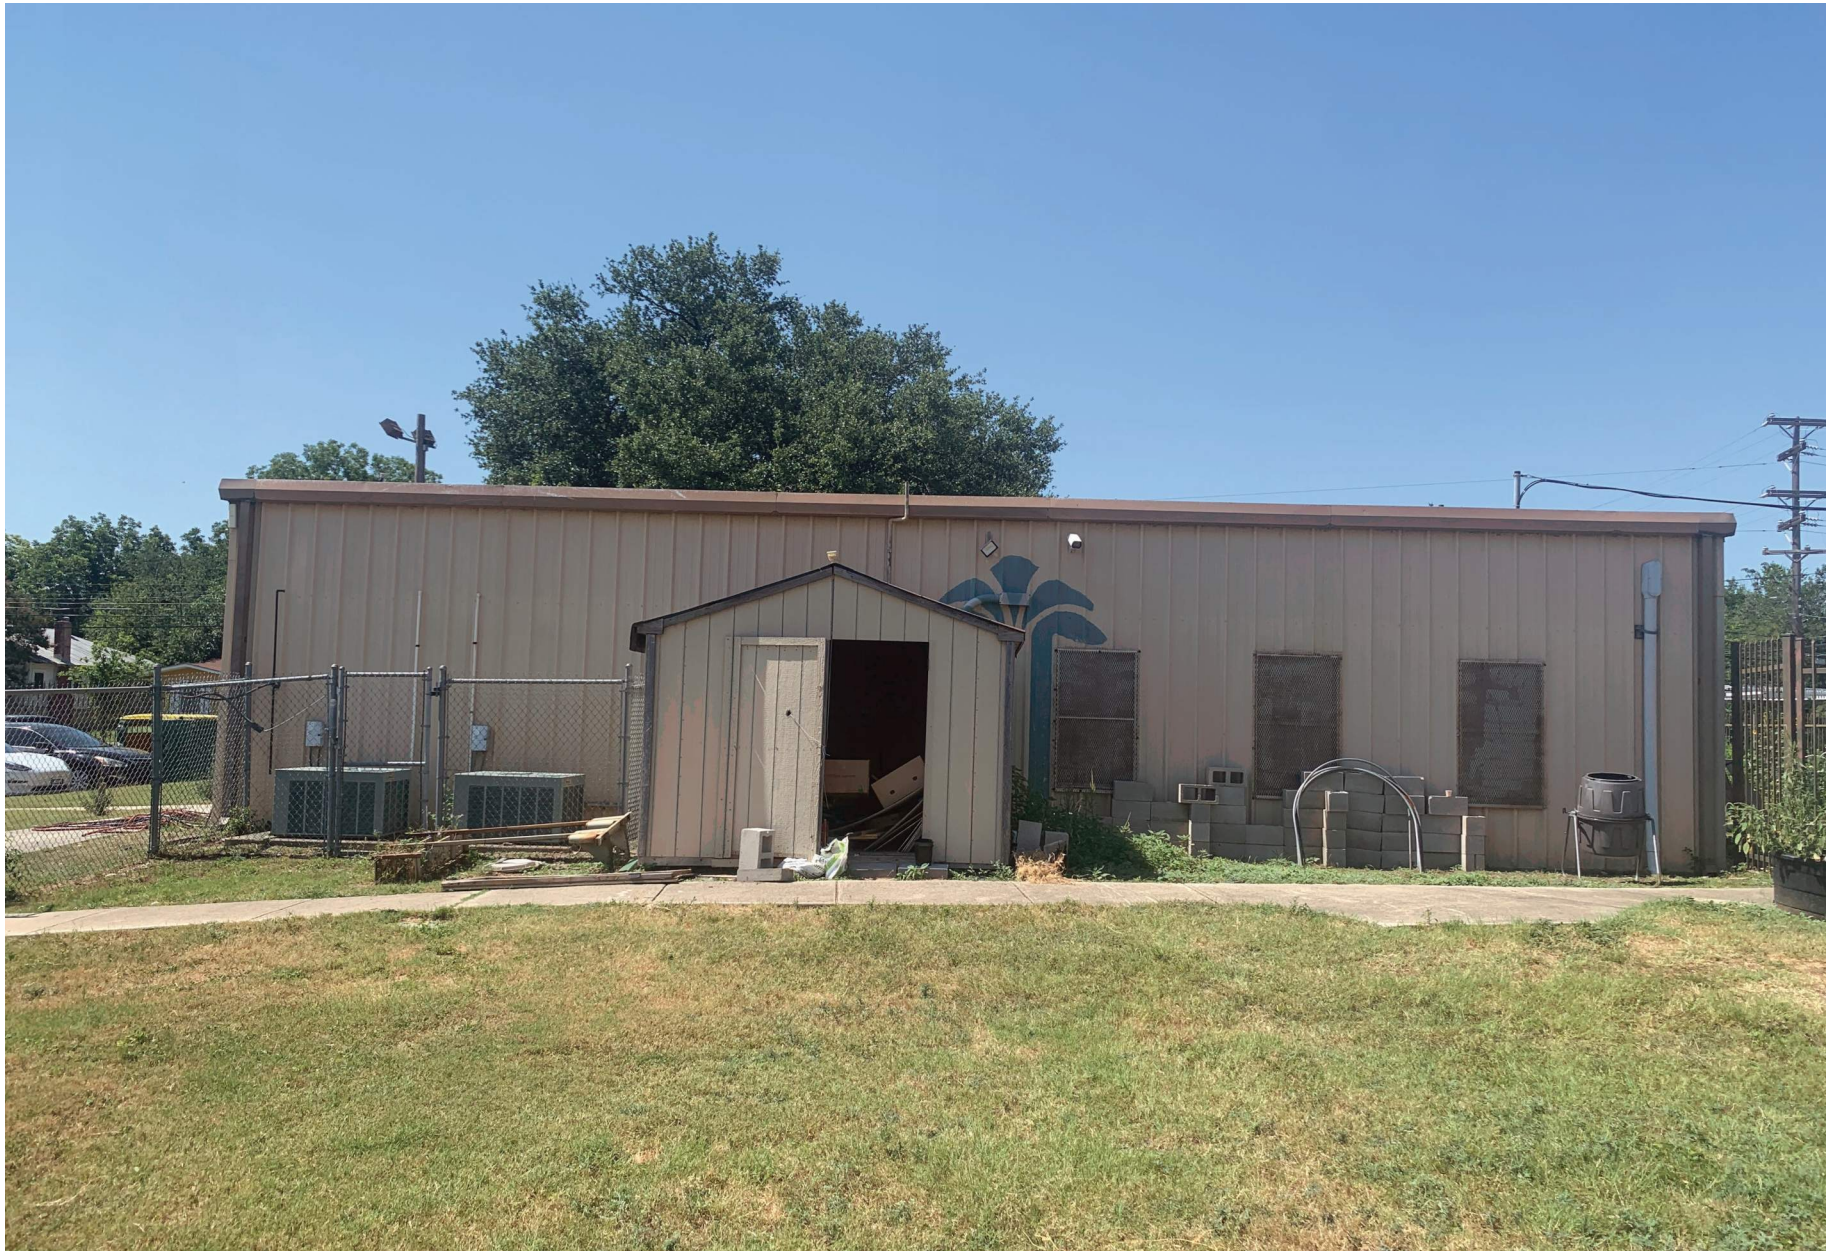
- Proposed demolition includes adjacent storage shed
- Significant infrastructural issues including leaks & electrical problems

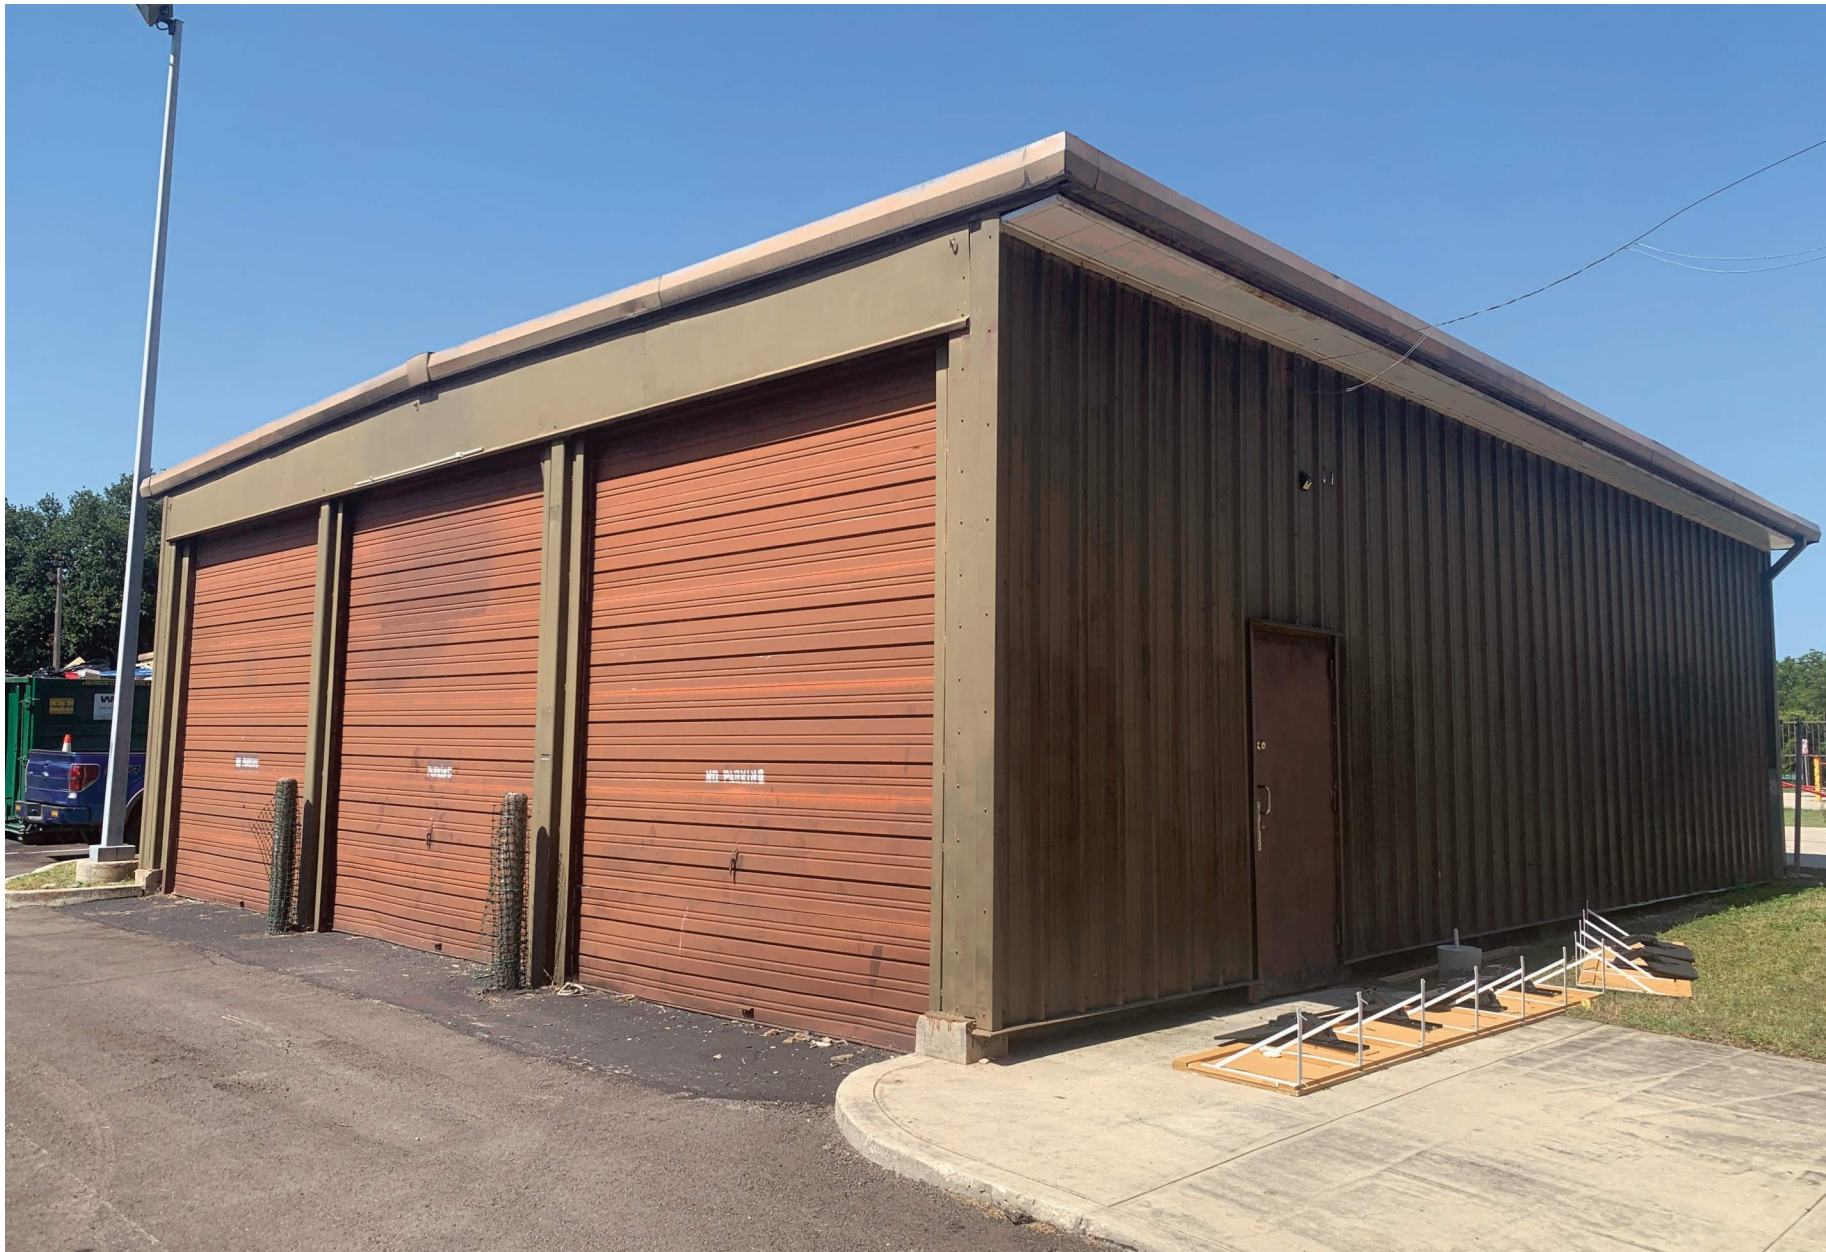
~1985 Storage

- Pre-engineered metal building located South of the Gymnasium.
- Aerial images suggest the building was constructed in 1985
- The storage building suffers from infrastructural issues including significant leaks.
- Significant corrosion is visible on structural supports

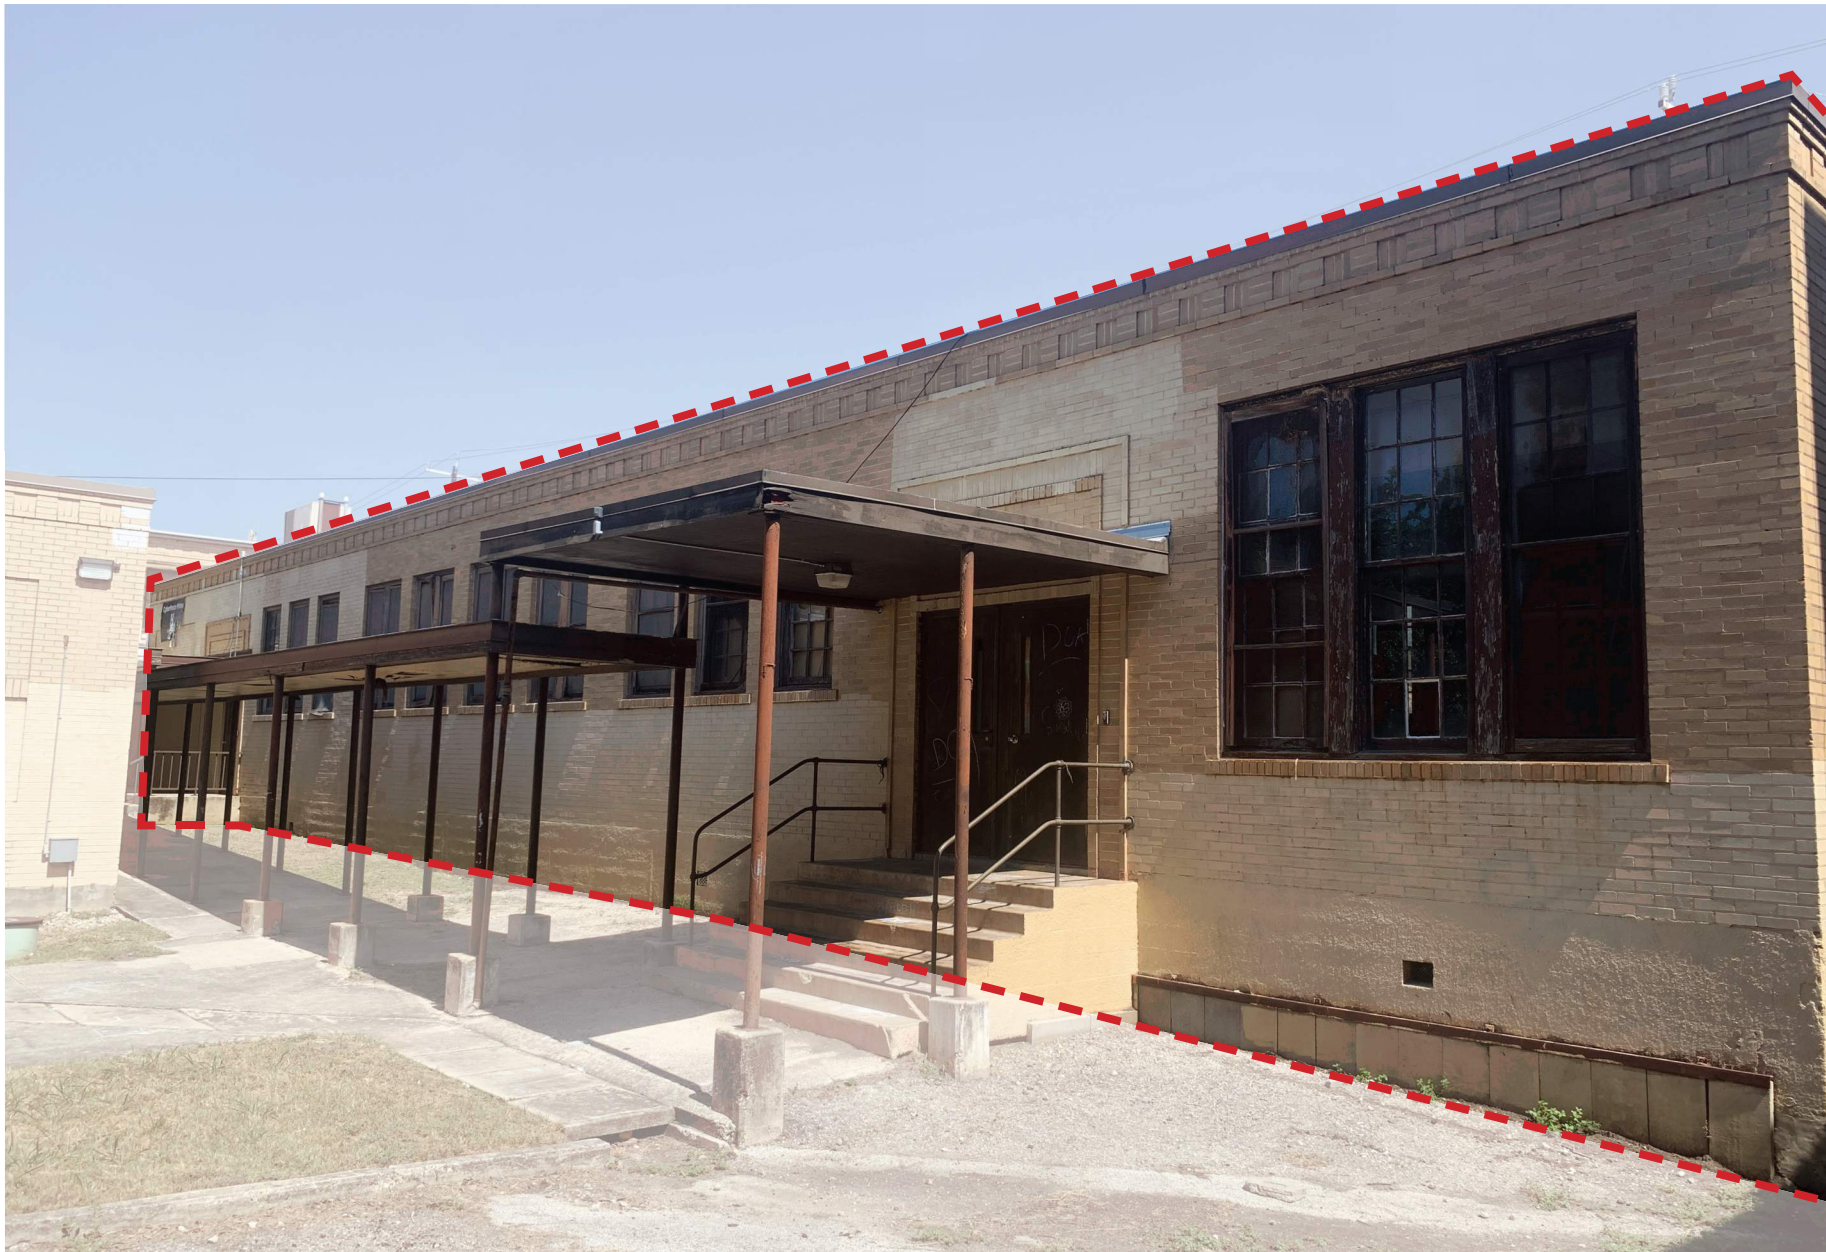
- The building exhibits some of the worst structural degradation on the entire site.
- A structural engineer's assessment identified significant settling and damage to the existing foundations and slab due to water migration
- Heaving and drops in the sub grade have created valleys in the floor slab exceeding a 2" differential.
- The foundation cannot be salvaged and must be replaced to make the building usable.

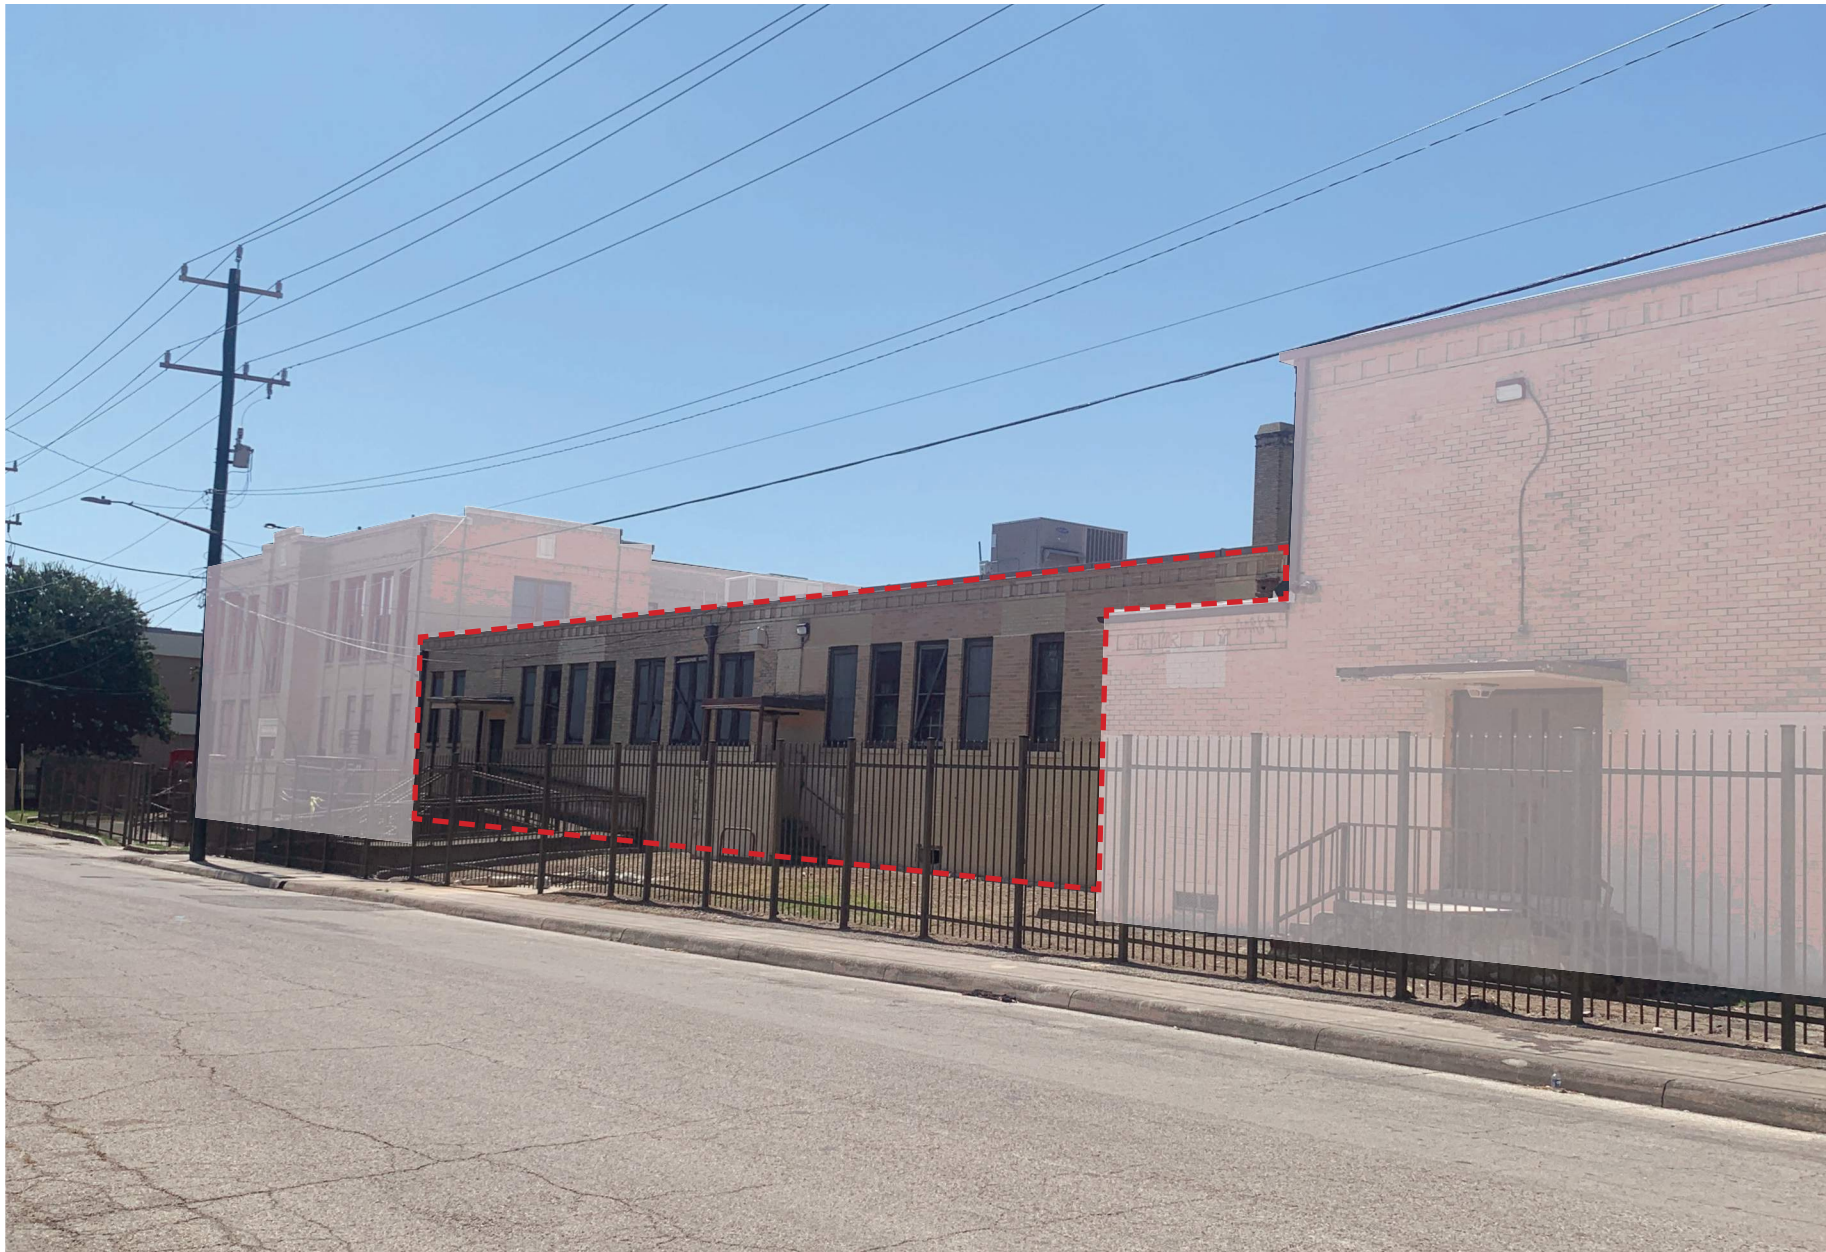
- In addition to foundation issues, the engineer's report identified corrosion on the roof deck and joists due to leaks. The report suggests the entire roof structure will have to be replaced.
- In addition to structural issues, all of the windows on the building require repair or replacement as they have succumbed to rot and damage.
- The brickwork requires significant cleaning and repointing

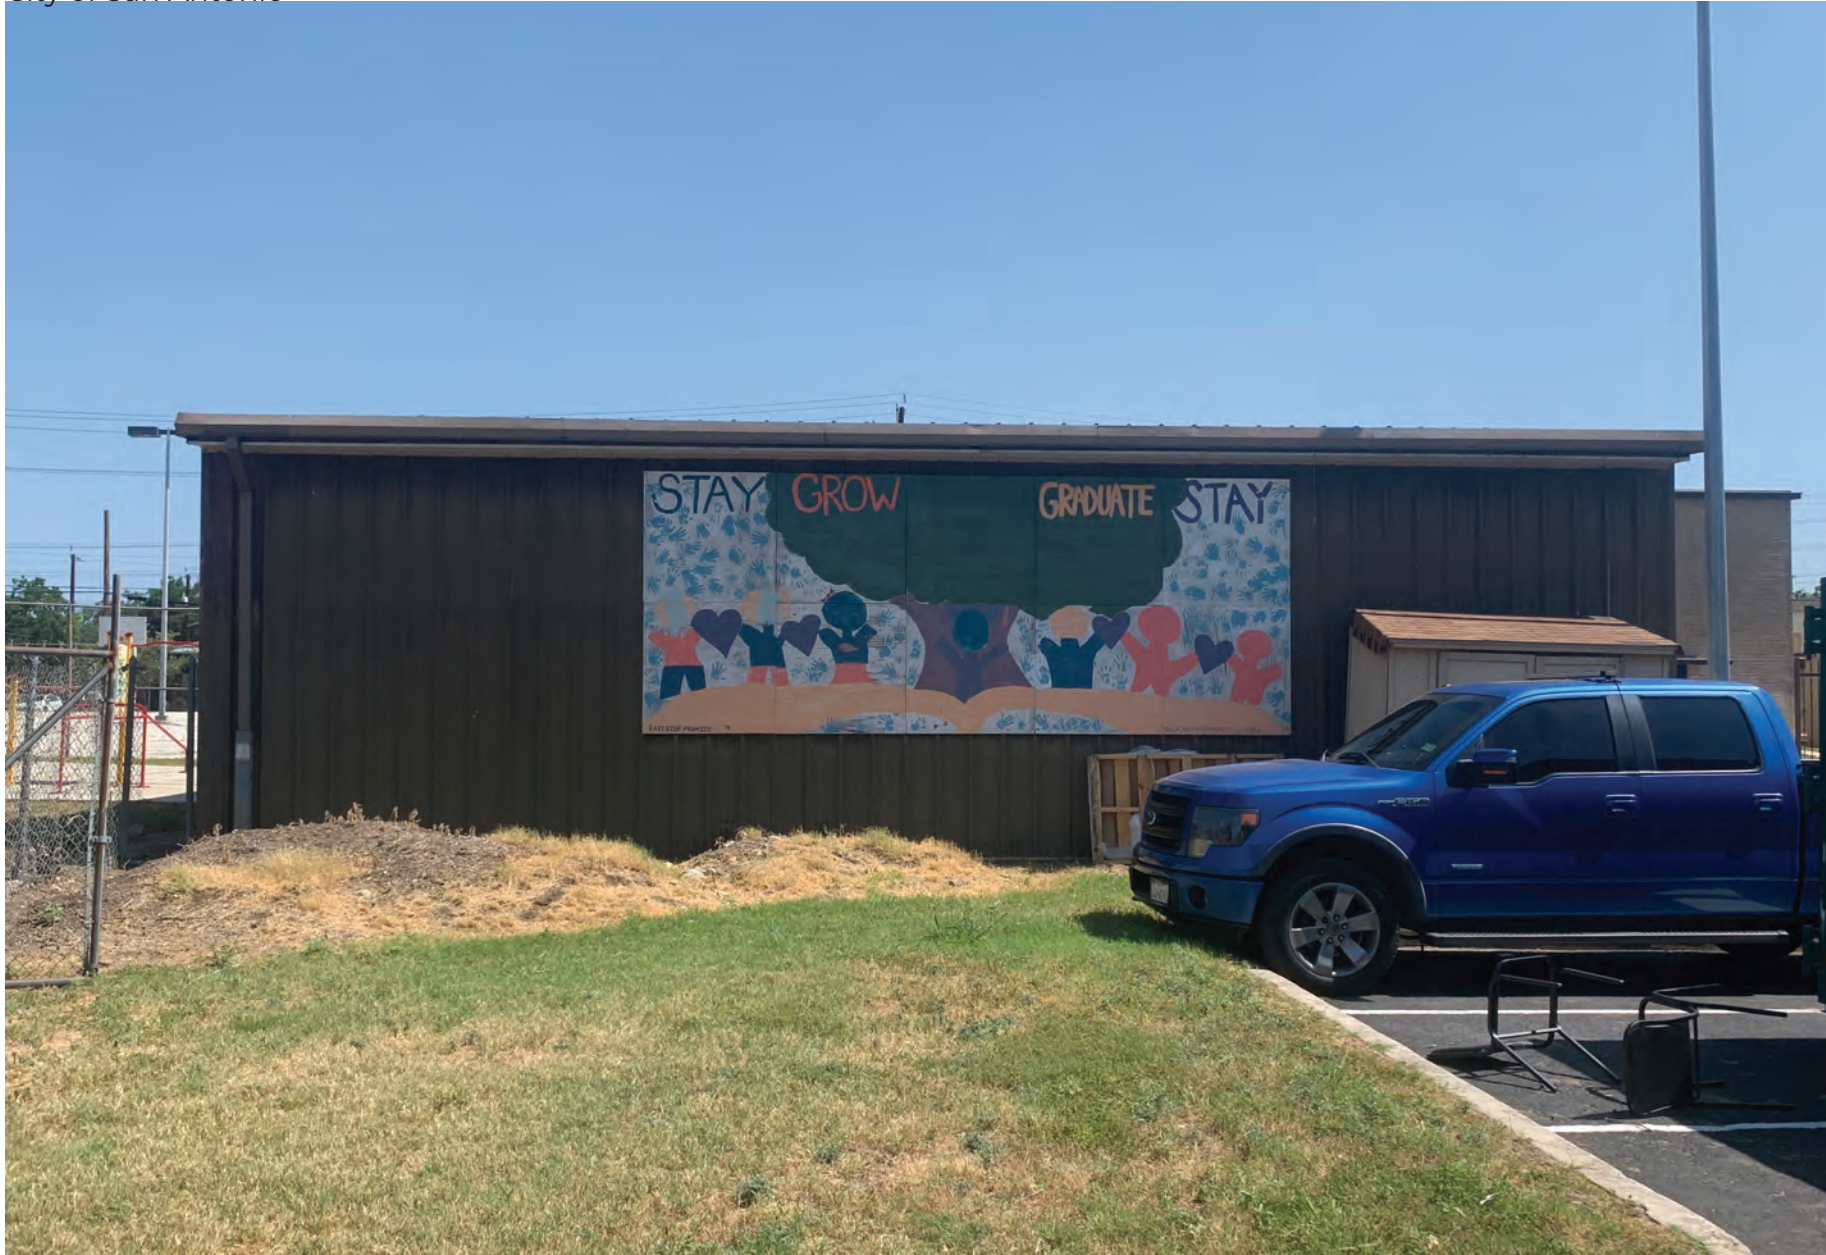
Site Storage (Circa 1985)

- Rusting is apparent throughout the structure as the result of significant leaks, and the building has reached the end of its servicable life.

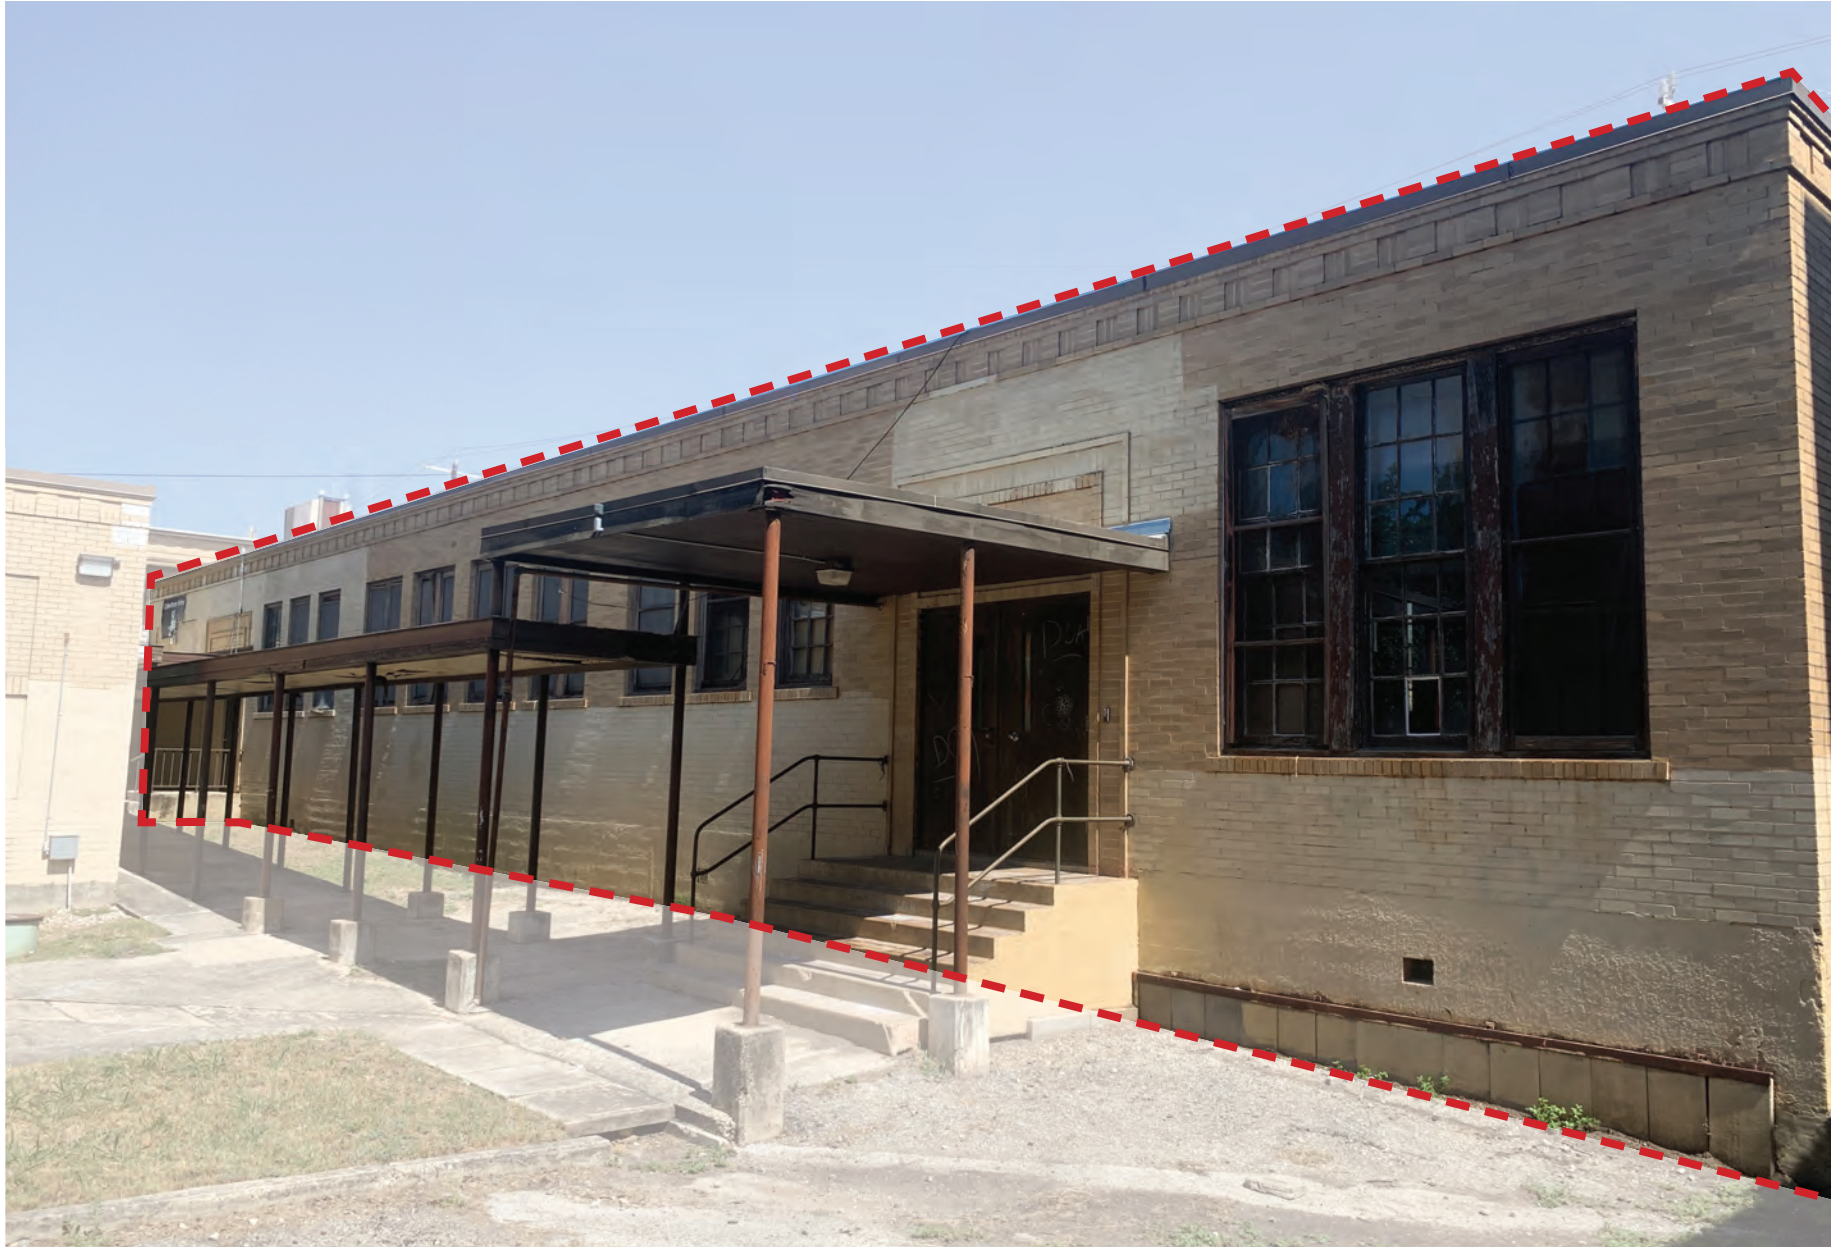
Physical Culture Building (Gym Annex)

An assessment of the structure was performed by a structural engineer, who produced their findings in a report dated May 19th, 2023. In the report, the Structural Engineer identified significant settling and damage to the existing foundation and slab due to water migration under the slab, creating valleys in the floor slab with differentials exceeding 2".

The foundation cannot be salvaged and must be replaced in order to make the building usable.

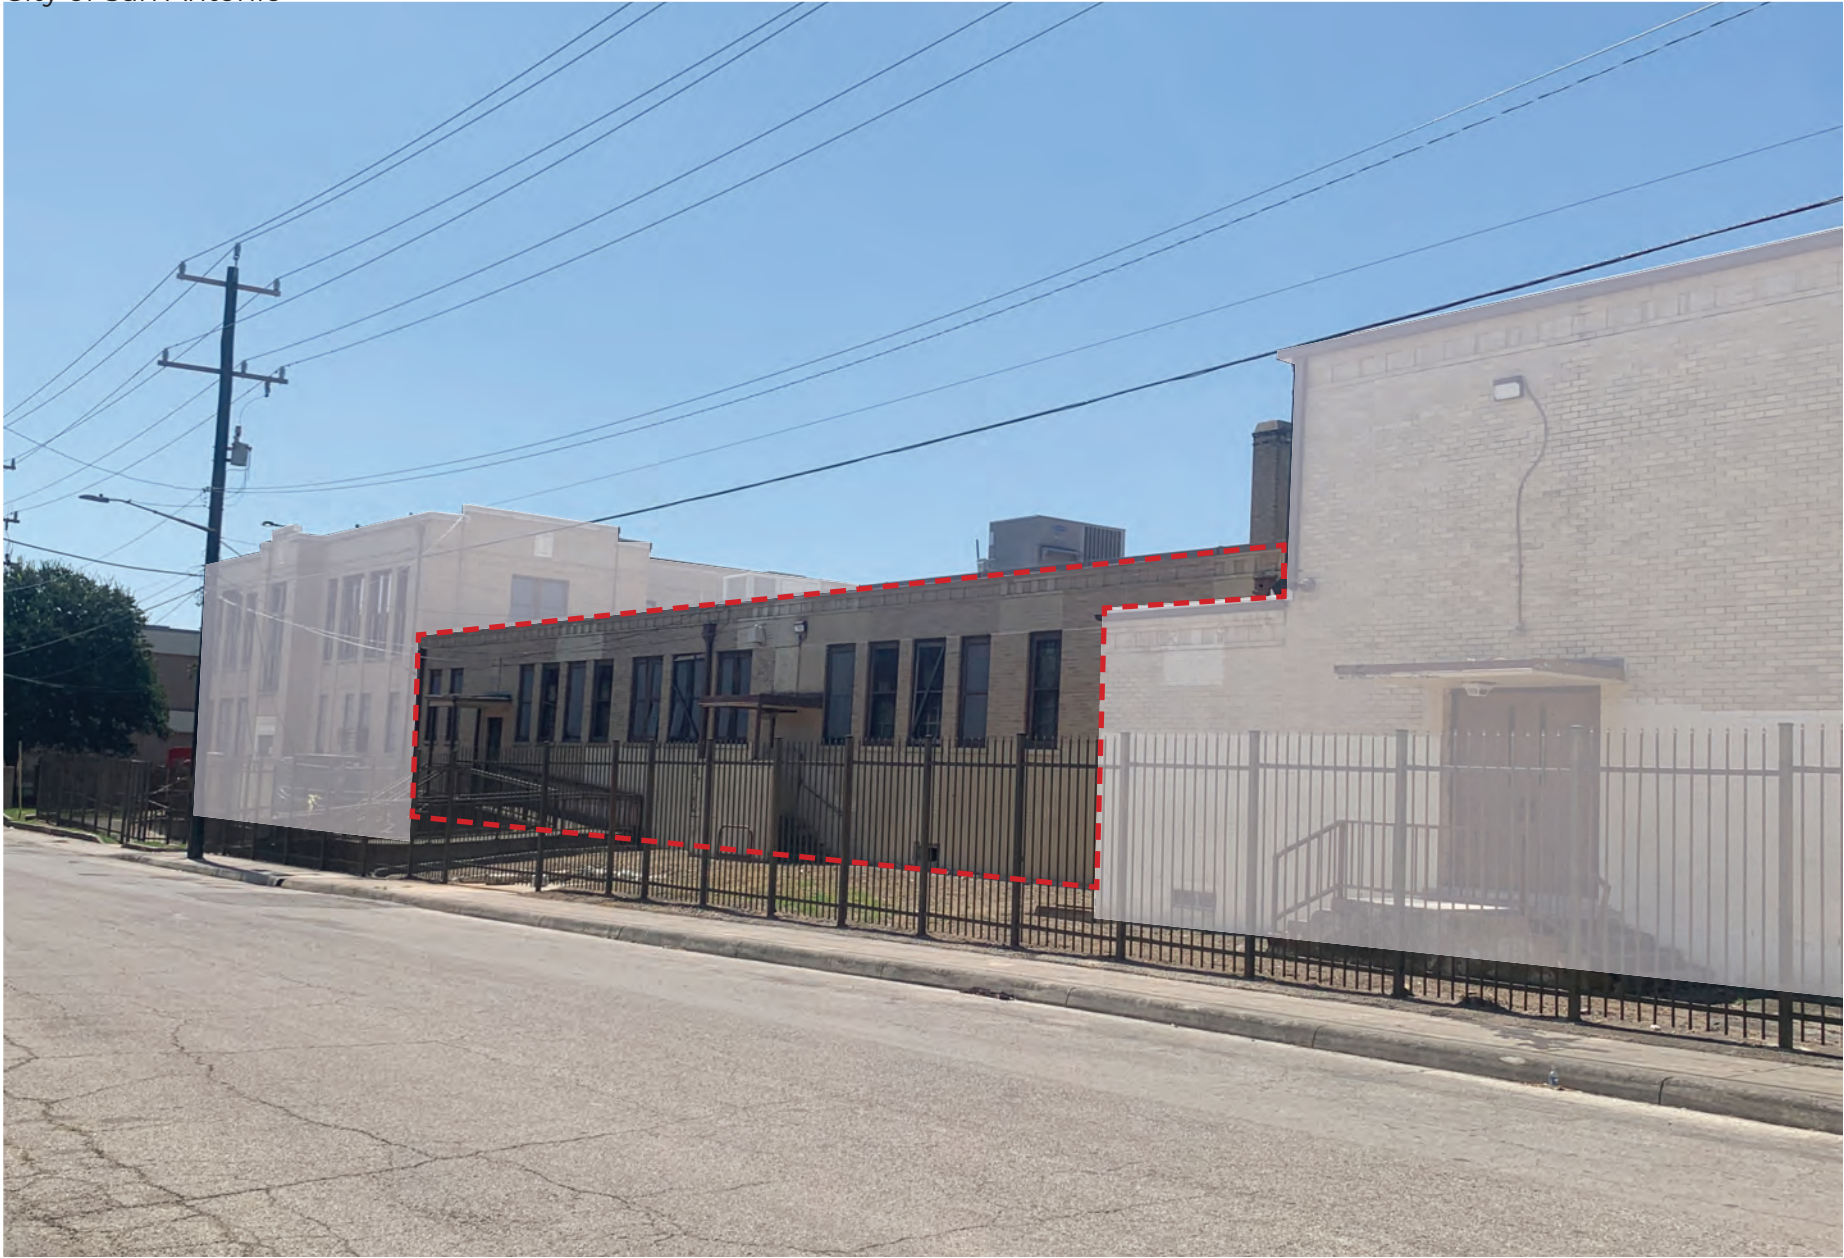
Physical Culture Building (Gym Annex)

In addition to the foundation issues, the structural engineer identified corrosion on the roof deck and joists due to leaks, and the report suggests that the entire roof structure will have to be replaced, including any damaged joists.

Outside of the structural issues, all the existing windows must be replaced as they have succumbed to rot and damage, and are no longer functional.

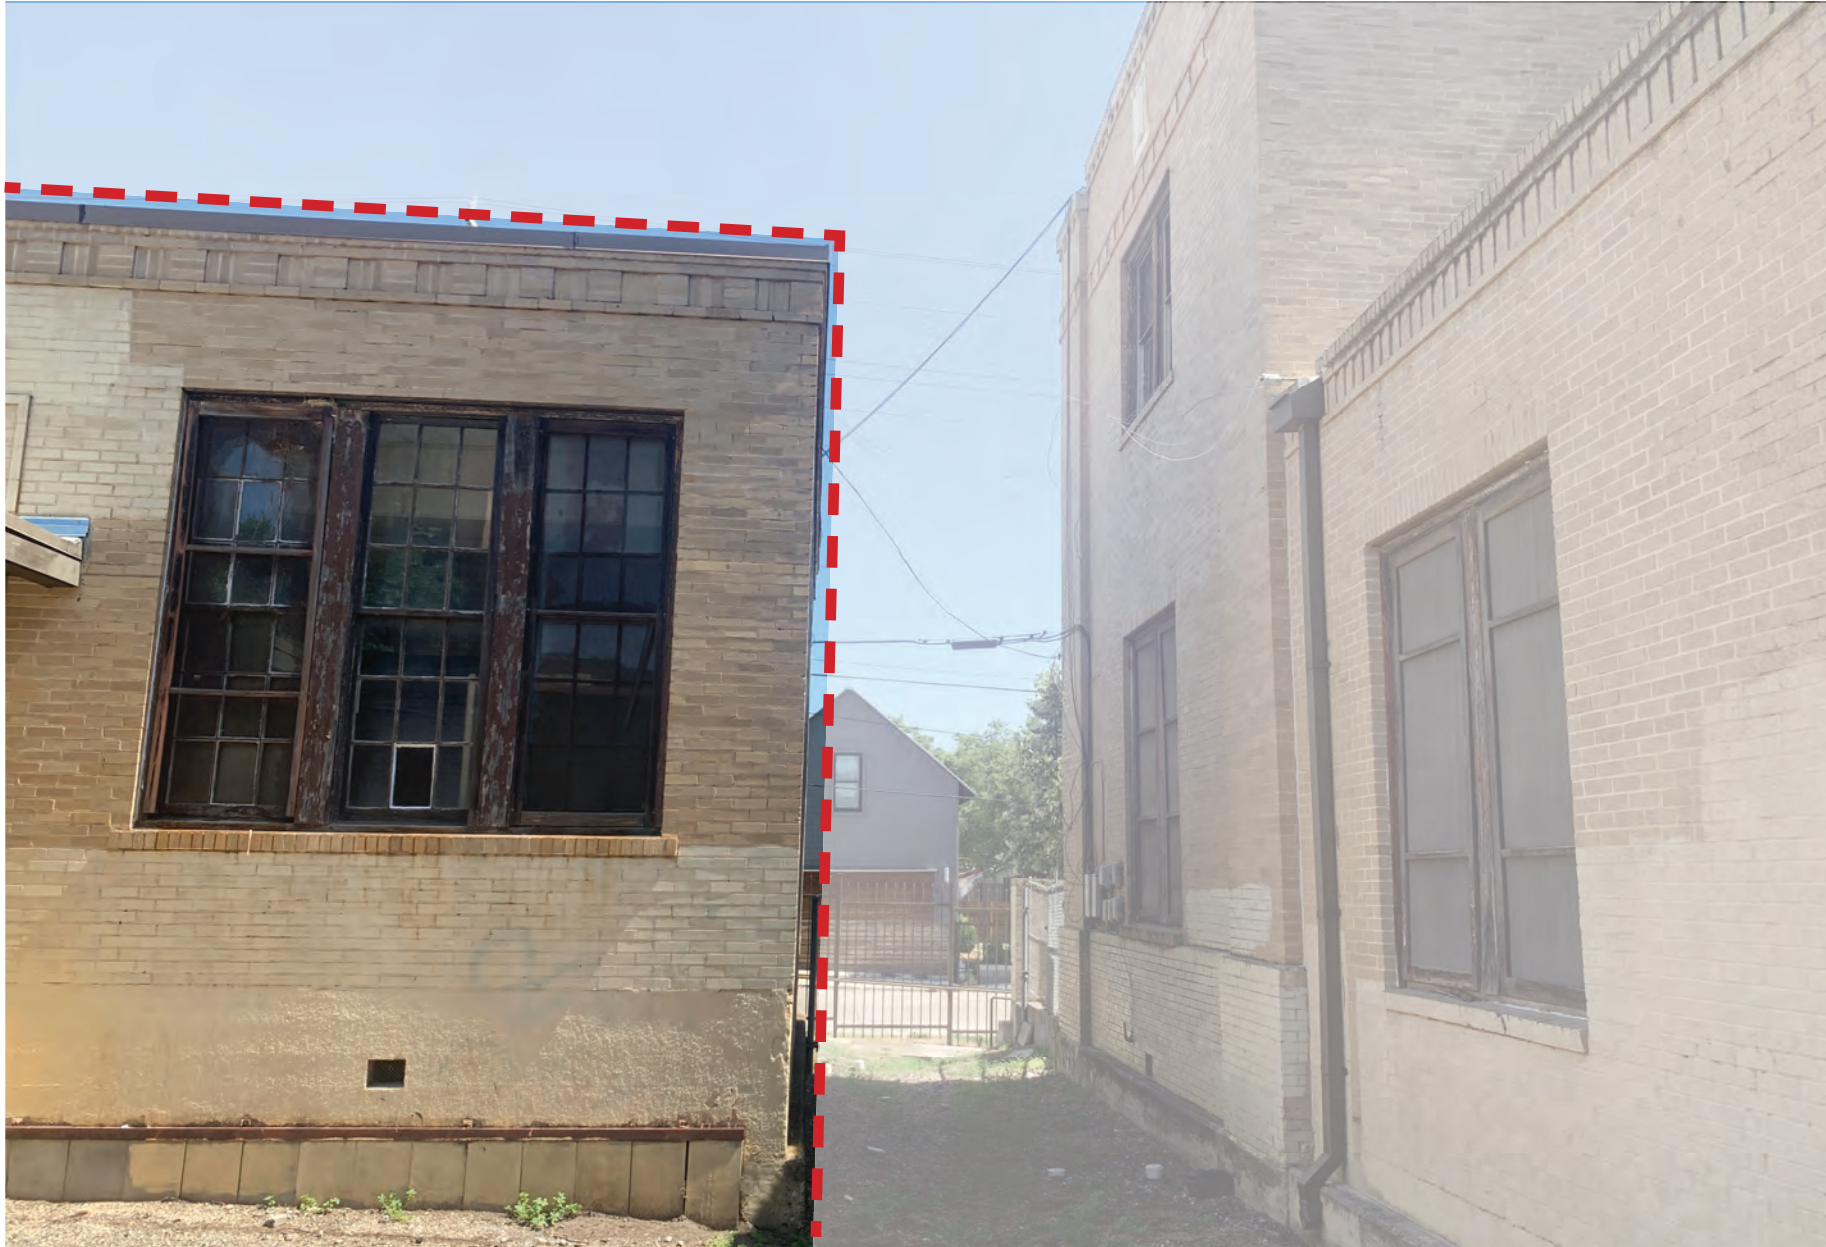
Physical Culture Building (Gym Annex)

The scope of repairs required for the building is such that the entire structure would have to be gutted, and the only portion of the building that could be salvaged are the exterior walls. However, the exterior walls are in poor condition as well, as the settling of the slab has caused cracks to form in the brick joints.

Due to the scope of repairs required, bringing the building into a usable state is not financially feasible and would create a severe economic hardship.

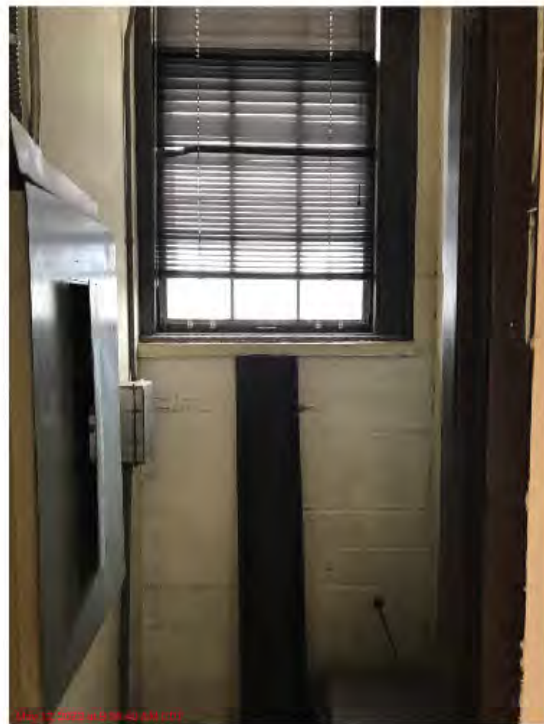
Issue #7 – OPEN (1/1)

Exposed joist soffit within insulation. Paint on joist peeling, cannot determine if it is steel that is delaminating or rusted.

LOCATION: Elec Closet Left
PRIORITY: Normal
DUE DATE: No due date
DISCIPLINES:
ASSIGNEE:

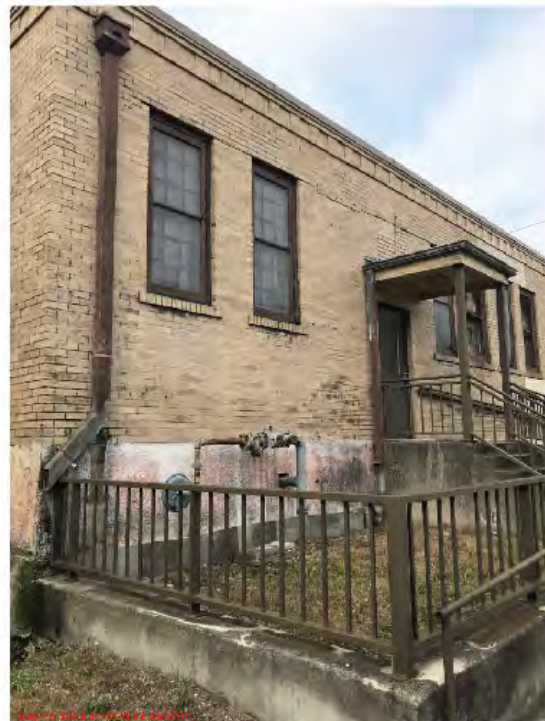
Issue #31 – OPEN (1/1)

cracking and movement at window headers.

LOCATION: Exterior North
PRIORITY: Normal
DUE DATE: No due date
DISCIPLINES:
ASSIGNEE:
