# HISTORIC AND DESIGN REVIEW COMMISSION

October 06, 2021

**HDRC CASE NO:** 2021-472  
**ADDRESS:** 114 PARKVIEW DR  
**LEGAL DESCRIPTION:** NCB 6919 BLK LOT E 20 FT OF 12 & W 15 FT OF 13  
**ZONING:** R-5, H  
**CITY COUNCIL DIST.:** 3  
**DISTRICT:** Mission Historic District  
**APPLICANT:** HMI Homes, LLC  
**OWNER:** HMI Homes, LLC  
**TYPE OF WORK:** Fenestration modifications, siding modifications  
**APPLICATION RECEIVED:** September 09, 2021  
**60-DAY REVIEW:** Not applicable due to City Council Emergency Orders  
**CASE MANAGER:** Katie Totman

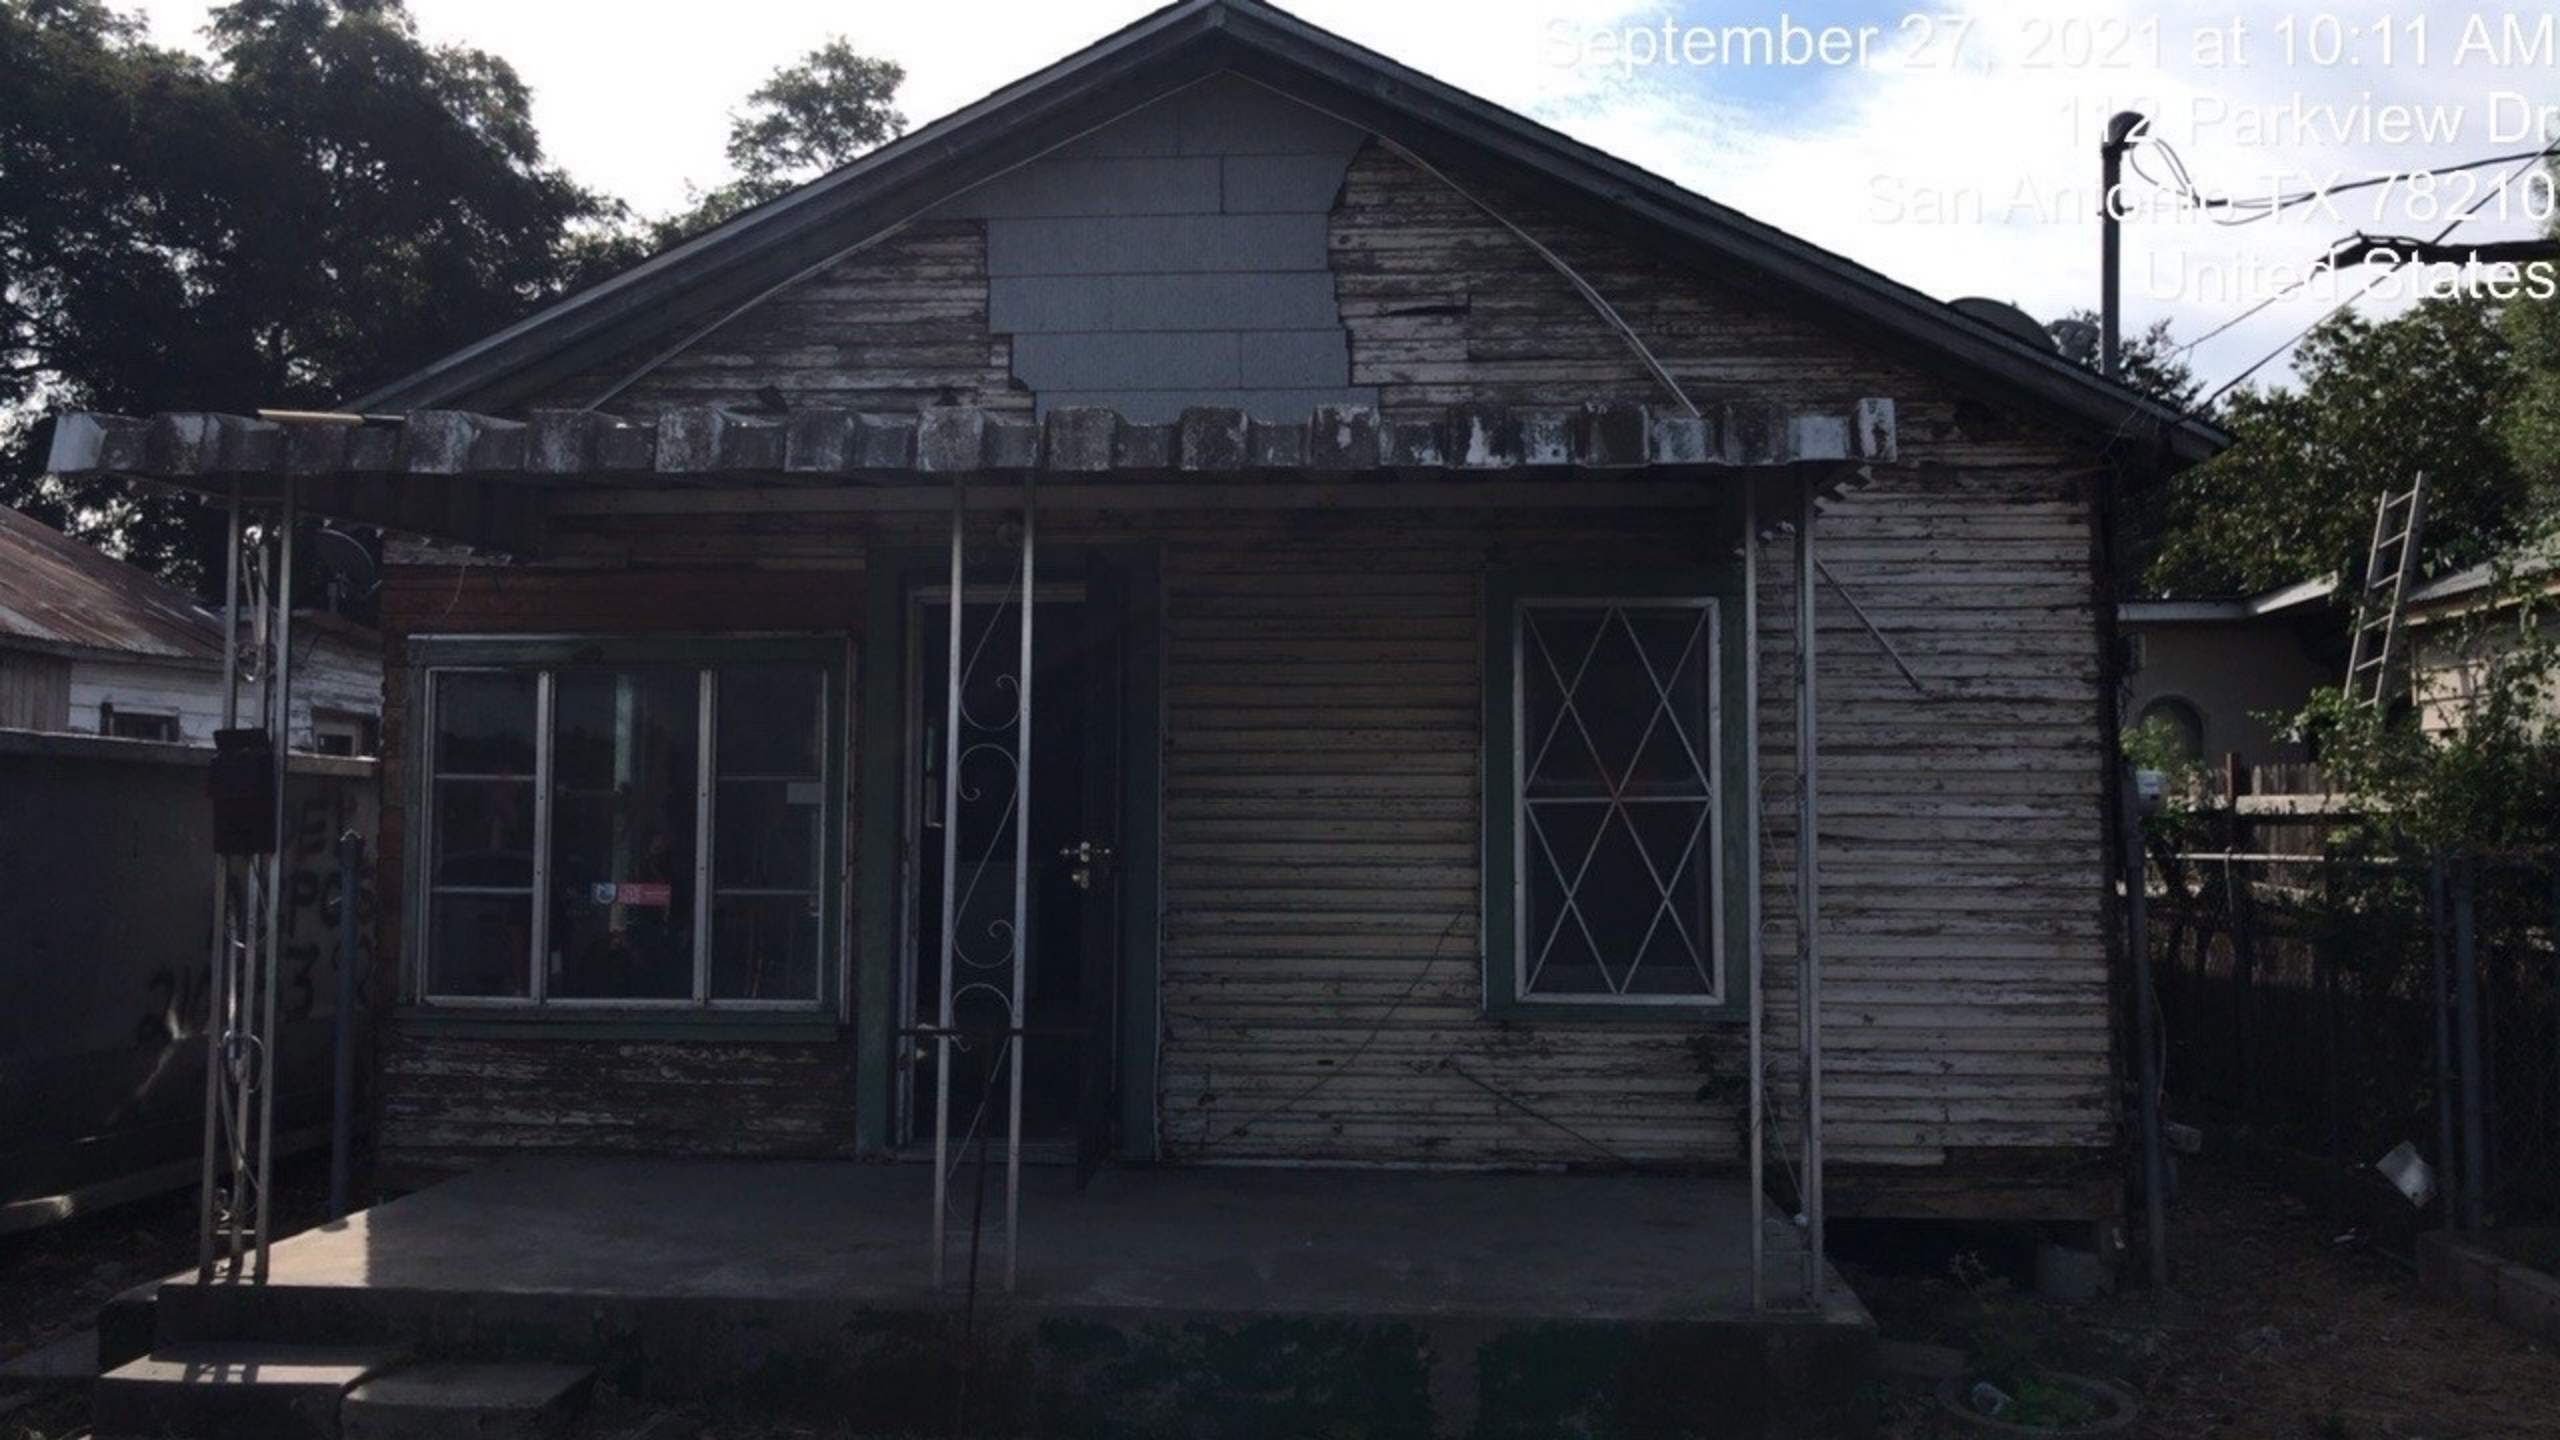
The existing porch cover is a recent addition to the home. It has a flat aluminum roof with metal posts. I request to remove this cover and replace it with one constructed of wood posts, wood covering and a gable style roof. The proposed porch cover is consistent with the other homes in the neighborhood.

- f. **FRONT PORCH MODIFICATIONS** – The applicant is requesting to remove the existing metal awning and construct an offset front gable porch cover with wood posts. Per the Historic Design Guidelines for Exterior Maintenance and Alterations 7.B.v., reconstruct porches, balconies, and porte-cocheres based on accurate evidence of the original, such as photographs. If no such evidence exists, the design should be based on the architectural style of the building and historic patterns. Many of the adjacent homes with similar architectural

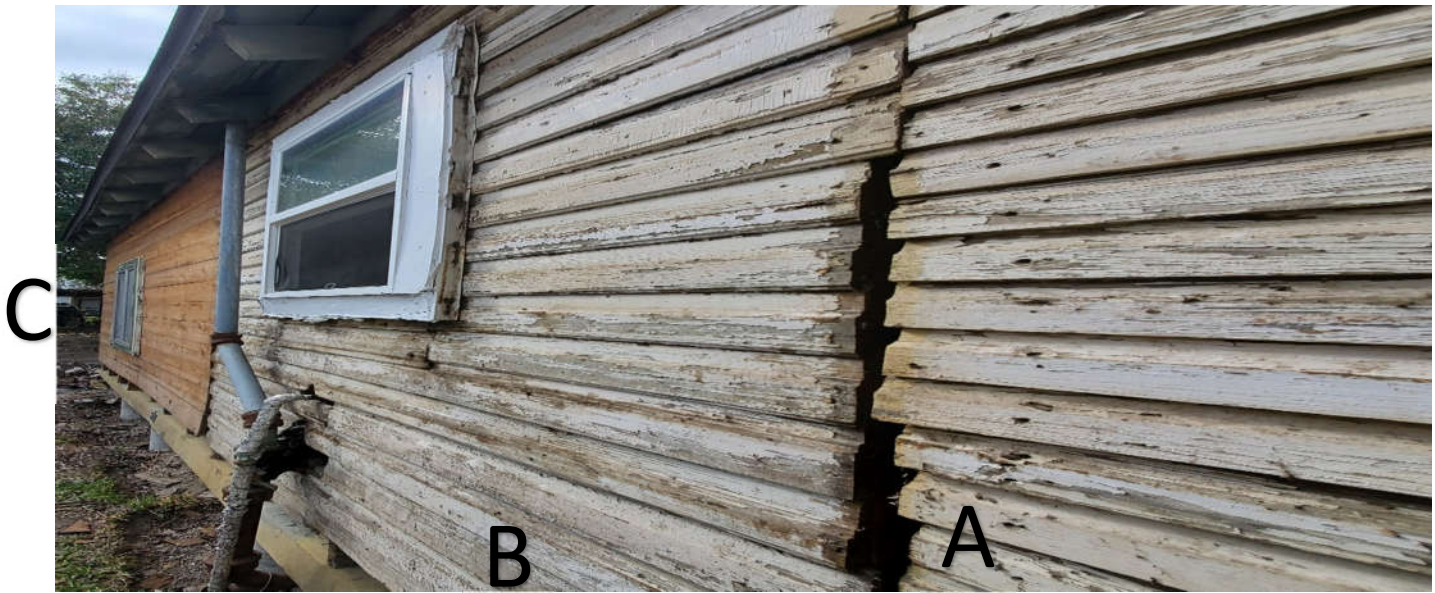
Pic 1

The exterior siding on the home is a hardboard/cardboard material that has not held up well over the years and is no longer manufactured. The siding is very damaged or missing on all sides of the home. On 9/22/2021, the OHP provided administrative approval to remove the existing composition siding from the exterior of the house to reveal the siding underneath. The removal process has been completed and revealed three different sidings on the structure. The three inconsistent sidings (siding A, siding B, siding C) each have a different profile and are in different stages of rotting.

I understand that the Office of Historic Preservation would prefer to repair and spot replace the existing wood siding, yet I respectfully request an alternative method that will stay in line with the OHP's vision of maintaining the historical appearance of the home. I request to install 4" dutch lap style wood siding over all three profiles. This will give a consistent look to the property, as well as provide strong and durable protection to the structure.

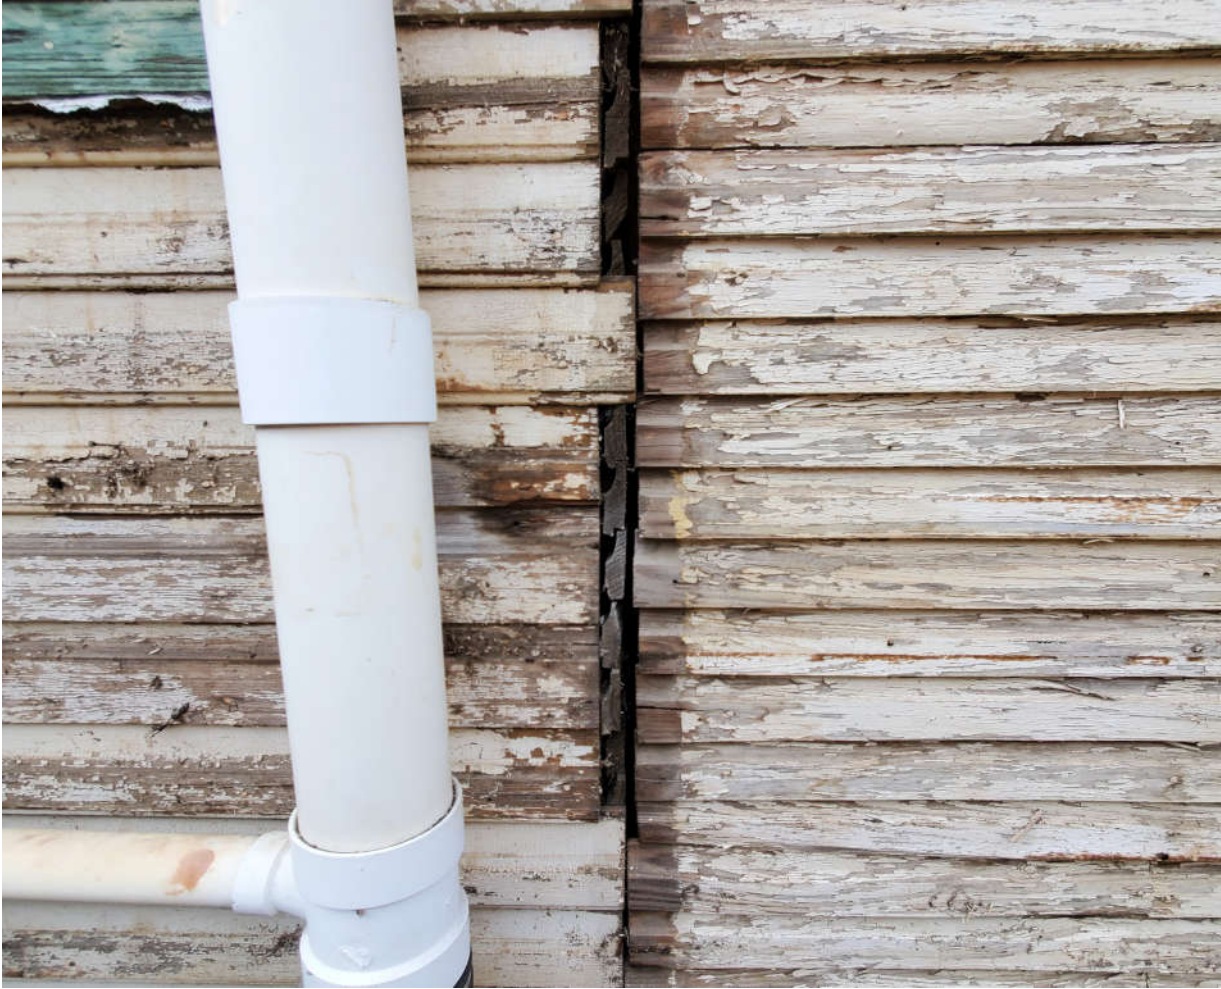
Pic 12

The middle part of the home is covered in a 6" dutch lap siding (siding B). Approximately 15% of the home is covered with this siding. This section of boards is also heavily damaged and show signs of rotting.

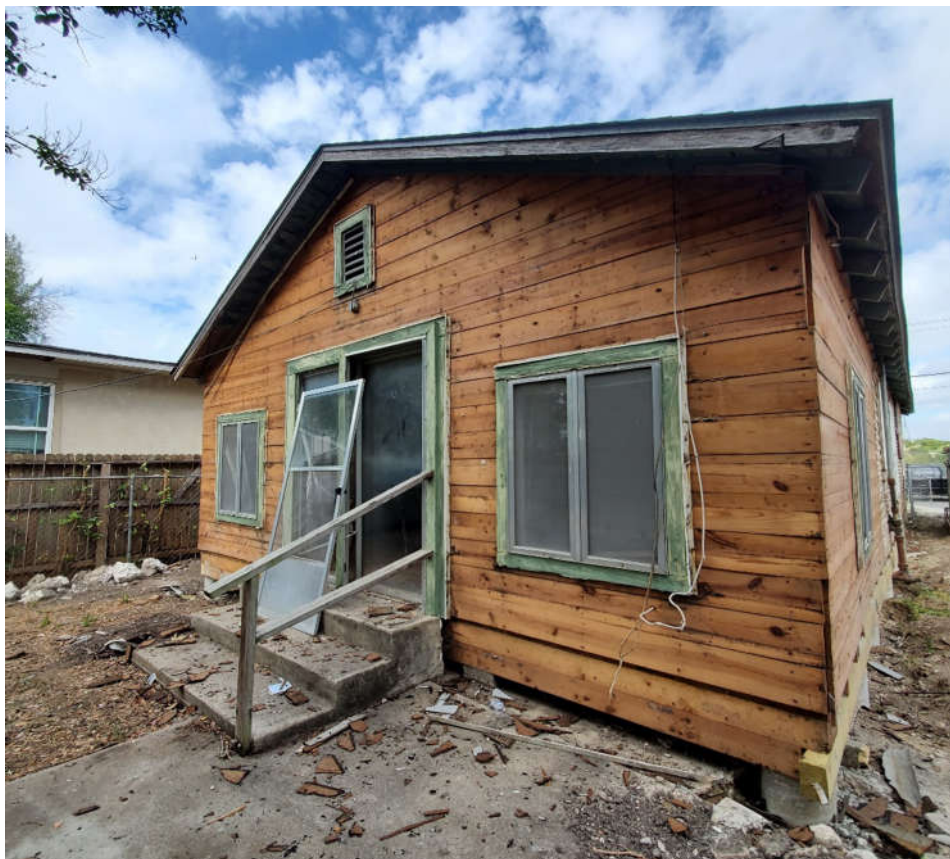
Pic 13

The third style are 1" x 6" boards (siding C) and covers the remaining 35% of the home. This siding is in the best condition of all three siding profiles yet does not provide contributing status to the home. This siding was added the most recently of the three. This siding was also used to frame around the street facing windows in the front of the home, see picture below.

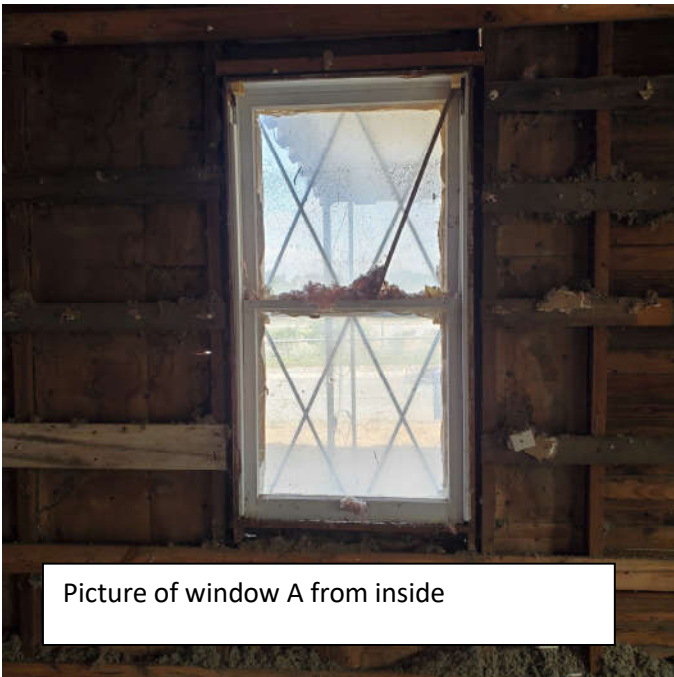
Pic 18

Picture of window A from inside

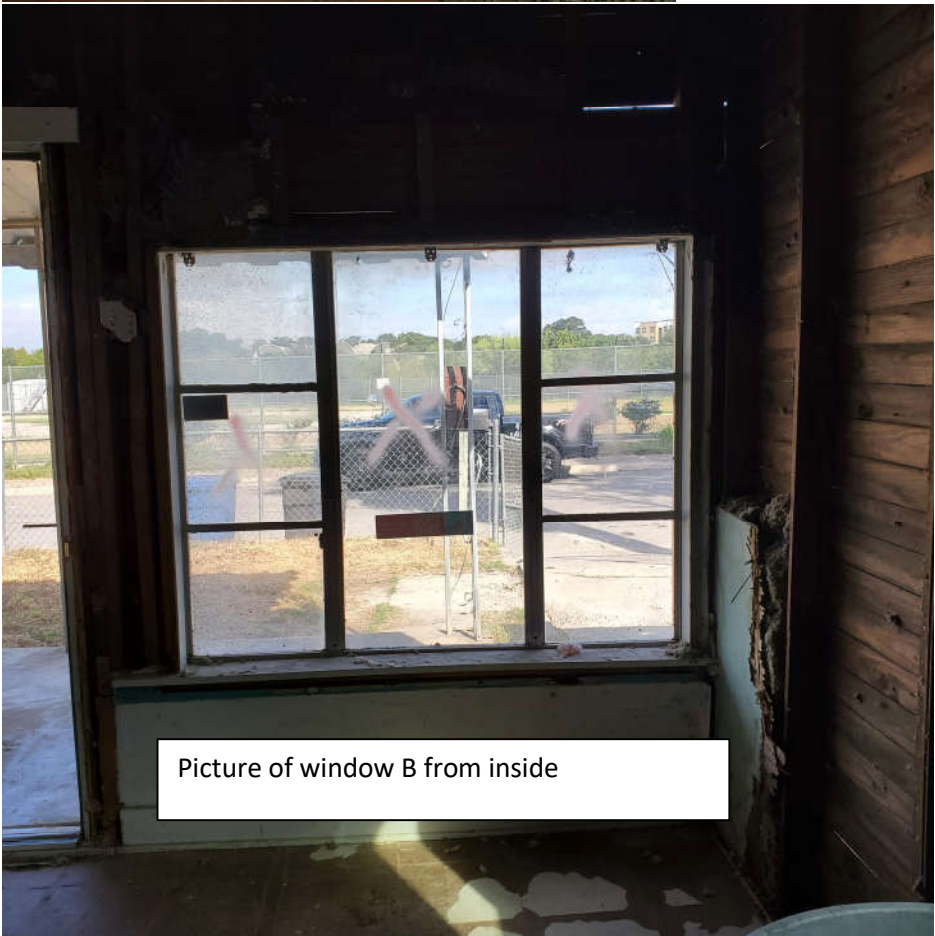
Pic 19

Picture of window B from inside

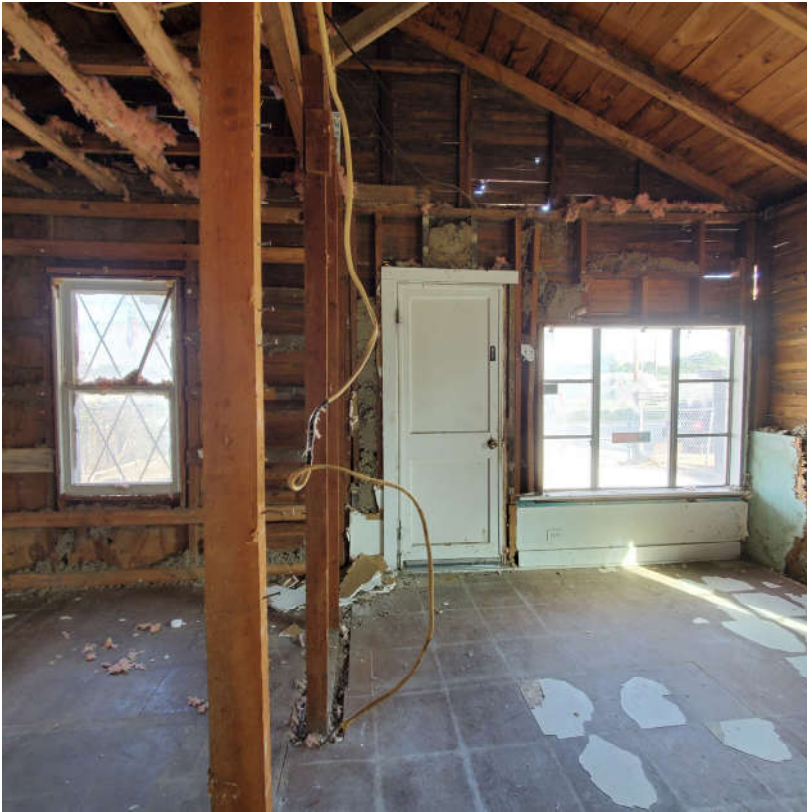
Pic 20

Picture of windows A and B from inside. We request to change window B to match window A.

- c. **WINDOW REPLACEMENT** – The applicant is requesting to replace one (1) existing aluminum window located on the front of the primary structure with a wood window to match the existing wood window located to the right side of the front door. Per the Historic Design Guidelines for Exterior Maintenance and Alterations 6.B.vii, replace non-historic incompatible windows with windows that are typical of the architectural style of the building. Staff finds that replacing the existing aluminum window with a wood window to be consistent with the guidelines.

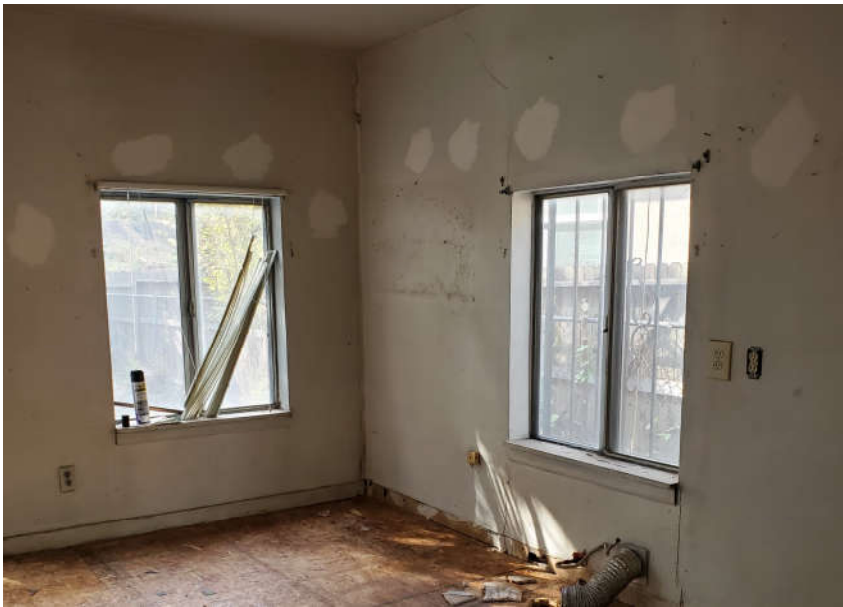
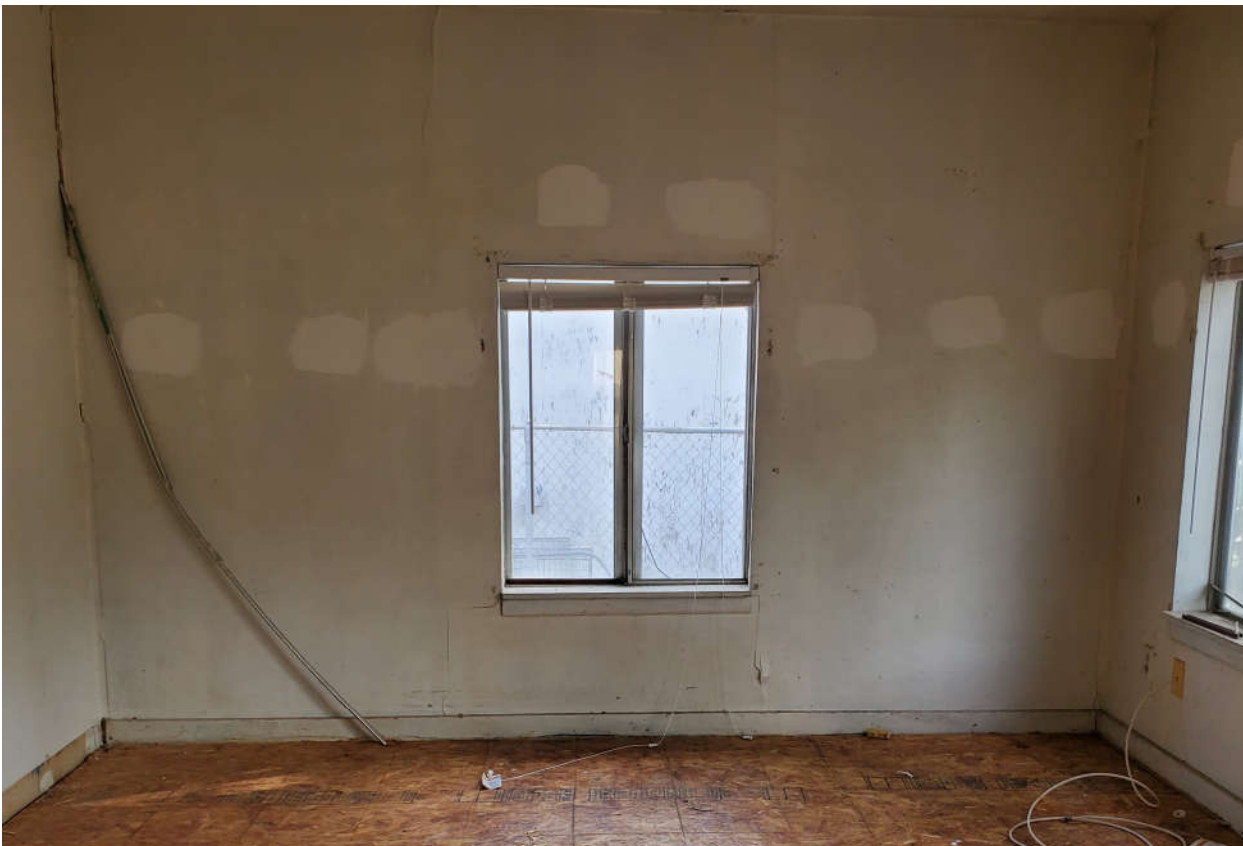
There are three aluminum windows in the rear of the home that are recent additions to the home and not of contributing status. I request to remove the three windows and frame them out in order to build a primary bedroom with a private bathroom.

- d. **FENESTRATION MODIFICATIONS** – The applicant is requesting to remove three (3) existing aluminum windows on the rear addition and cover the openings with 4” Dutch lap siding. Guidelines 6.A.i for Exterior Maintenance and Alterations states that filling in historic door or window openings should be avoided. However, the existing windows are non-historic aluminum frame windows, and are located on a later addition. Staff does not find that the removal of these windows will negatively impact the integrity of the primary structure. Staff finds the request appropriate.

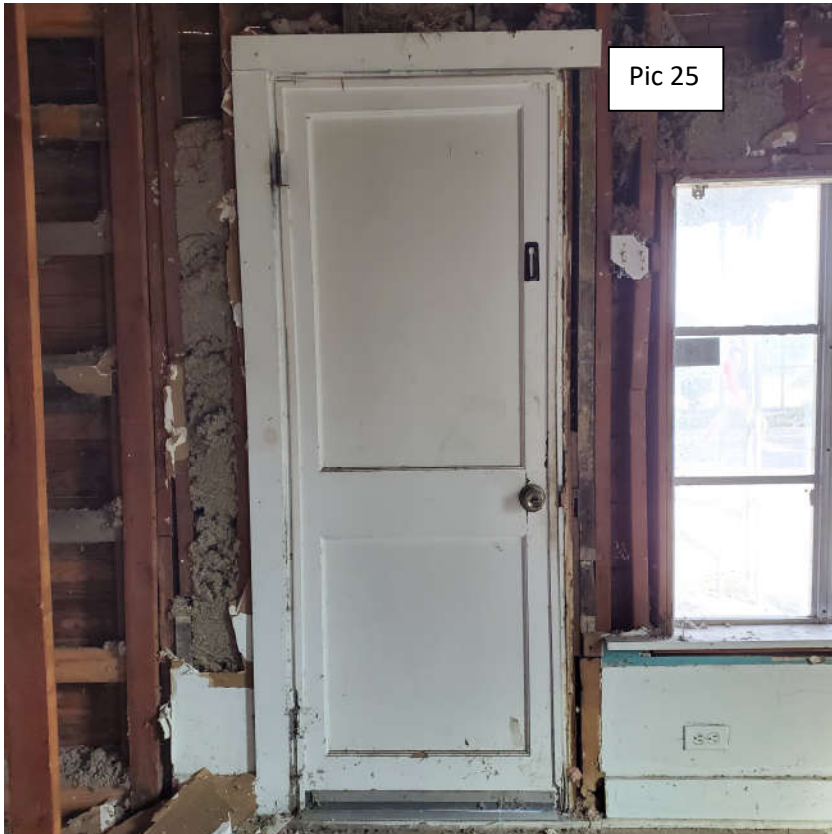
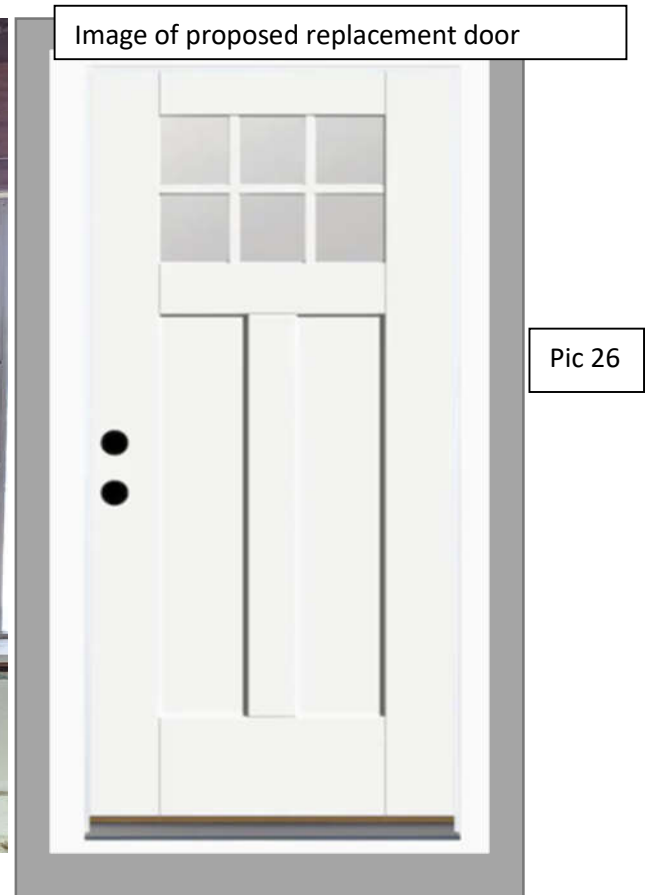
The front door is a late addition to the home and is not a standard size exterior door. It is a 27" x 80" door. There is also no header in the framing. I would like to update the framing, add a header and replace the front door and remove the metal screen door as it is non-operational and needs to be held closed with a 2"x4" piece of wood. The door is too narrow and appliances cannot fit through it. The replacement will be a 36" x 80" fiberglass door with a historical style and will create an inviting look to the front exterior of the home.

- e. **FRONT DOOR REPLACEMENT** – The applicant is requesting to replace the existing front door with a 36” x 80” fiberglass Craftsman door. The existing door is likely not original to the structure as it is a contemporary material and appearance. Per the Historic Design Guidelines for Exterior Maintenance and Alterations 6.B.i, Replace doors, hardware, fanlight, sidelights, pilasters, and entablatures in-kind when possible and when deteriorated beyond repair. When in-kind replacement is not feasible, ensure features match the size, material, and profile of the historic element. Staff finds that the proposed style of the door to be consistent with the Craftsman features of the primary structure and finds that the door should be solid wood or a salvaged wood door where possible.
