## HISTORIC AND DESIGN REVIEW COMMISSION

November 17, 2021

**HDRC CASE NO:** 2021-562  
**ADDRESS:** 324 E MYRTLE  
**LEGAL DESCRIPTION:** NCB 1751 BLK 6 LOT 3  
**ZONING:** MF-33  
**CITY COUNCIL DIST.:** 1  
**DISTRICT:** Tobin Hill Historic District  
**APPLICANT:** Michael Castro/CASTRO MICHAEL &  
**OWNER:** Michael Castro/CASTRO MICHAEL &  
**TYPE OF WORK:** Window replacement, exterior alterations  
**APPLICATION RECEIVED:** October 26, 2021  
**60-DAY REVIEW:** Not applicable due to City Council Emergency Orders  
**CASE MANAGER:** Katie Totman  
**REQUEST:**

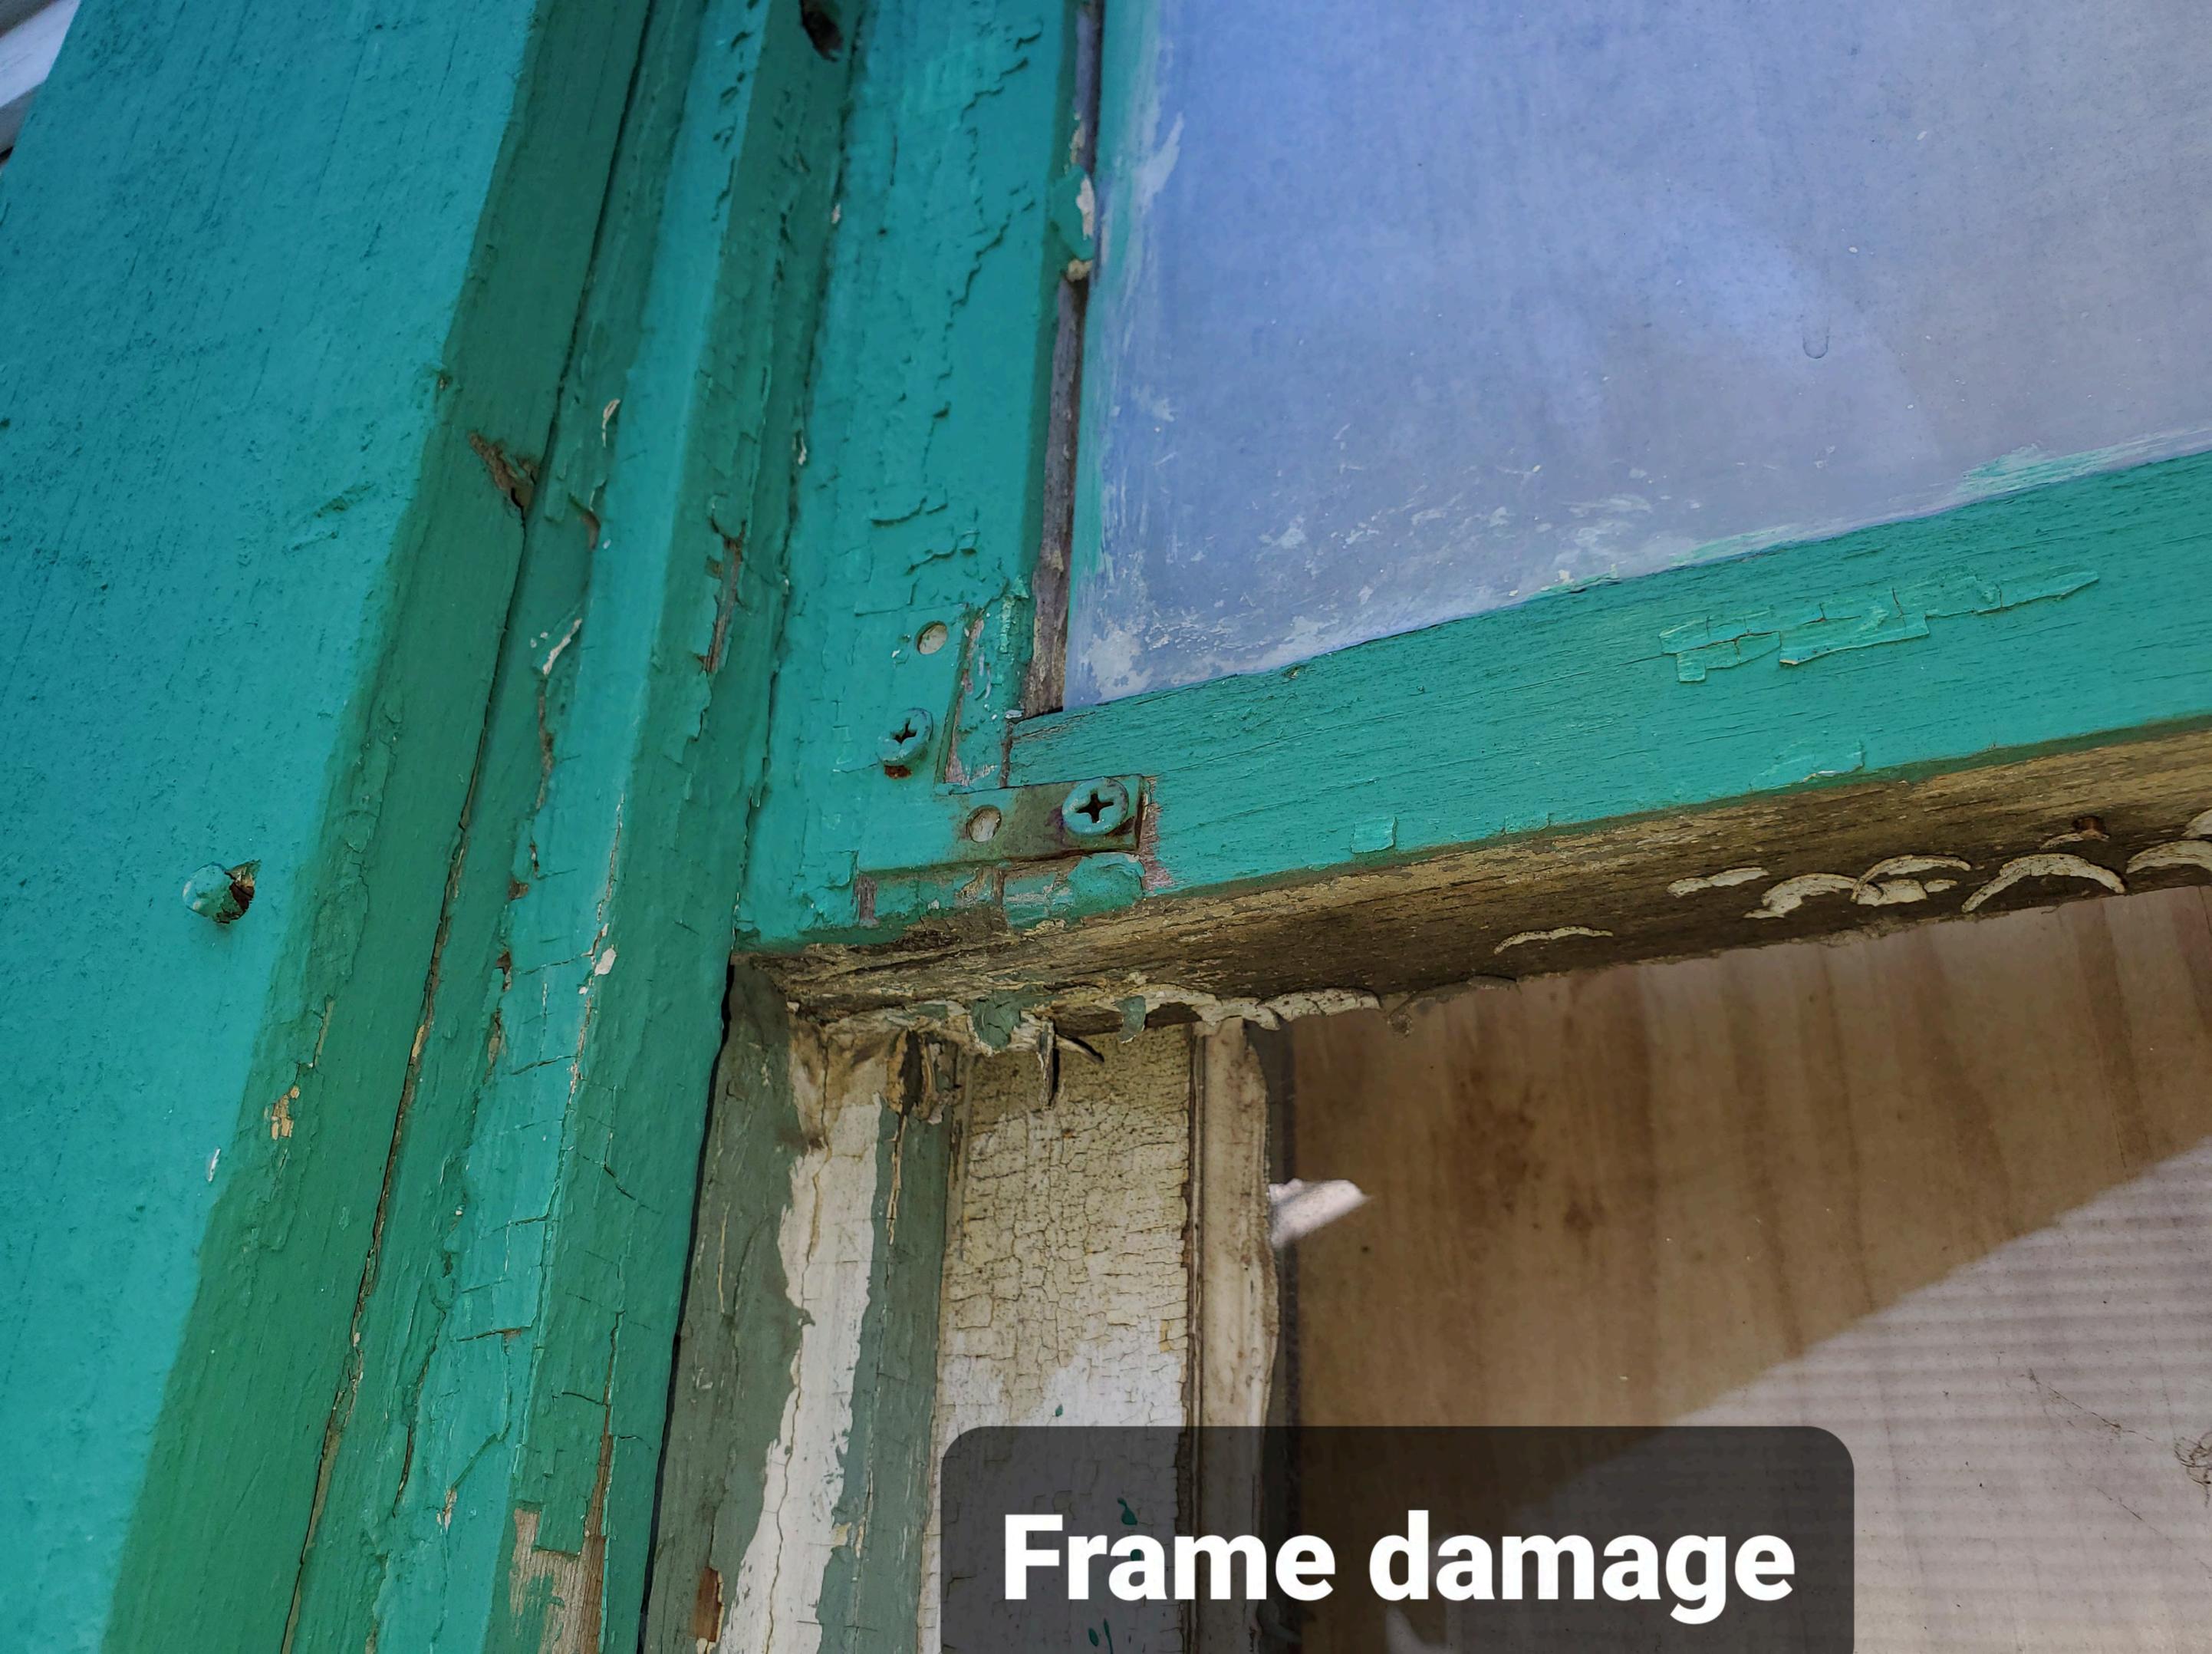
**Frame damage**

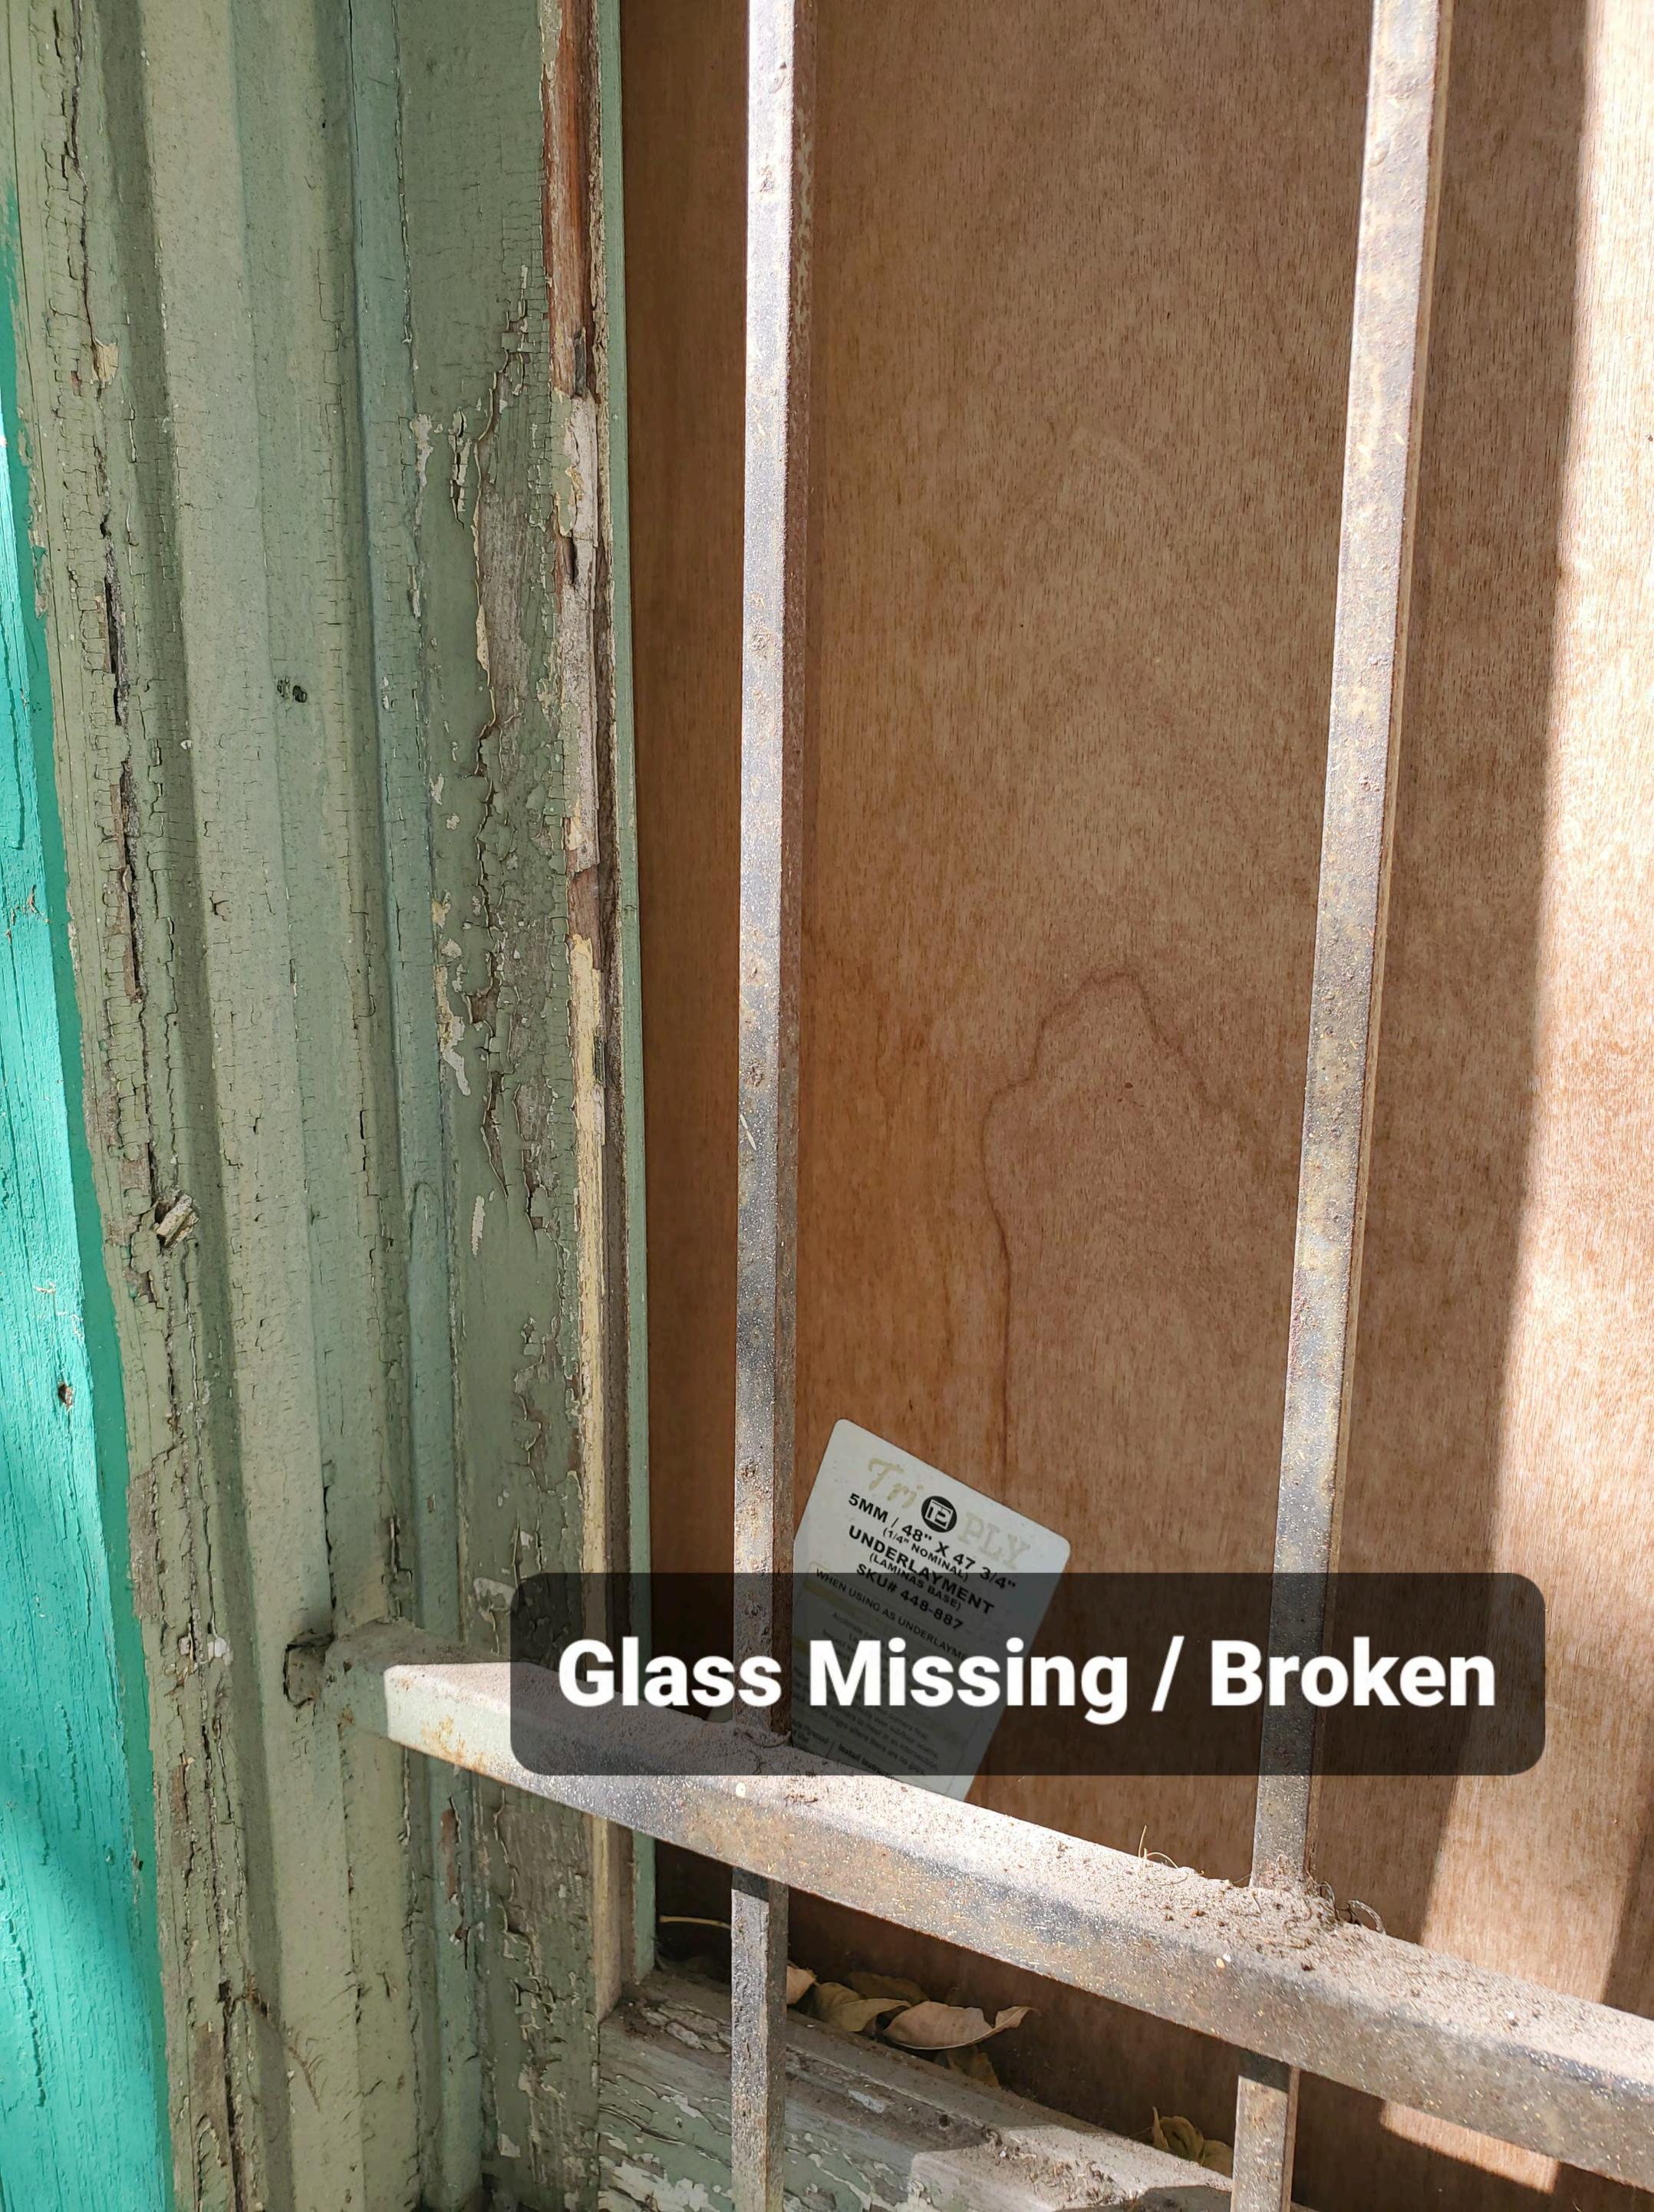
**Glass Missing / Broken**

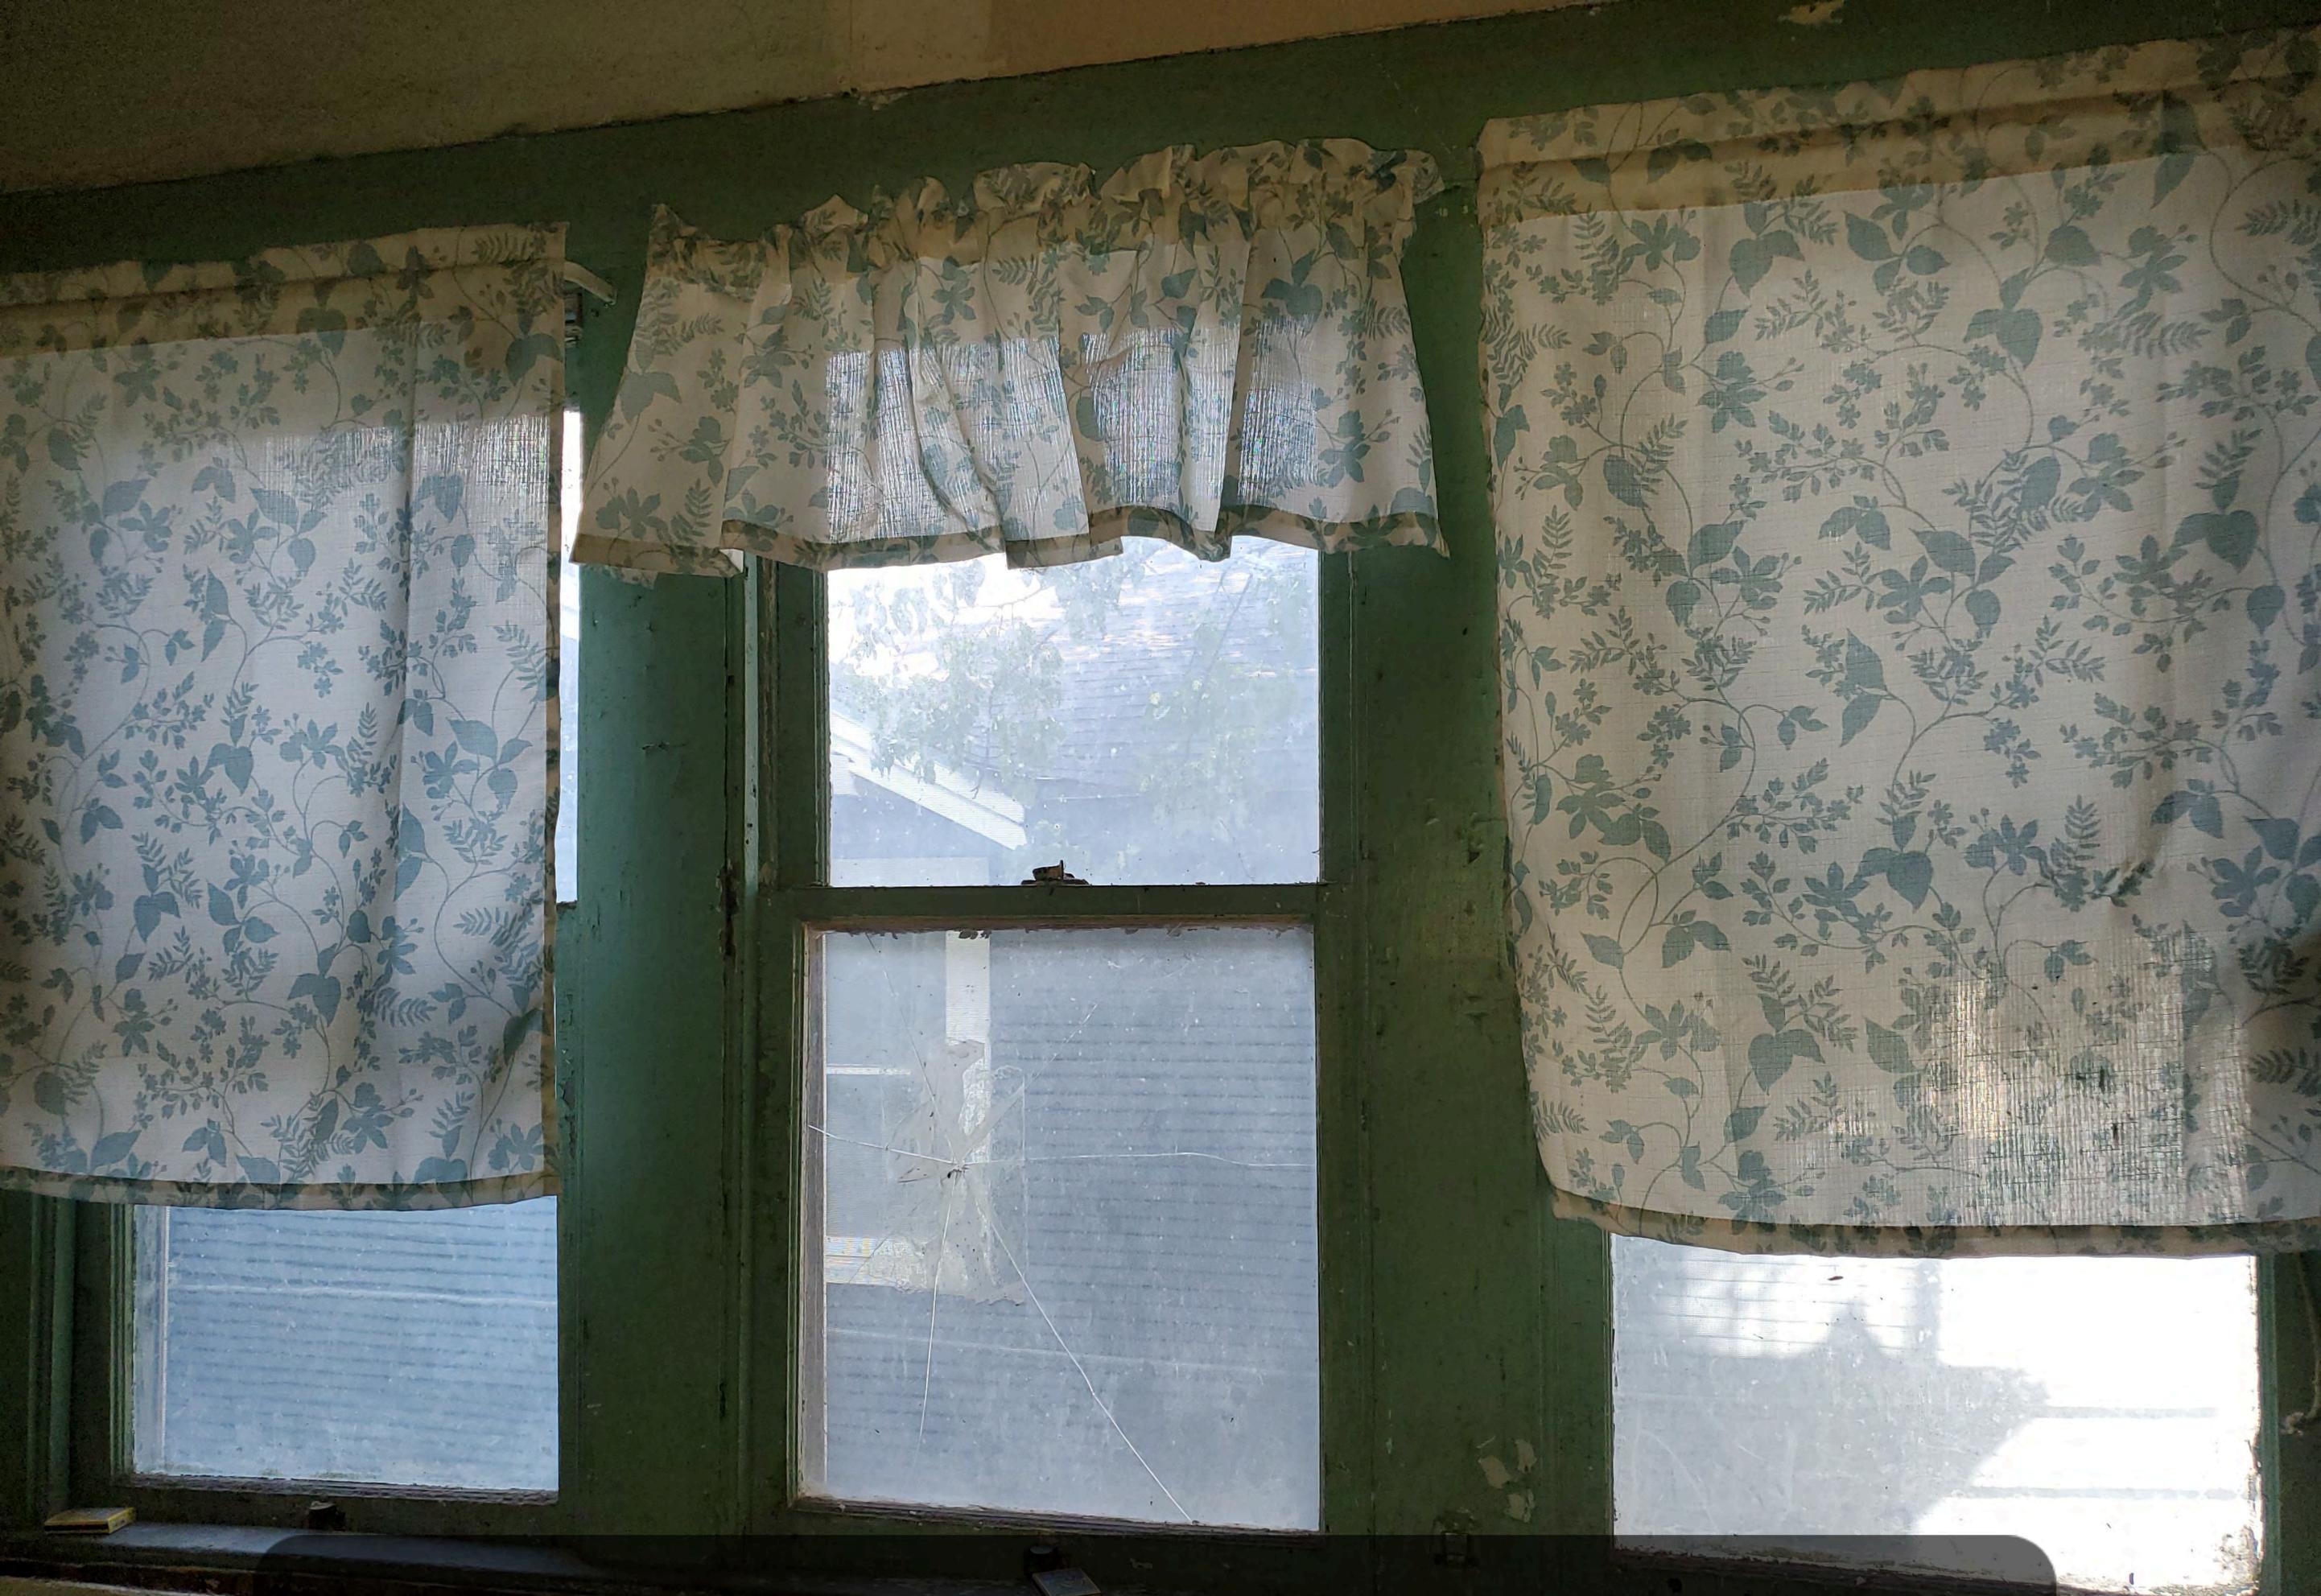
**broken glass or missing pieces.**

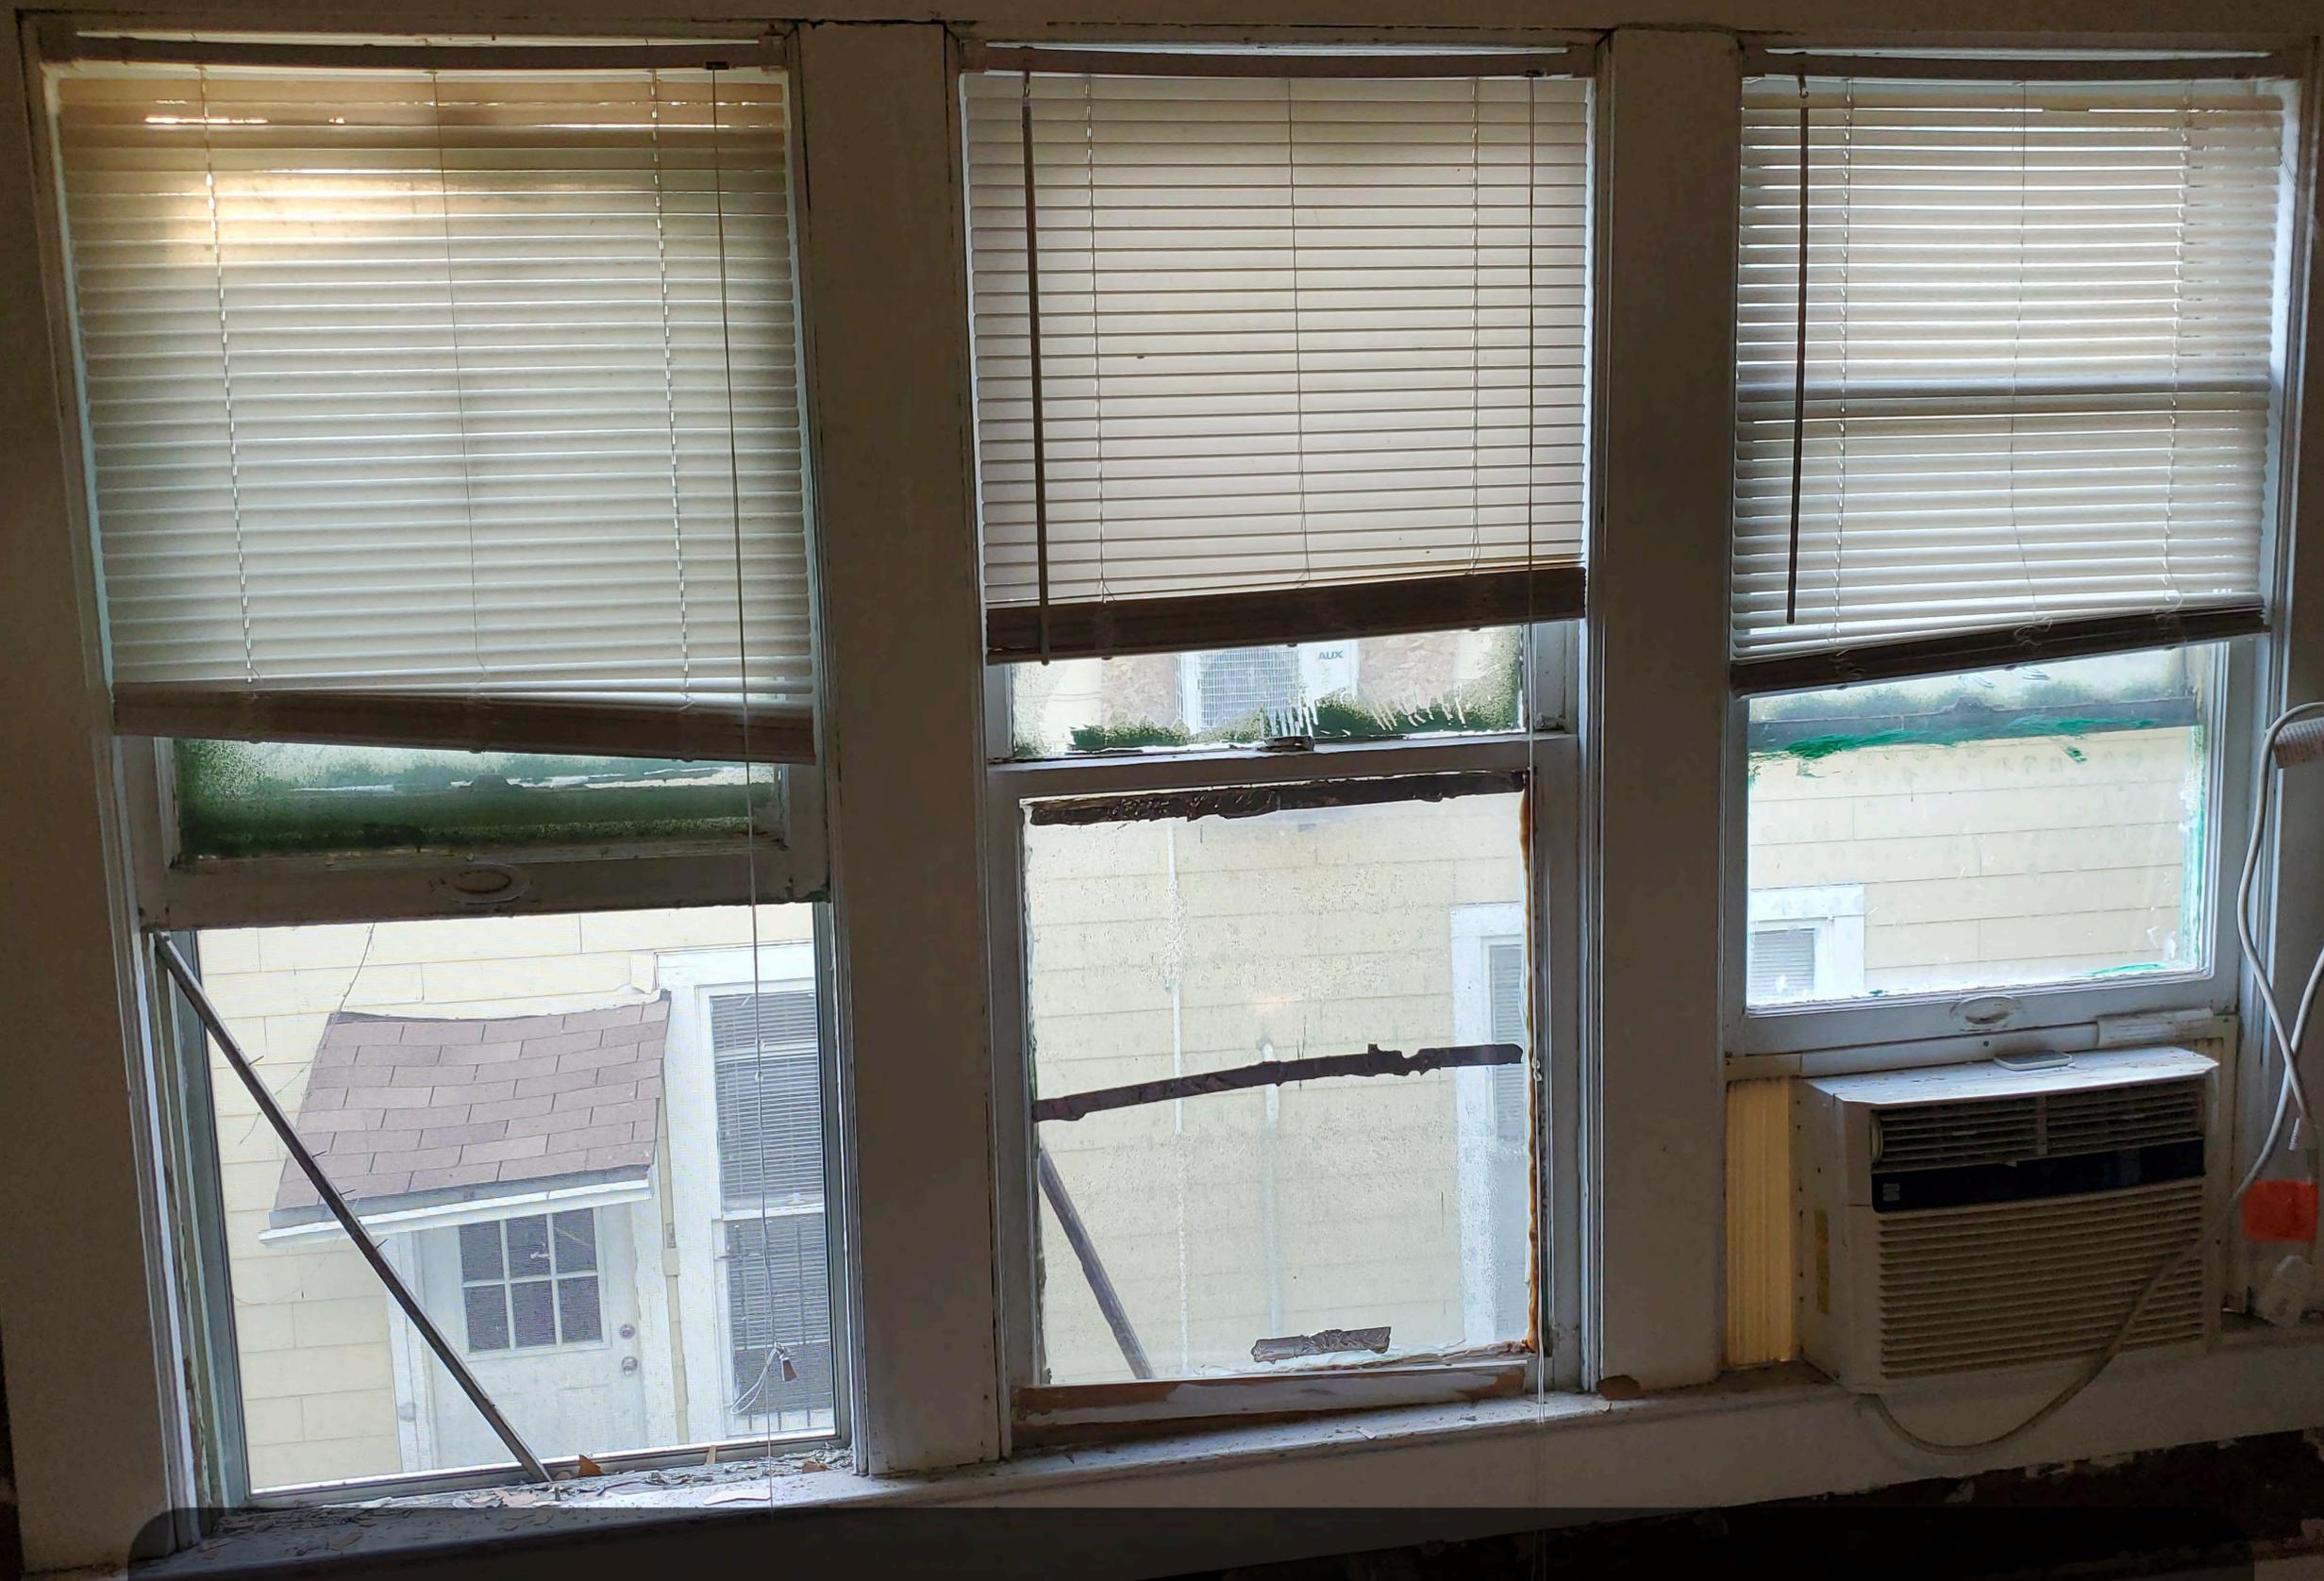
**broken glass, damaged frames**

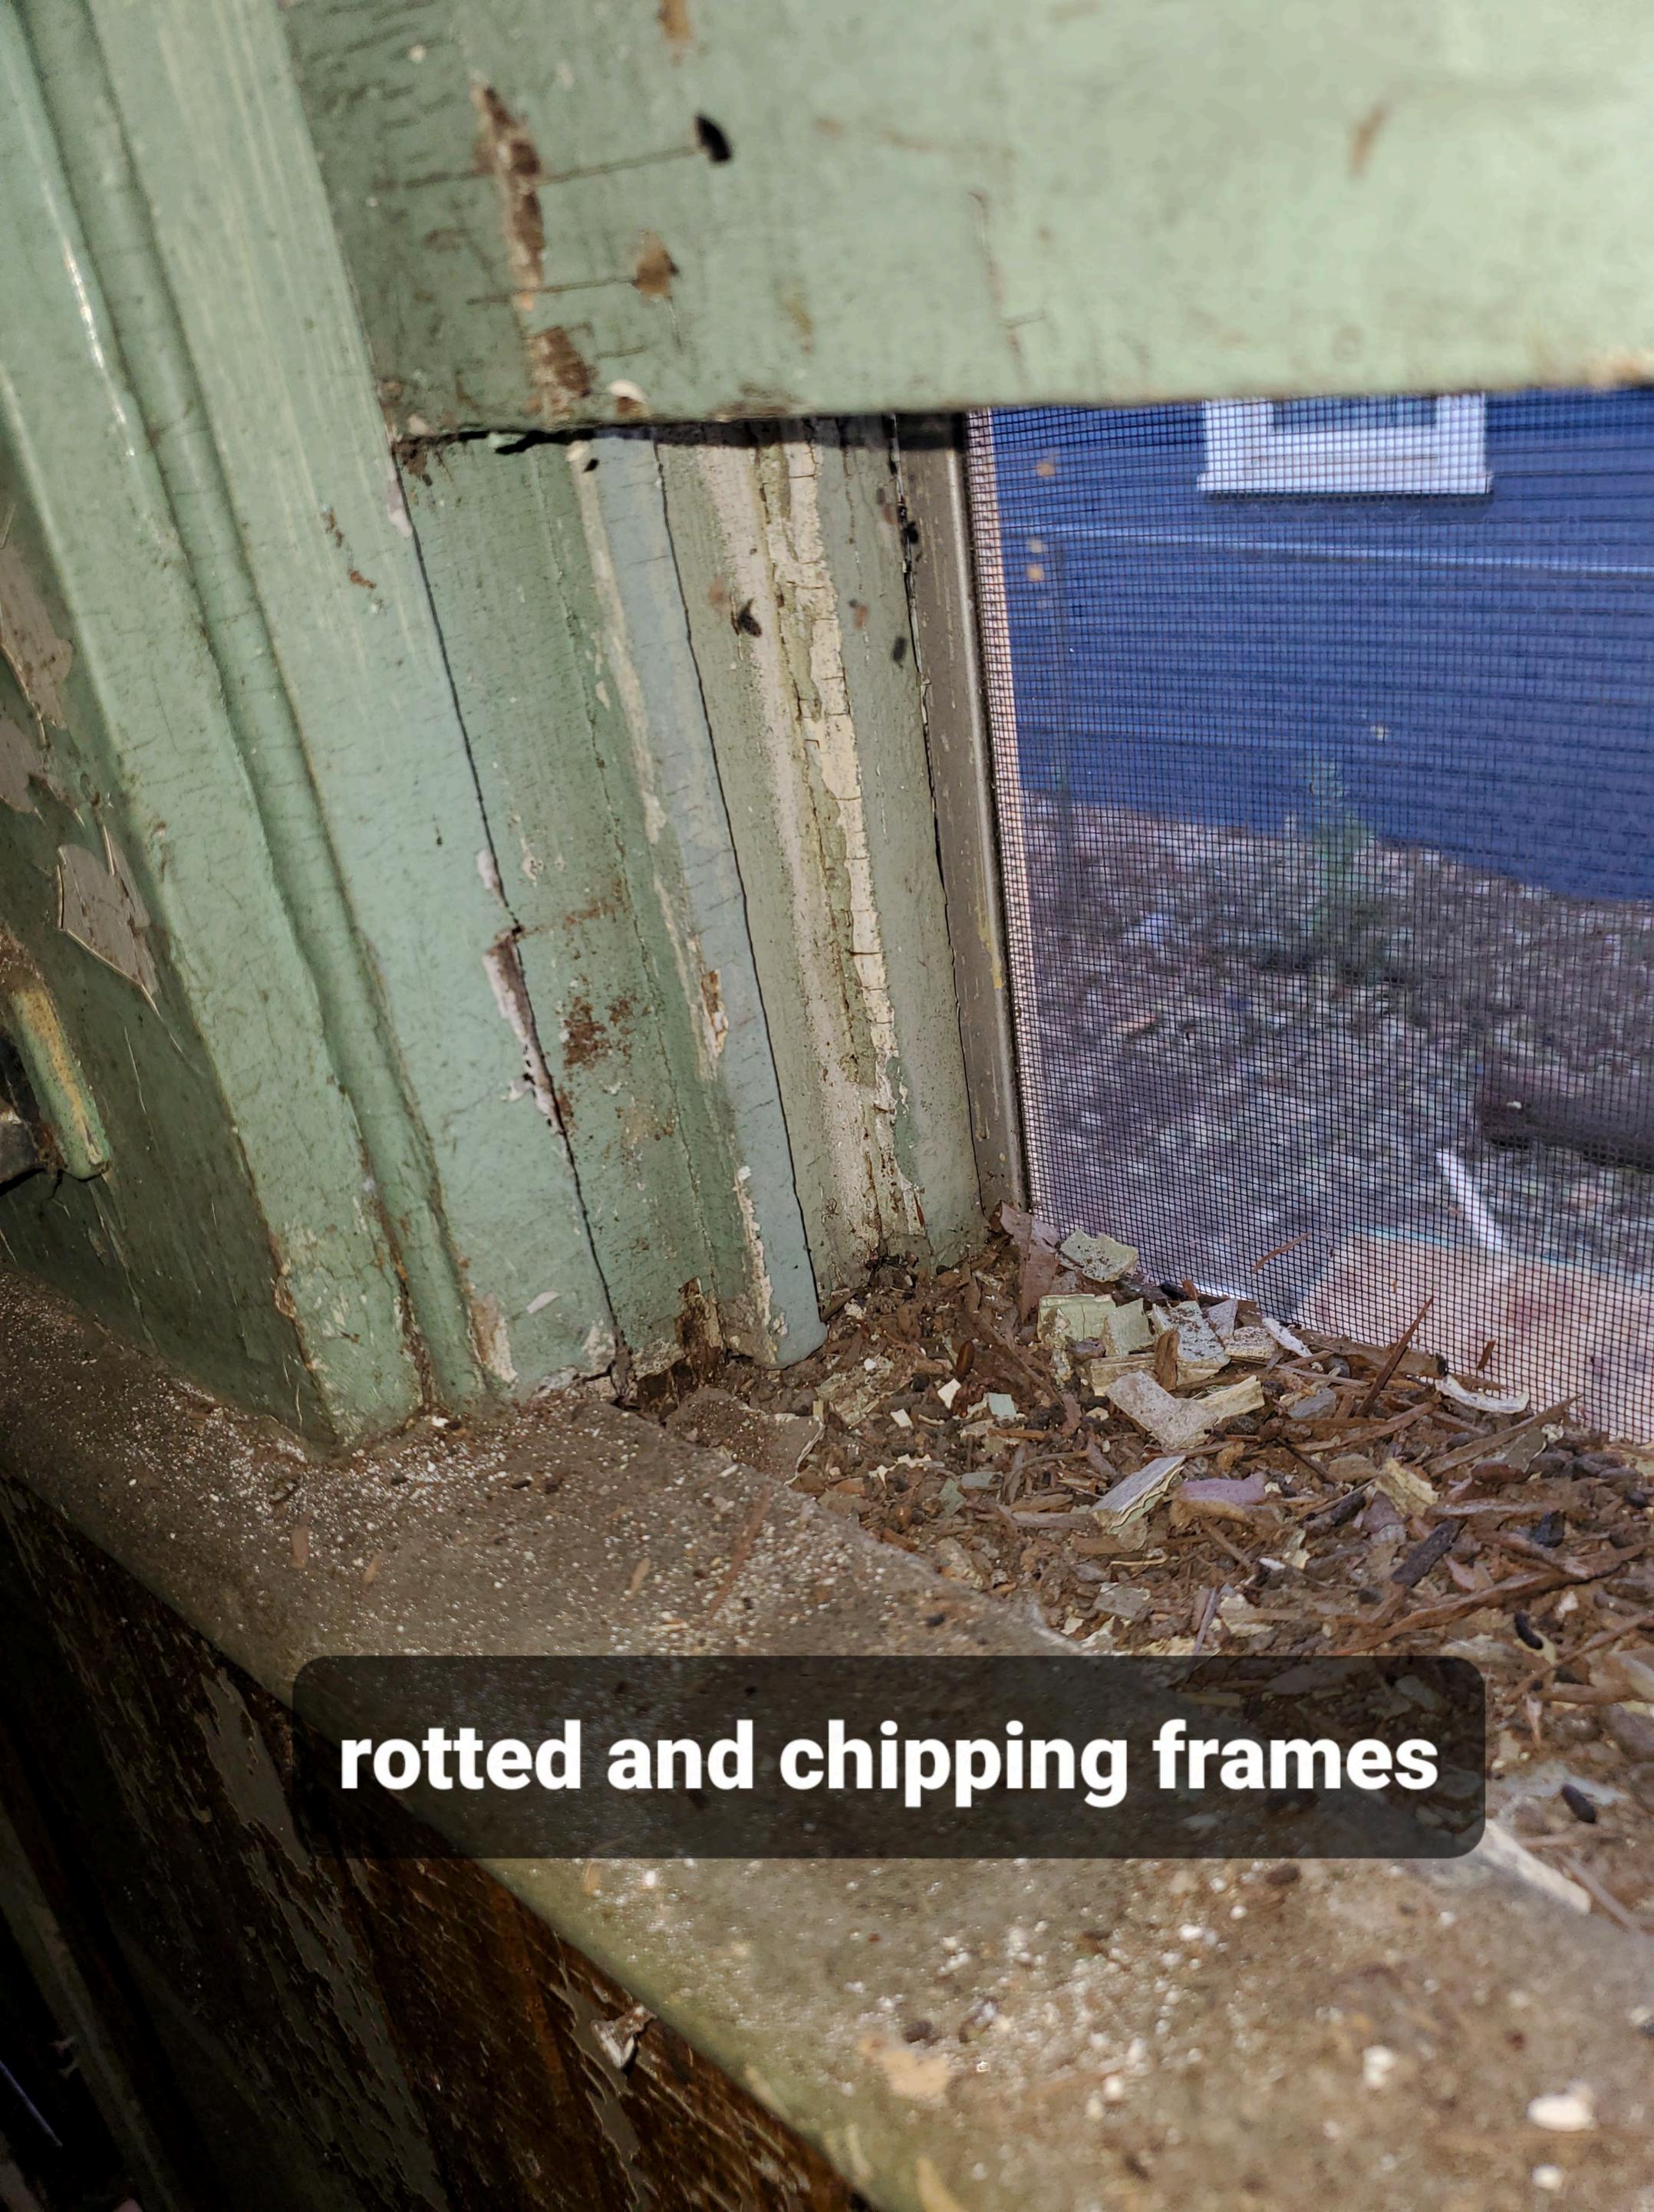
**rotted and chipping frames**

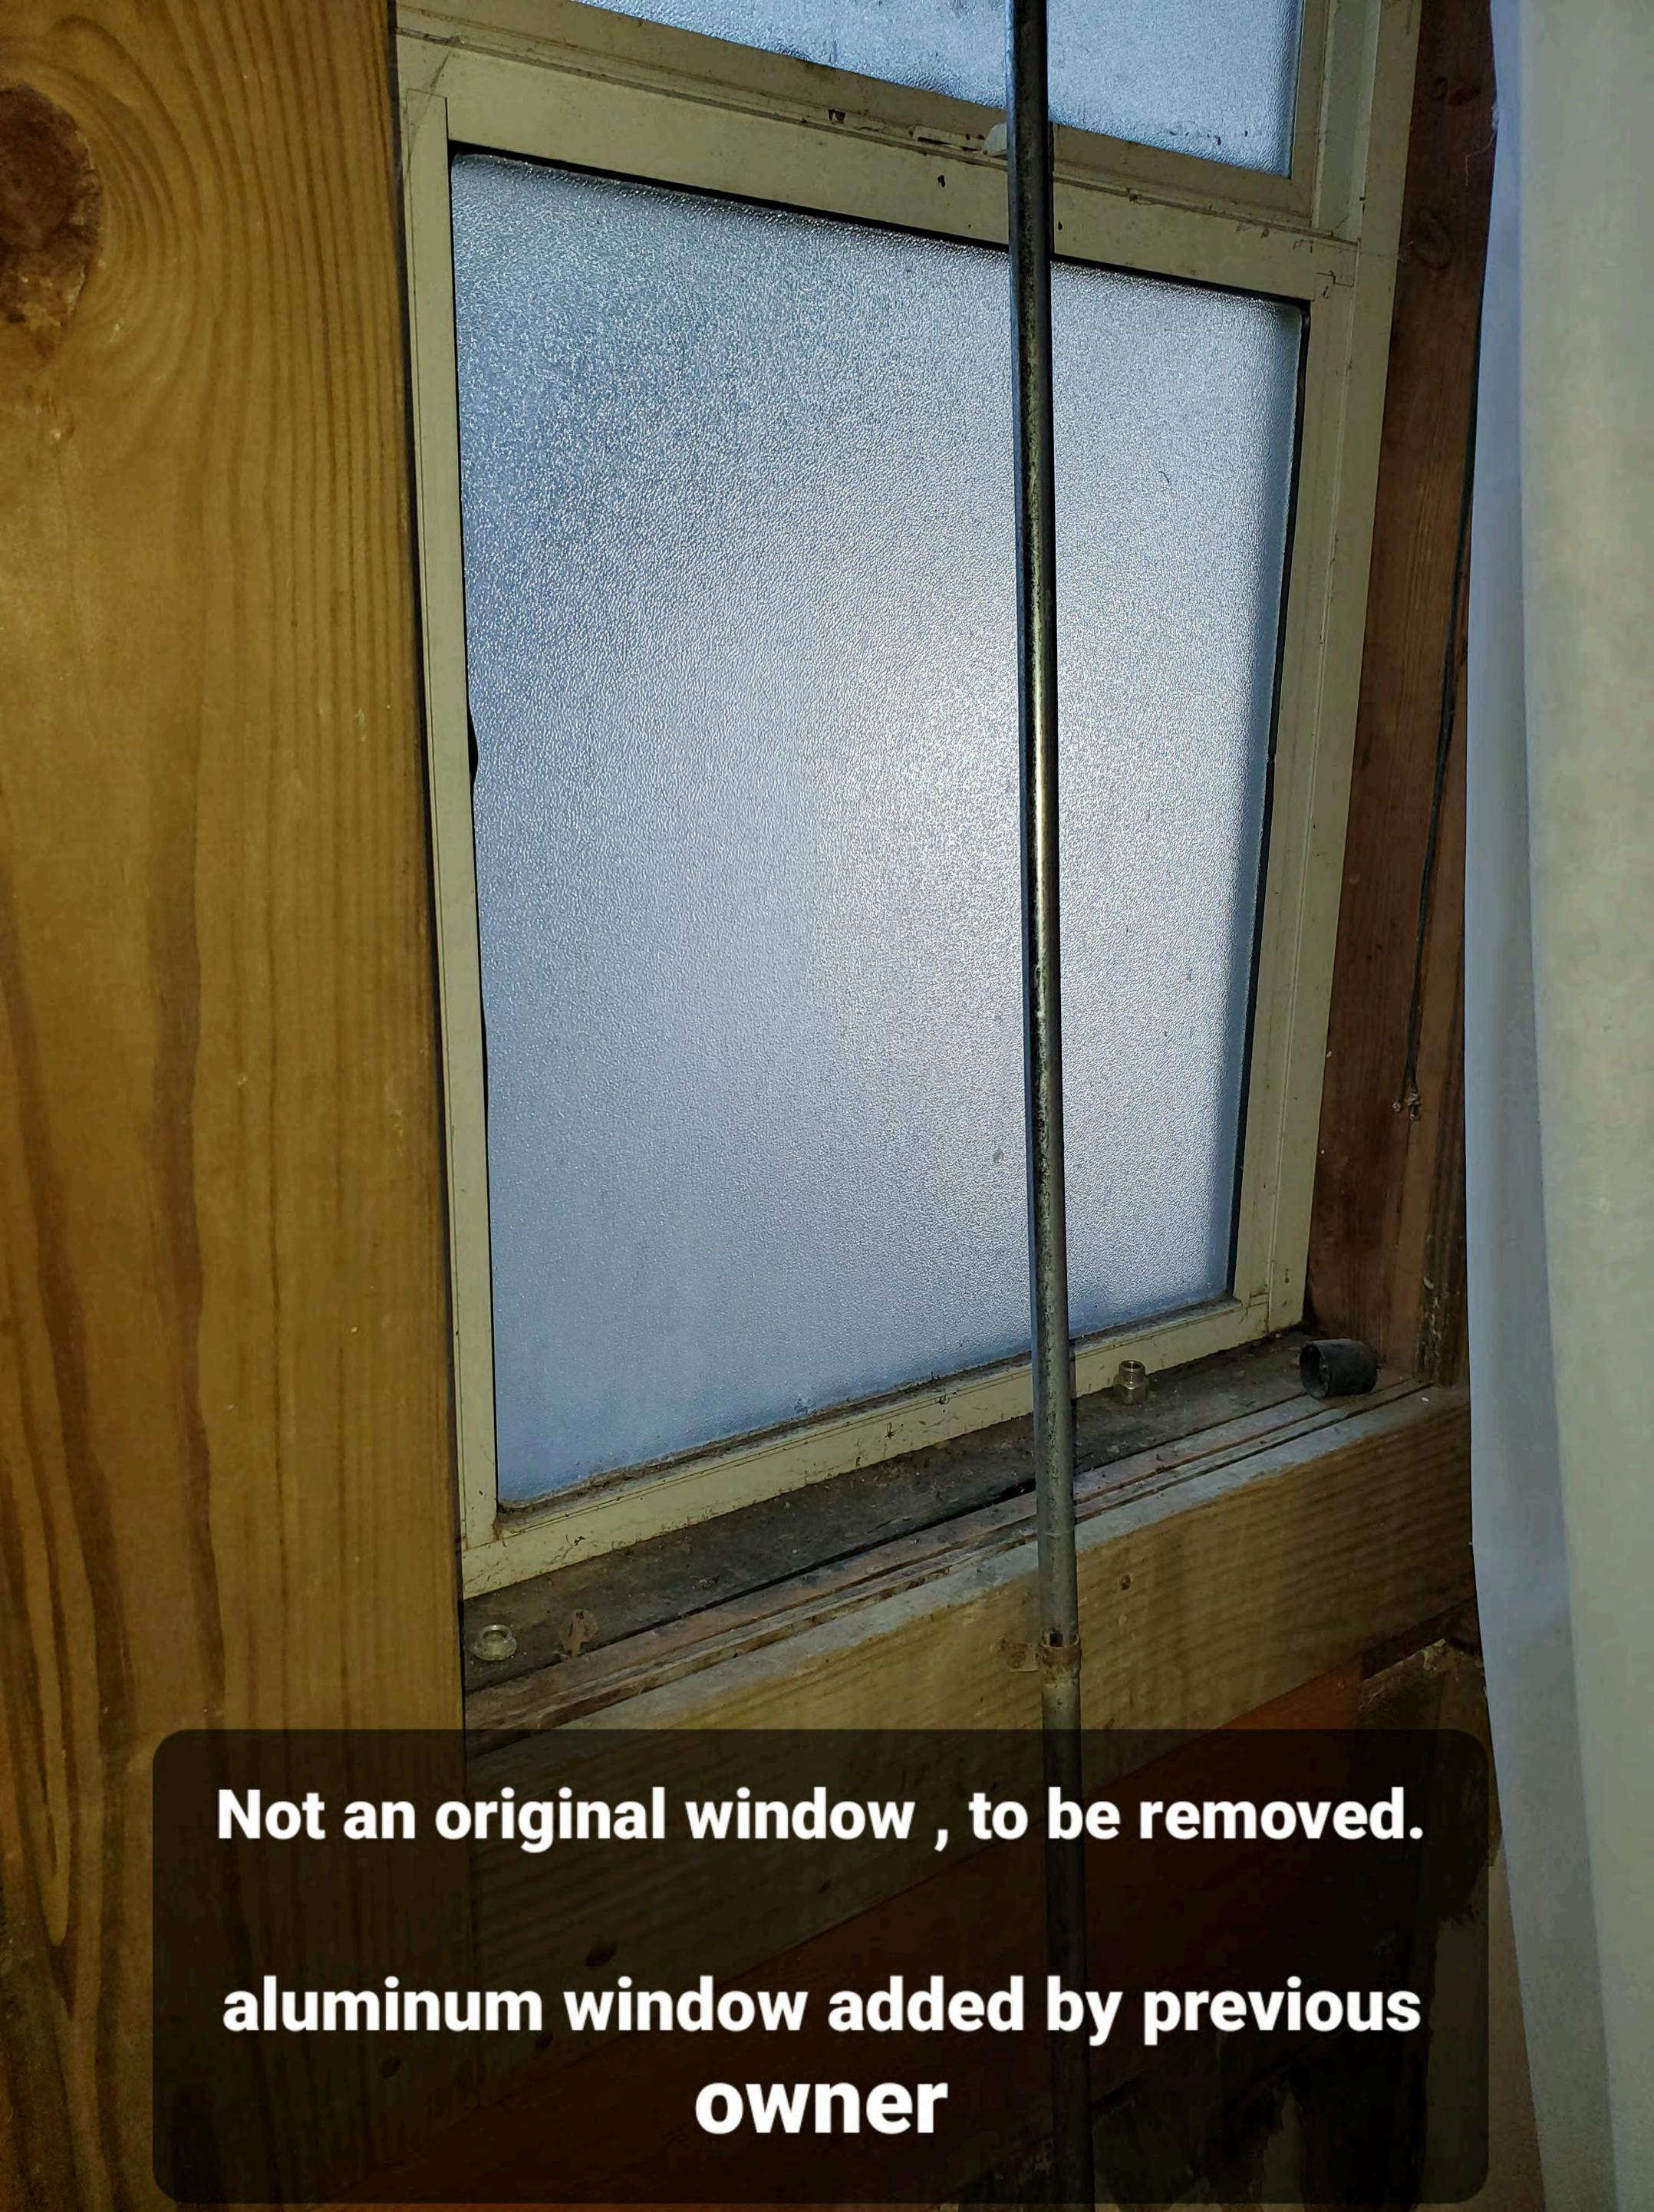
**FENESTRATION MODIFICATIONS** – The applicant is requesting to remove a non-conforming window from the first-floor east elevation. Staff observed during the site visit that it is likely that this window was added later, and the opening is not original to the house. According to the Historic Design Guidelines, new elements should not significantly alter or destroy historic building character. Opening modifications should be compatible and should be appropriate for the building style. The proposed removal of the non-conforming window and enclosing it with matching siding is generally consistent with the existing pattern on the opposite side of the house. Staff finds the request to be an appropriate treatment.

**Not an original window , to be removed.  
aluminum window added by previous  
owner**

Staff recommends approval of the removal of the non-conforming window located on the first-floor east elevation as submitted.
