HISTORIC AND DESIGN REVIEW COMMISSION

August 18, 2021

HDRC CASE NO: 2021-370
ADDRESS: 1017 S ALAMO ST
LEGAL DESCRIPTION: NCB 744 BLK 3 LOT 5
ZONING: NC S, H
CITY COUNCIL DIST.: 1
DISTRICT: King William Historic District
LANDMARK: Individual Landmark
APPLICANT: Bryce Johnson/Bravo Roofing
OWNER: RED BLUE PROPERTIES LLC
TYPE OF WORK: Installation of a standing seam metal roof featuring brown panels and a ridge cap
APPLICATION RECEIVED: July 21, 2021
60-DAY REVIEW: Not applicable due to City Council Emergency Orders
CASE MANAGER: Edward Hall

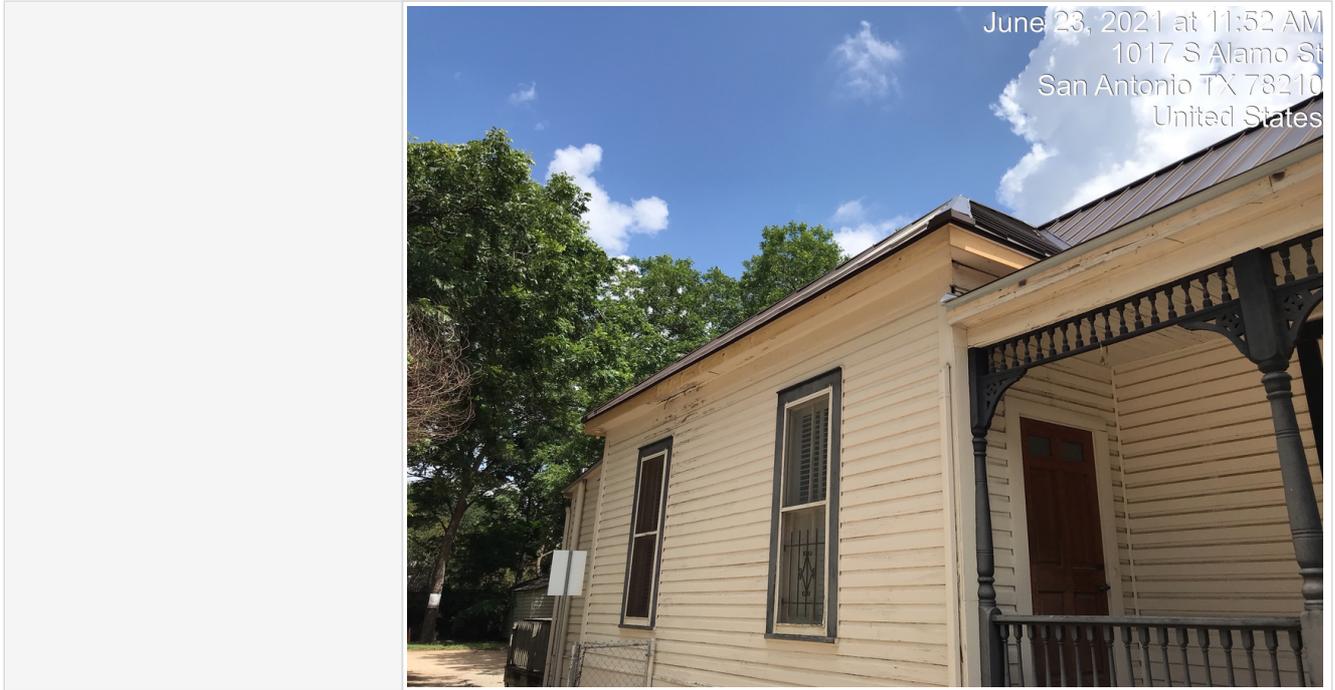
- b. VIOLATION – On June 23, 2021, OHP staff found that a standing seam metal roof has been installed at 1017 S Alamo prior to the issuance of a Certificate of Appropriateness and permit. OHP staff issued a notice of violation at that time. The standing seam metal roof features ridge caps, a brown color and replaced an existing, asphalt shingle roof.

Date	06/23/2021
Time	11:57 AM (-5 GMT)
Context	citizen report
Present Staff	Edward Hall
Present Individuals	Other
Types of Work Observed	Exterior Maintenance and Alterations
Amount of Work Completed	Completed
Description of work	The installation of a brown standing seam metal roof with a large ridge cap and fascia and trim replacement.
Description of interaction	EH spoke with office staff. A Notice of Violation was issued.

Staff does not recommend approval based on finding c. Staff recommends that a standing seam metal roof be installed that is consistent with the Guidelines and adheres to the following specifications: panels should be smooth and feature 18 to 21 inches in width, seams should be 1 to 2 inches tall, ridge seams should featured a crimped ridge seam, and

panels should feature a standard galvalume finish. Staff finds the color and ridge caps to be inconsistent with the Guidelines.

A standing seam metal roof inspection is to be schedule with OHP staff to ensure that roofing materials are consistent with approved design.
