# HISTORIC AND DESIGN REVIEW COMMISSION

**HDRC CASE NO:** 2024-106  
**ADDRESS:** 2619 MCCULLOUGH AVE  
**LEGAL DESCRIPTION:** NCB 1704 BLK 12 LOT N1-2 OF 12 & 13  
**ZONING:** O-1, H  
**CITY COUNCIL DIST.:** 1  
**DISTRICT:** Monte Vista Historic District  
**APPLICANT:** Bertha Zuniga/Zuniga Law, PLLC  
**OWNER:** Bertha Zuniga/Zuniga Law, PLLC  
**TYPE OF WORK:** Fenestration modifications and infill of eight wood windows  
**APPLICATION RECEIVED:** March 07, 2024  
**60-DAY REVIEW:** May 6, 2024  
**CASE MANAGER:** Claudia Espinosa

The applicant is requesting a Certificate of Appropriateness for approval to:

1. Remove and infill eight wood windows on the north and south façade of the second-floor previously enclosed porch.
2. Replace the five existing operable windows on the south façade with fixed windows.

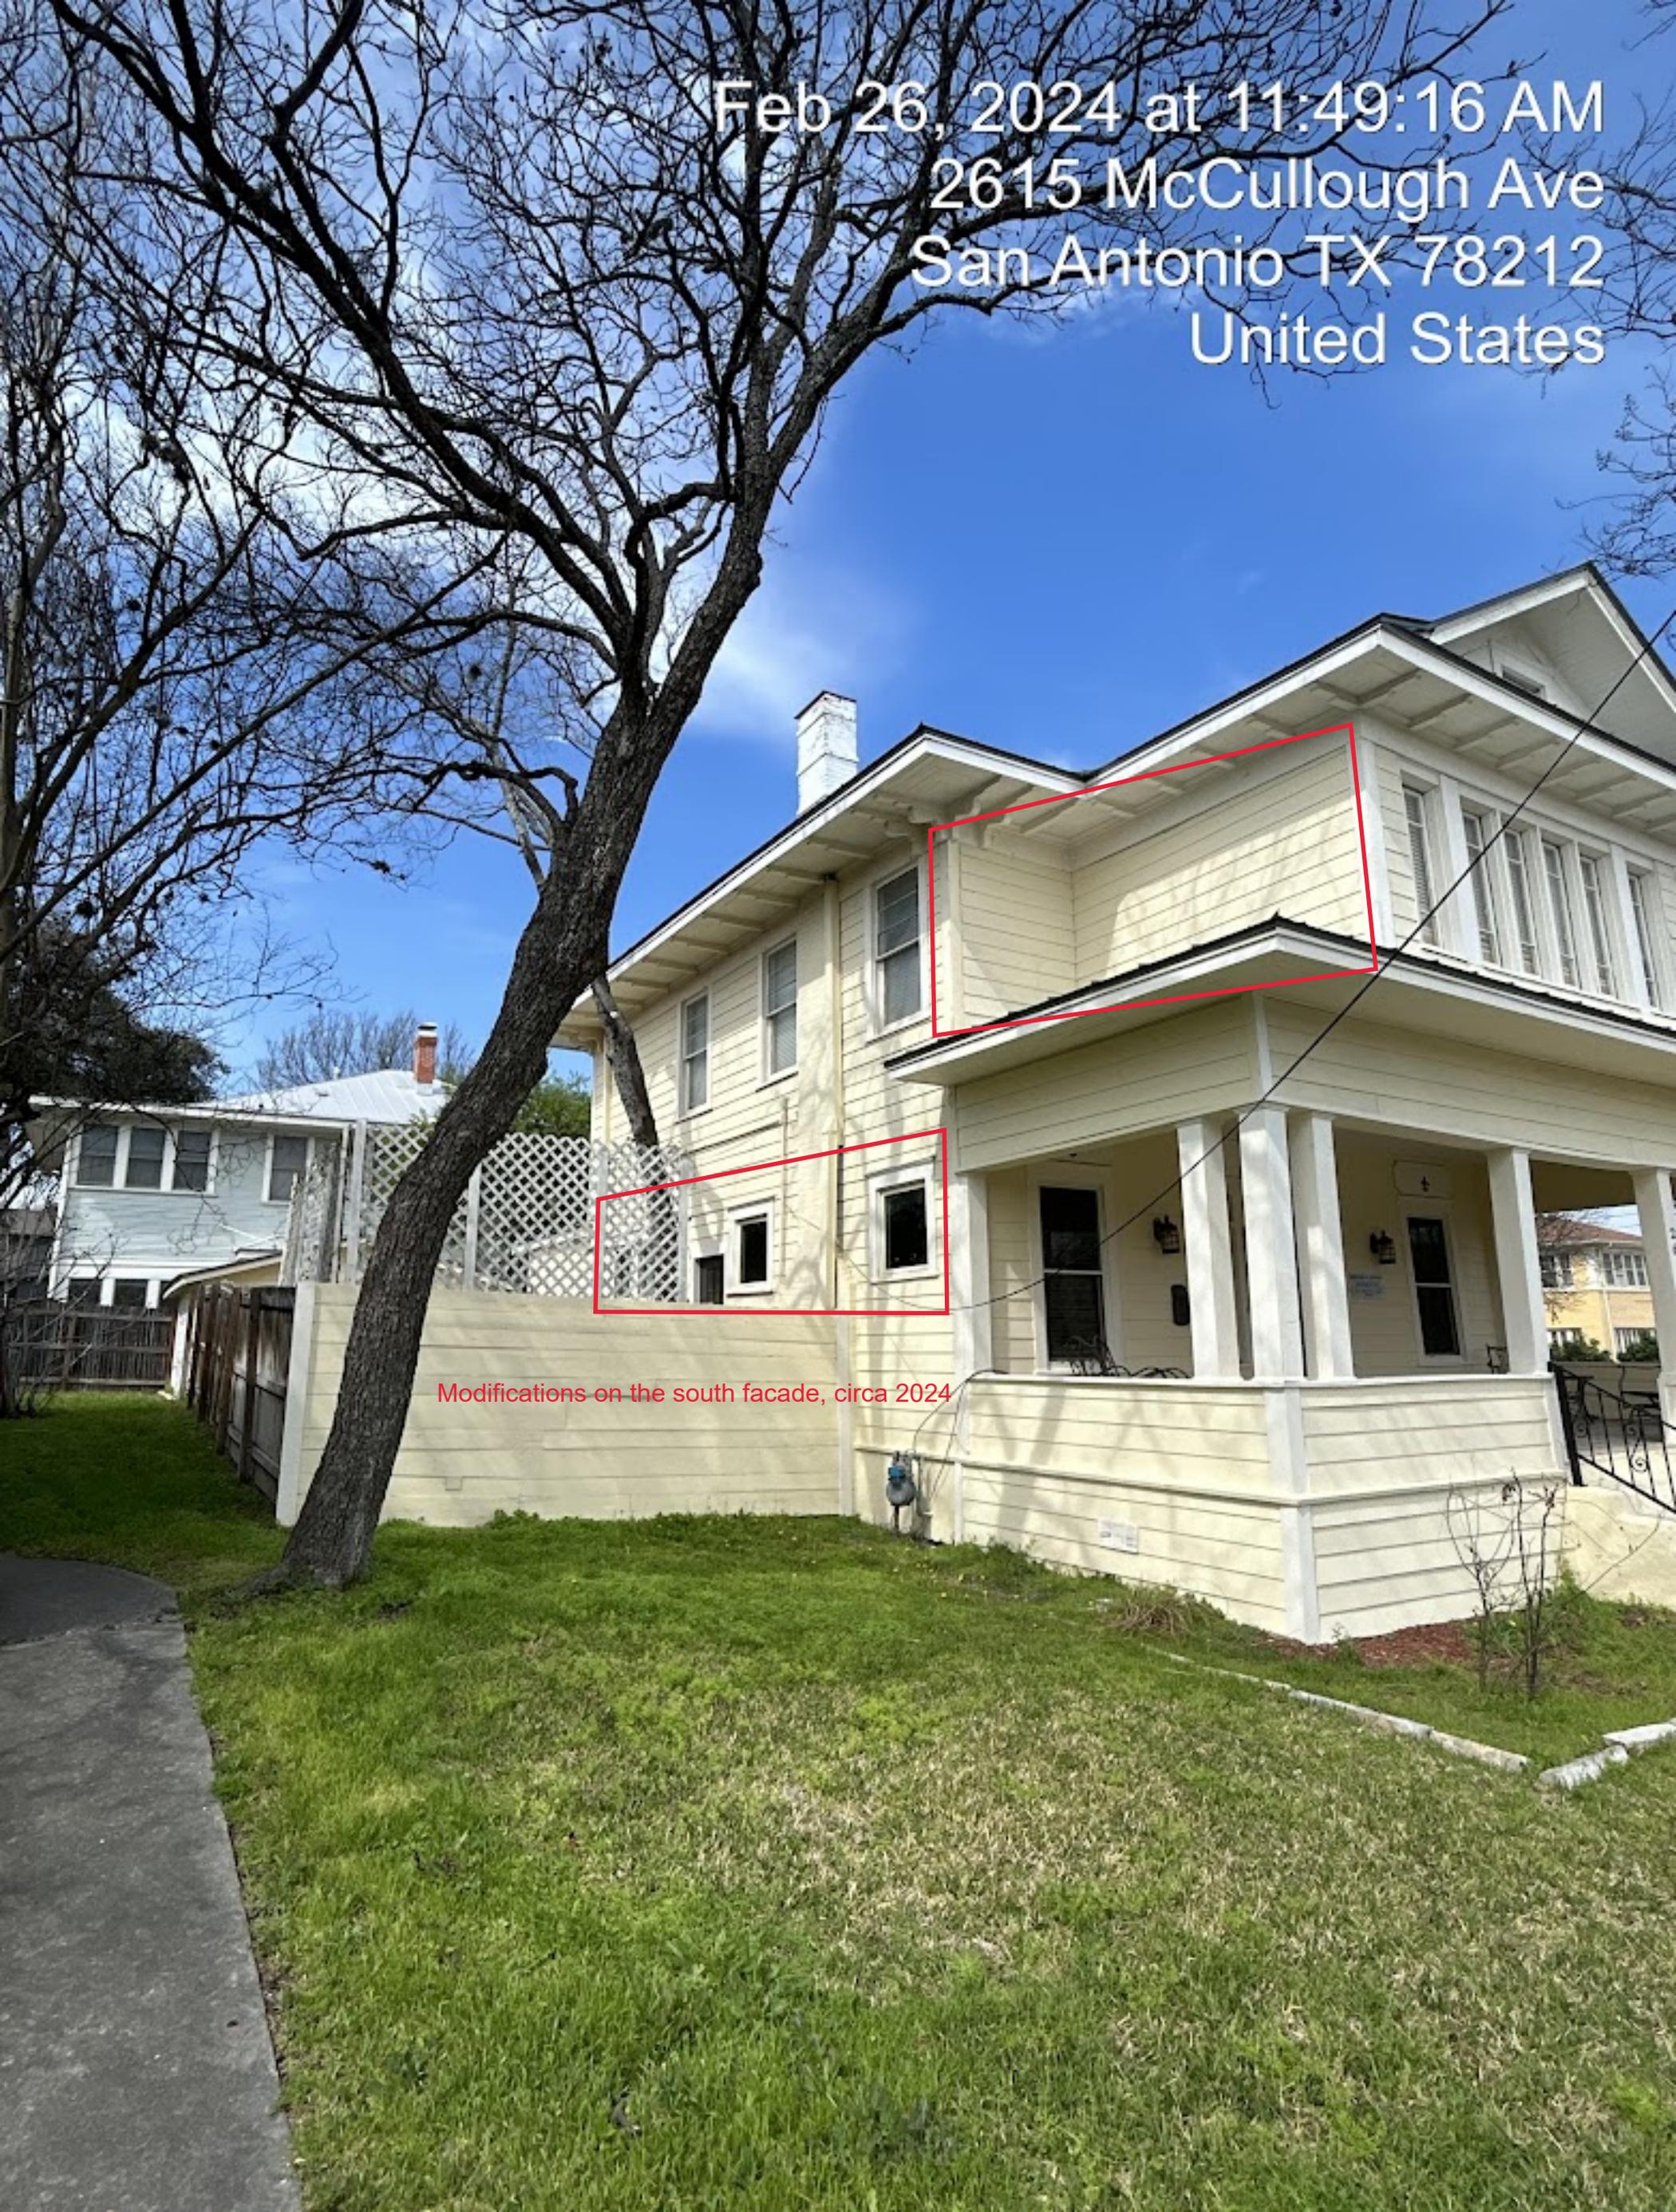
e. WINDOW OPENING MODIFICATION (SOUTH FACADE) – The applicant has proposed to modify five (5) window opening on the south façade of the original structure by shortening the overall size of the opening. The Guidelines for Exterior Maintenance and Alterations 6.A.i. notes that existing window and door openings should be preserved. Staff finds the proposed modifications to be inconsistent with the Guidelines.

Modifications on the south facade, circa 2024

Item 2, staff does not recommend approval of the window replacement on the south façade, based on finding d. Staff recommends that the applicant reinstall the wood windows that were previously in place or a salvaged product that replicates the previously installed windows in size, operation, design, and configuration.

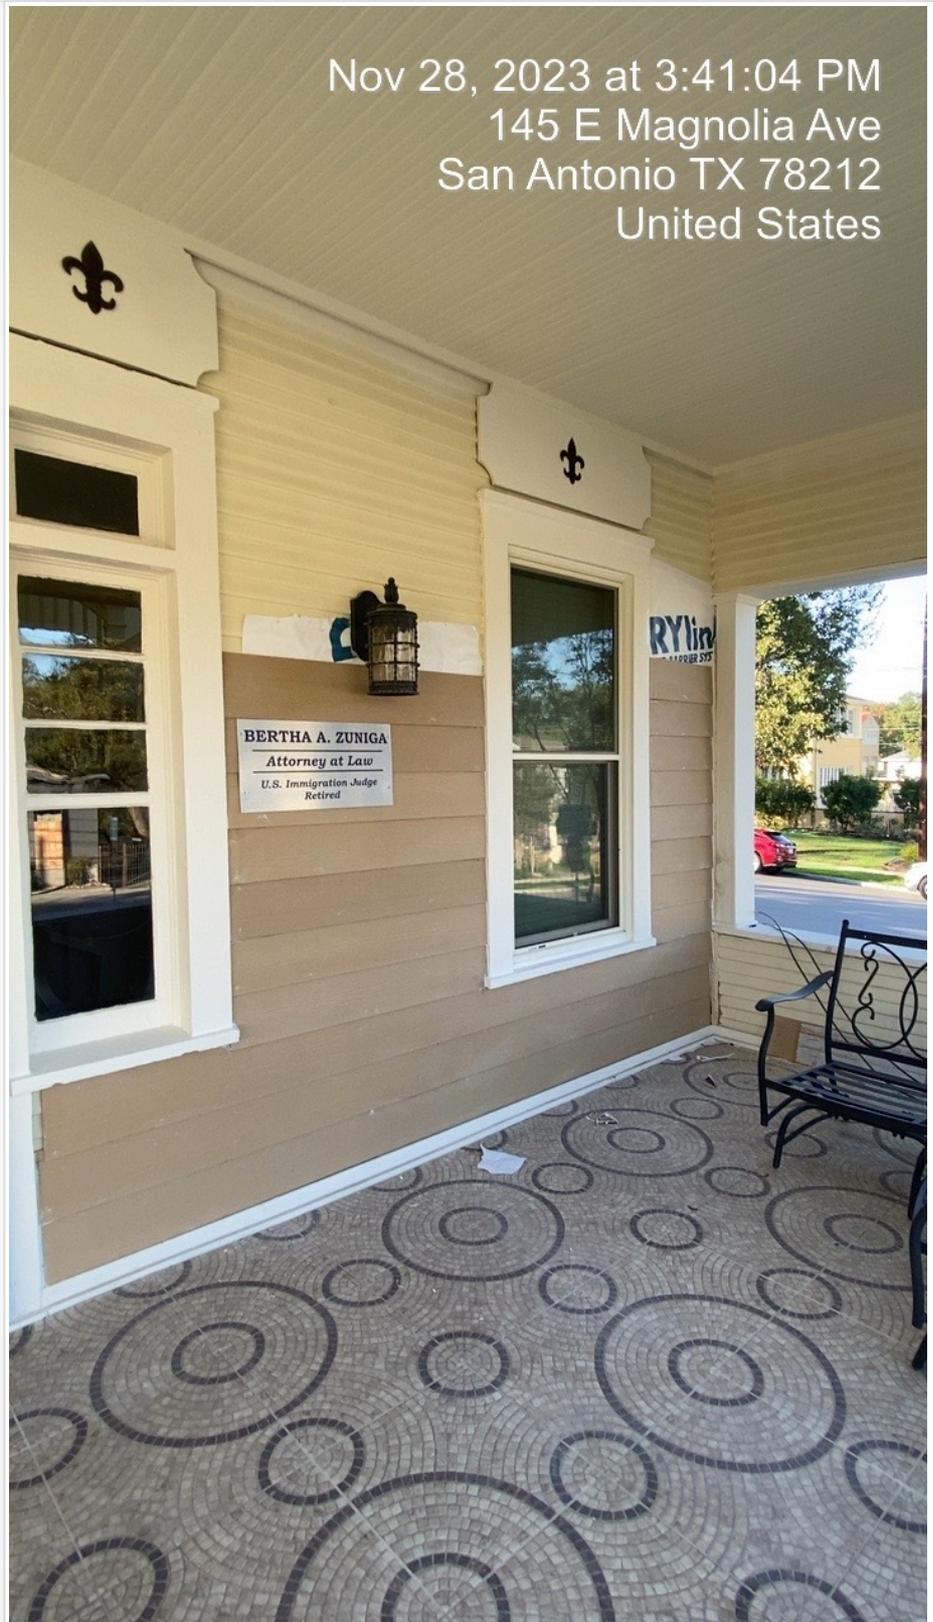
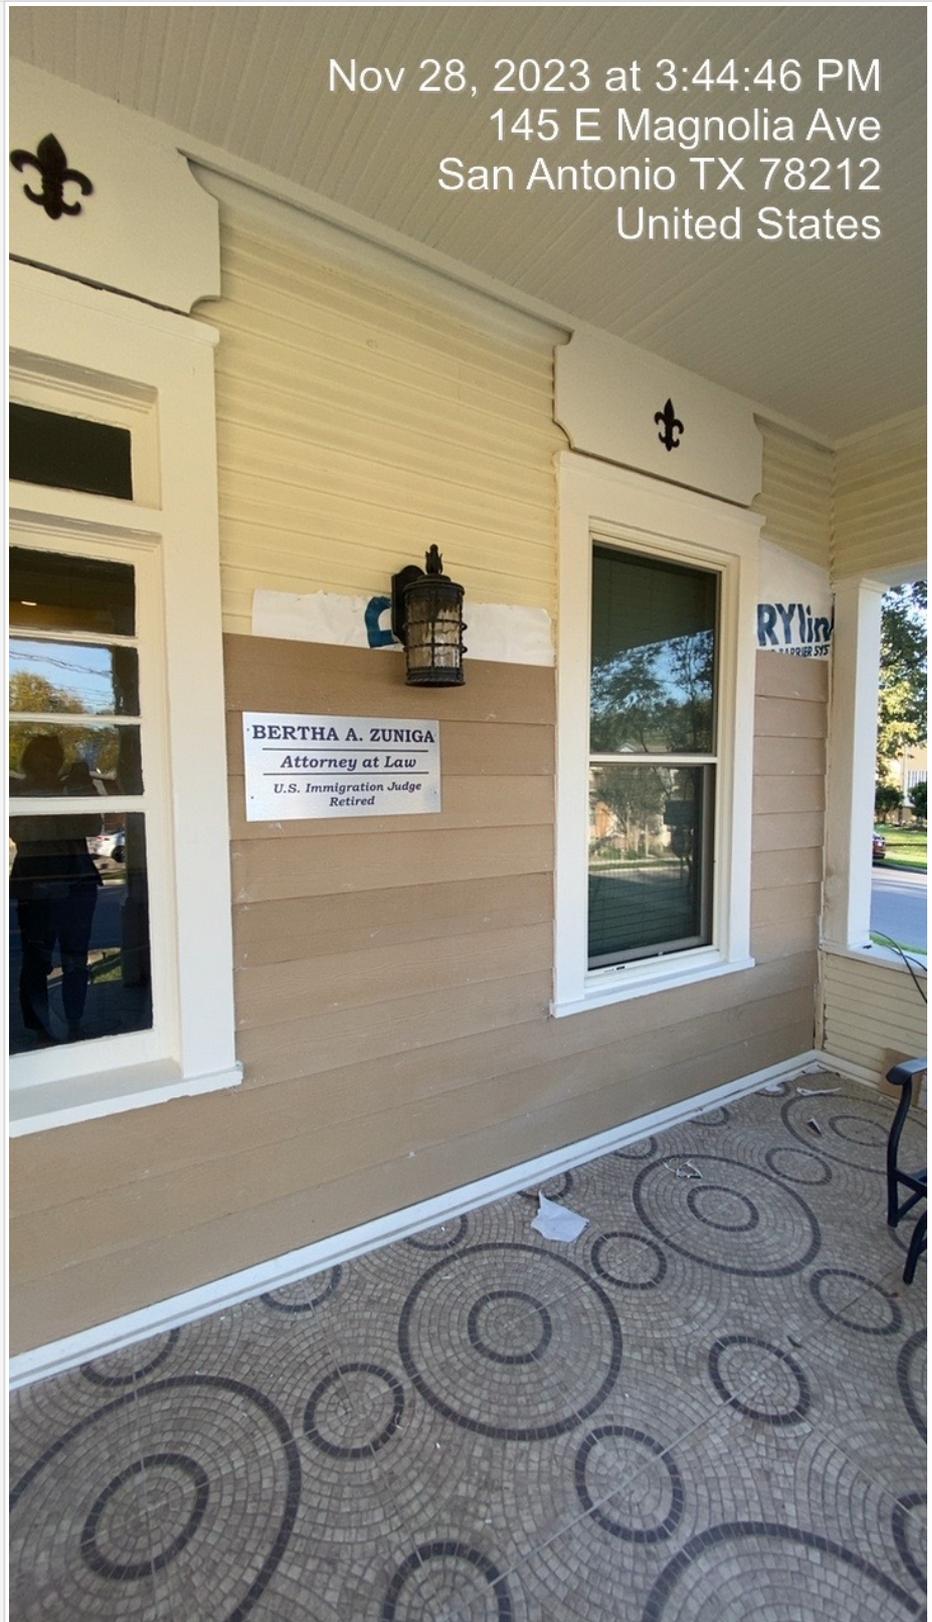
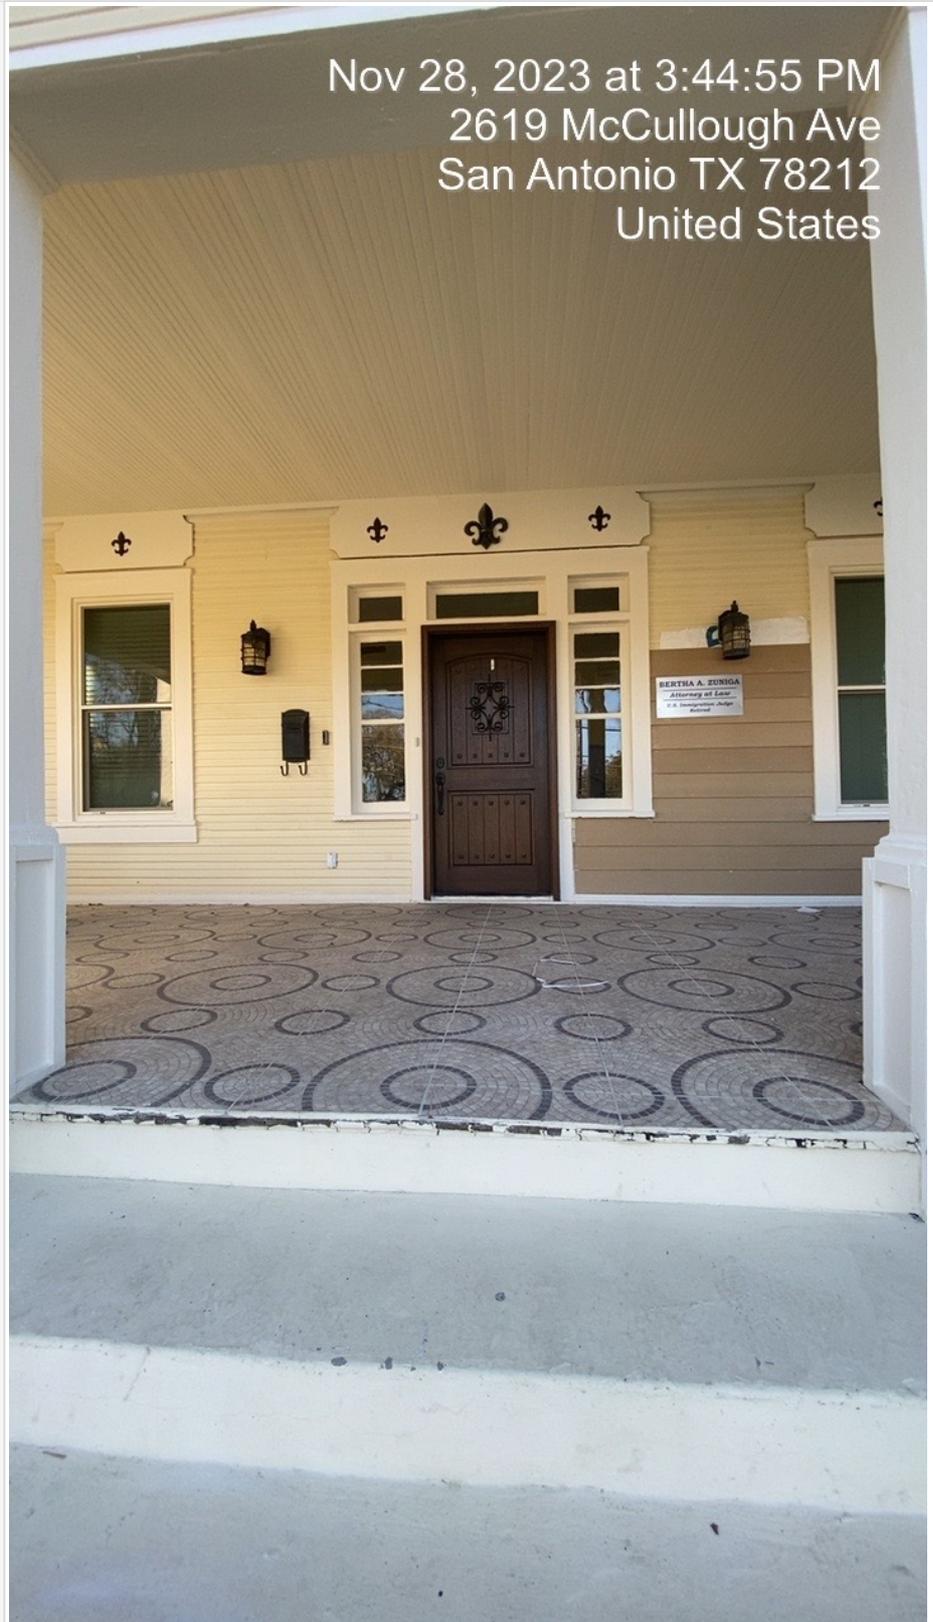
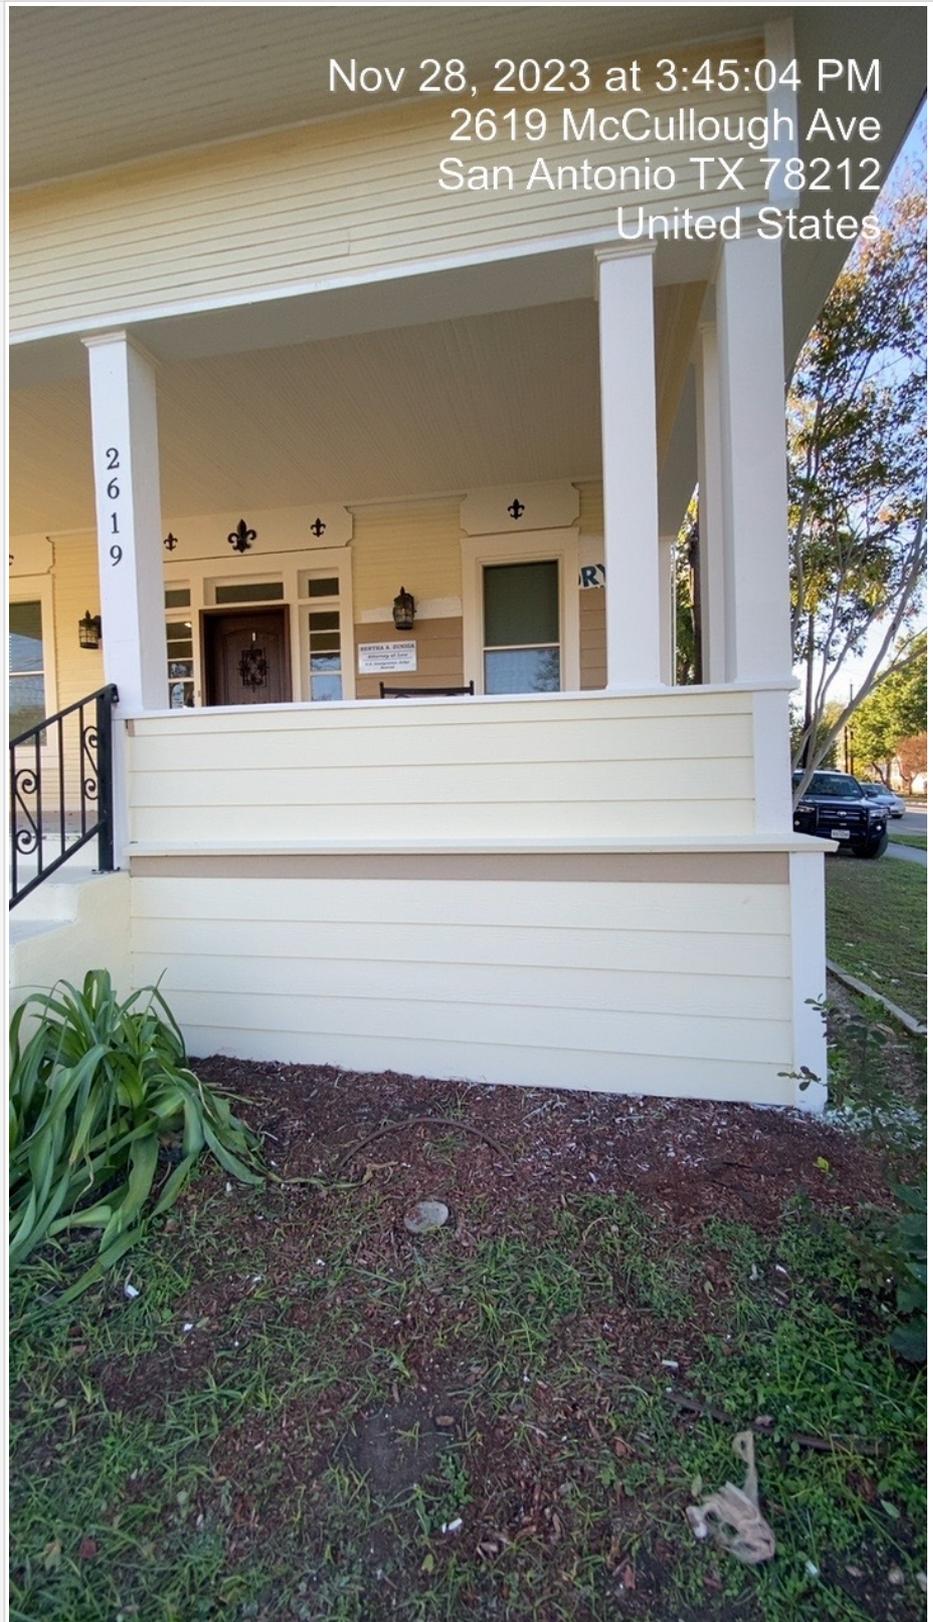
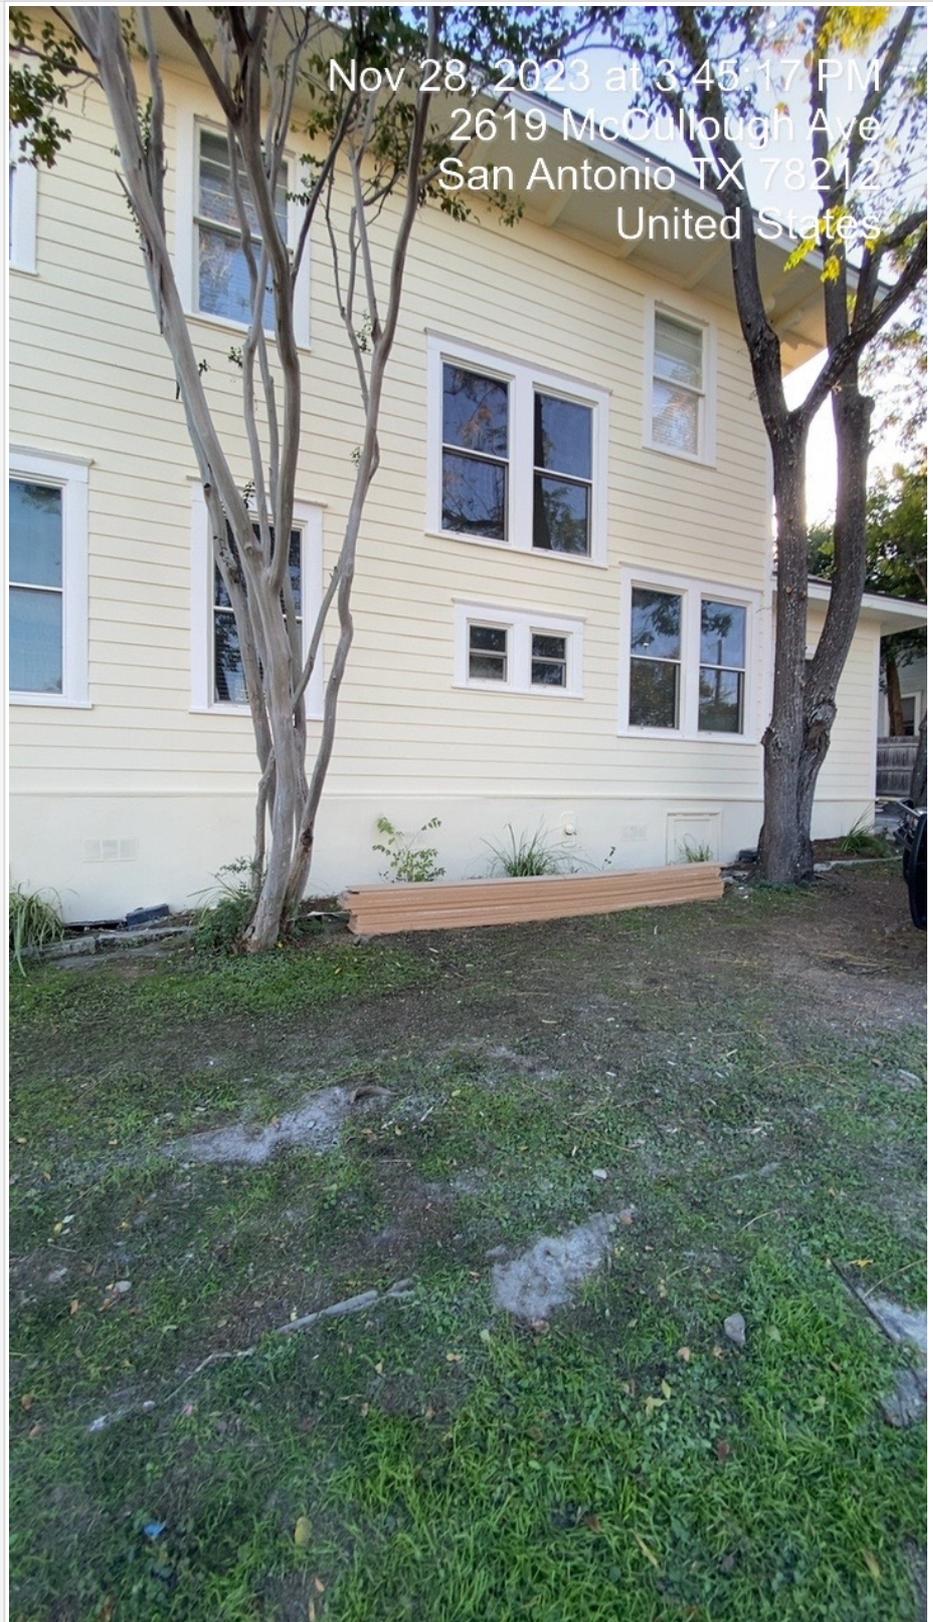
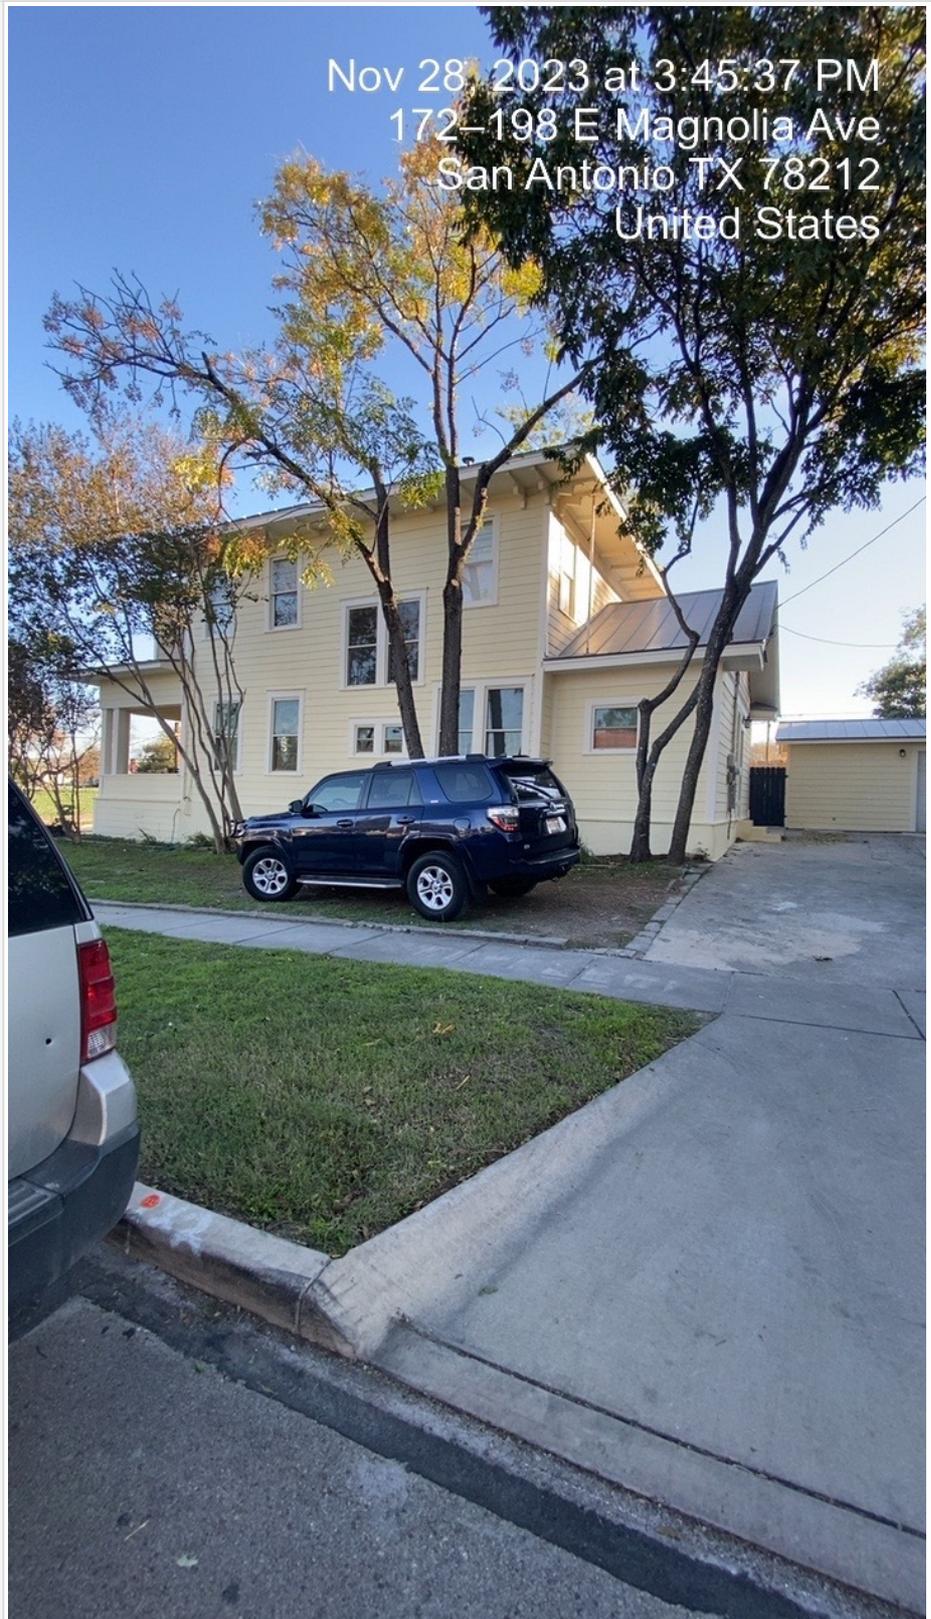
| Description of work | Installation of siding on top of existing siding. |
