# HISTORIC AND DESIGN REVIEW COMMISSION

**HDRC CASE NO:** 2024-106  
**ADDRESS:** 2619 MCCULLOUGH AVE  
**LEGAL DESCRIPTION:** NCB 1704 BLK 12 LOT N1-2 OF 12 & 13  
**ZONING:** O-1, H  
**CITY COUNCIL DIST.:** 1  
**DISTRICT:** Monte Vista Historic District  
**APPLICANT:** Bertha Zuniga/Zuniga Law, PLLC  
**OWNER:** Bertha Zuniga/Zuniga Law, PLLC  
**TYPE OF WORK:** Fenestration modifications and infill of eight wood windows  
**APPLICATION RECEIVED:** March 07, 2024  
**60-DAY REVIEW:** May 6, 2024  
**CASE MANAGER:** Claudia Espinosa

The applicant is requesting a Certificate of Appropriateness for approval to:

1. Remove and infill eight wood windows on the north and south façade of the second-floor previously enclosed porch.
2. Replace the five existing operable windows on the south façade with fixed windows.

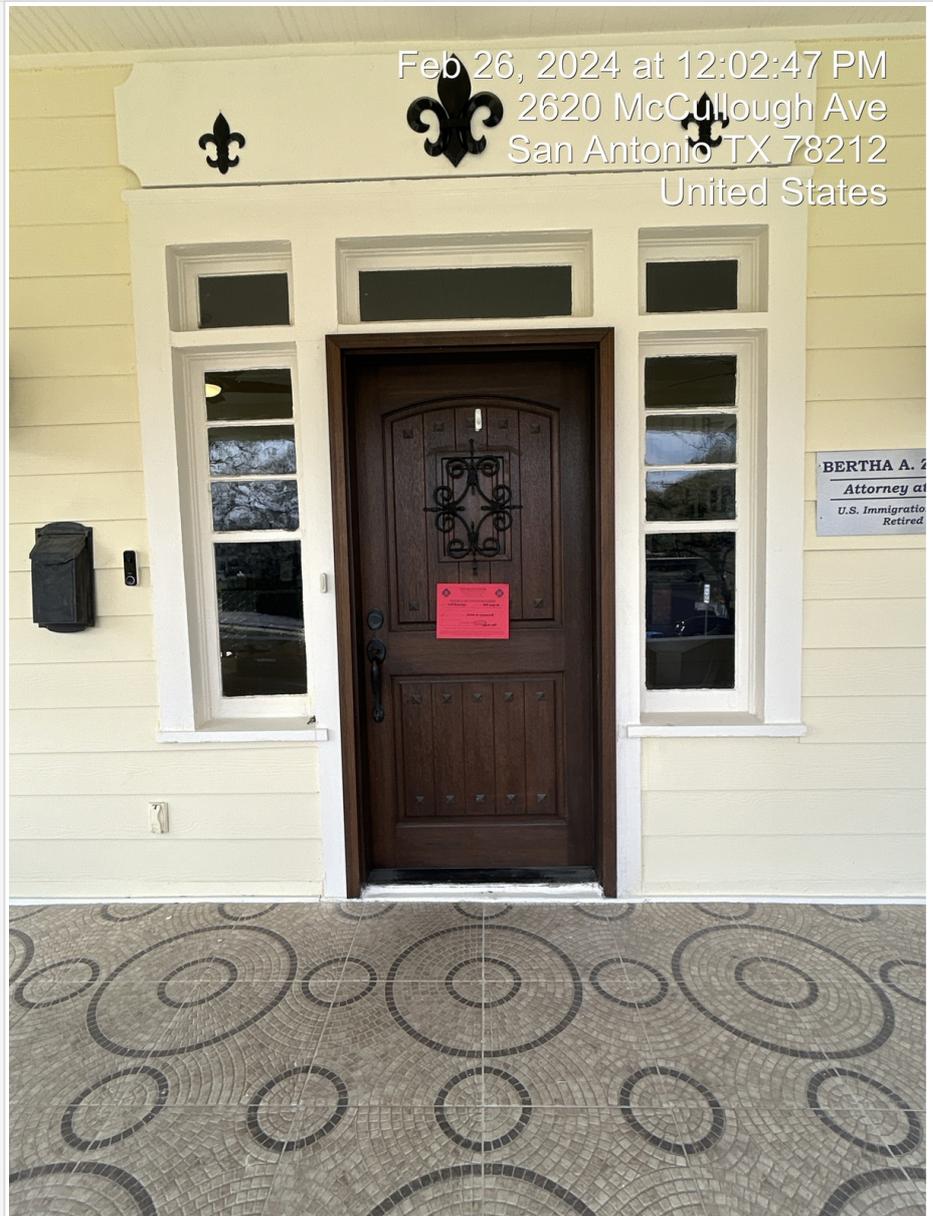
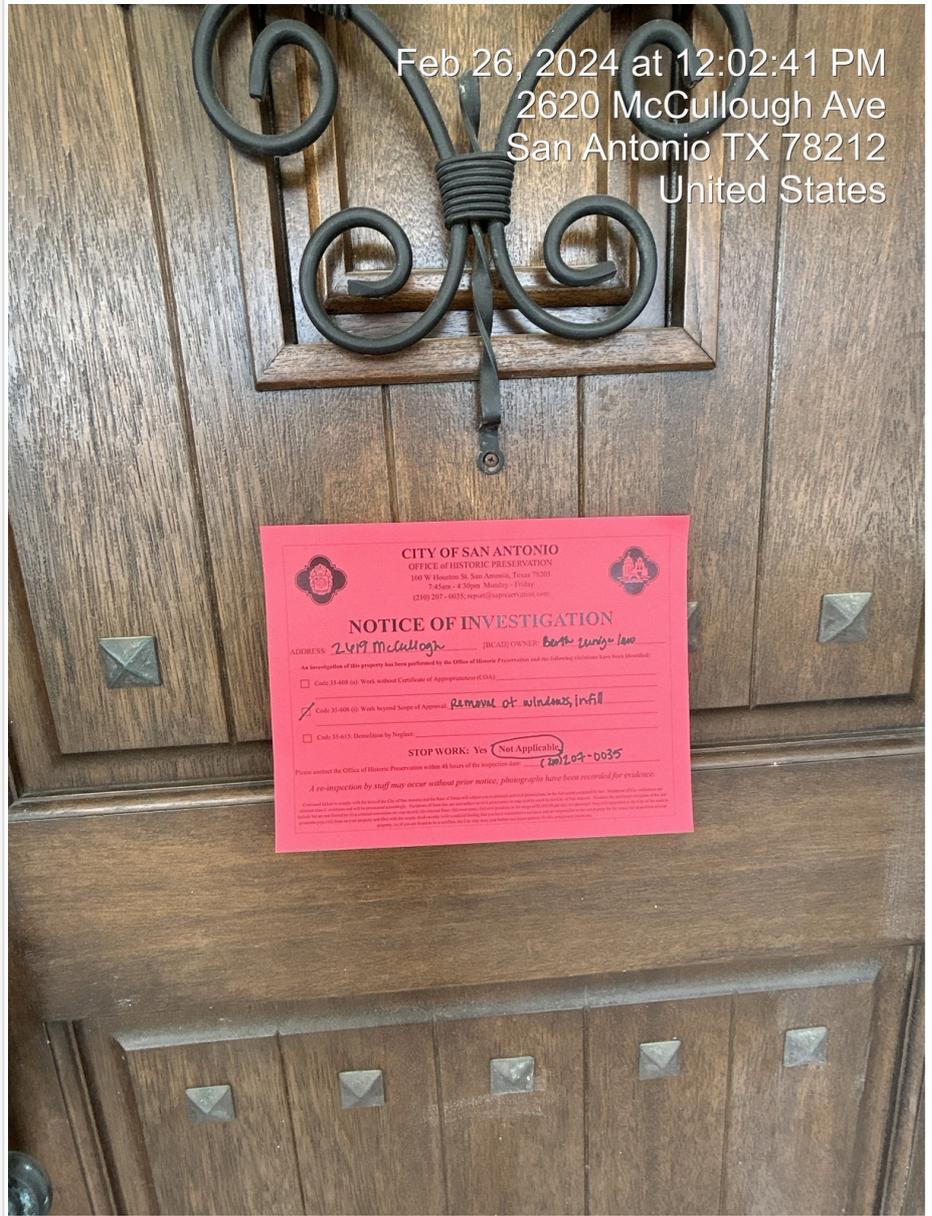
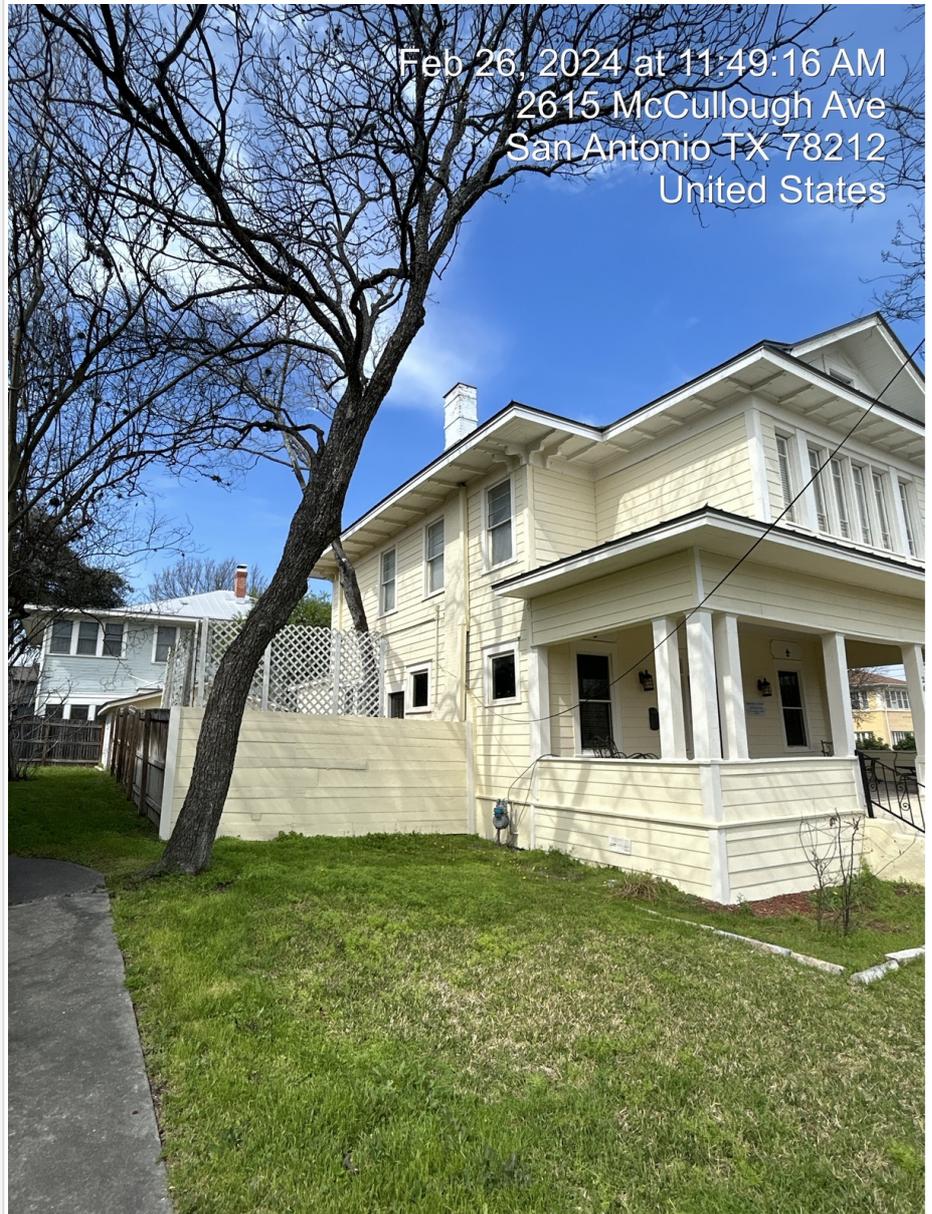
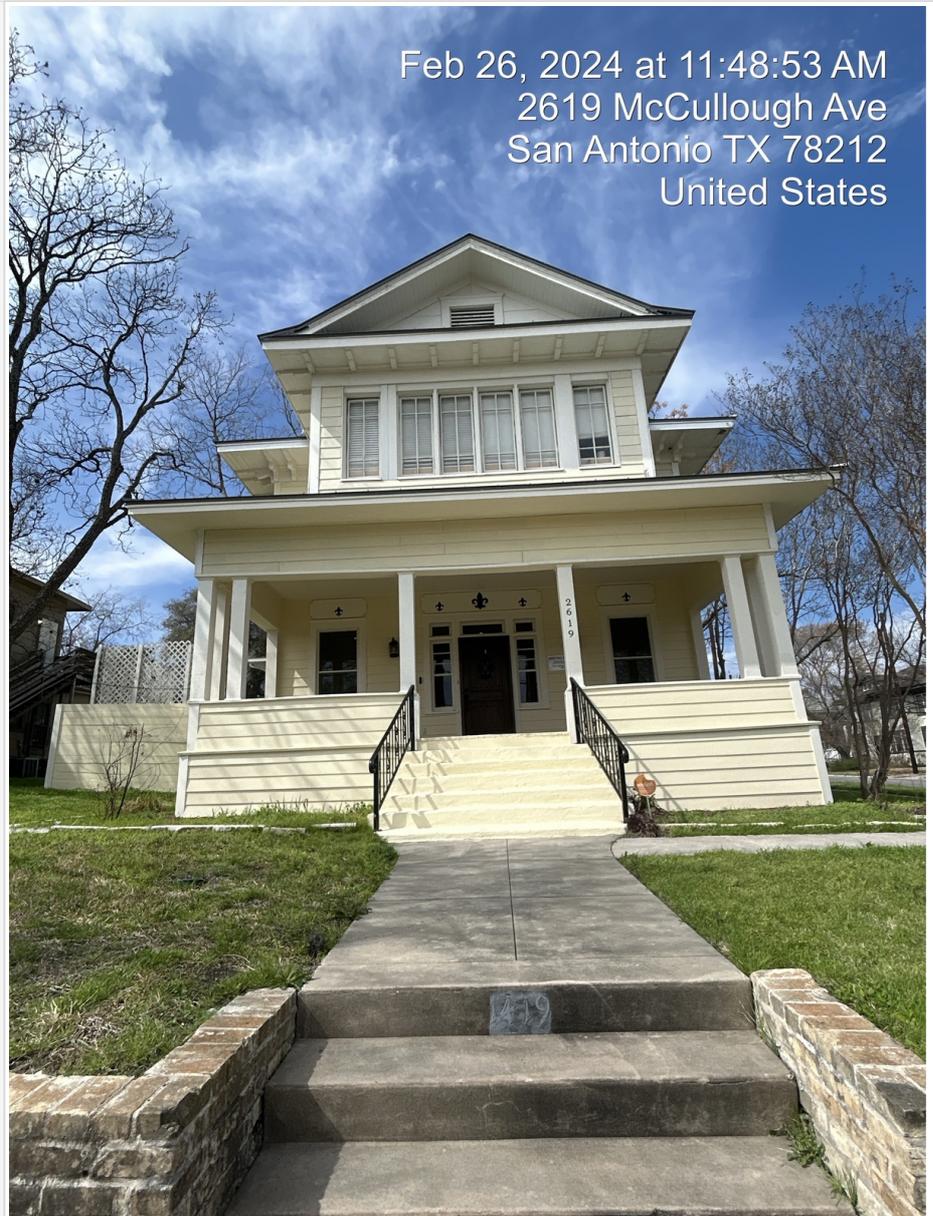
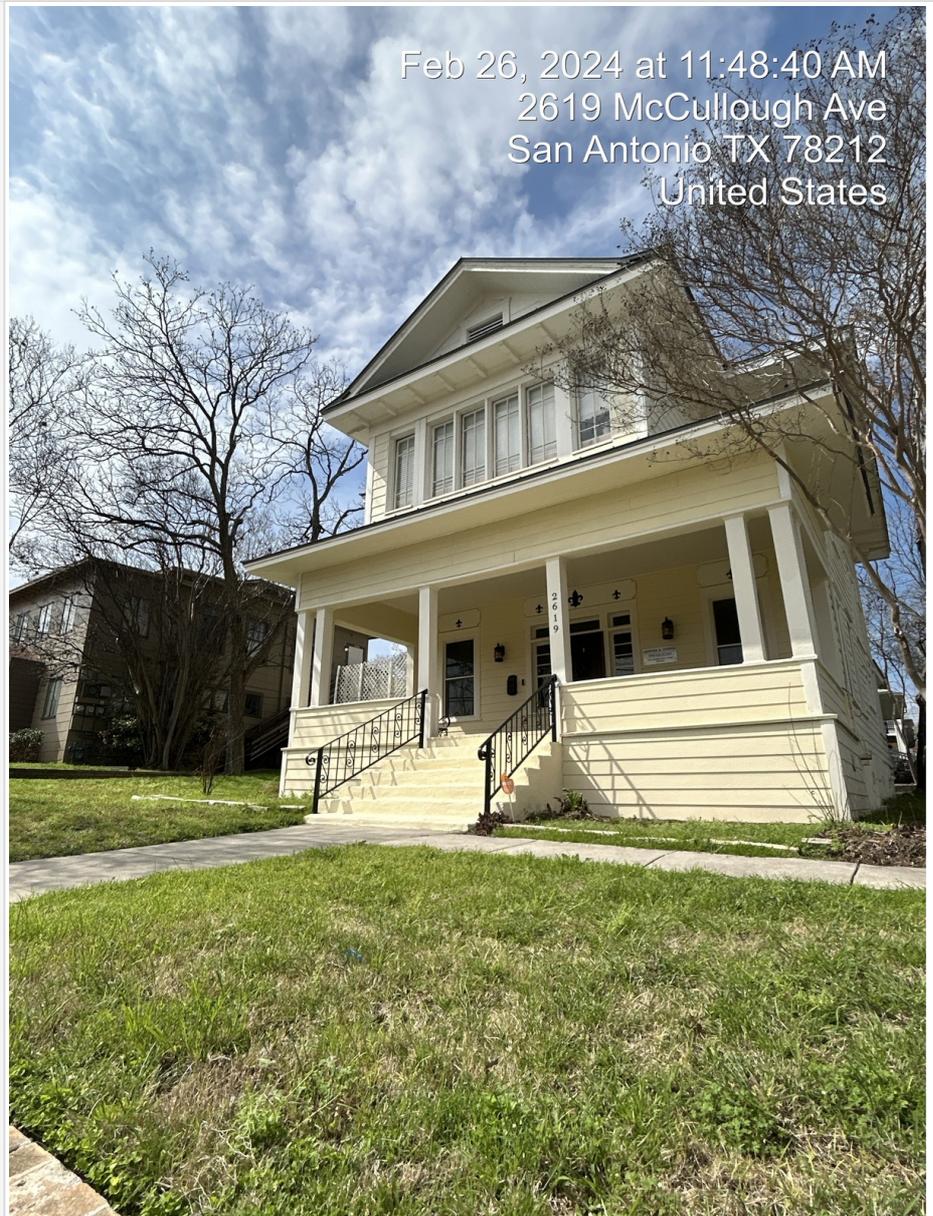
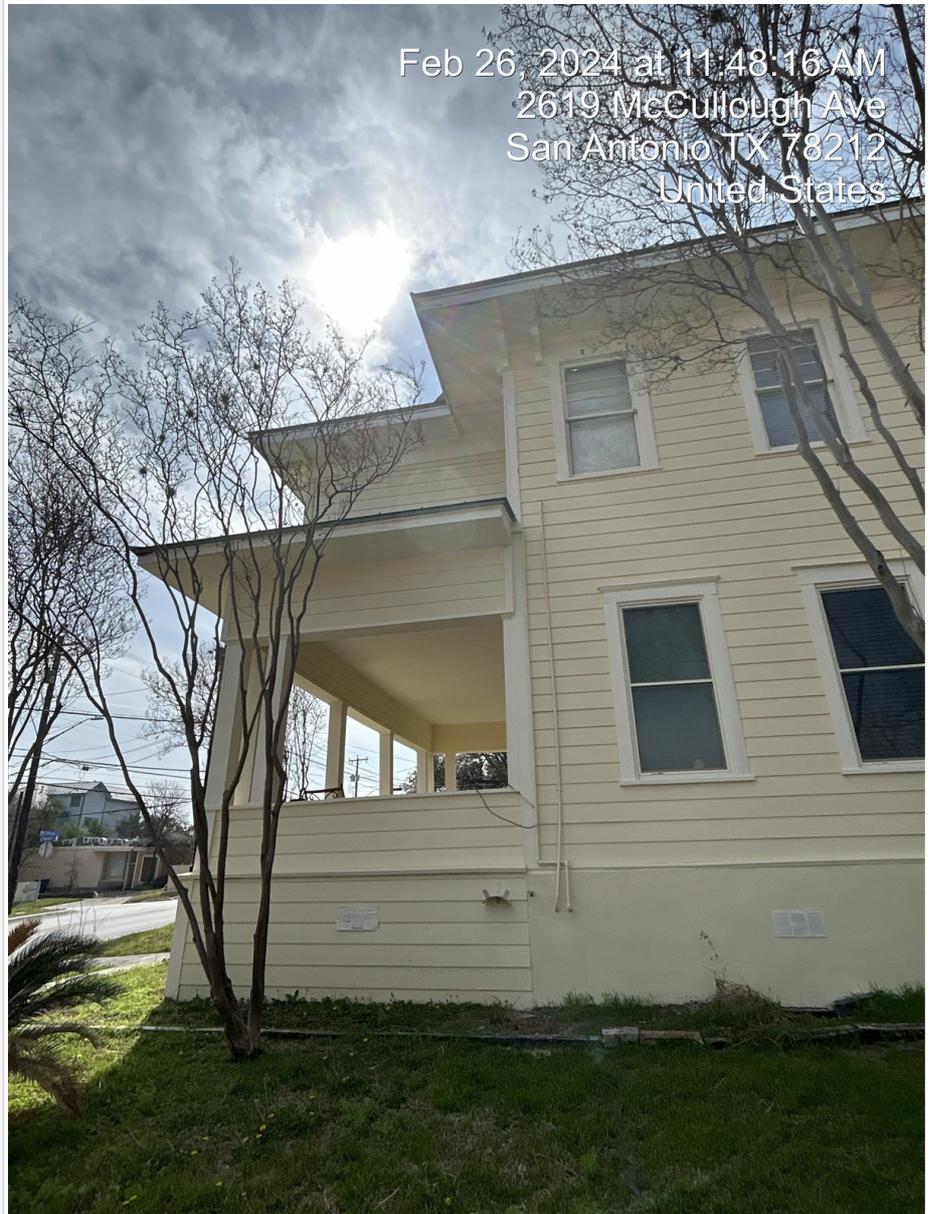
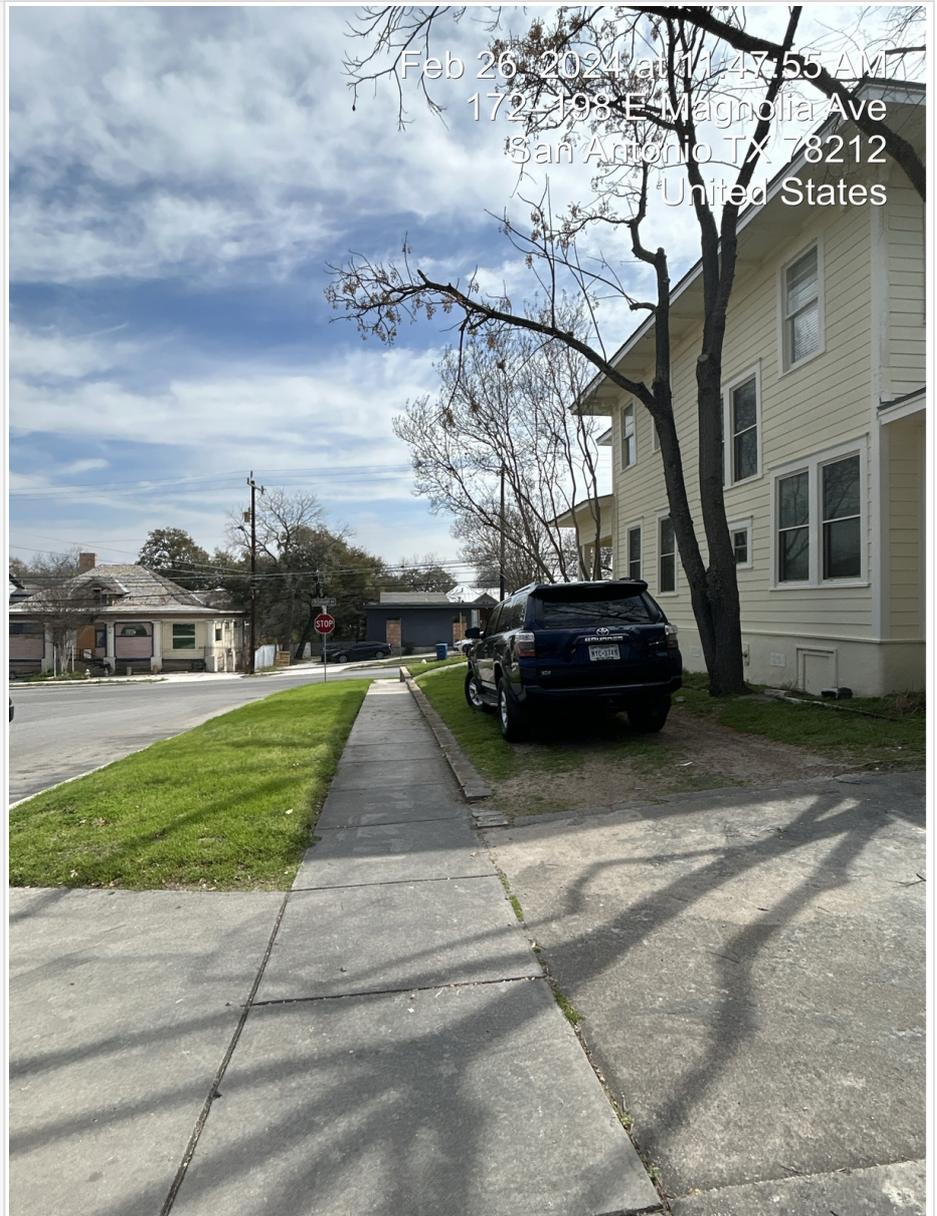
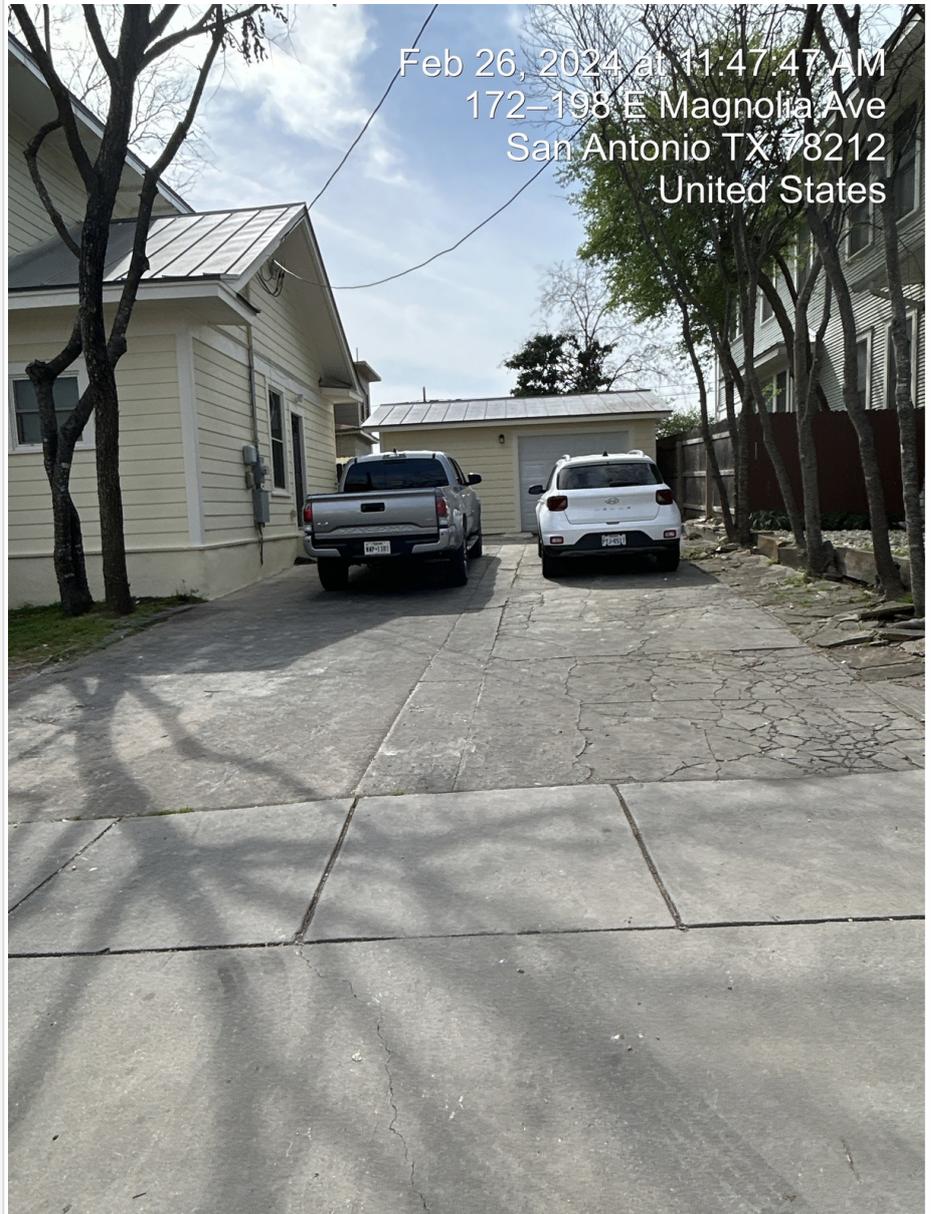
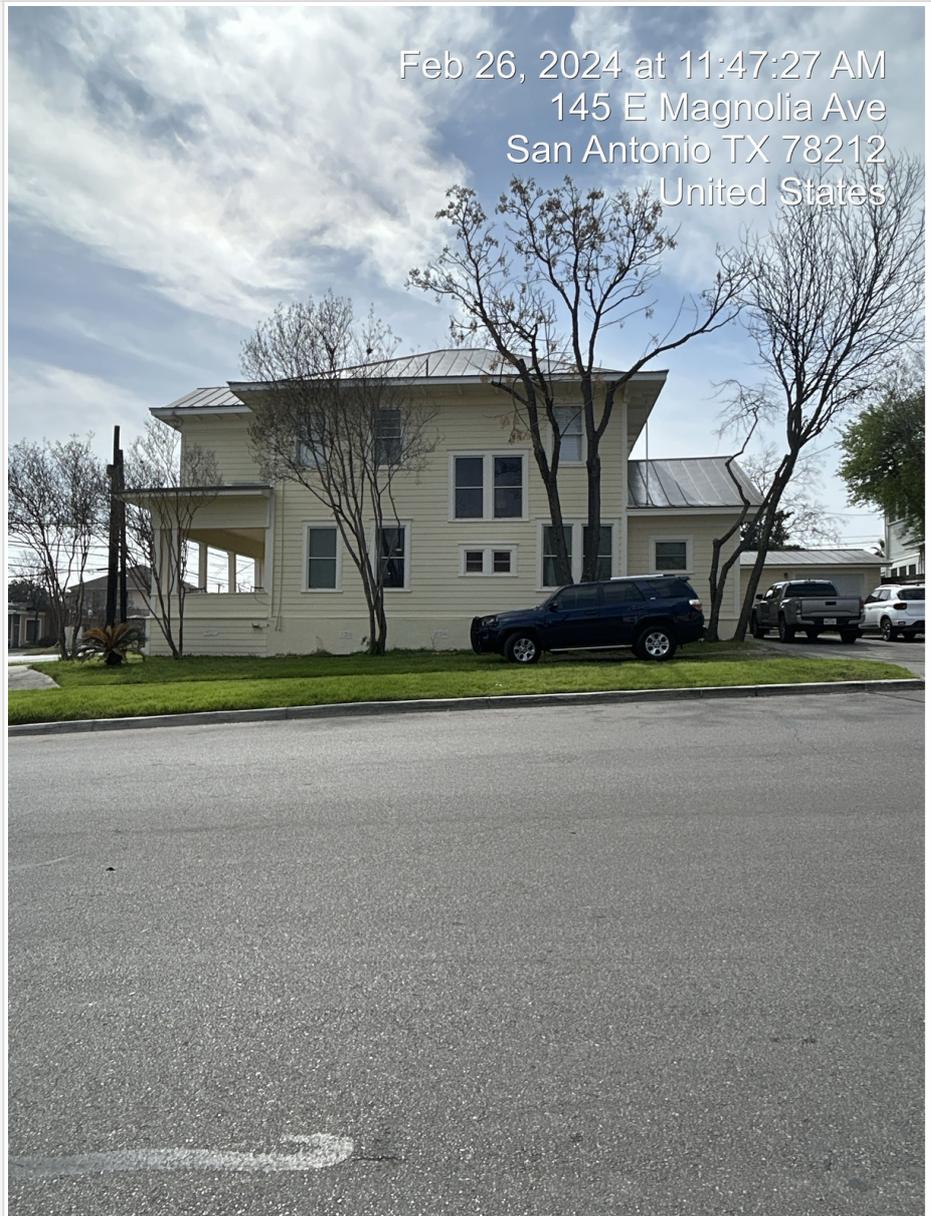
| Description of work | Wood window removal and infill |
| Description of interaction | Staff spoke with the property owner regarding the reported scope of work. The property owner stated she made the decision to remove windows on the north and south facade on the second floor sunroom and infill the openings without approval. Staff discussed the COA process and the CTAB process. The property owner stated she would apply for a COA regarding the infill. As of today, 3/4/2024, no application is on file. |
